**OCAS-DRI-FCW-18-03  
NEW CAR ASSESSMENT PROGRAM  
FORWARD COLLISION WARNING CONFIRMATION TEST**

**2018 Hyundai Sonata**

**Final Report**

1. Report No. OCAS-DRI-FCW-18-03	2. Government Accession No.	3. Recipient's Catalog No.	
4. Title and Subtitle Final Report of Forward Collision Warning Testing of a 2018 Hyundai Sonata.		5. Report Date 11 June 2018

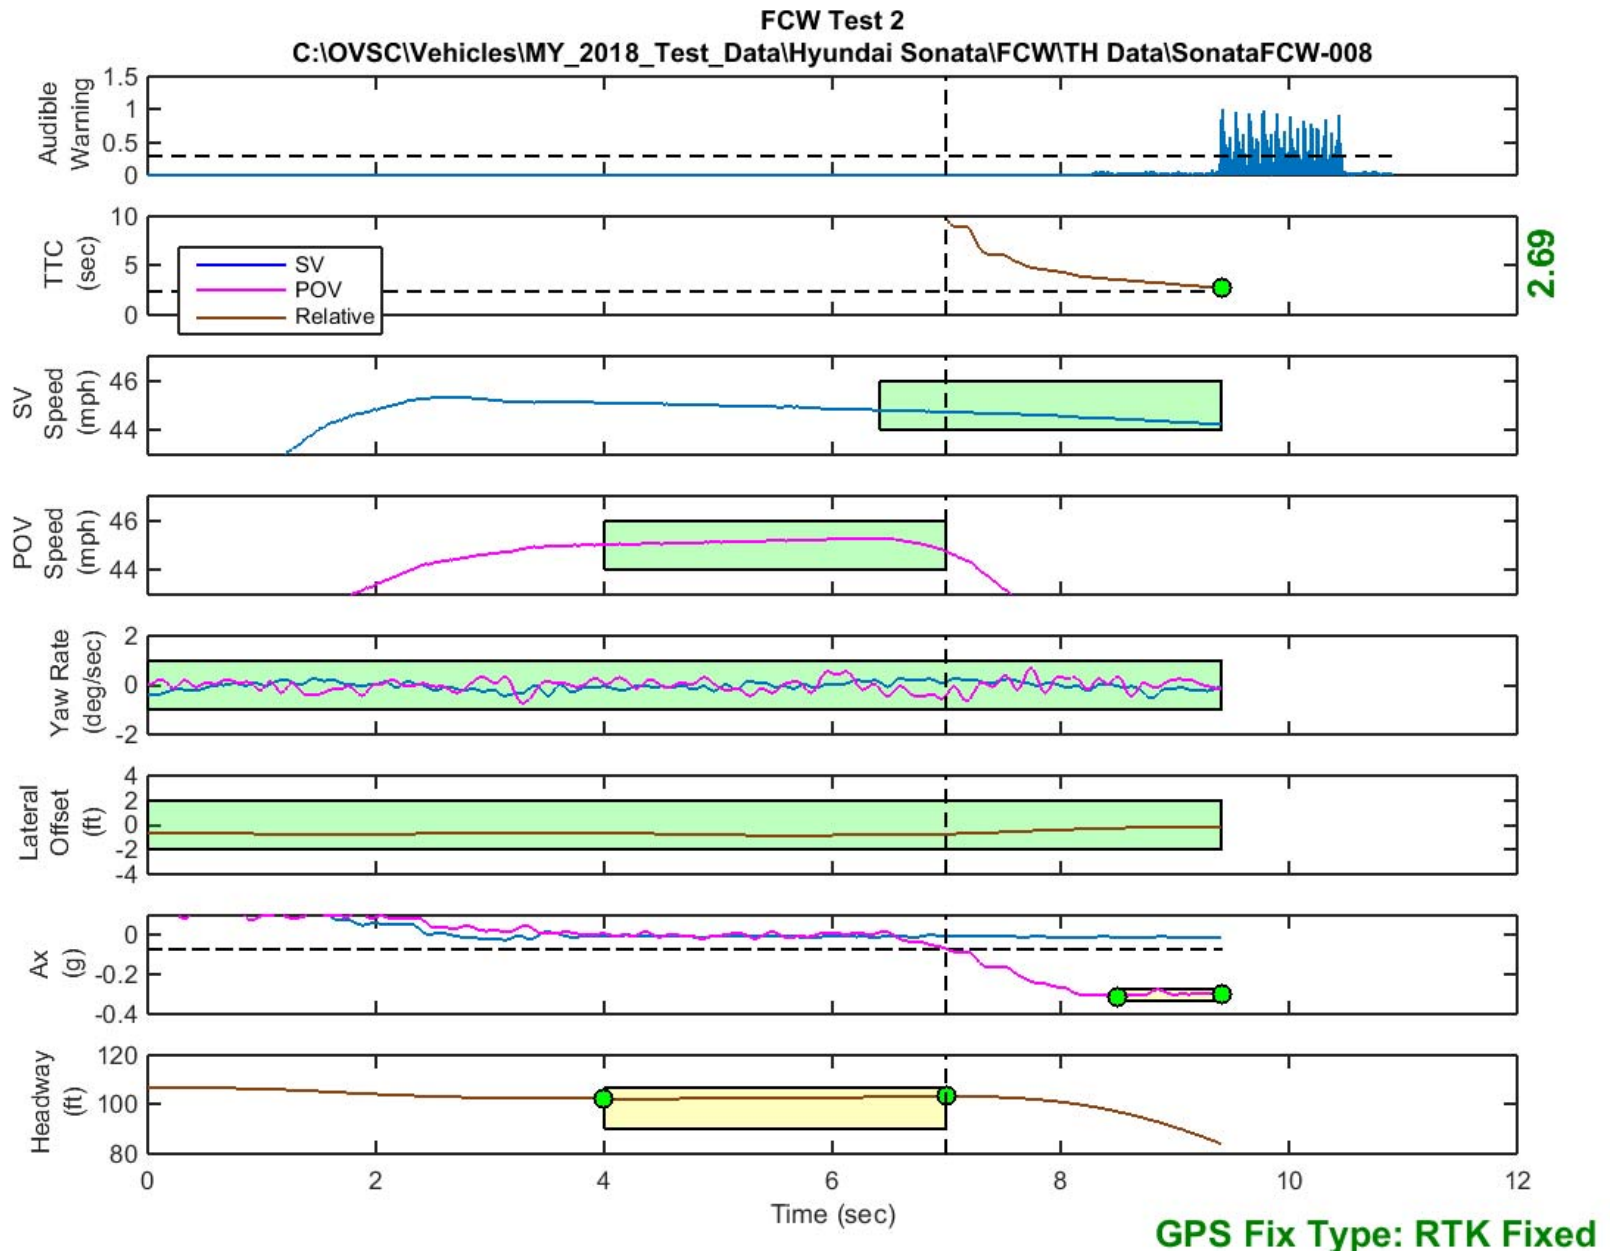
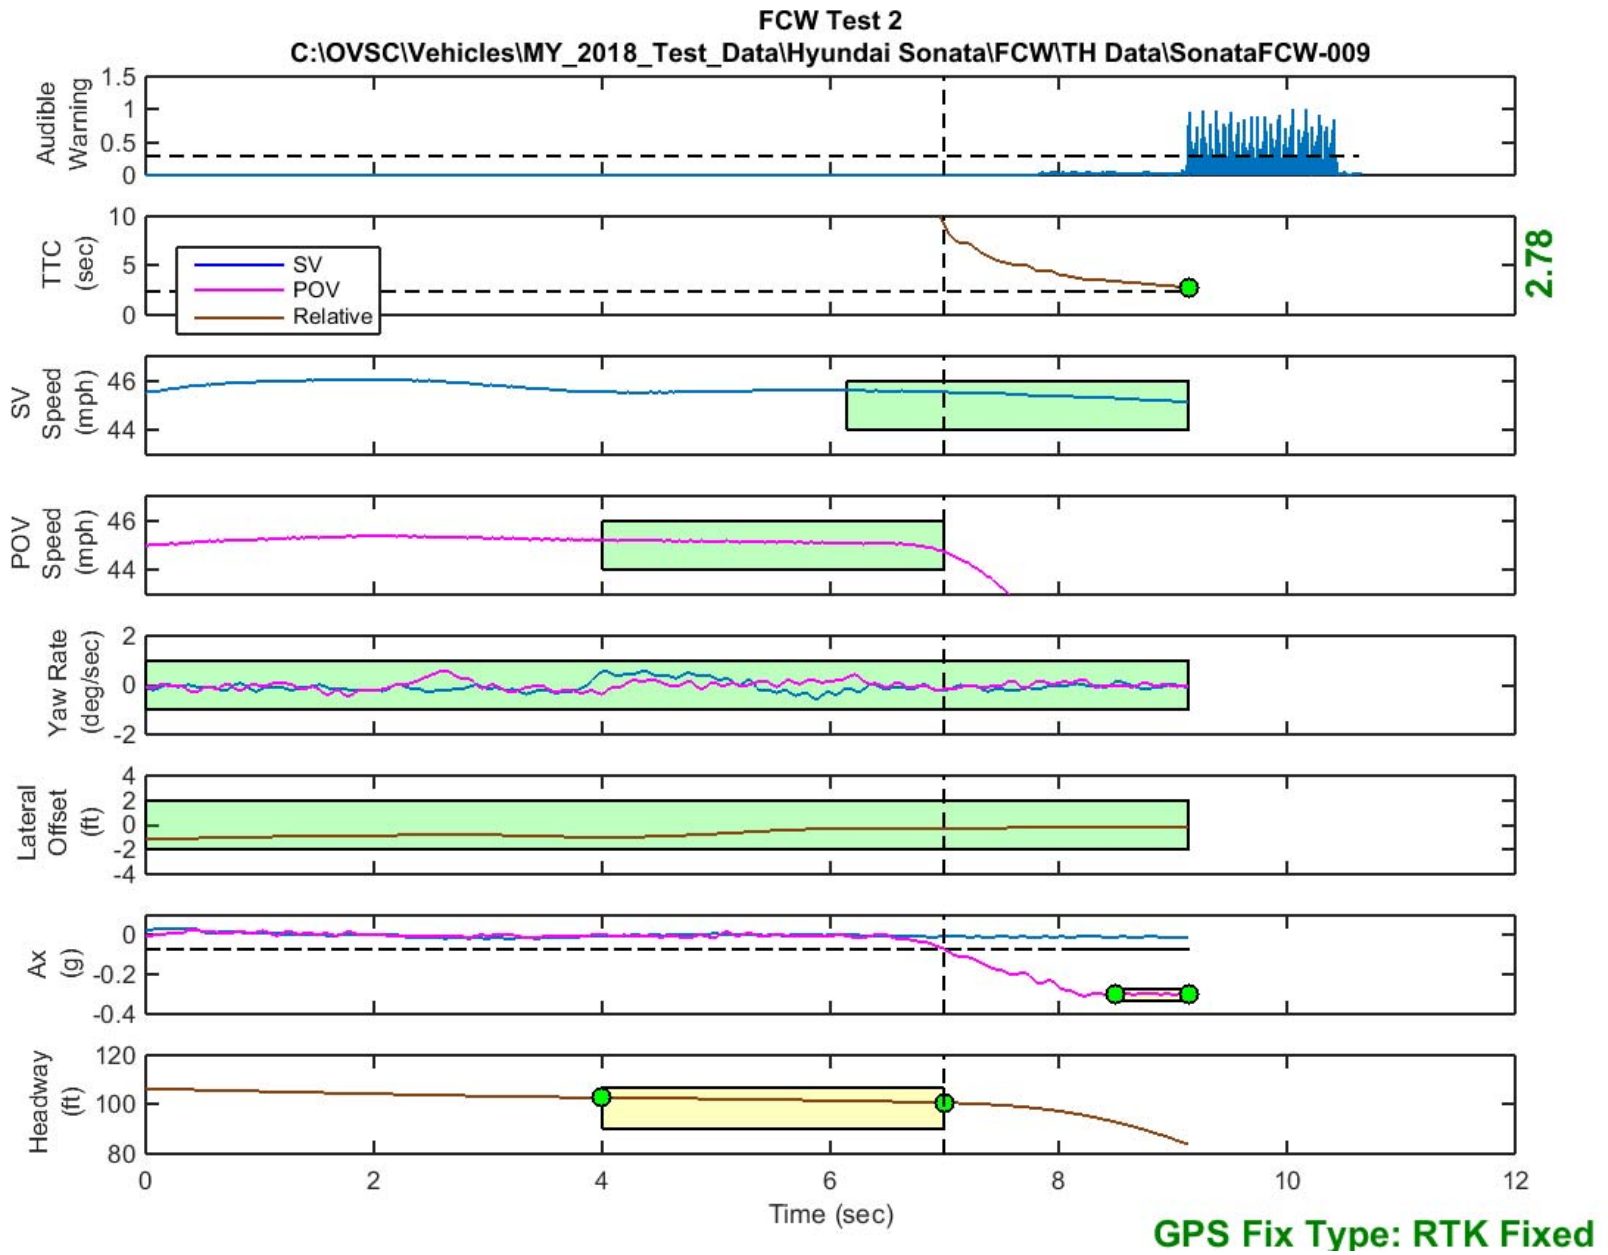
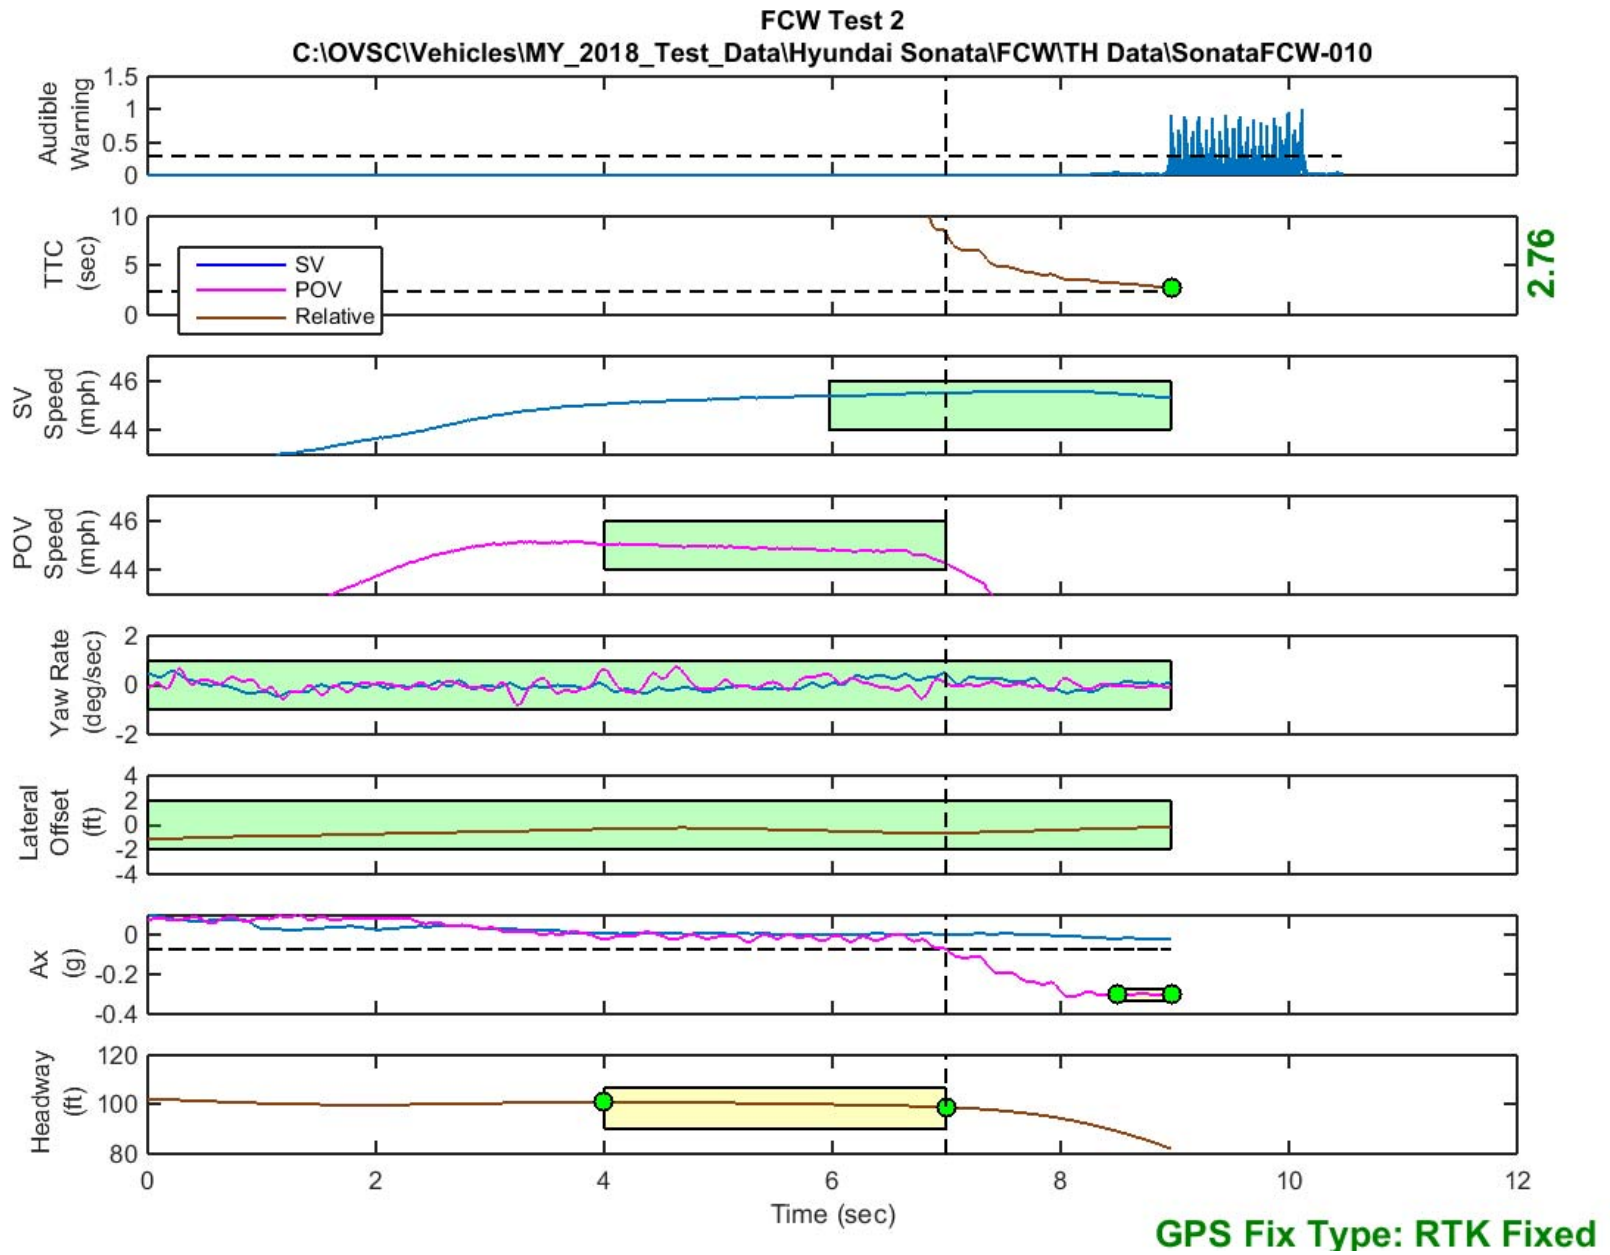
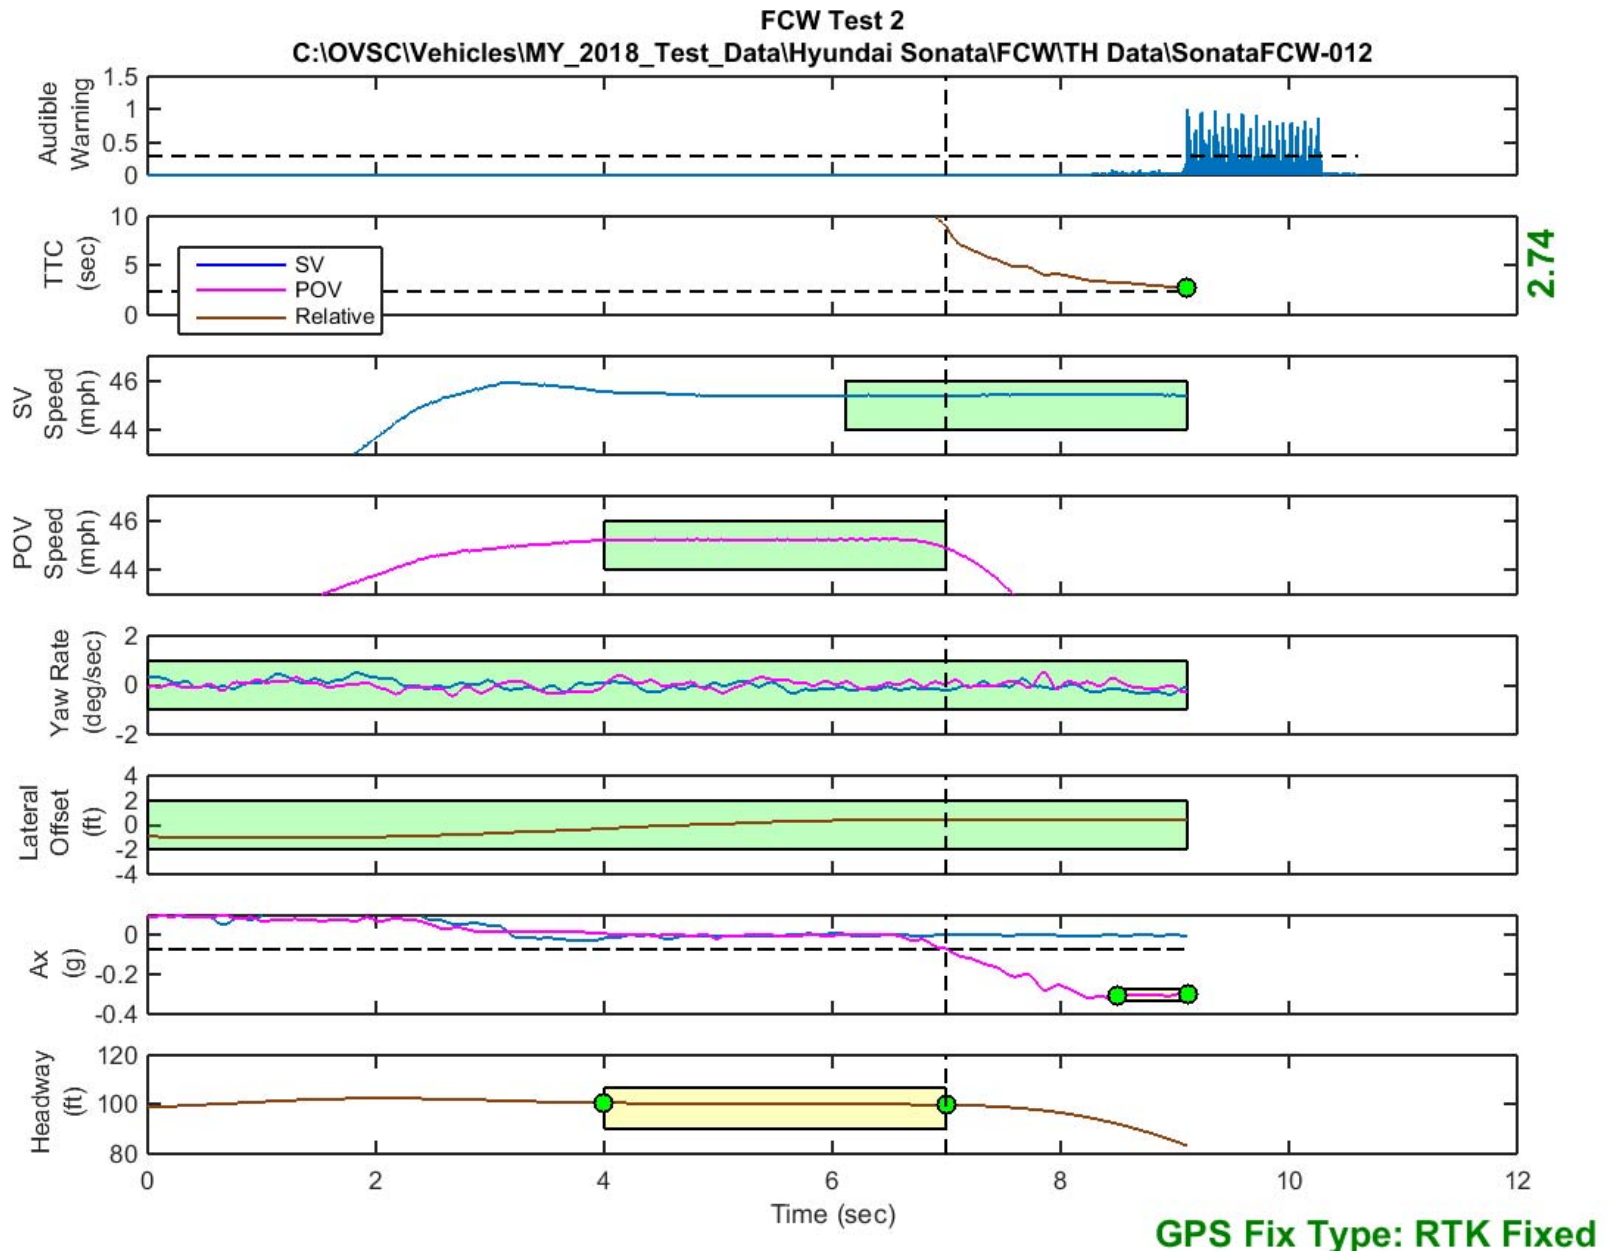
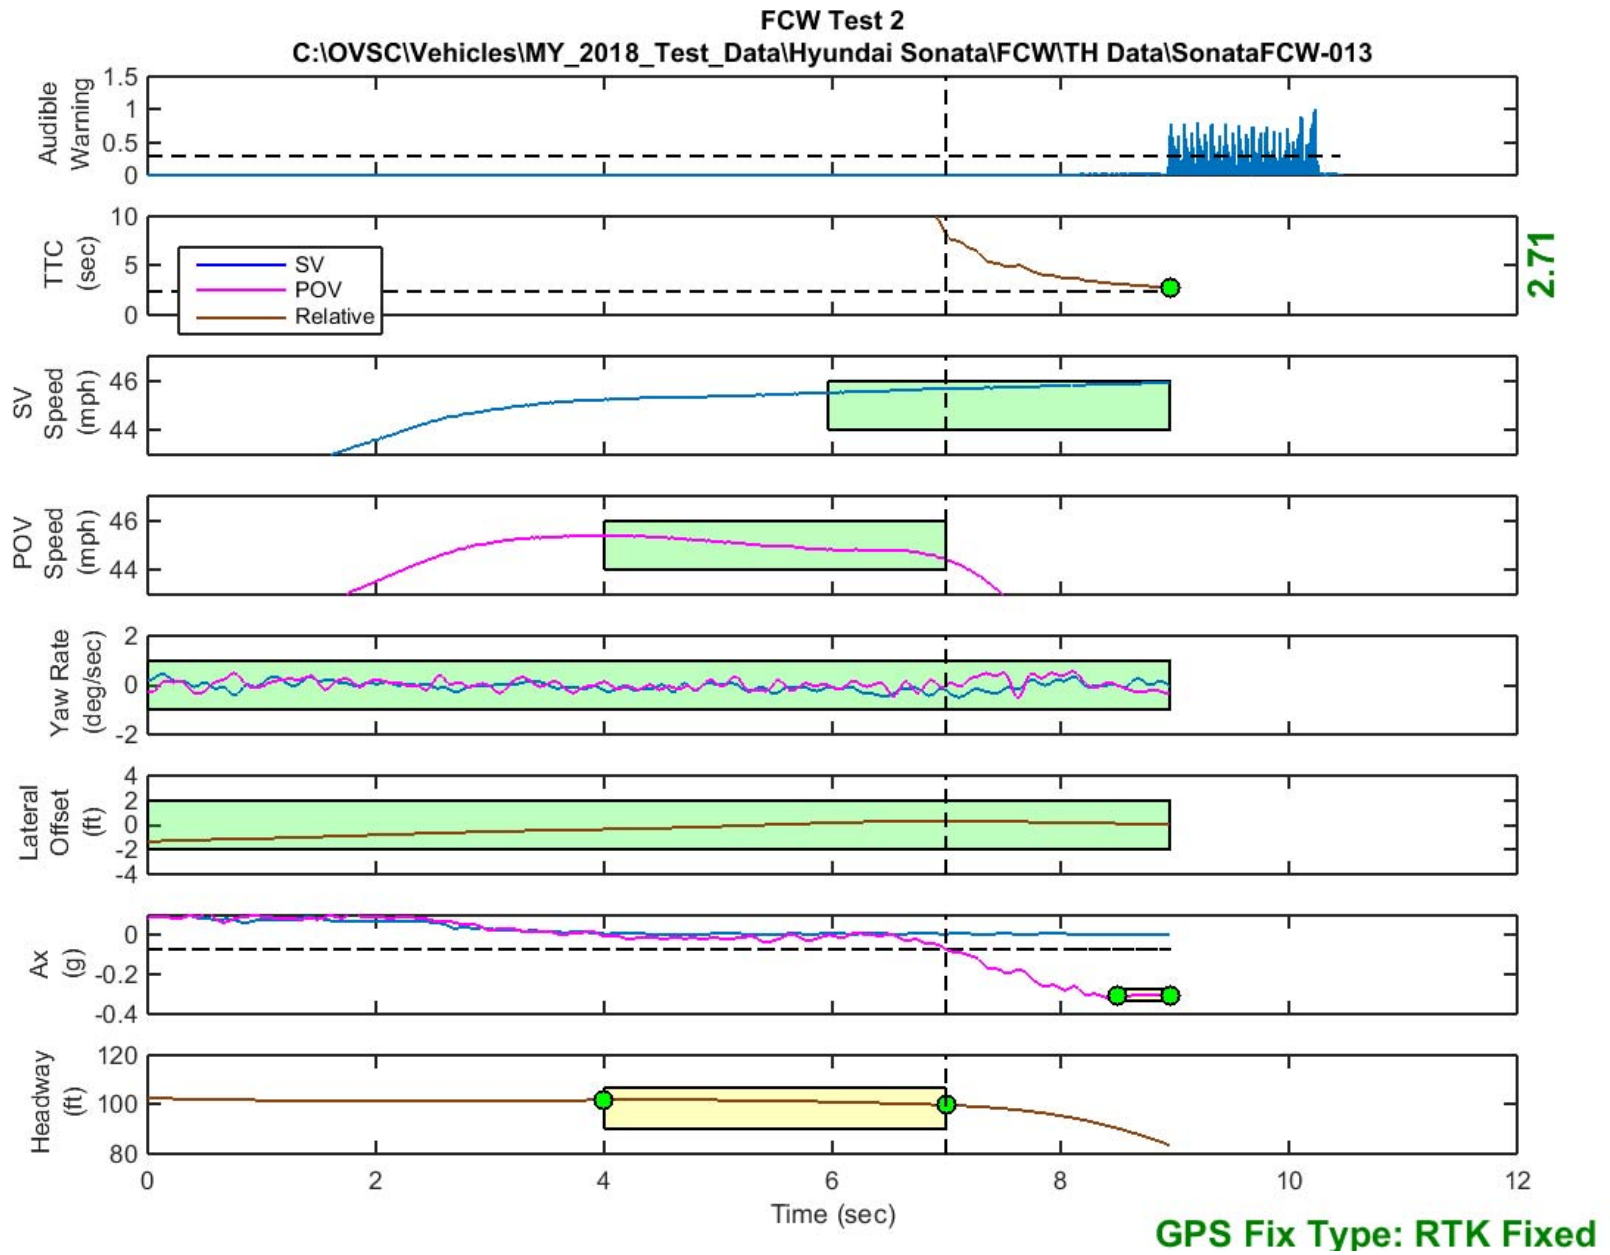
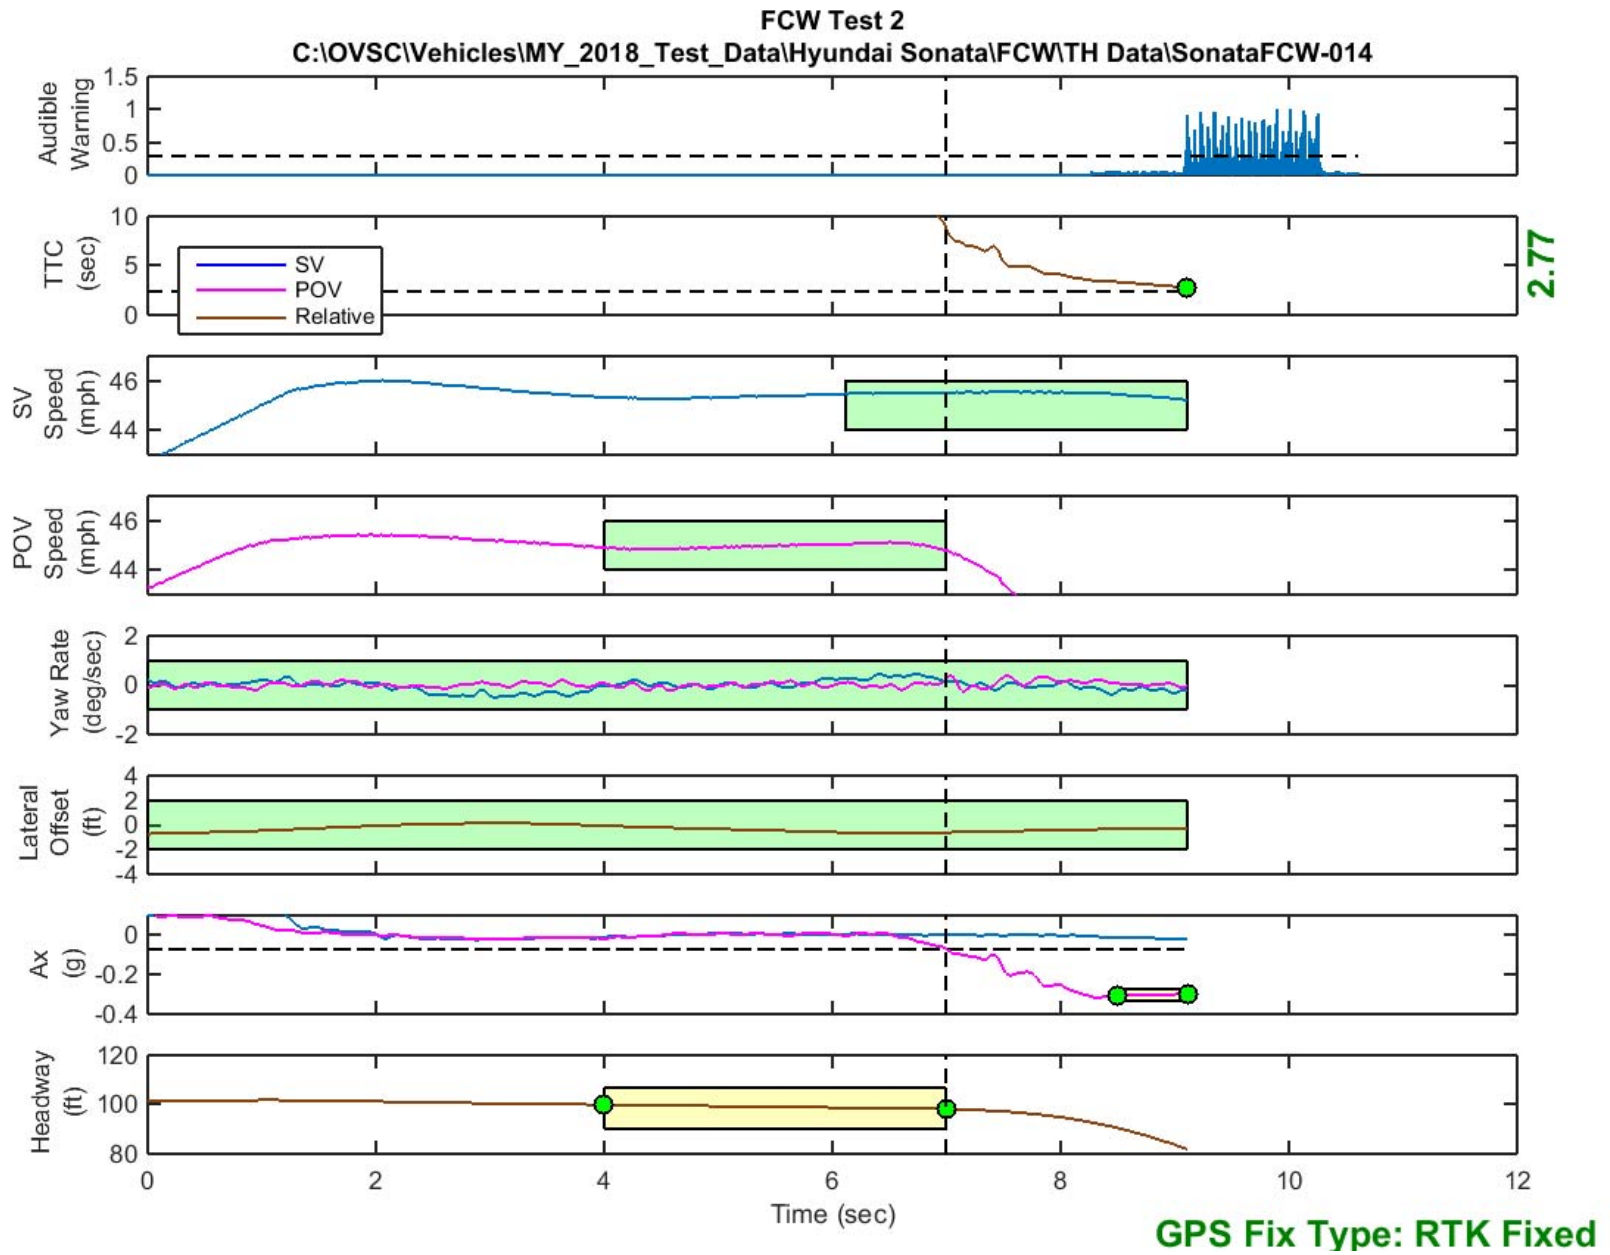
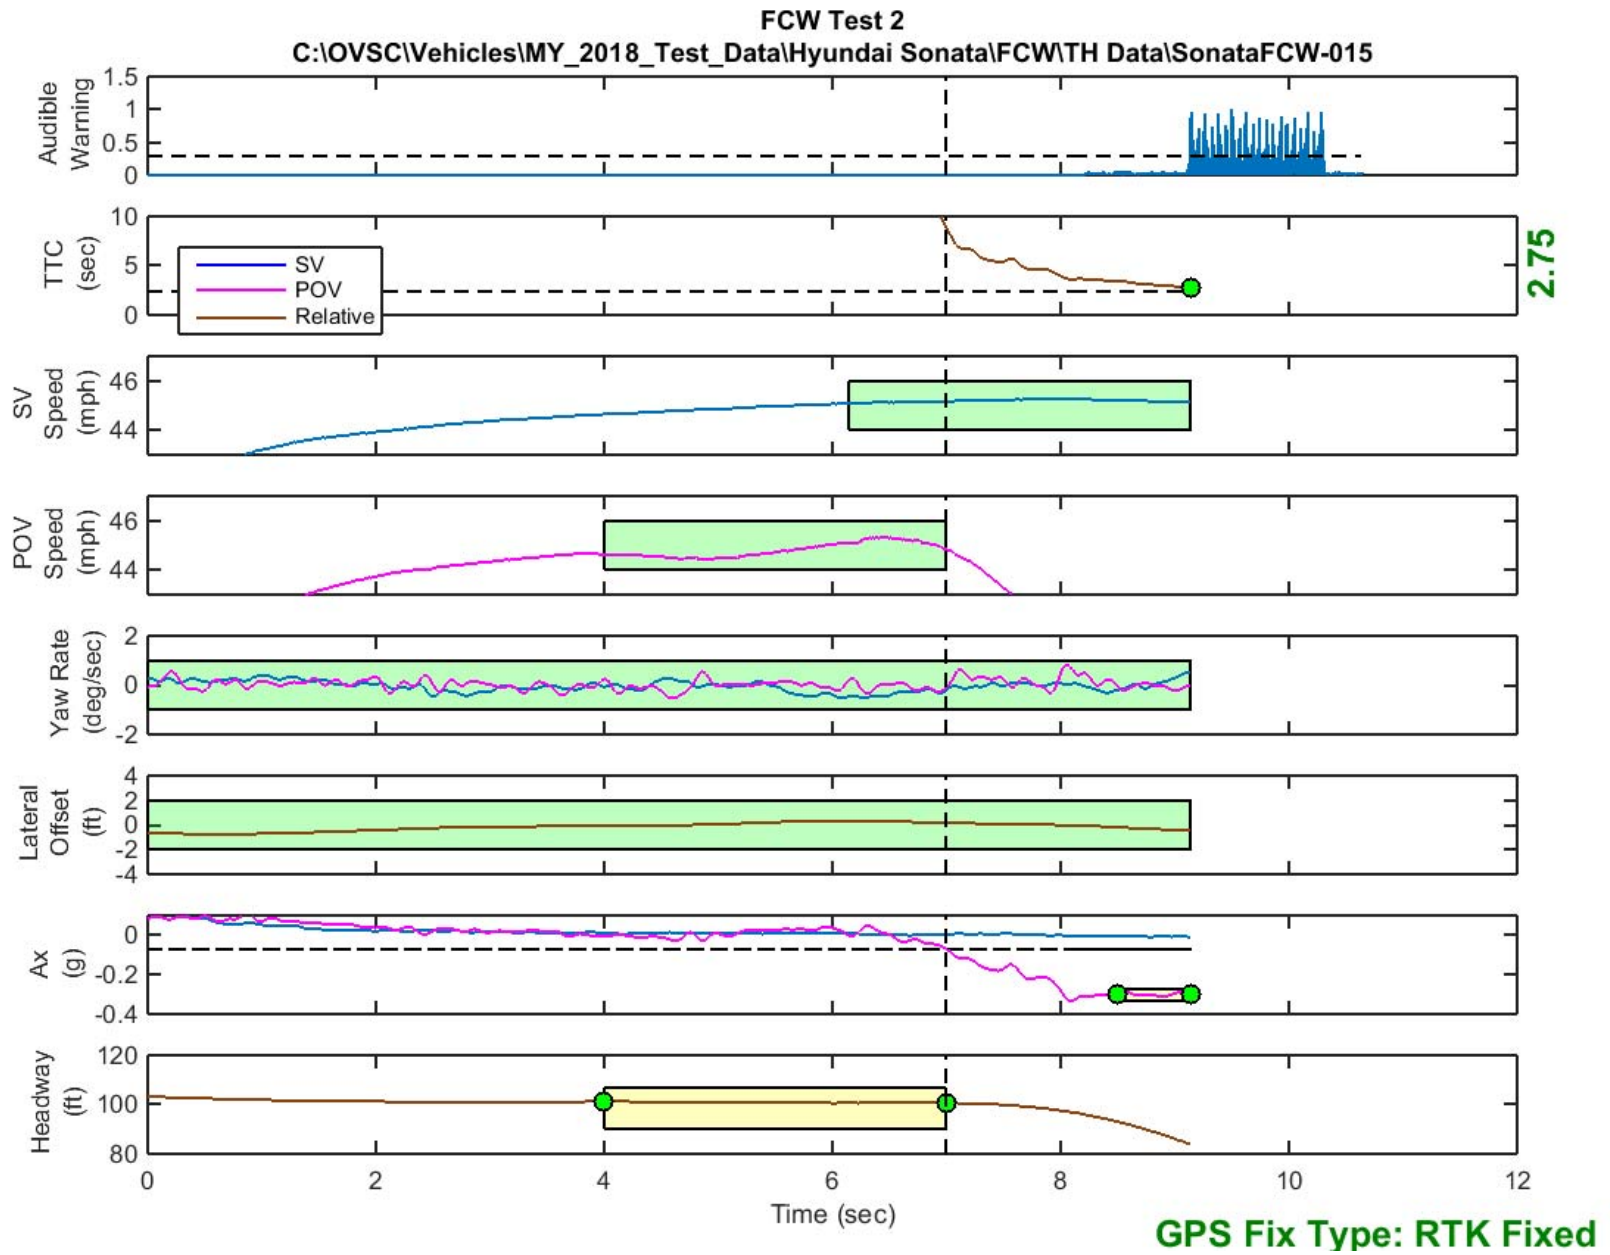
Figure D12. Time History for Run 8, FCW Test 2, Audible Warning

Figure D13. Time History for Run 9, FCW Test 2, Audible Warning

Figure D14. Time History for Run 10, FCW Test 2, Audible Warning

Figure D15. Time History for Run 12, FCW Test 2, Audible Warning

Figure D16. Time History for Run 13, FCW Test 2, Audible Warning

Figure D17. Time History for Run 14, FCW Test 2, Audible Warning

Figure D18. Time History for Run 15, FCW Test 2, Audible Warning
