**OCAS-DRI-FCW-18-03  
NEW CAR ASSESSMENT PROGRAM  
FORWARD COLLISION WARNING CONFIRMATION TEST**

**2018 Hyundai Sonata**

**Final Report**

1. Report No. OCAS-DRI-FCW-18-03	2. Government Accession No.	3. Recipient's Catalog No.	
4. Title and Subtitle Final Report of Forward Collision Warning Testing of a 2018 Hyundai Sonata.		5. Report Date 11 June 2018

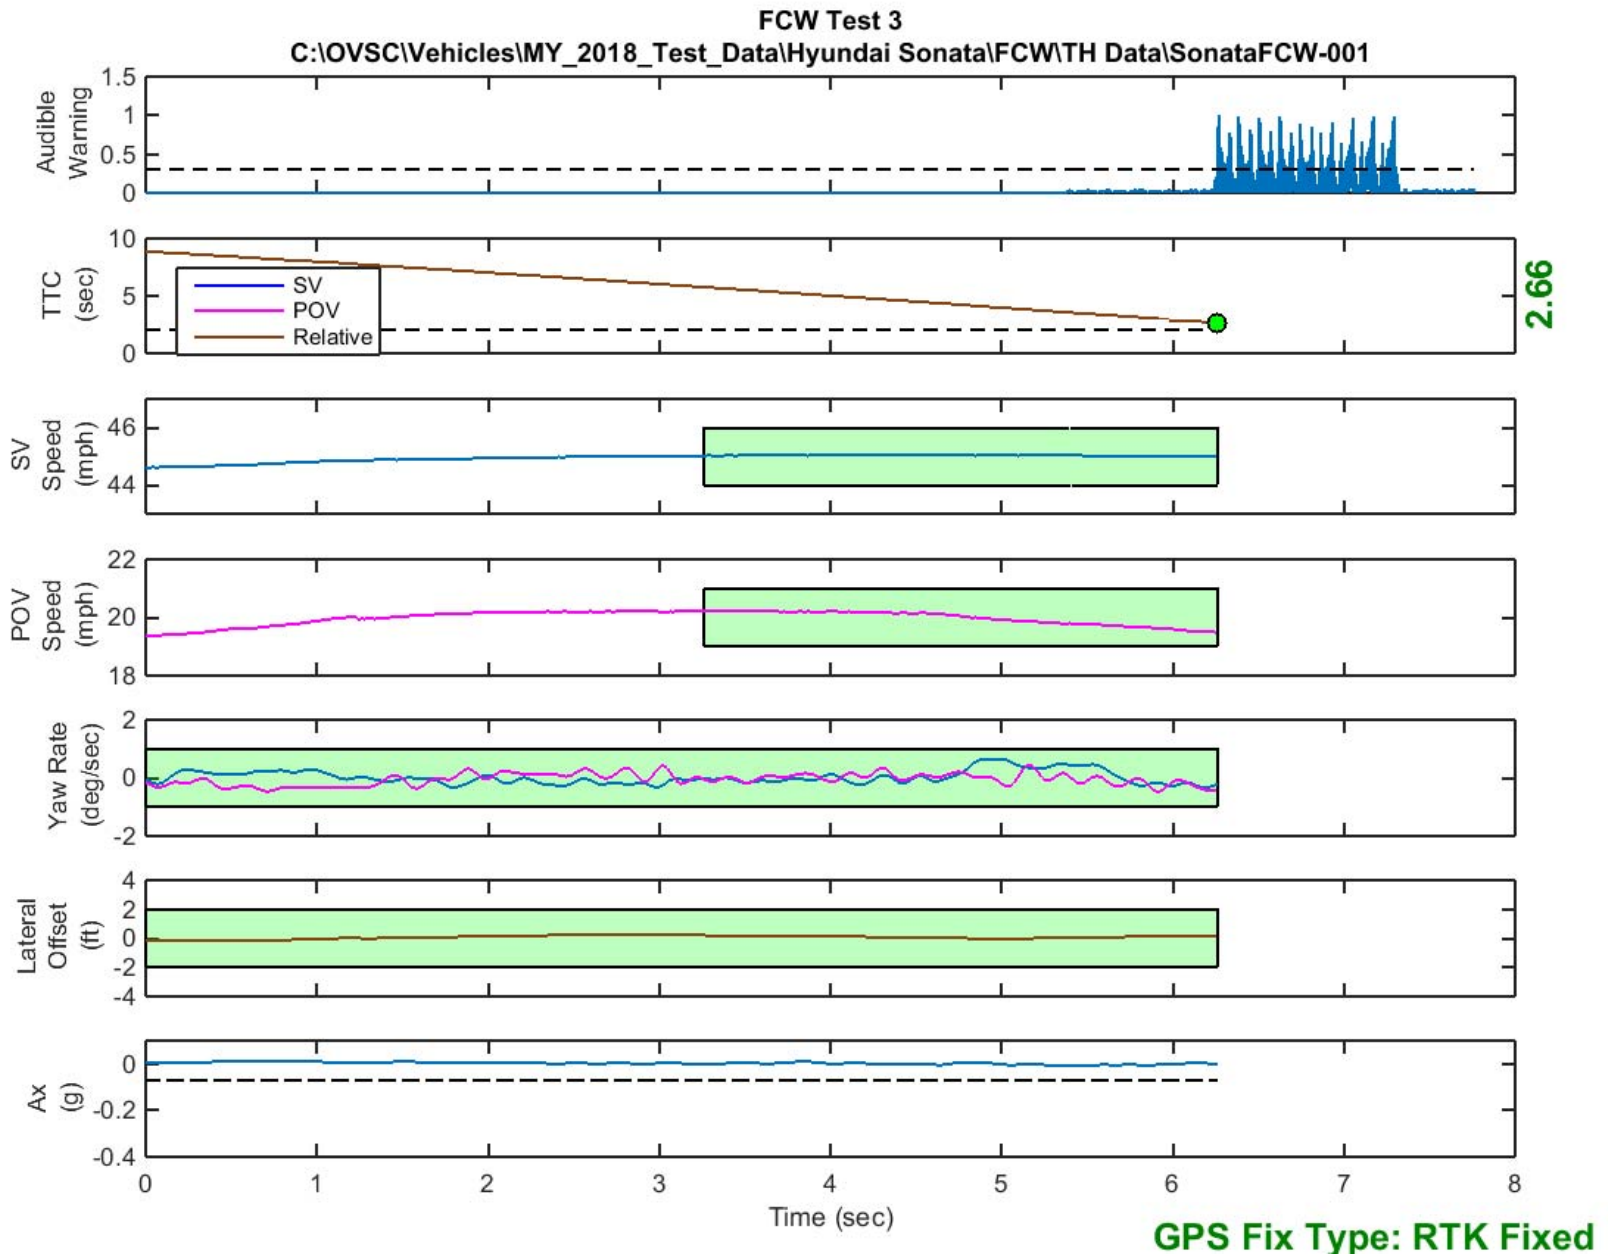
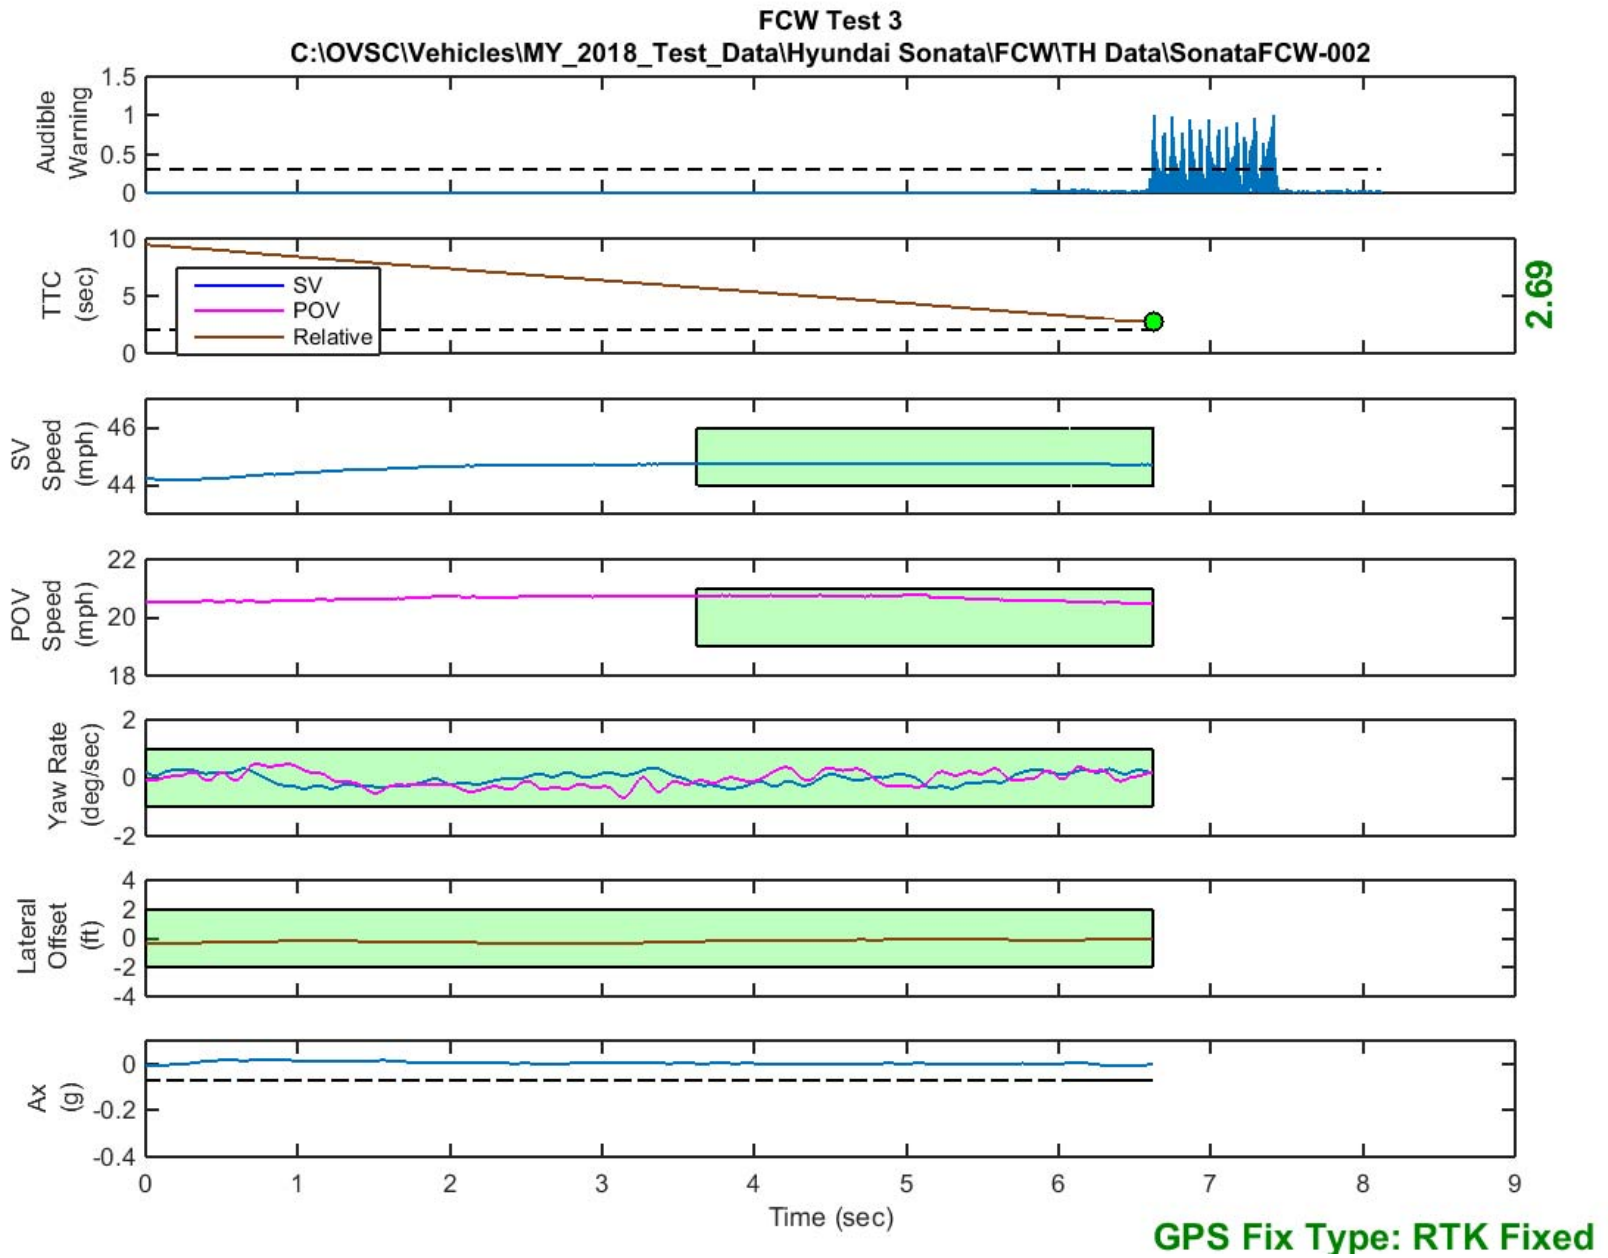
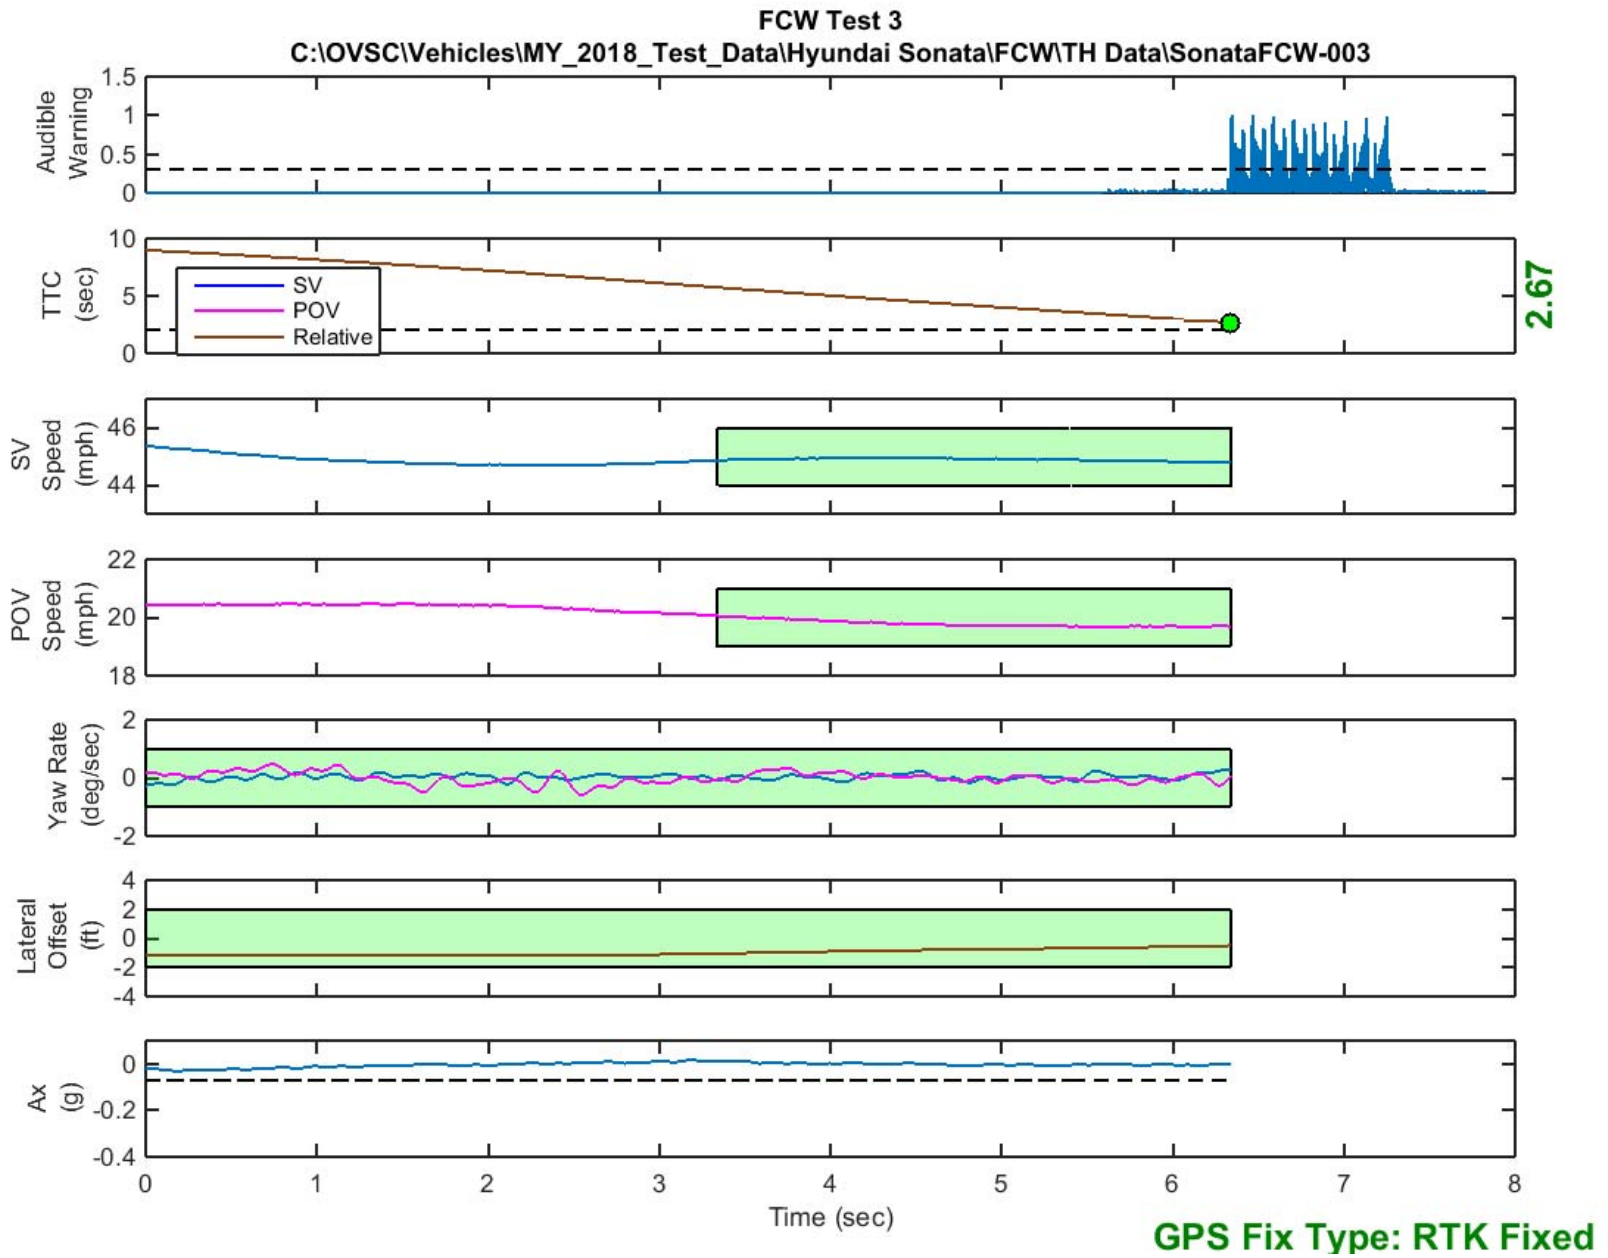
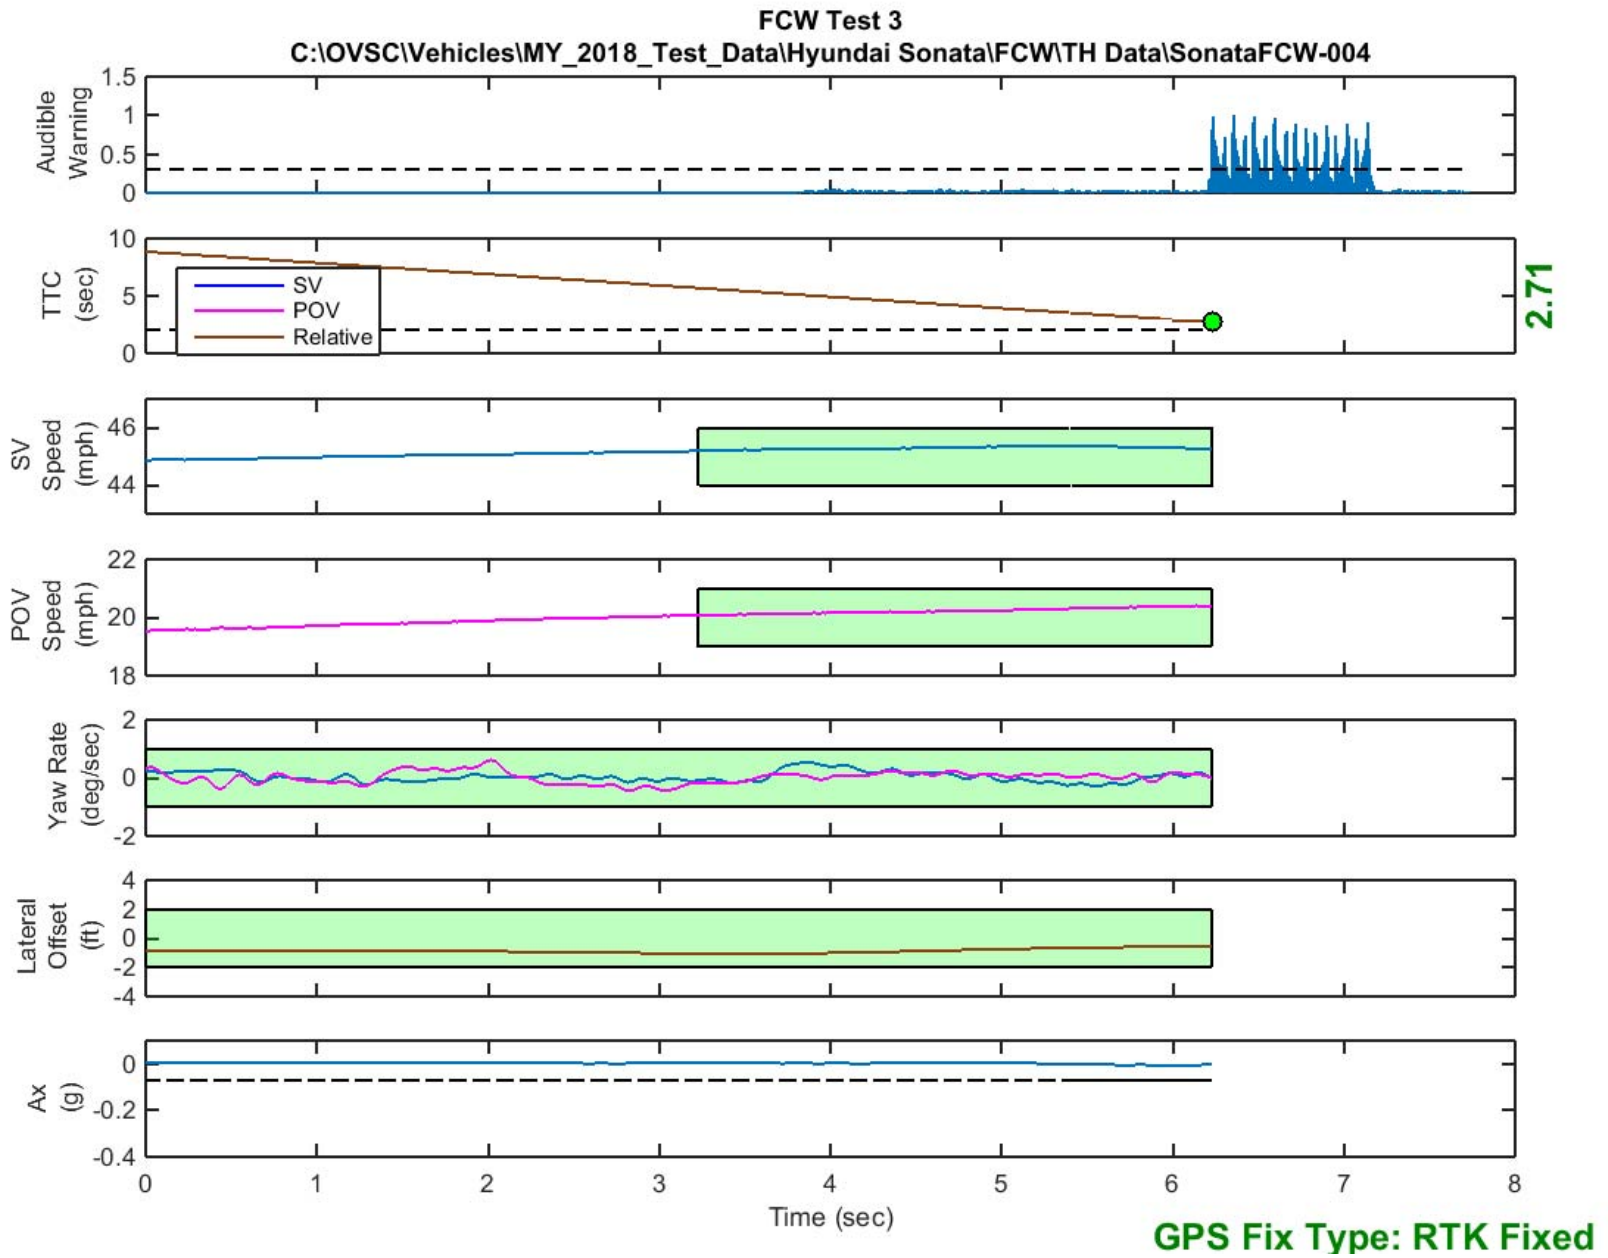
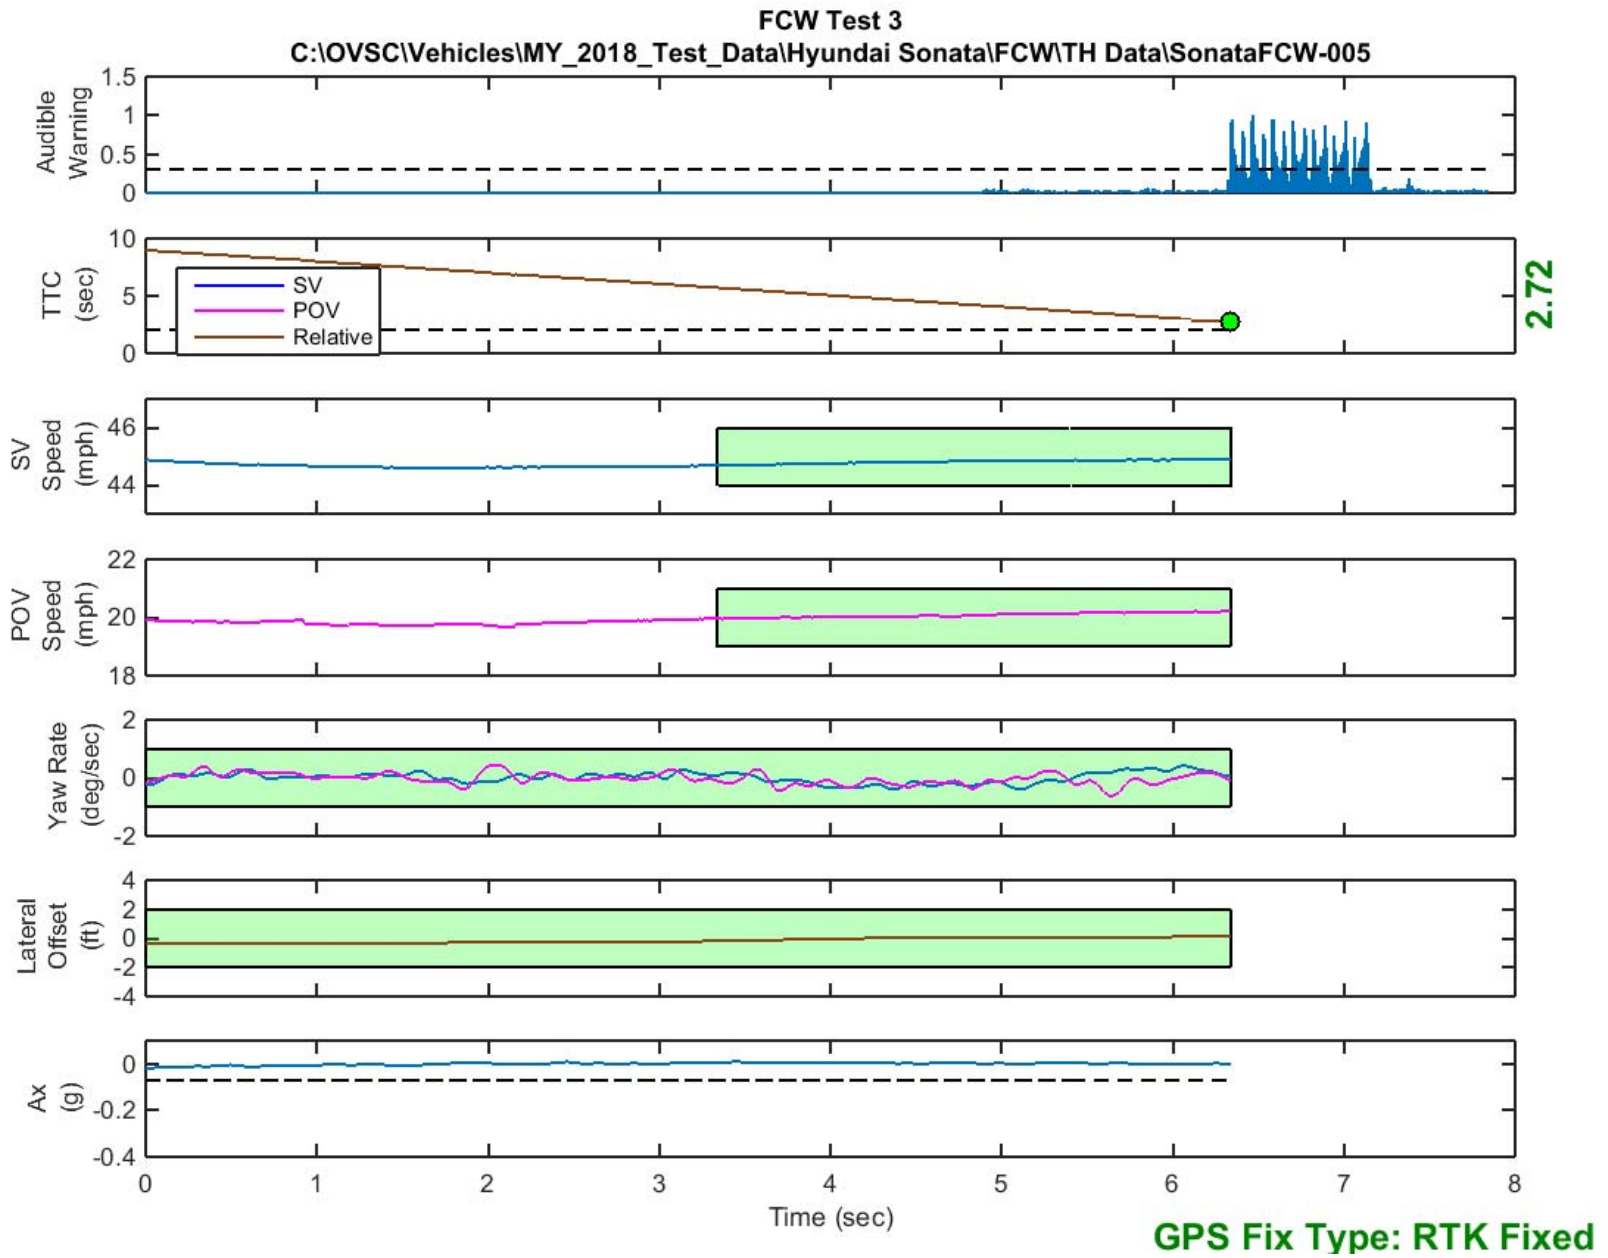
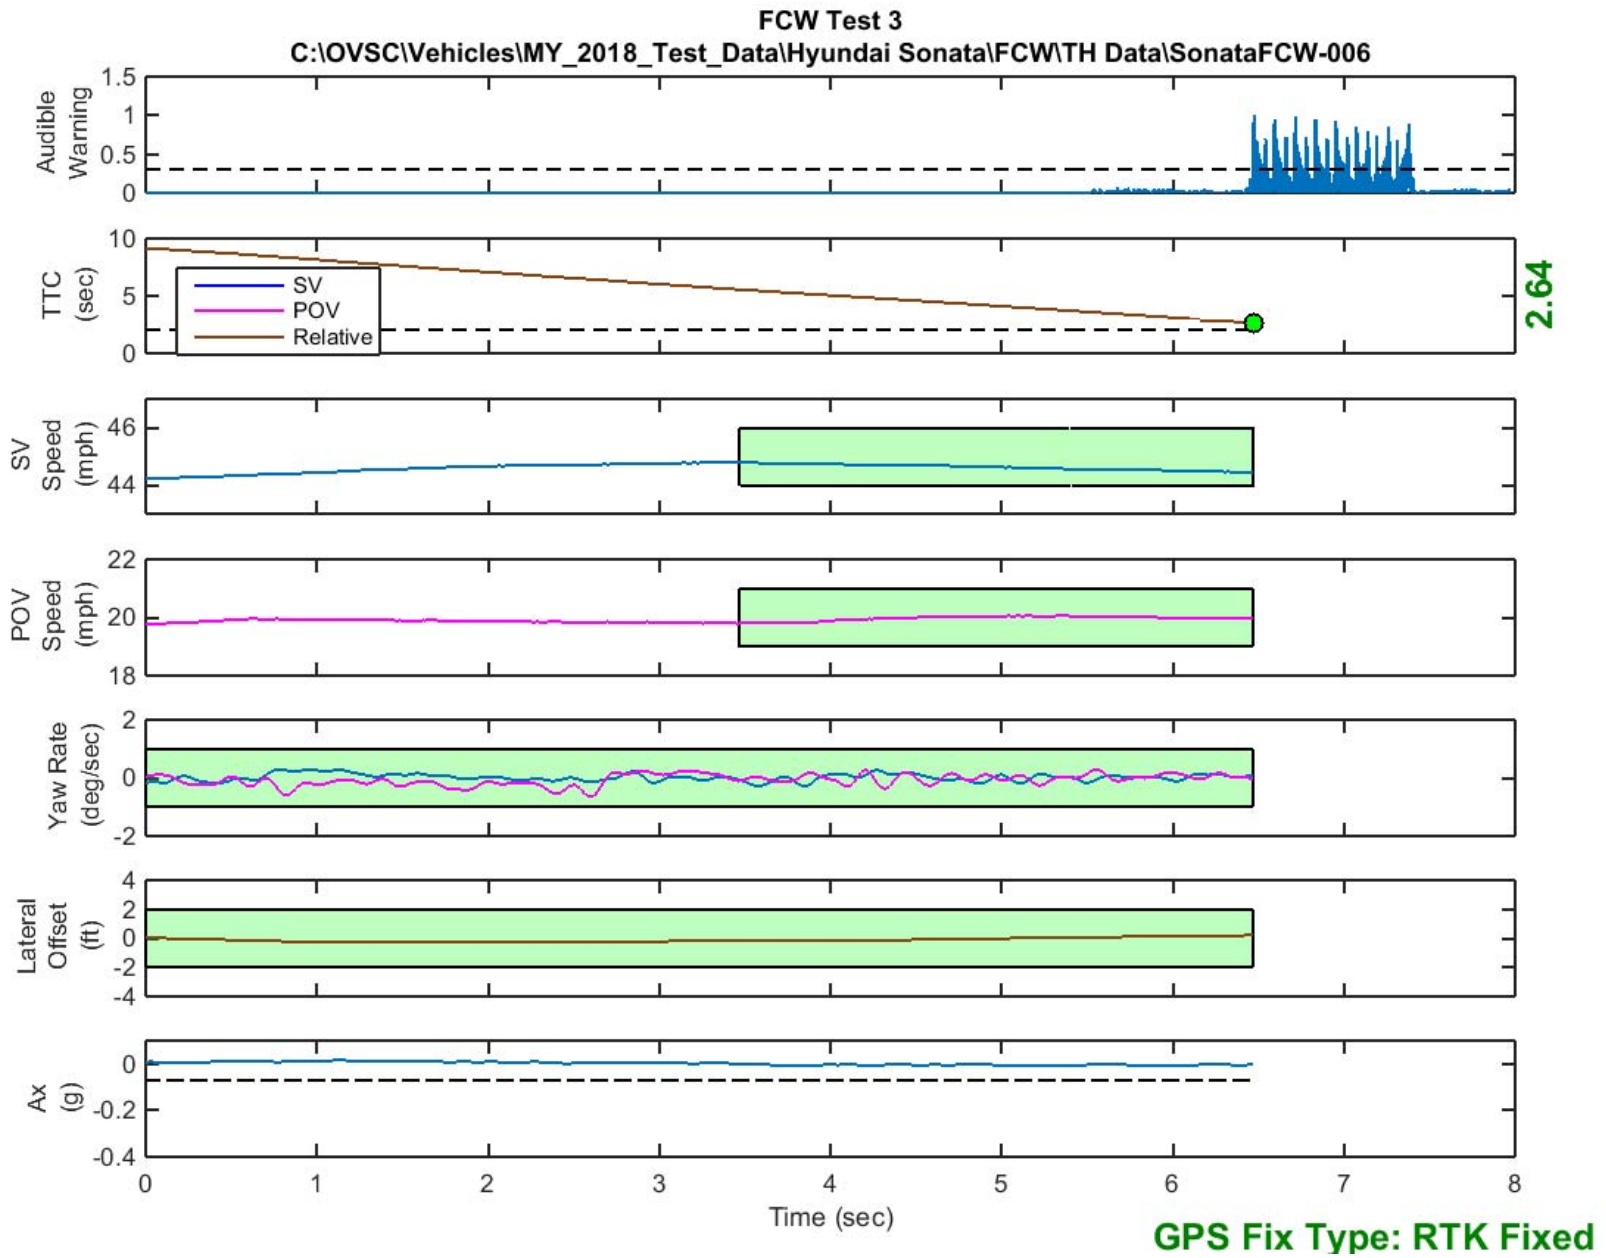
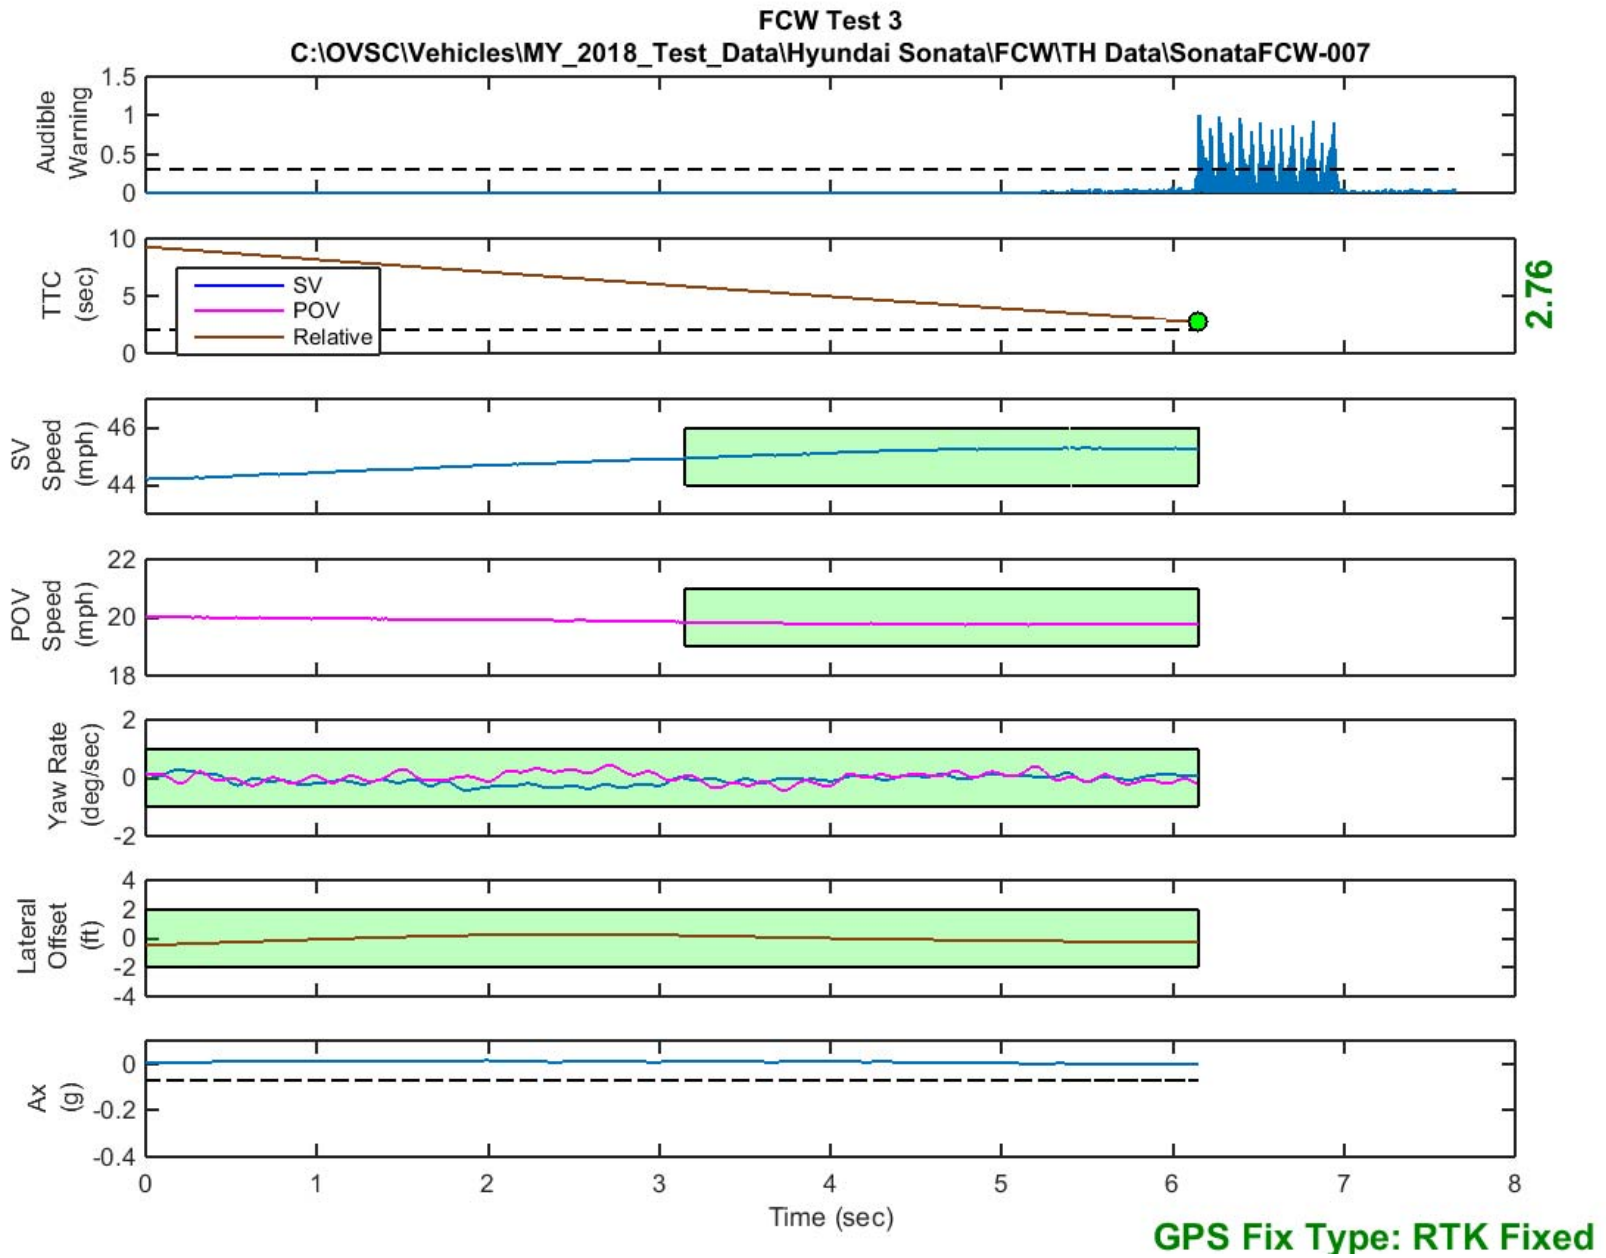
Figure D19. Time History for Run 1, FCW Test 3, Audible Warning

Figure D20. Time History for Run 2, FCW Test 3, Audible Warning

Figure D21. Time History for Run 3, FCW Test 3, Audible Warning

Figure D22. Time History for Run 4, FCW Test 3, Audible Warning

Figure D23. Time History for Run 5, FCW Test 3, Audible Warning

Figure D24. Time History for Run 6, FCW Test 3, Audible Warning

Figure D25. Time History for Run 7, FCW Test 3, Audible Warning

Run	Test Type	Valid Run?	TTCW Sound (sec)	TTCW Light (sec)	TTCW Margin (sec)	Pass/Fail	Notes
1	<b>Slower POV, 45 vs 20</b>	Y	2.66		0.66	Pass	
2		Y	2.69		0.69	Pass	
3		Y	2.67		0.67	Pass	
4		Y	2.71		0.71	Pass	
5		Y	2.72		0.72	Pass	
6		Y	2.64		0.64	Pass	
7		Y	2.76		0.76	Pass	
8	<b>Braking POV, 45</b>	Y	2.69		0.29	Pass	
9		Y	2.78		0.38	Pass	
10		Y	2.76		0.36	Pass	
11		N					POV speed
12		Y	2.74		0.34	Pass	
13		Y	2.71		0.31	Pass	
14		Y	2.77		0.37	Pass	
15		Y	2.75		0.35	Pass
