REPORT NUMBER: NCAP-MGA-19-058

**NEW CAR ASSESSMENT PROGRAM (NCAP)
Frontal Barrier Impact Test**

**AUDI AG
2019 Audi Q3 45 TFSI quattro 5-Door SUV
NHTSA No.: Q20195803**

**MGA RESEARCH CORPORATION
5000 Warren Road
Burlington, WI 53105**

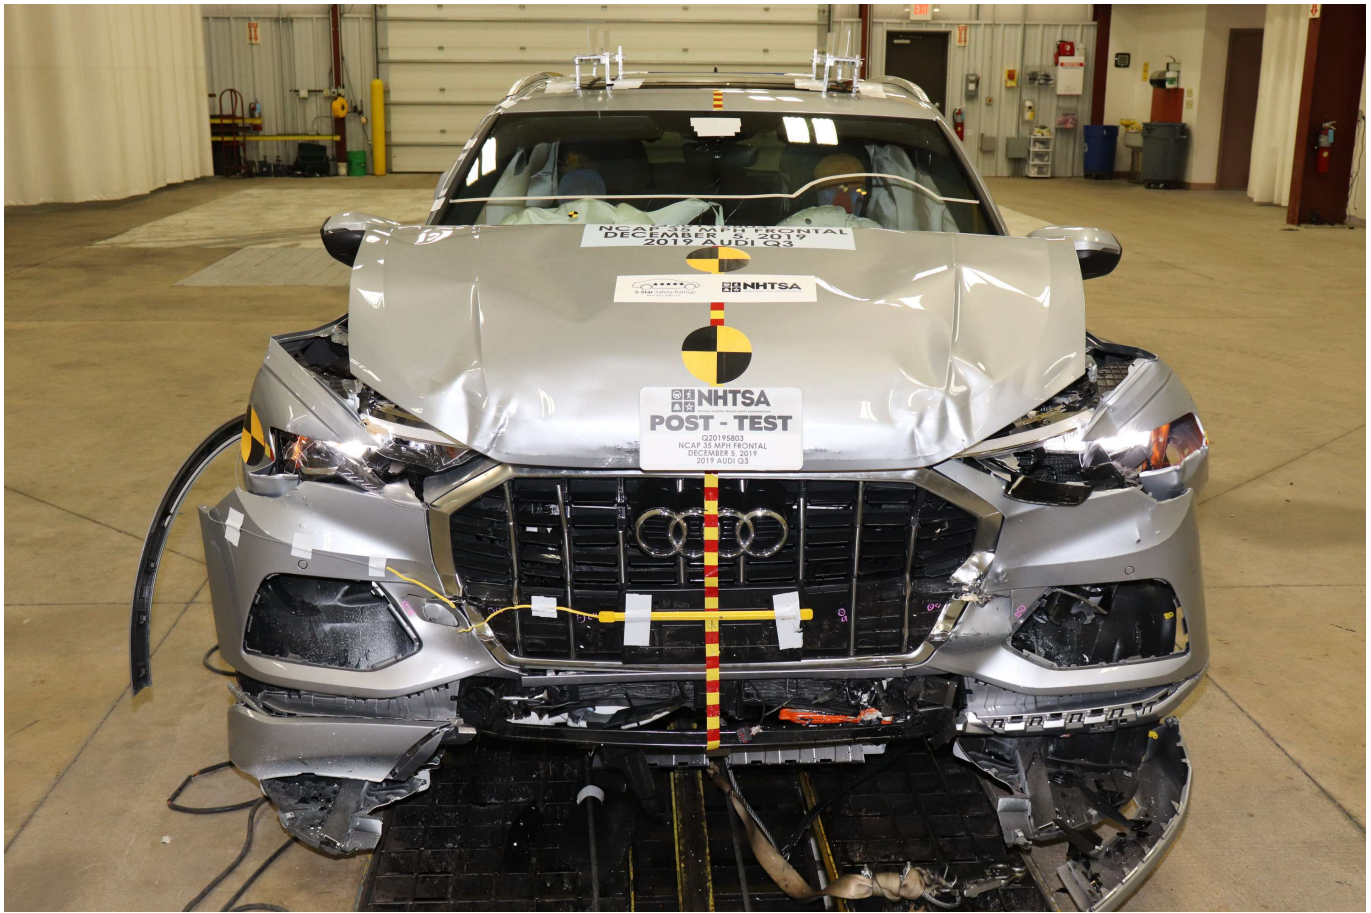
Photo No. 009 - Post-Test Front View of Test Vehicle

The maximum static crush of the vehicle was 440 mm located at the vehicle centerline and both the driver and passenger side doors remained closed during the impact event and were operable after the impact.

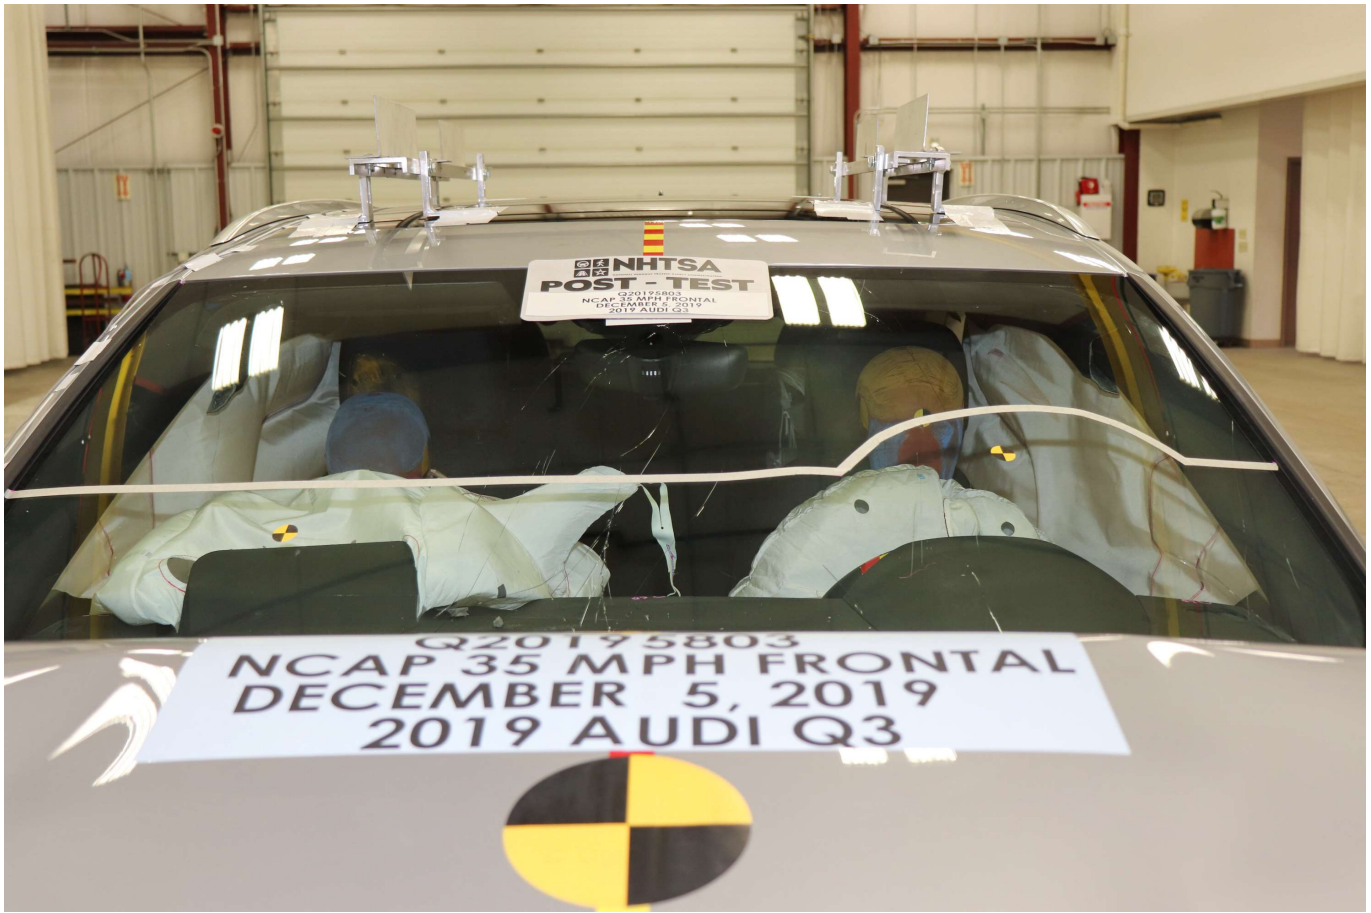
Photo No. 019 - Post-Test Windshield View

Critical Areas of Performance	Observations and Conclusions
Windshield Damage	Cracked
Window Damage	None
Other Notable Effects	None

There was 100 percent windshield retention and no intrusion into the protected zone of the windshield during the event. There was no Stoddard Solvent leakage after the event or during any phase of the static rollover.

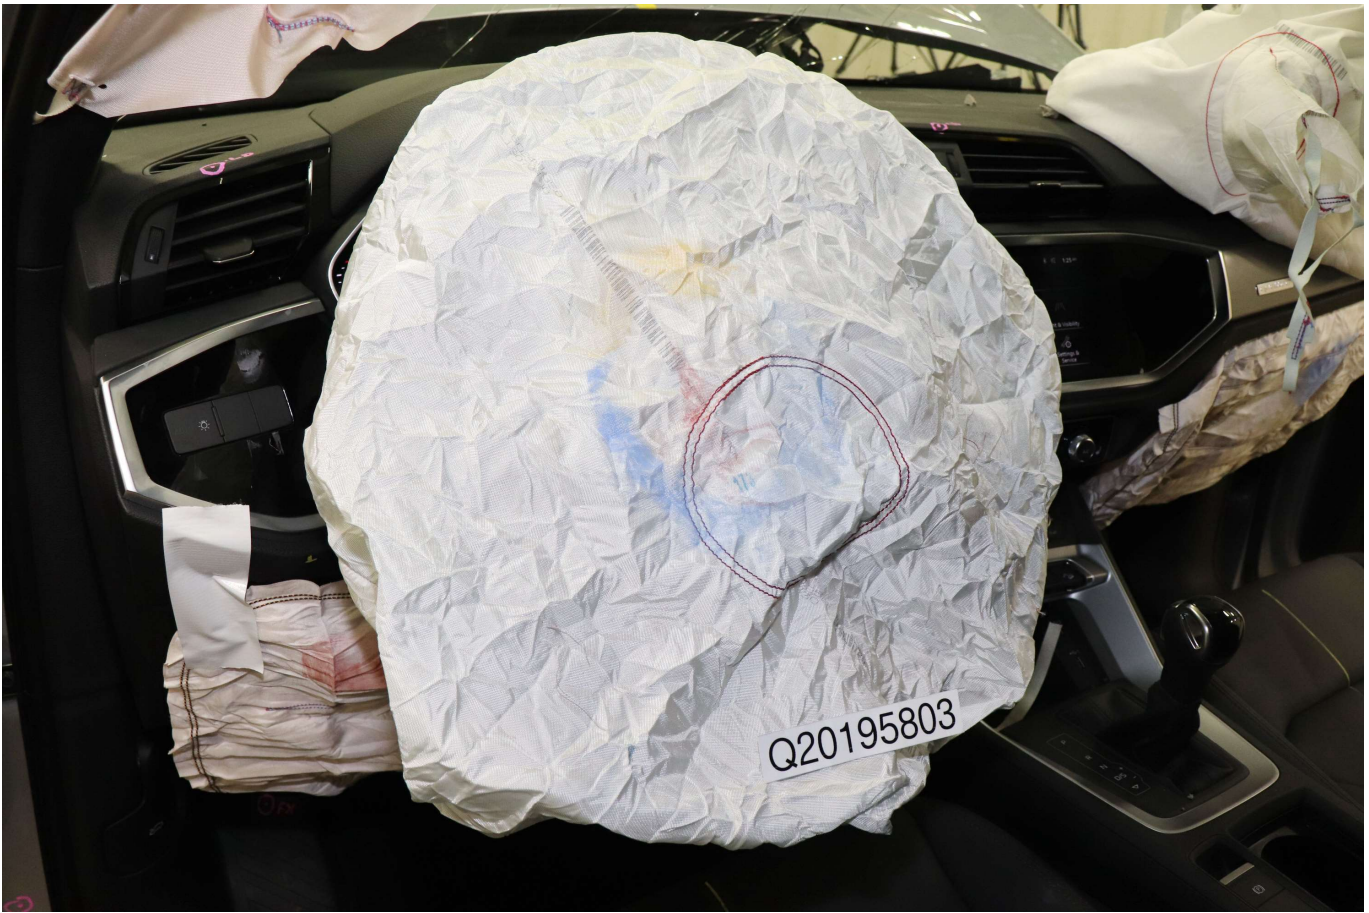
Photo No. 049 - Post-Test Driver Dummy Contact with Airbag

The driver's visible contact points were as follows: The driver's head contacted the airbag. The driver's head also contacted the headrest. The driver's knees contacted the knee airbag.

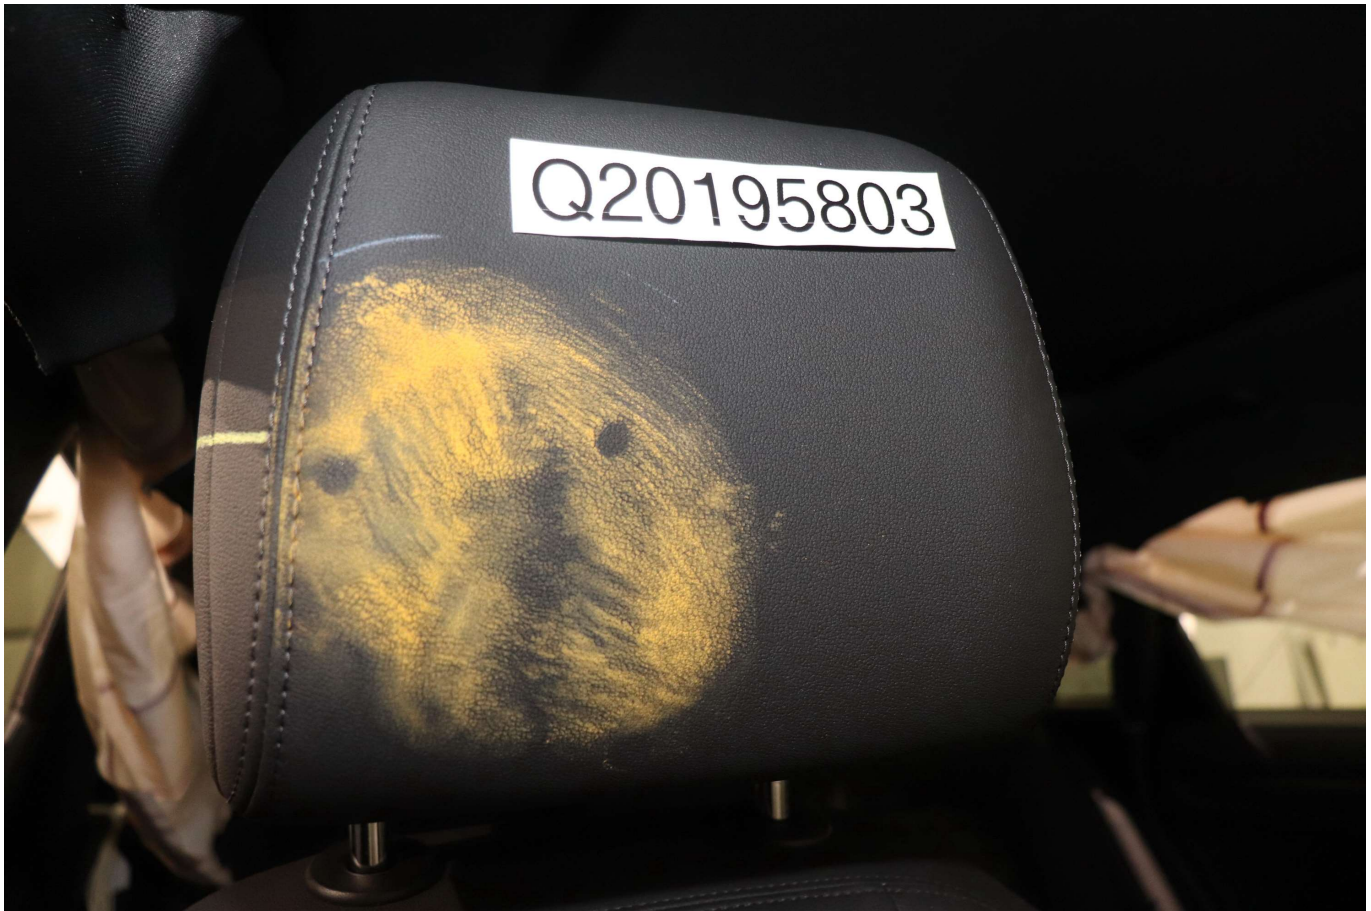
Photo No. 073 - Post-Test Passenger Dummy Contact with Headrest

The passenger's visible contact points were as follows: The passenger's head contacted the airbag. The passenger's head also contacted the headrest. The passenger's knees contacted the knee airbag.
