**REPORT NUMBER: SPNCAP-MGA-20-003**

**NEW CAR ASSESSMENT PROGRAM (NCAP)  
Side Impact Pole Test**

**KIA MOTORS MANUFACTURING GEORGIA, INC.  
2020 Kia Telluride EX 5-Door SUV  
NHTSA No.: M20204219**

**FINAL REPORT**

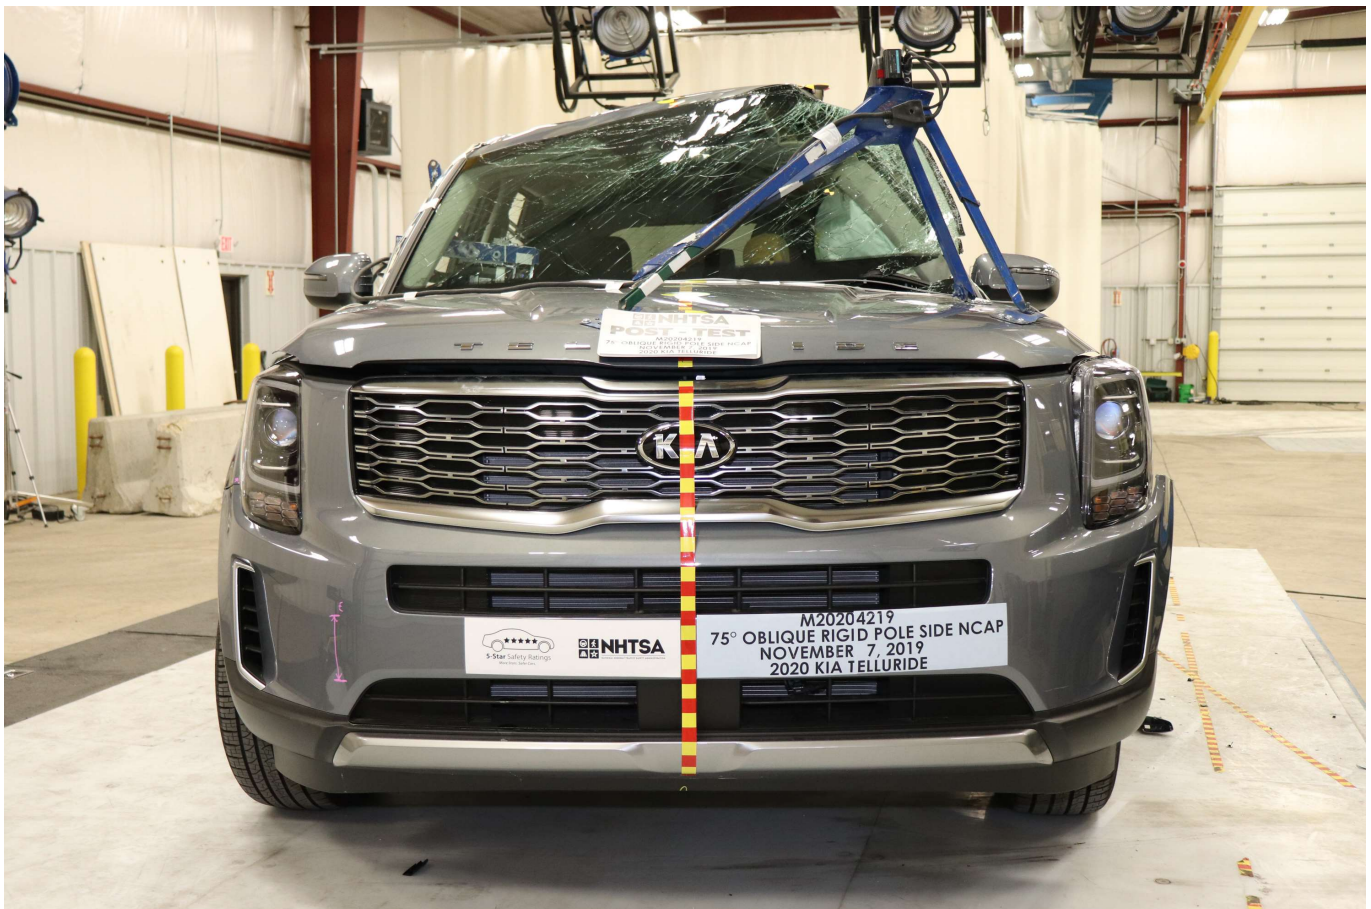
Photo No. 004 - Post-Test Frontal View of Test Vehicle

Critical Areas of Performance	Observations and Conclusions
Pillar Performance	No Separation
Sill Separation	None
Windshield Damage	Cracked
Side Window Damage	LF window cracked
Other Notable Effects	None

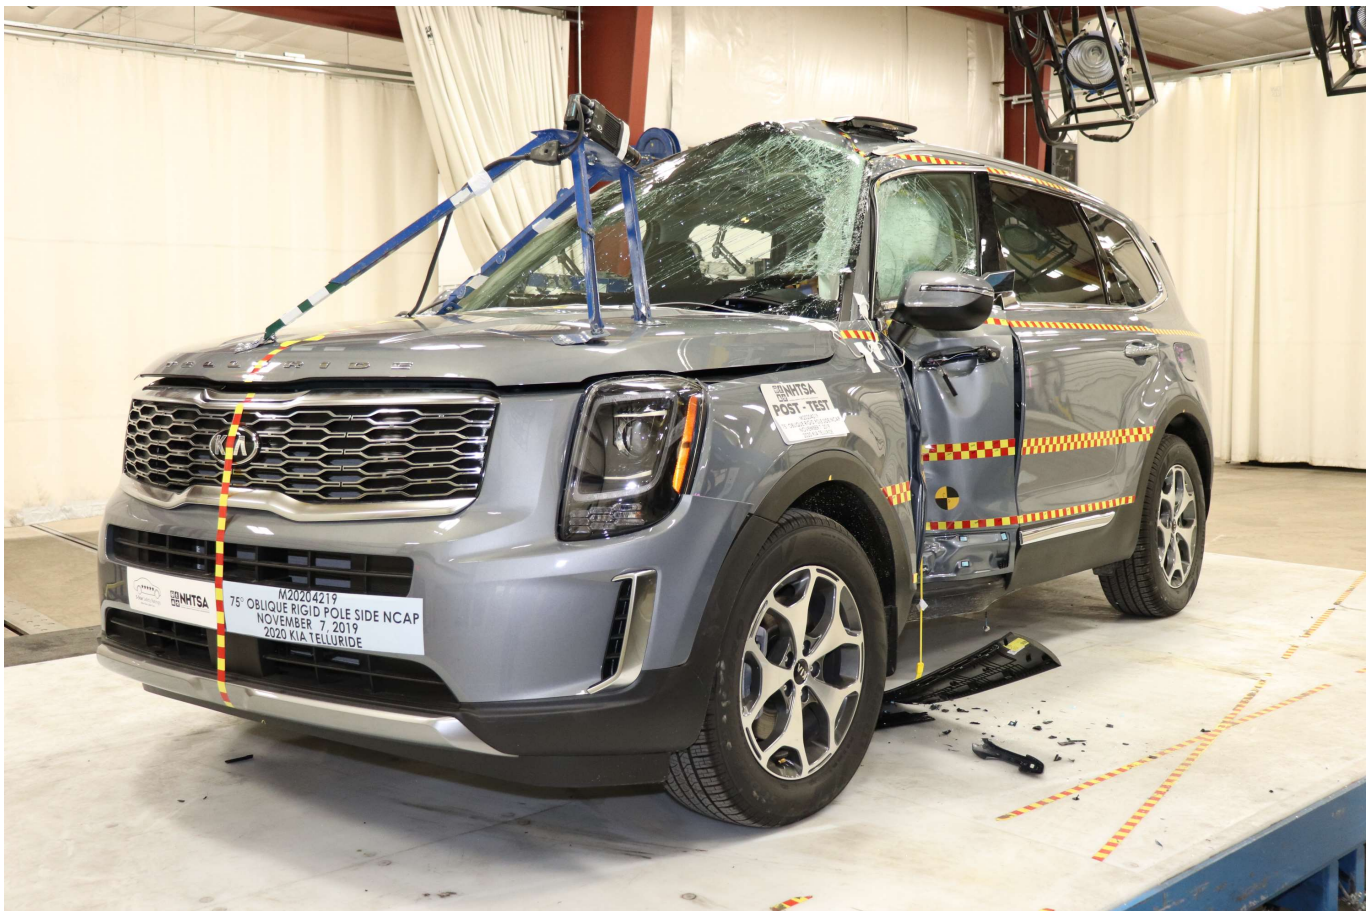
Photo No. 006 - Post-Test Left Front Three-Quarter View of Test Vehicle

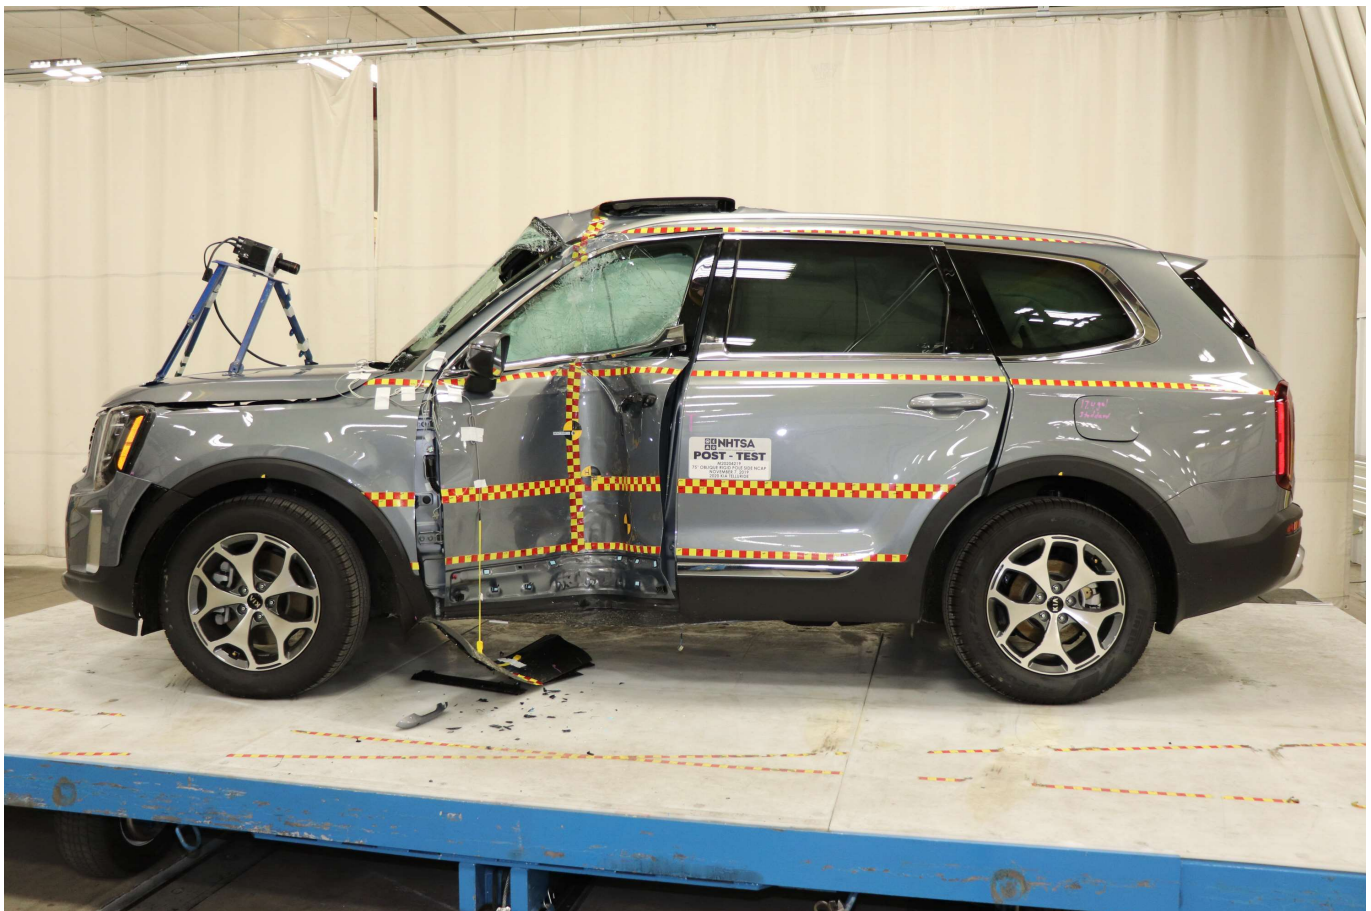
Photo No. 008 - Post-Test Left Side View of Test Vehicle

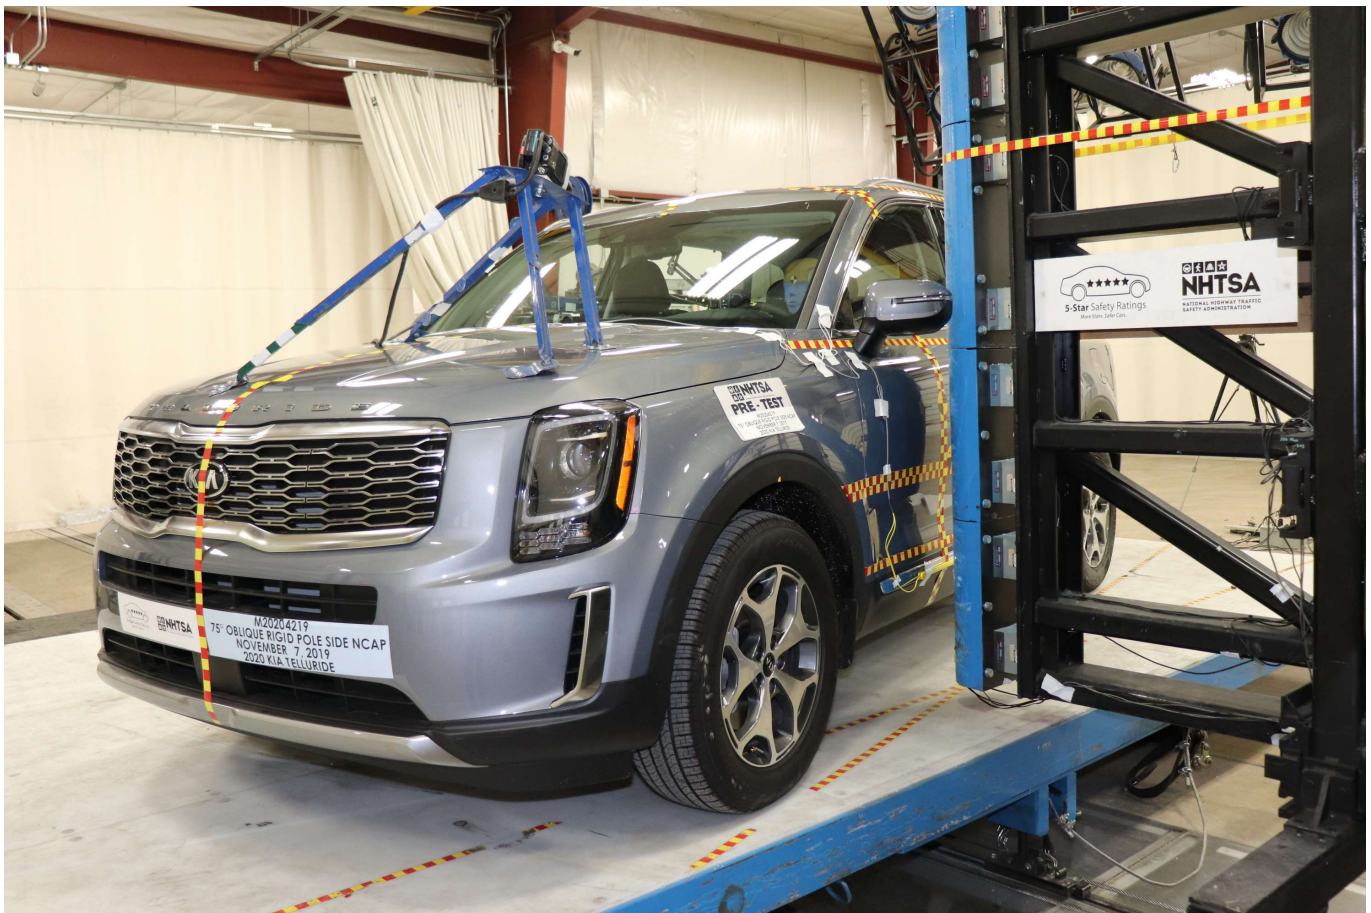
Photo No. 017 - Pre-Test Left Side View of Pole Positioned Against Side of Vehicle

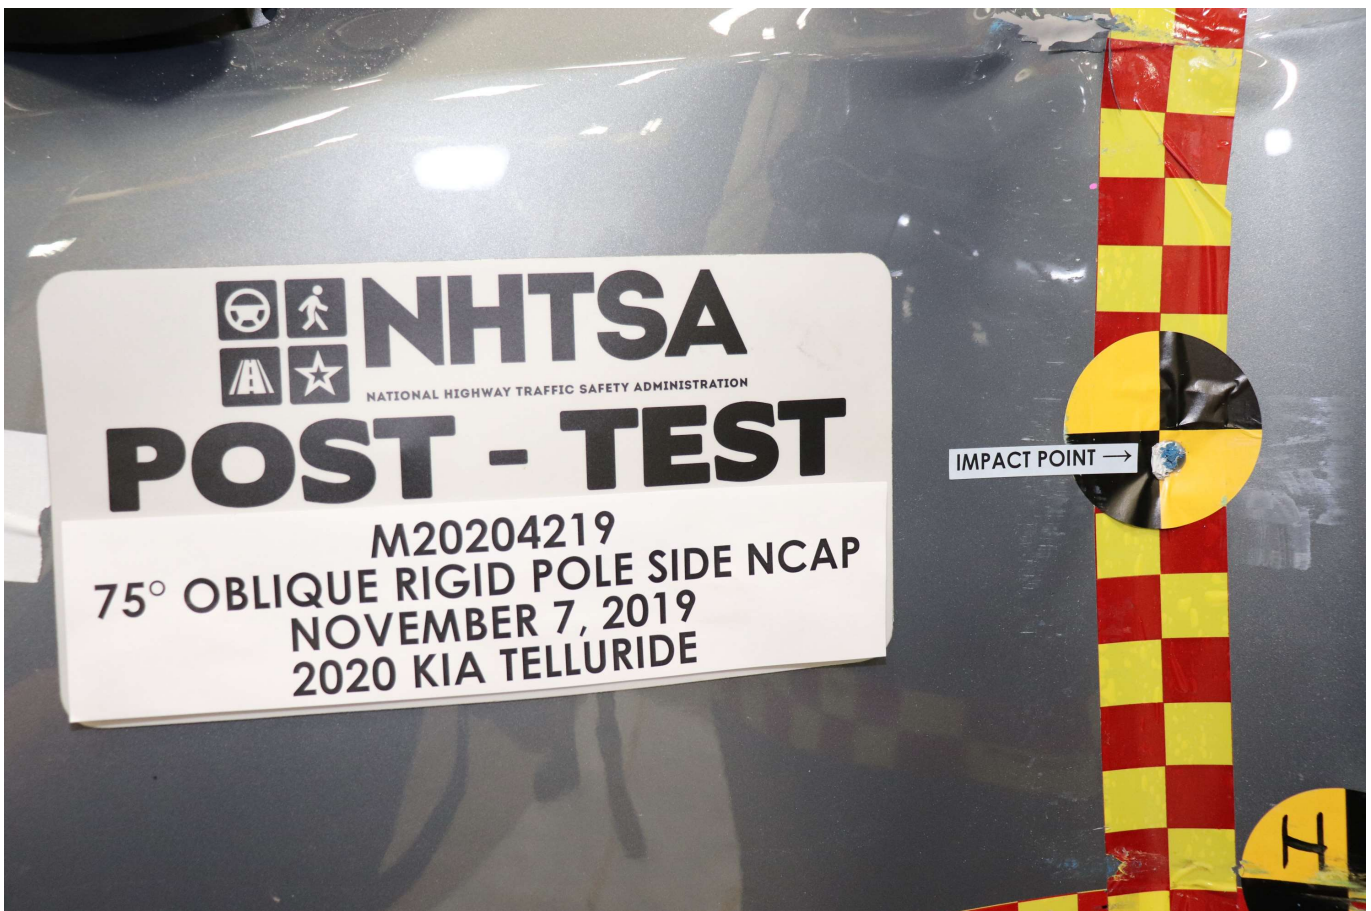
Photo No. 020 - Post-Test Close-Up View of Impact Point Target Showing Impact Location

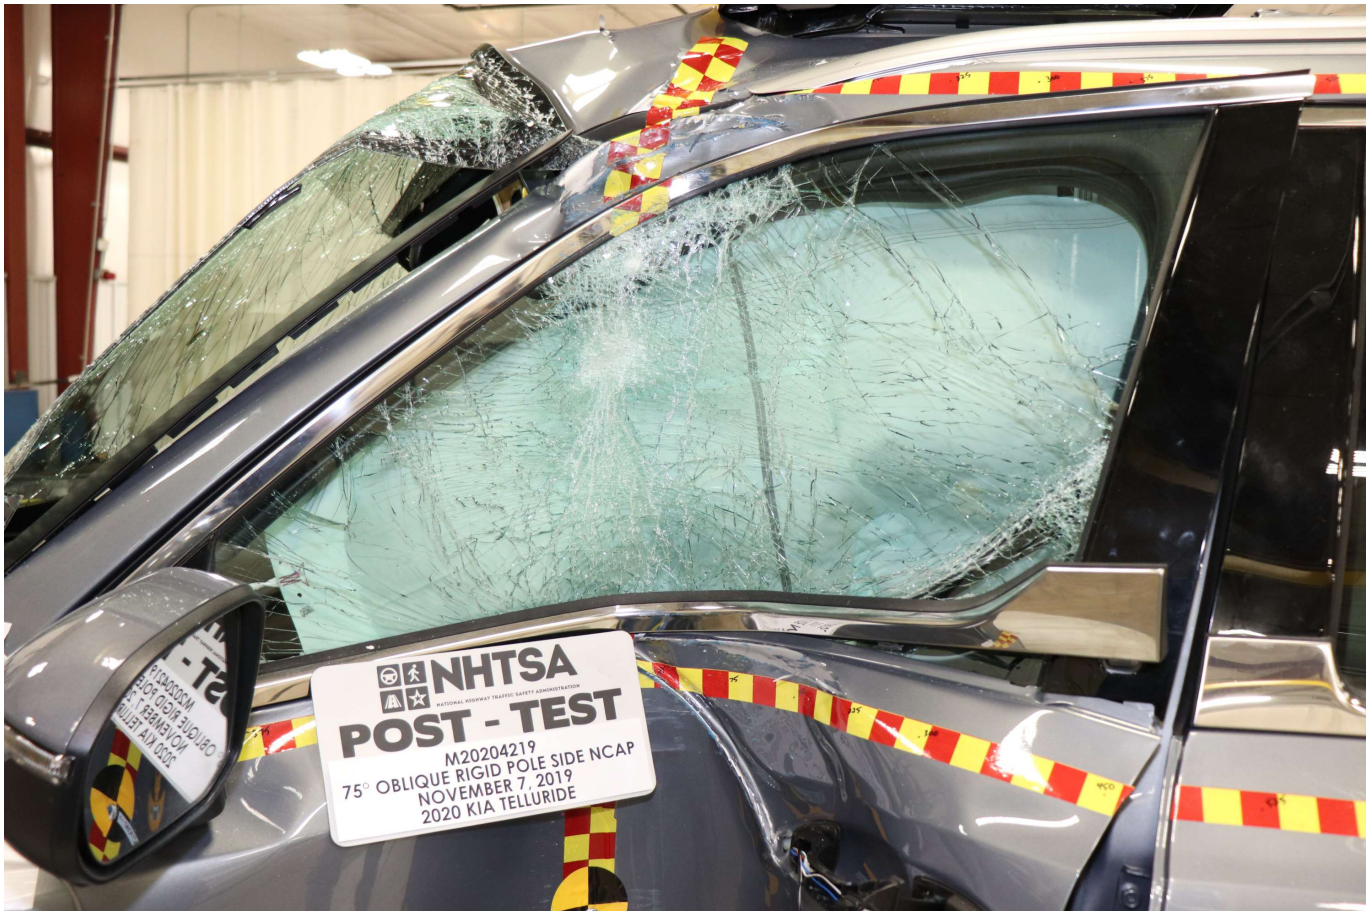
Photo No. 025 - Post-Test Left Side View of Dummy Shoulder and Door Top View

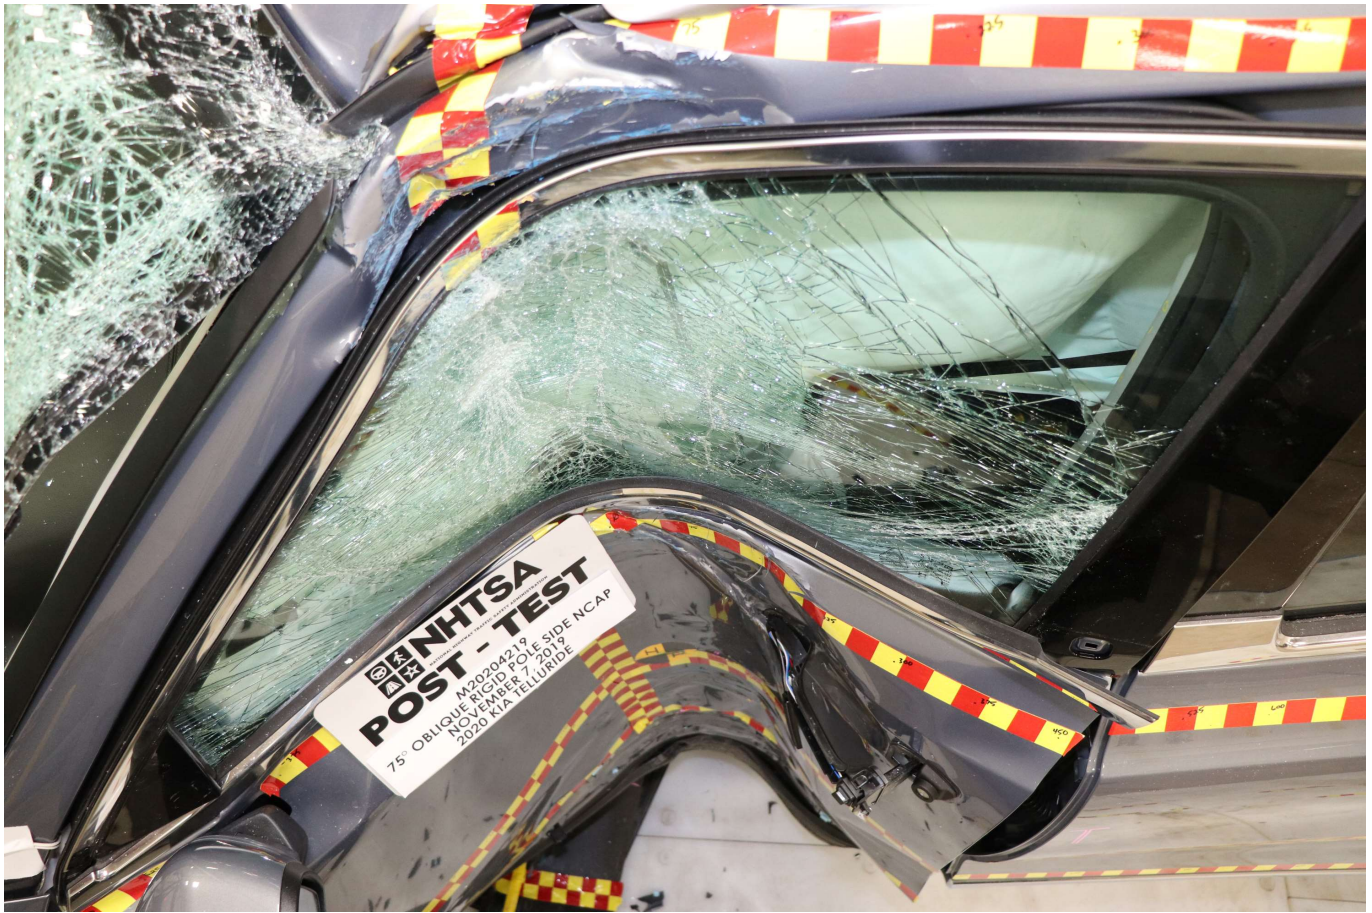
Photo No. 041 - Post-Test Dummy and Door Clearance View

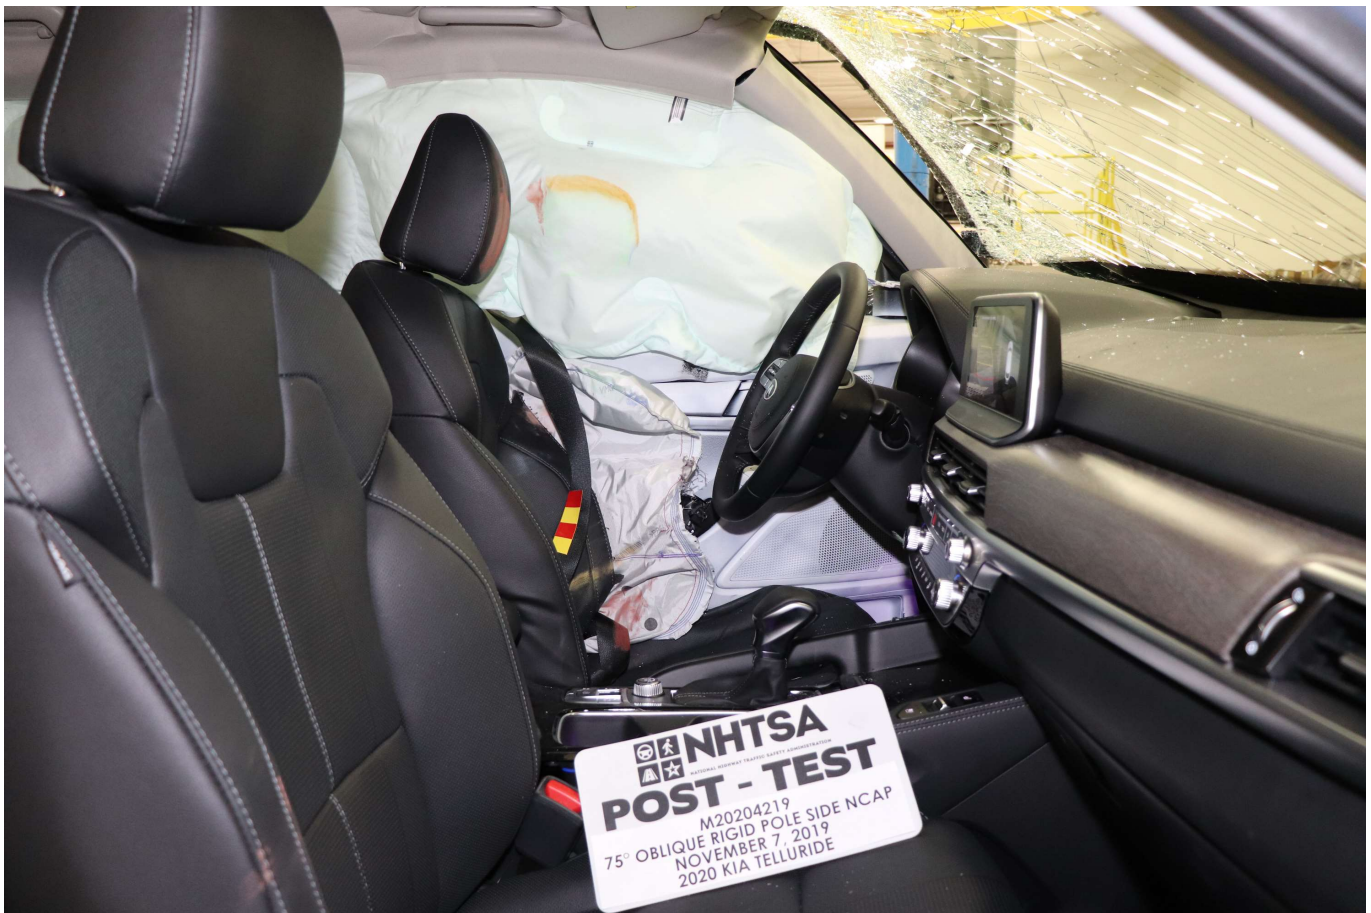
Photo No. 045 - Post-Test Inner Door Panel View Showing Dummy Contact Location

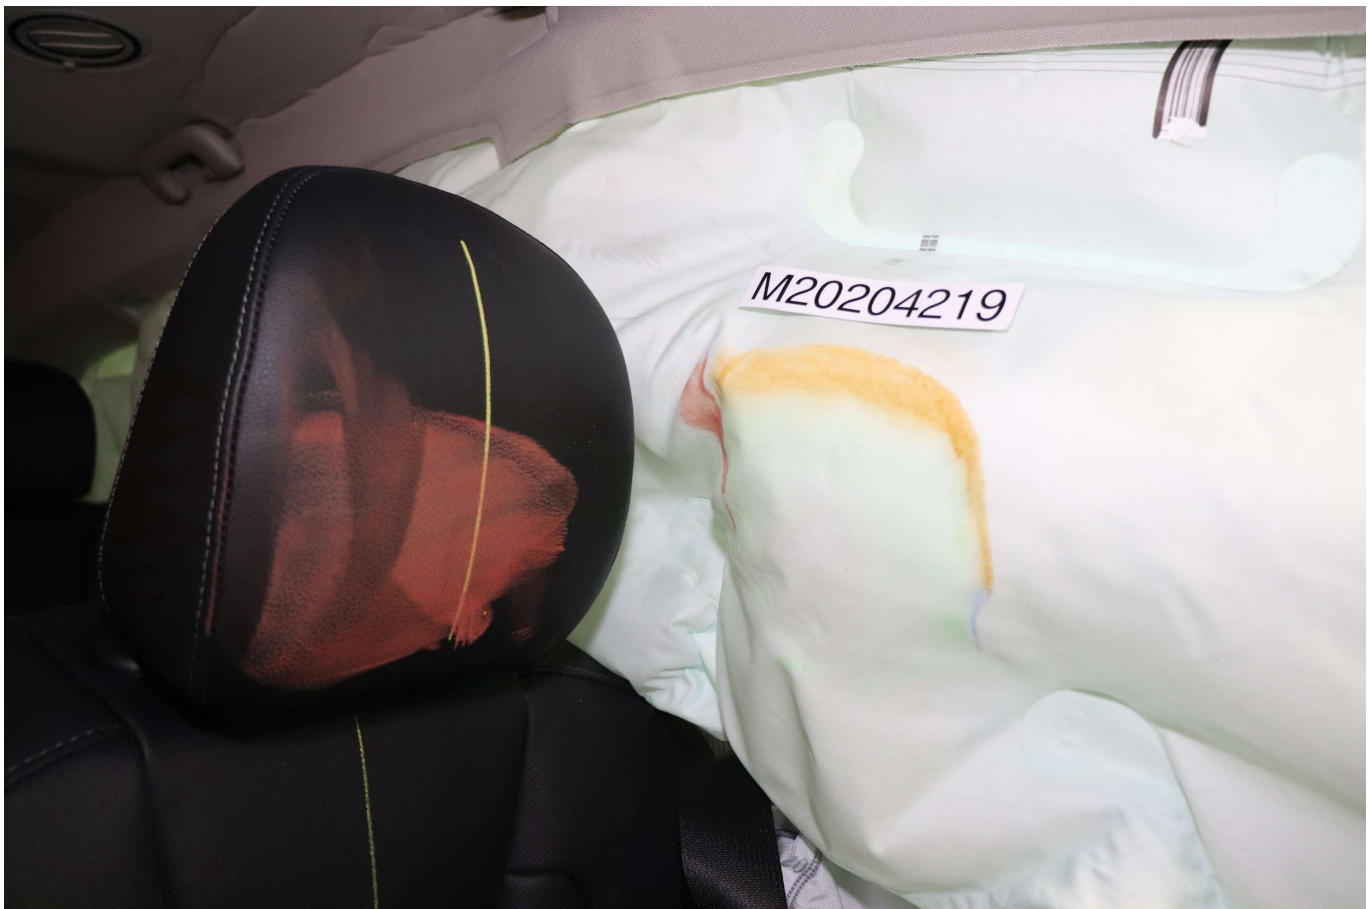
Photo No. 046 - Post-Test Dummy Close-Up Head Contact with Vehicle Interior View

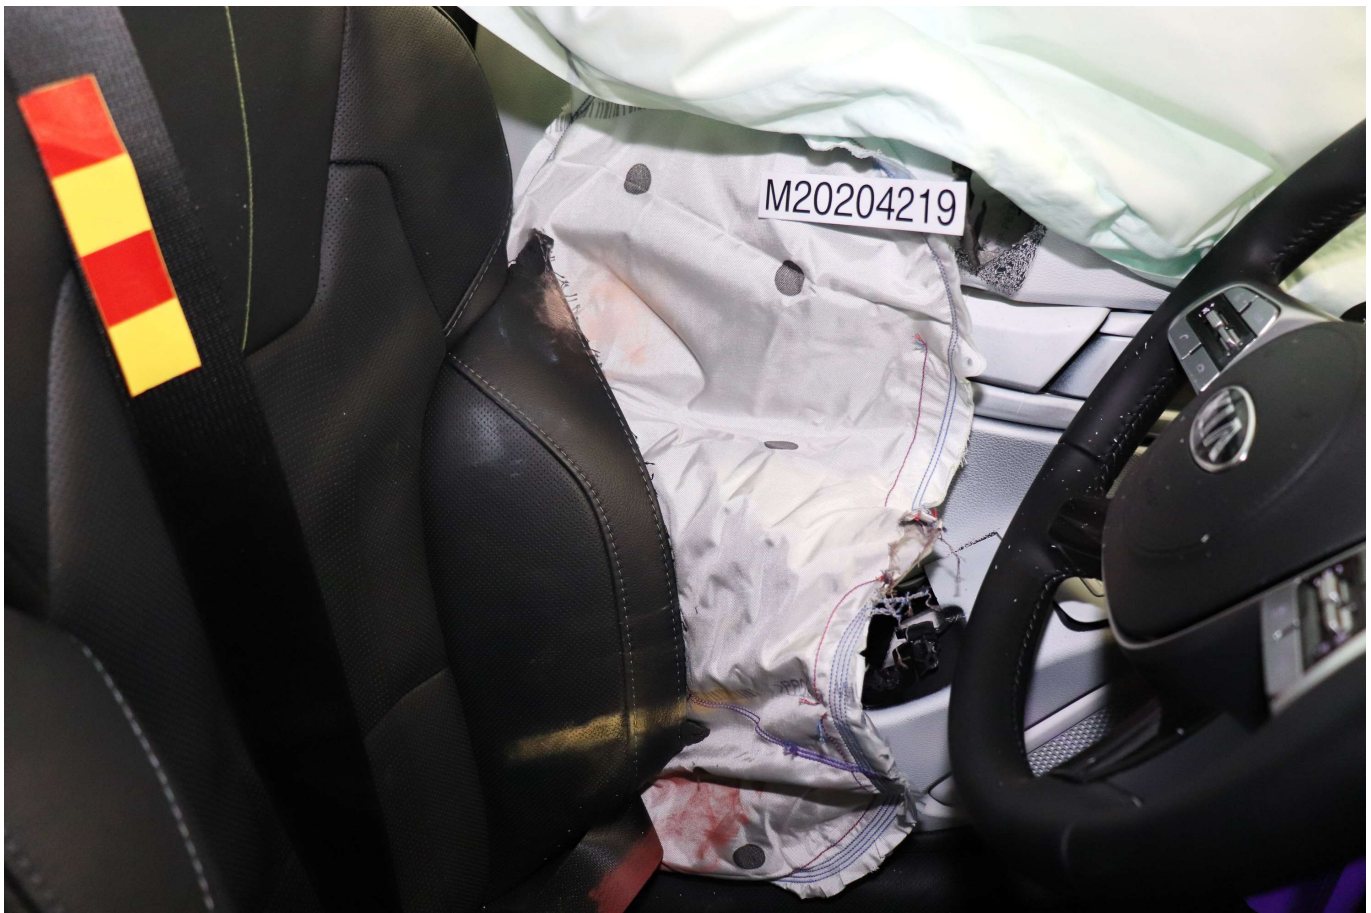
Photo No. 049 - Post-Test Dummy Close-Up Torso Contact with Side Air Bag View

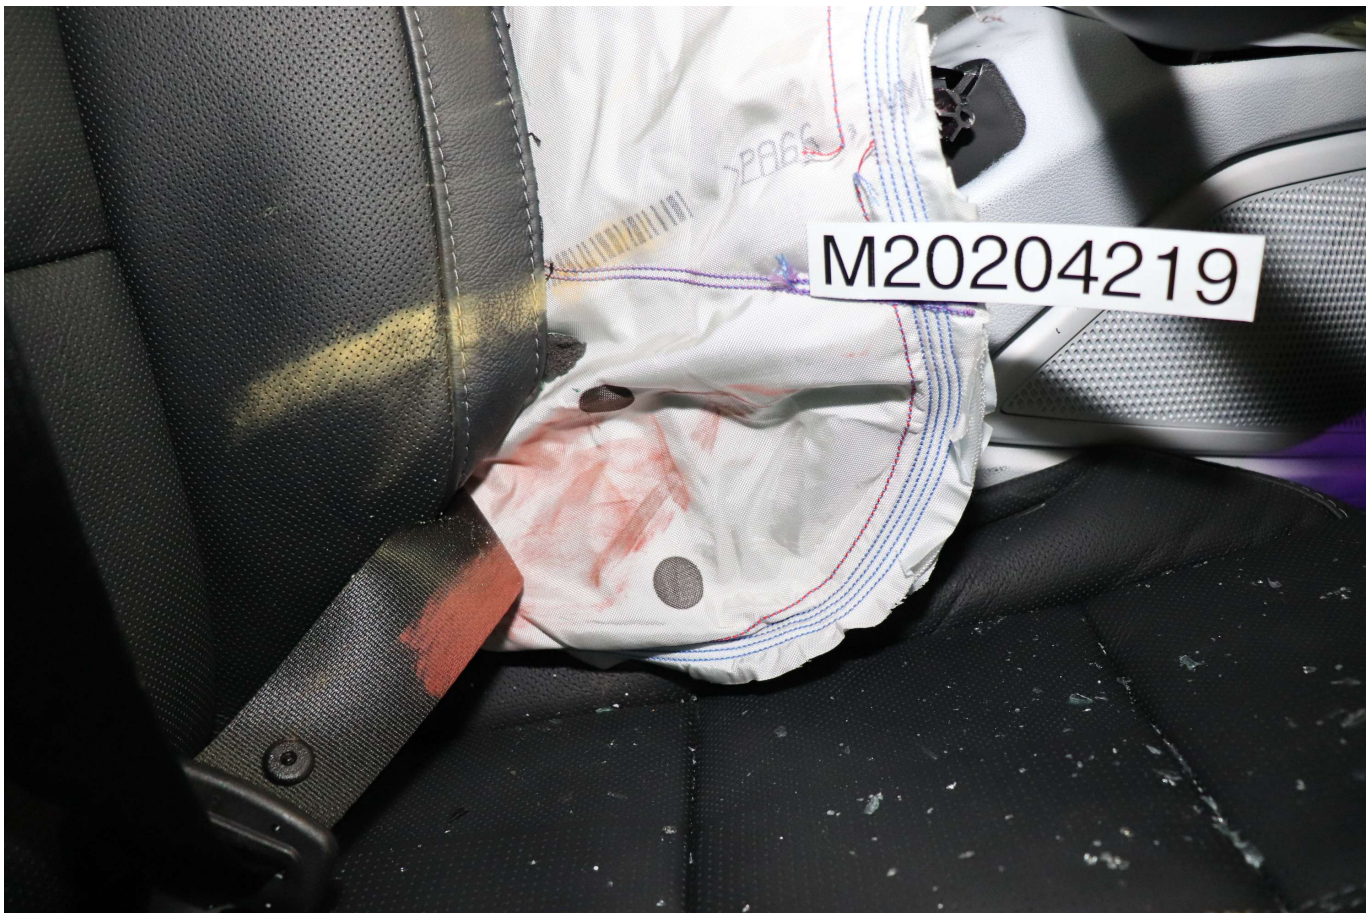
Photo No. 051 - Post-Test Dummy Close-Up Pelvis Contact with Side Air Bag View

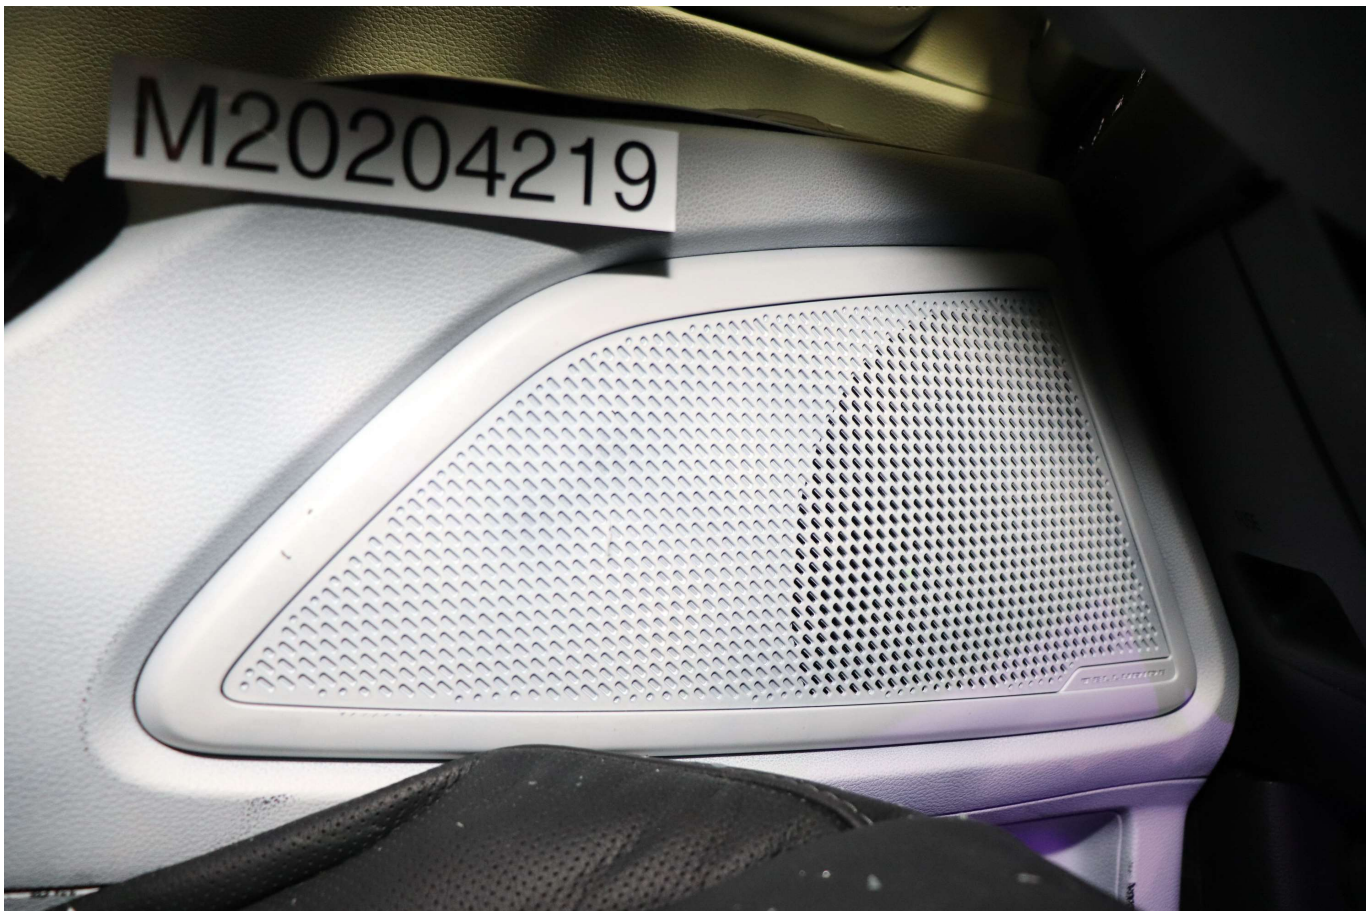
Photo No. 052 - Post-Test Dummy Close-Up Knee Contact with Vehicle Interior View

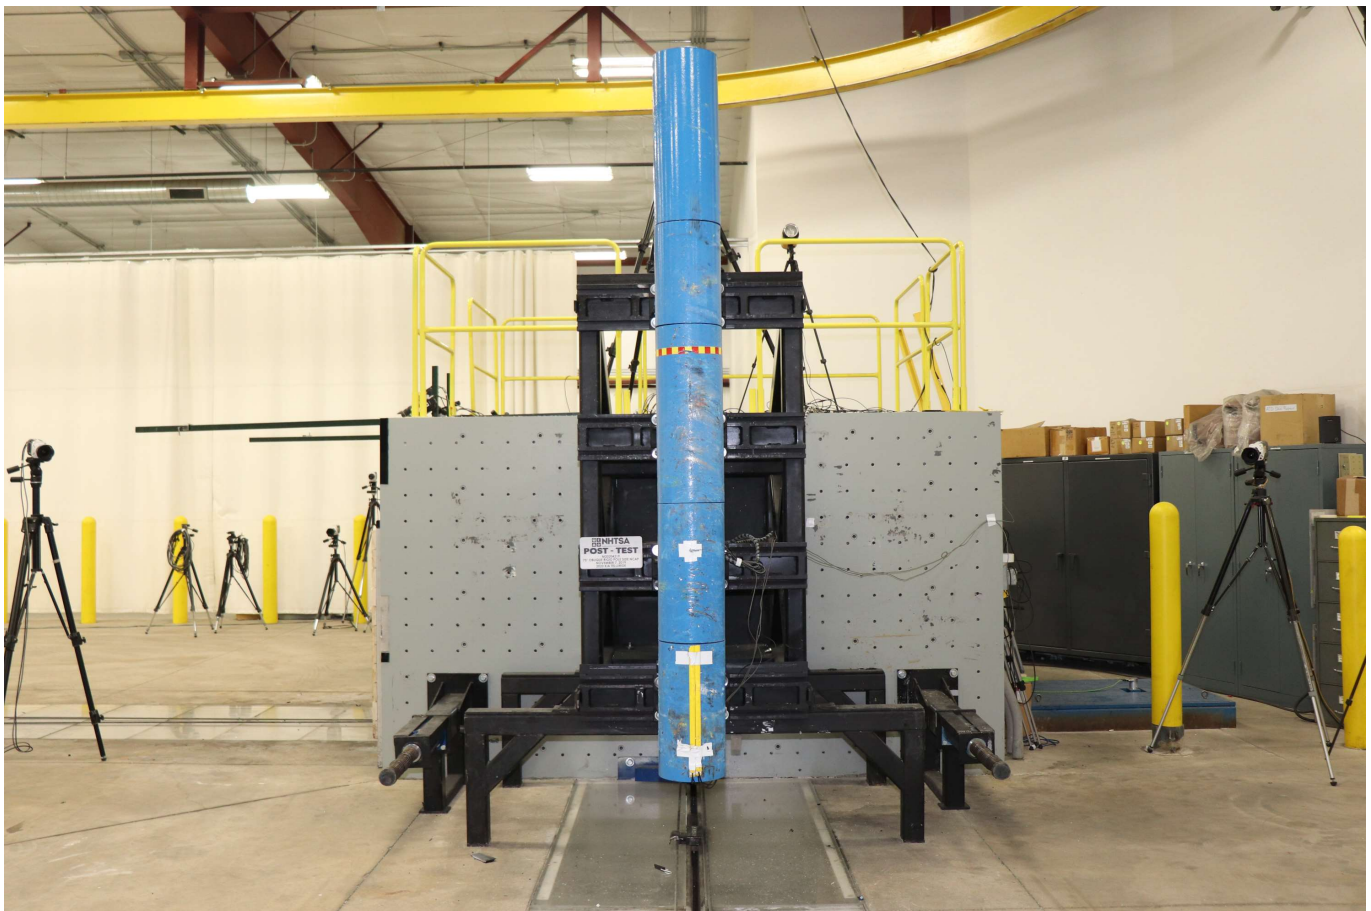
Photo No. 058 - Post-Test Pole Barrier Front View

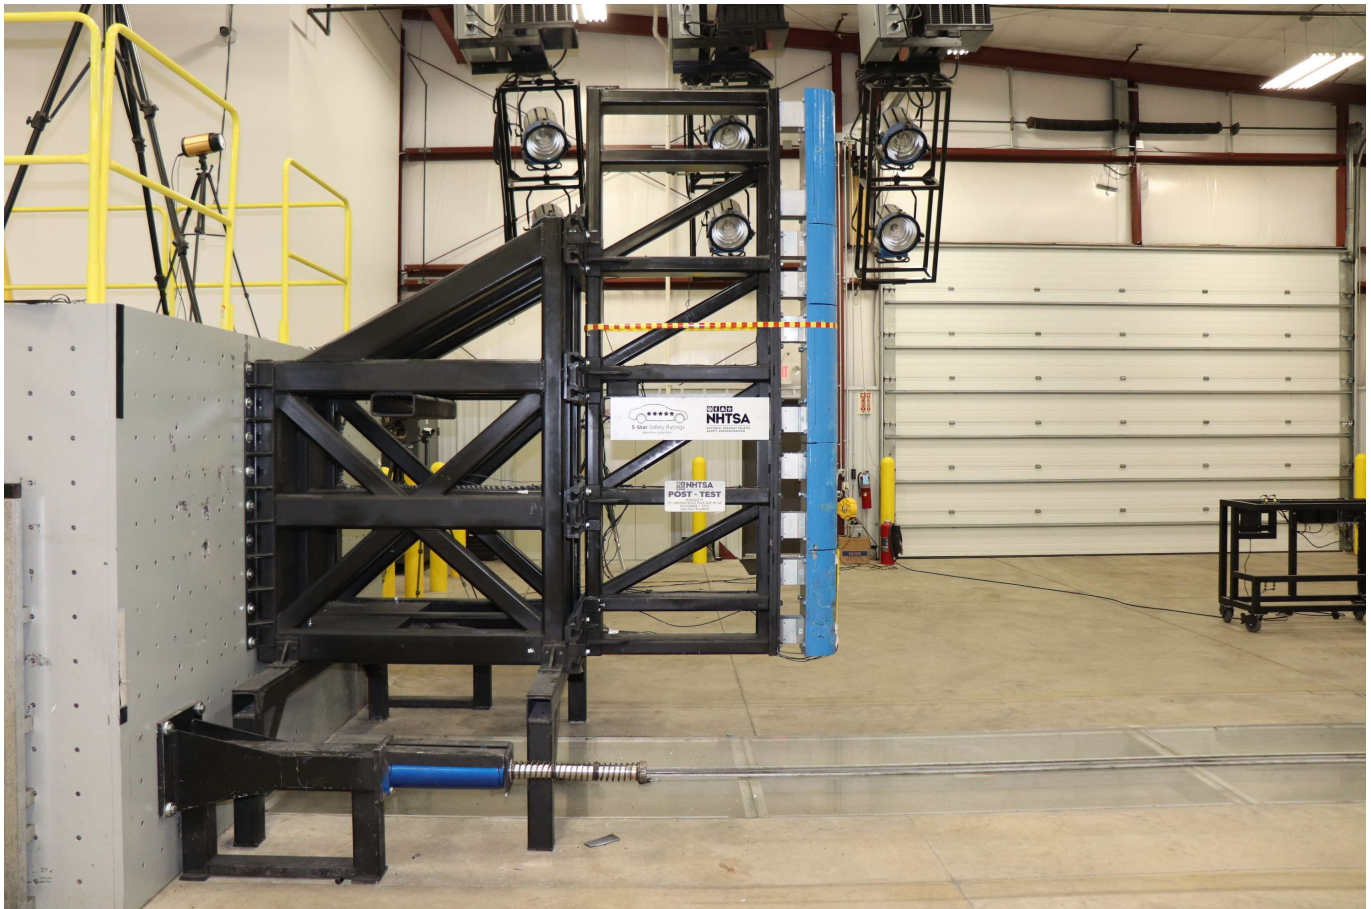
Photo No. 060 - Post-Test Pole Barrier Side View

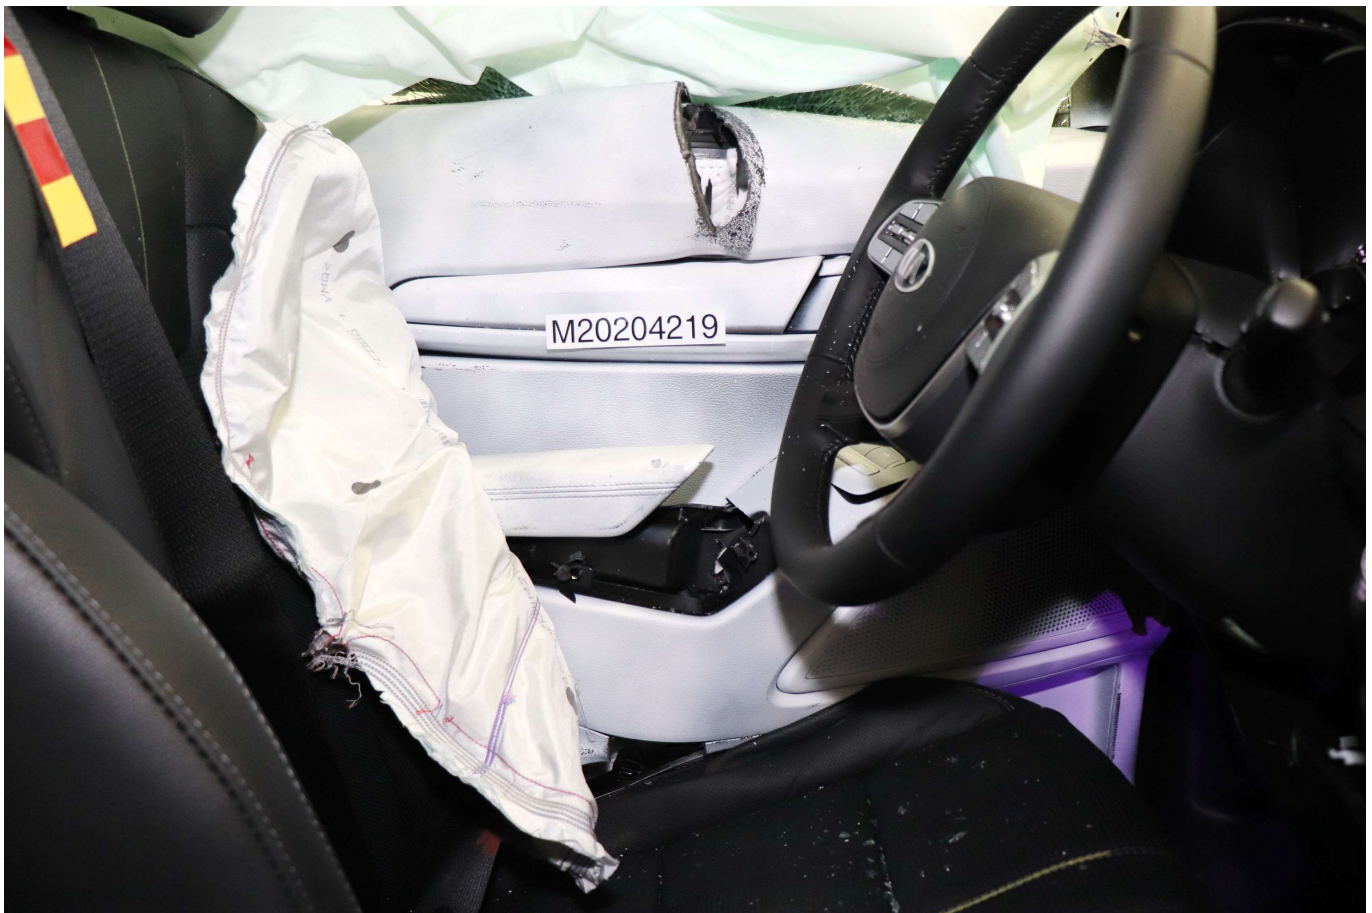
Photo No. 071 - Post-Test View of Shattered Vehicle Inner Door Panel
