**REPORT NUMBER: NCAP-MGA-20-002**

**NEW CAR ASSESSMENT PROGRAM (NCAP)  
Frontal Barrier Impact Test**

**KIA MOTORS MANUFACTURING GEORGIA, INC.  
2020 Kia Telluride LX AWD 5-Door SUV  
NHTSA No.: M20204218**

**FINAL REPORT**

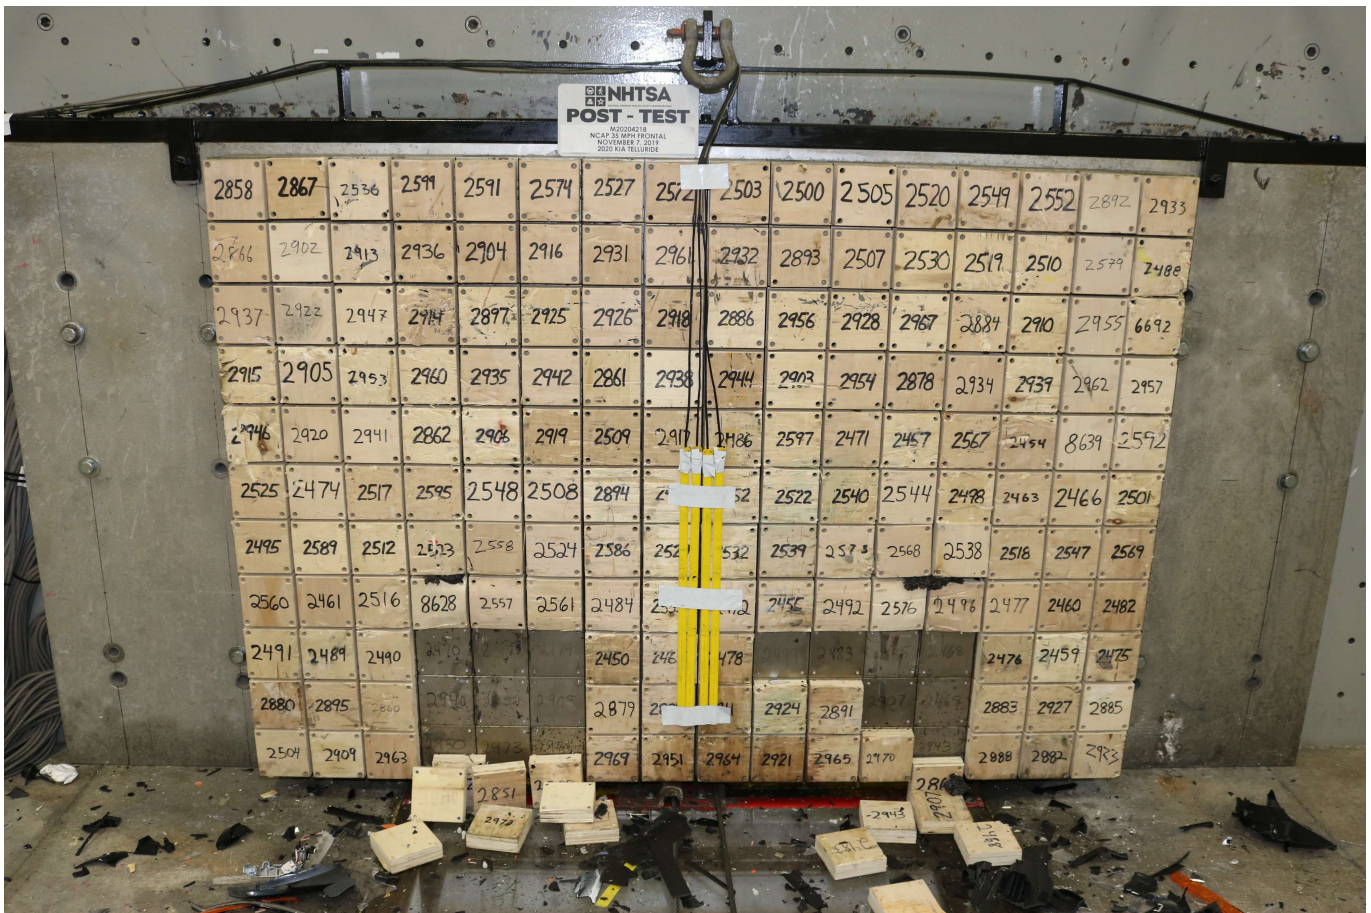
Photo No. 003 - Post-Test Load Cell Wall

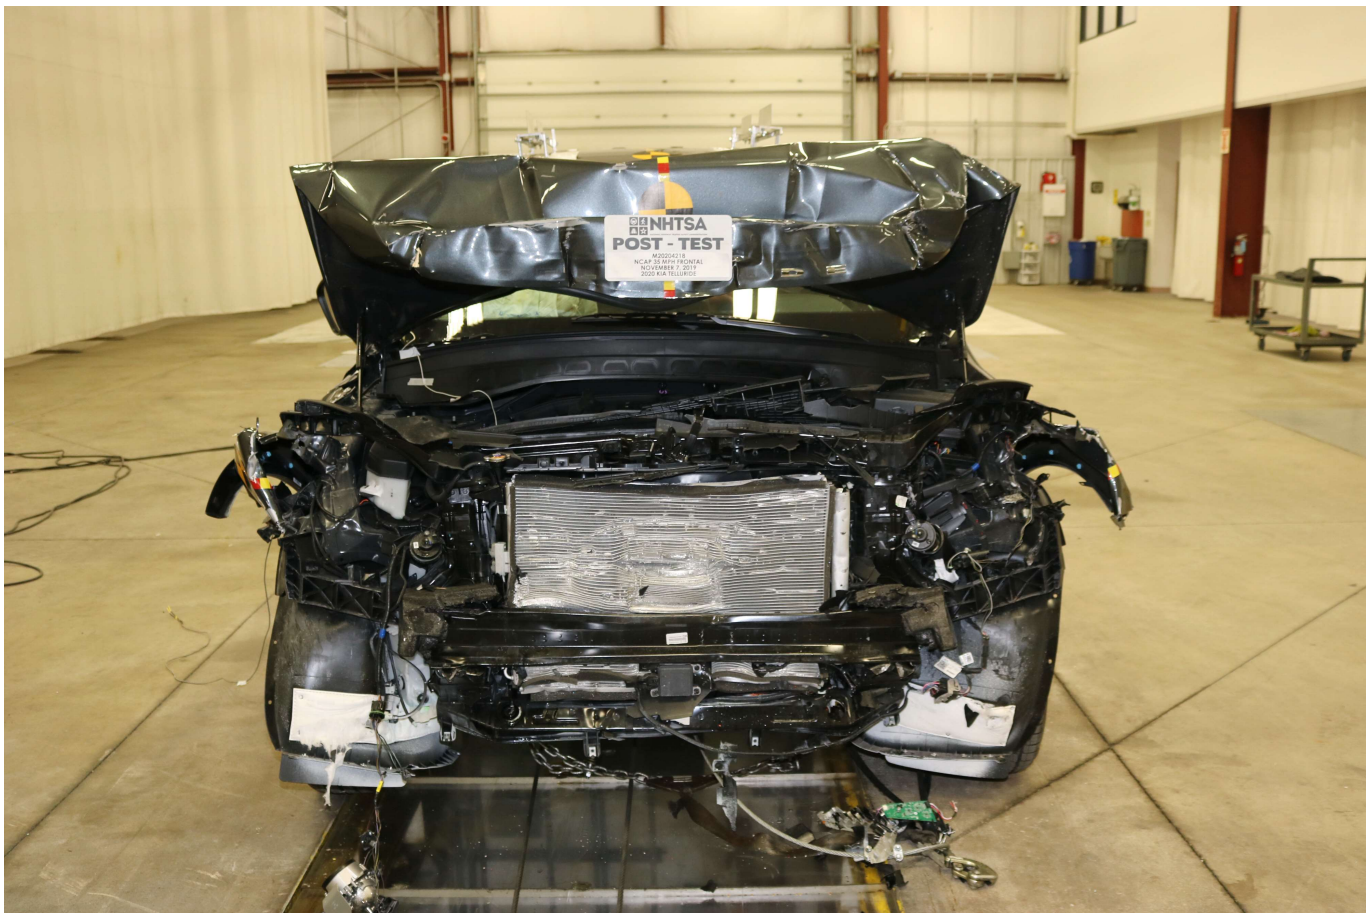
Photo No. 009 - Post-Test Front View of Test Vehicle

The maximum static crush of the vehicle was 436 mm located to the left of the vehicle centerline and both the driver and passenger side doors remained closed during the impact event and were operable after the impact.

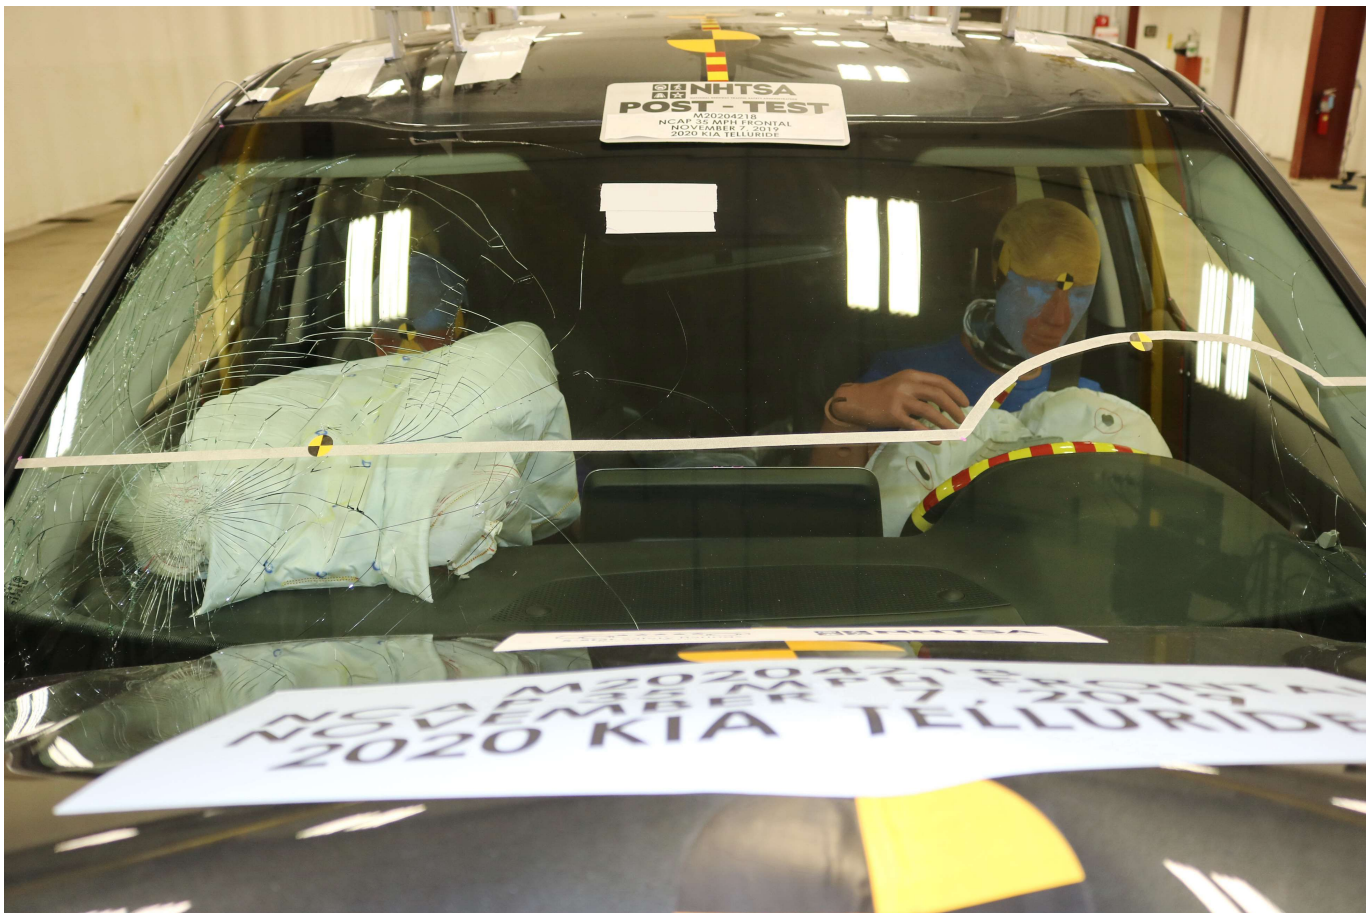
Photo No. 019 - Post-Test Windshield View

There was 100 percent windshield retention and no intrusion into the protected zone of the windshield during the event. There was no Stoddard Solvent leakage after the event or during any phase of the static rollover.

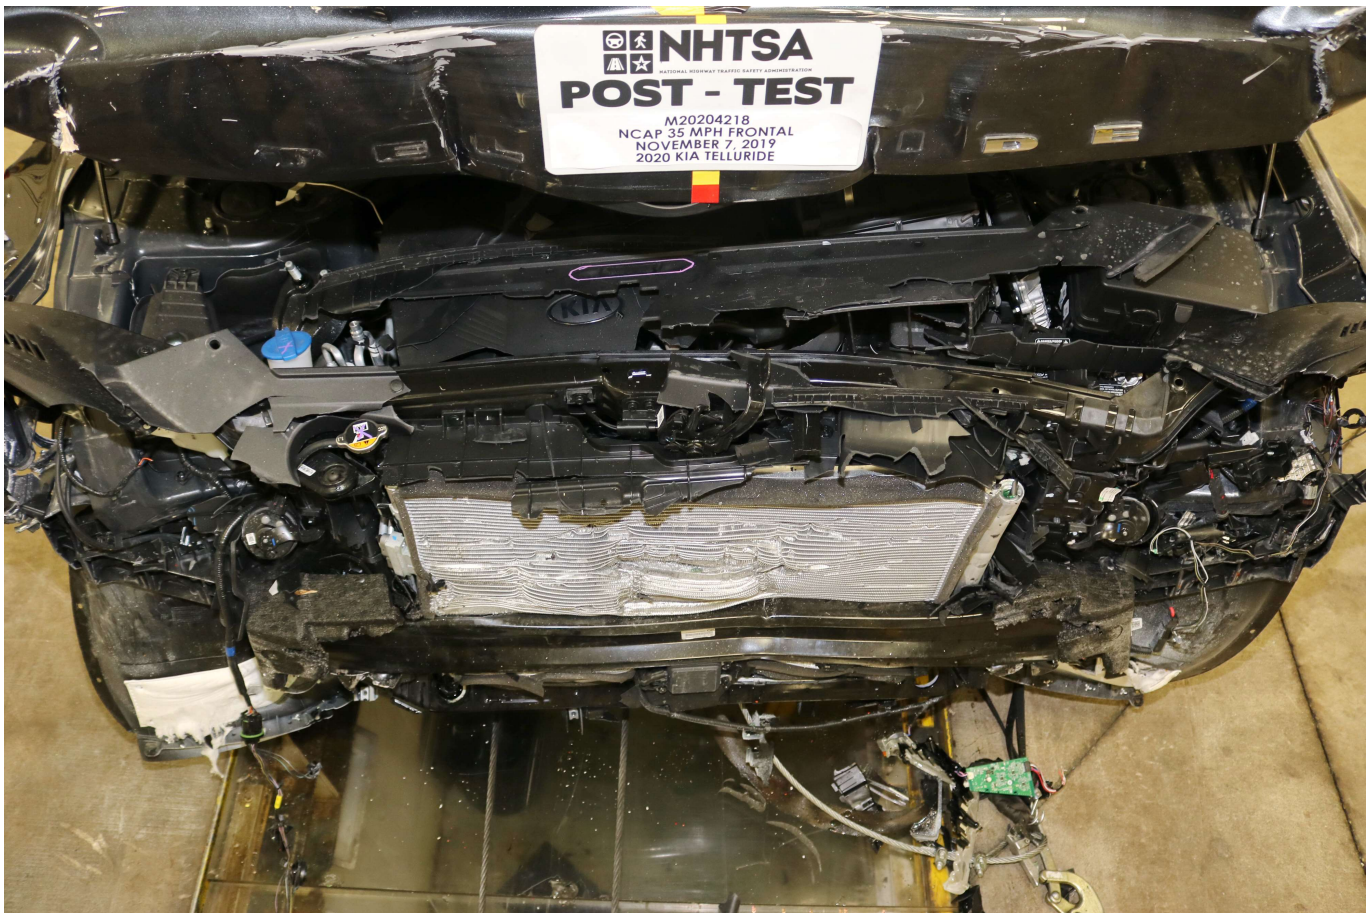
Photo No. 021 - Post-Test Engine Compartment View

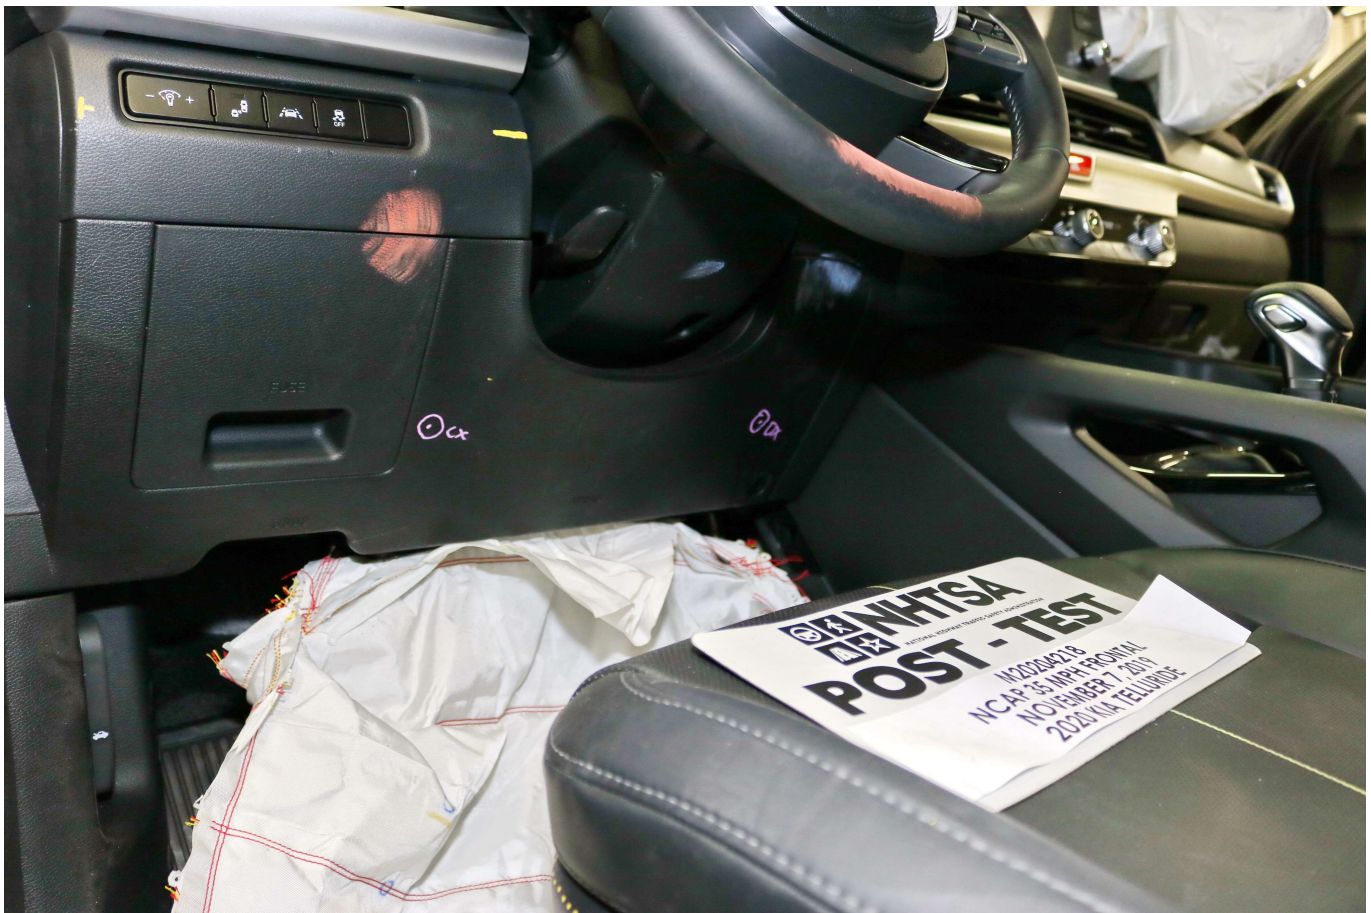
Photo No. 045 - Post-Test Driver Side Knee Bolster

The driver's visible contact points were as follows: The driver's head contacted the airbag. The driver's head also contacted the headrest. The driver's knees contacted the knee bolster.

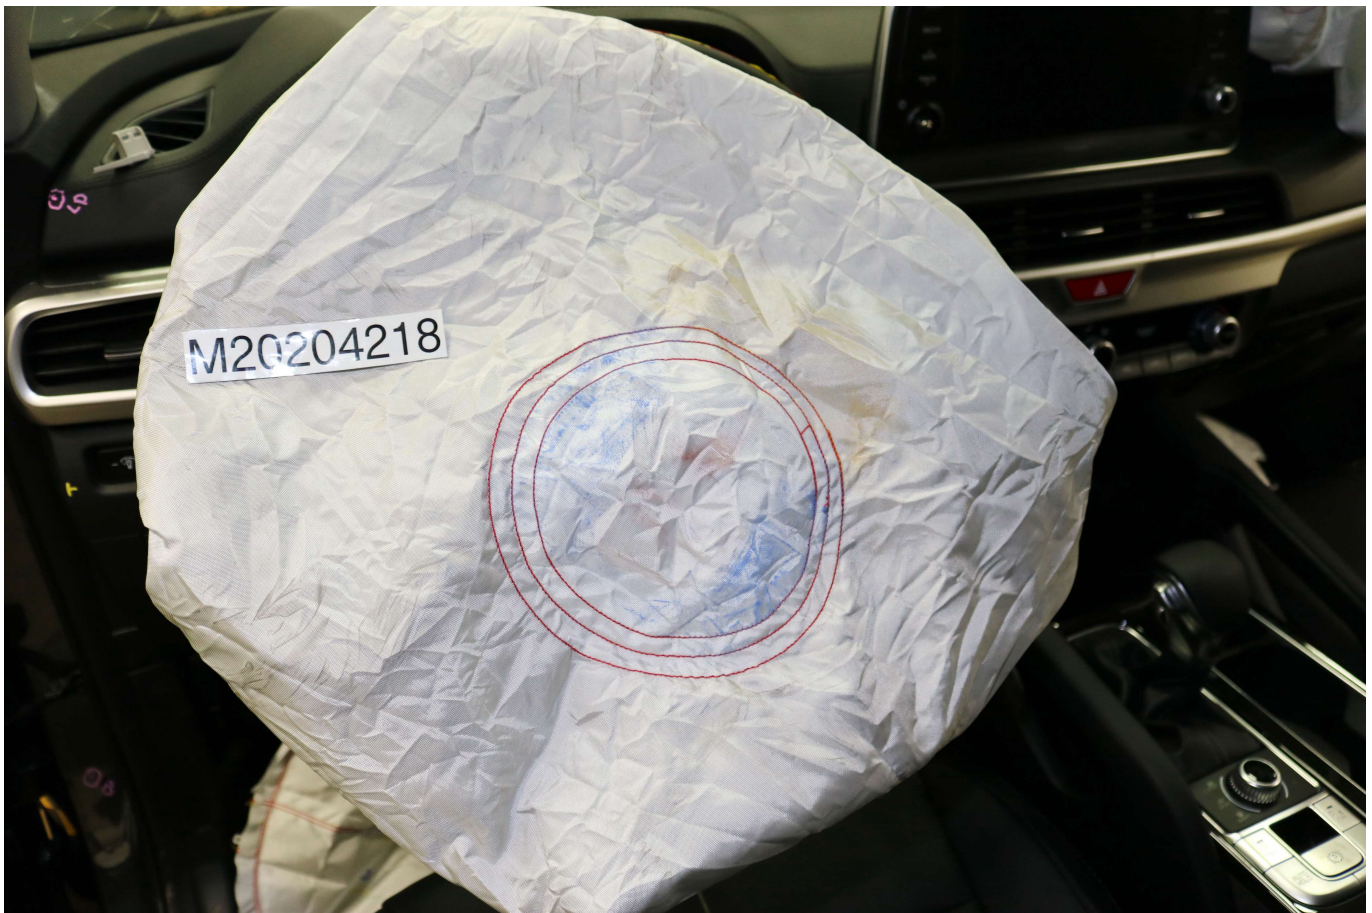
Photo No. 049 - Post-Test Driver Dummy Contact with Airbag

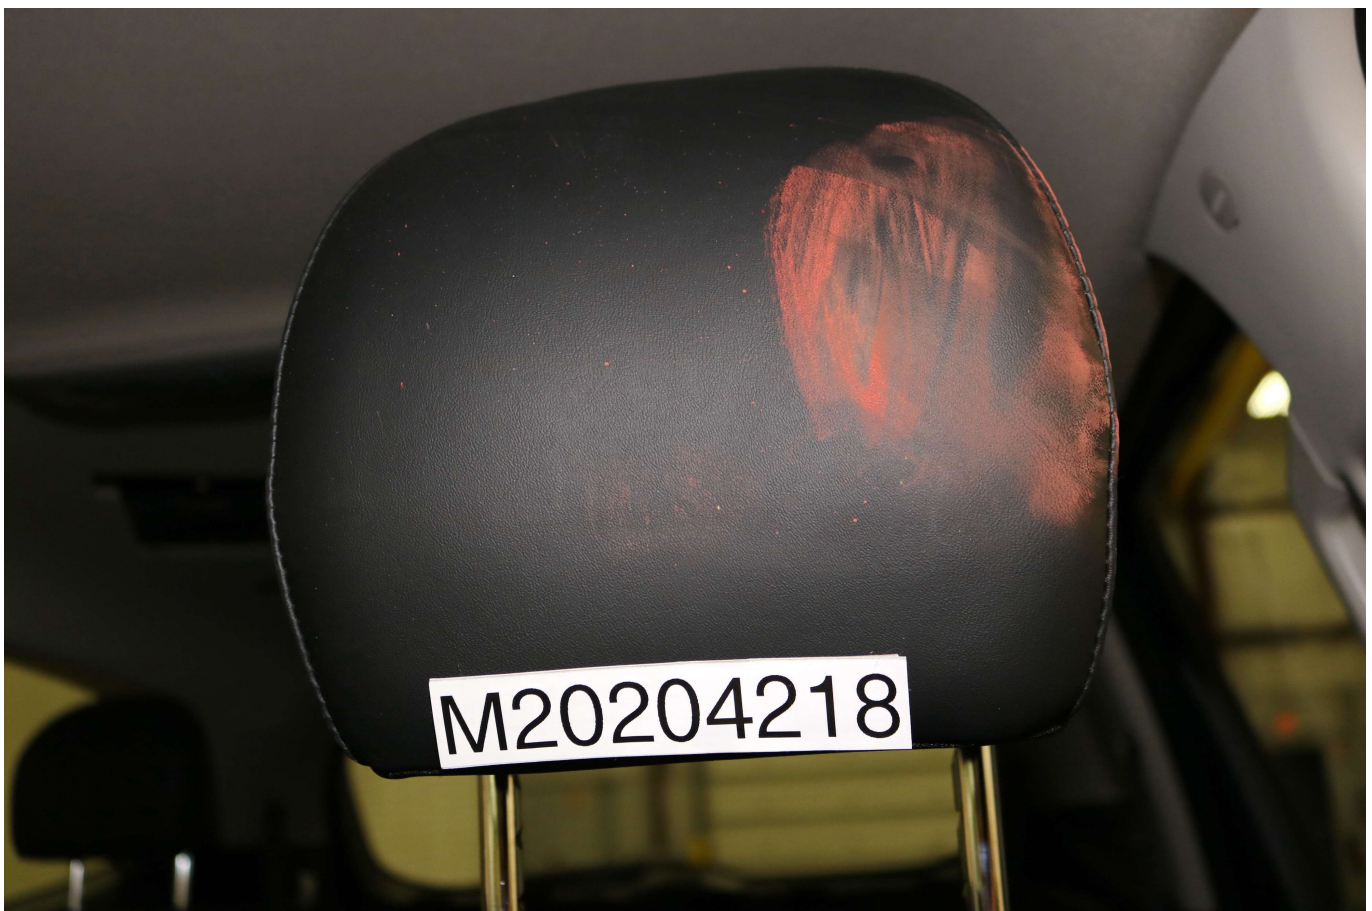
Photo No. 050 - Post-Test Driver Dummy Contact with Headrest

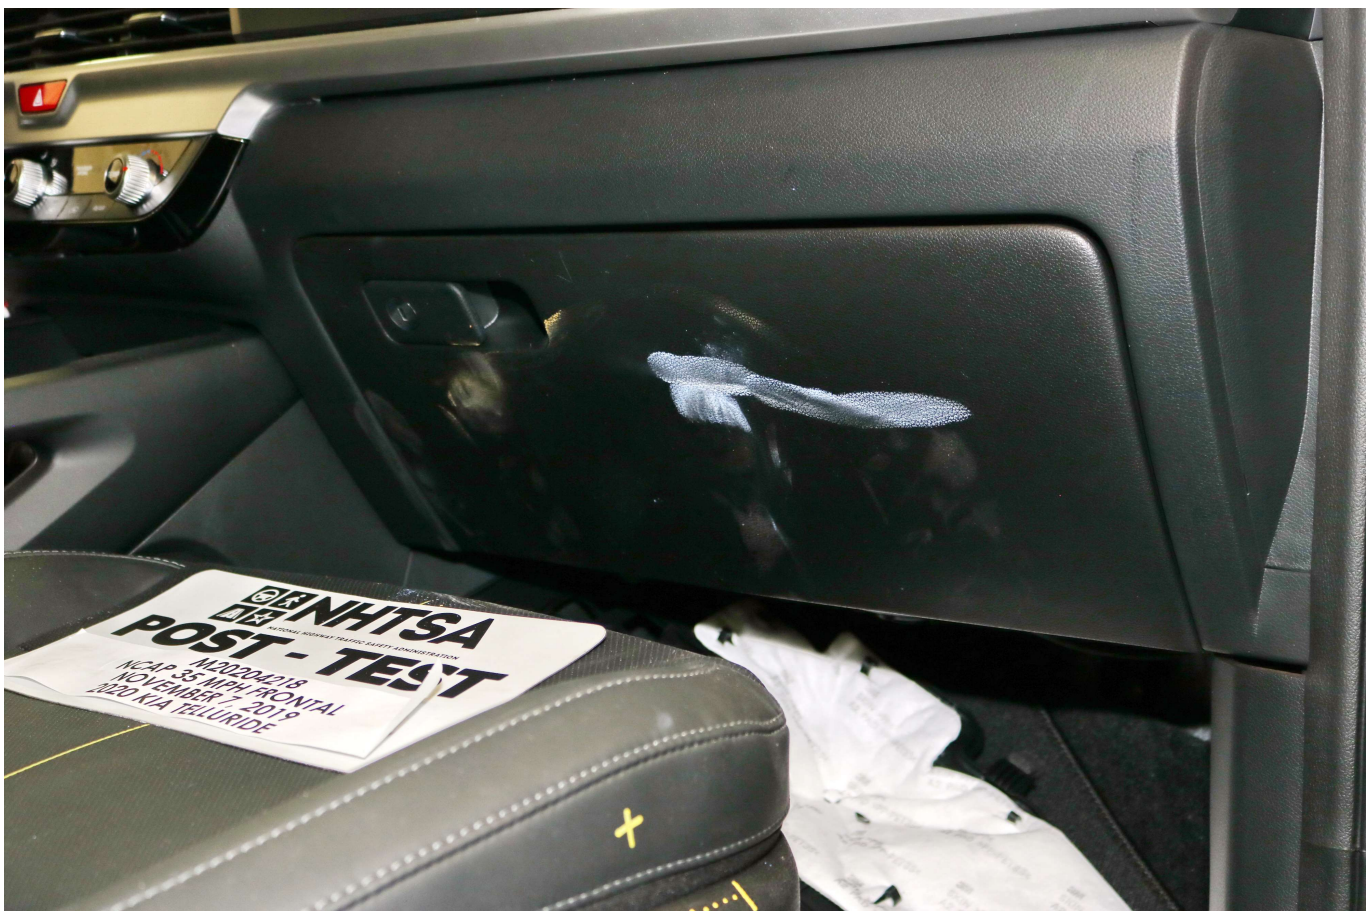
Photo No. 068 - Post-Test Passenger Side Knee Bolster

The passenger's visible contact points were as follows: The passenger's head contacted the airbag. The passenger's head also contacted the headrest. The passenger's knees contacted the glove box.

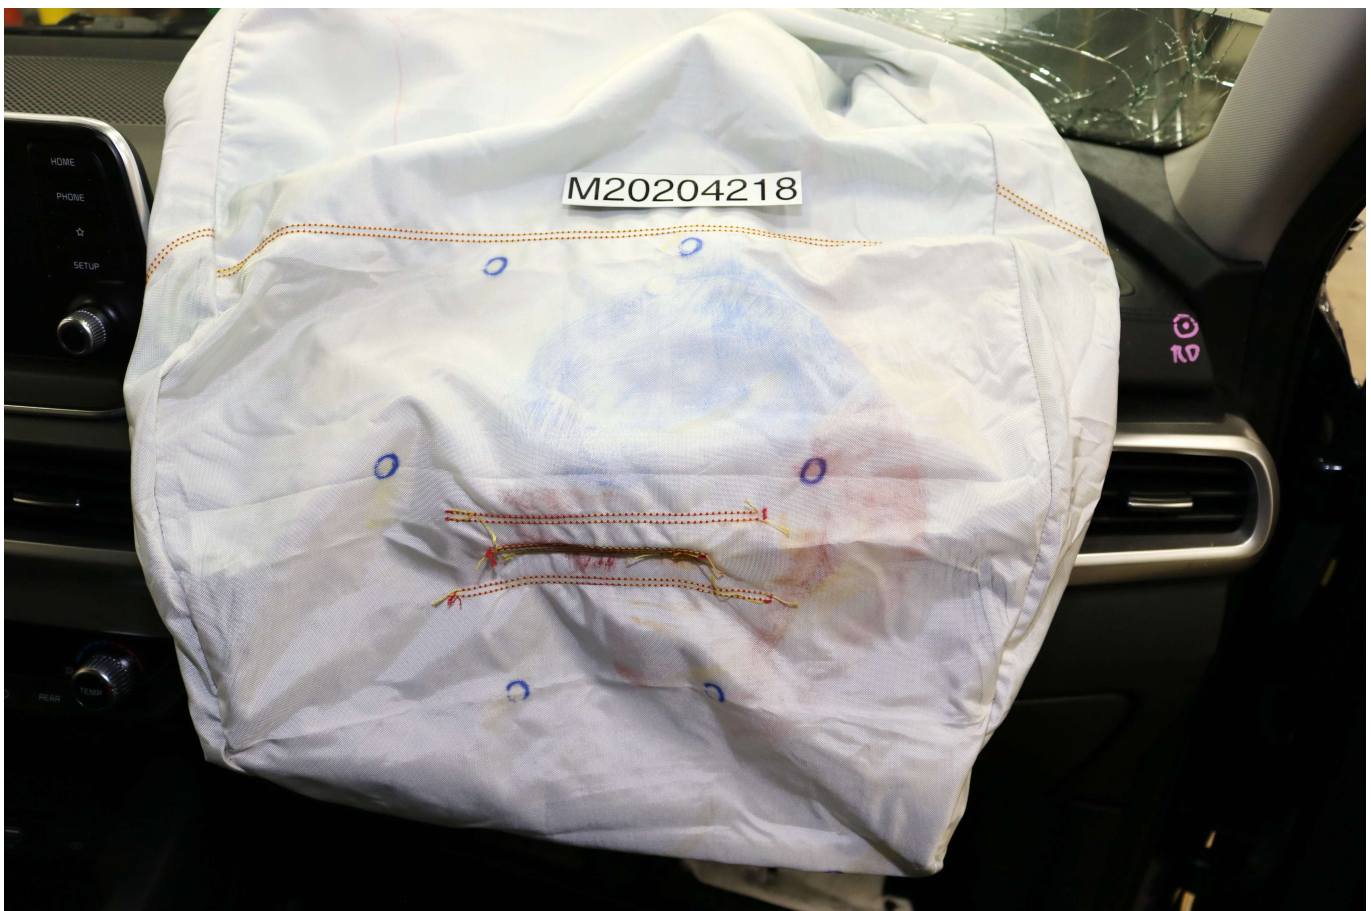
Photo No. 072 - Post-Test Passenger Dummy Contact with Airbag

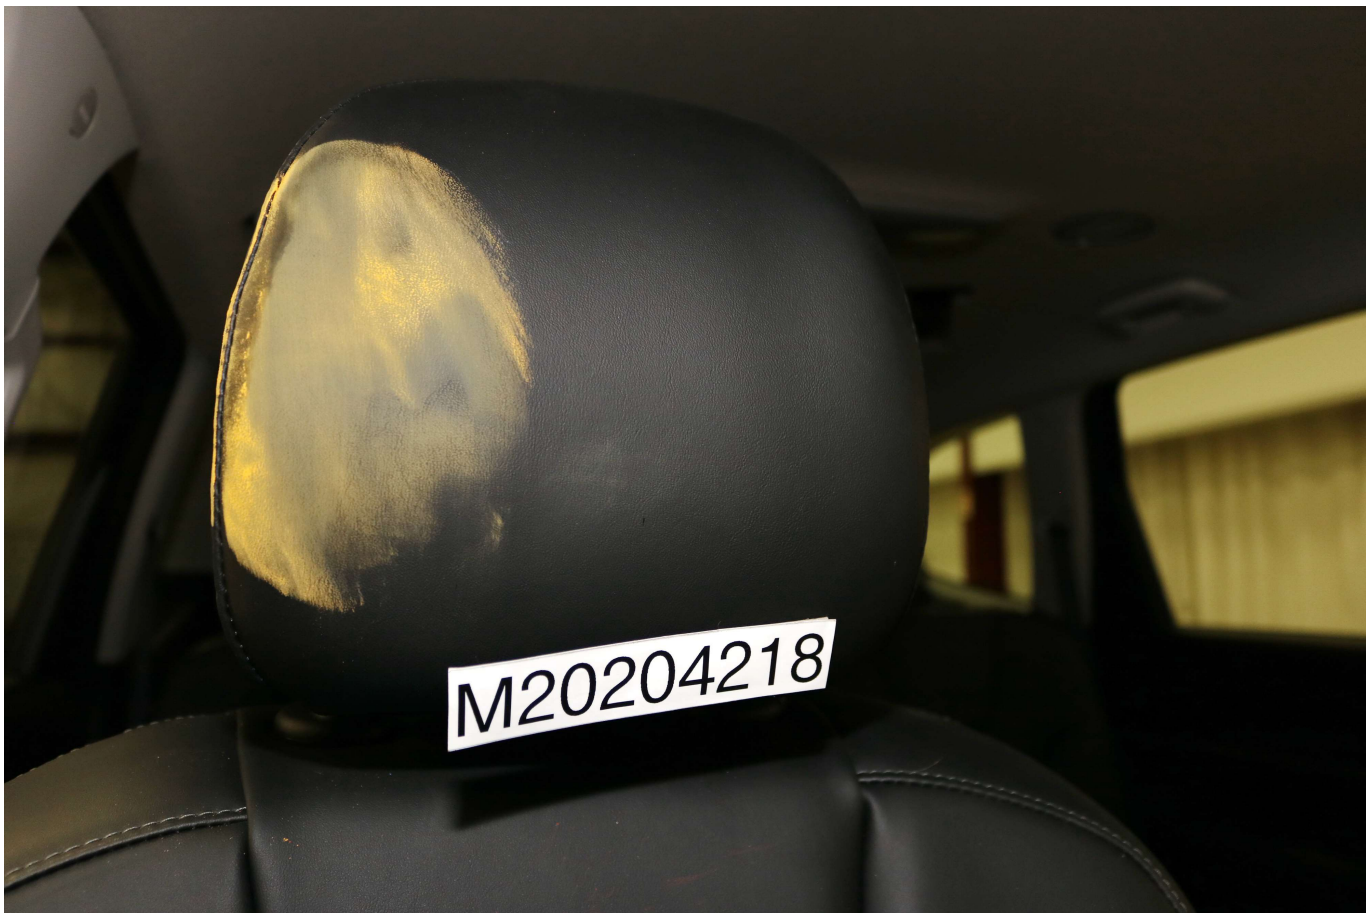
Photo No. 073 - Post-Test Passenger Dummy Contact with Headrest
