**REPORT NUMBER: SINCAP-MGA-20-005**

**NEW CAR ASSESSMENT PROGRAM (NCAP)  
Moving Deformable Barrier Side Impact Test**

**VOLVO CAR CORPORATION  
2020 Volvo XC40 T4 Momentum 5-Door SUV  
NHTSA No.: O20205902**

**FINAL REPORT**

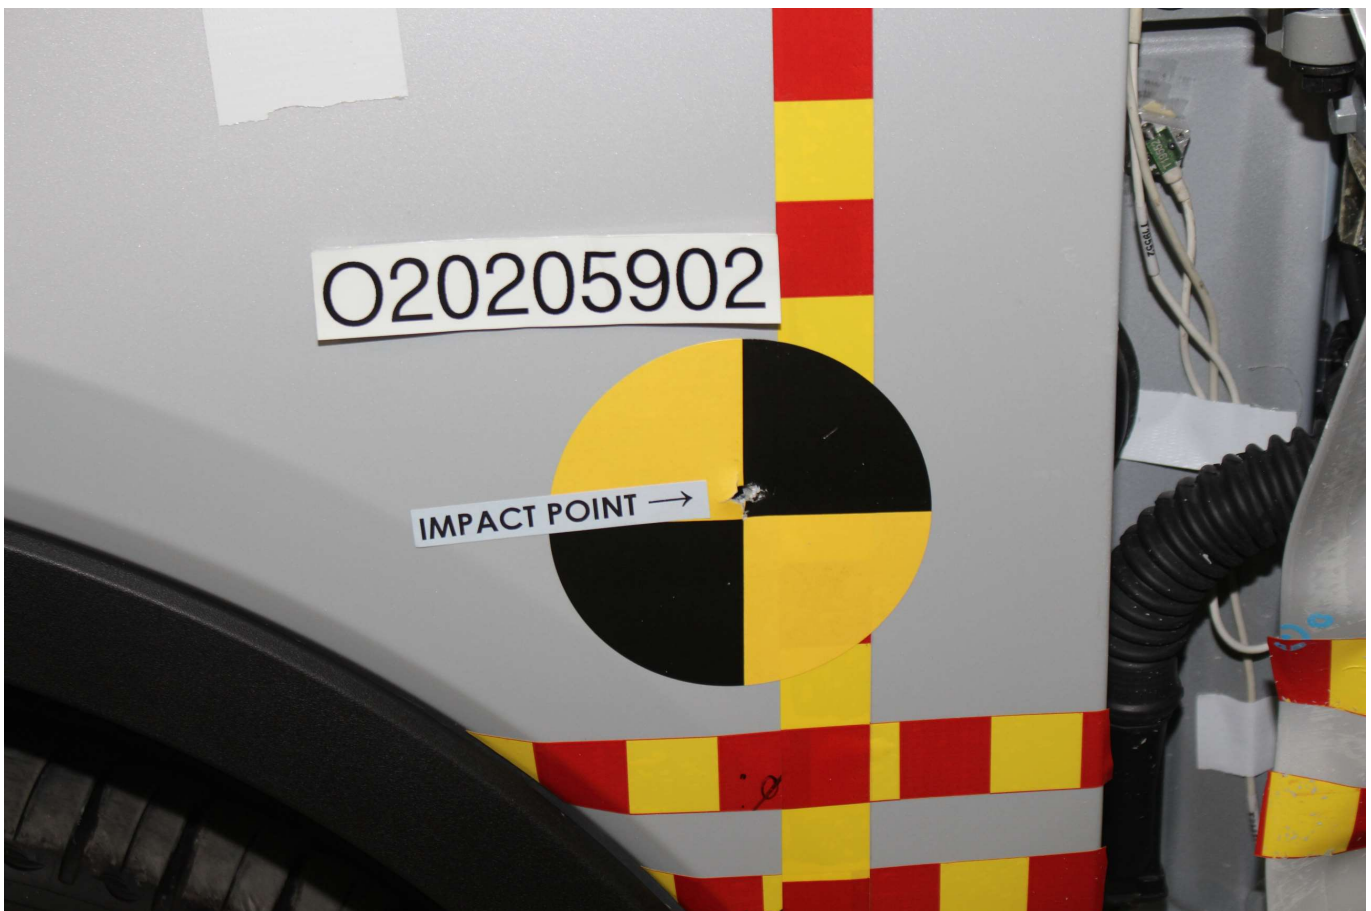
Photo No. 020 - Post-Test Close-Up View of Impact Point Target

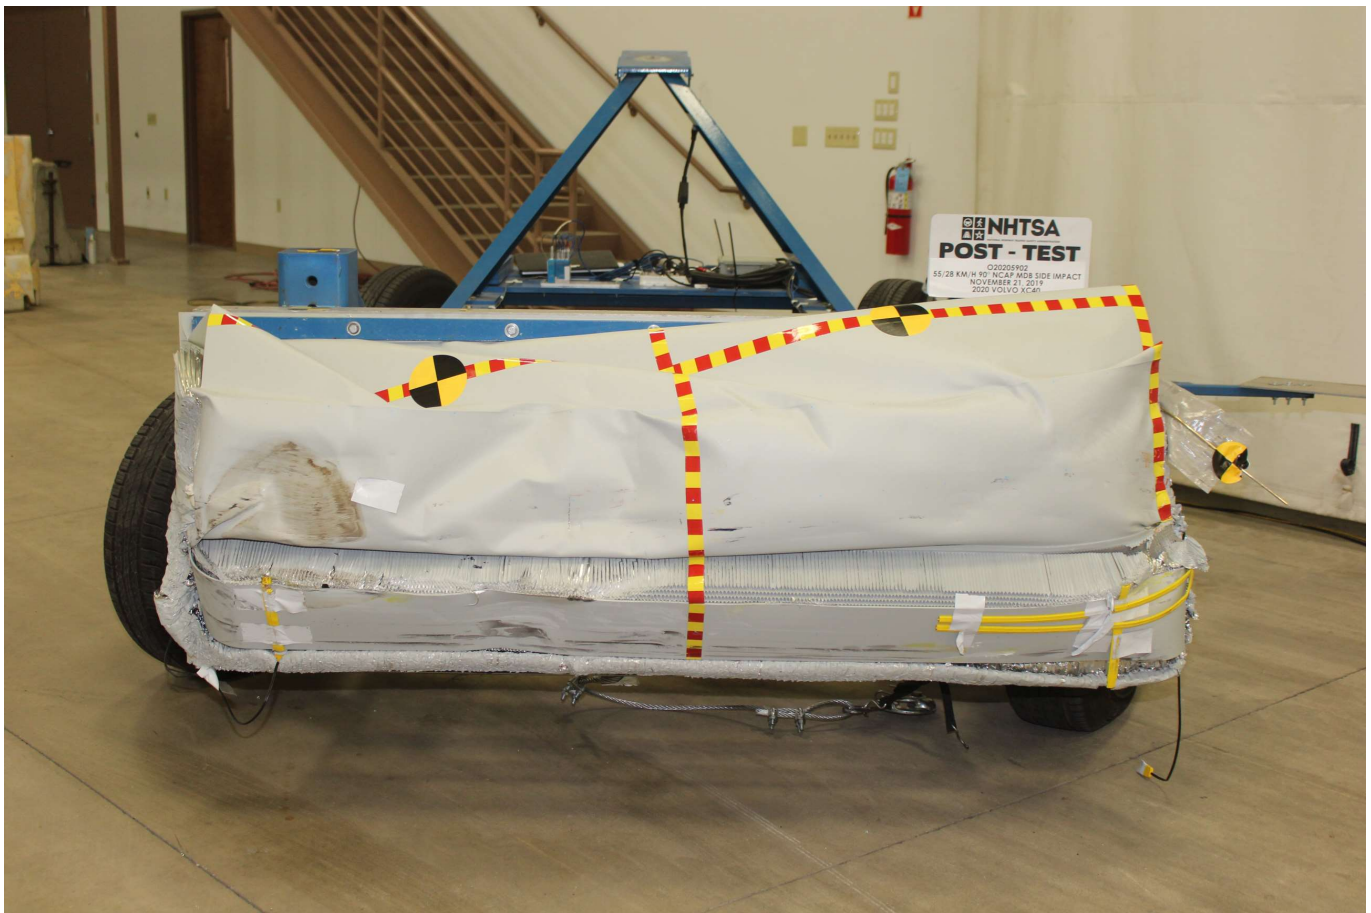
Photo No. 085 - Post-Test Front View of MDB Impactor Face

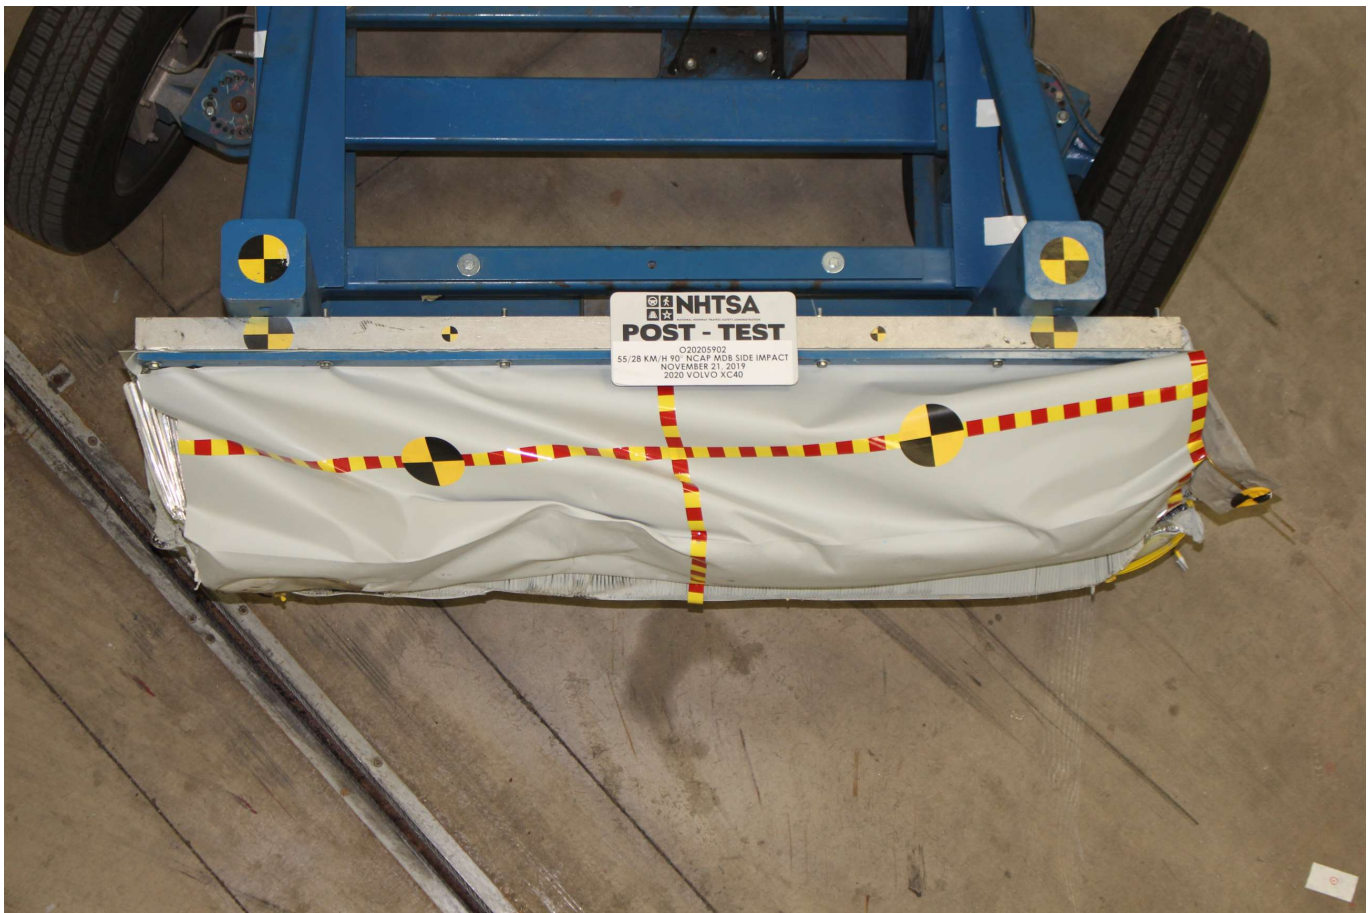
Photo No. 087 - Post-Test Top View of MDB Impactor Face

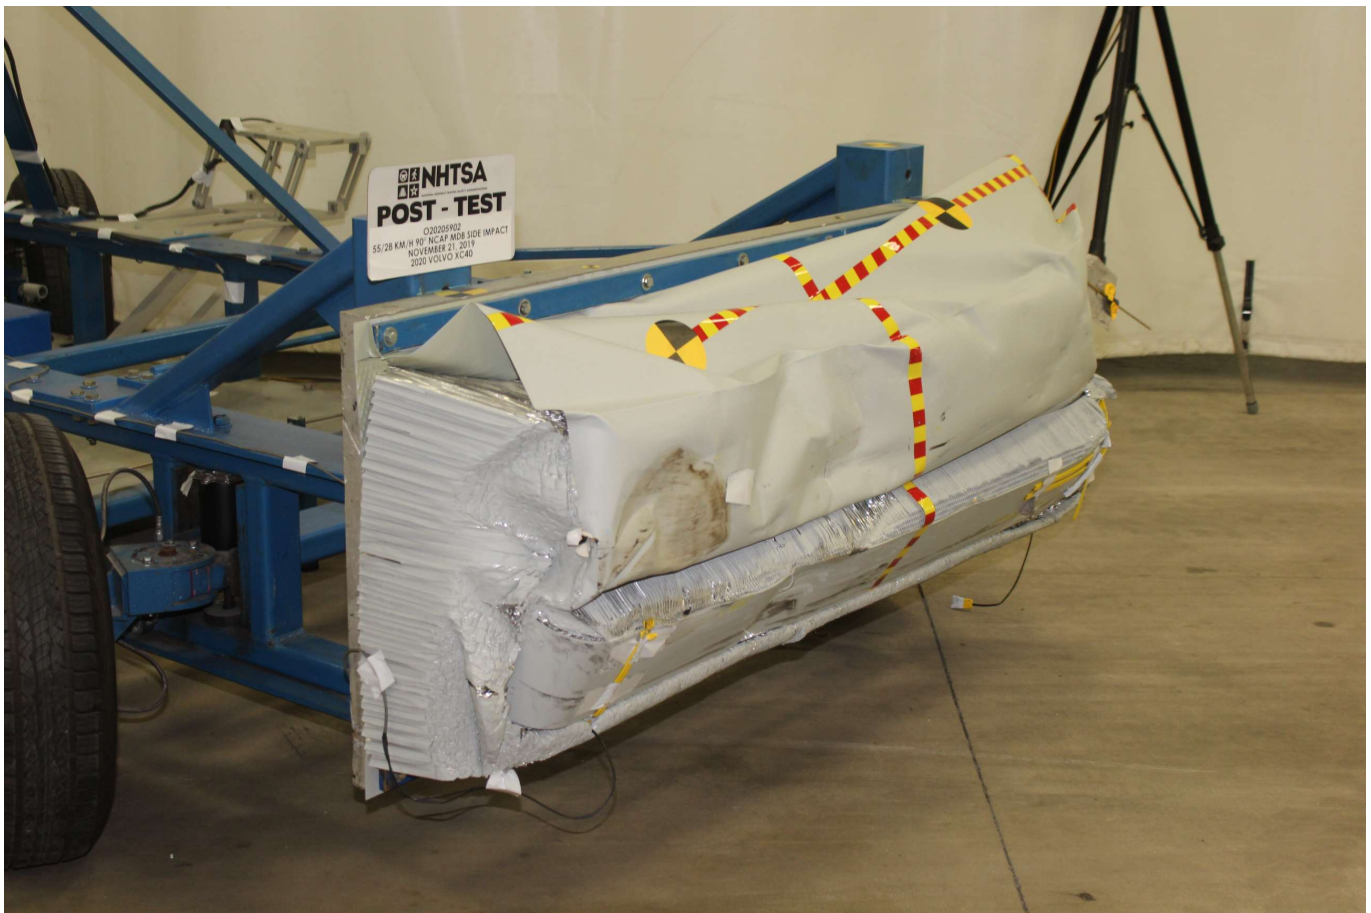
Photo No. 091 - Post-Test Right Side View of MDB Impactor Face
