**REPORT NUMBER: SPNCAP-KAR-20-002  
NEW CAR ASSESSMENT PROGRAM (NCAP)  
SIDE IMPACT POLE TEST**

**SUBARU CORPORATION  
2020 SUBARU OUTBACK 5-DOOR MPV**

**NHTSA No: O20205503**

**FINAL REPORT**

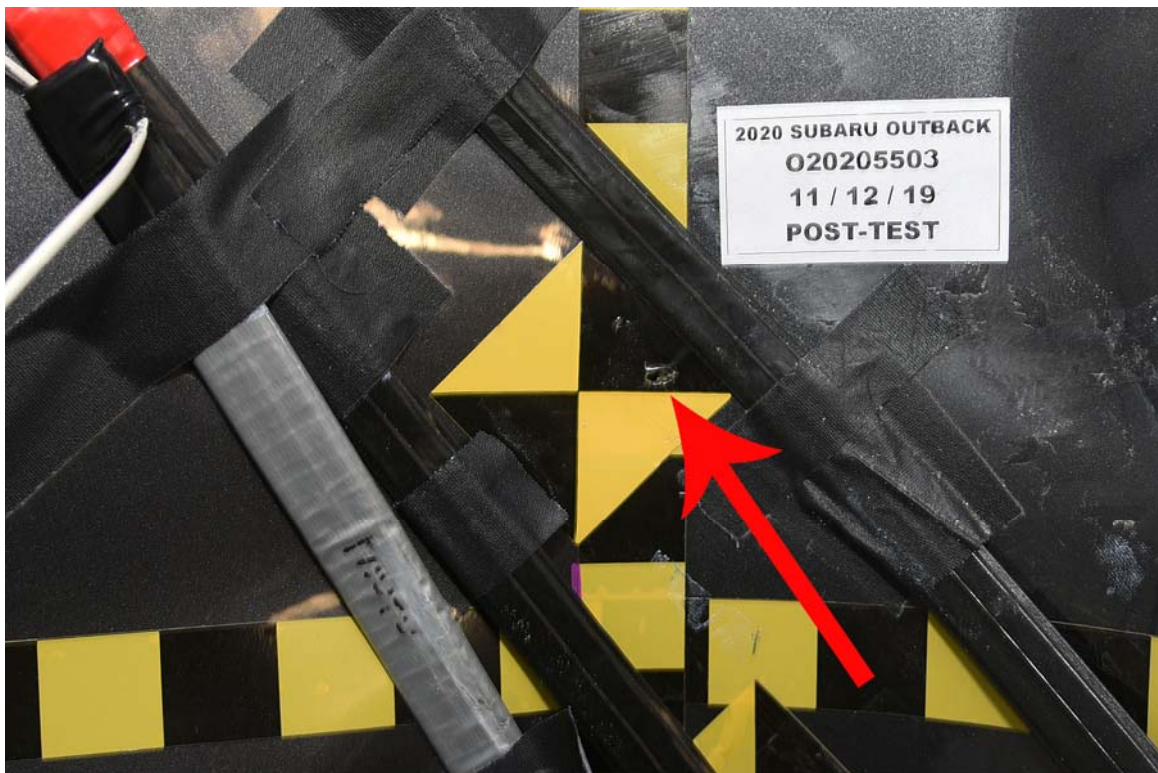
FIGURE 20. Post-Test Close-Up View of Impact Point Target Showing Impact Location

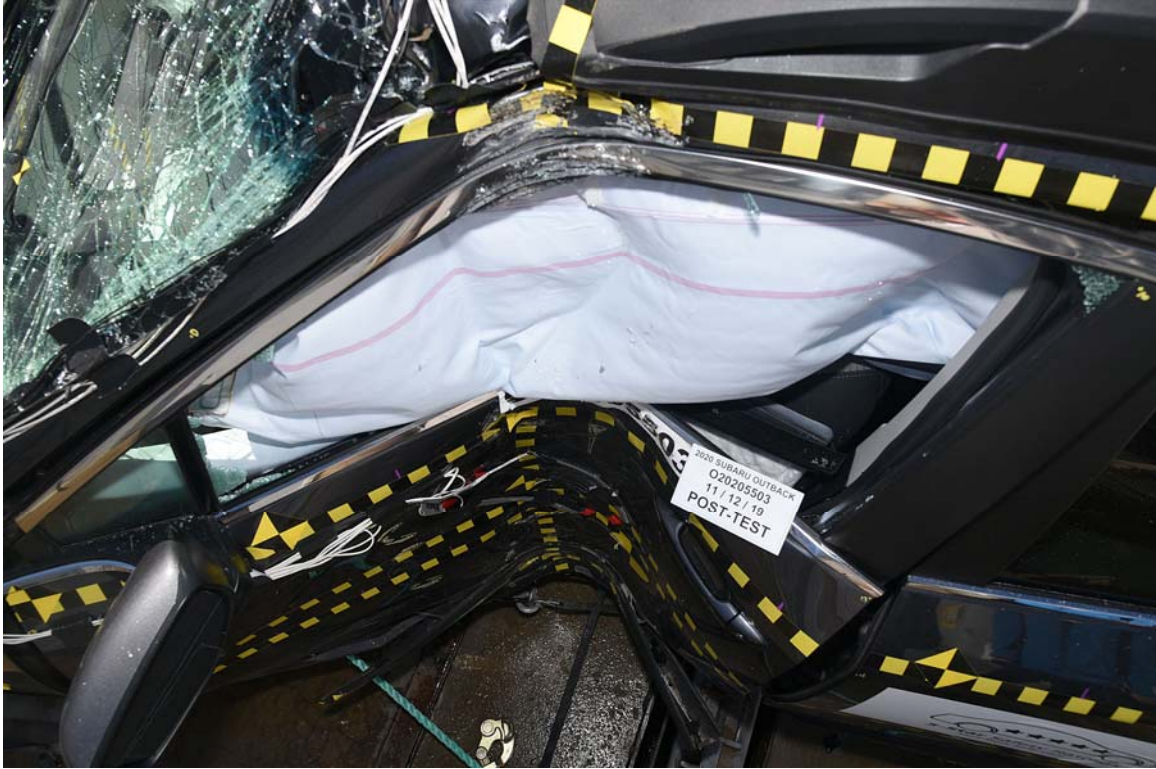
FIGURE 41. Post-Test Dummy and Door Clearance View

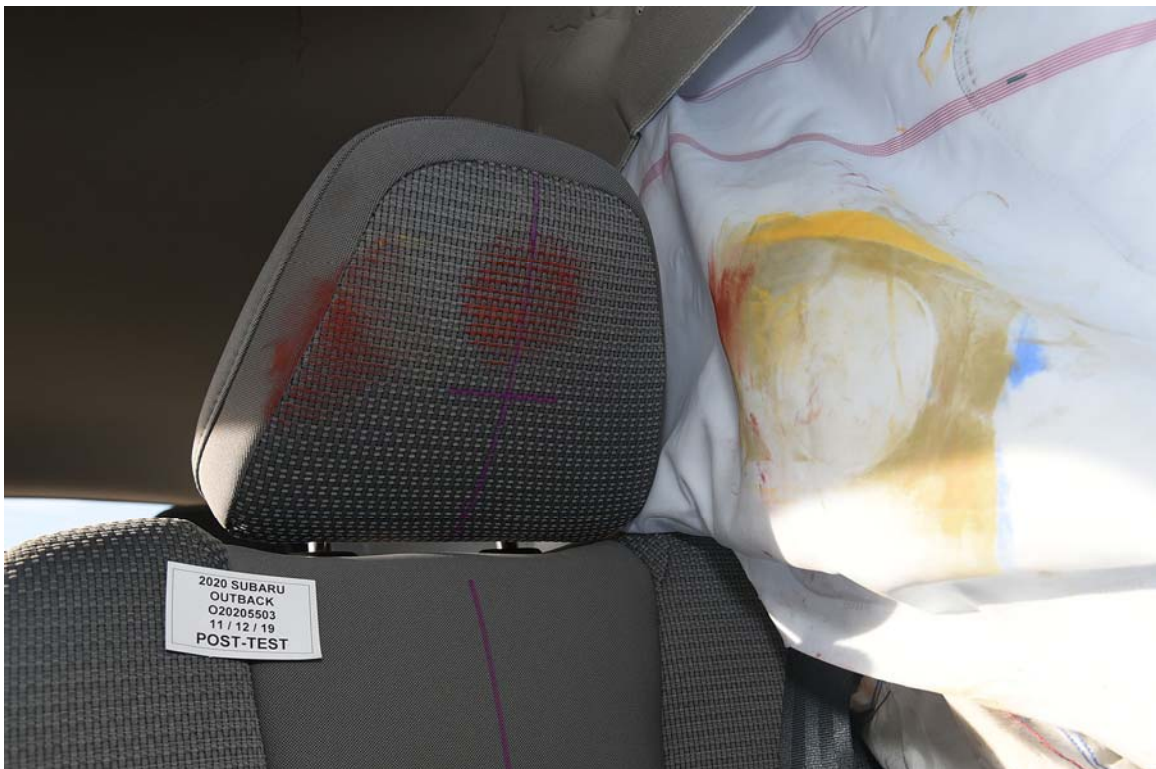
FIGURE 46. Post-Test Dummy Close-Up Head Contact with Vehicle Interior View

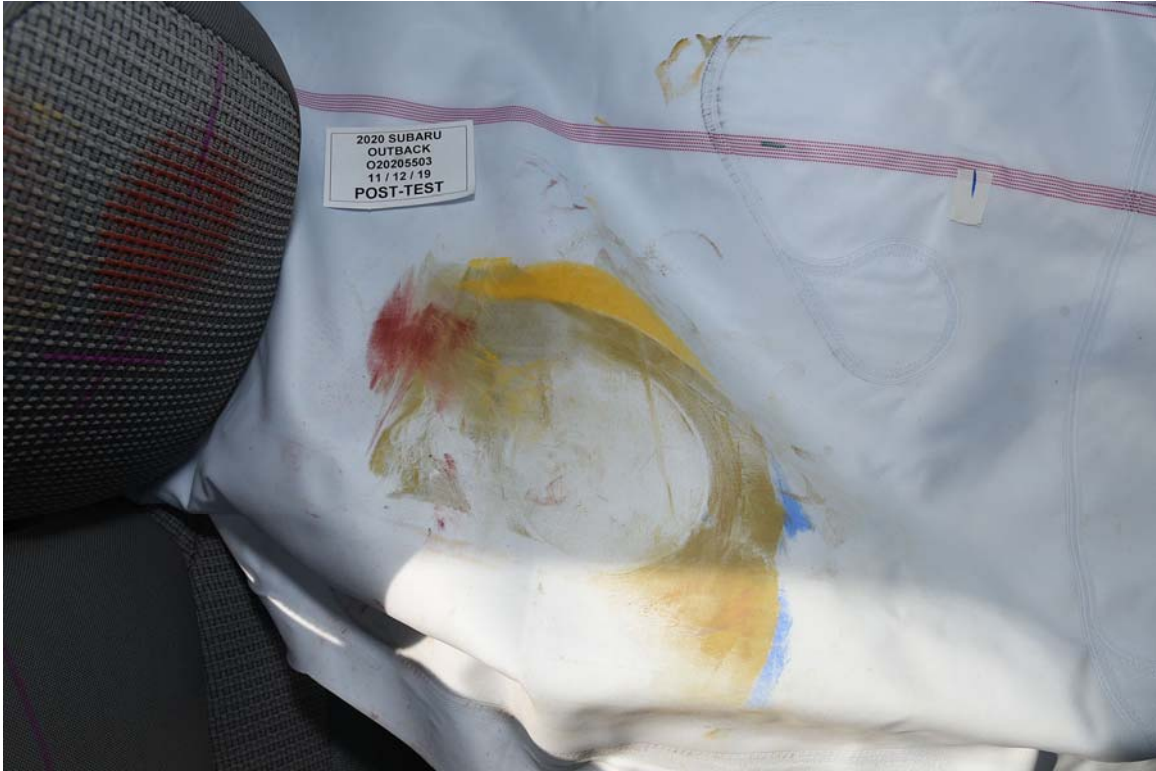
FIGURE 47. Post-Test Dummy Close-Up Head Contact With Side Airbag View

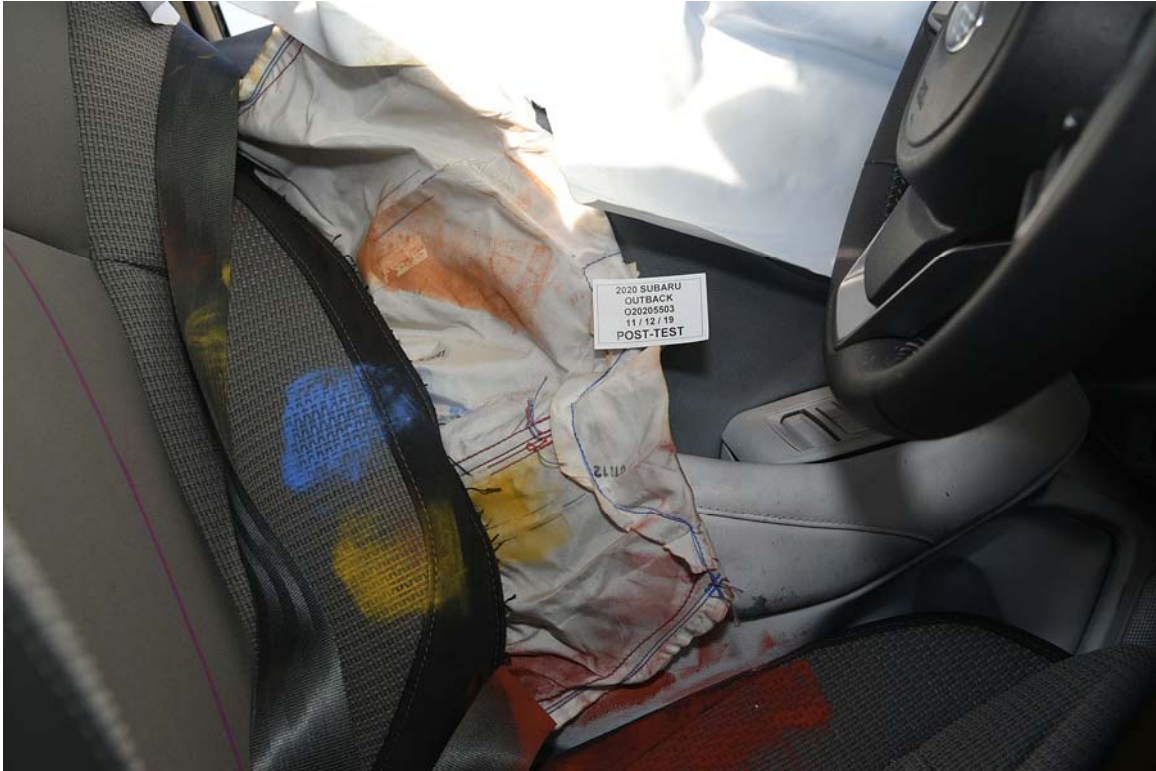
FIGURE 49. Post-Test Dummy Close-Up Torso Contact With Side Airbag View

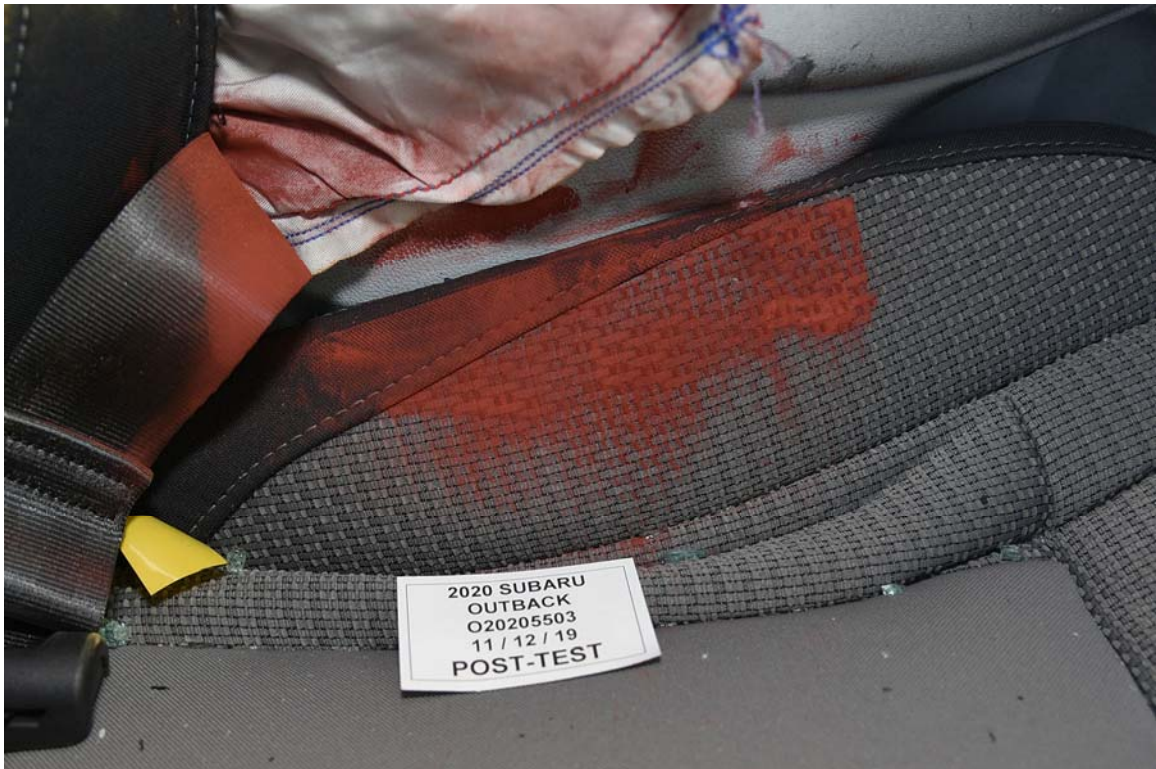
FIGURE 50. Post-Test Dummy Close-Up Pelvis Contact With Vehicle Interior View

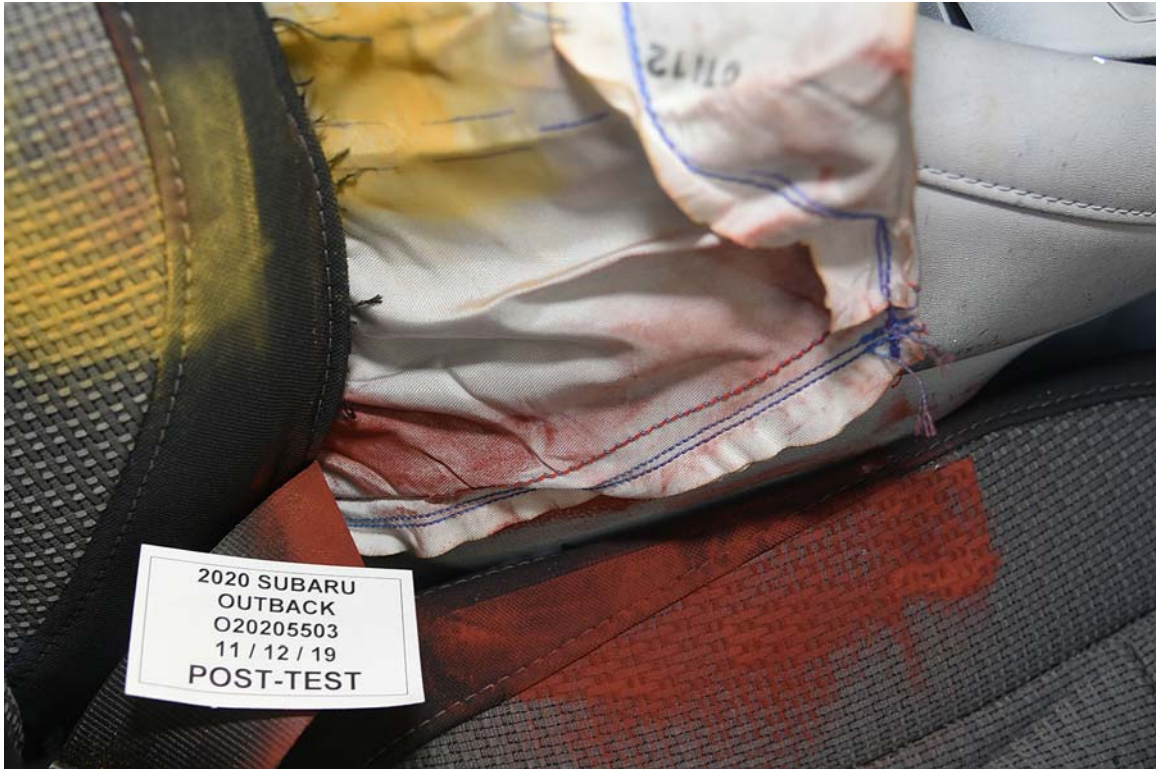
FIGURE 51. Post-Test Dummy Close-Up Pelvis Contact With Side Airbag View

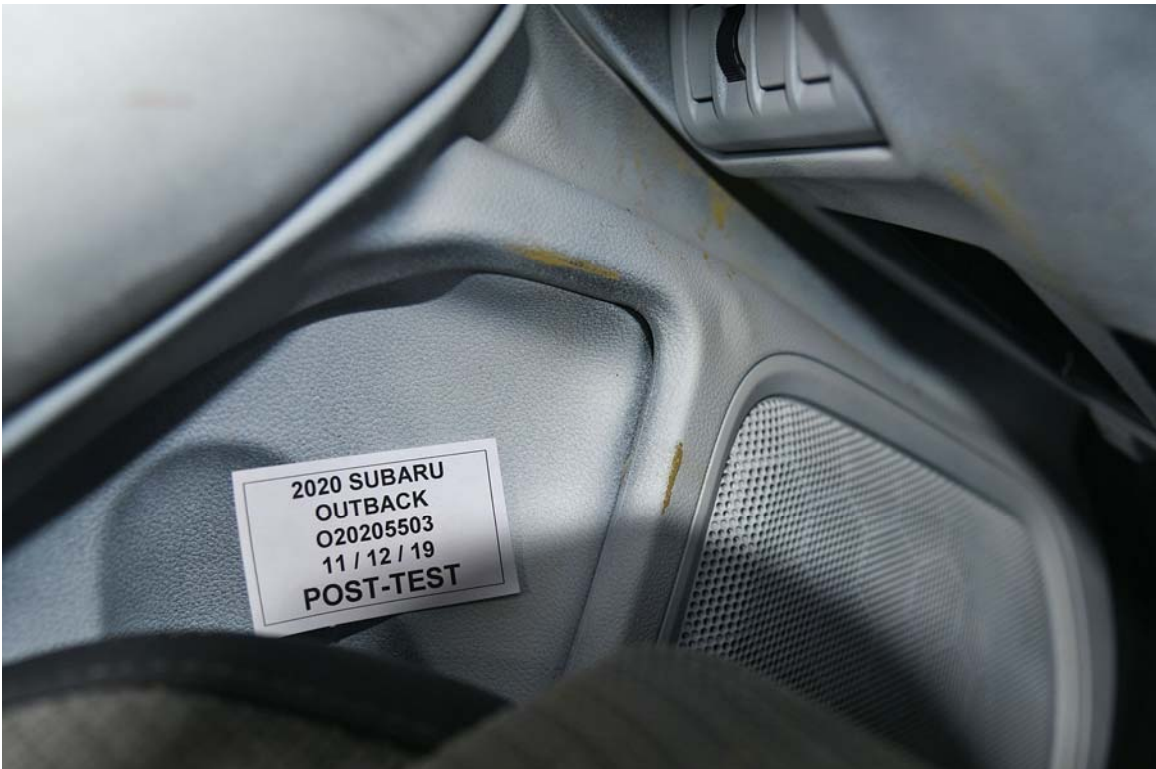
FIGURE 52. Post-Test Dummy Close-Up Knee Contact with Vehicle Interior View

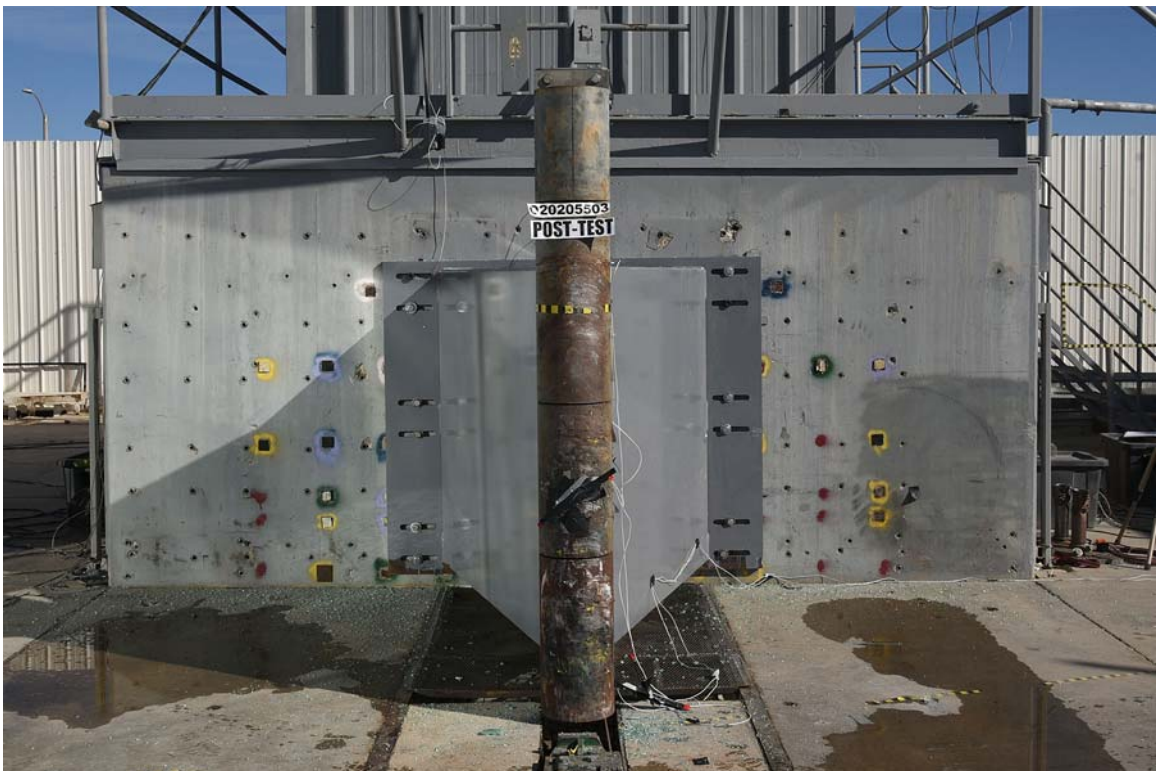
FIGURE 58. Post-Test Pole Barrier Front View

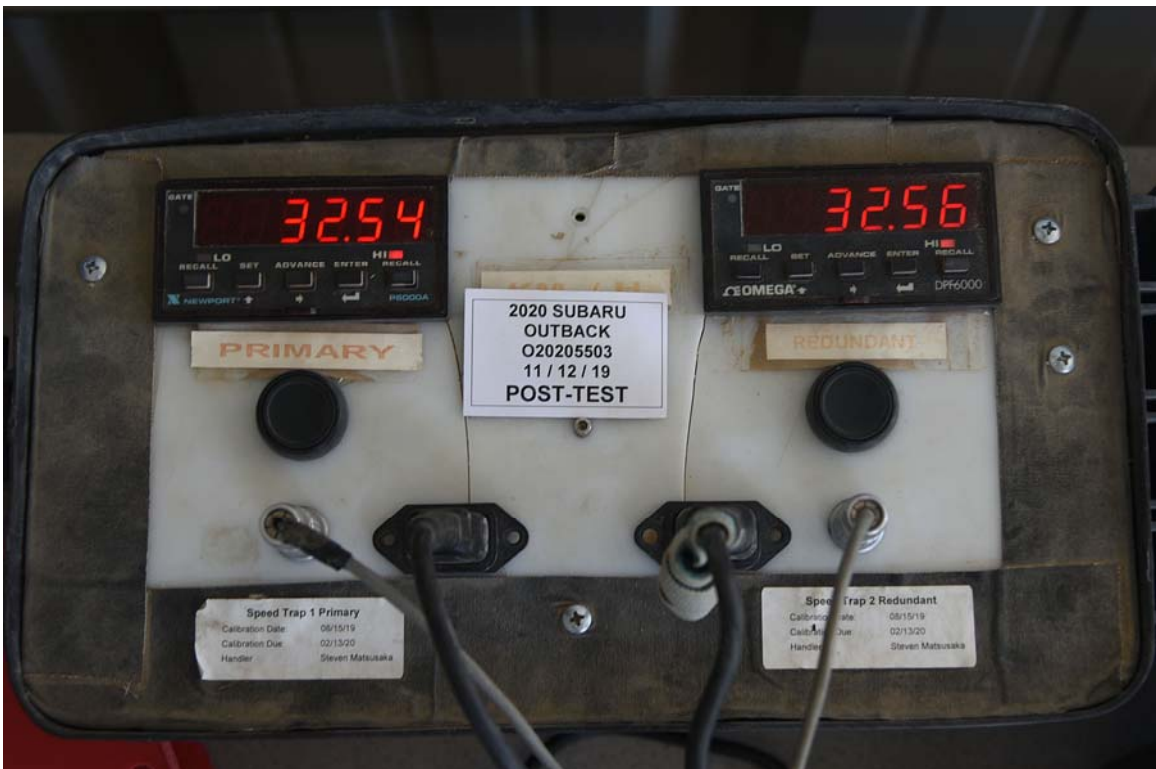
FIGURE 62. Post-Test Primary and Redundant Speed Trap Read-Out

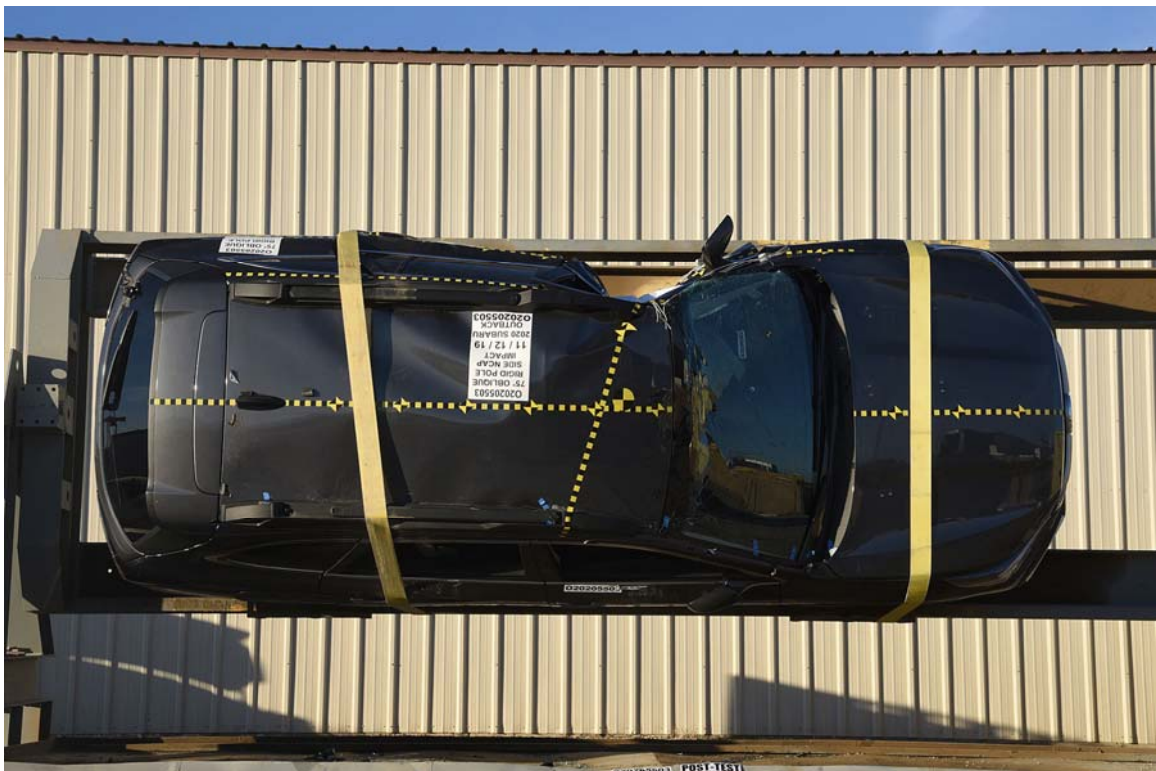
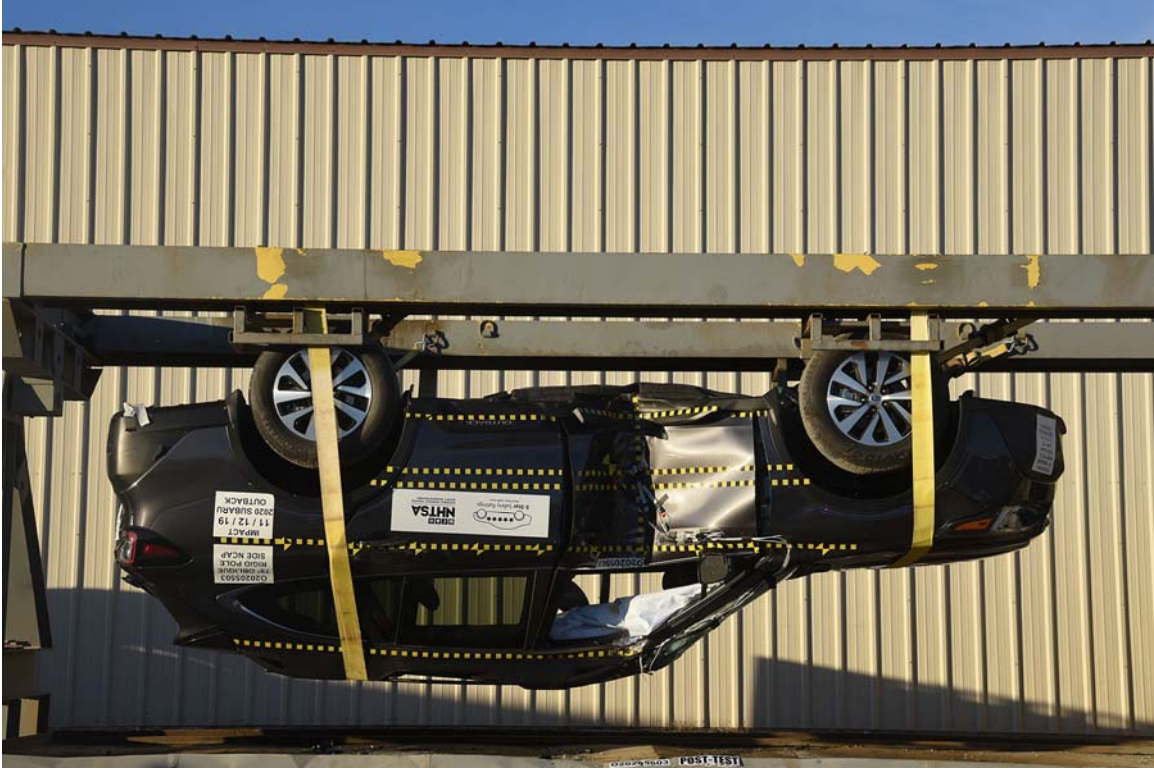
FIGURE 63. FMVSS No. 301 Static Rollover 0 Degrees

FIGURE 64. FMVSS No. 301 Static Rollover 90 Degrees

FIGURE 65. FMVSS No. 301 Static Rollover 180 Degrees

FIGURE 66. FMVSS No. 301 Static Rollover 270 Degrees

FIGURE 67. FMVSS No. 301 Static Rollover 360 Degrees
