**REPORT NUMBER: SINCAP-KAR-20-004**

**NEW CAR ASSESSMENT PROGRAM (NCAP)  
MOVING DEFORMABLE BARRIER SIDE IMPACT TEST**

**SUBARU CORPORATION  
2020 SUBARU OUTBACK 5-DOOR MPV**

**NHTSA No: O20205504**

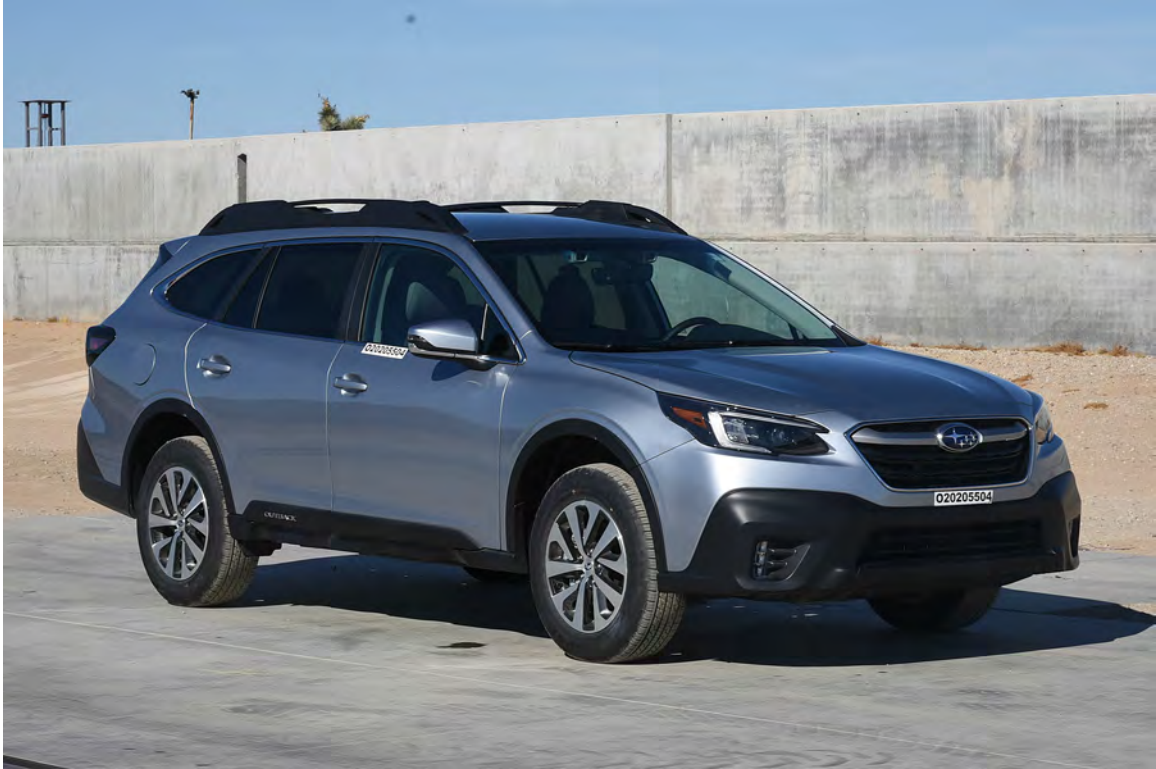
FIGURE 1. As-Delivered Right Front  $\frac{3}{4}$  View of Test Vehicle

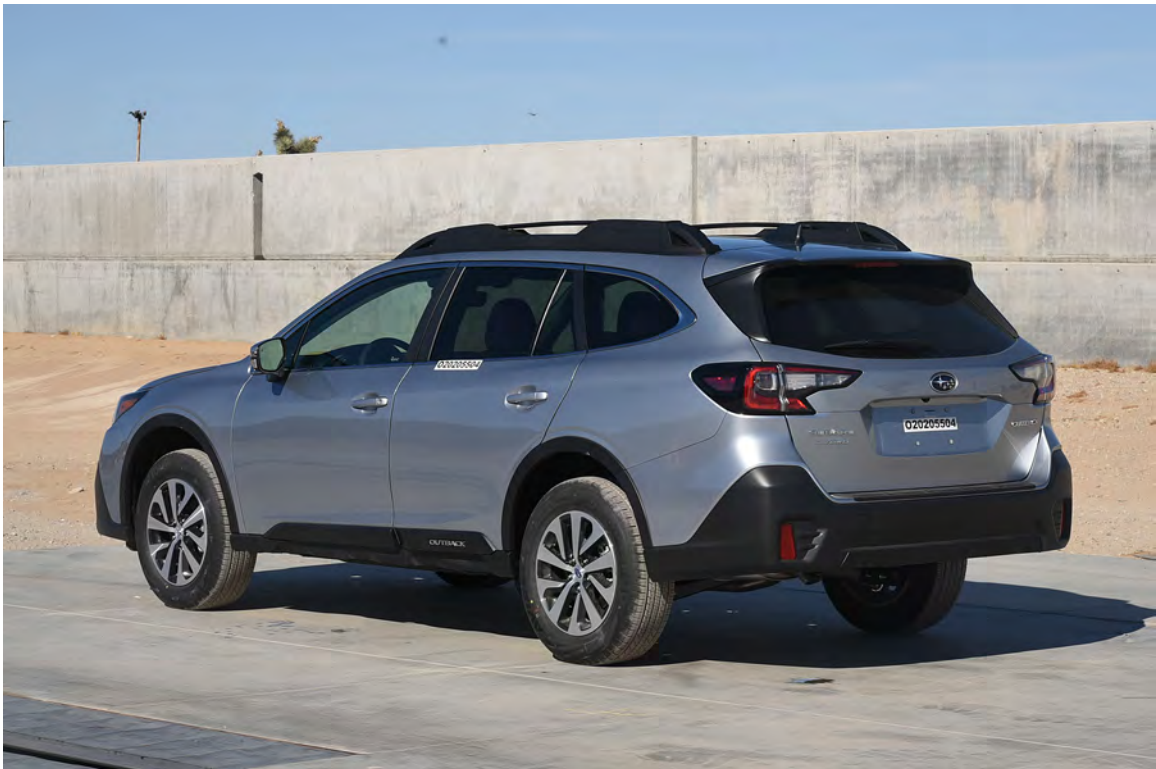
FIGURE 2. As-Delivered Left Rear  $\frac{3}{4}$  View of Test Vehicle

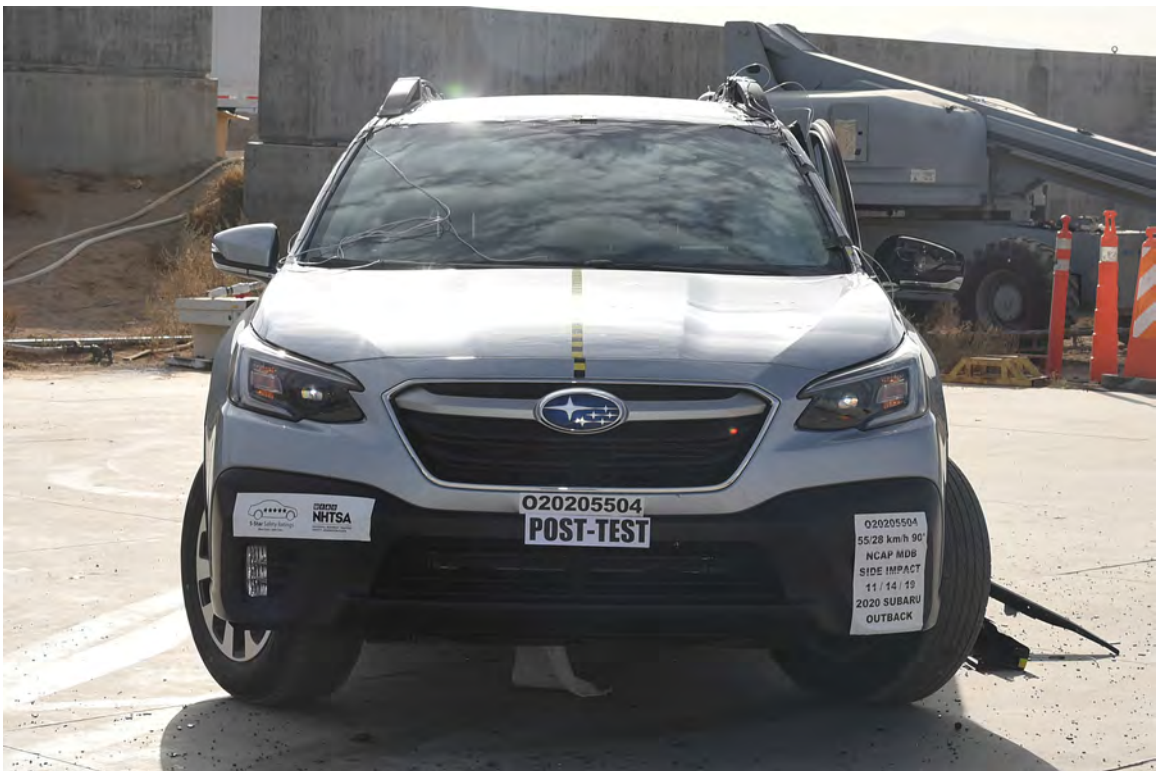
FIGURE 4. Post-Test Frontal View of Test Vehicle

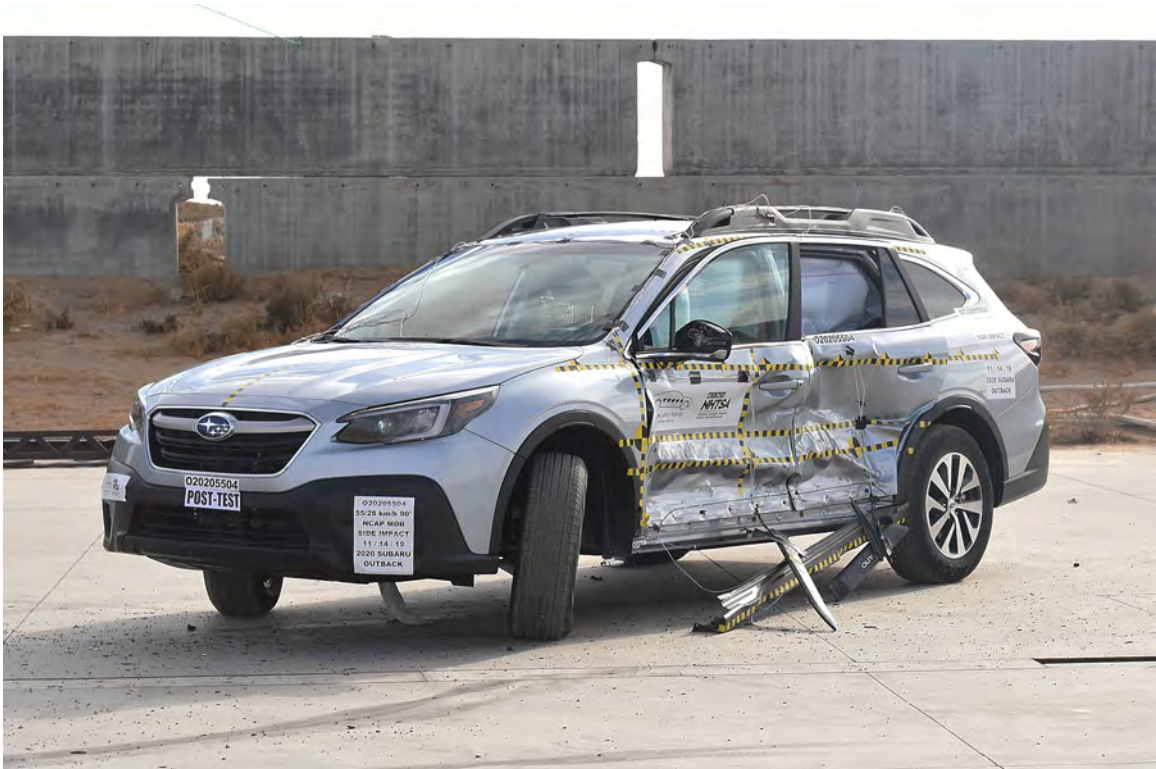
FIGURE 6. Post-Test Left Front  $\frac{3}{4}$  View of Test Vehicle

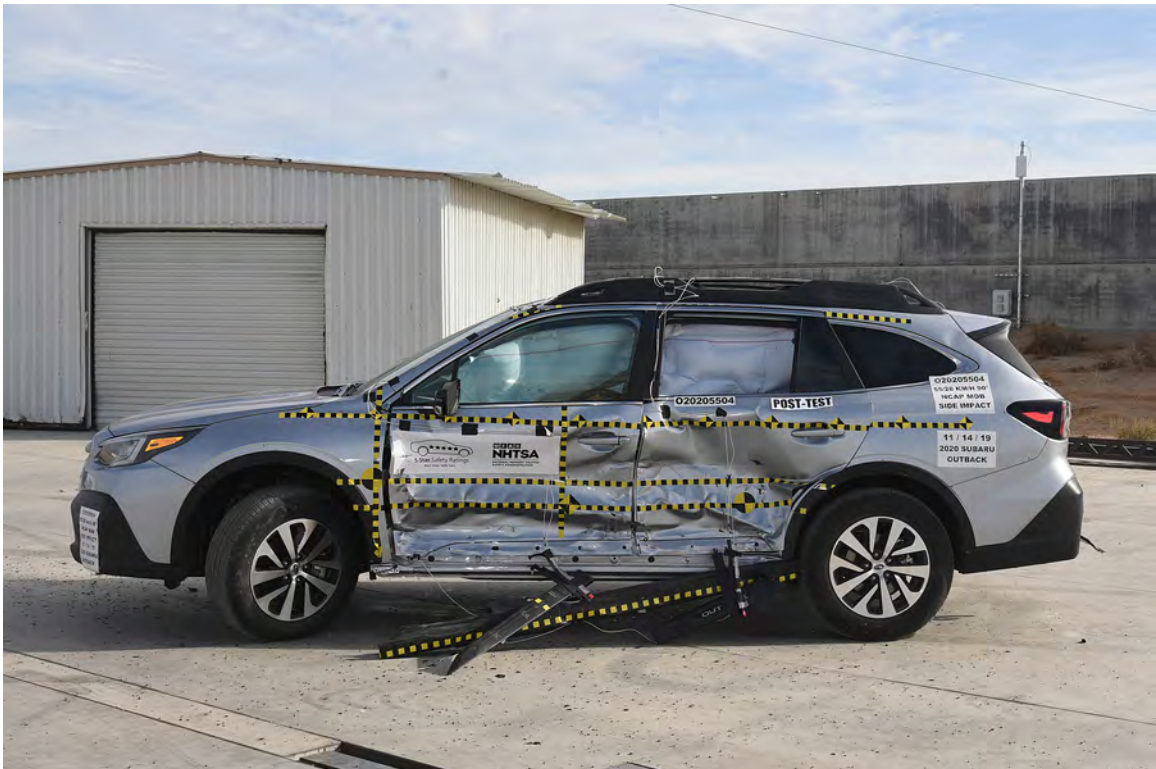
FIGURE 8. Post-Test Left Side View of Test Vehicle

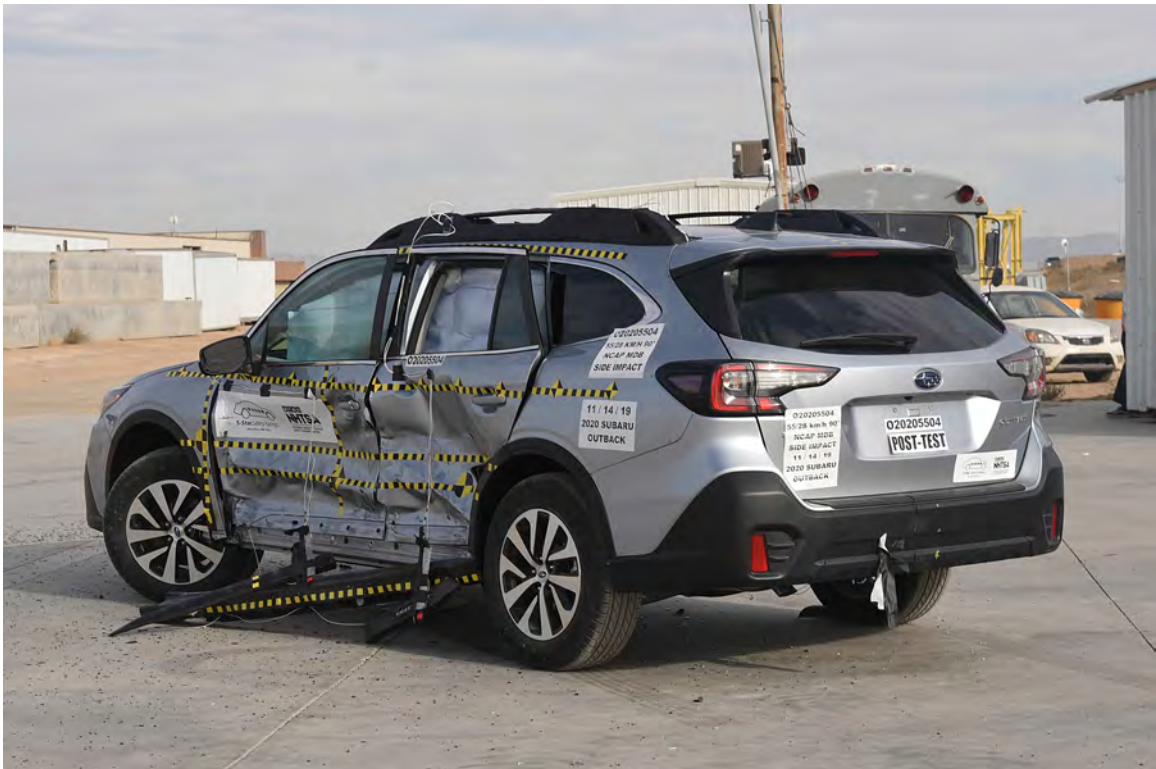
FIGURE 10. Post-Test Left Rear  $\frac{3}{4}$  View of Test Vehicle

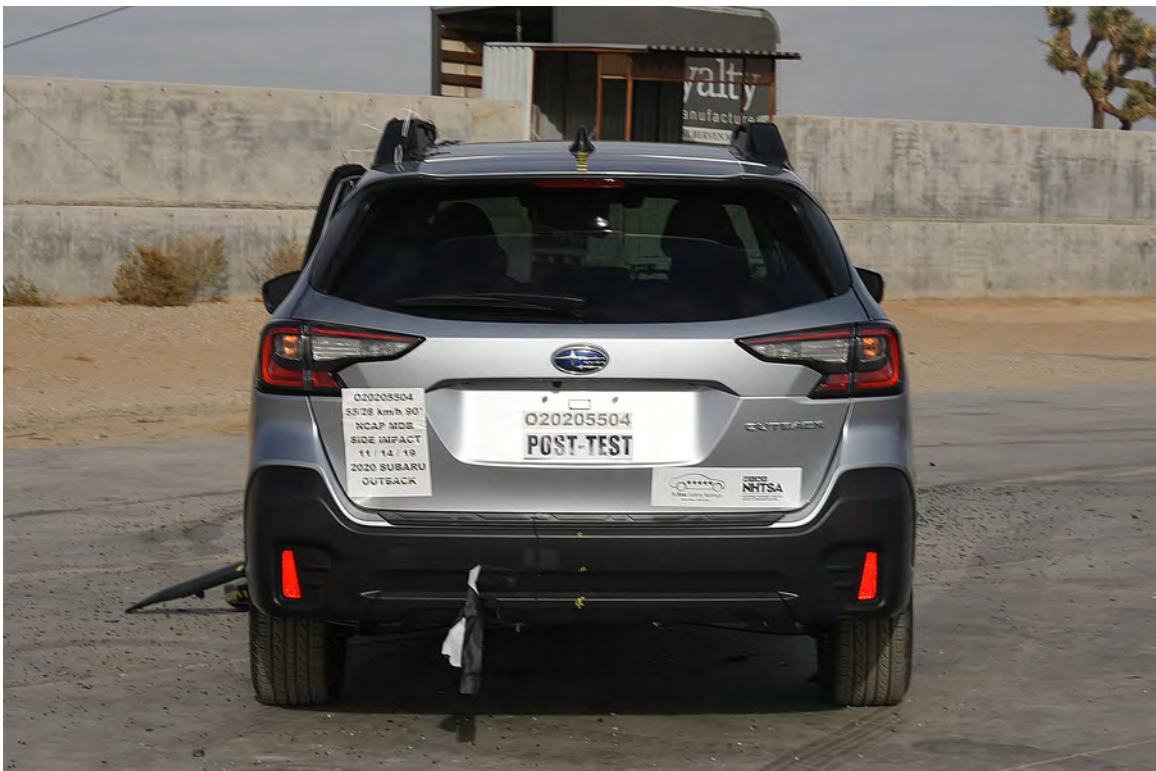
FIGURE 12. Post-Test Rear View of Test Vehicle

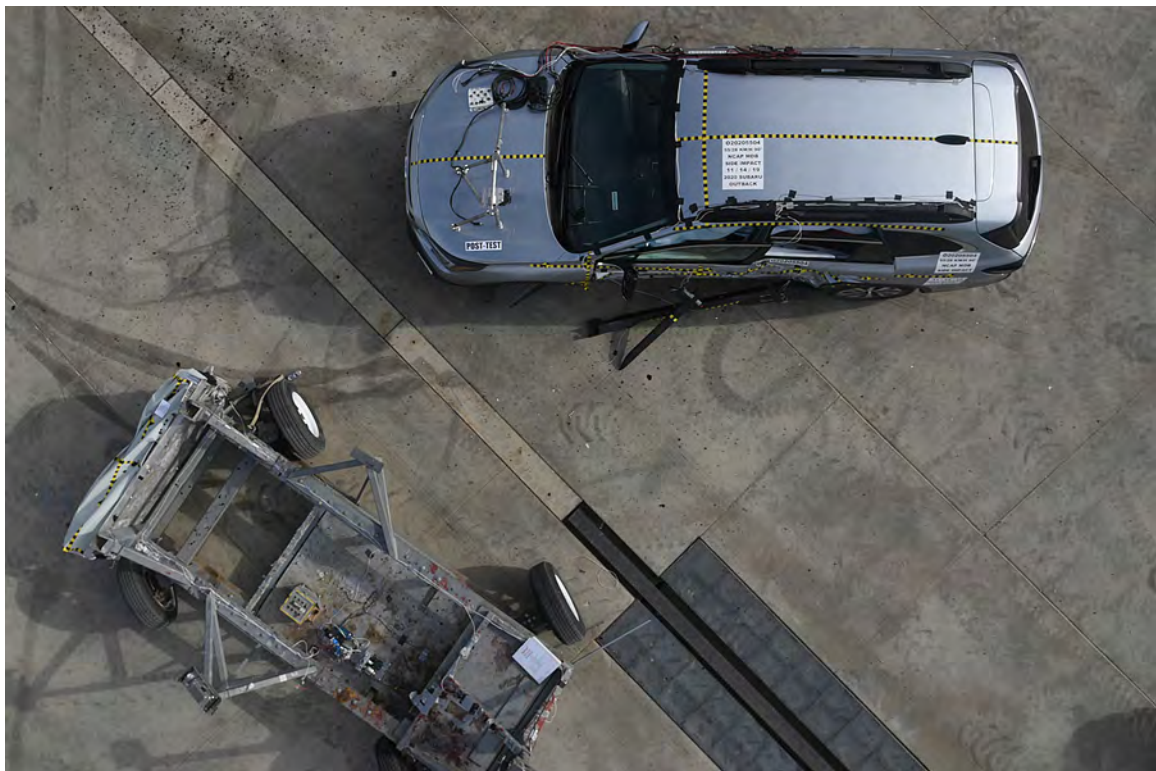
FIGURE 16. Post-Test Overhead View of Test Area

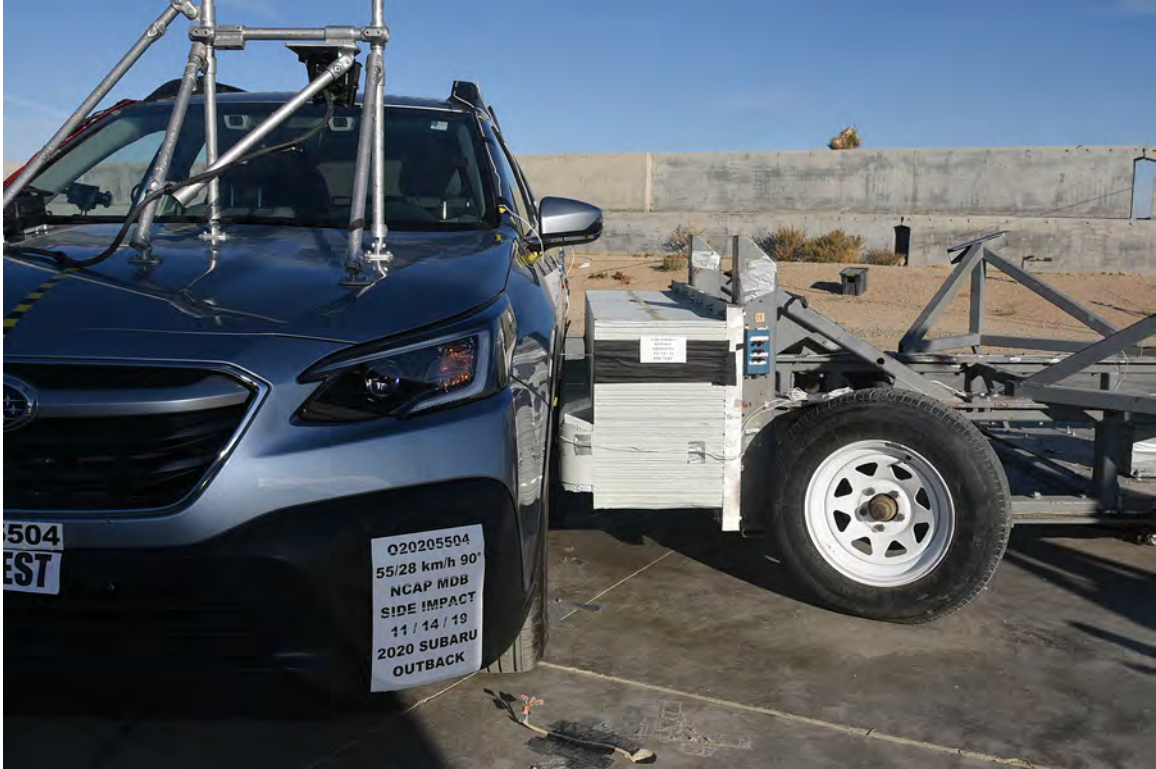
FIGURE 17. Pre-Test Left Side View of MDB Positioned  
Against Side of Test Vehicle

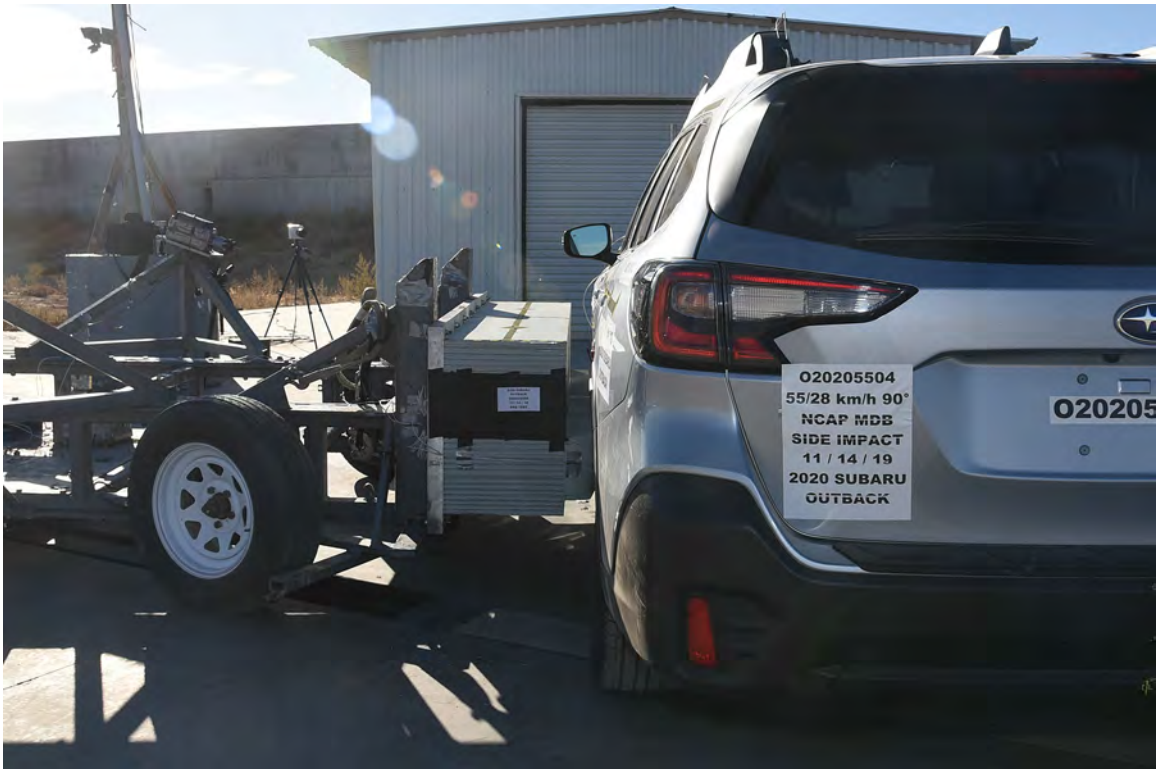
FIGURE 18. Pre-Test Right Side View of MDB Positioned  
Against Side of Test Vehicle

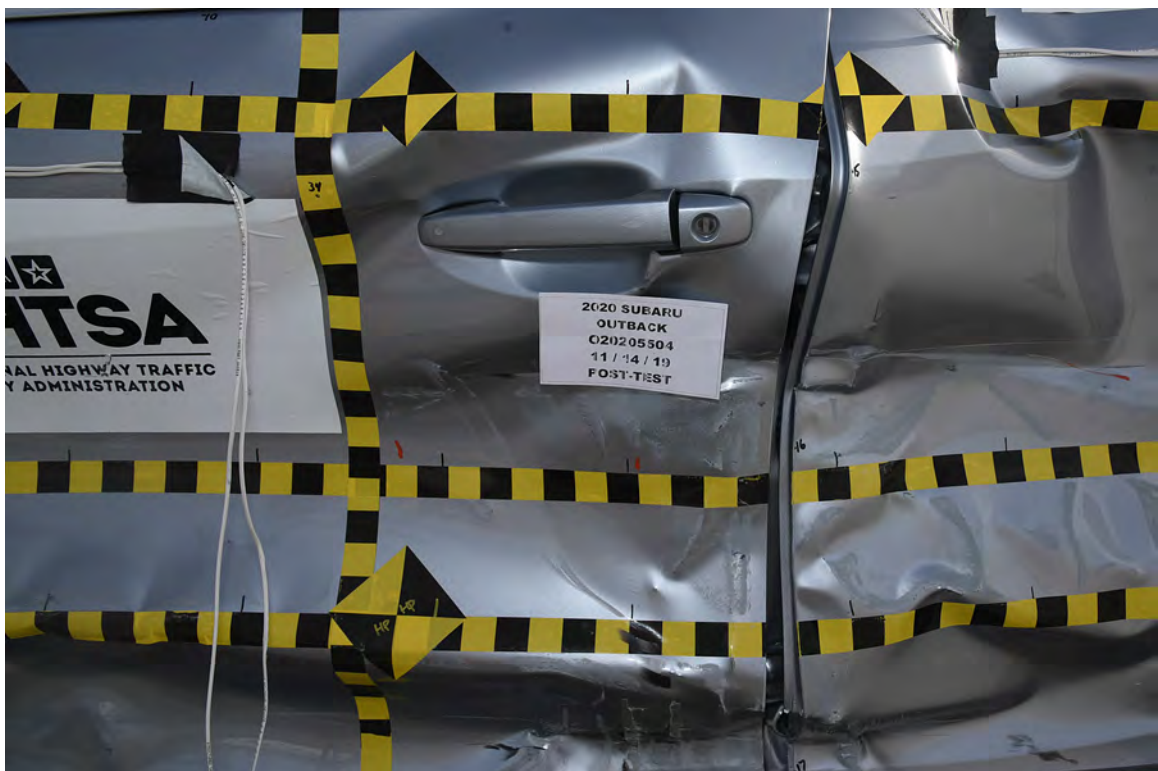
FIGURE 22. Post-Test Left Front Door Latch Close-Up

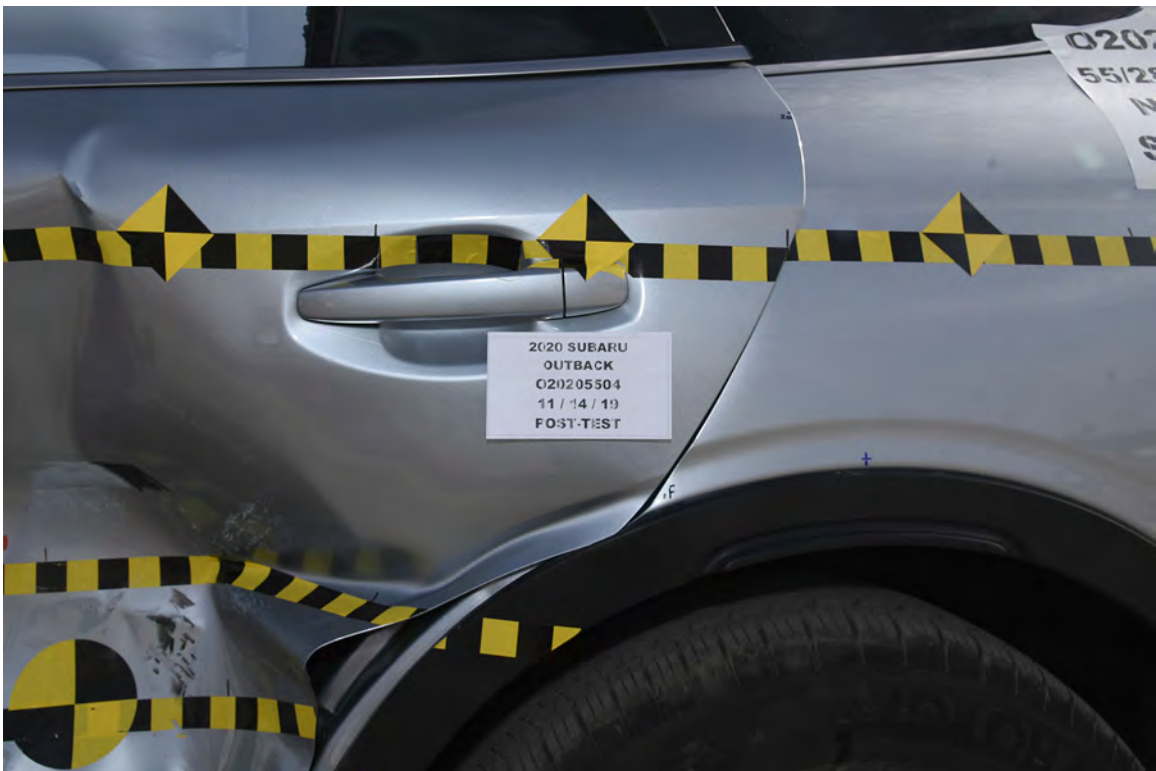
FIGURE 24. Post-Test Left Rear Door Latch Close-Up

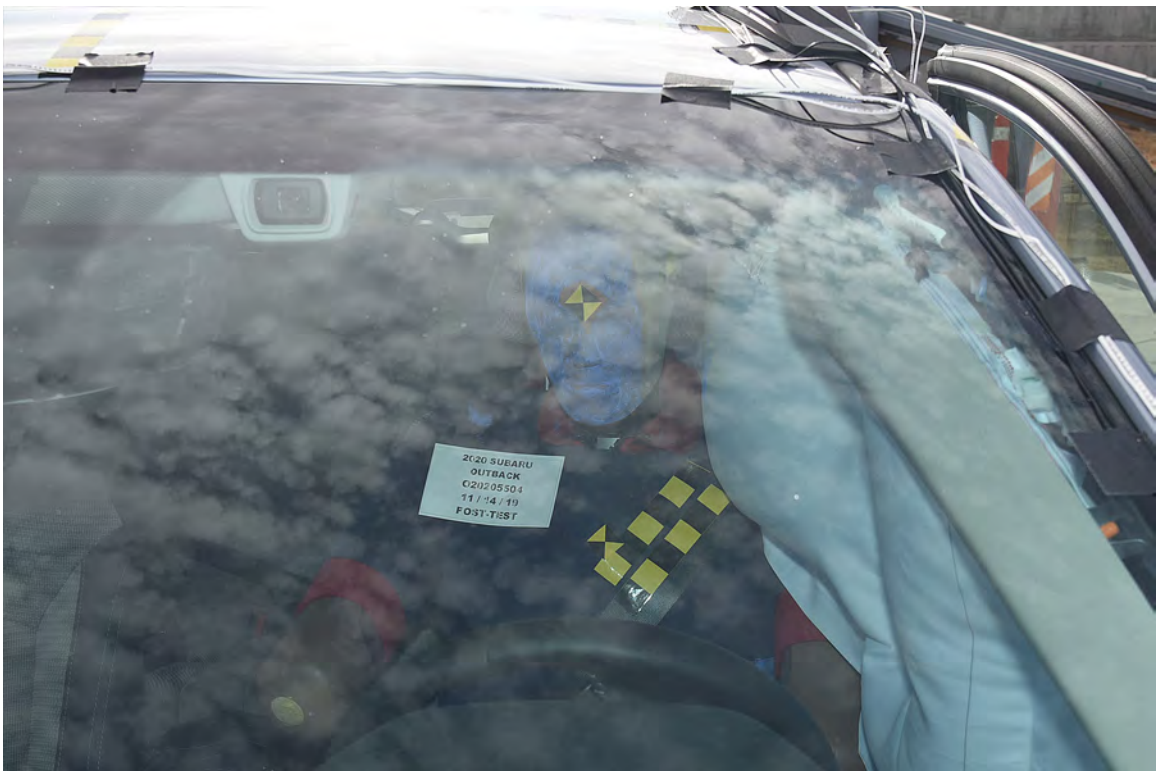
FIGURE 26. Post-Test Front Close-Up View of Driver Dummy

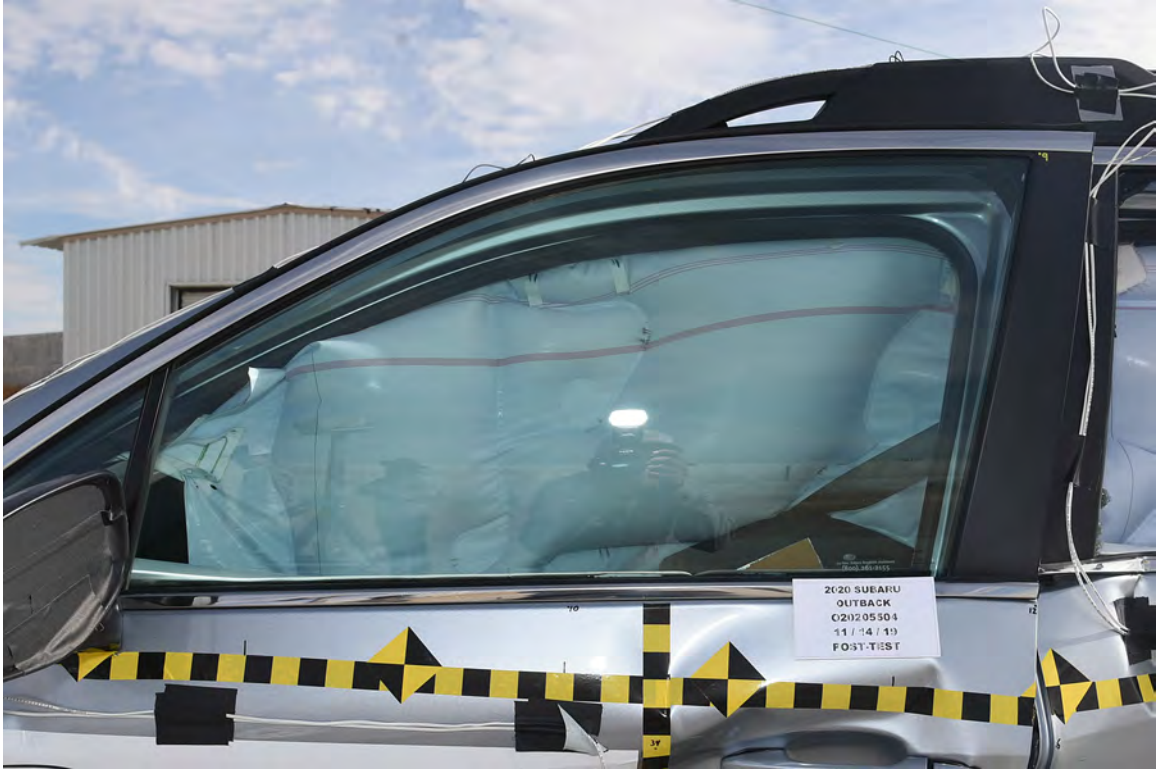
FIGURE 29. Post-Test Left Side View of Driver Dummy Shoulder and Door Top View

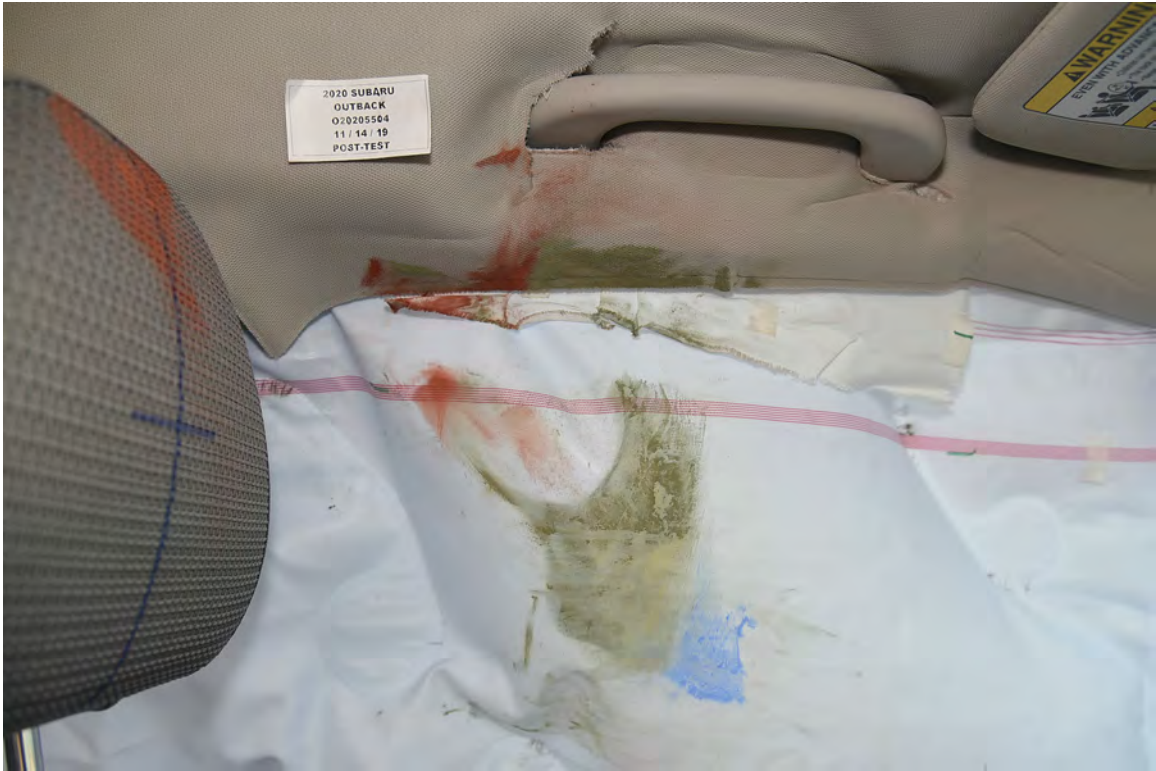
FIGURE 49. Post-Test Driver Dummy Close-Up Head Contact with Side Airbag View

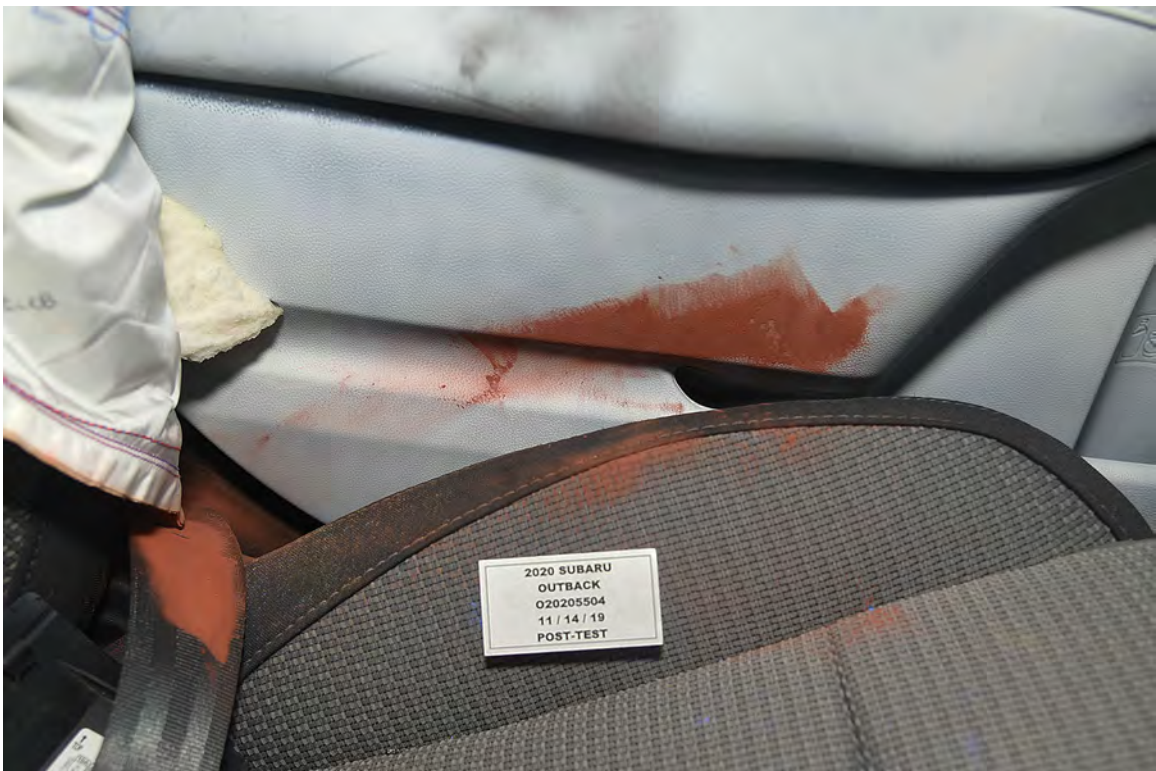
FIGURE 52. Post-Test Driver Dummy Close-Up Pelvis Contact  
with Vehicle Interior View

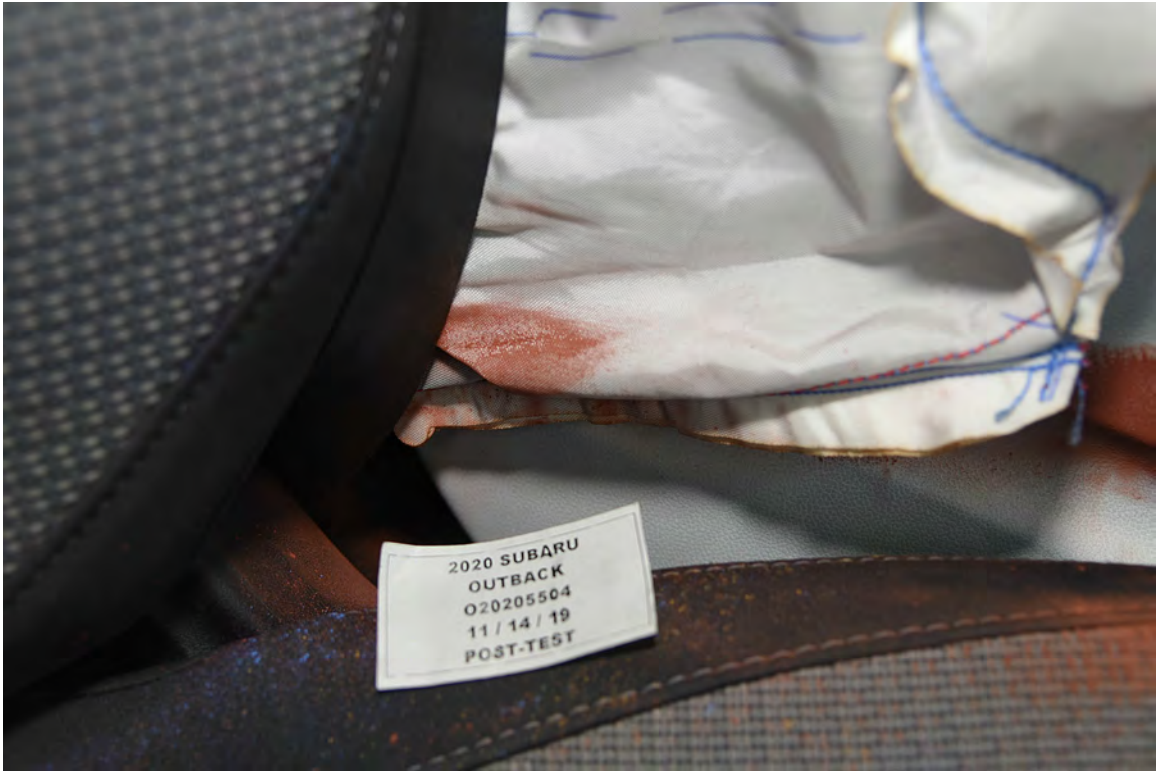
FIGURE 53. Post-Test Driver Dummy Close-Up Pelvis Contact with Side Airbag View

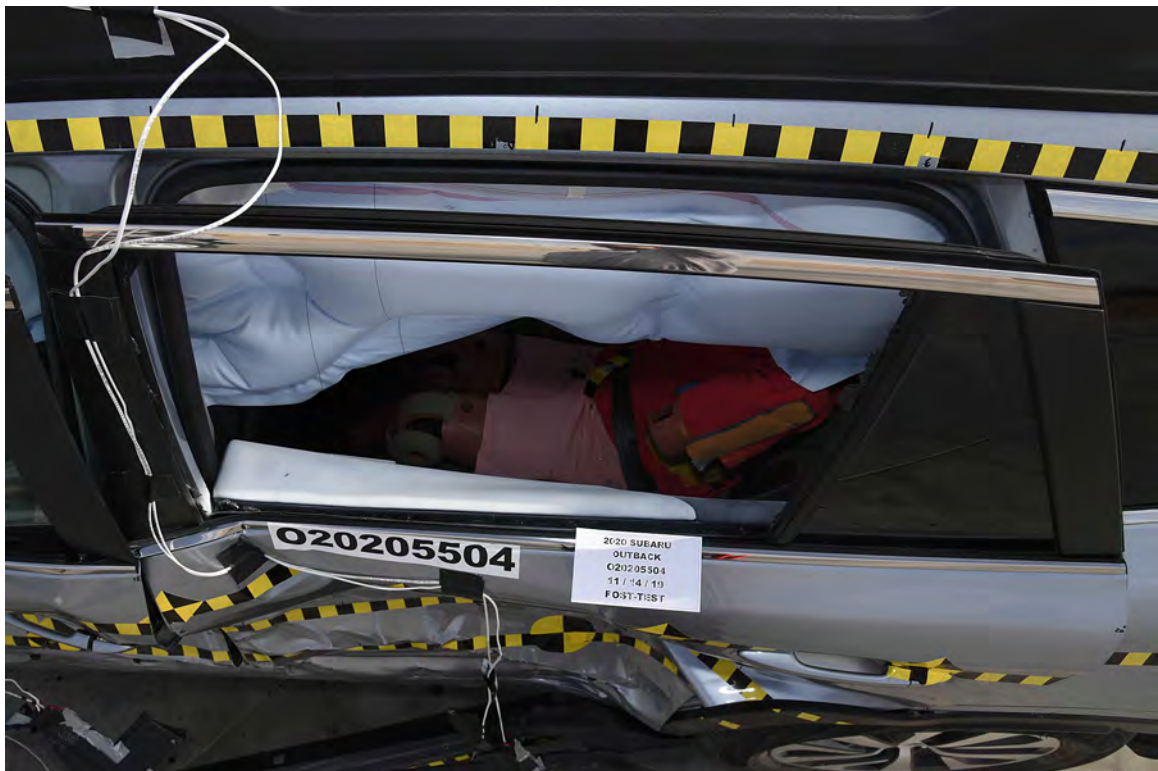
FIGURE 70. Post-Test Rear Passenger Dummy and Door Clearance View

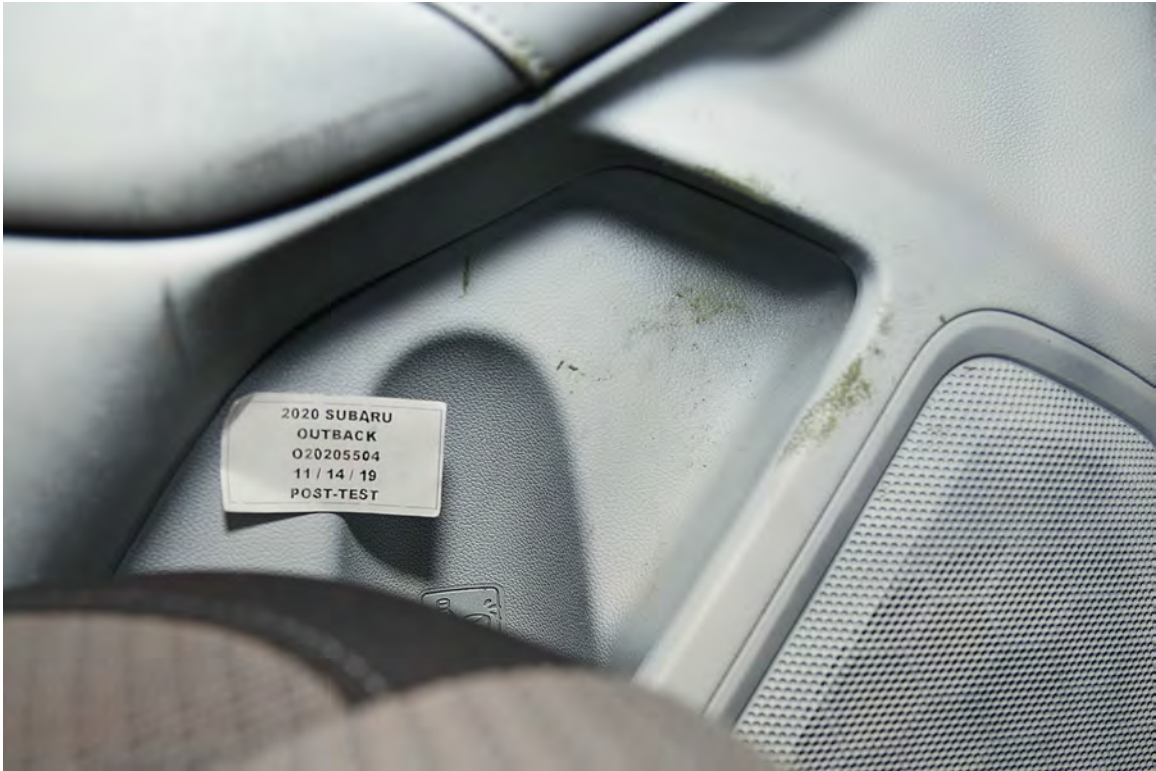
FIGURE 81. Post-Test Rear Passenger Dummy Close-Up Knee Contact View
