REPORT NUMBER: SPNCAP-CAL-20-002

**NEW CAR ASSESSMENT PROGRAM (NCAP)
SIDE IMPACT POLE TEST**

**Subaru Corporation
2020 Subaru WRX
Four Door Sedan**

NHTSA No: M20205501

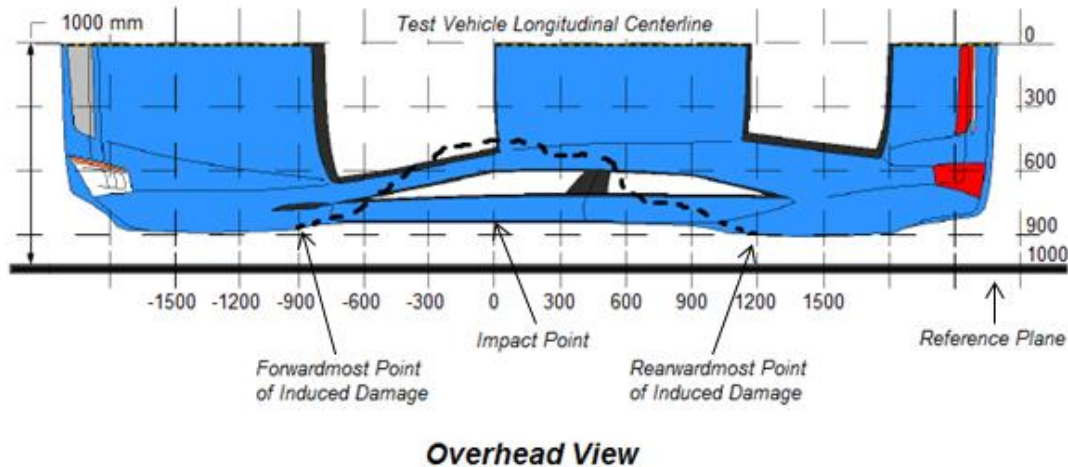
VEHICLE DAMAGE PROFILE DISTANCES

DPD	Distance From Impact Point (mm)	Level	Post-Test (mm)	Pre-Test (mm)	Crush (mm)
1	-900	3	86	103	-17
2	-450	3	193	136	57
3	0	3	489	131	358
4	450	3	215	131	84
5	900	3	160	131	29
6	1350	3	109	104	5

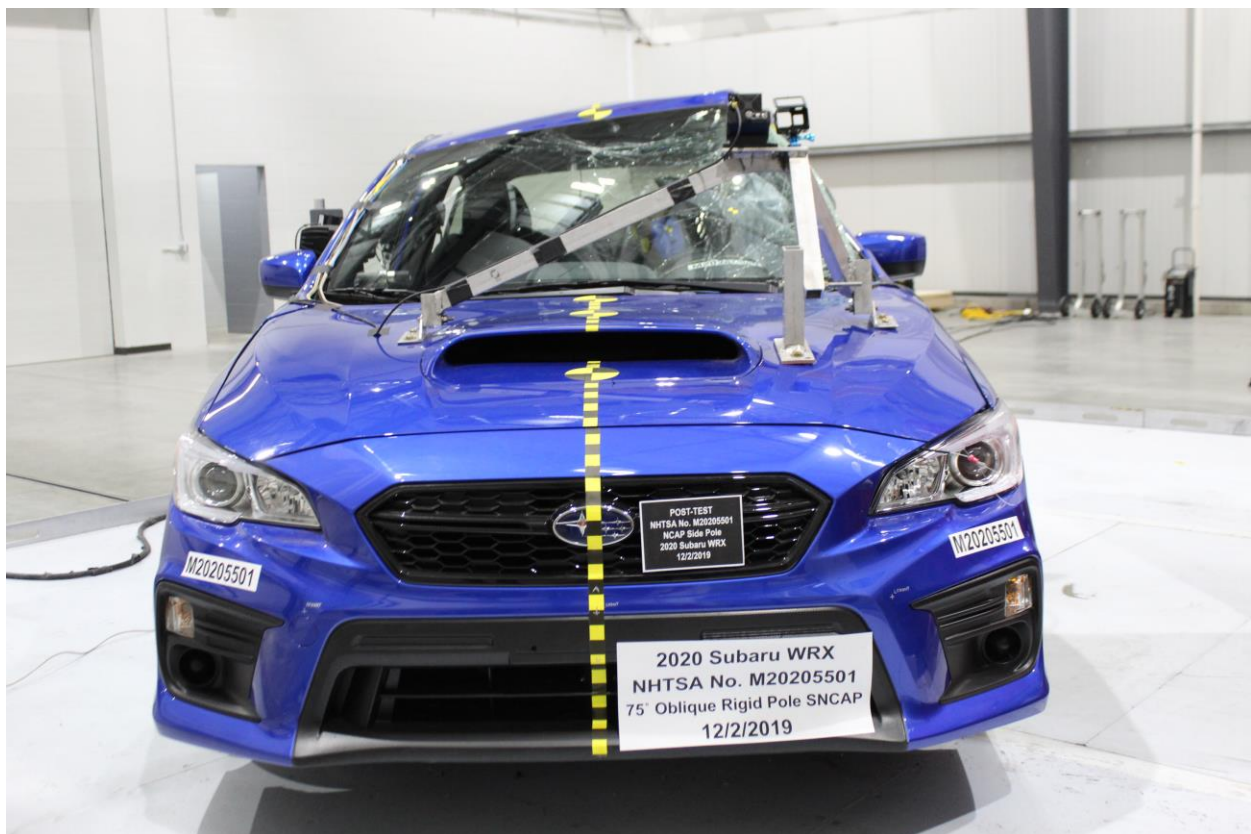
Figure A-4: Post-Test Frontal View of Test Vehicle

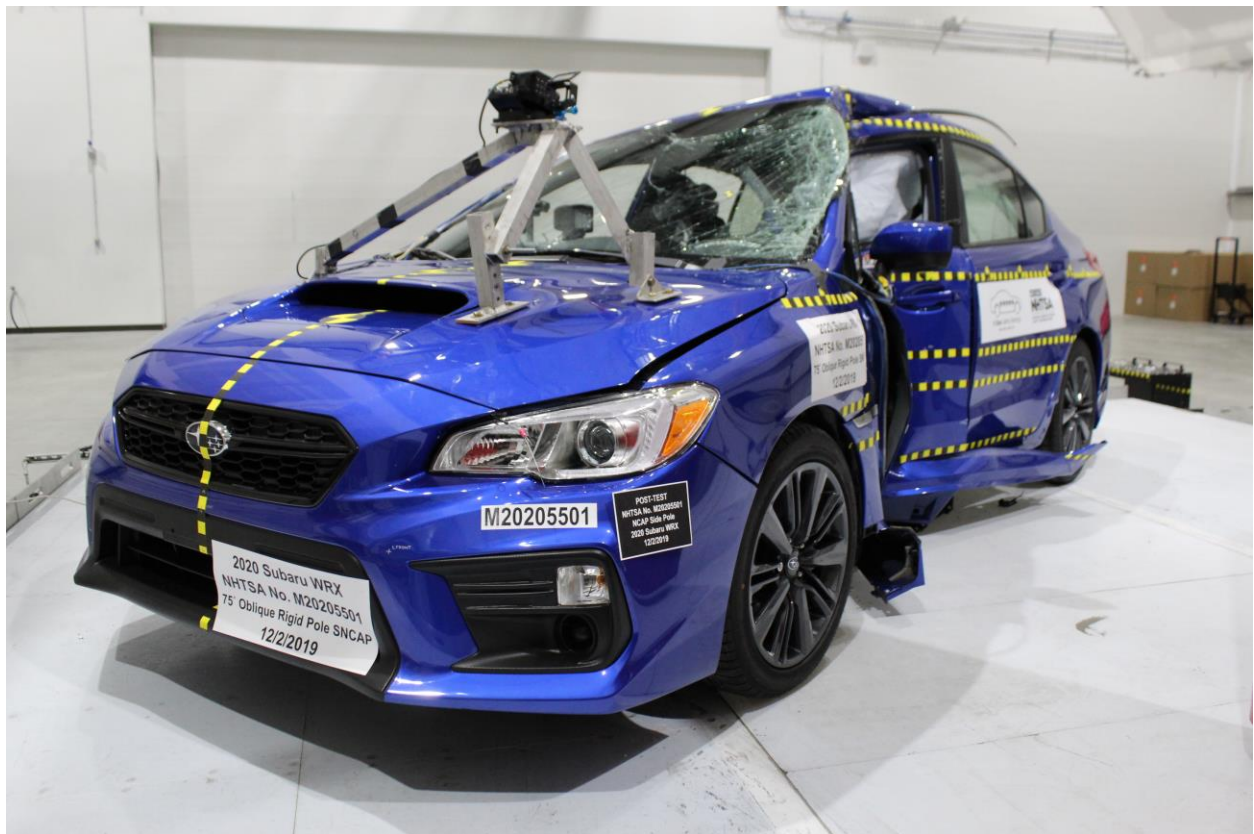
Figure A-6: Post-Test Left Front $\frac{3}{4}$ View of Test Vehicle

Critical Areas of Performance	Observations and Conclusions
Pillar Performance	A-Pillar, B-Pillar, & C-Pillar Buckled
Sill Separation	None
Windshield Damage	Cracks throughout with separation along driver A-Pillar
Side Window Damage	Driver window shattered
Other Notable Effects	None

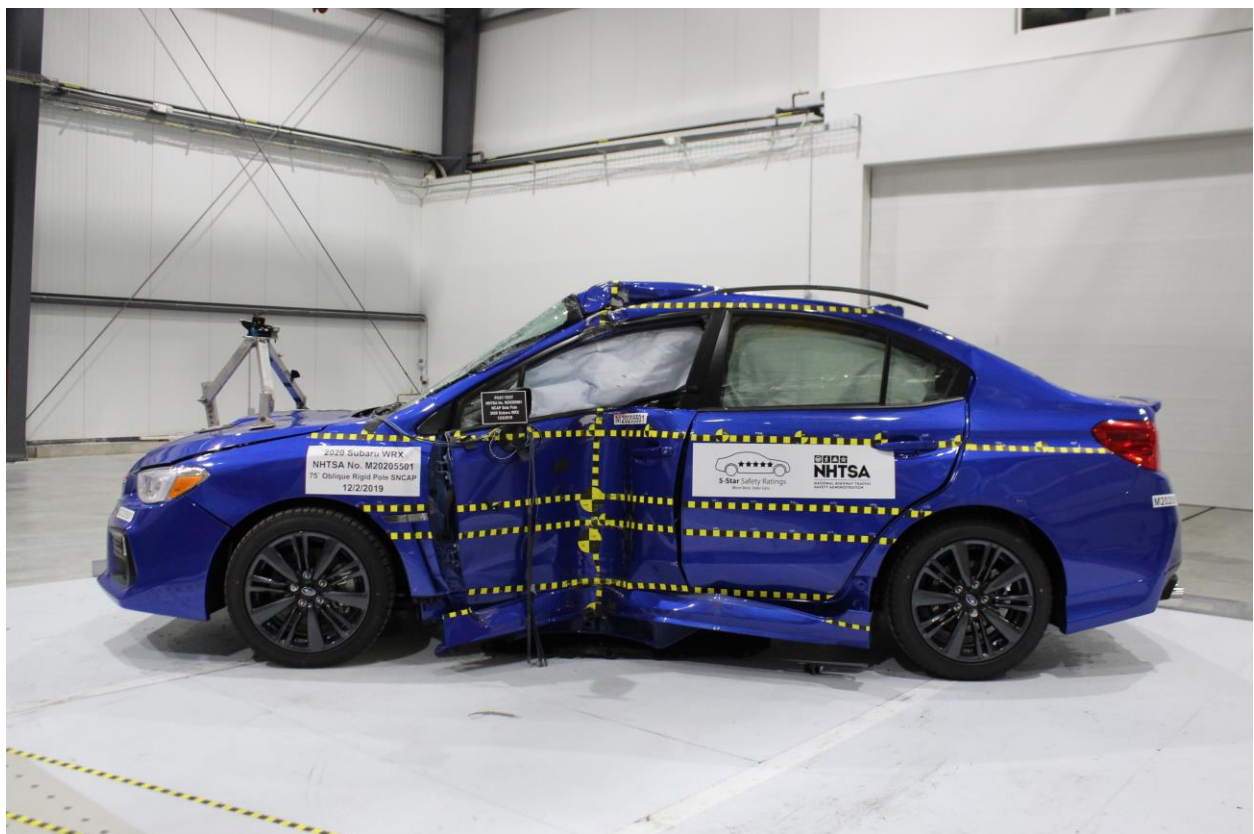
Figure A-8: Post-Test Left Side View of Test Vehicle

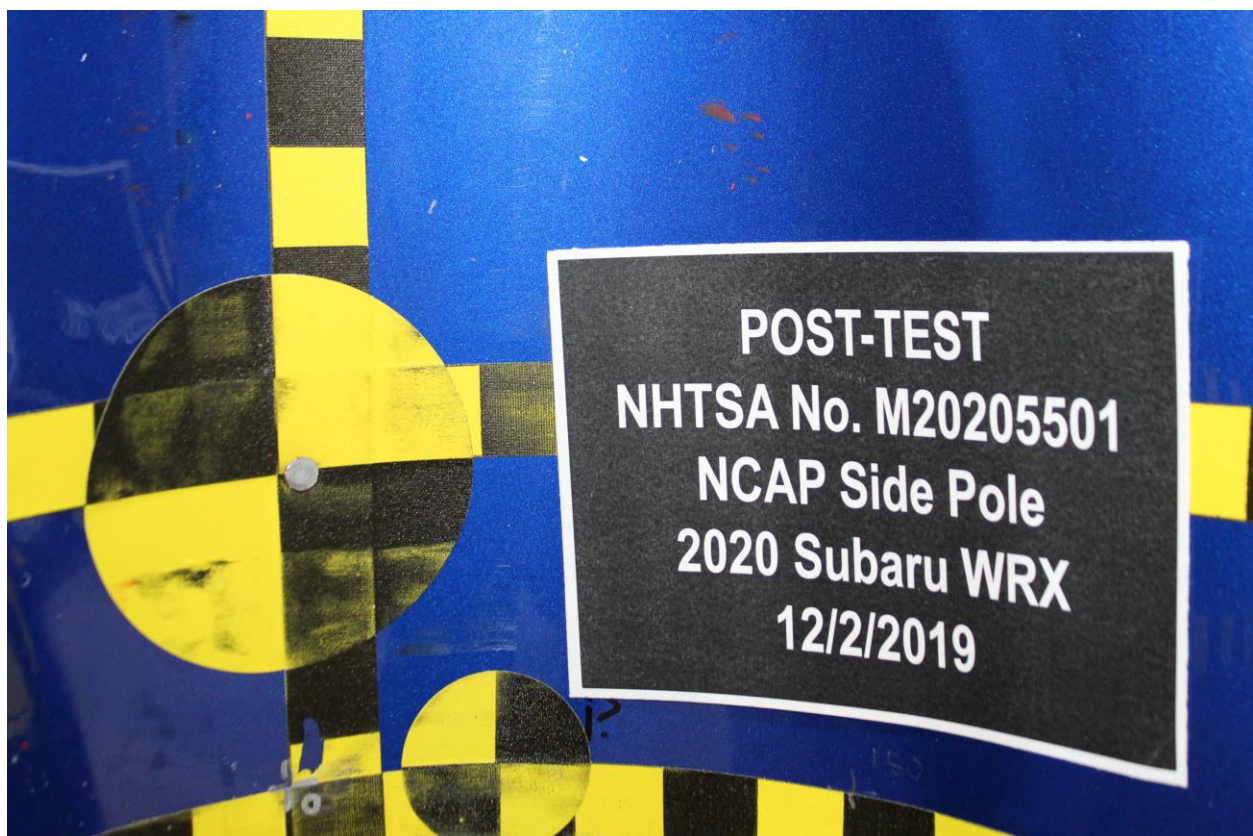
Figure A-20: Post-Test Close-Up View of Impact Point Target Showing Impact Location

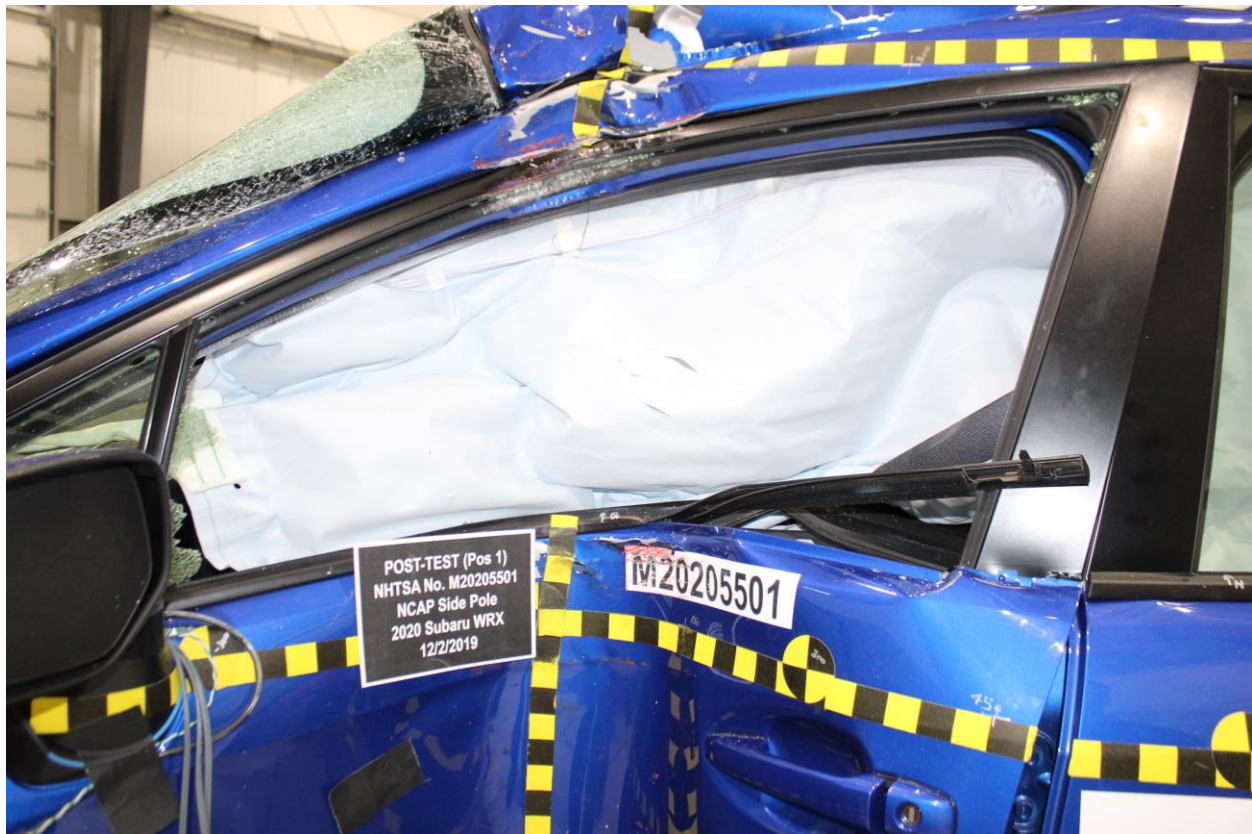
Figure A-25: Post-Test Left Side View of Dummy Shoulder and Door Top View

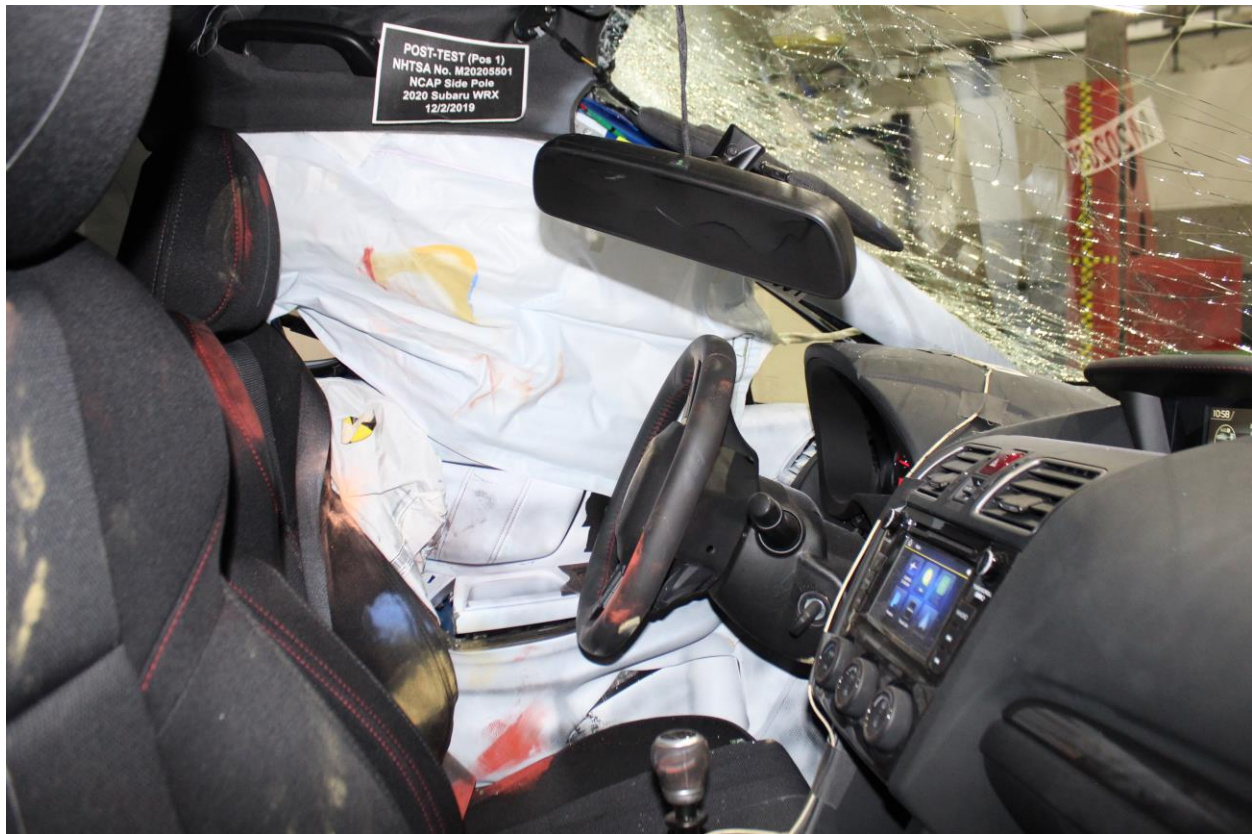
Figure A-45: Post-Test Inner Door Panel View Showing Dummy Contact Location

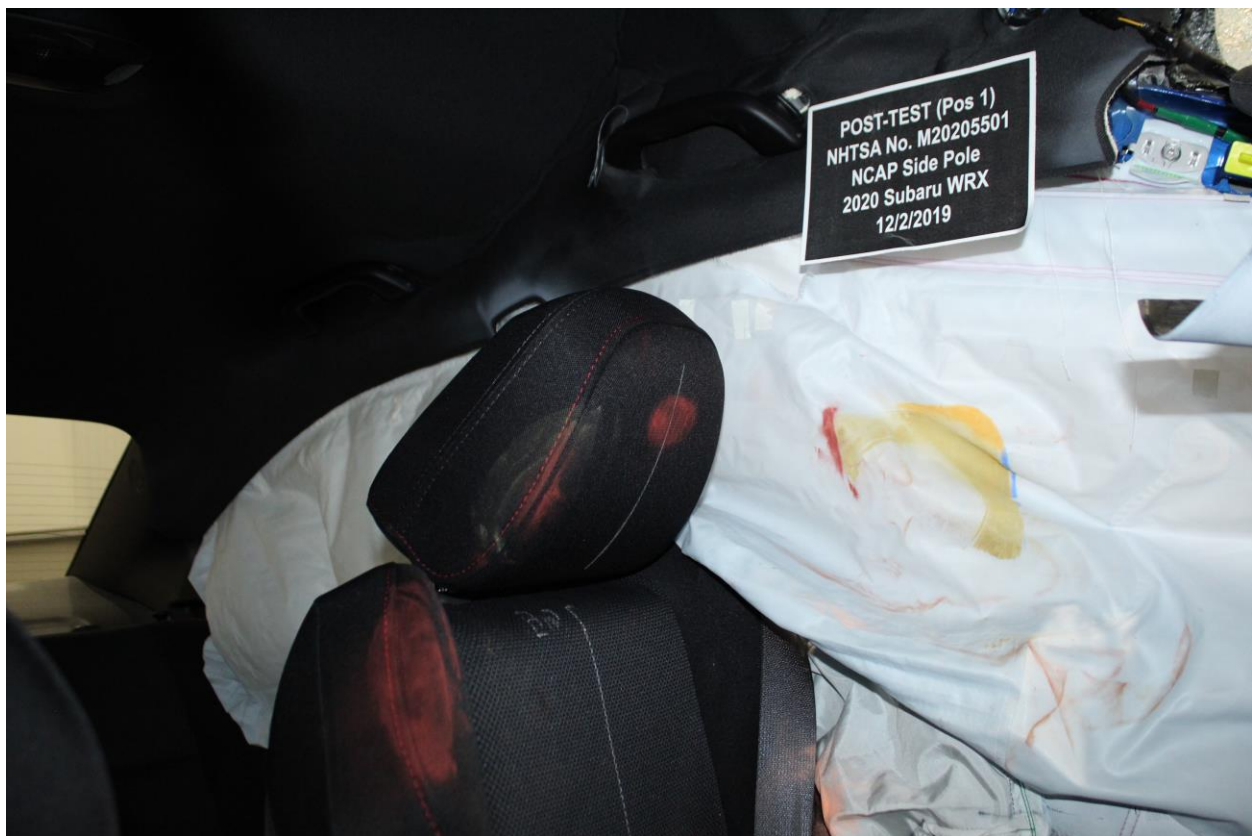
Figure A-46: Post-Test Dummy Close-Up Head Contact with Vehicle Interior View

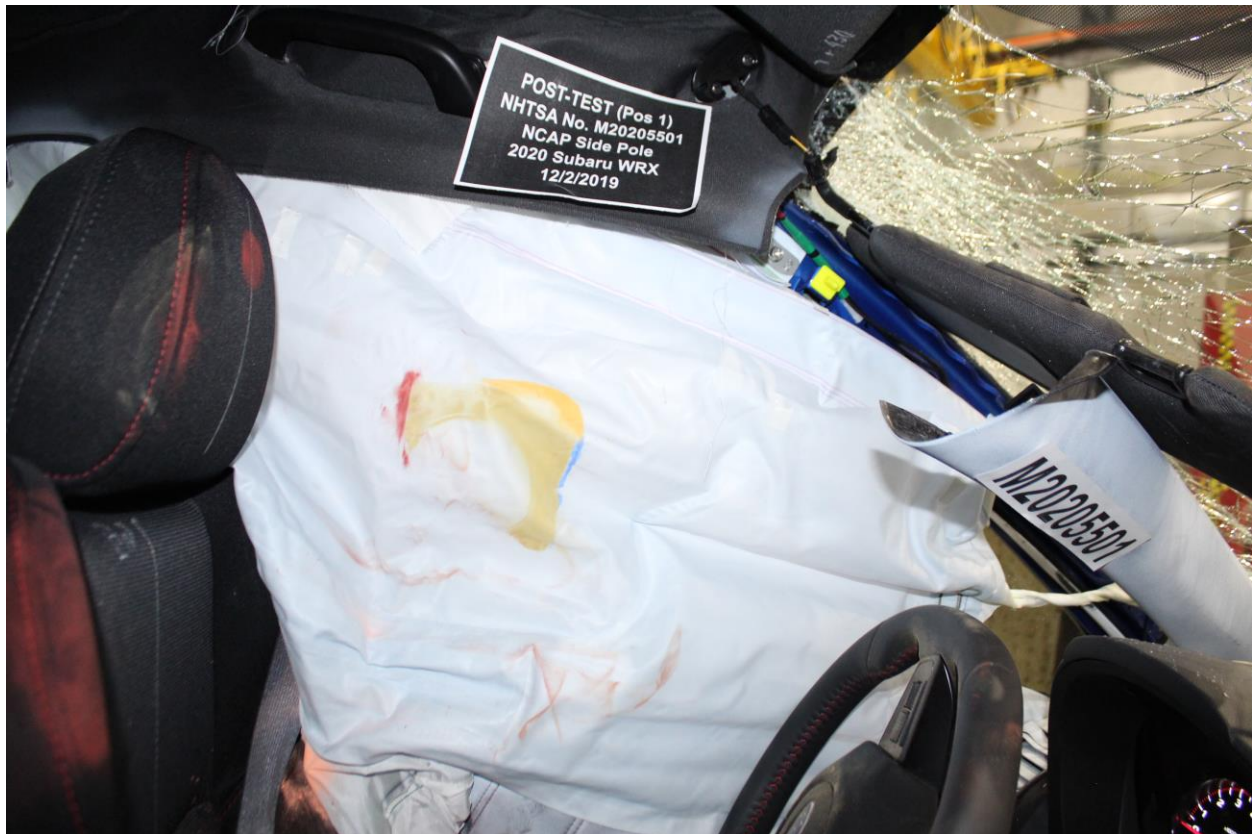
Figure A-47: Post-Test Dummy Close-Up Head Contact with Side Airbag View

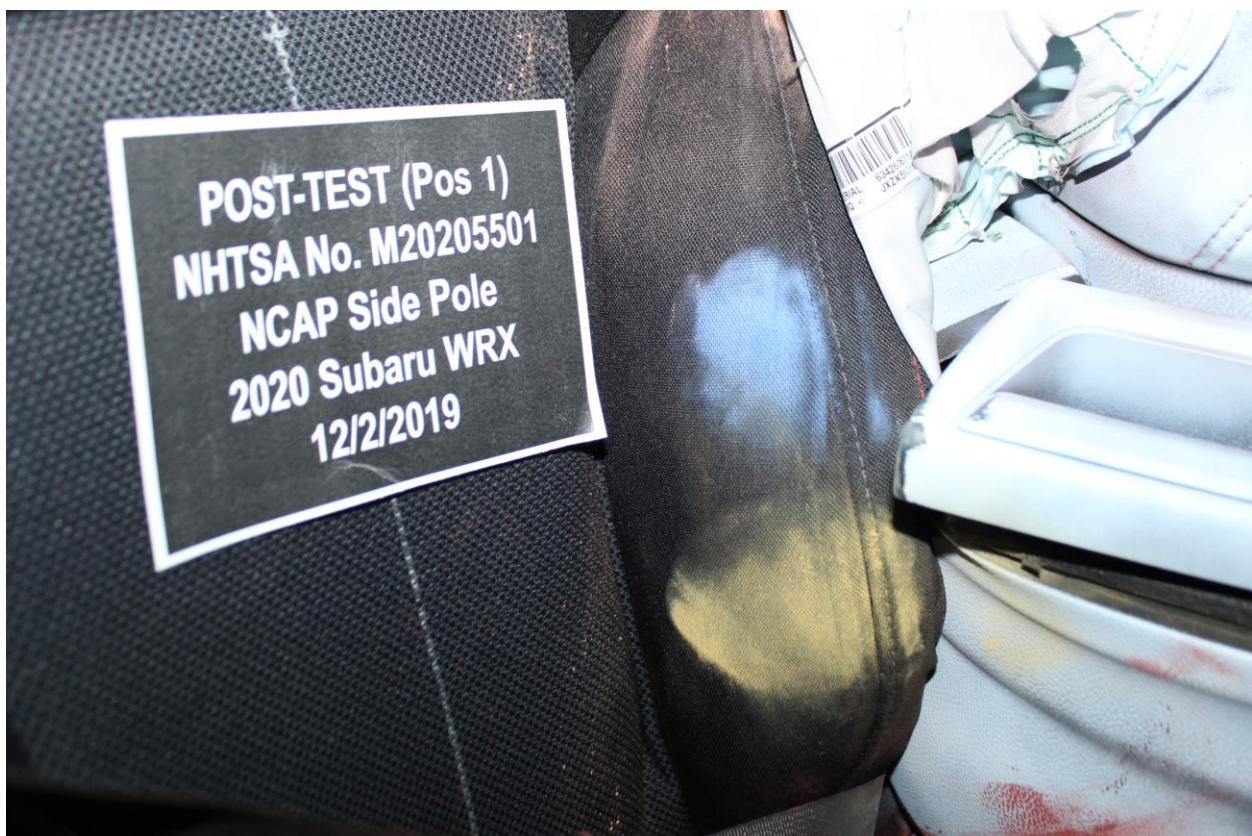
Figure A-48: Post-Test Dummy Close-Up Torso Contact with Vehicle Interior View

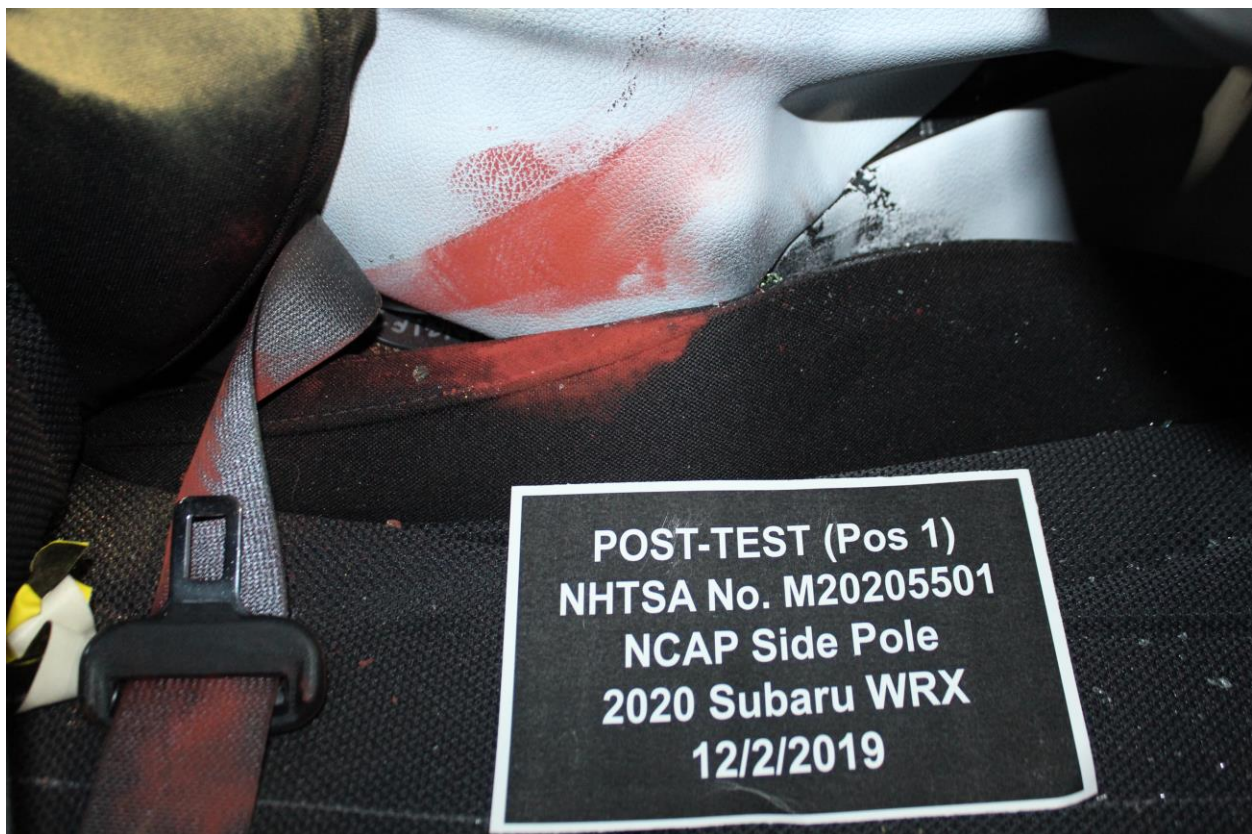
Figure A-50: Post-Test Dummy Close-Up Pelvis Contact with Vehicle Interior View

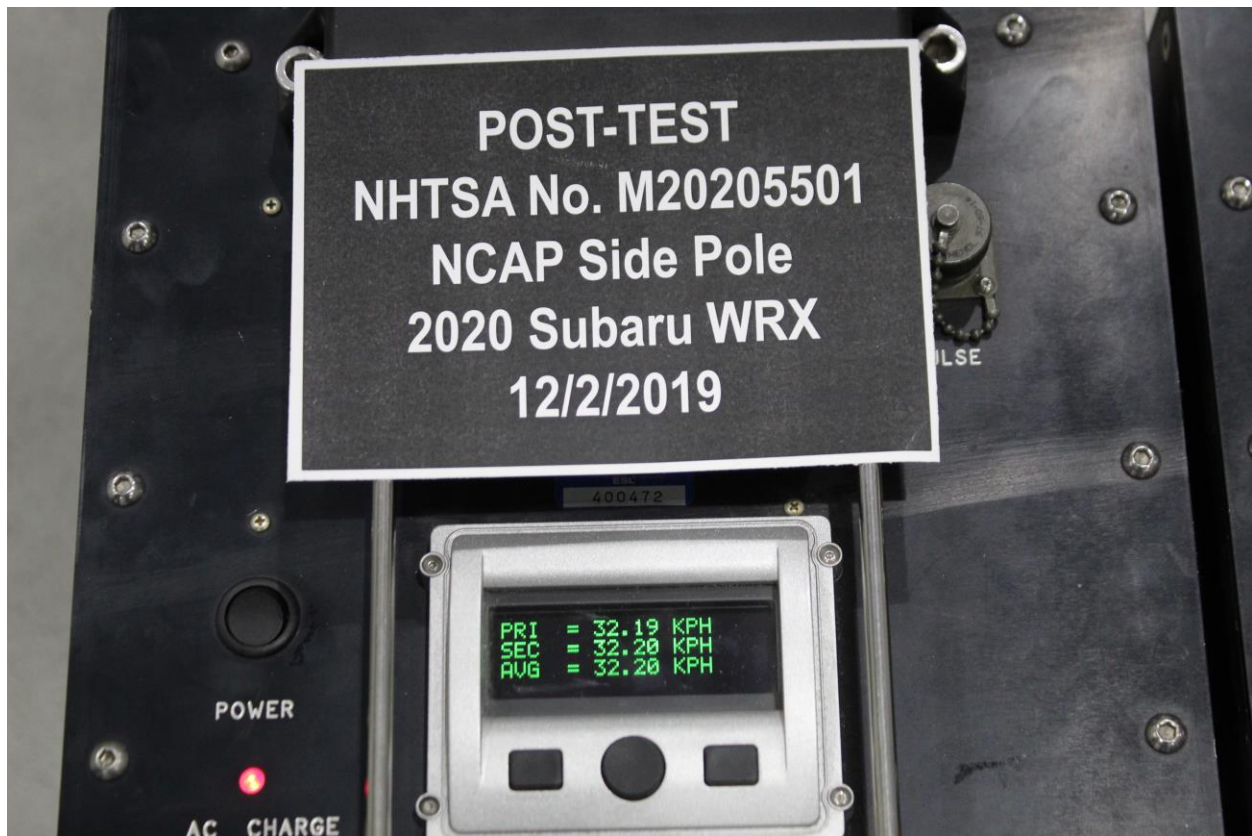
Figure A-62: Post-Test Primary and Redundant Speed Trap Read-Out

A rigid pole side impact test was conducted on a 2020 Subaru WRX four door sedan. The subject vehicle was towed into the rigid pole at an angle of 75° and a velocity of 32.19 km/h. The test was conducted by Calspan Corporation's Transportation Test Operations facility in Buffalo, New York on December 2, 2019. Pre-test and post-test photographs of the test vehicle and side impact dummy (SID-IIs) are included in Appendix A of this report.

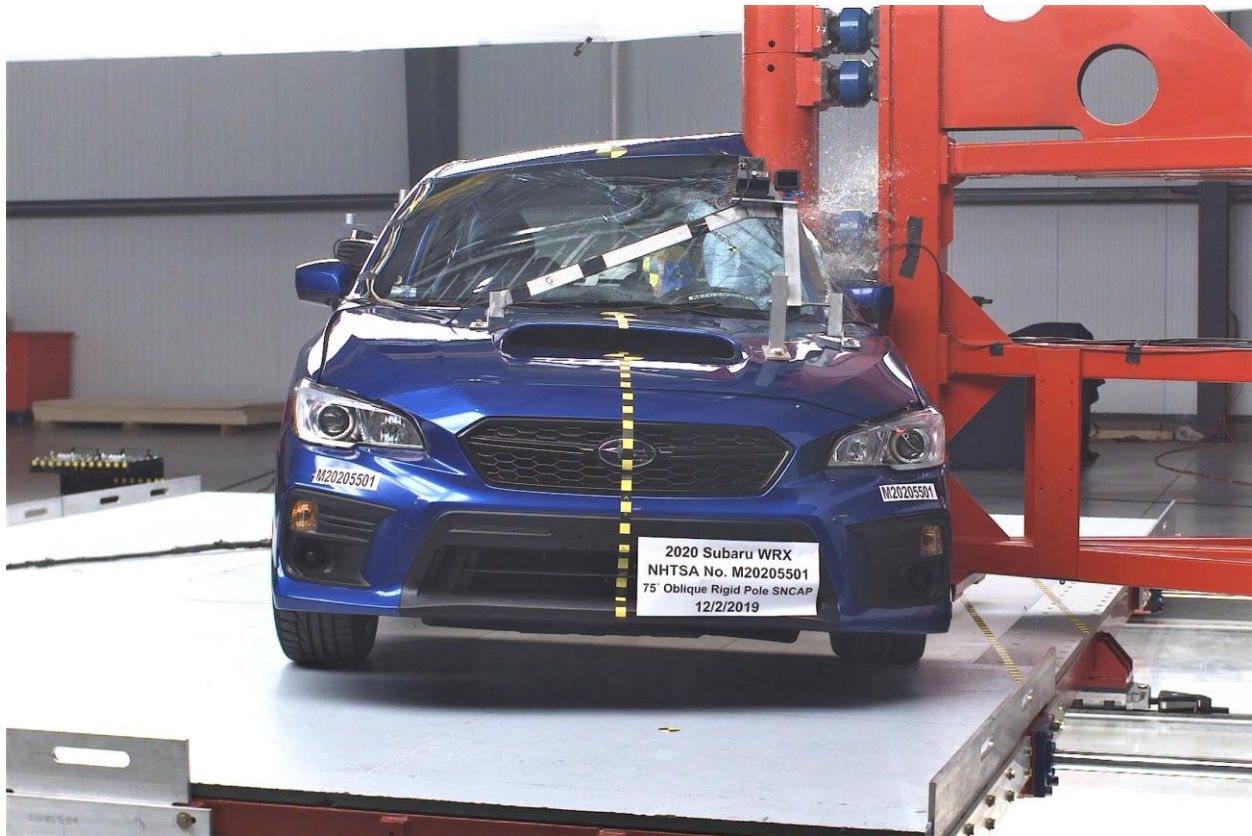
Figure A-68: Impact Event
