**REPORT NUMBER: SINCAP-KAR-20-003**

**NEW CAR ASSESSMENT PROGRAM (NCAP)  
MOVING DEFORMABLE BARRIER SIDE IMPACT TEST**

**SUBARU CORPORATION  
2020 SUBARU LEGACY 4-DOOR SEDAN**

**NHTSA No: O20205501**

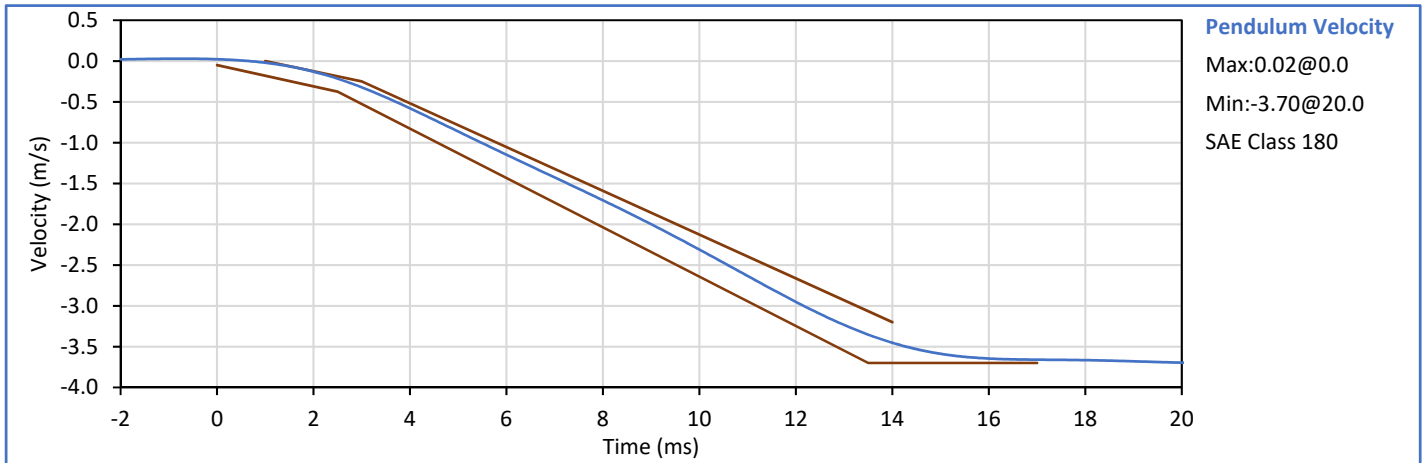
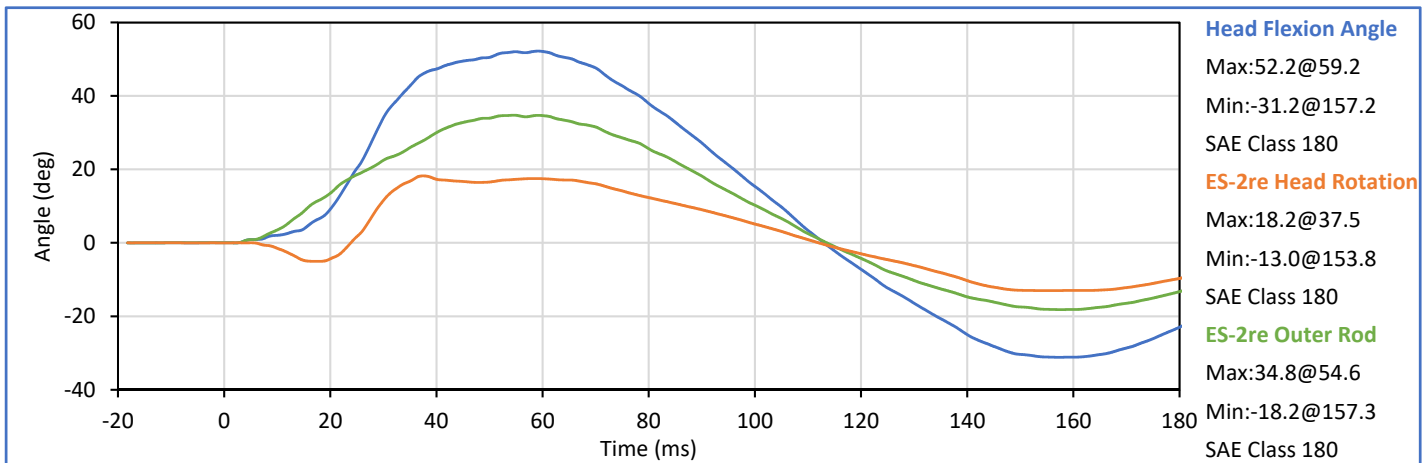
Tested Parameter	Units	Spec. Low	Spec. High	Result	Pass/Fail
Laboratory Temperature	°C	20.6	22.2	21.1	Pass
Laboratory Humidity	%	10	70	19	Pass
Pendulum Velocity	m/s	3.30	3.50	3.48	Pass
Peak Headform Flexion	deg	49.0	59.0	52.2	Pass
Time of Peak Headform Flexion	ms	54.0	66.0	59.2	Pass
Flexion Decay (Peak to zero)	ms	53.0	88.0	53.9	Pass
Overall Test Results					Pass

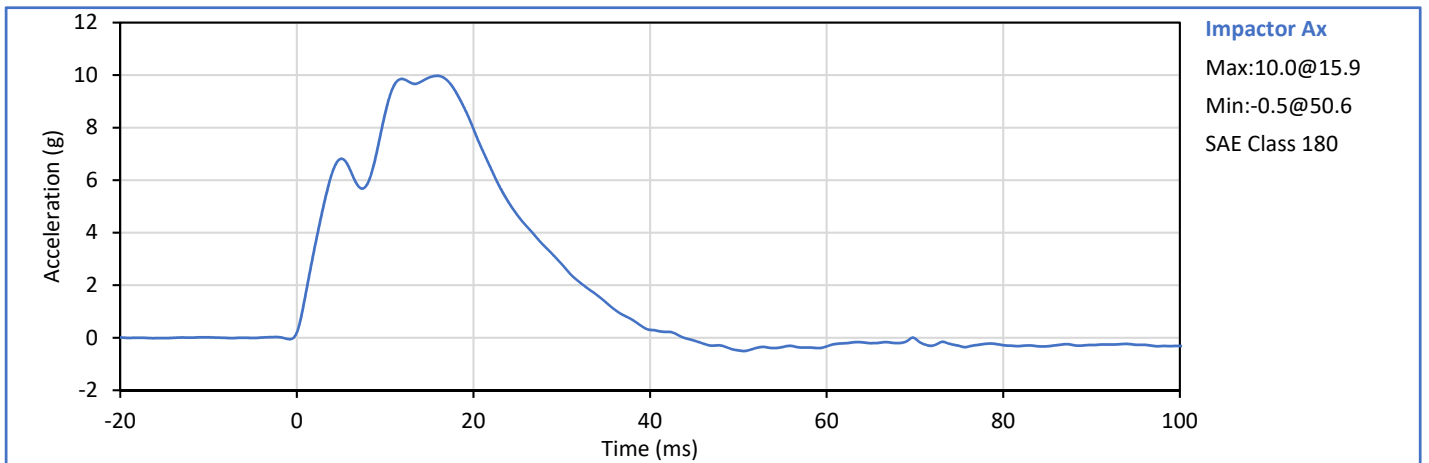
Tested Parameter	Units	Spec. Low	Spec. High	Result	Pass/Fail
Laboratory Temperature	°C	20.6	22.2	21.1	Pass
Laboratory Humidity	%	10	70	17	Pass
Impactor Velocity	m/s	4.20	4.40	4.31	Pass
Peak Impactor Ax	g	7.5	10.5	10.0	Pass
Overall Test Results					Pass

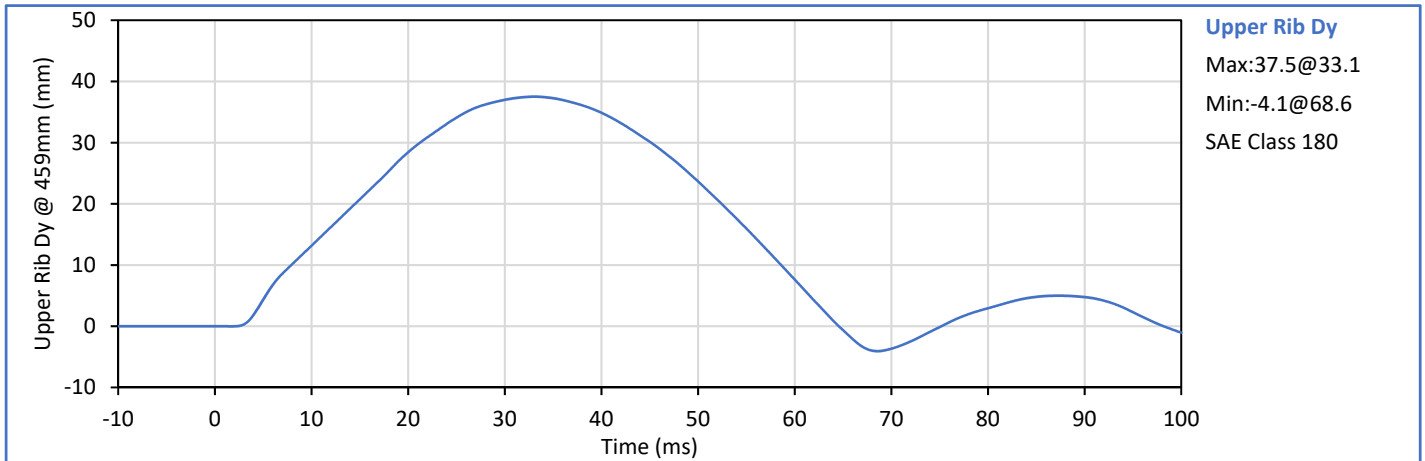
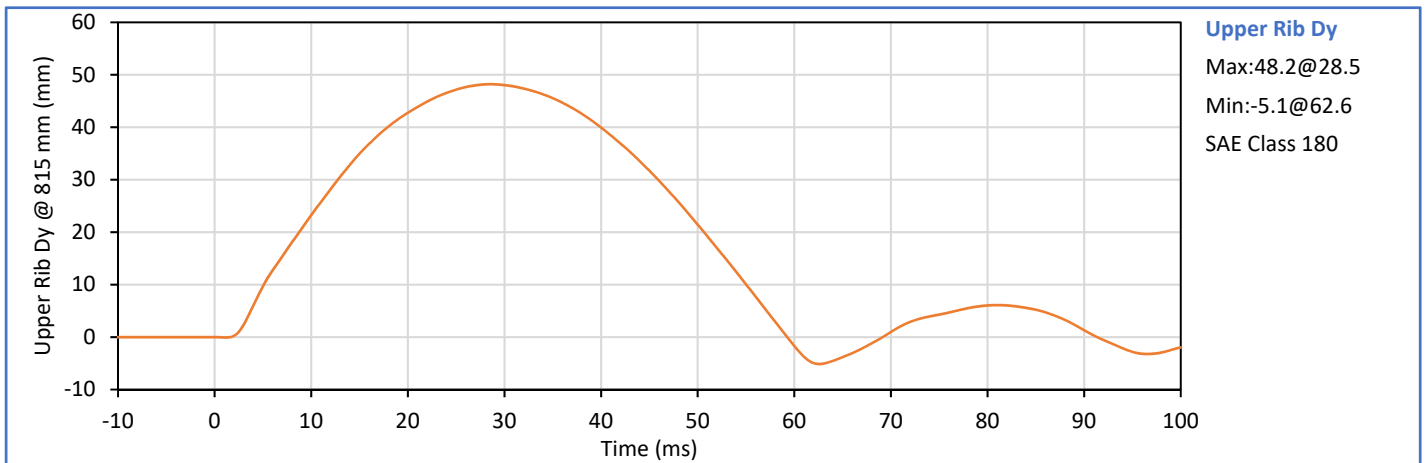
Tested Parameter	Units	Spec. Low	Spec. High	Result	Pass/Fail
Laboratory Temperature	°C	20.6	22.2	21.1	Pass
Laboratory Humidity	%	10	70	20	Pass
Upper Rib Dy @ 459mm	mm	36.0	40.0	37.5	Pass
Upper Rib Dy @ 815mm	mm	46.0	51.0	48.2	Pass
Overall Test Results					Pass

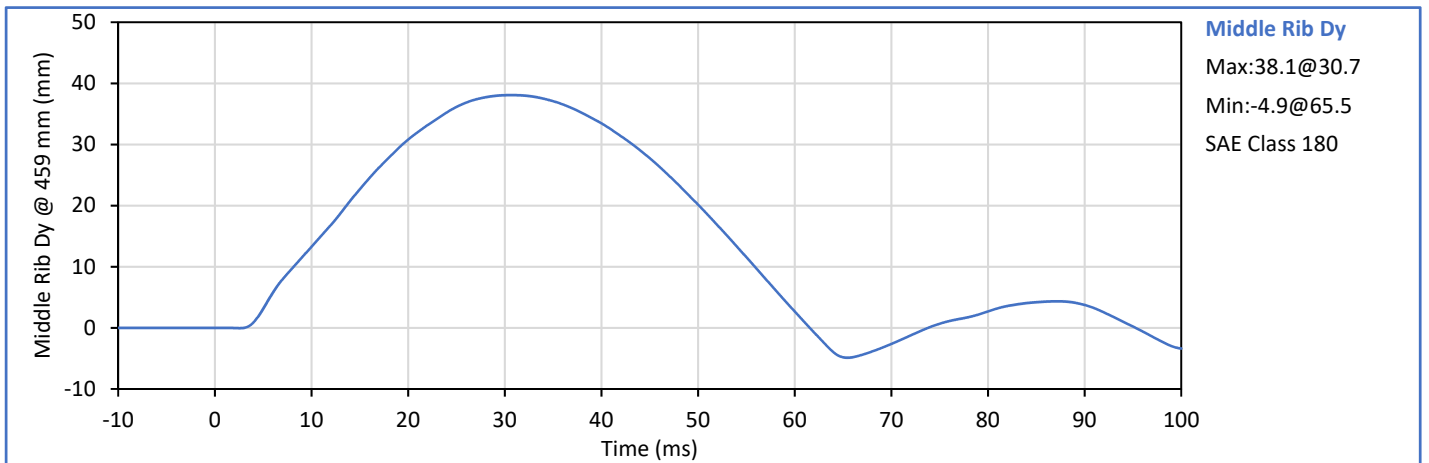
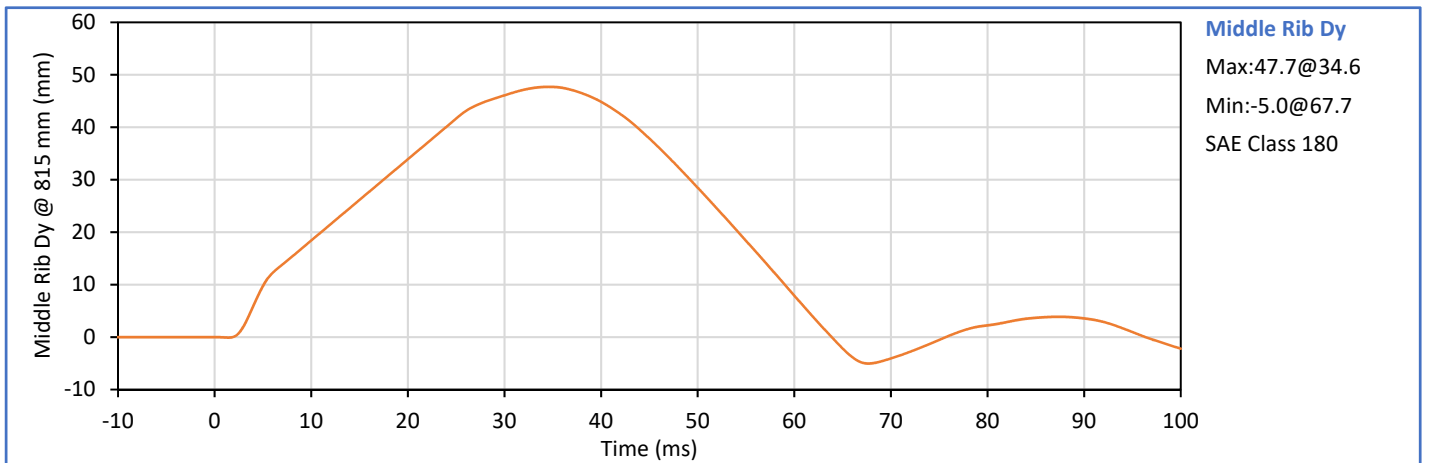
Tested Parameter	Units	Spec. Low	Spec. High	Result	Pass/Fail
Laboratory Temperature	°C	20.6	22.2	21.1	Pass
Laboratory Humidity	%	10	70	20	Pass
Middle Rib Dy @ 459mm	mm	36.0	40.0	38.1	Pass
Middle Rib Dy @ 815mm	mm	46.0	51.0	47.7	Pass
Overall Test Results					Pass

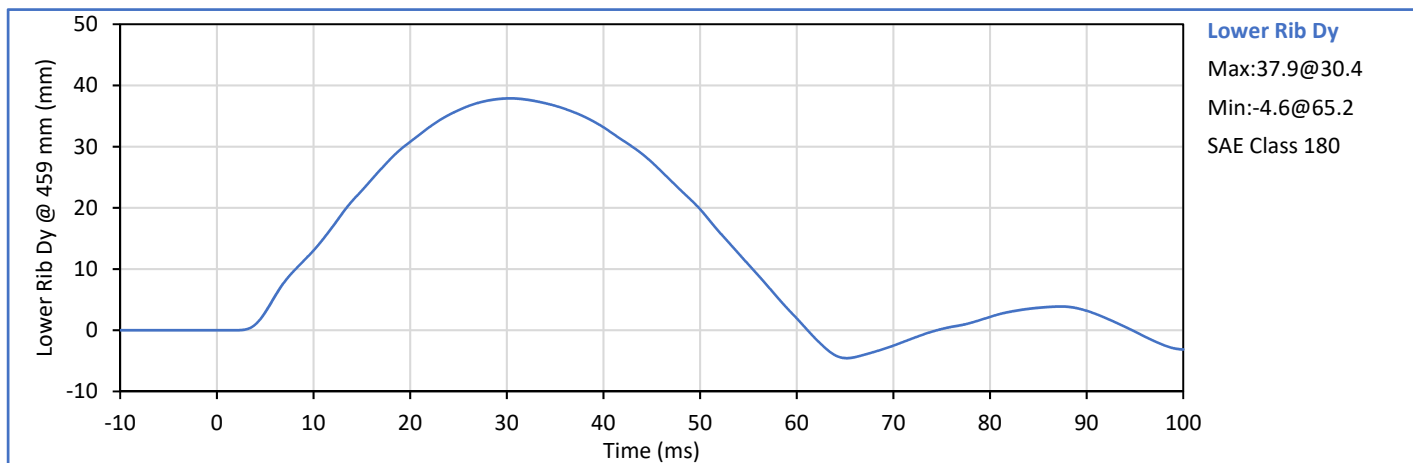
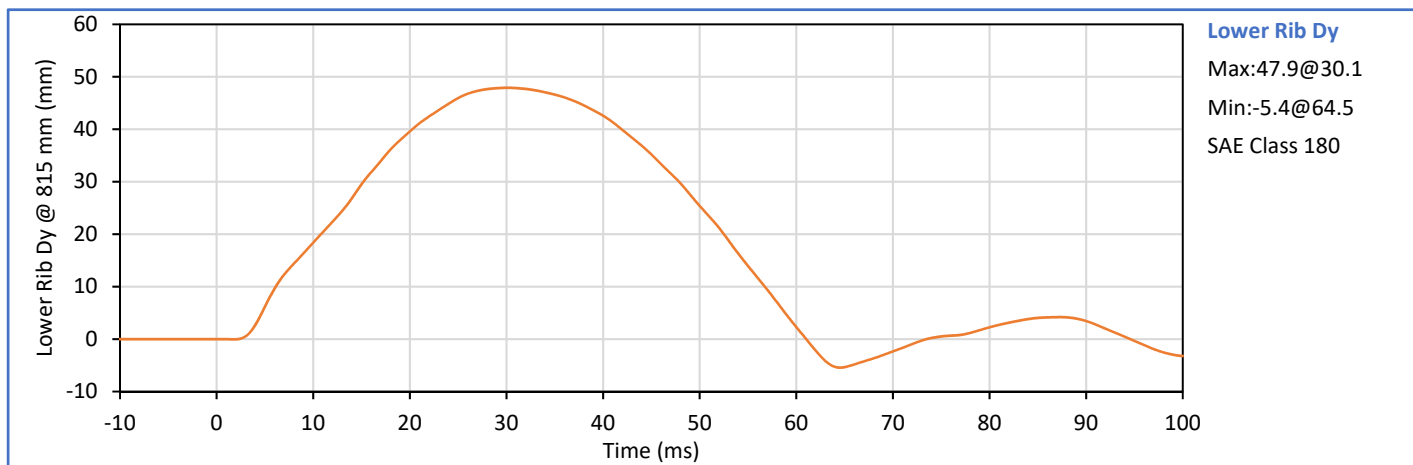
Tested Parameter	Units	Spec. Low	Spec. High	Result	Pass/Fail
Laboratory Temperature	°C	20.6	22.2	21.1	Pass
Laboratory Humidity	%	10	70	20	Pass
Lower Rib Dy @ 459mm	mm	36.0	40.0	37.9	Pass
Lower Rib Dy @ 815mm	mm	46.0	51.0	47.9	Pass
Overall Test Results					Pass

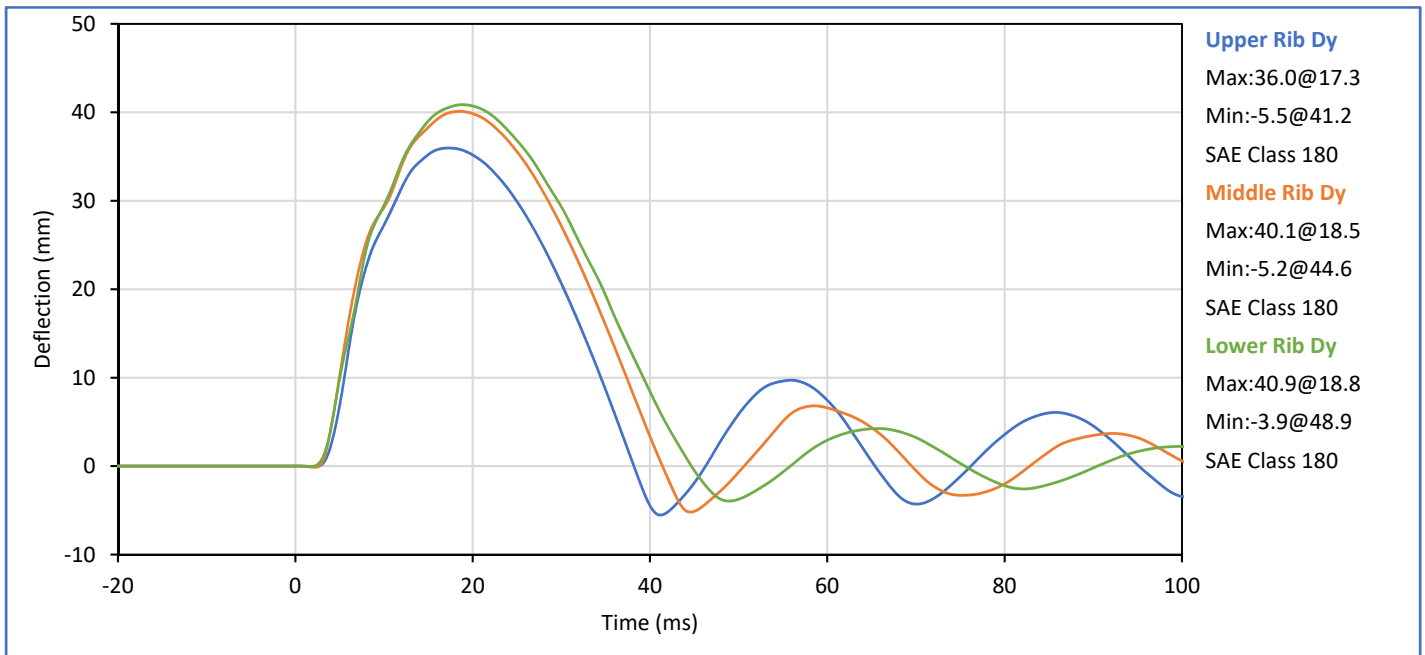
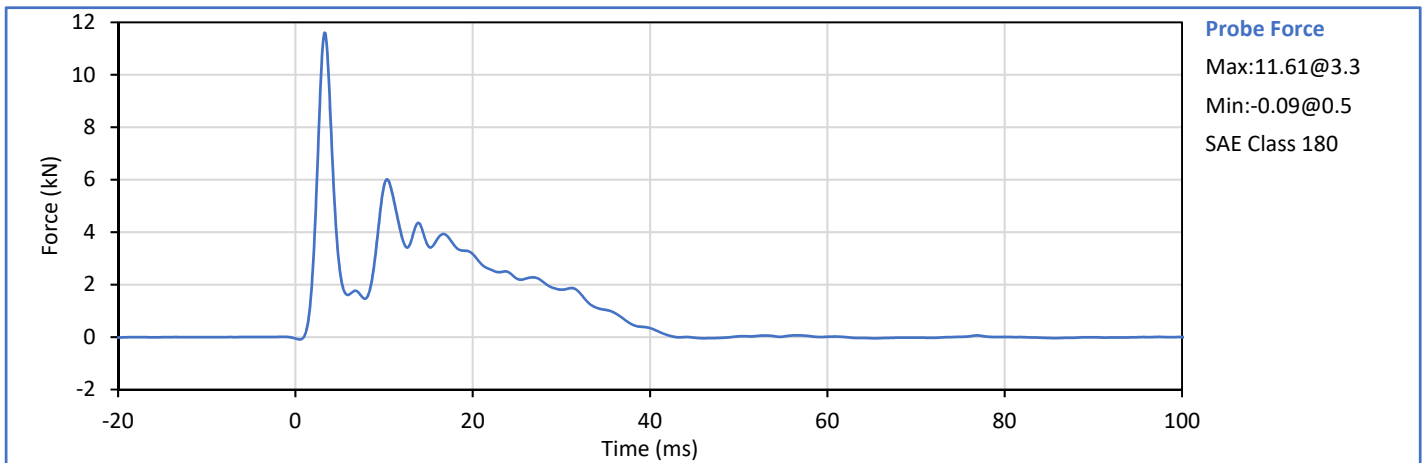
Tested Parameter	Units	Spec. Low	Spec. High	Result	Pass/Fail
Laboratory Temperature	°C	20.6	22.2	21.1	Pass
Laboratory Humidity	%	10	70	16	Pass
Impactor Velocity	m/s	5.40	5.60	5.45	Pass
Peak Upper Rib Dy	mm	34.0	41.0	36.0	Pass
Peak Middle Rib Dy	mm	37.0	45.0	40.1	Pass
Peak Lower Rib Dy	mm	37.0	44.0	40.9	Pass
Peak Impactor Force After 6 ms	kN	5.10	6.20	6.01	Pass
<b>Overall Test Results</b>					<b>Pass</b>

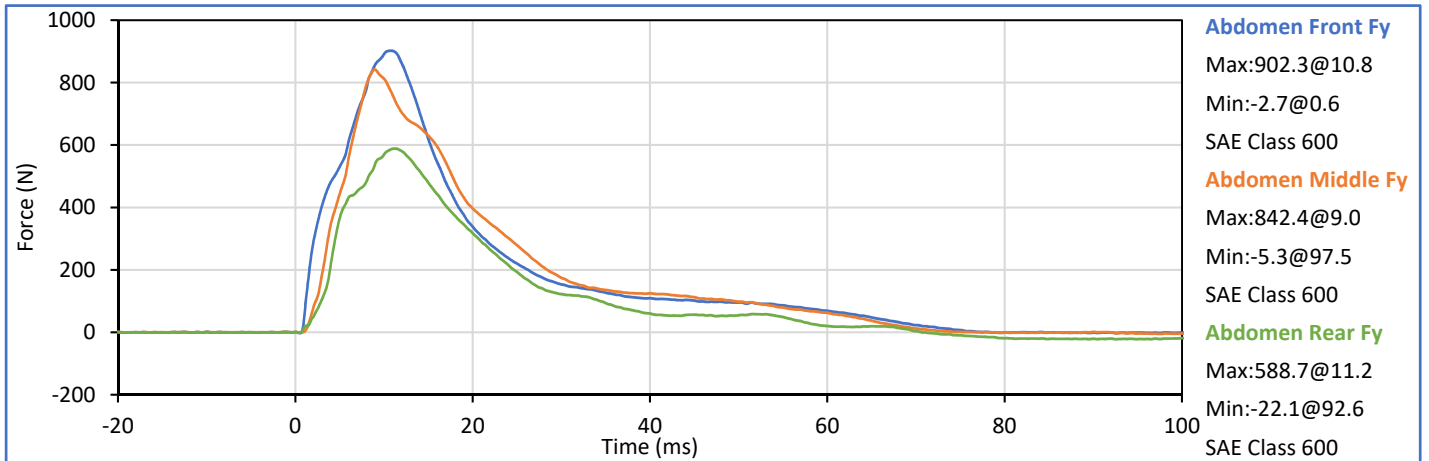
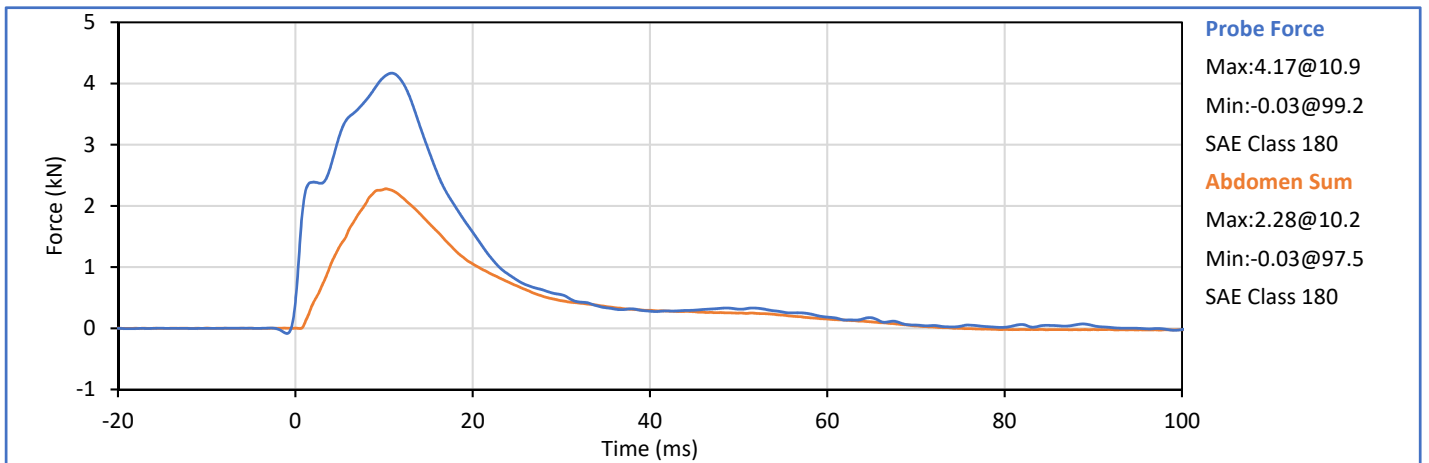
Tested Parameter	Units	Spec. Low	Spec. High	Result	Pass/Fail
Laboratory Temperature	°C	20.6	22.2	21.1	Pass
Laboratory Humidity	%	10	70	15	Pass
Impactor Velocity	m/s	3.90	4.10	4.09	Pass
Peak Impactor Force	kN	4.00	4.80	4.17	Pass
Time of Peak Impactor Force	ms	10.6	13.0	10.9	Pass
Sum of Abdomen Forces	kN	2.20	2.70	2.28	Pass
Time of Peak Sum Abdomen Force	ms	10.0	12.3	10.2	Pass
Overall Test Results					Pass

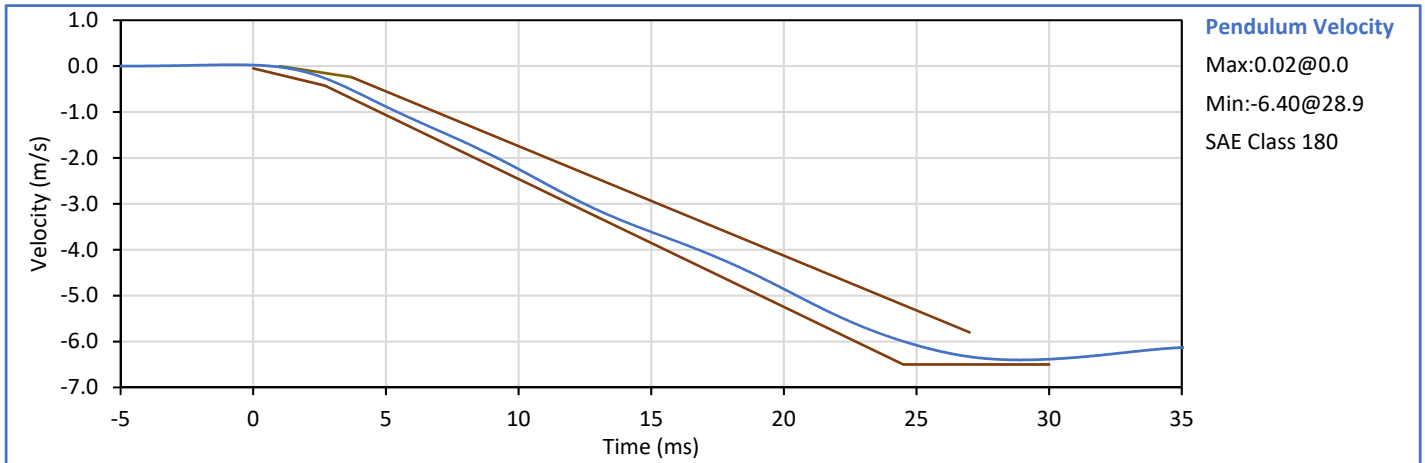
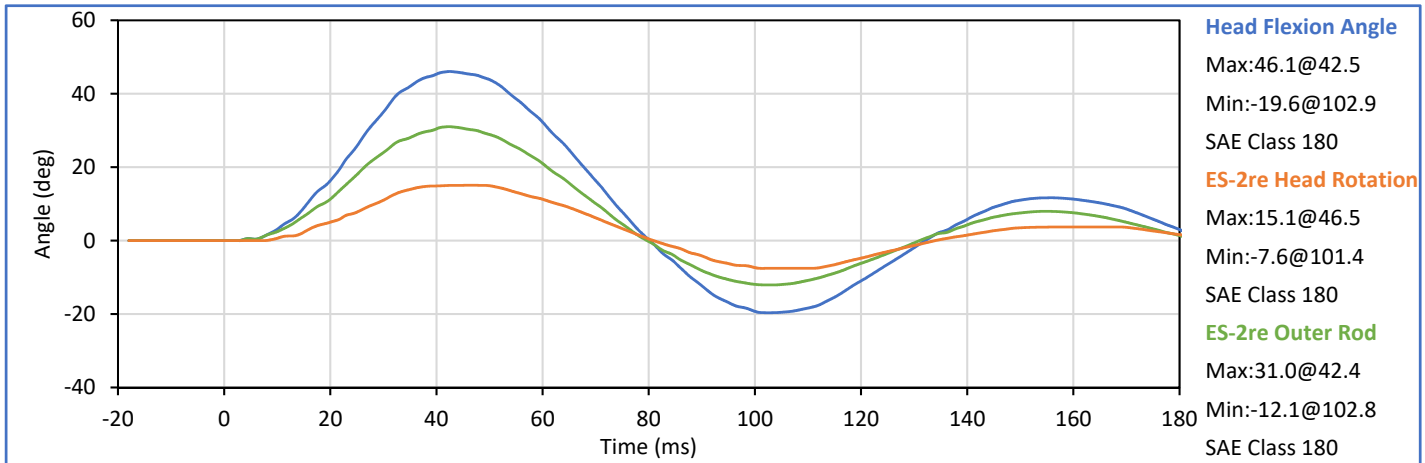
Tested Parameter	Units	Spec. Low	Spec. High	Result	Pass/Fail
Laboratory Temperature	°C	20.6	22.2	21.1	Pass
Laboratory Humidity	%	10	70	20	Pass
Pendulum Velocity	m/s	5.95	6.15	6.12	Pass
Peak Headform Flexion	deg	45.0	55.0	46.1	Pass
Time of Peak Headform Flexion	ms	39.0	53.0	42.5	Pass
Flexion Decay (Peak to zero)	ms	37.0	57.0	37.7	Pass
Overall Test Results					Pass

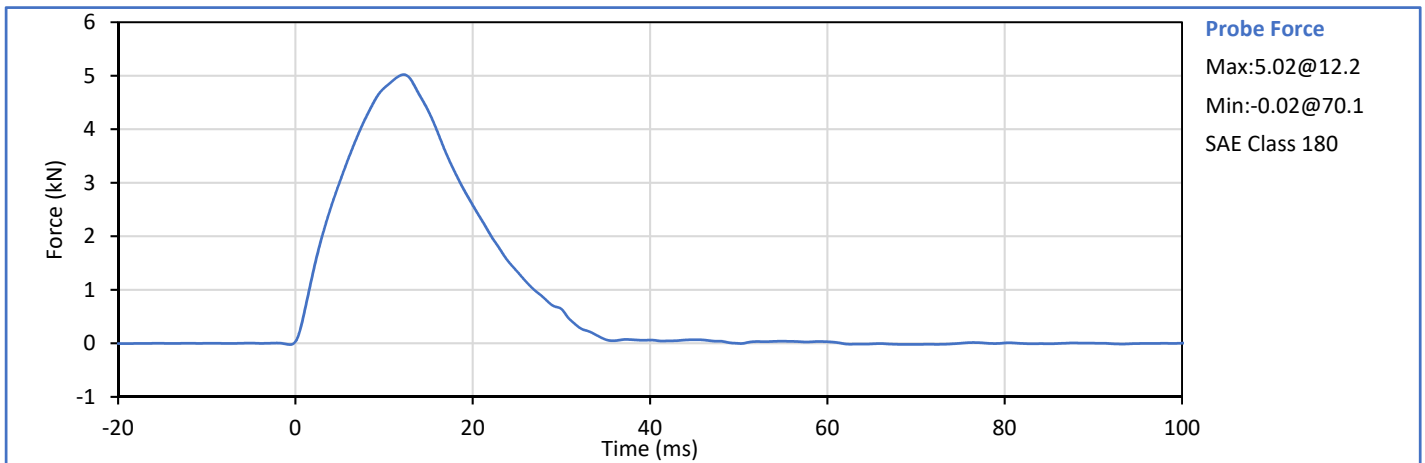
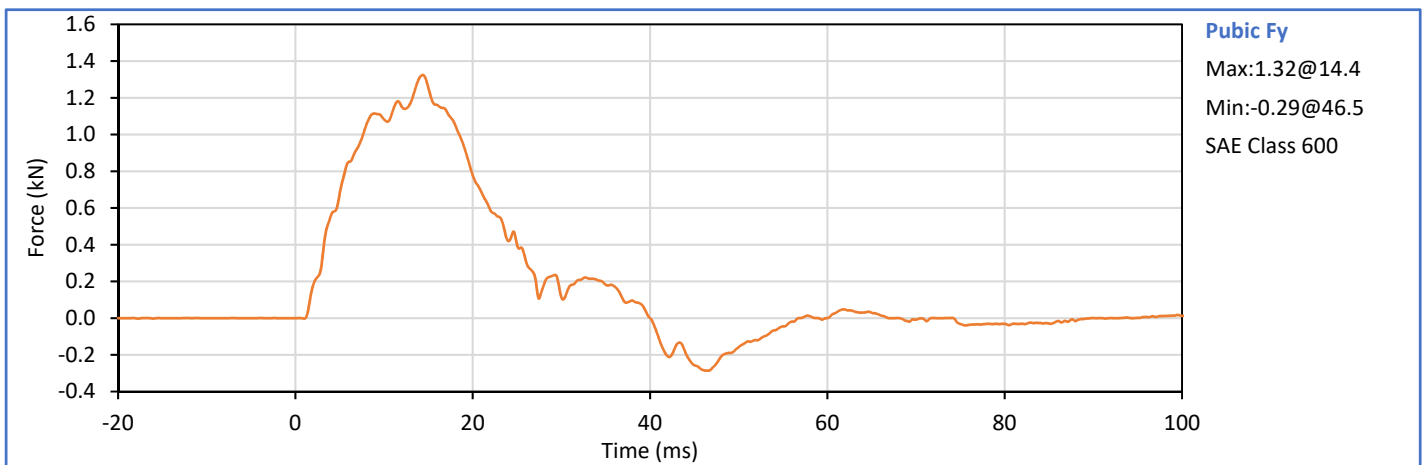
Tested Parameter	Units	Spec. Low	Spec. High	Result	Pass/Fail
Laboratory Temperature	°C	20.6	22.2	21.1	Pass
Laboratory Humidity	%	10	70	16	Pass
Impactor Velocity	m/s	4.20	4.40	4.32	Pass
Peak Impactor Force	kN	4.70	5.40	5.02	Pass
Time of Peak Impactor Force	ms	11.8	16.1	12.2	Pass
Pubic Symphysis Fy	kN	1.23	1.59	1.32	Pass
Time of Peak Pubic Symphysis Fy	ms	12.2	17.0	14.4	Pass
Overall Test Results					Pass

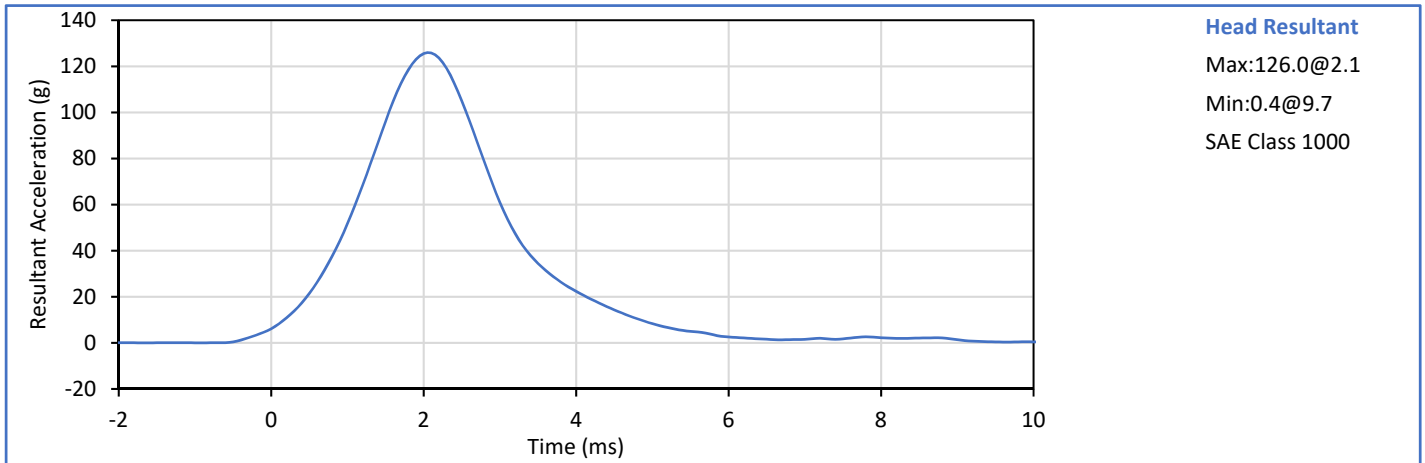
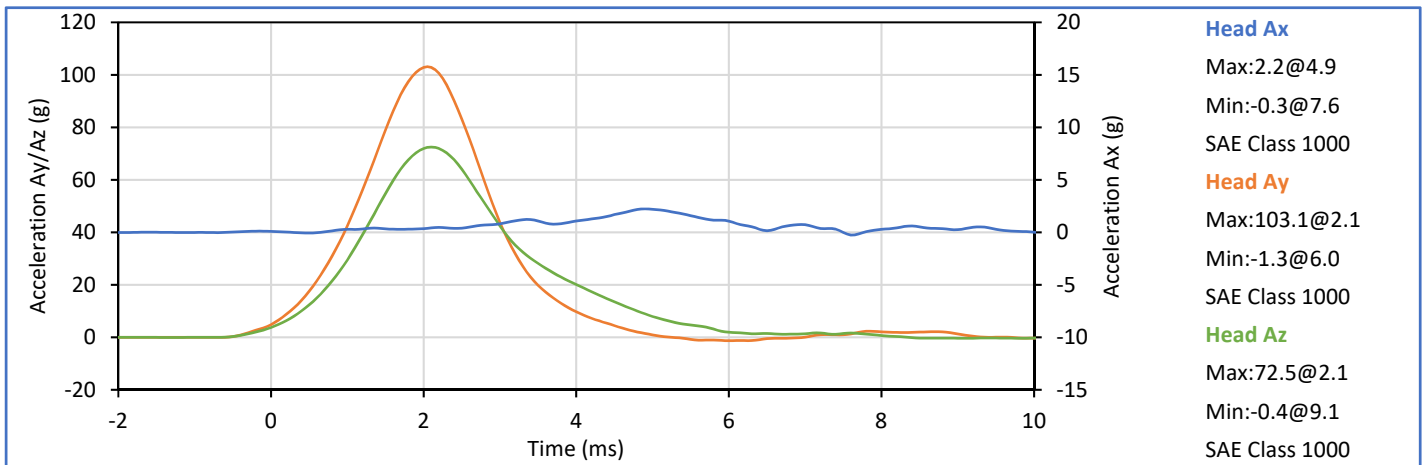
Tested Parameter	Units	Spec. Low	Spec. High	Result	Pass/Fail
Laboratory Temperature	°C	18.9	25.6	21.1	Pass
Laboratory Humidity	%	10	70	17	Pass
Peak Resultant Acceleration	g	115.0	137.0	126.0	Pass
Peak Head Ax	g	-15.0	15.0	-0.4	Pass
Oscillations After Main Pulse	%	0.0	15.0	2.1	Pass
Is Acceleration Unimodal?	Yes/No	Yes		Yes	Pass
Overall Test Results					Pass

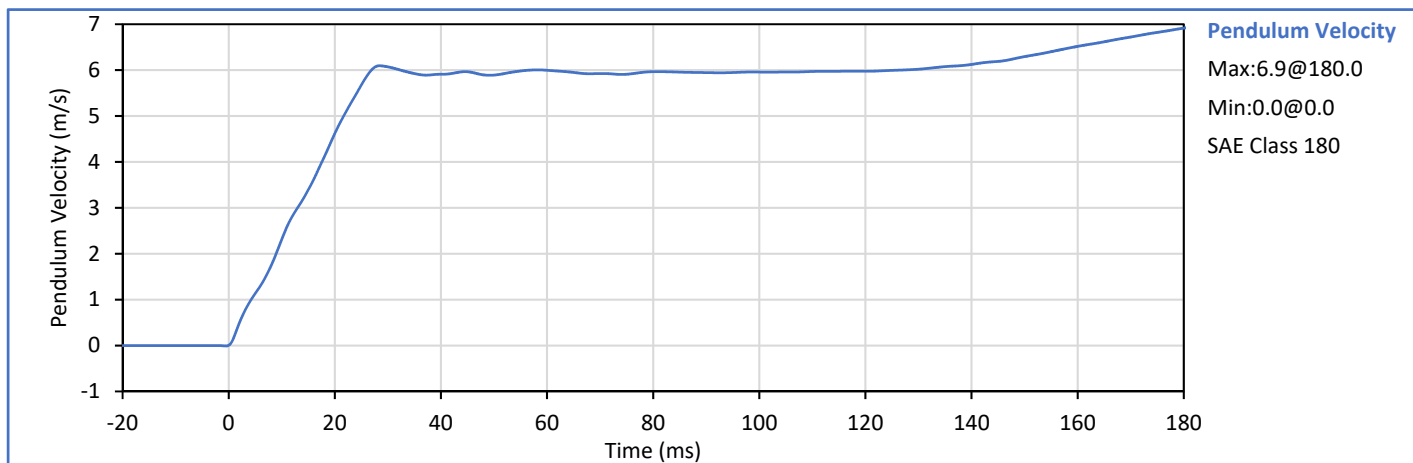
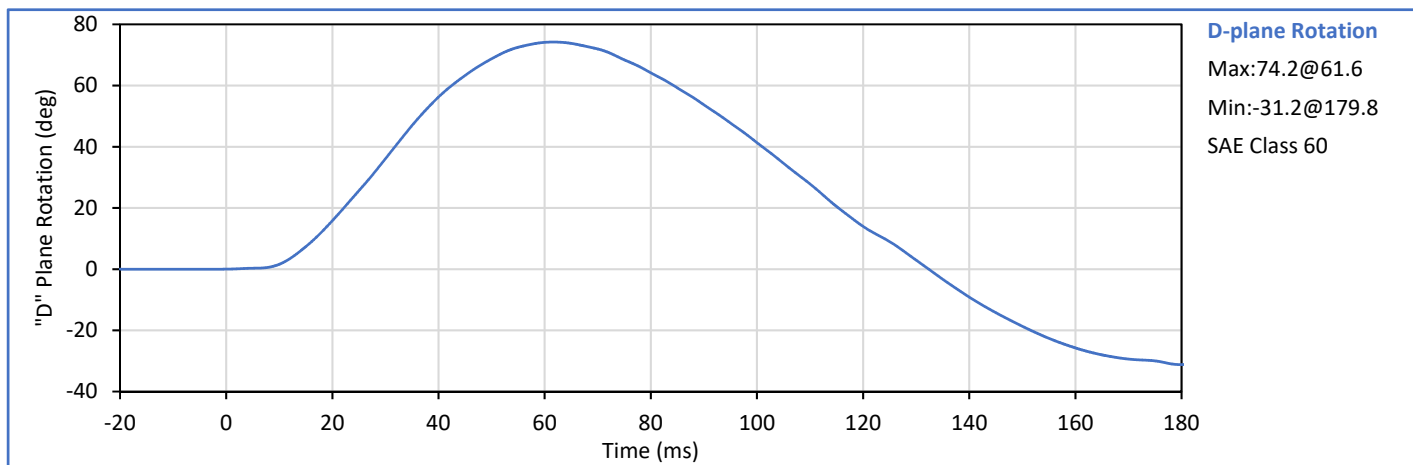
Tested Parameter	Units	Spec. Low	Spec. High	Result	Pass/Fail
Laboratory Temperature	°C	20.6	22.2	21.1	Pass
Laboratory Humidity	%	10	70	16	Pass
Pendulum Velocity	m/s	5.51	5.63	5.60	Pass
Pendulum Decel at 10 ms	m/s	2.20	2.80	2.31	Pass
Pendulum Decel at 15 ms	m/s	3.30	4.10	3.39	Pass
Pendulum Decel at 20 ms	m/s	4.40	5.40	4.62	Pass
Pendulum Decel at 25 ms	m/s	5.40	6.10	5.68	Pass
Pendulum Decel from 25-100 ms	m/s	5.50	6.20	6.10	Pass
Peak "D" Plane Rotation	deg	71.0	81.0	74.2	Pass
Time of Peak "D" Plane Rotation	ms	50.0	70.0	61.6	Pass
Peak Occ. Condyle Moment	Nm	-44.0	-36.0	-40.7	Pass
Time of Moment Decay to 0 Nm	ms	102.0	126.0	114.5	Pass
<b>Overall Test Results</b>					<b>Pass</b>

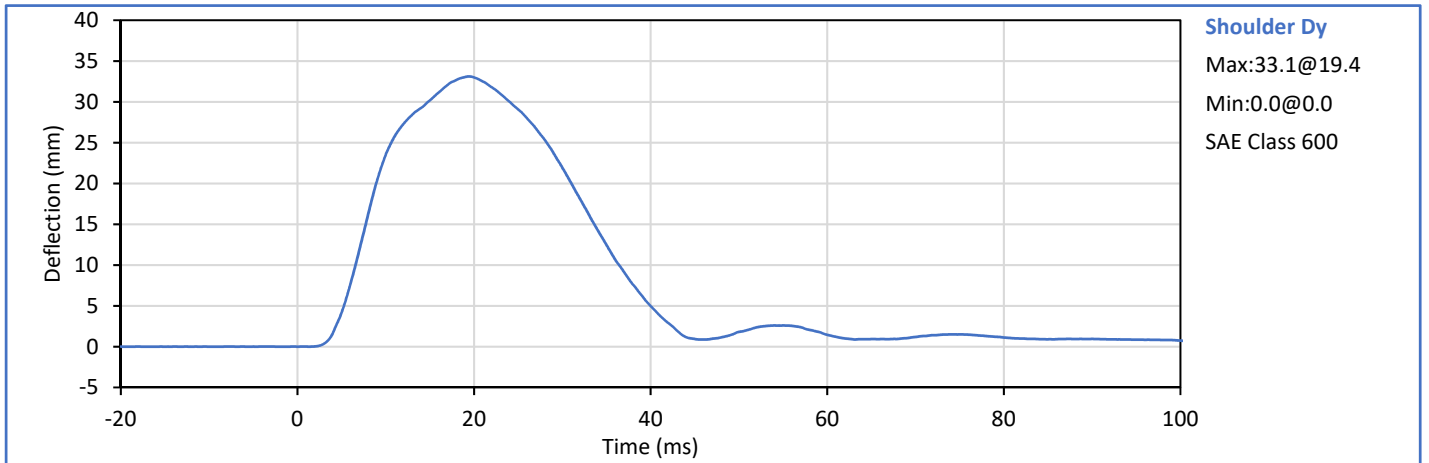
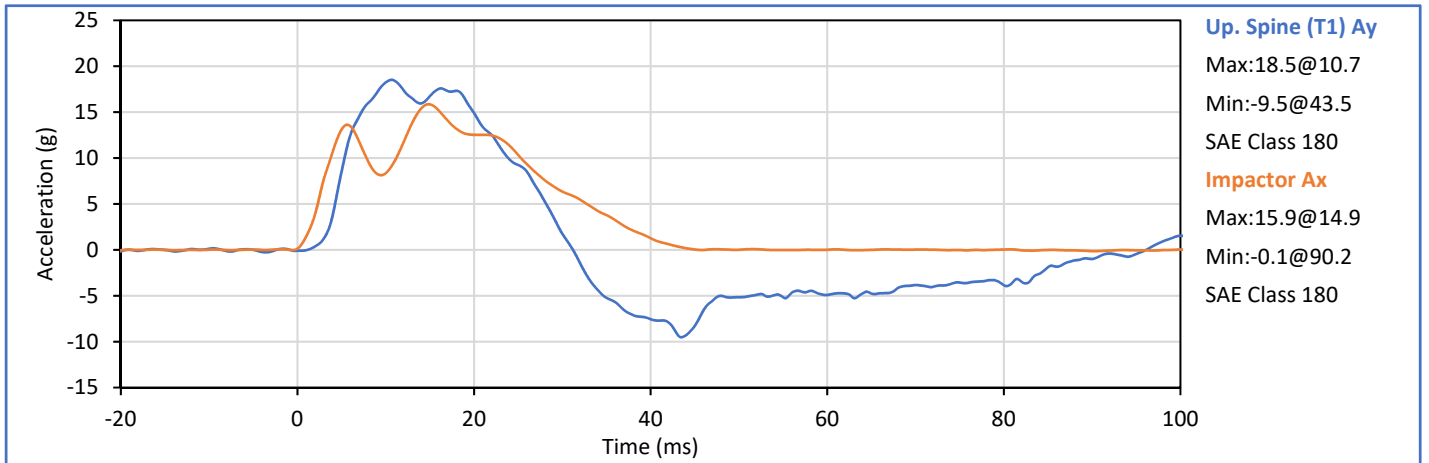
Tested Parameter	Units	Spec. Low	Spec. High	Result	Pass/Fail
Laboratory Temperature	°C	20.6	22.2	21.1	Pass
Laboratory Humidity	%	10	70	39	Pass
Impactor Velocity	m/s	4.20	4.40	4.28	Pass
Peak Shoulder Dy	mm	28.0	37.0	33.1	Pass
Peak Upper Spine (T1) Ay	g	17.0	22.0	18.5	Pass
Peak Impactor Ax	g	13.0	18.0	15.9	Pass
Overall Test Results					Pass

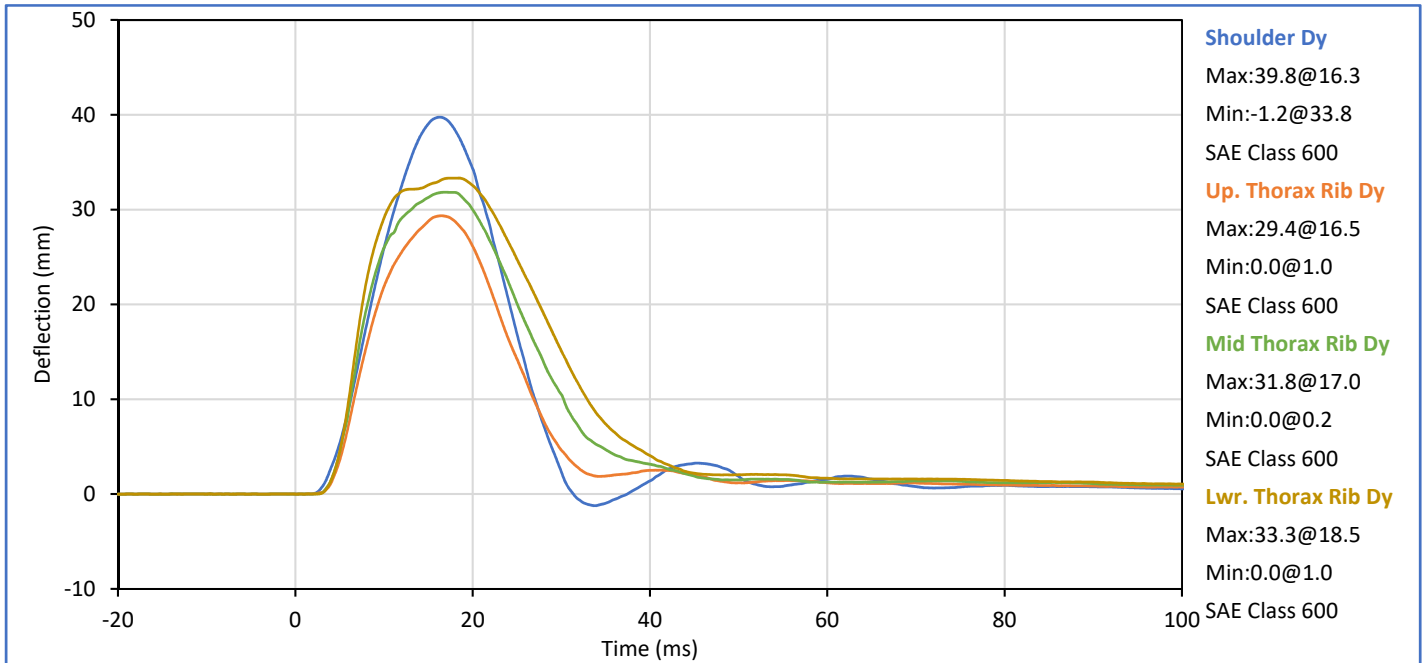
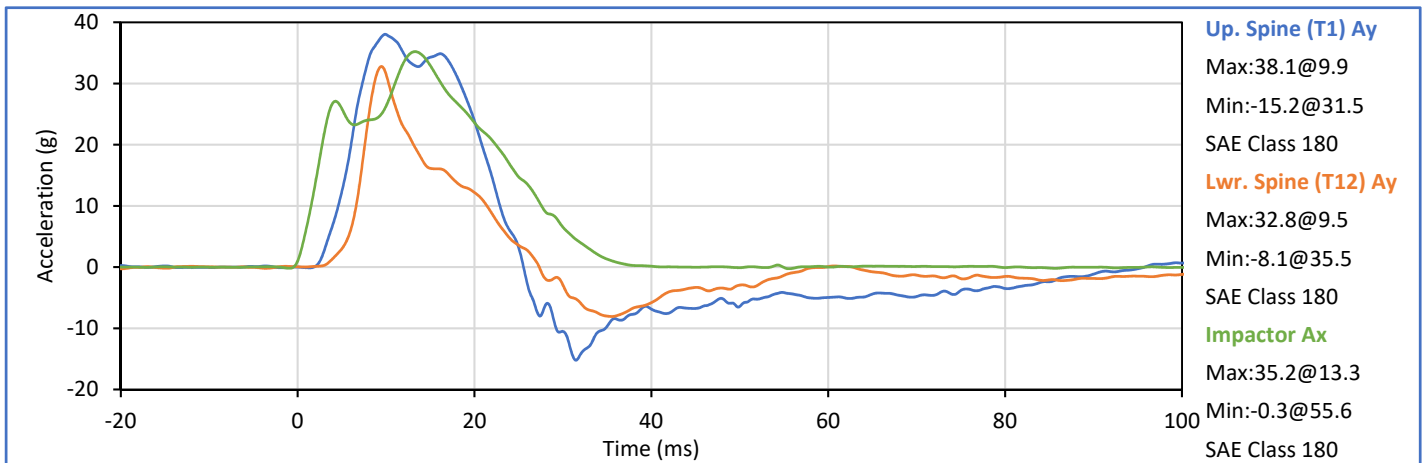
Tested Parameter	Units	Spec. Low	Spec. High	Result	Pass/Fail
Laboratory Temperature	°C	20.6	22.2	21.1	Pass
Laboratory Humidity	%	10	70	17	Pass
Impactor Velocity	m/s	6.60	6.80	6.75	Pass
Peak Shoulder Dy	mm	31.0	40.0	39.8	Pass
Peak Upper Rib Dy	mm	25.0	32.0	29.4	Pass
Peak Middle Rib Dy	mm	30.0	36.0	31.8	Pass
Peak Lower Rib Dy	mm	32.0	38.0	33.3	Pass
Peak Upper Spine (T1) Ay	g	34.0	43.0	38.1	Pass
Peak Lower Spine (T12) Ay	g	29.0	37.0	32.8	Pass
Peak Impactor Ax	g	30.0	36.0	35.2	Pass
<b>Overall Test Results</b>					<b>Pass</b>

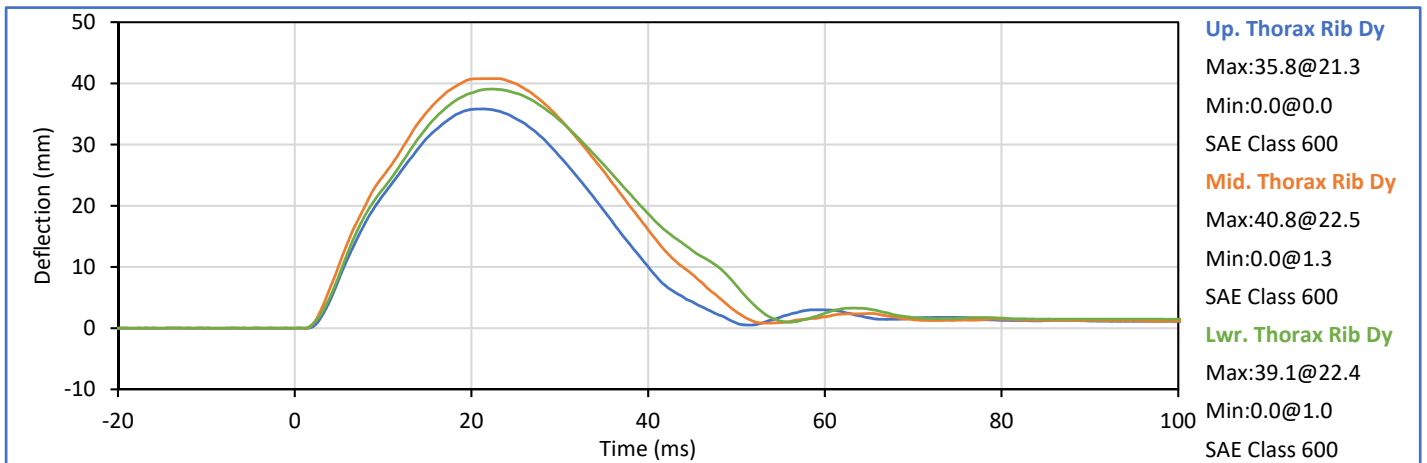
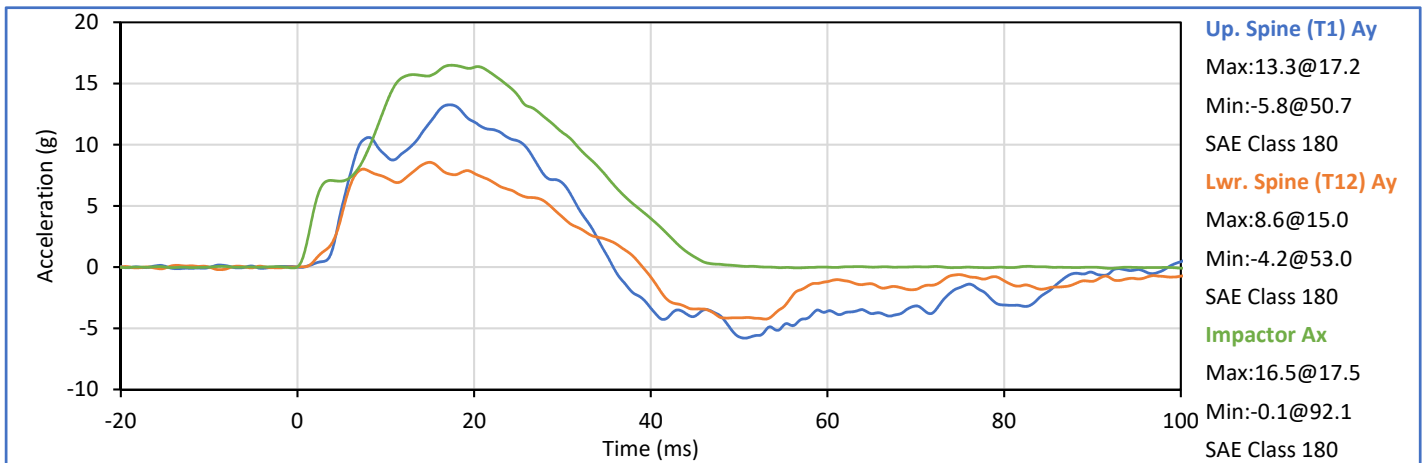
Tested Parameter	Units	Spec. Low	Spec. High	Result	Pass/Fail
Laboratory Temperature	°C	20.6	22.2	21.1	Pass
Laboratory Humidity	%	10	70	18	Pass
Impactor Velocity	m/s	4.20	4.40	4.38	Pass
Peak Upper Rib Dy	mm	32.0	40.0	35.8	Pass
Peak Middle Rib Dy	mm	39.0	45.0	40.8	Pass
Peak Lower Rib Dy	mm	35.0	43.0	39.1	Pass
Peak Upper Spine (T1) Ay	g	13.0	17.0	13.3	Pass
Peak Lower Spine (T12) Ay	g	7.0	11.0	8.6	Pass
Peak Impactor Ax	g	14.0	18.0	16.5	Pass
Overall Test Results					Pass

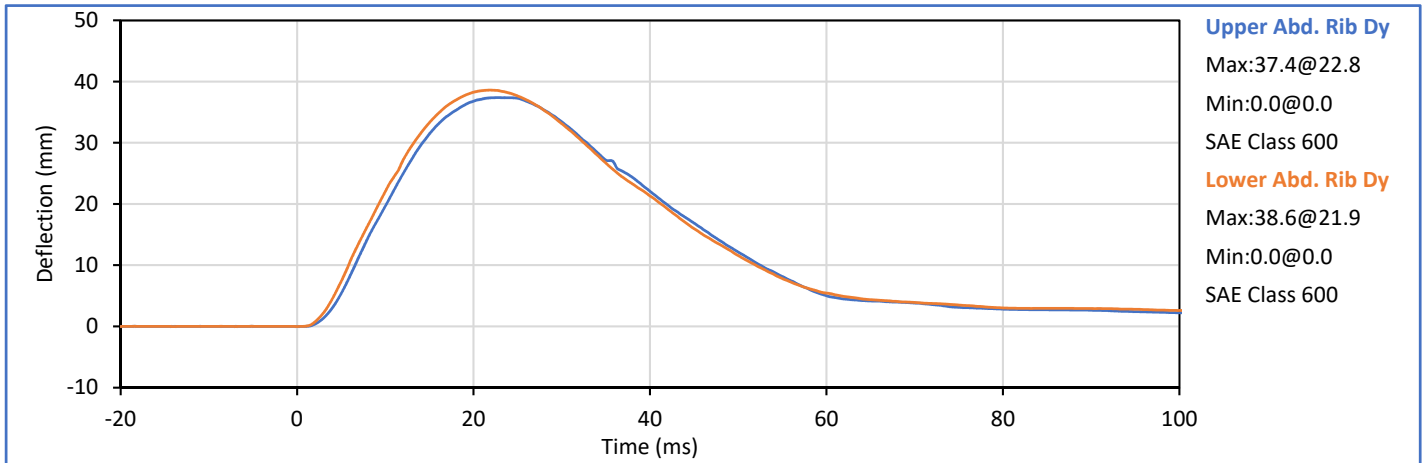
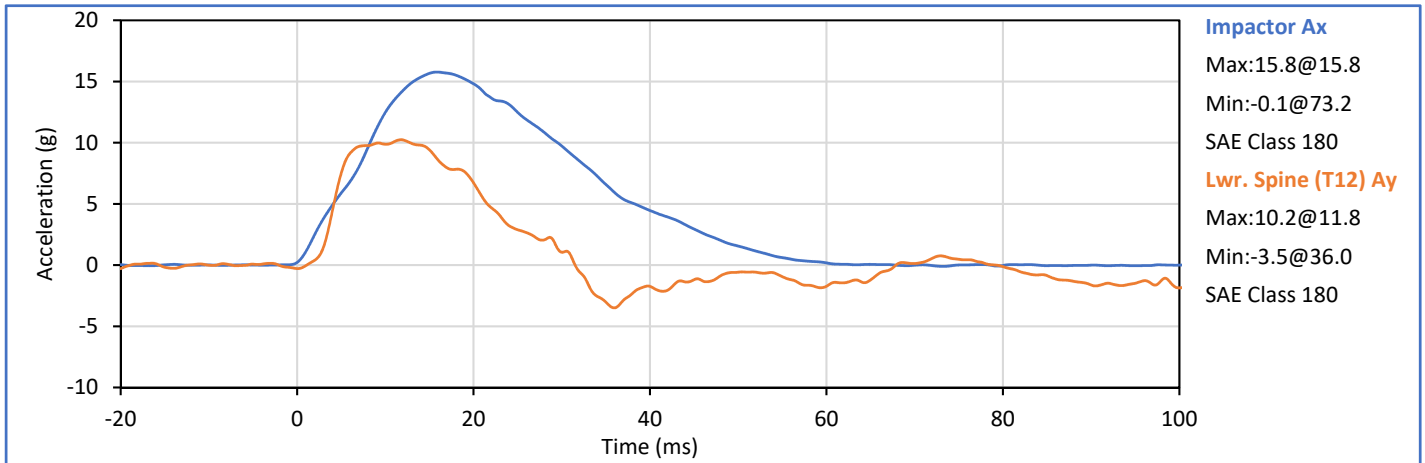
Tested Parameter	Units	Spec. Low	Spec. High	Result	Pass/Fail
Laboratory Temperature	°C	20.6	22.2	21.1	Pass
Laboratory Humidity	%	10	70	19	Pass
Impactor Velocity	m/s	4.20	4.40	4.36	Pass
Peak Upper Abdomen Rib Dy	mm	36.0	47.0	37.4	Pass
Peak Lower Abdomen Rib Dy	mm	33.0	44.0	38.6	Pass
Peak Lower Spine T12 Ay	mm	9.0	14.0	10.2	Pass
Peak Impactor Ax	g	12.0	16.0	15.8	Pass
Overall Test Results					Pass

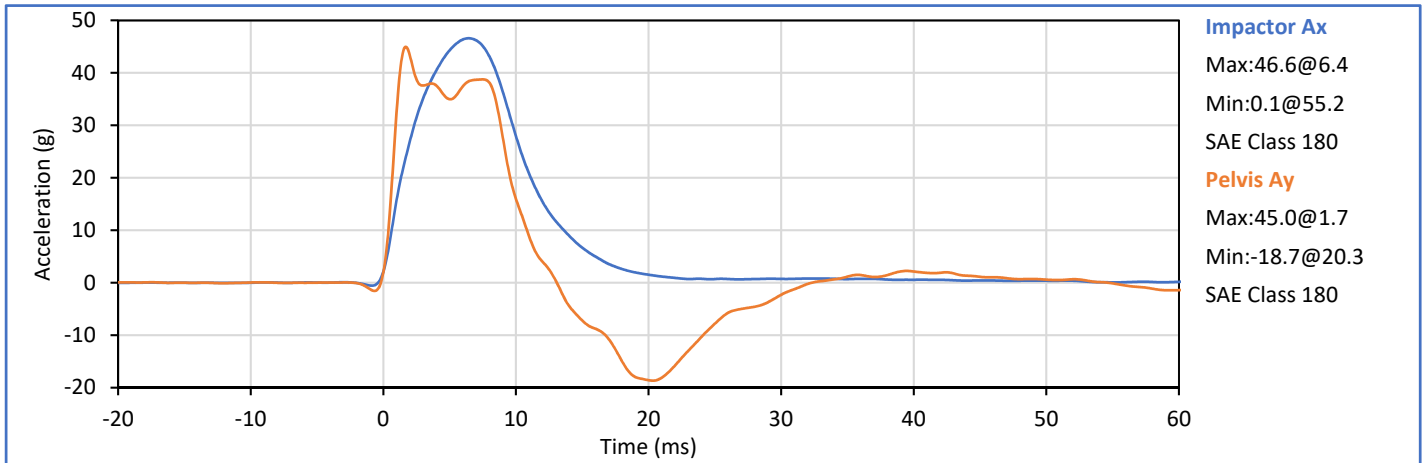
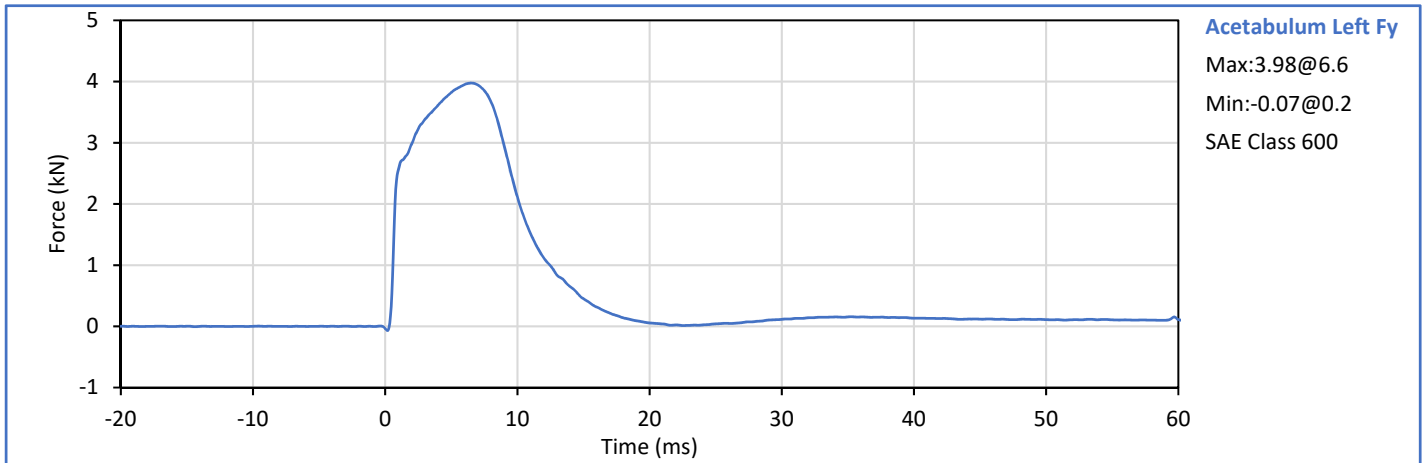
Tested Parameter	Units	Spec. Low	Spec. High	Result	Pass/Fail
Laboratory Temperature	°C	20.6	22.2	21.1	Pass
Laboratory Humidity	%	10	70	16	Pass
Impactor Velocity	m/s	6.60	6.80	6.71	Pass
Peak Acetabulum Fy	kN	3.60	4.30	3.98	Pass
Pelvis Ay after 6ms	g	34.0	42.0	38.8	Pass
Peak Impactor Ax	g	38.0	47.0	46.6	Pass
Overall Test Results					Pass
