**REPORT NUMBER: SINCAP-KAR-20-003**

**NEW CAR ASSESSMENT PROGRAM (NCAP)  
MOVING DEFORMABLE BARRIER SIDE IMPACT TEST**

**SUBARU CORPORATION  
2020 SUBARU LEGACY 4-DOOR SEDAN**

**NHTSA No: O20205501**

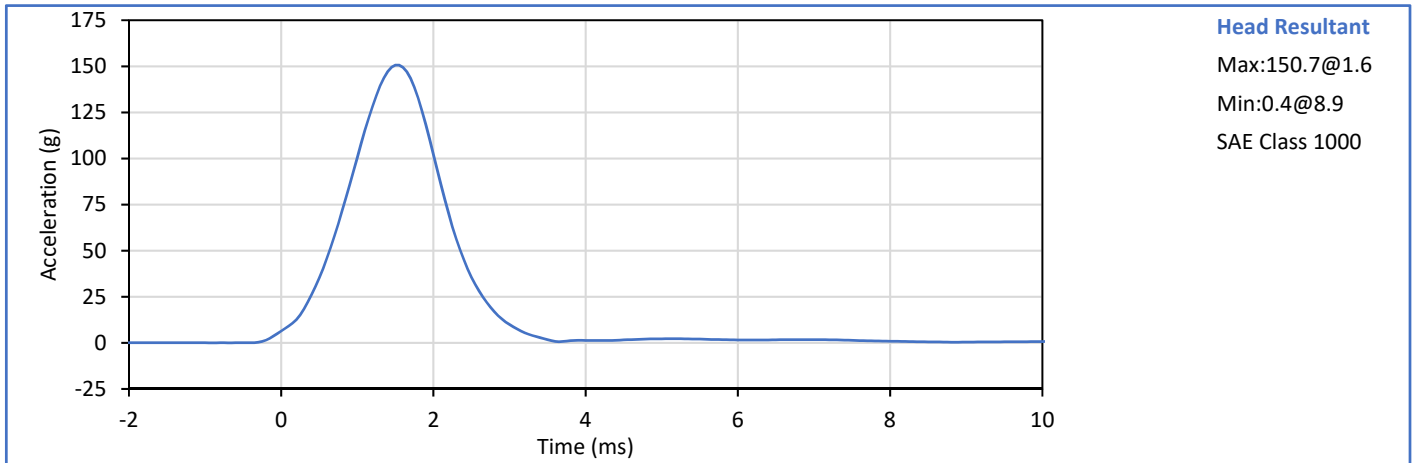
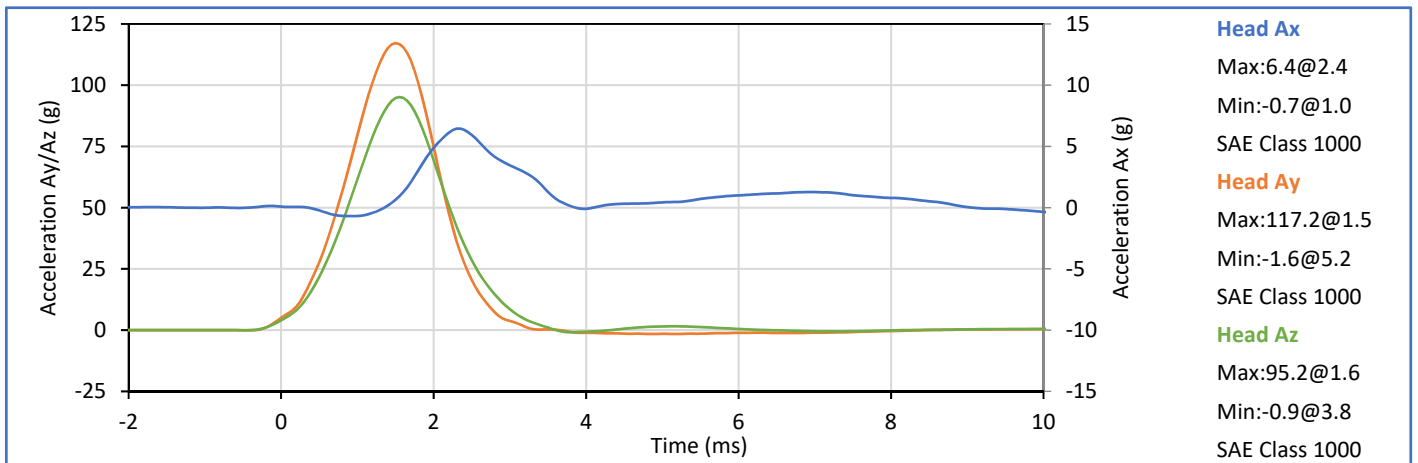
Tested Parameter	Units	Spec. Low	Spec. High	Result	Pass/Fail
Laboratory Temperature	°C	18.9	25.6	21.1	Pass
Laboratory Humidity	%	10	70	32	Pass
Peak Resultant Acceleration	g	125.0	155.0	150.7	Pass
Peak Head Ax	g	-15.0	15.0	6.4	Pass
Oscillations After Main Pulse	%	0.0	15.0	1.3	Pass
Is Acceleration Unimodal?	Yes/No	Yes		Yes	Pass
Overall Test Results					Pass

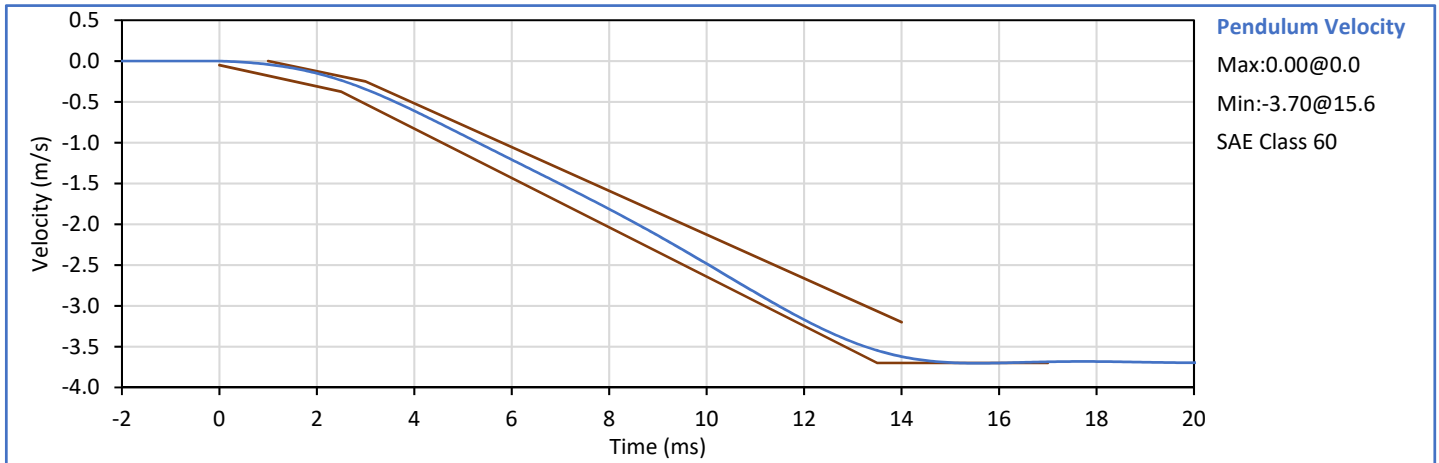
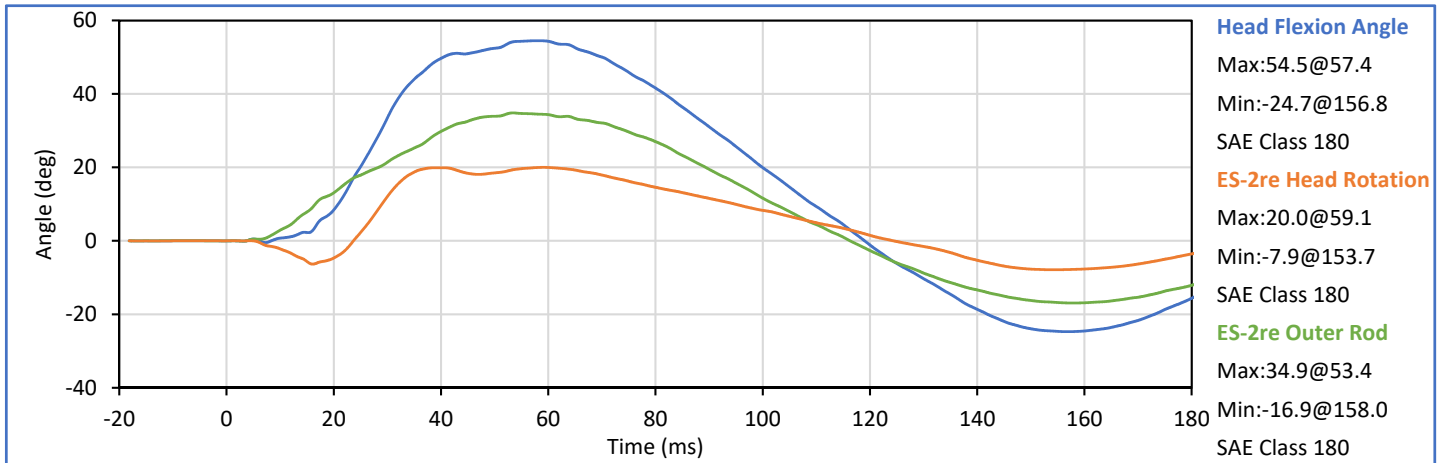
Tested Parameter	Units	Spec. Low	Spec. High	Result	Pass/Fail
Laboratory Temperature	°C	20.6	22.2	21.1	Pass
Laboratory Humidity	%	10	70	30	Pass
Pendulum Velocity	m/s	3.30	3.50	3.46	Pass
Peak Headform Flexion	deg	49.0	59.0	54.5	Pass
Time of Peak Headform Flexion	ms	54.0	66.0	57.4	Pass
Flexion Decay (Peak to zero)	ms	53.0	88.0	61.6	Pass
Overall Test Results					Pass

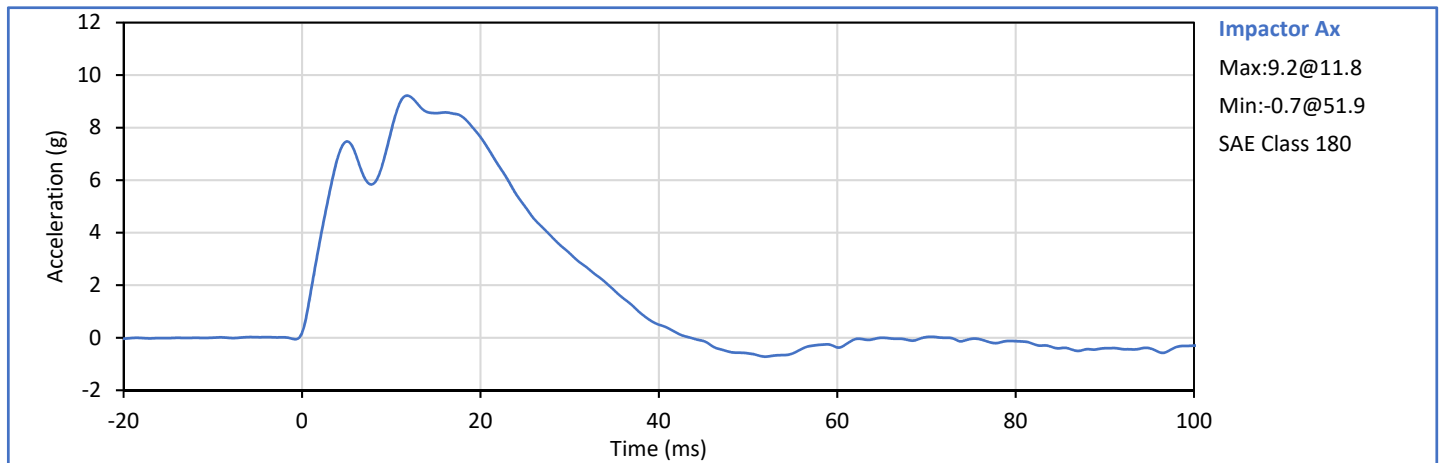
Tested Parameter	Units	Spec. Low	Spec. High	Result	Pass/Fail
Laboratory Temperature	°C	20.6	22.2	21.1	Pass
Laboratory Humidity	%	10	70	32	Pass
Impactor Velocity	m/s	4.20	4.40	4.36	Pass
Peak Impactor Ax	g	7.5	10.5	9.2	Pass
Overall Test Results					Pass

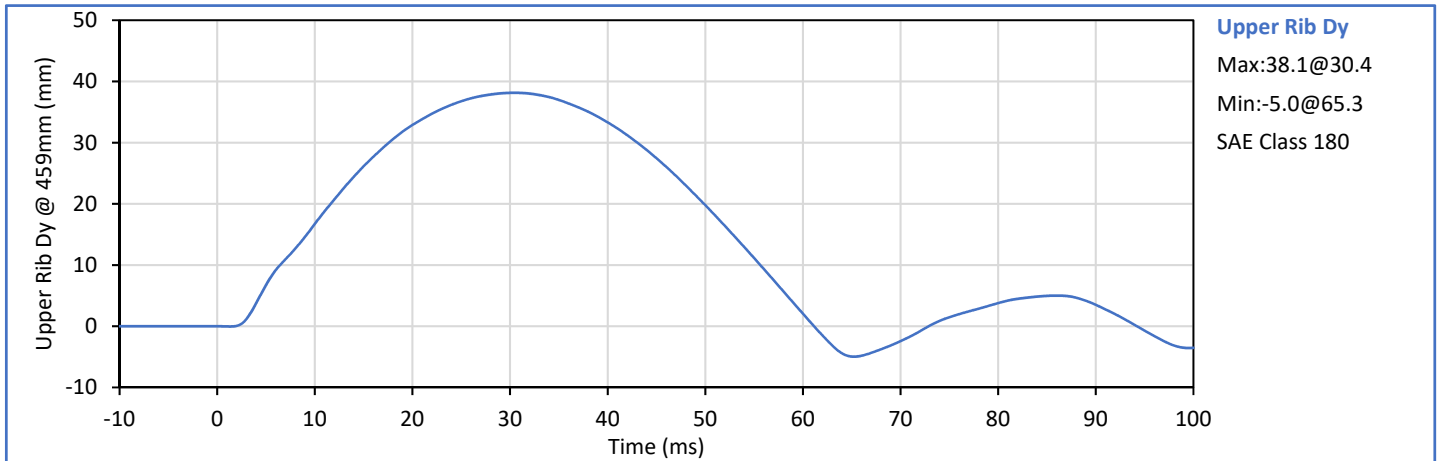
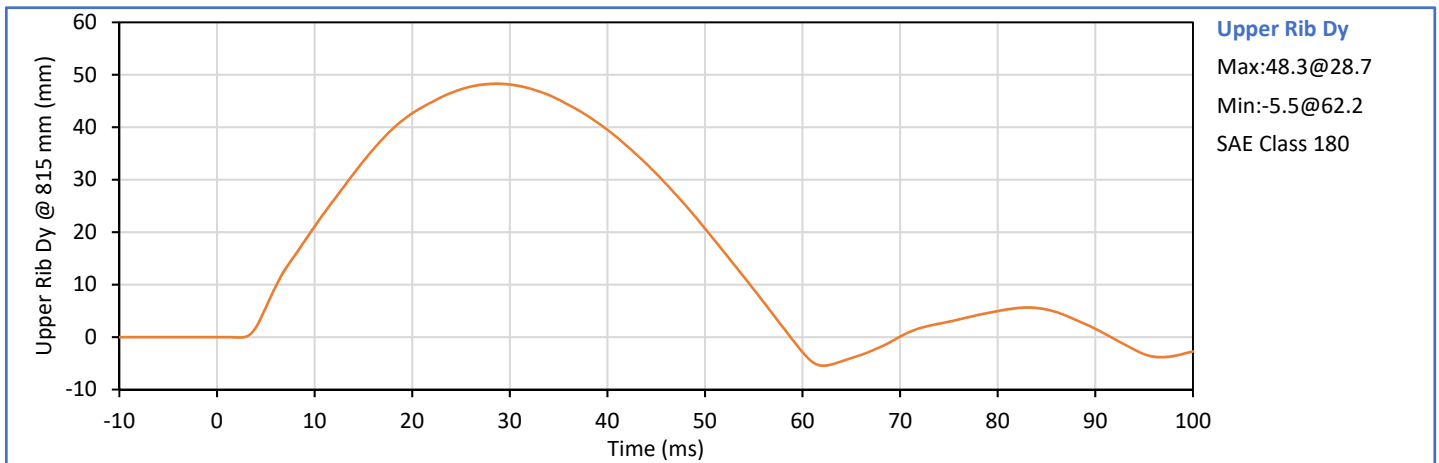
Tested Parameter	Units	Spec. Low	Spec. High	Result	Pass/Fail
Laboratory Temperature	°C	20.6	22.2	21.1	Pass
Laboratory Humidity	%	10	70	33	Pass
Upper Rib Dy @ 459mm	mm	36.0	40.0	38.1	Pass
Upper Rib Dy @ 815mm	mm	46.0	51.0	48.3	Pass
Overall Test Results					Pass

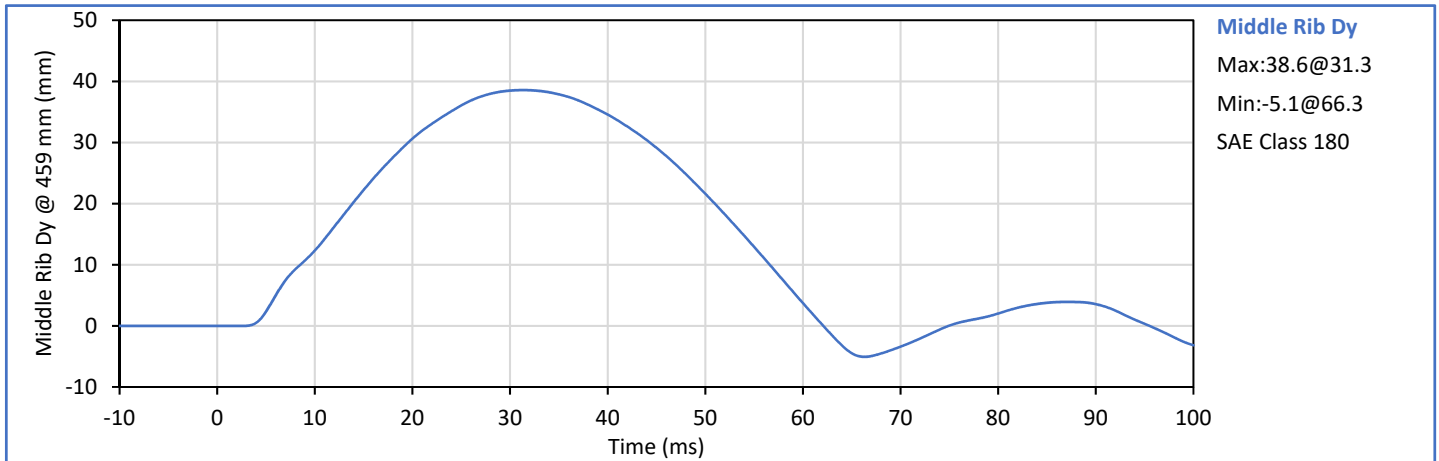
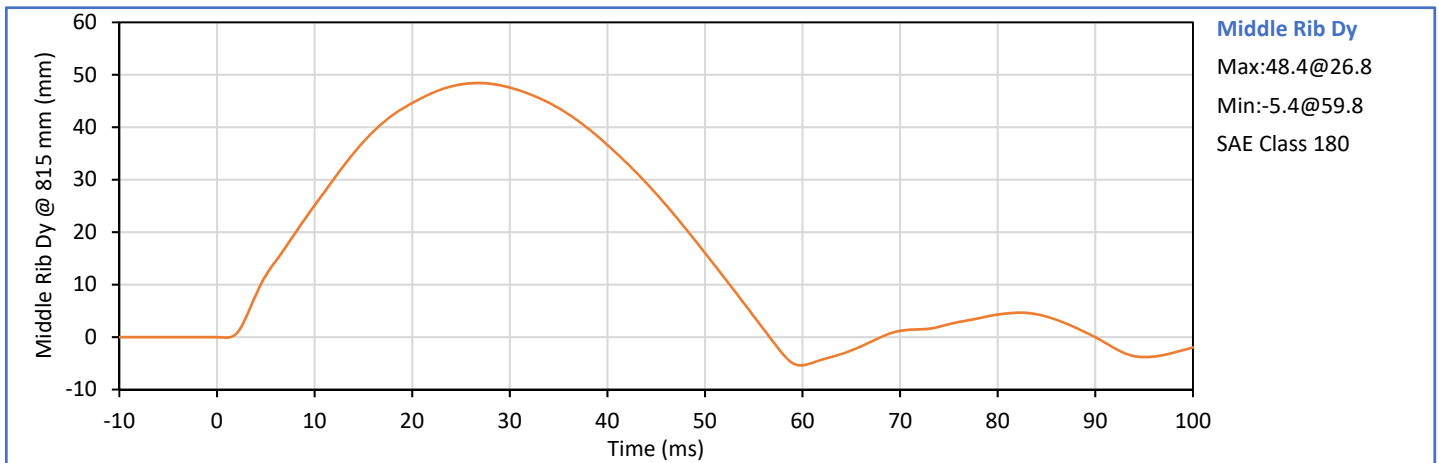
Tested Parameter	Units	Spec. Low	Spec. High	Result	Pass/Fail
Laboratory Temperature	°C	20.6	22.2	21.1	Pass
Laboratory Humidity	%	10	70	33	Pass
Middle Rib Dy @ 459mm	mm	36.0	40.0	38.6	Pass
Middle Rib Dy @ 815mm	mm	46.0	51.0	48.4	Pass
Overall Test Results					Pass

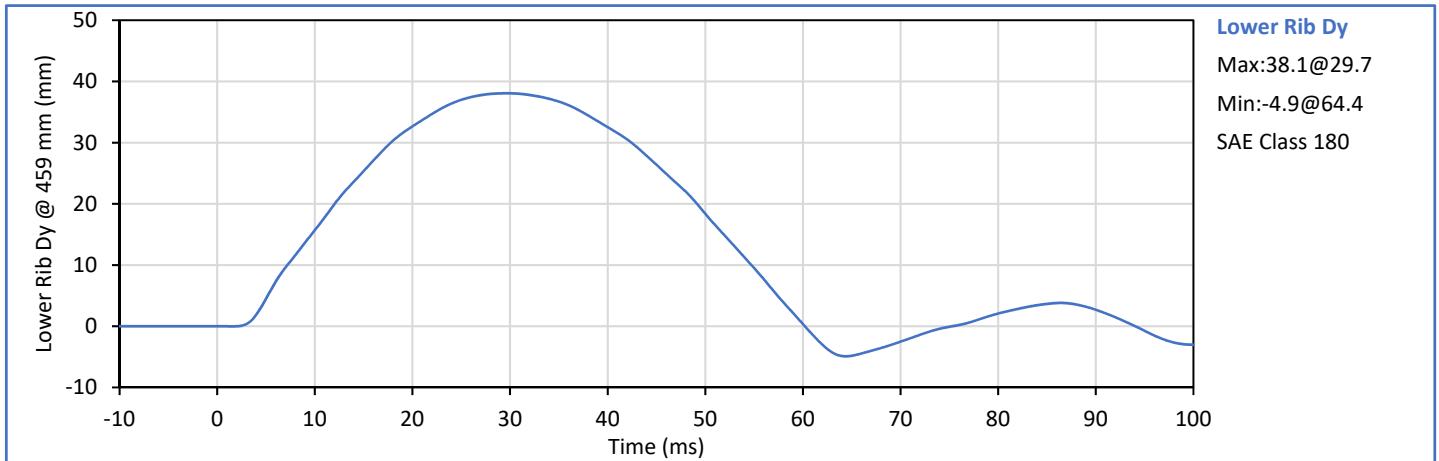
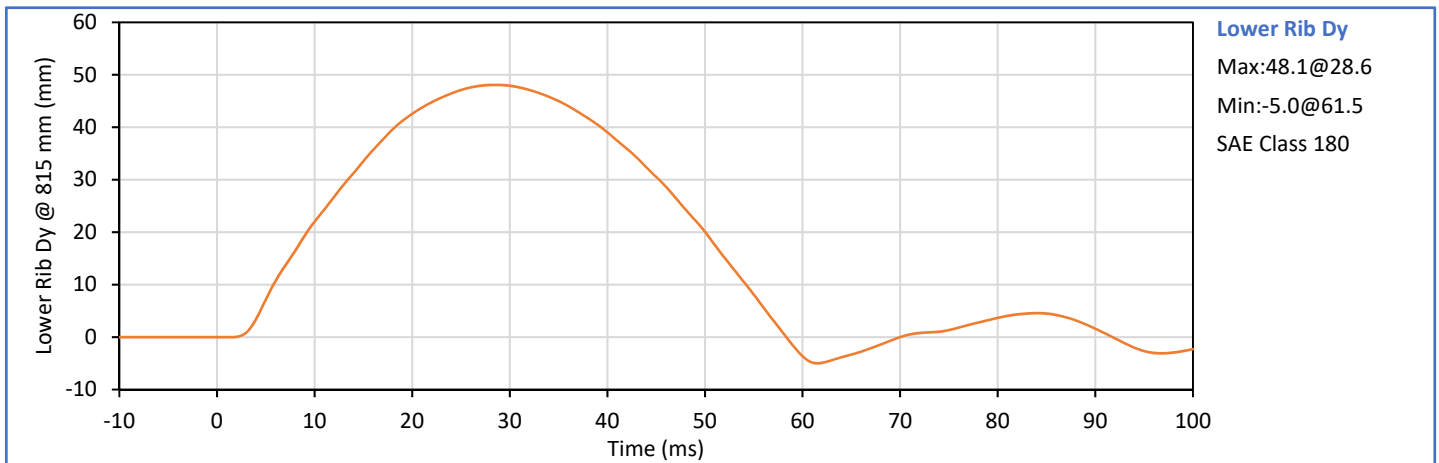
Tested Parameter	Units	Spec. Low	Spec. High	Result	Pass/Fail
Laboratory Temperature	°C	20.6	22.2	21.1	Pass
Laboratory Humidity	%	10	70	33	Pass
Lower Rib Dy @ 459mm	mm	36.0	40.0	38.1	Pass
Lower Rib Dy @ 815mm	mm	46.0	51.0	48.1	Pass
Overall Test Results					Pass

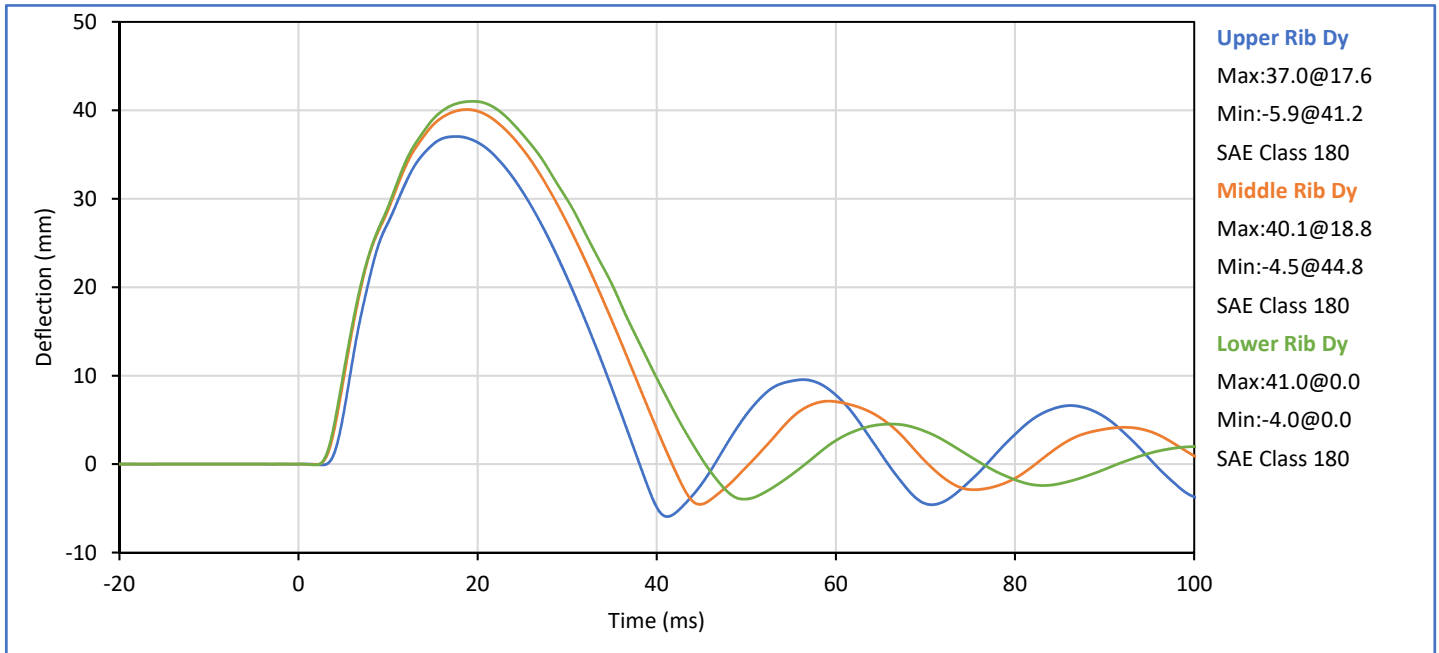
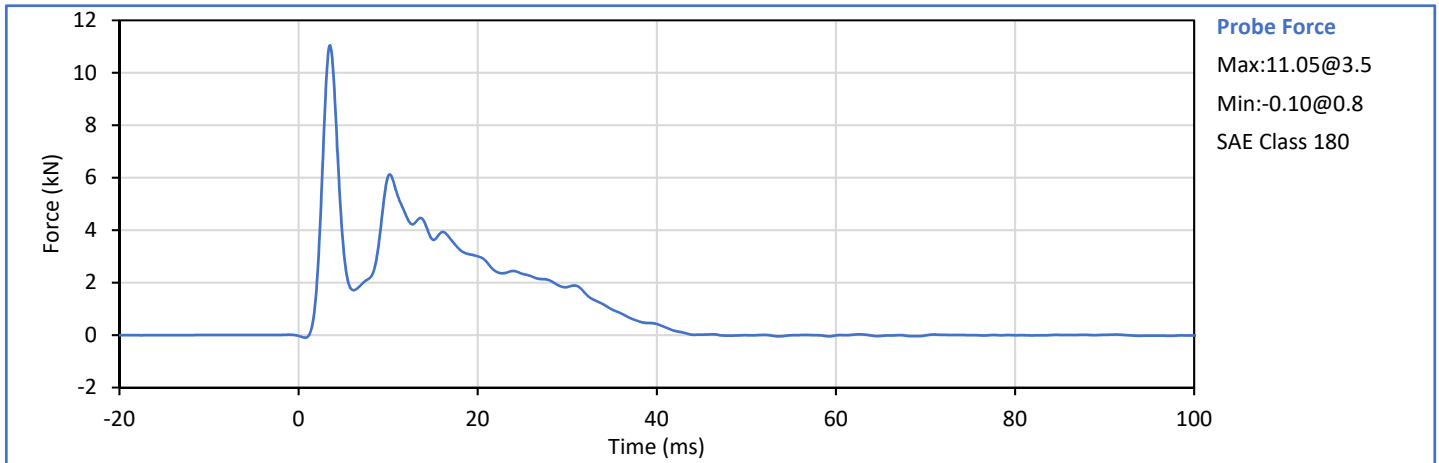
Tested Parameter	Units	Spec. Low	Spec. High	Result	Pass/Fail
Laboratory Temperature	°C	20.6	22.2	21.1	Pass
Laboratory Humidity	%	10	70	32	Pass
Impactor Velocity	m/s	5.40	5.60	5.50	Pass
Peak Upper Rib Dy	mm	34.0	41.0	37.0	Pass
Peak Middle Rib Dy	mm	37.0	45.0	40.1	Pass
Peak Lower Rib Dy	mm	37.0	44.0	41.0	Pass
Peak Impactor Force After 6 ms	kN	5.10	6.20	6.13	Pass
<b>Overall Test Results</b>					<b>Pass</b>

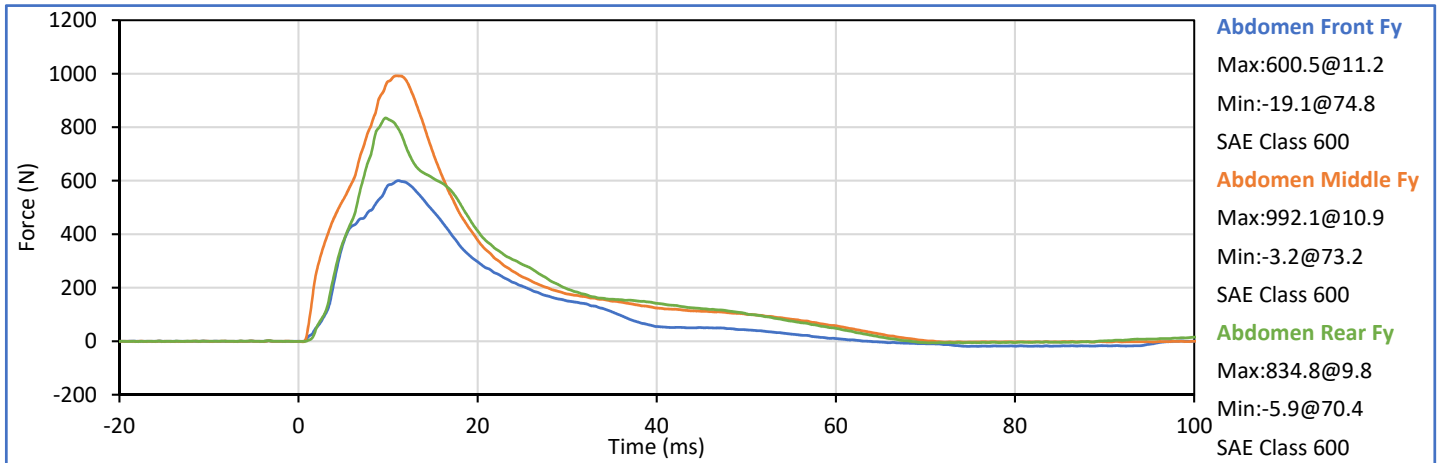
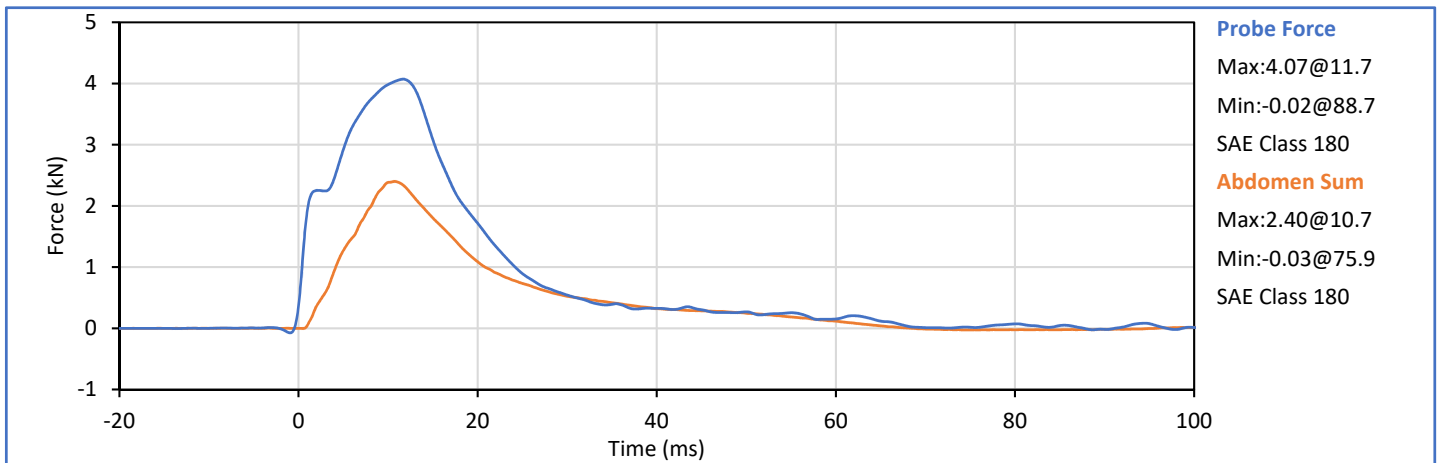
Tested Parameter	Units	Spec. Low	Spec. High	Result	Pass/Fail
Laboratory Temperature	°C	20.6	22.2	21.1	Pass
Laboratory Humidity	%	10	70	32	Pass
Impactor Velocity	m/s	3.90	4.10	3.98	Pass
Peak Impactor Force	kN	4.00	4.80	4.07	Pass
Time of Peak Impactor Force	ms	10.6	13.0	11.7	Pass
Sum of Abdomen Forces	kN	2.20	2.70	2.40	Pass
Time of Peak Sum Abdomen Force	ms	10.0	12.3	10.7	Pass
<b>Overall Test Results</b>					<b>Pass</b>

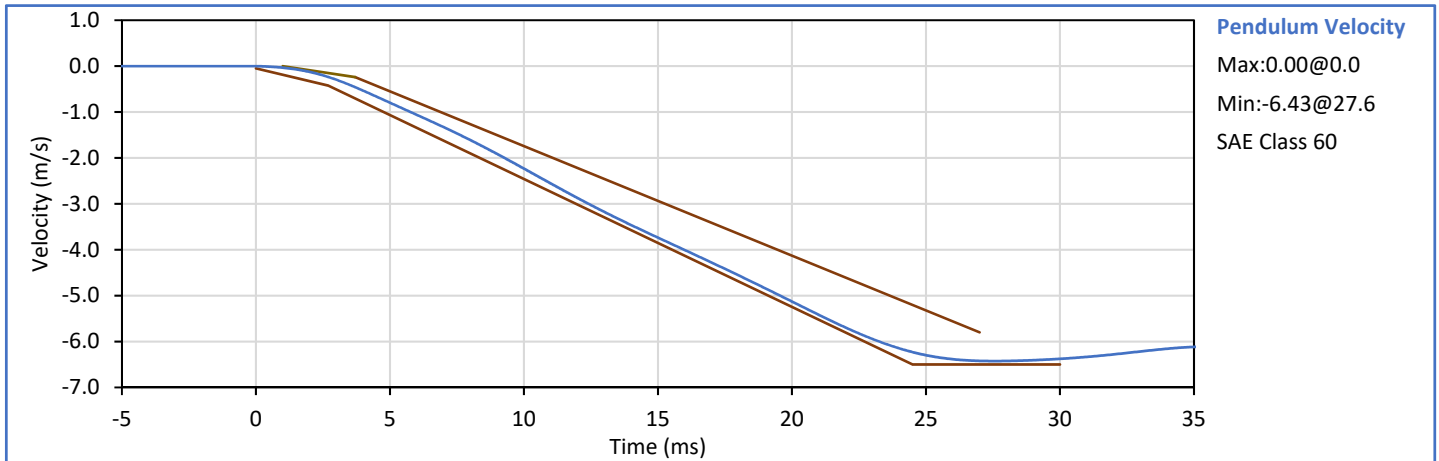
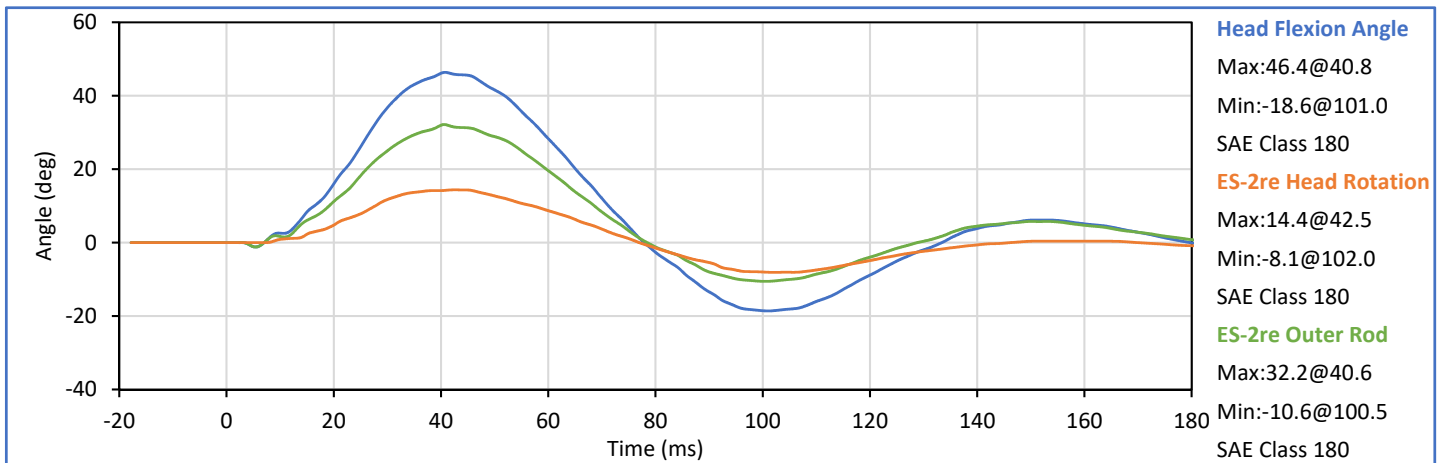
Tested Parameter	Units	Spec. Low	Spec. High	Result	Pass/Fail
Laboratory Temperature	°C	20.6	22.2	21.1	Pass
Laboratory Humidity	%	10	70	31	Pass
Pendulum Velocity	m/s	5.95	6.15	6.08	Pass
Peak Headform Flexion	deg	45.0	55.0	46.4	Pass
Time of Peak Headform Flexion	ms	39.0	53.0	40.8	Pass
Flexion Decay (Peak to zero)	ms	37.0	57.0	37.2	Pass
Overall Test Results					Pass

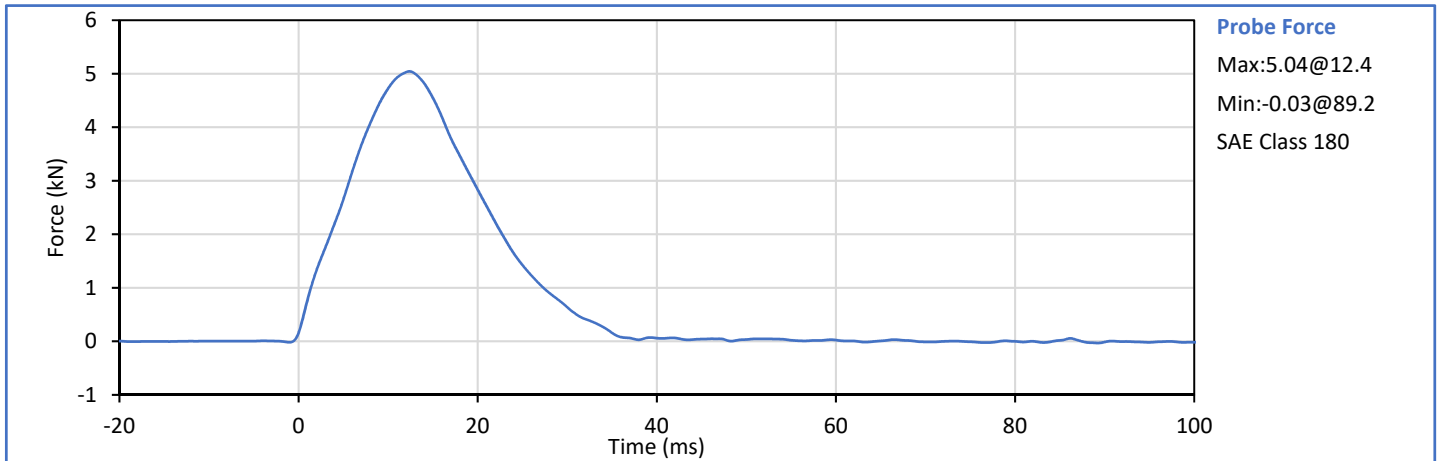
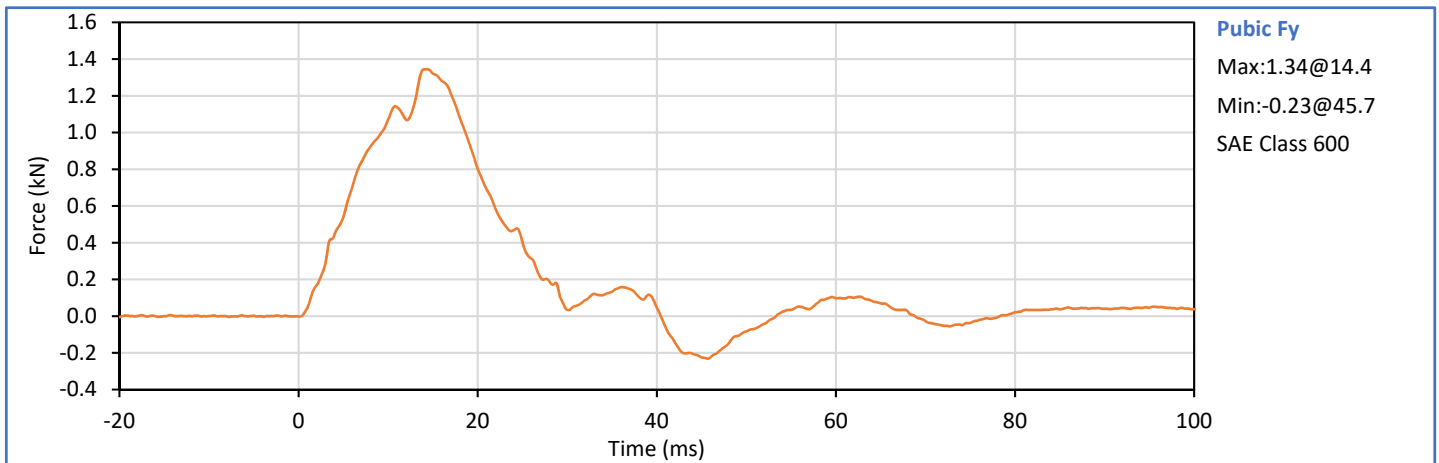
Tested Parameter	Units	Spec. Low	Spec. High	Result	Pass/Fail
Laboratory Temperature	°C	20.6	22.2	21.1	Pass
Laboratory Humidity	%	10	70	32	Pass
Impactor Velocity	m/s	4.20	4.40	4.32	Pass
Peak Impactor Force	kN	4.70	5.40	5.04	Pass
Time of Peak Impactor Force	ms	11.8	16.1	12.4	Pass
Pubic Symphysis Fy	kN	1.23	1.59	1.34	Pass
Time of Peak Pubic Symphysis Fy	ms	12.2	17.0	14.4	Pass
<b>Overall Test Results</b>					<b>Pass</b>

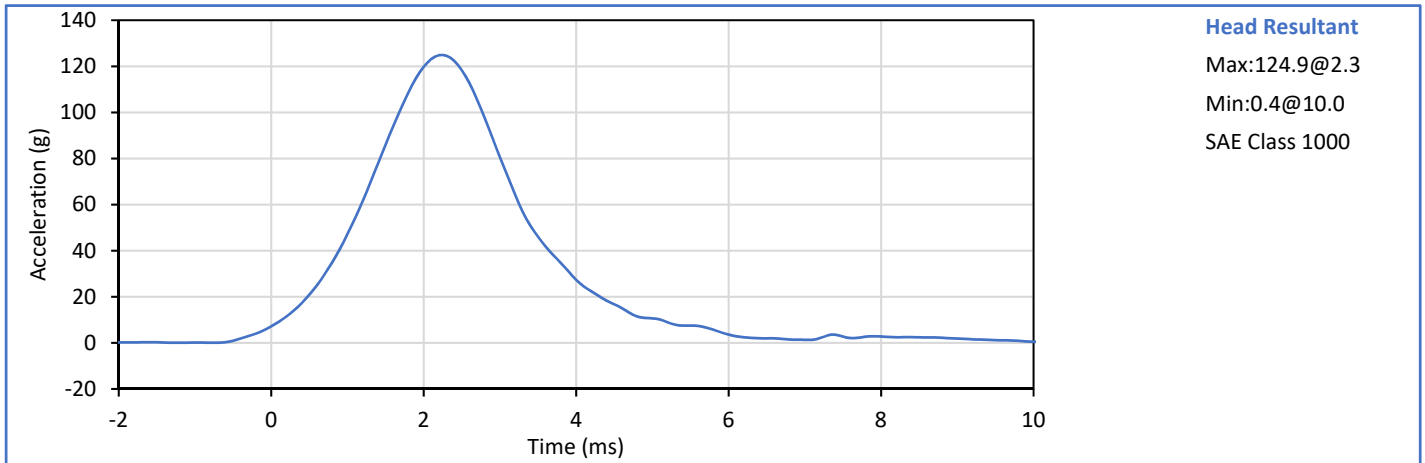
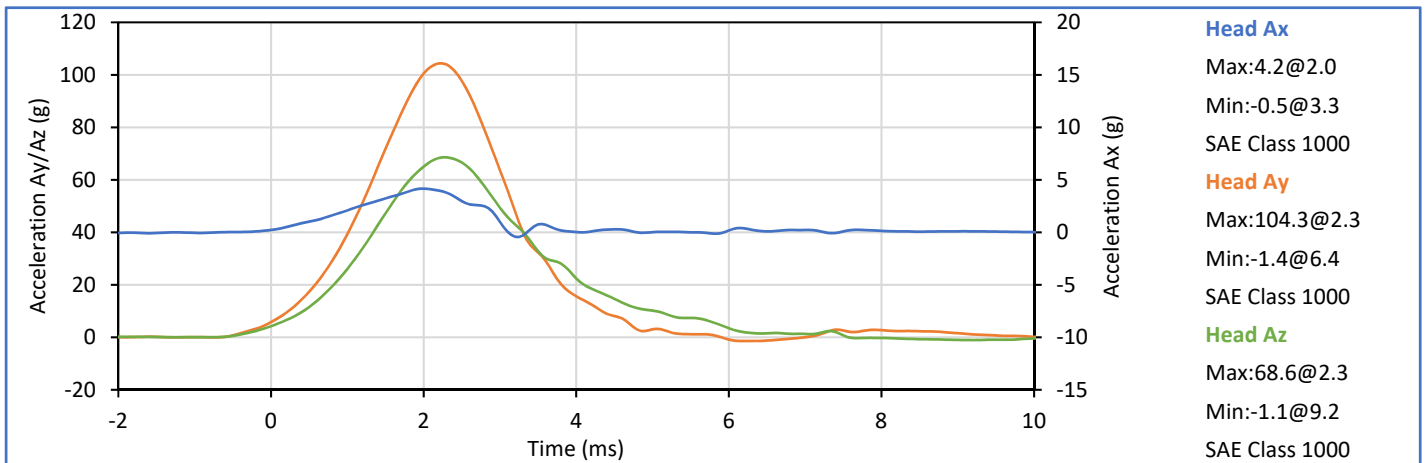
Tested Parameter	Units	Spec. Low	Spec. High	Result	Pass/Fail
Laboratory Temperature	°C	18.9	25.6	21.1	Pass
Laboratory Humidity	%	10	70	24	Pass
Peak Resultant Acceleration	g	115.0	137.0	124.9	Pass
Peak Head Ax	g	-15.0	15.0	-0.7	Pass
Oscillations After Main Pulse	%	0.0	15.0	2.9	Pass
Is Acceleration Unimodal?	Yes/No	Yes		Yes	Pass
Overall Test Results					Pass

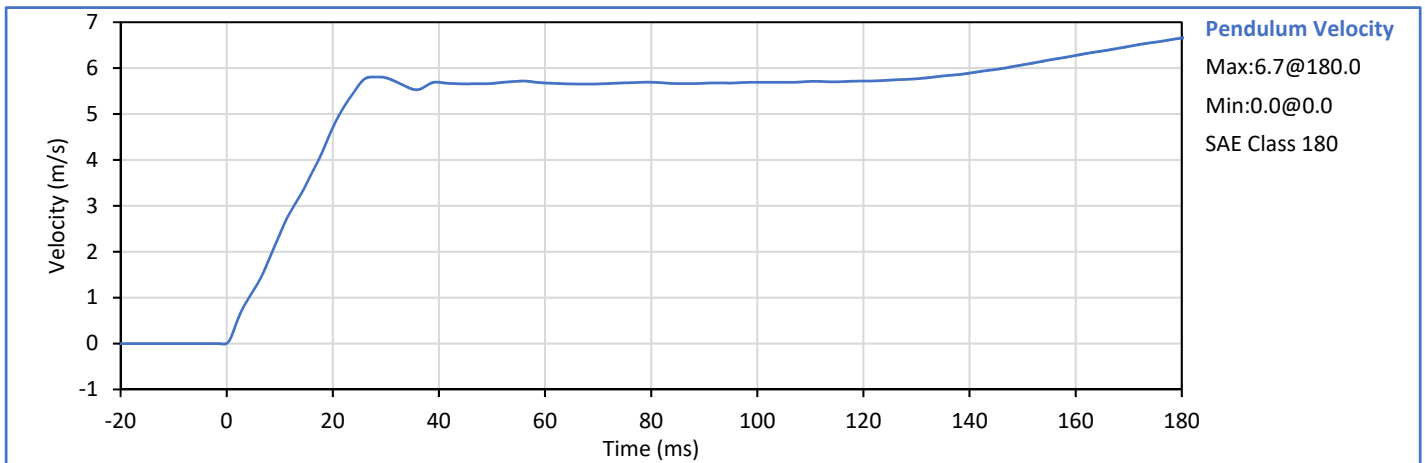
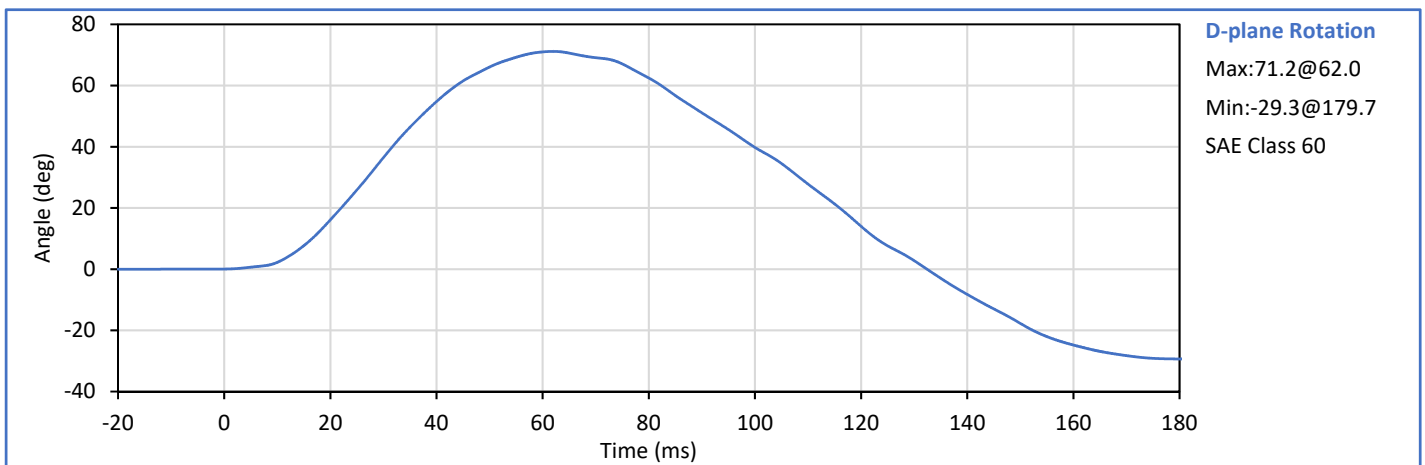
Tested Parameter	Units	Spec. Low	Spec. High	Result	Pass/Fail
Laboratory Temperature	°C	20.6	22.2	21.1	Pass
Laboratory Humidity	%	10	70	20	Pass
Pendulum Velocity	m/s	5.51	5.63	5.58	Pass
Pendulum Decel at 10 ms	m/s	2.20	2.80	2.38	Pass
Pendulum Decel at 15 ms	m/s	3.30	4.10	3.47	Pass
Pendulum Decel at 20 ms	m/s	4.40	5.40	4.71	Pass
Pendulum Decel at 25 ms	m/s	5.40	6.10	5.65	Pass
Pendulum Decel from 25-100 ms	m/s	5.50	6.20	5.81	Pass
Peak "D" Plane Rotation	deg	71.0	81.0	71.2	Pass
Time of Peak "D" Plane Rotation	ms	50.0	70.0	62.0	Pass
Peak Occ. Condyle Moment	Nm	-44.0	-36.0	-41.3	Pass
Time of Moment Decay to 0 Nm	ms	102.0	126.0	111.8	Pass
<b>Overall Test Results</b>					<b>Pass</b>

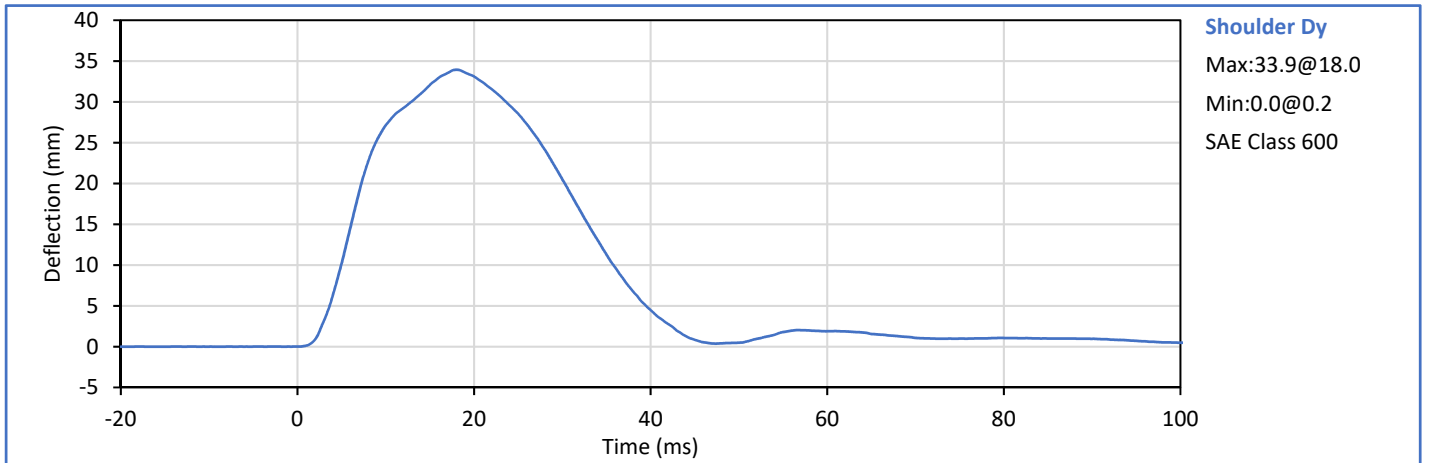
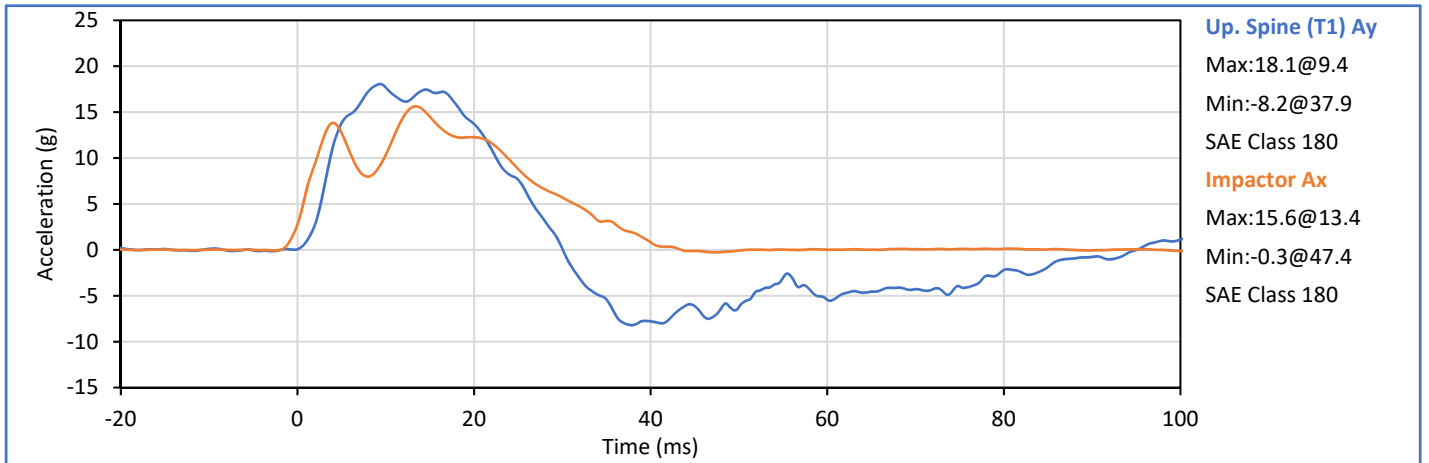
Tested Parameter	Units	Spec. Low	Spec. High	Result	Pass/Fail
Laboratory Temperature	°C	20.6	22.2	21.1	Pass
Laboratory Humidity	%	10	70	24	Pass
Impactor Velocity	m/s	4.20	4.40	4.32	Pass
Peak Shoulder Dy	mm	28.0	37.0	33.9	Pass
Peak Upper Spine (T1) Ay	g	17.0	22.0	18.1	Pass
Peak Impactor Ax	g	13.0	18.0	15.6	Pass
Overall Test Results					Pass

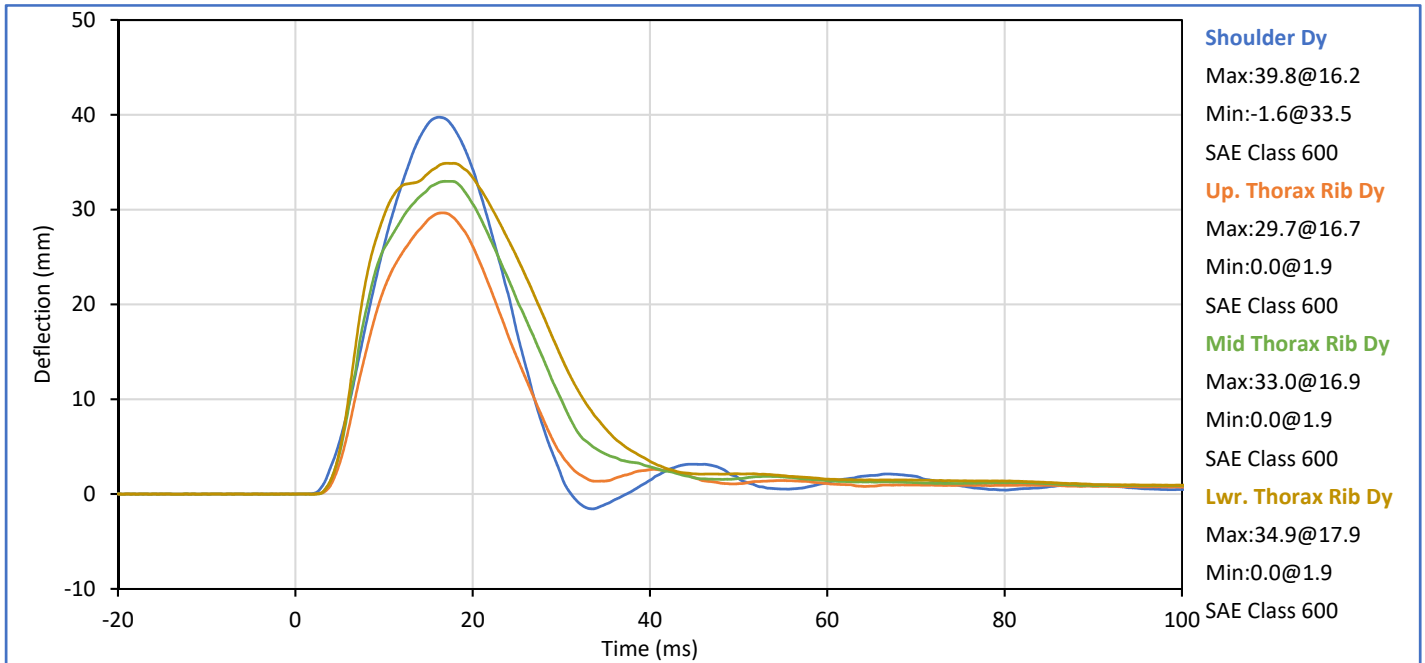
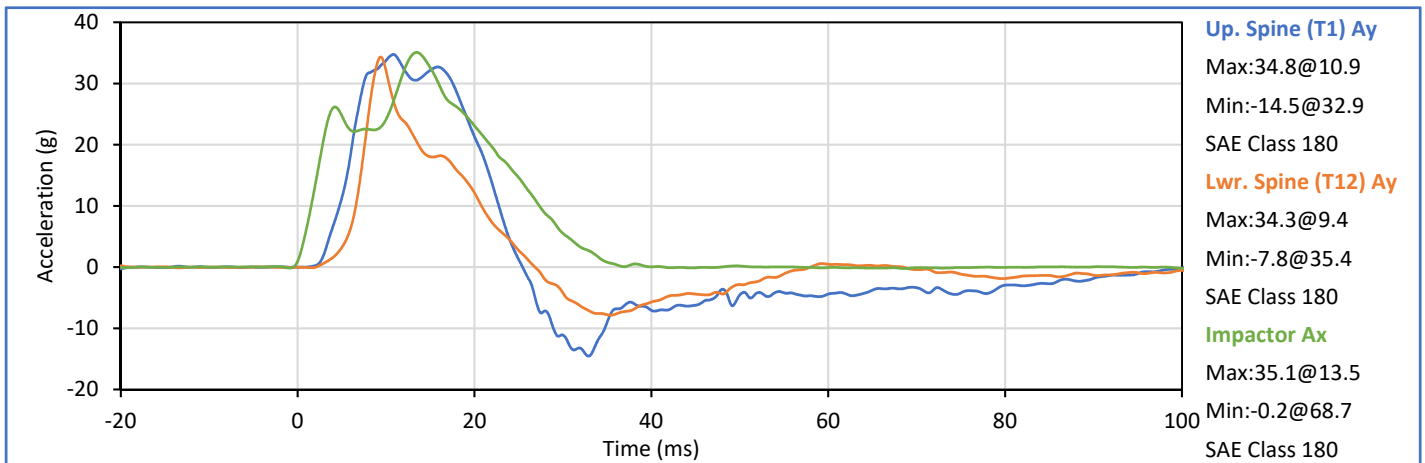
Tested Parameter	Units	Spec. Low	Spec. High	Result	Pass/Fail
Laboratory Temperature	°C	20.6	22.2	21.1	Pass
Laboratory Humidity	%	10	70	24	Pass
Impactor Velocity	m/s	6.60	6.80	6.70	Pass
Peak Shoulder Dy	mm	31.0	40.0	39.8	Pass
Peak Upper Rib Dy	mm	25.0	32.0	29.7	Pass
Peak Middle Rib Dy	mm	30.0	36.0	33.0	Pass
Peak Lower Rib Dy	mm	32.0	38.0	34.9	Pass
Peak Upper Spine (T1) Ay	g	34.0	43.0	34.8	Pass
Peak Lower Spine (T12) Ay	g	29.0	37.0	34.3	Pass
Peak Impactor Ax	g	30.0	36.0	35.1	Pass
<b>Overall Test Results</b>					<b>Pass</b>

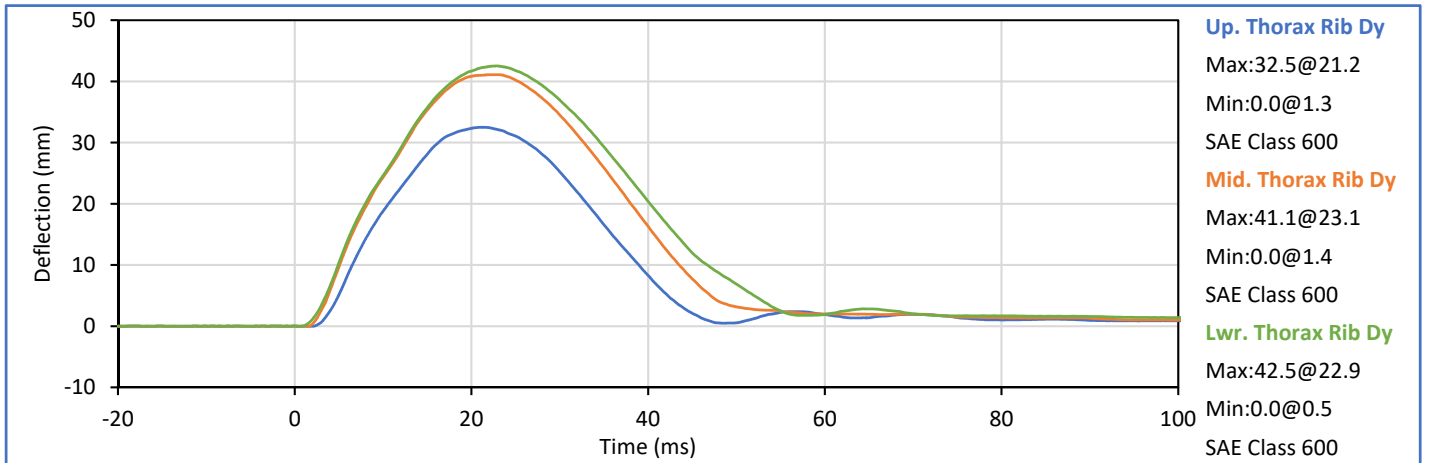
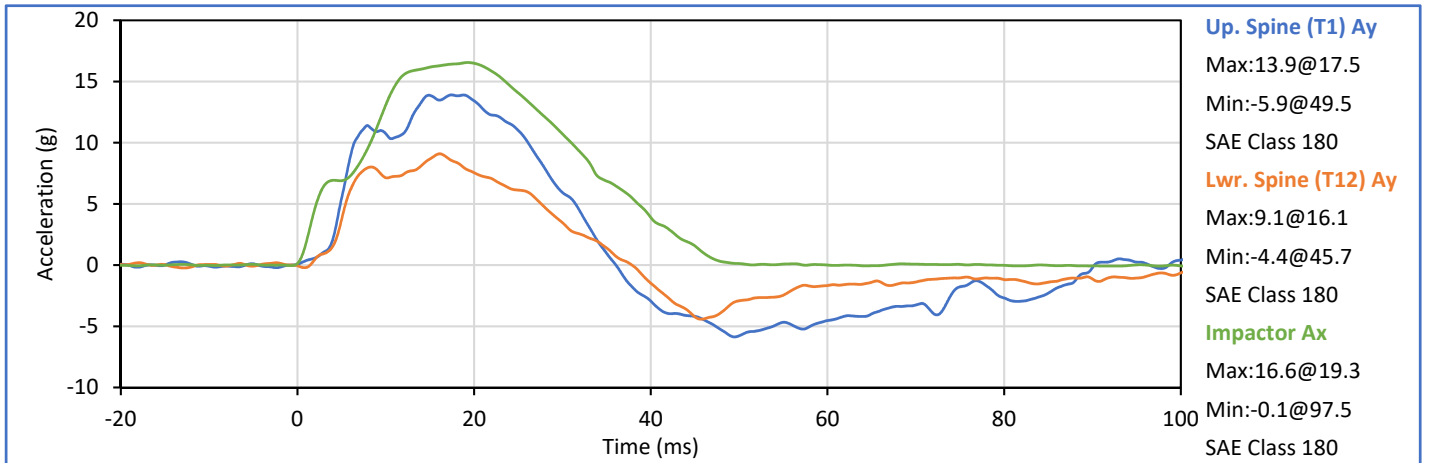
Tested Parameter	Units	Spec. Low	Spec. High	Result	Pass/Fail
Laboratory Temperature	°C	20.6	22.2	21.1	Pass
Laboratory Humidity	%	10	70	24	Pass
Impactor Velocity	m/s	4.20	4.40	4.31	Pass
Peak Upper Rib Dy	mm	32.0	40.0	32.5	Pass
Peak Middle Rib Dy	mm	39.0	45.0	41.1	Pass
Peak Lower Rib Dy	mm	35.0	43.0	42.5	Pass
Peak Upper Spine (T1) Ay	g	13.0	17.0	13.9	Pass
Peak Lower Spine (T12) Ay	g	7.0	11.0	9.1	Pass
Peak Impactor Ax	g	14.0	18.0	16.6	Pass
Overall Test Results					Pass

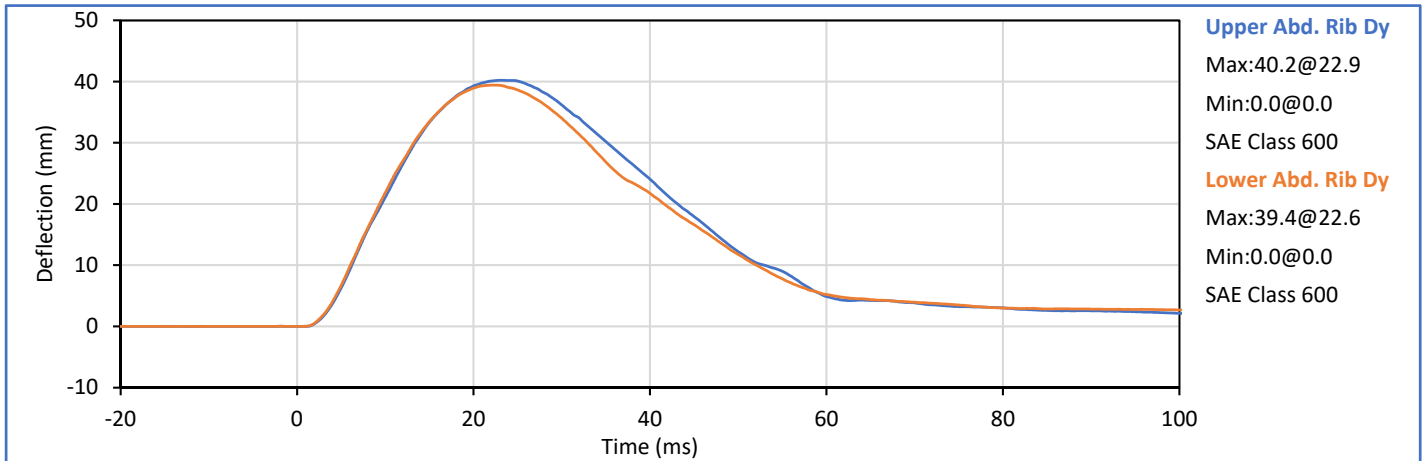
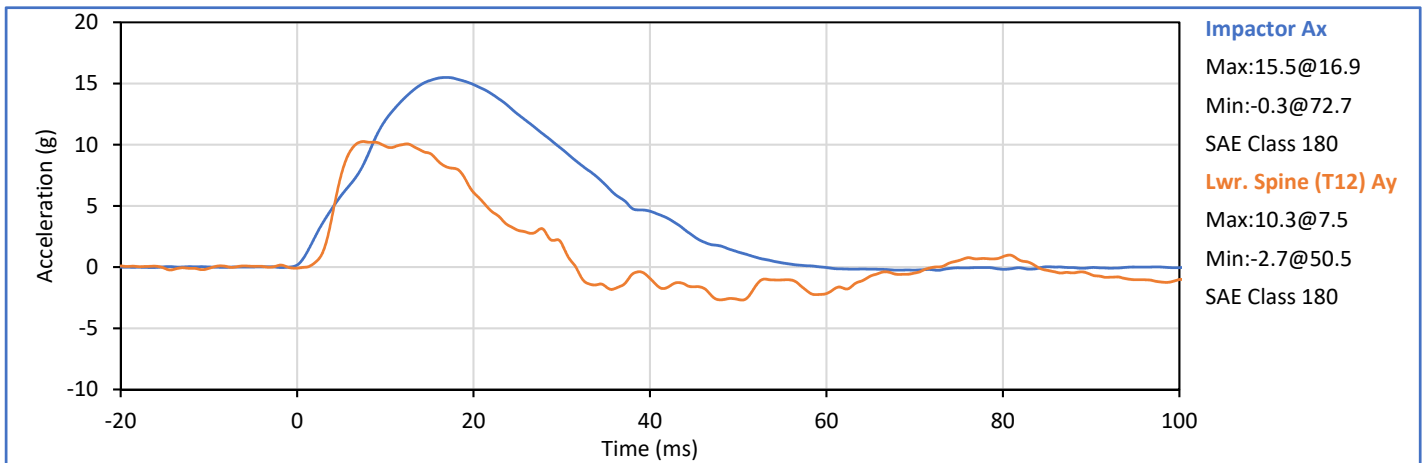
Tested Parameter	Units	Spec. Low	Spec. High	Result	Pass/Fail
Laboratory Temperature	°C	20.6	22.2	21.1	Pass
Laboratory Humidity	%	10	70	25	Pass
Impactor Velocity	m/s	4.20	4.40	4.36	Pass
Peak Upper Abdomen Rib Dy	mm	36.0	47.0	40.2	Pass
Peak Lower Abdomen Rib Dy	mm	33.0	44.0	39.4	Pass
Peak Lower Spine T12 Ay	mm	9.0	14.0	10.3	Pass
Peak Impactor Ax	g	12.0	16.0	15.5	Pass
Overall Test Results					Pass
