**REPORT NUMBER: SINCAP-KAR-20-003**

**NEW CAR ASSESSMENT PROGRAM (NCAP)  
MOVING DEFORMABLE BARRIER SIDE IMPACT TEST**

**SUBARU CORPORATION  
2020 SUBARU LEGACY 4-DOOR SEDAN**

**NHTSA No: O20205501**

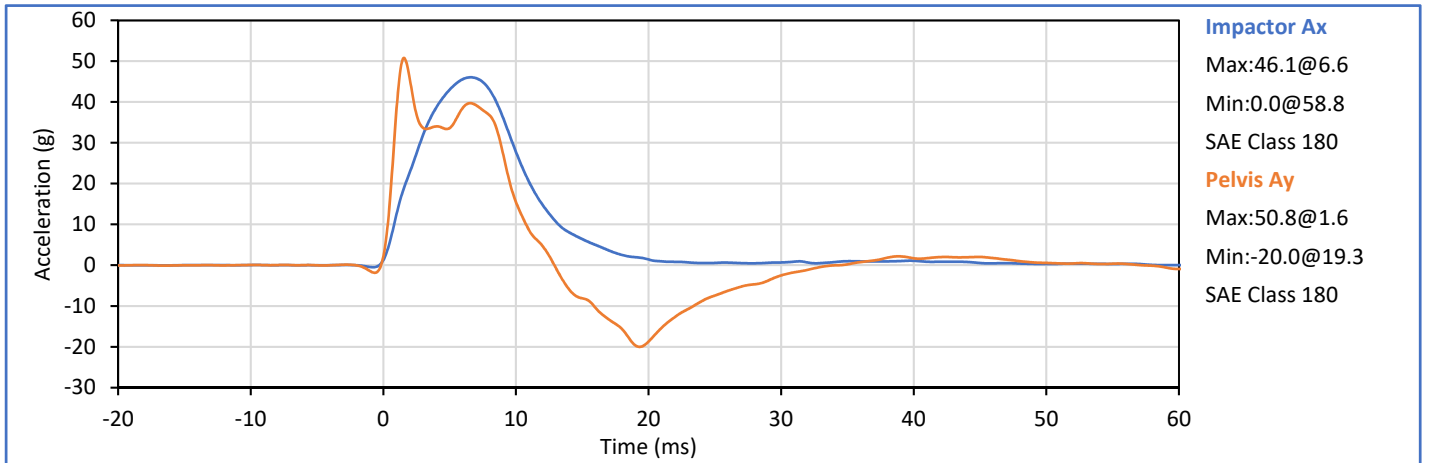
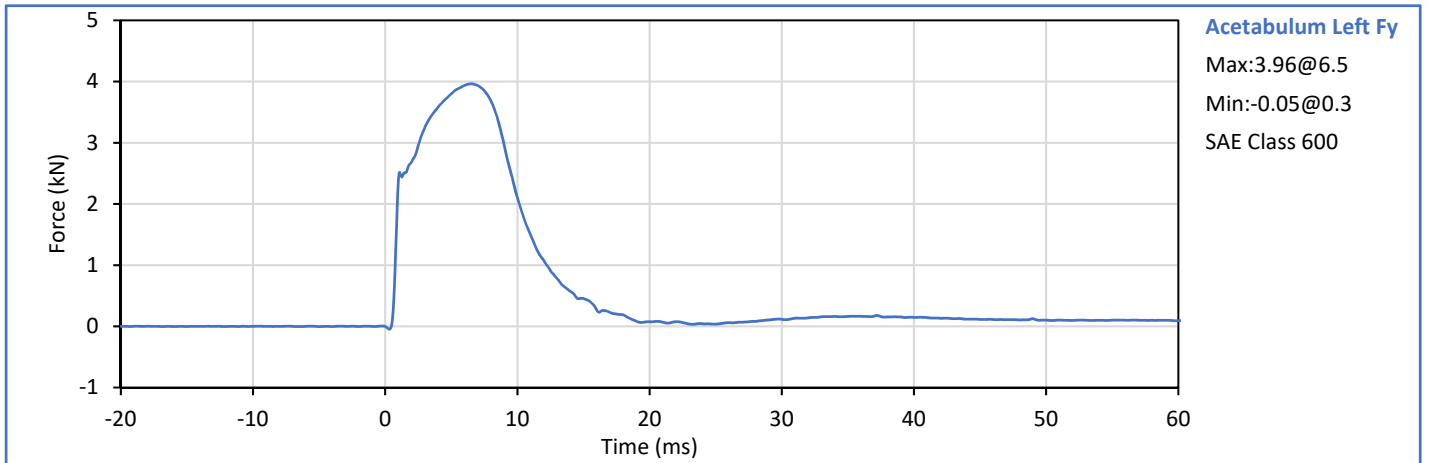
Tested Parameter	Units	Spec. Low	Spec. High	Result	Pass/Fail
Laboratory Temperature	°C	20.6	22.2	21.1	Pass
Laboratory Humidity	%	10	70	24	Pass
Impactor Velocity	m/s	6.60	6.80	6.71	Pass
Peak Acetabulum Fy	kN	3.60	4.30	3.96	Pass
Pelvis Ay after 6ms	g	34.0	42.0	39.7	Pass
Peak Impactor Ax	g	38.0	47.0	46.1	Pass
Overall Test Results					Pass
