Final Report Number: NCAP-TRC-20-003

Frontal Barrier Impact Test

## GENERAL MOTORS LLC 2020 Cadillac XT5 SUV NHTSA Number: M20200106

#### FINAL REPORT

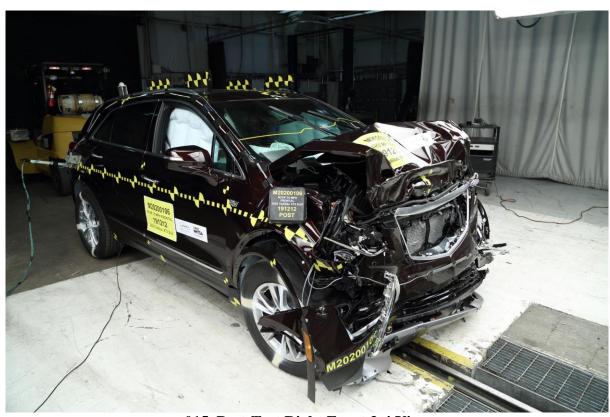
015 Post-Test Right Front 3-4 View

Critical Areas of Performance	Observations
Windshield Damage	None
Window Damage	None
Other Notable Effects	Left & right front tires flat

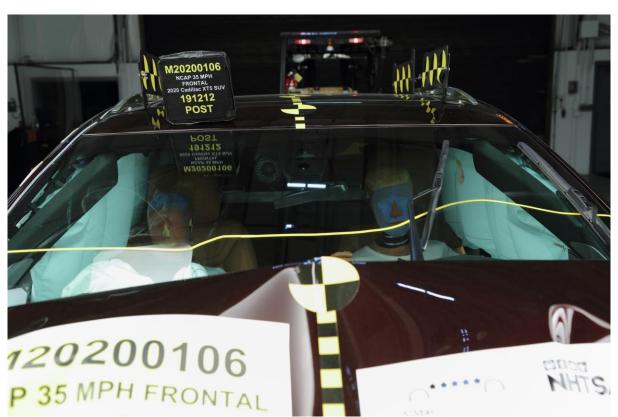
019 Post-Test Windshield View

There was 100.0 percent windshield retention and no intrusion into the protected zone of the windshield during the event. There was no Stoddard solvent leakage (or electrolyte spillage) after the event or during any phase of the static rollover.

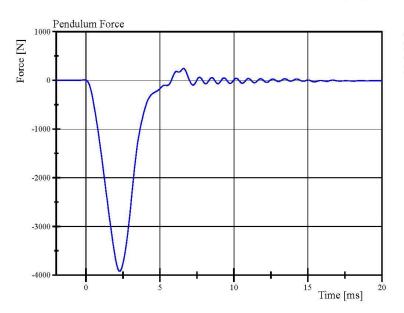
Filter Class: CFC\_600 Max: 242.3 N at 6.6 ms Min: -3,917.0 N at 2.2 ms
