REPORT NUMBER: SINCAP-MGA-20-010

**NEW CAR ASSESSMENT PROGRAM (NCAP)
Moving Deformable Barrier Side Impact Test**

**NISSAN MOTOR CO., LTD.
2020 Nissan Maxima S 4-Door Sedan
NHTSA No.: M20205208**

**MGA RESEARCH CORPORATION
5000 Warren Road
Burlington, WI 53105**

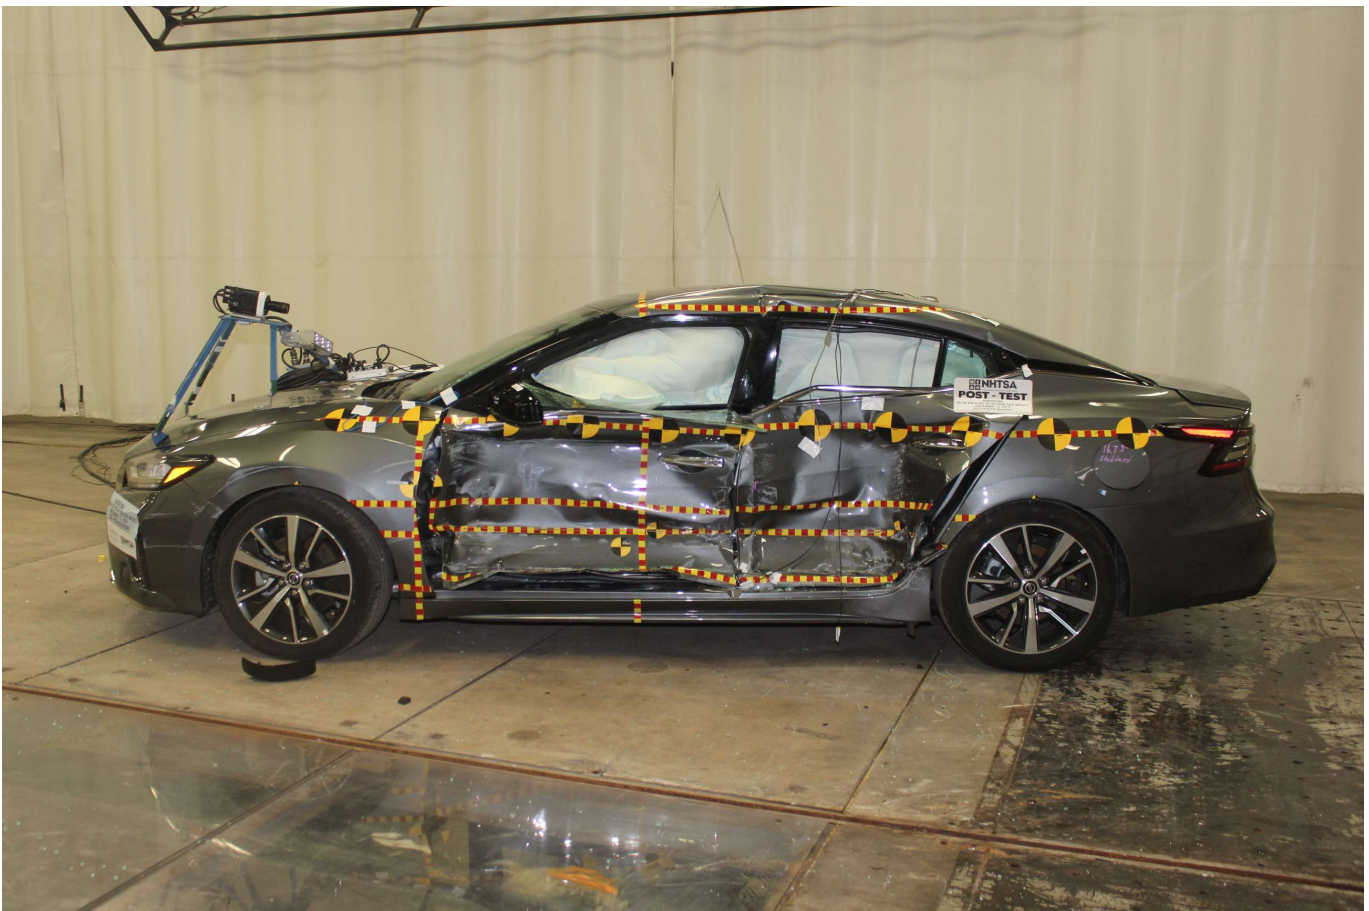
Photo No. 008 - Post-Test Left Side View of Test Vehicle

Critical Areas of Performance	Observations and Conclusions
Pillar Performance	No Separation
Sill Separation	None
Windshield Damage	Cracked
Side Window Damage	LF, LR window broken
Other Notable Effects	Doors remained locked after impact

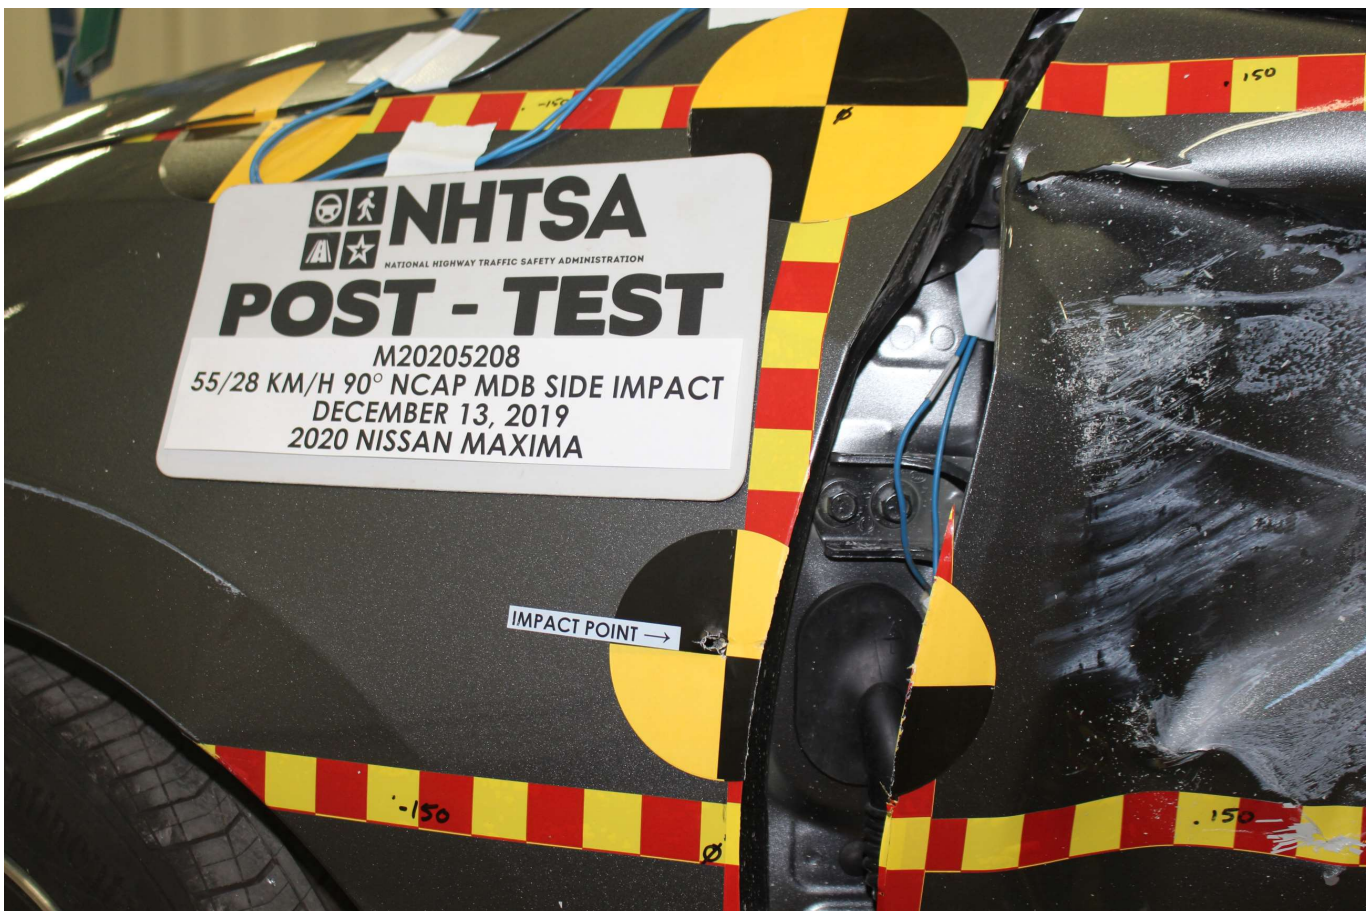
Photo No. 020 - Post-Test Close-Up View of Impact Point Target

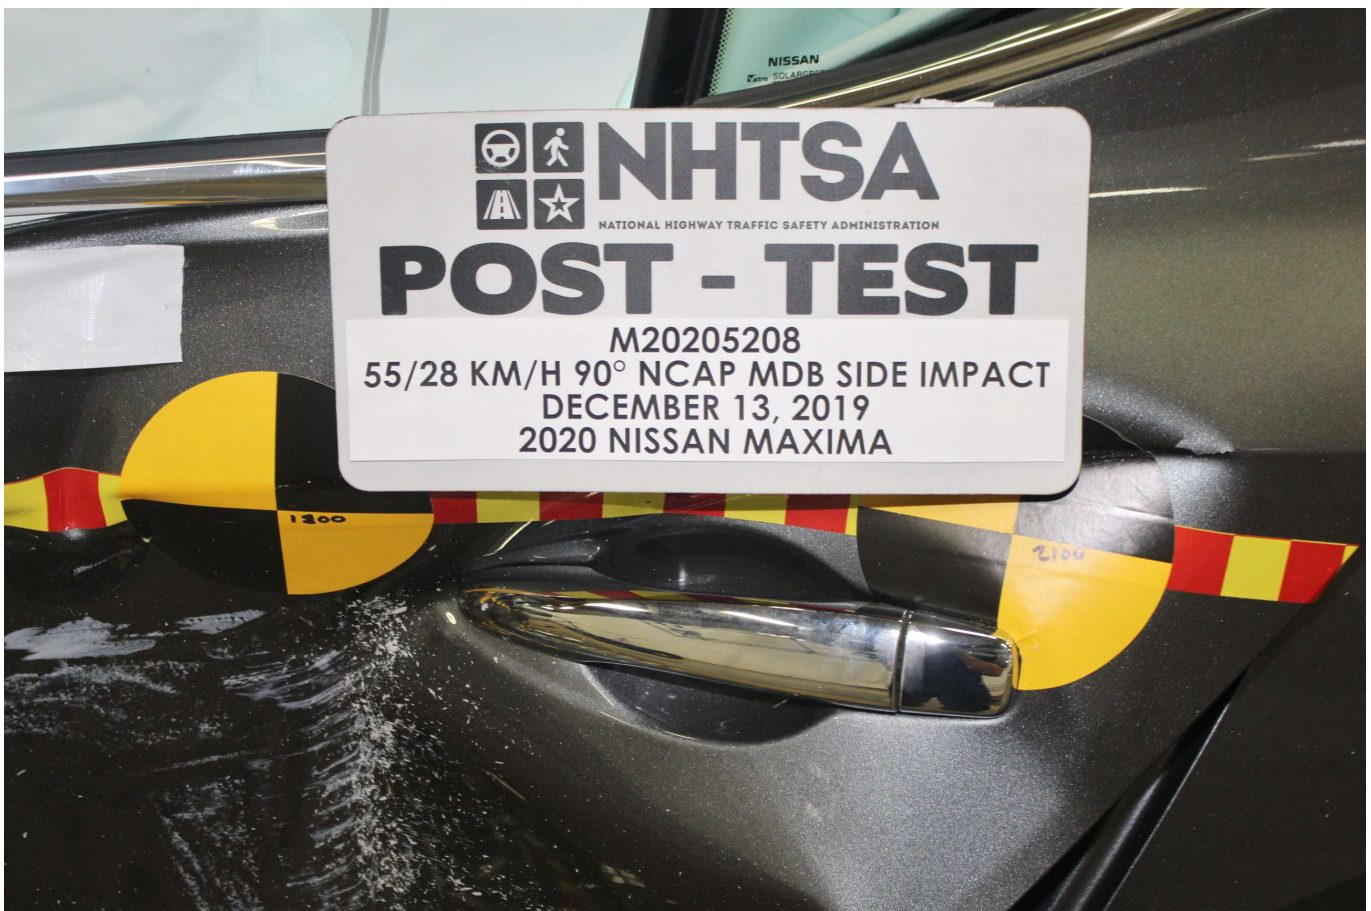
Photo No. 024 - Post-Test Left Rear Door Latch Close-Up

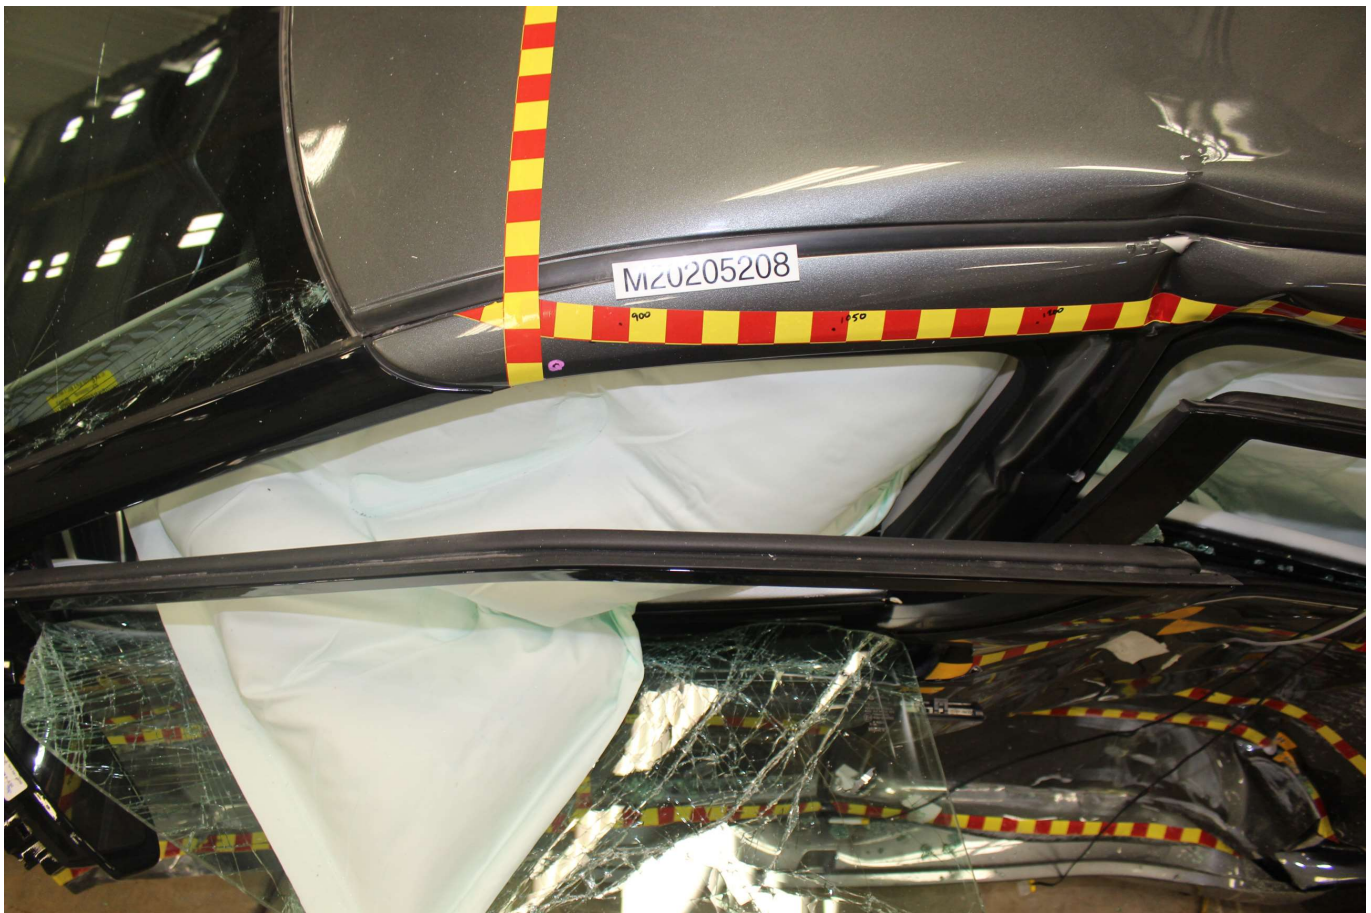
Photo No. 043 - Post-Test Driver Dummy and Door Clearance View

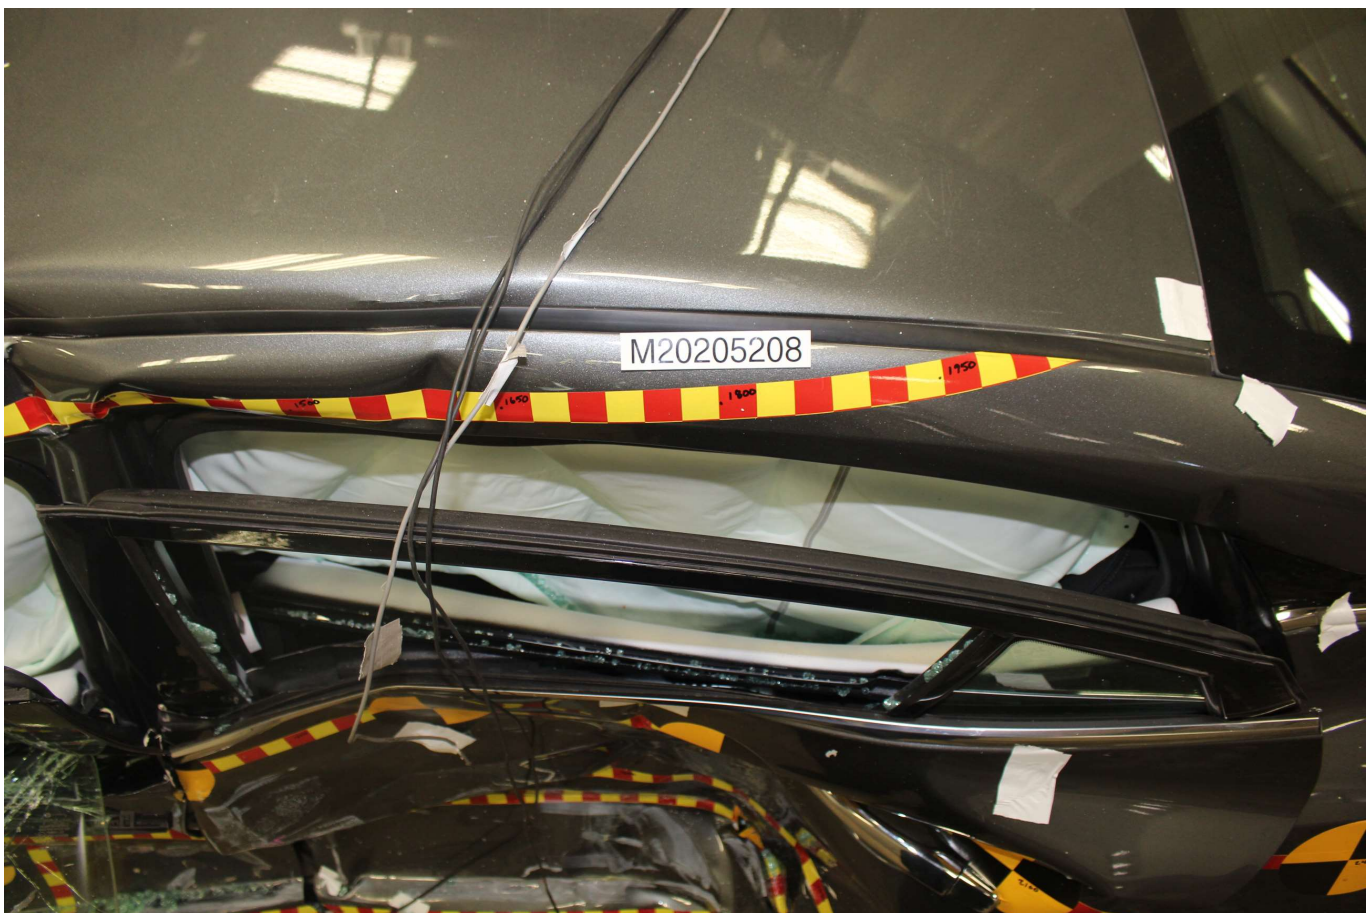
Photo No. 070 - Post-Test Rear Passenger Dummy and Door Clearance View

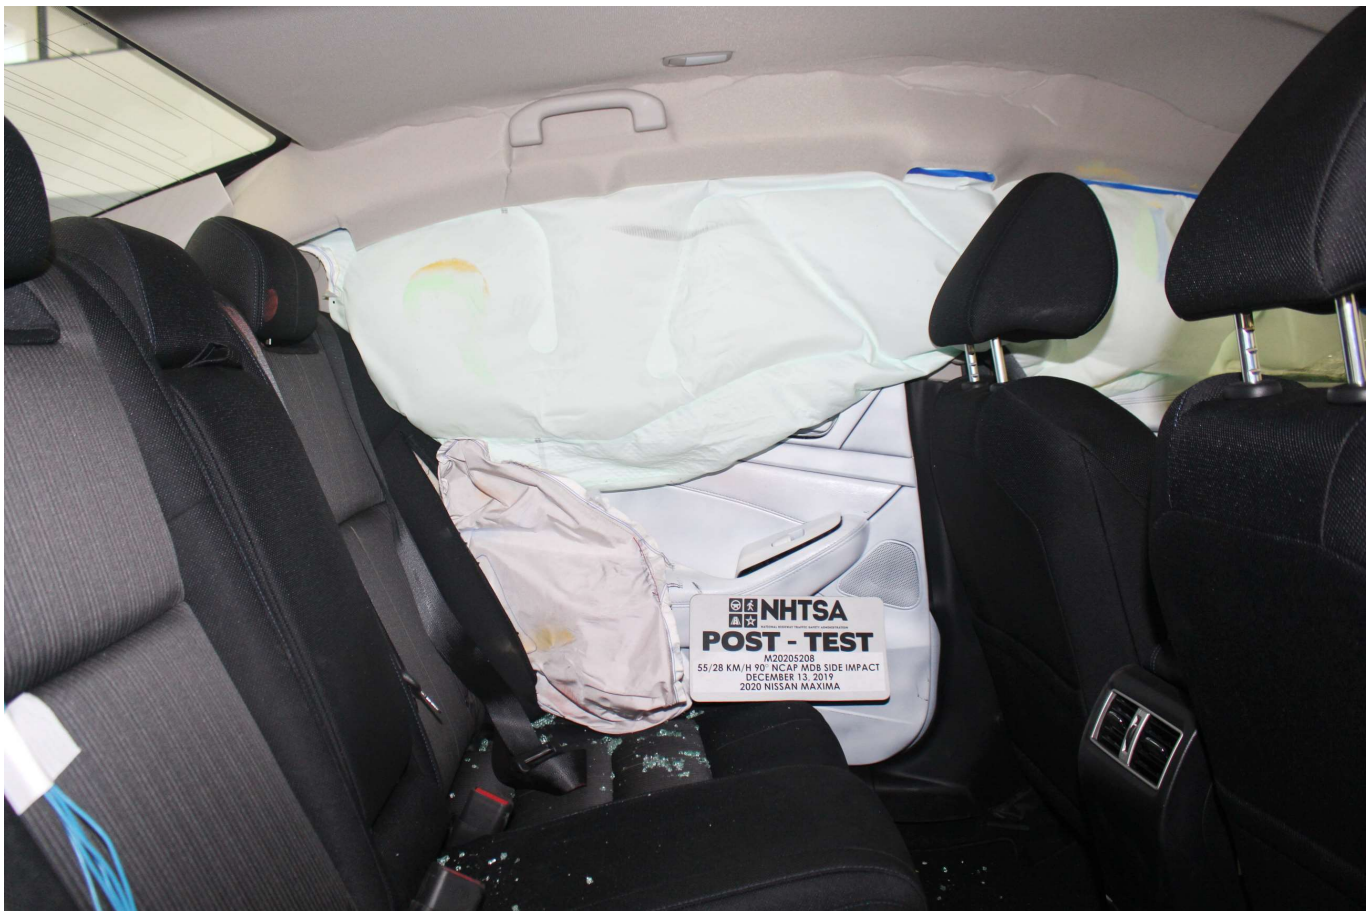
Photo No. 074 - Post-Test Rear Passenger Inner Door Panel View

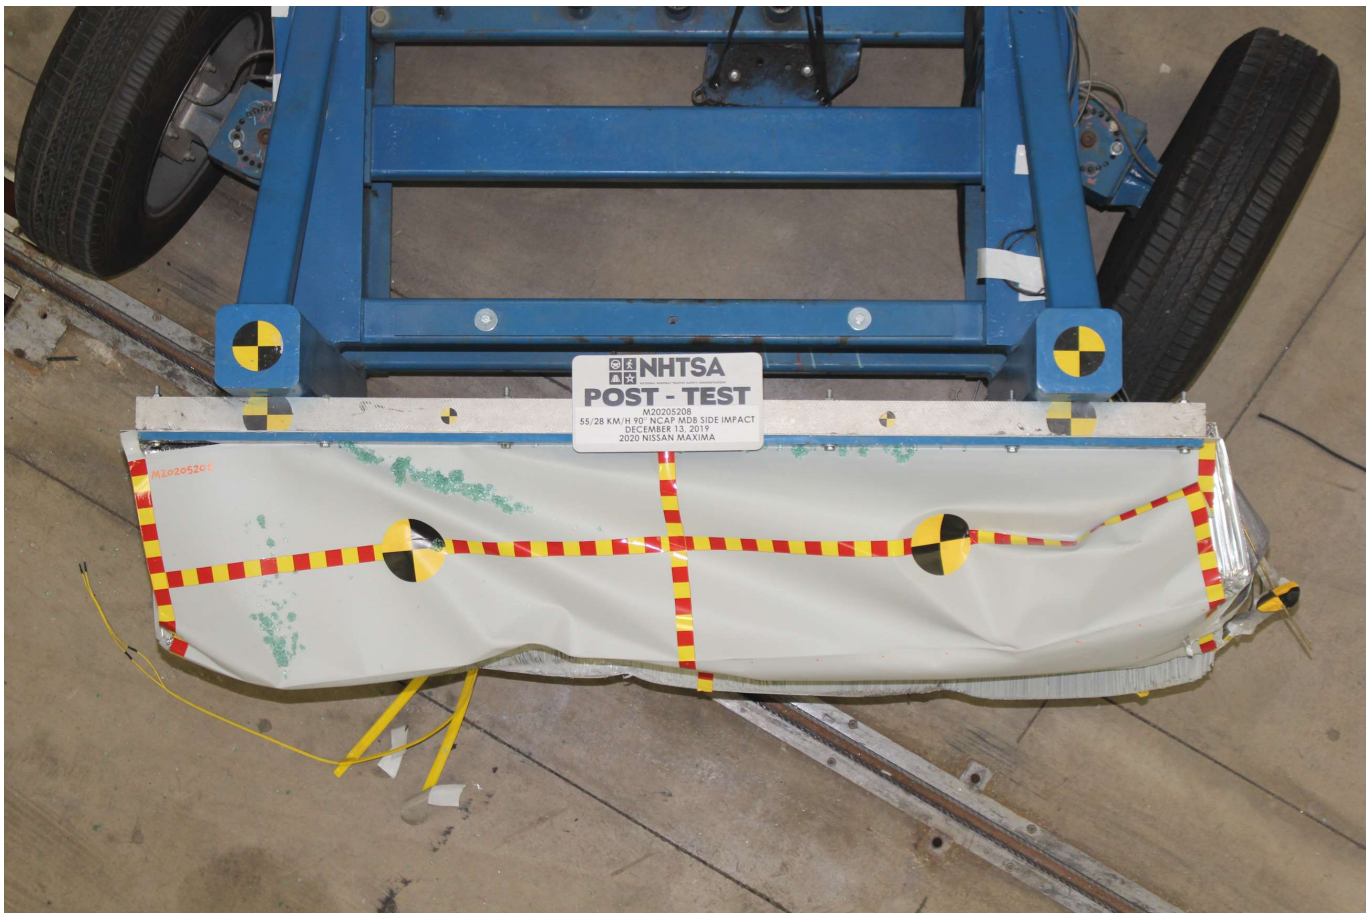
Photo No. 087 - Post-Test Top View of MDB Impactor Face

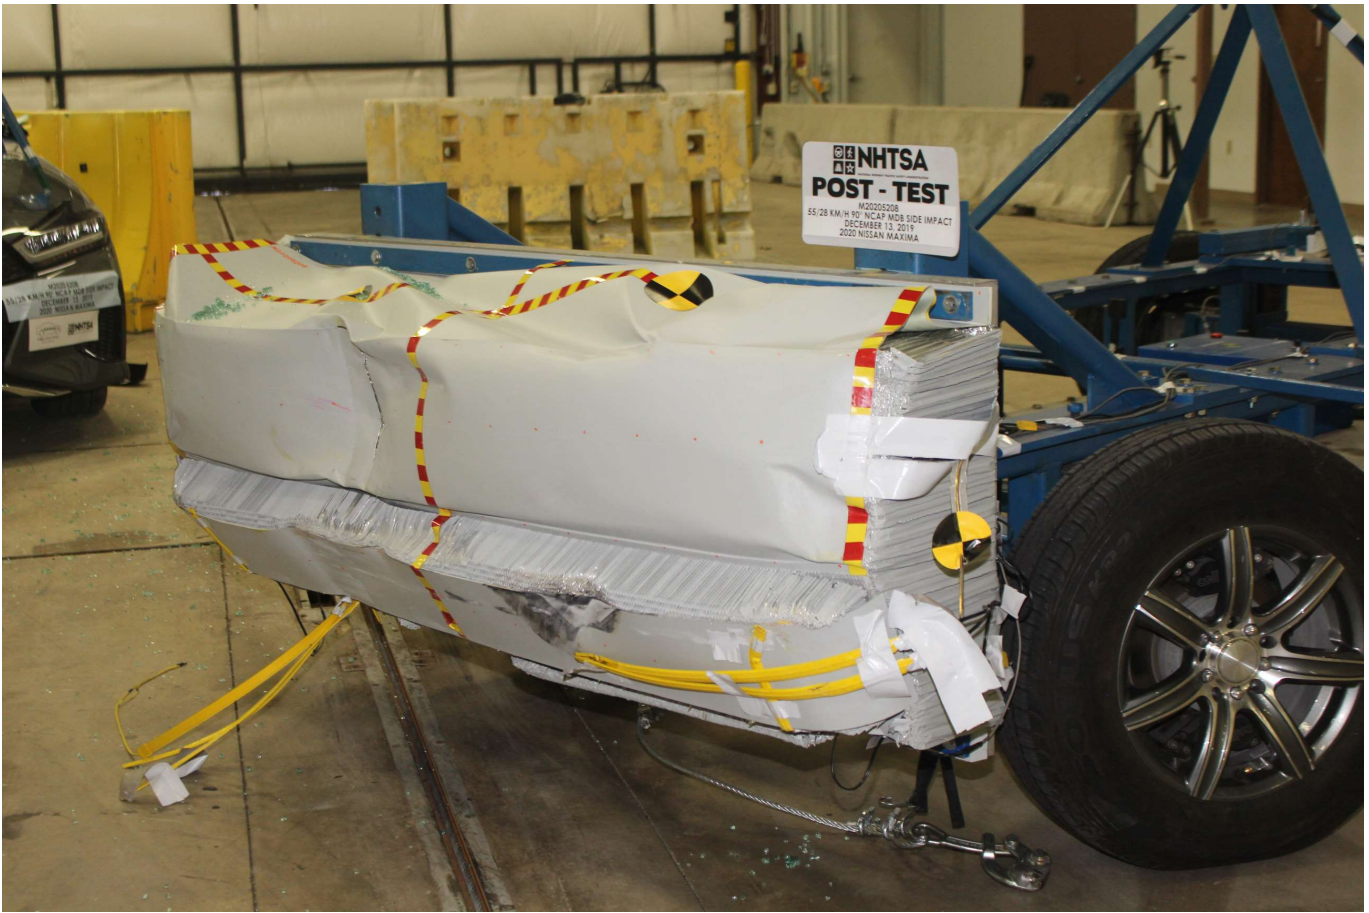
Photo No. 089 - Post-Test Left Side View of MDB Impactor Face

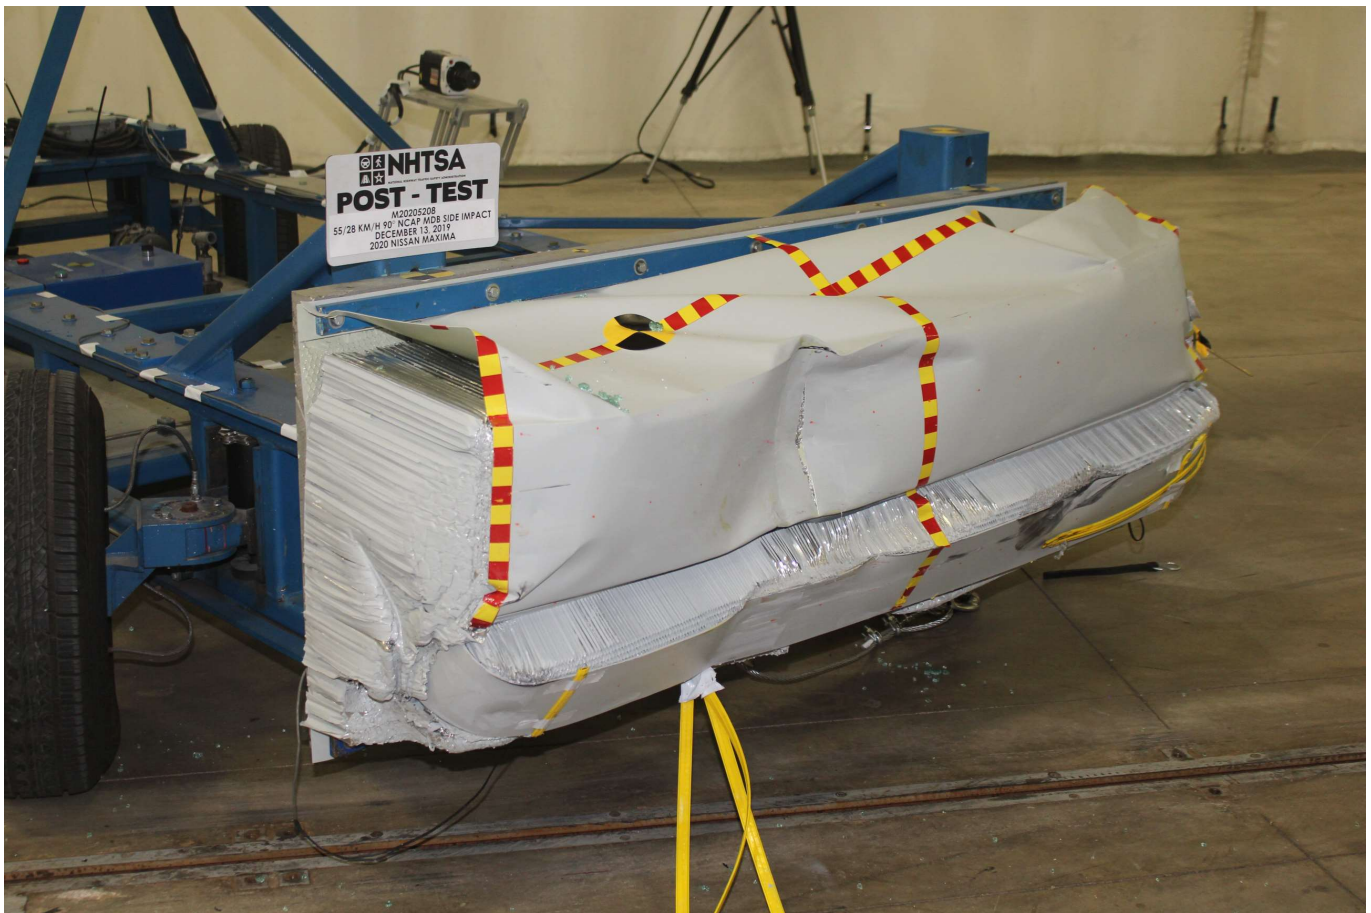
Photo No. 091 - Post-Test Right Side View of MDB Impactor Face

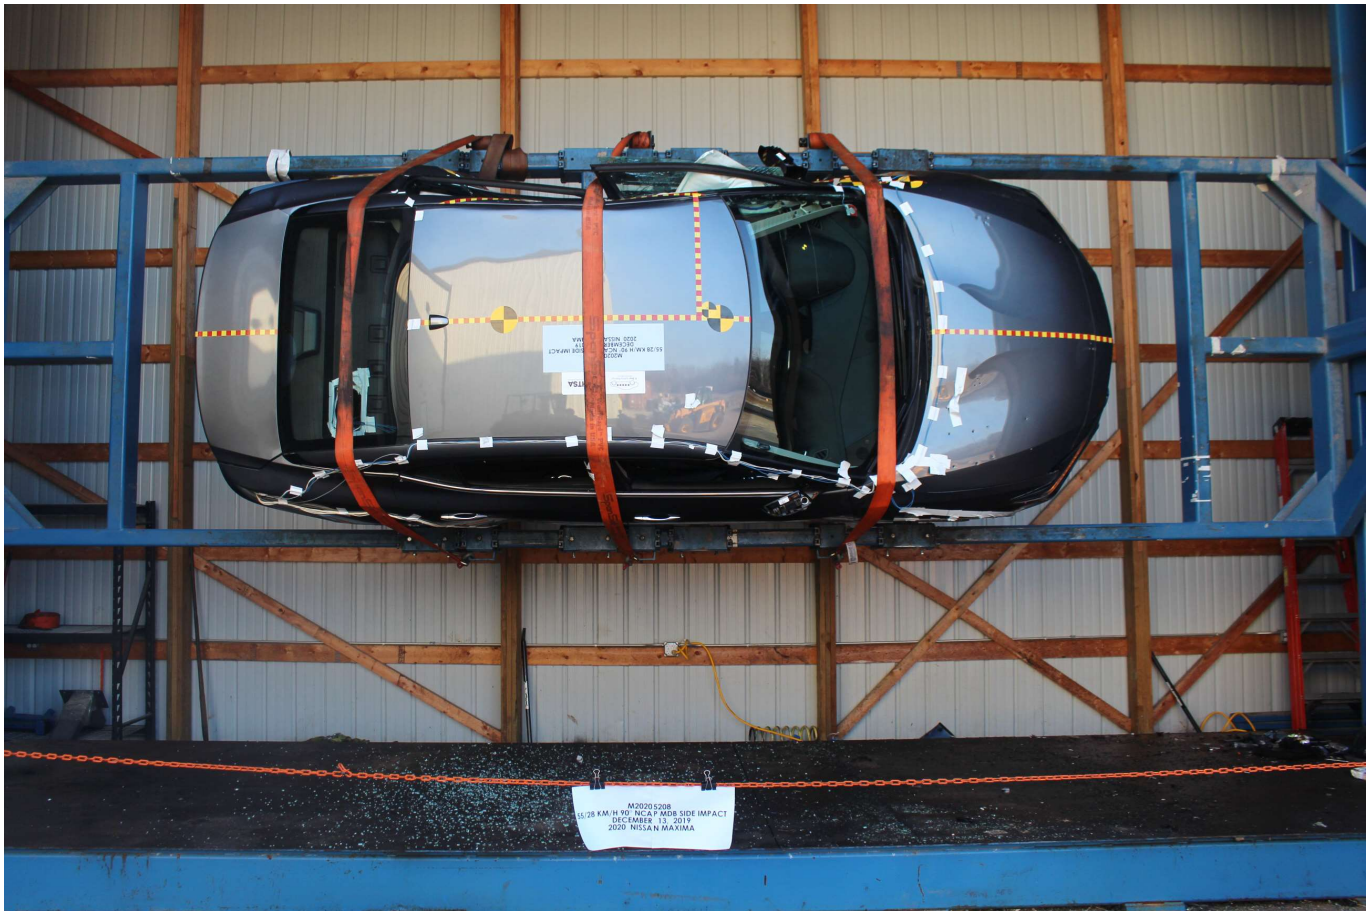
Photo No. 099 - FMVSS Photo No. 301 Static Rollover 270 Degrees
