**REPORT NUMBER: SPNCAP-MGA-20-008**

**NEW CAR ASSESSMENT PROGRAM (NCAP)  
Side Impact Pole Test**

**NISSAN MOTOR CO., LTD.  
2020 Nissan Maxima S 4-Door Sedan  
NHTSA No.: M20205207**

**MGA RESEARCH CORPORATION  
5000 Warren Road  
Burlington, WI 53105**

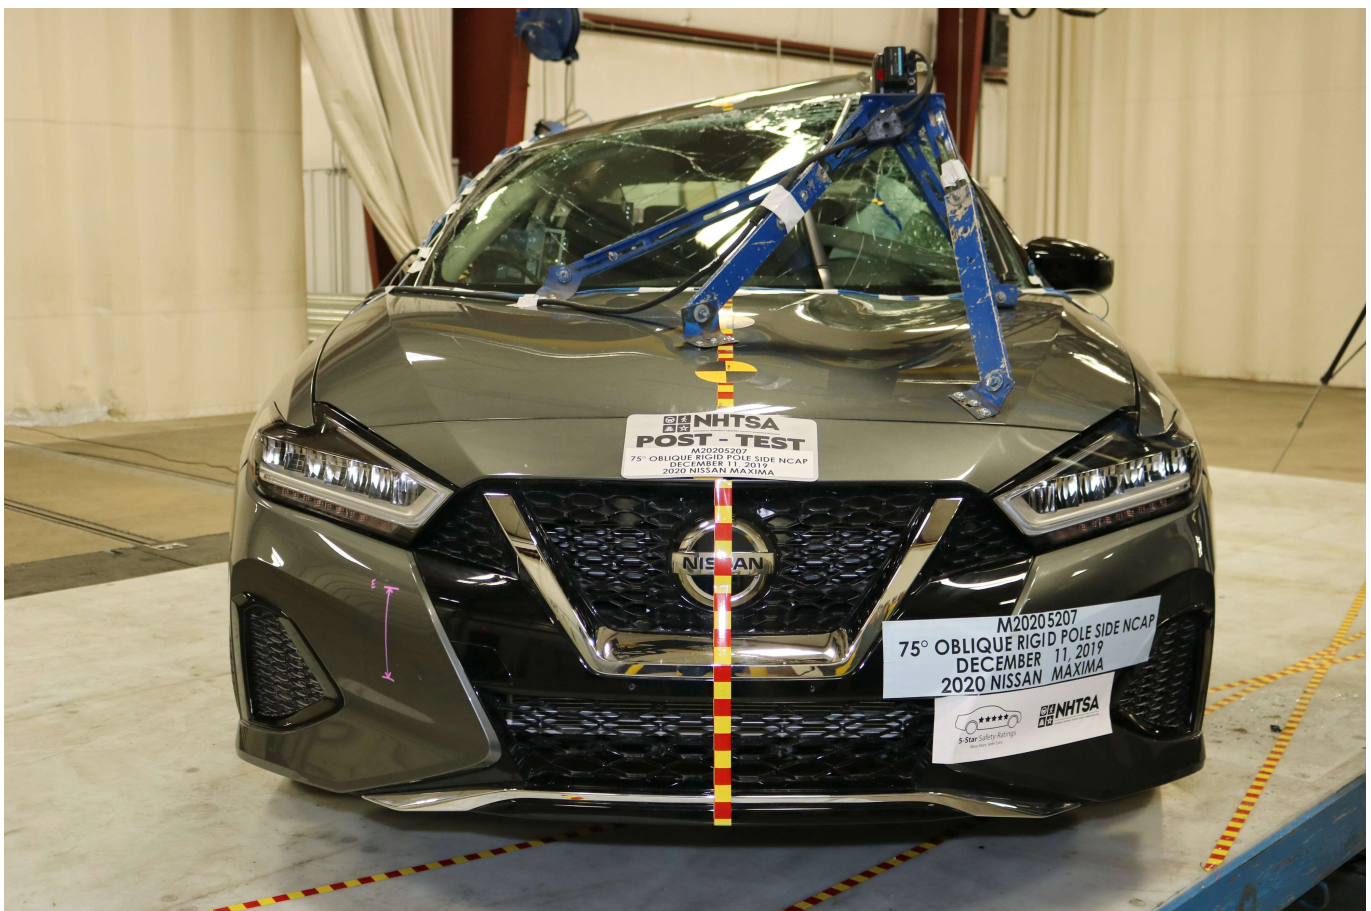
Photo No. 004 - Post-Test Frontal View of Test Vehicle

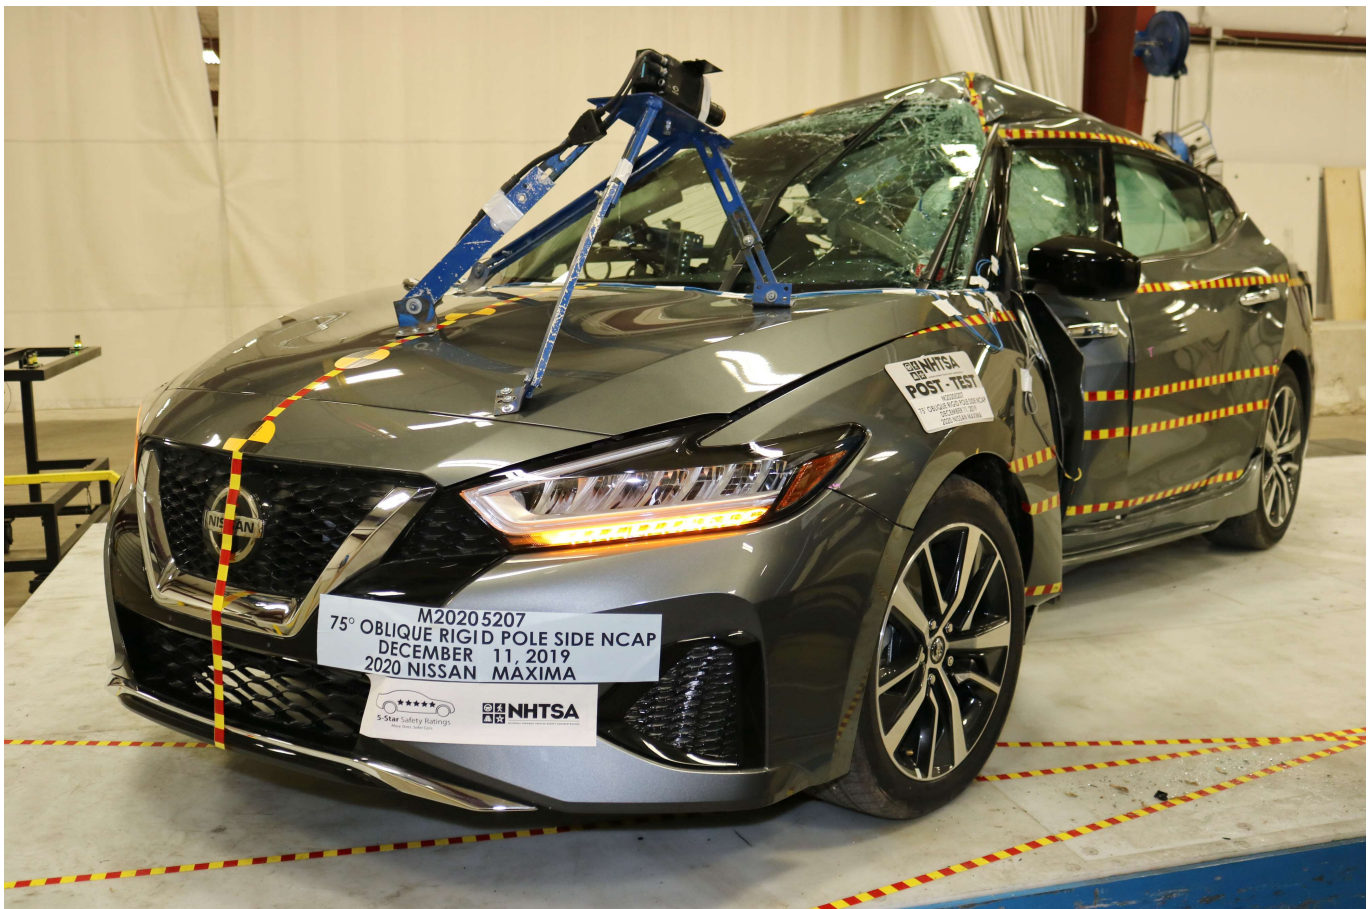
Photo No. 006 - Post-Test Left Front Three-Quarter View of Test Vehicle

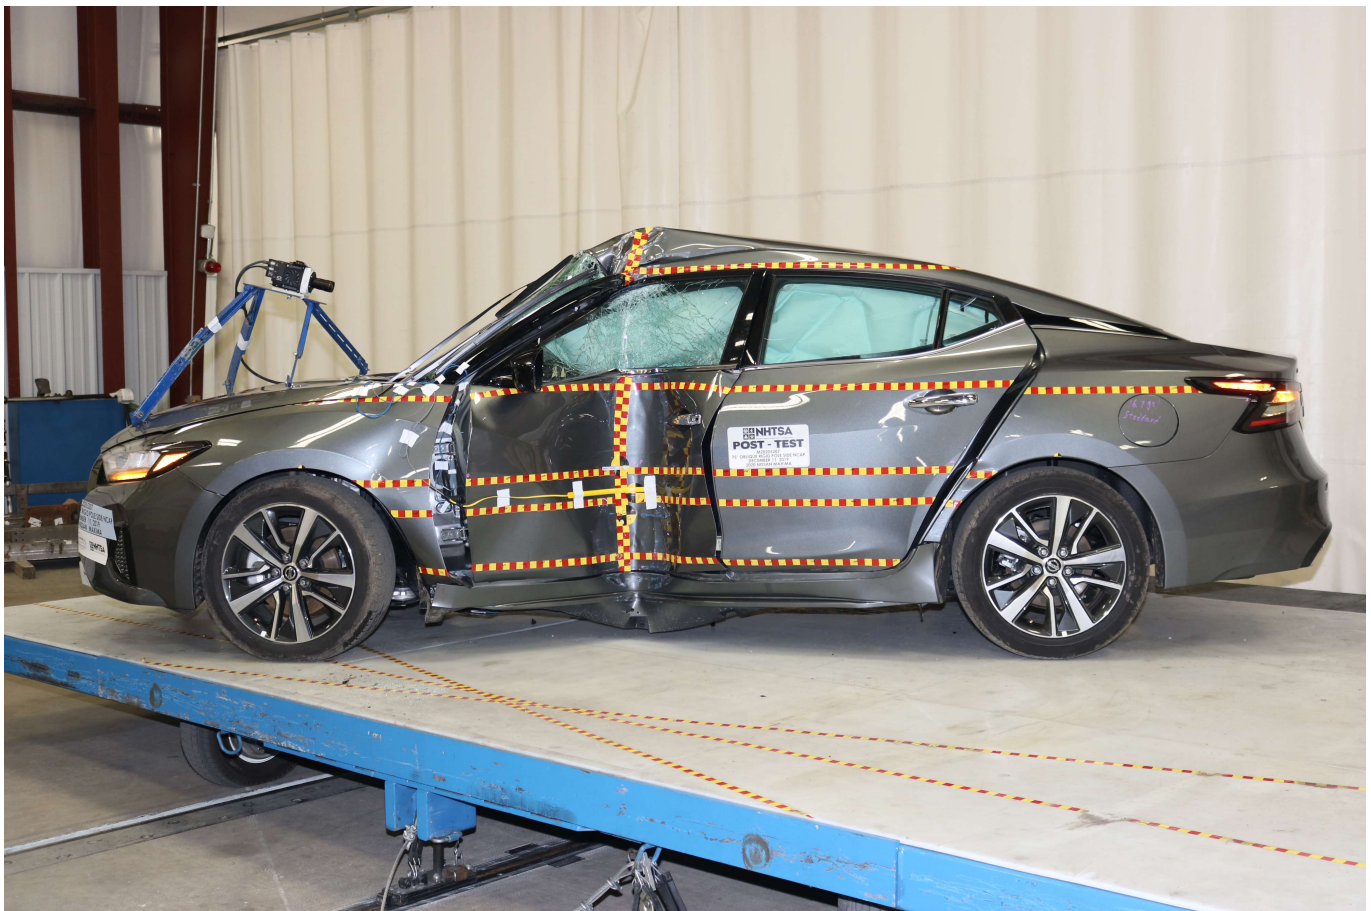
Photo No. 008 - Post-Test Left Side View of Test Vehicle

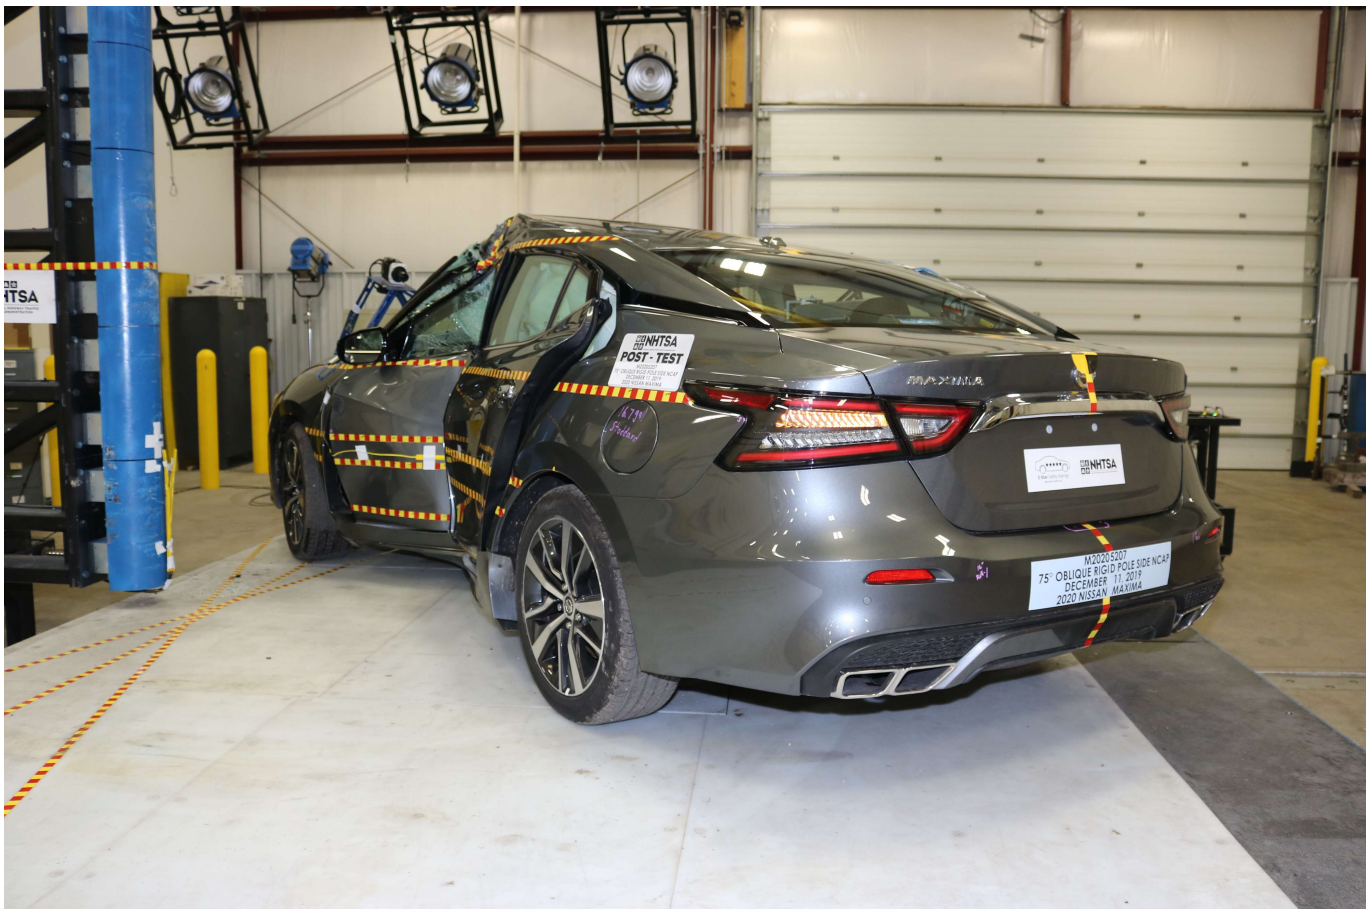
Photo No. 010 - Post-Test Left Rear Three-Quarter View of Test Vehicle

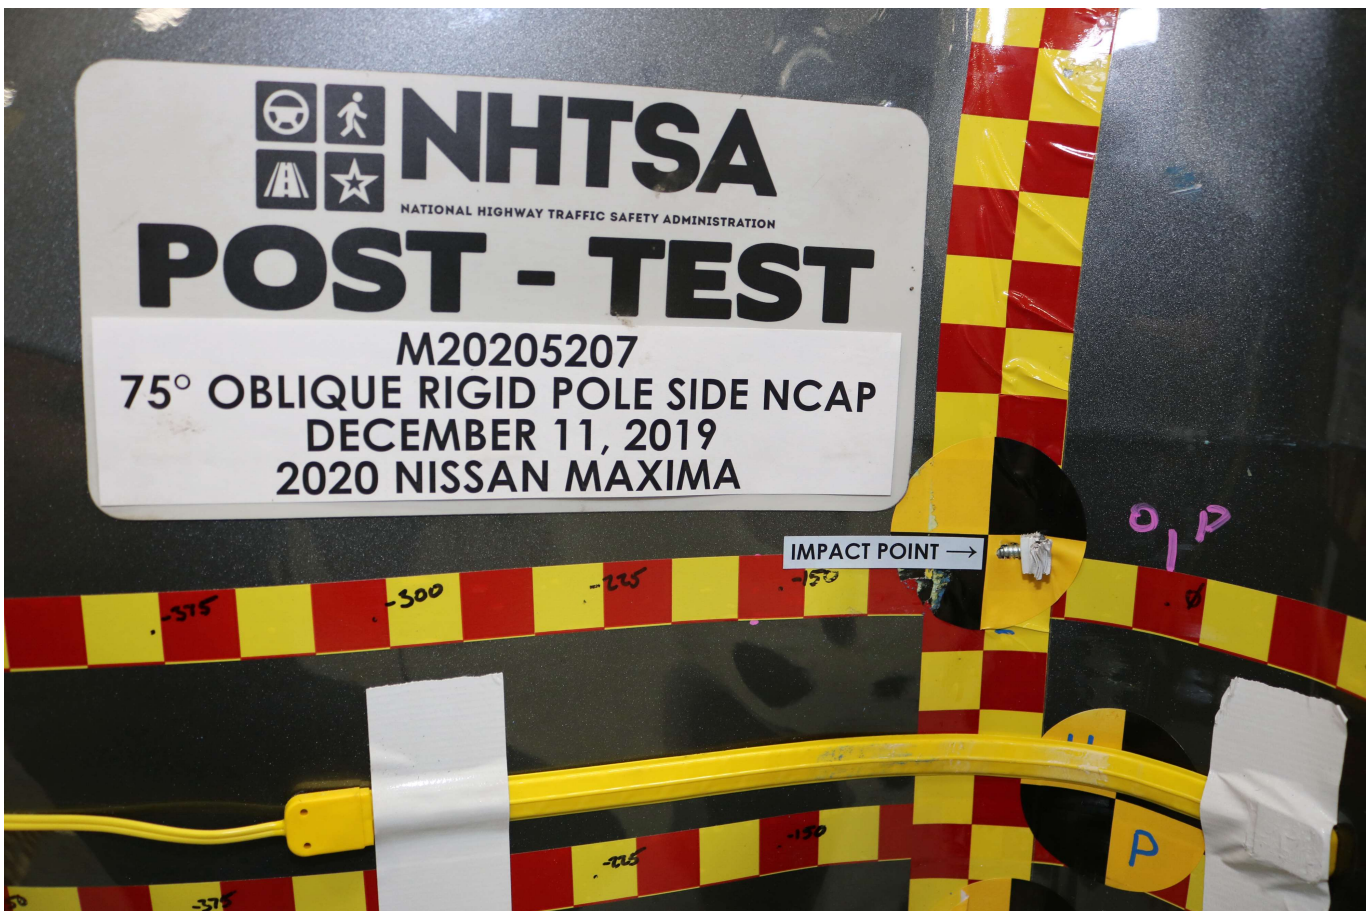
Photo No. 020 - Post-Test Close-Up View of Impact Point Target Showing Impact Location

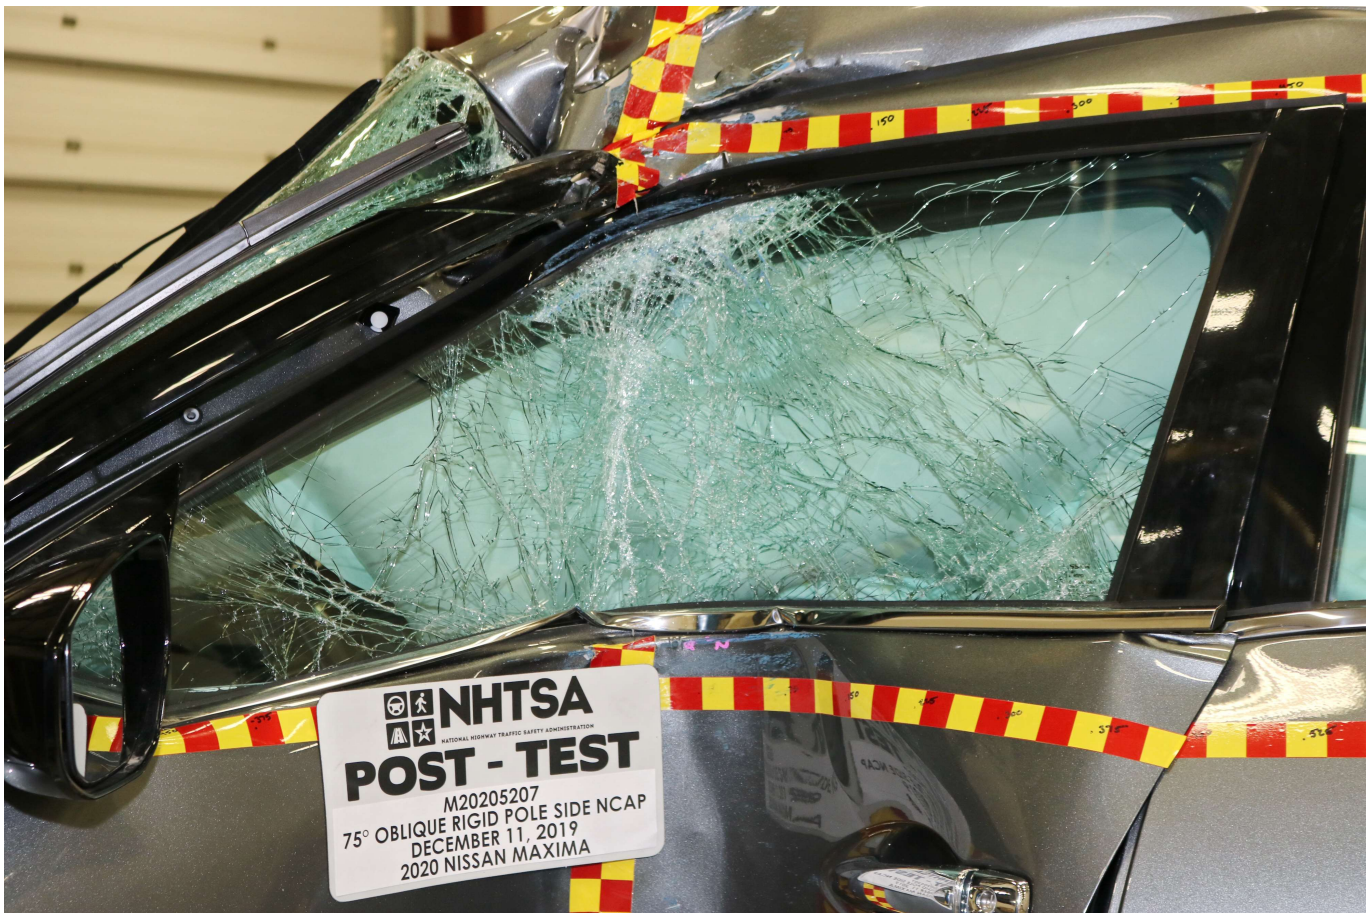
Photo No. 025 - Post-Test Left Side View of Dummy Shoulder and Door Top View

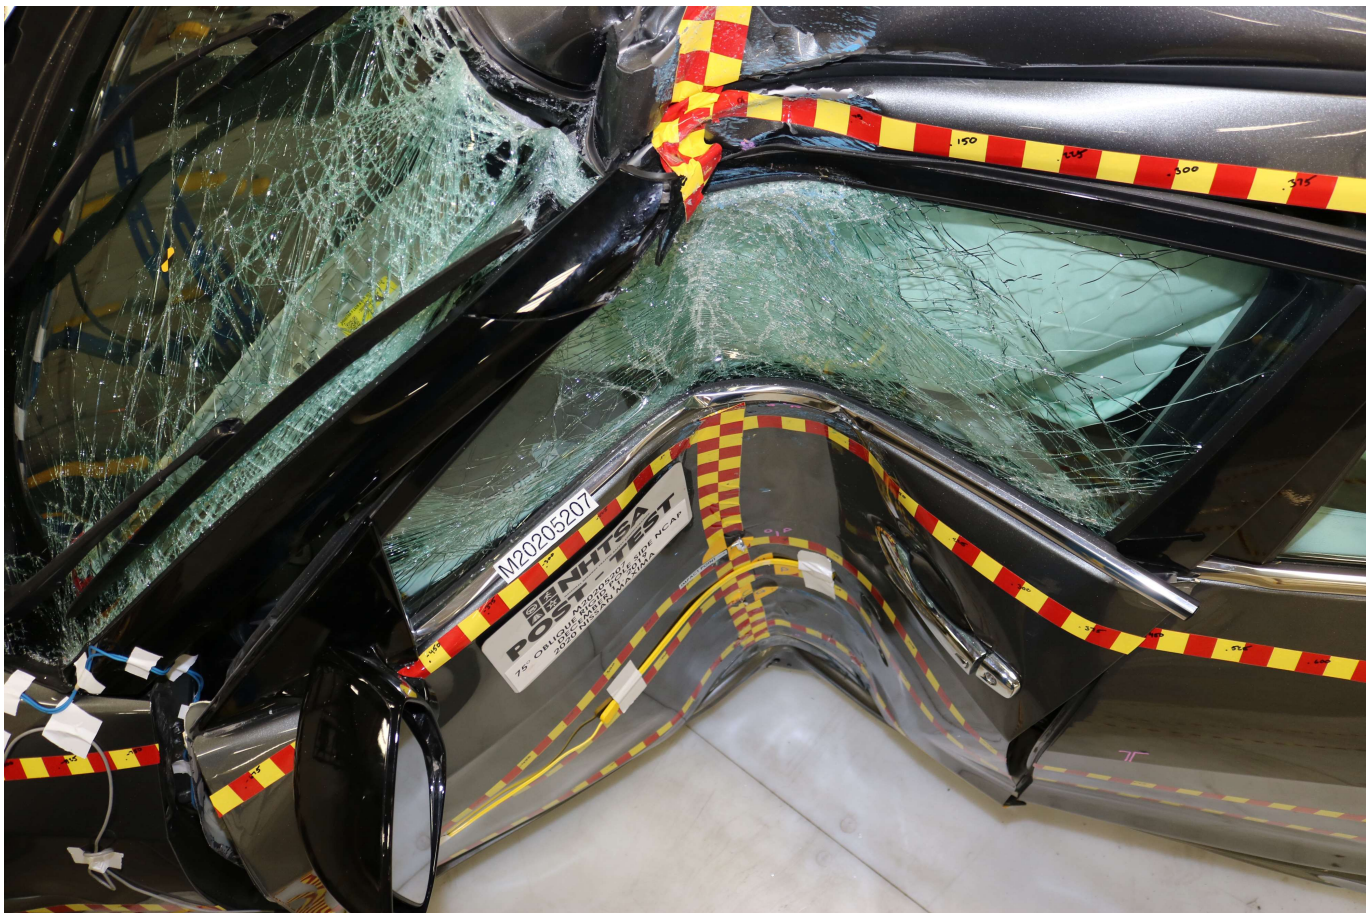
Photo No. 041 - Post-Test Dummy and Door Clearance View

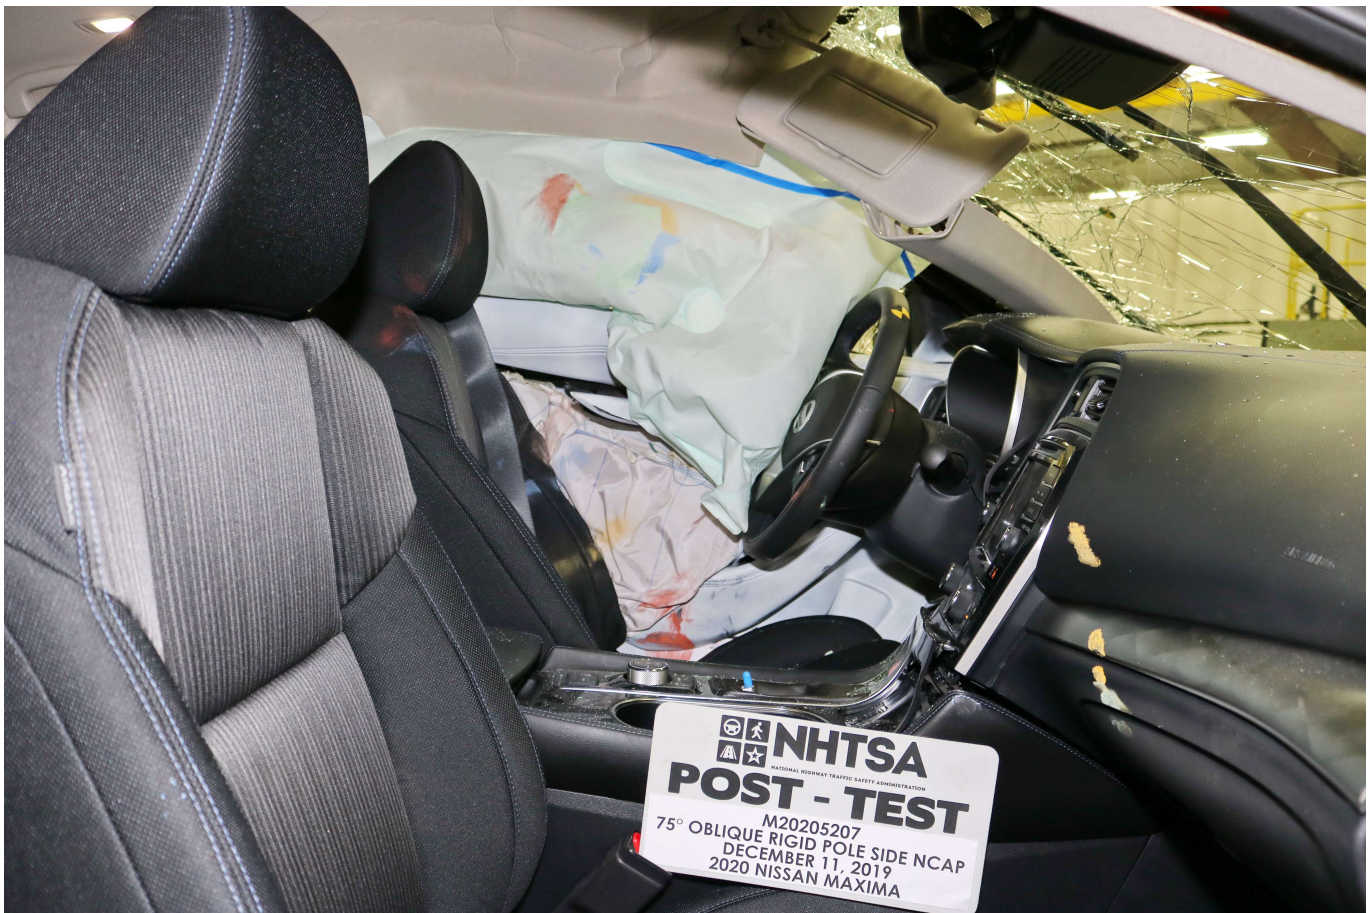
Photo No. 045 - Post-Test Inner Door Panel View Showing Dummy Contact Location

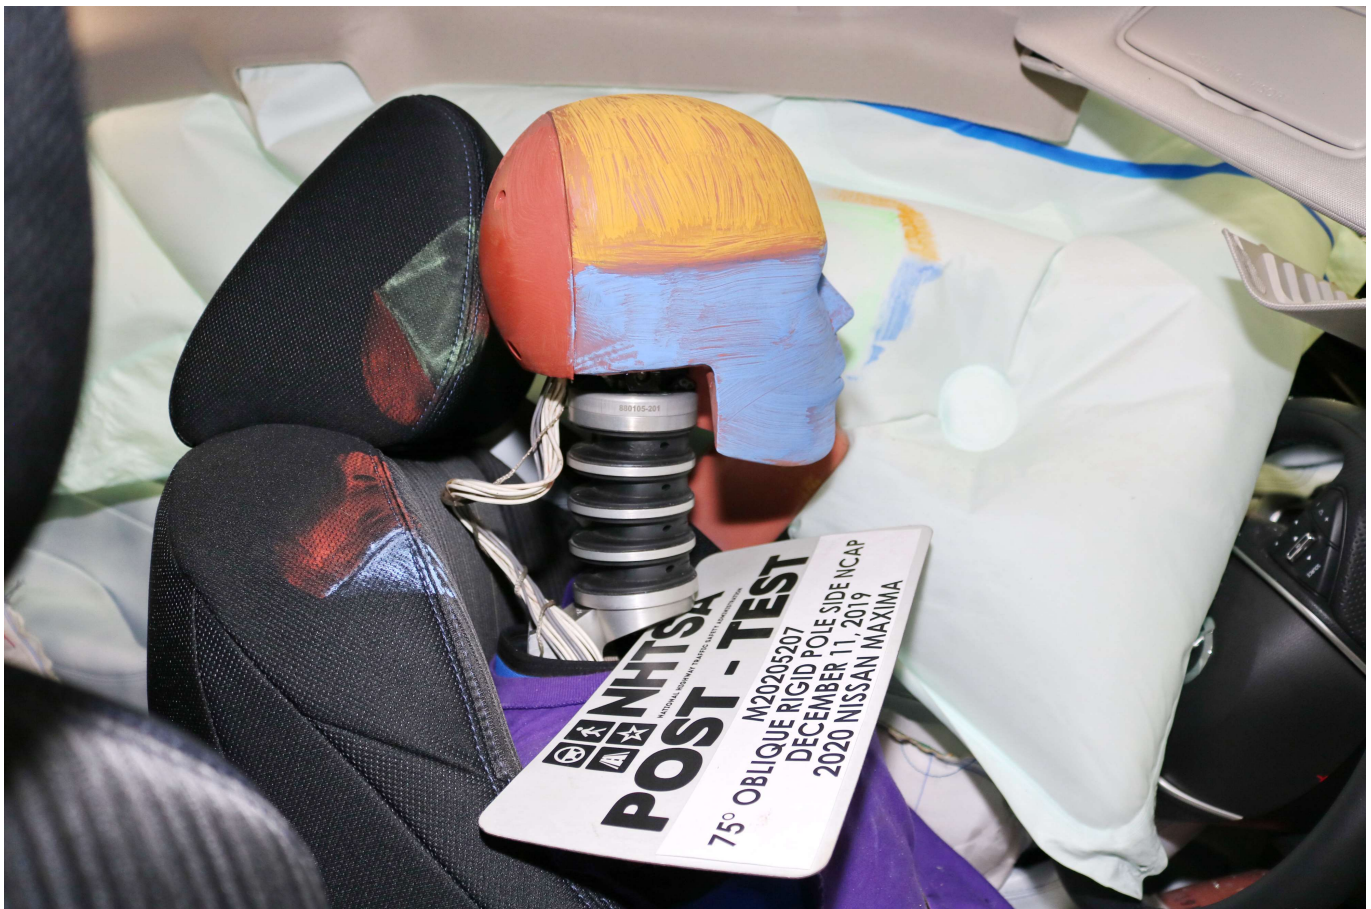
Photo No. 046 - Post-Test Dummy Close-Up Head Contact with Vehicle Interior View

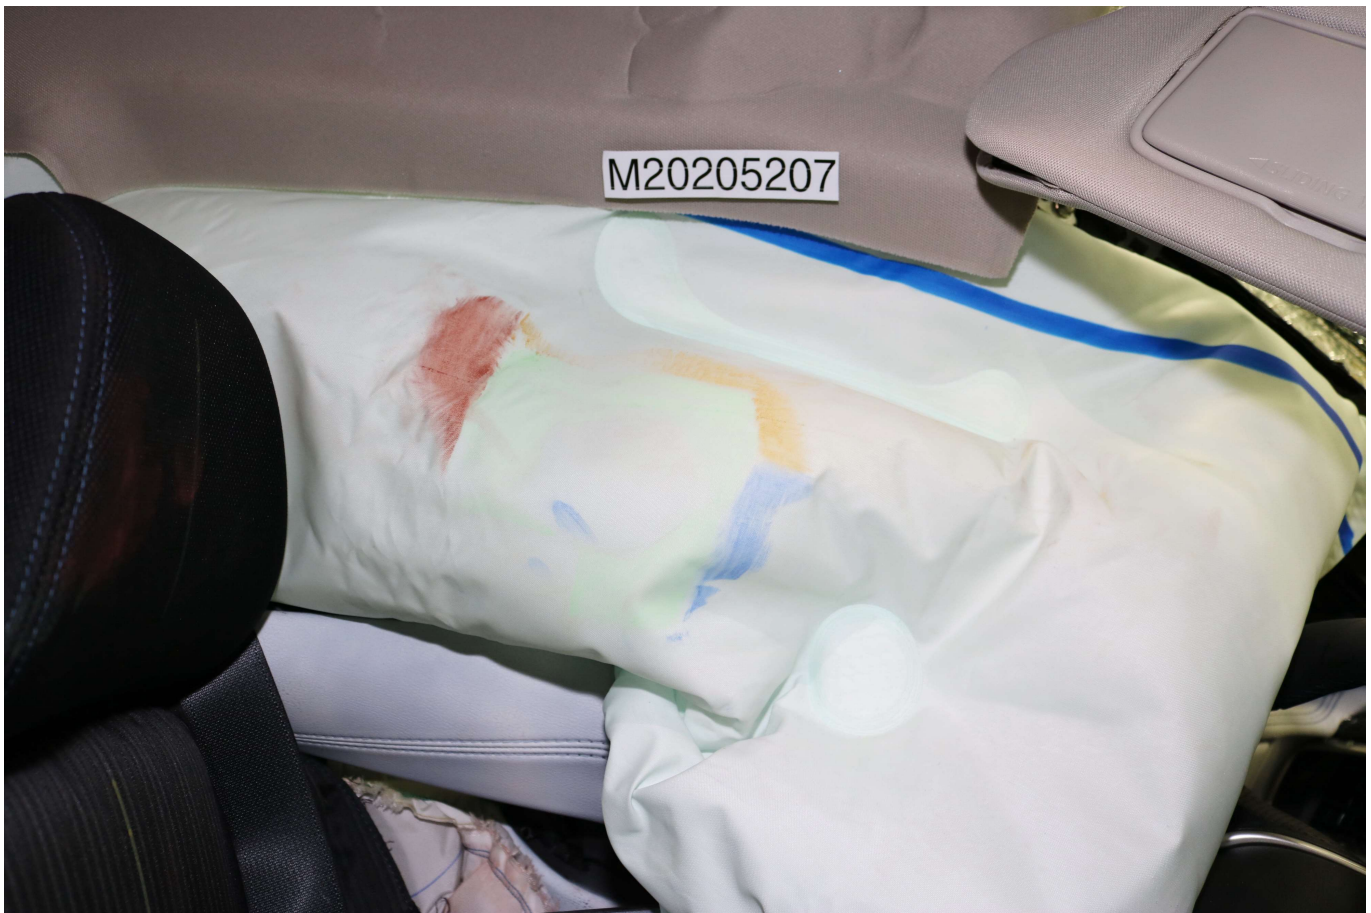
Photo No. 047 - Post-Test Dummy Close-Up Head Contact with Side Air Bag View

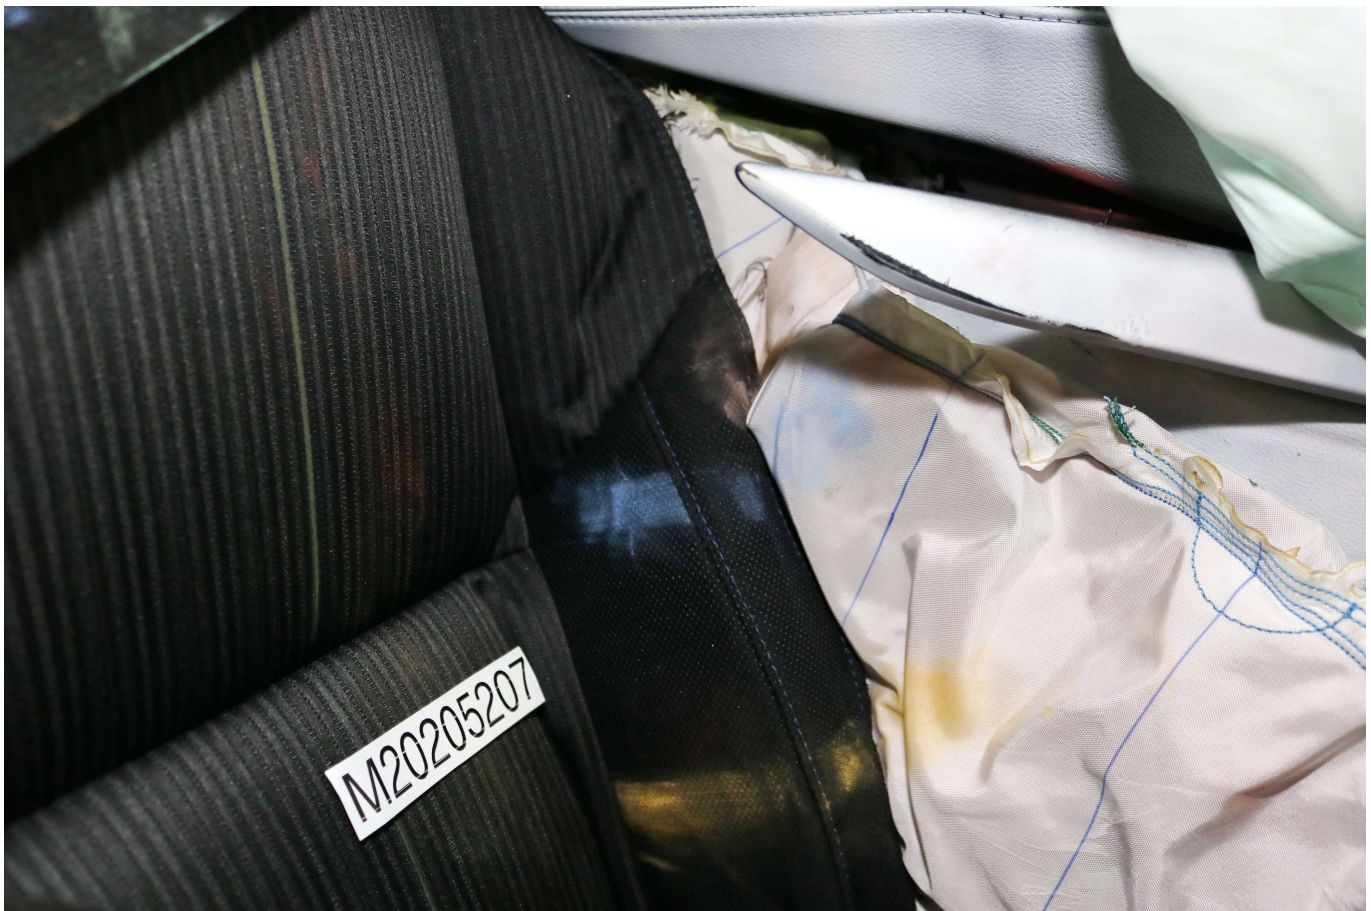
Photo No. 048 - Post-Test Dummy Close-Up Torso Contact with Vehicle Interior View

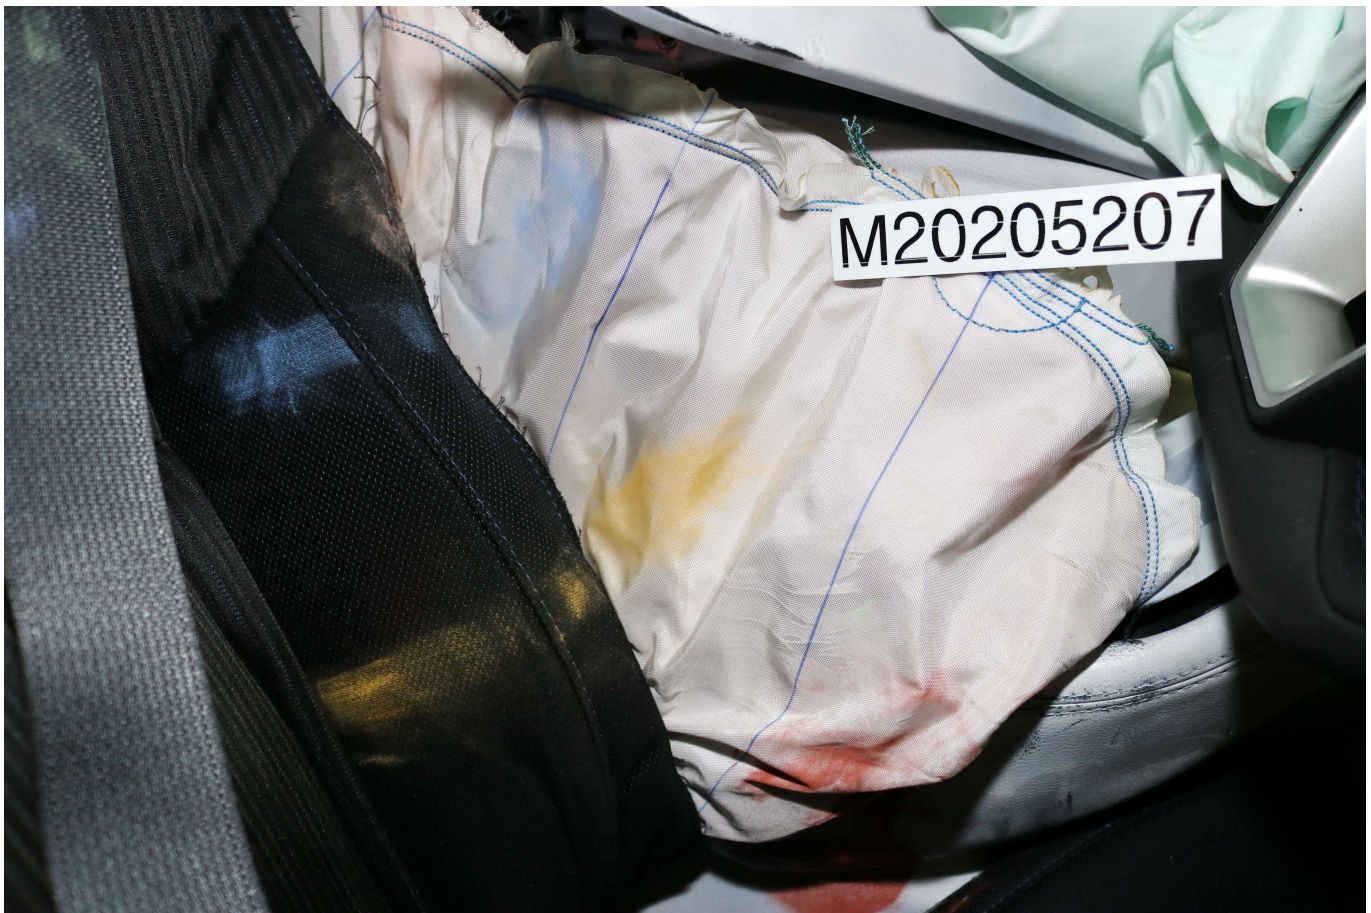
Photo No. 049 - Post-Test Dummy Close-Up Torso Contact with Side Air Bag View

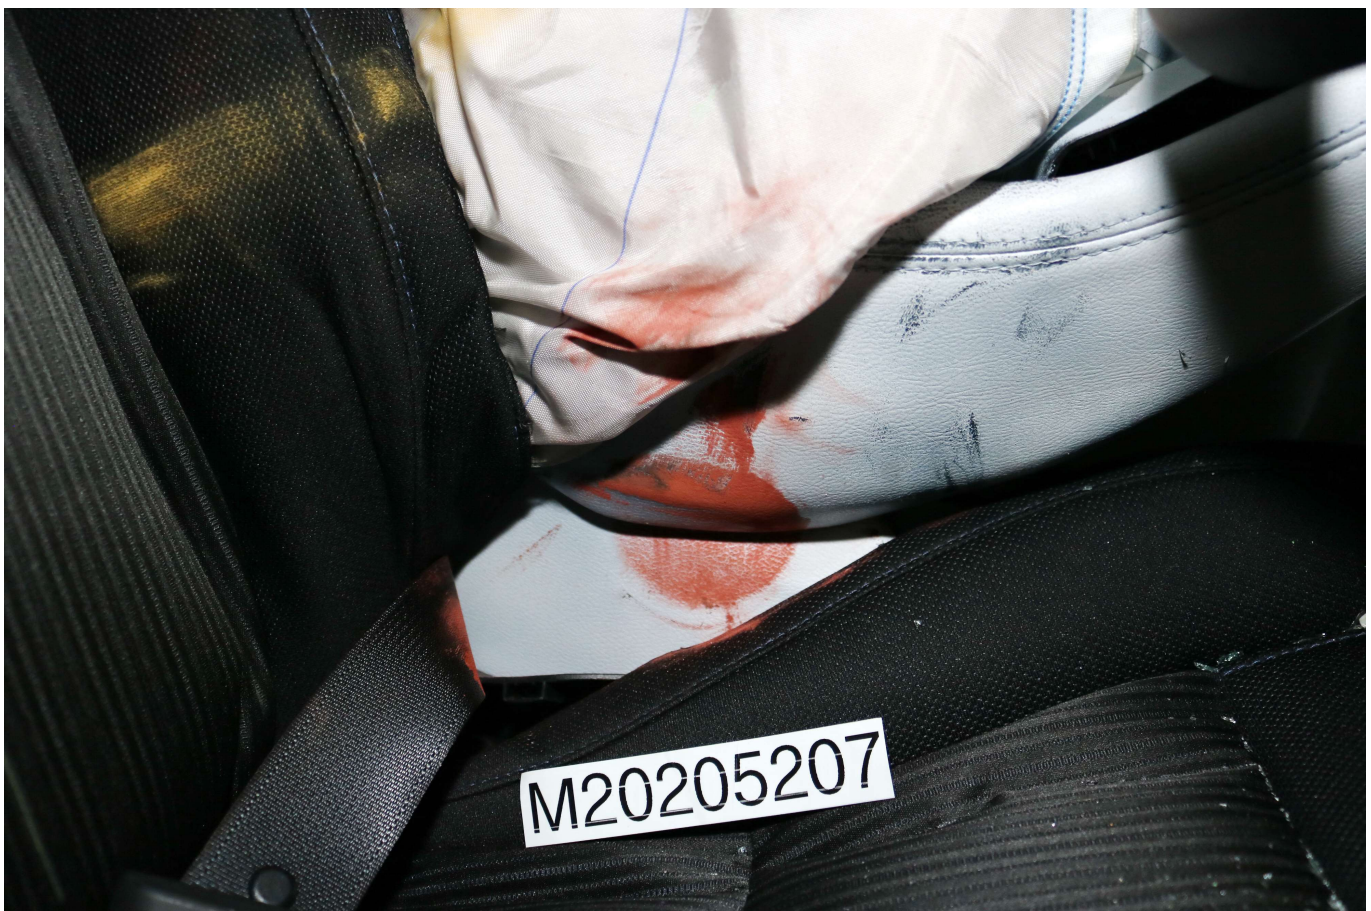
Photo No. 050 - Post-Test Dummy Close-Up Pelvis Contact with Vehicle Interior View

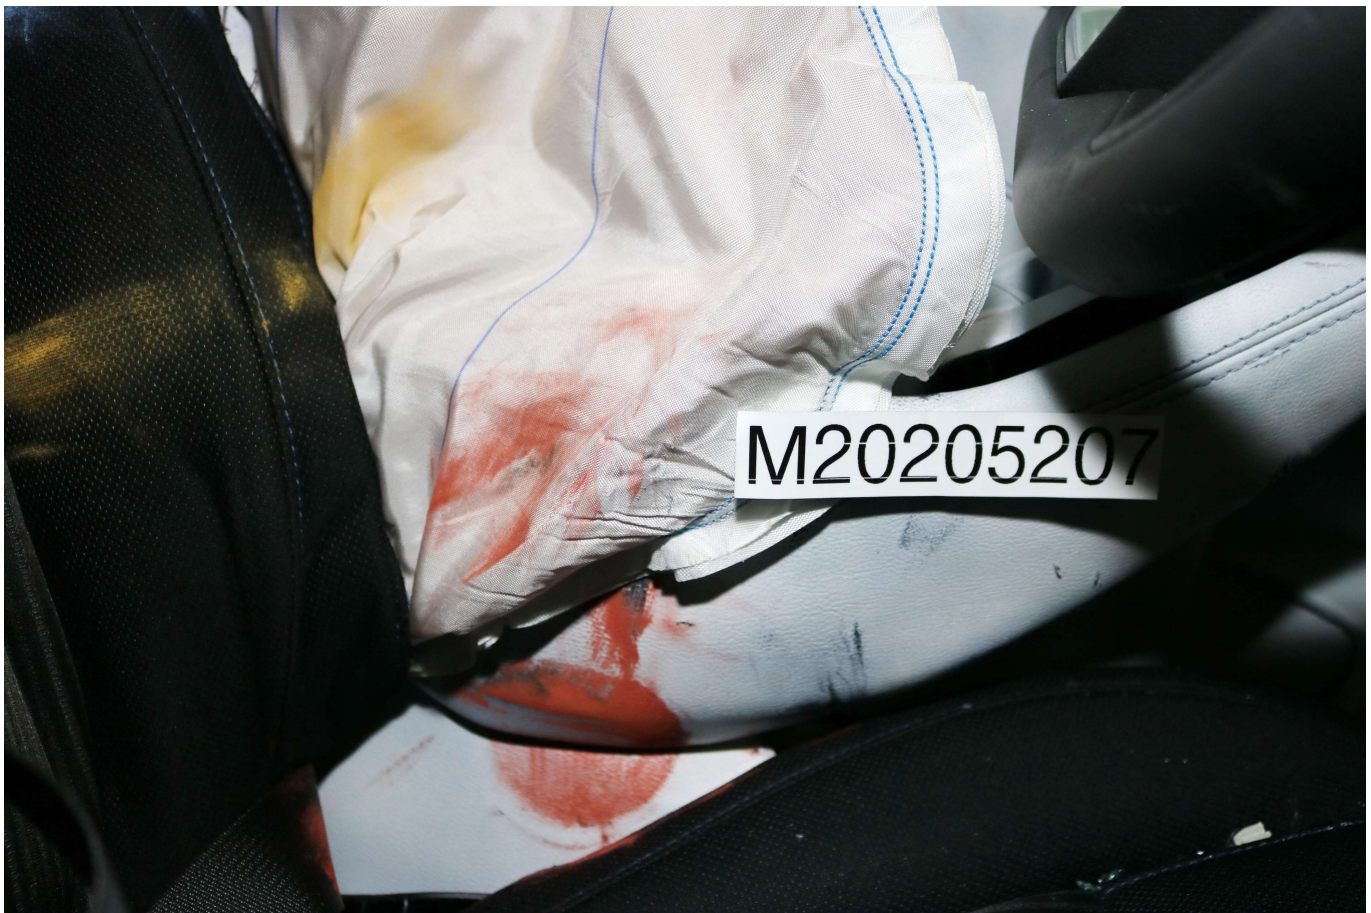
Photo No. 051 - Post-Test Dummy Close-Up Pelvis Contact with Side Air Bag View

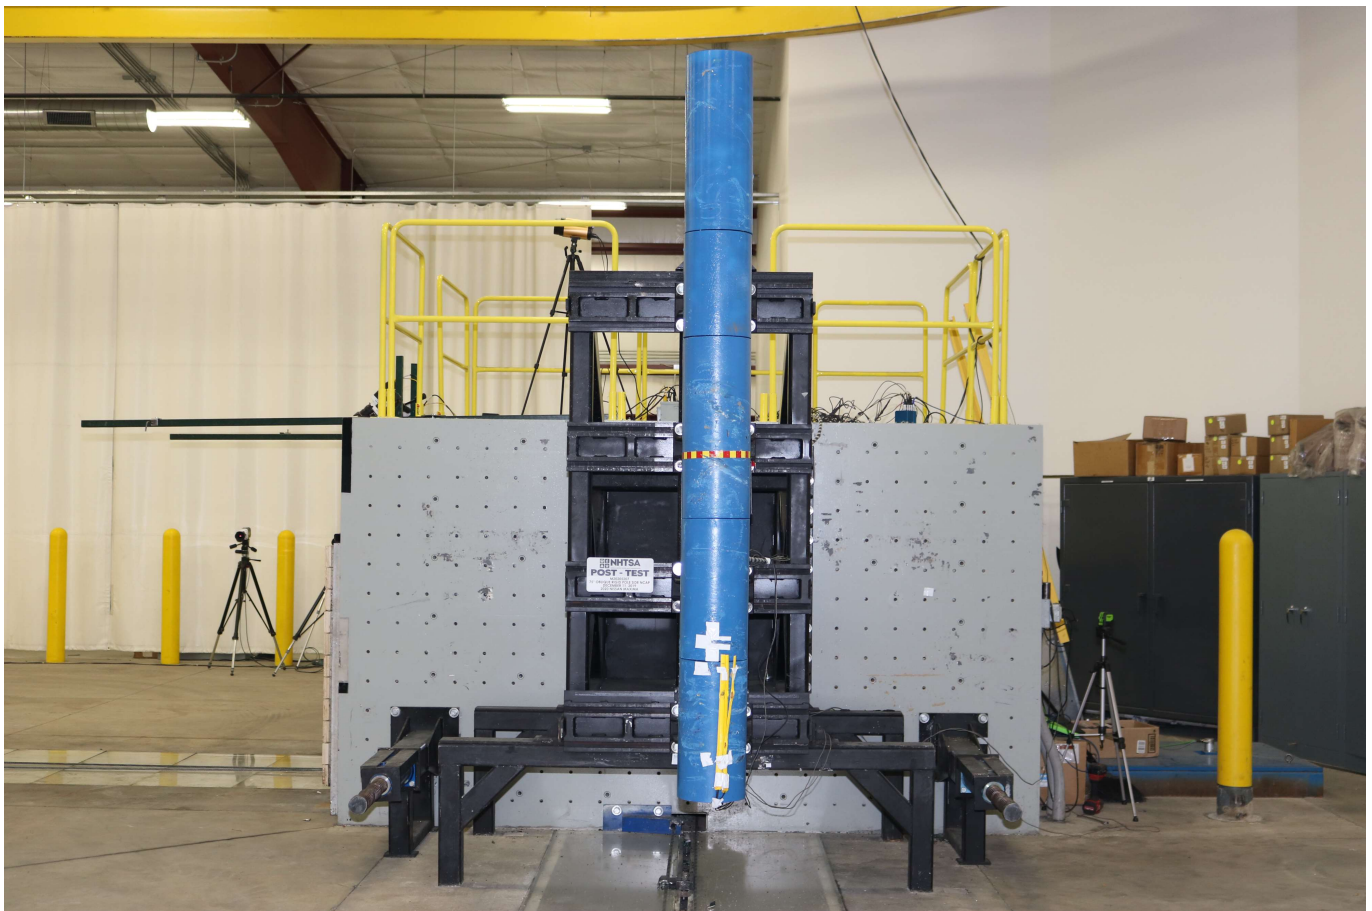
Photo No. 058 - Post-Test Pole Barrier Front View

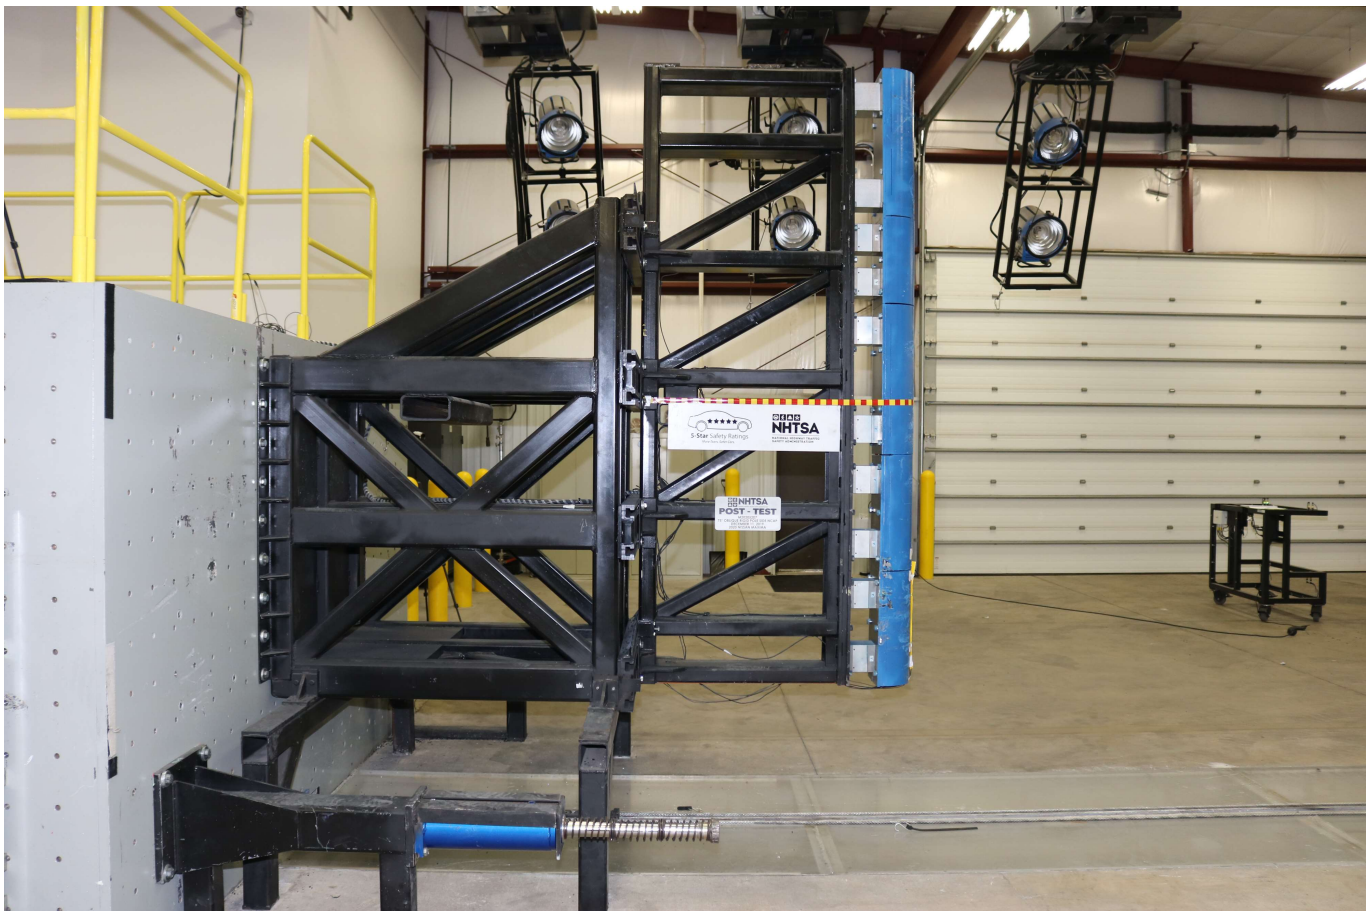
Photo No. 060 - Post-Test Pole Barrier Side View

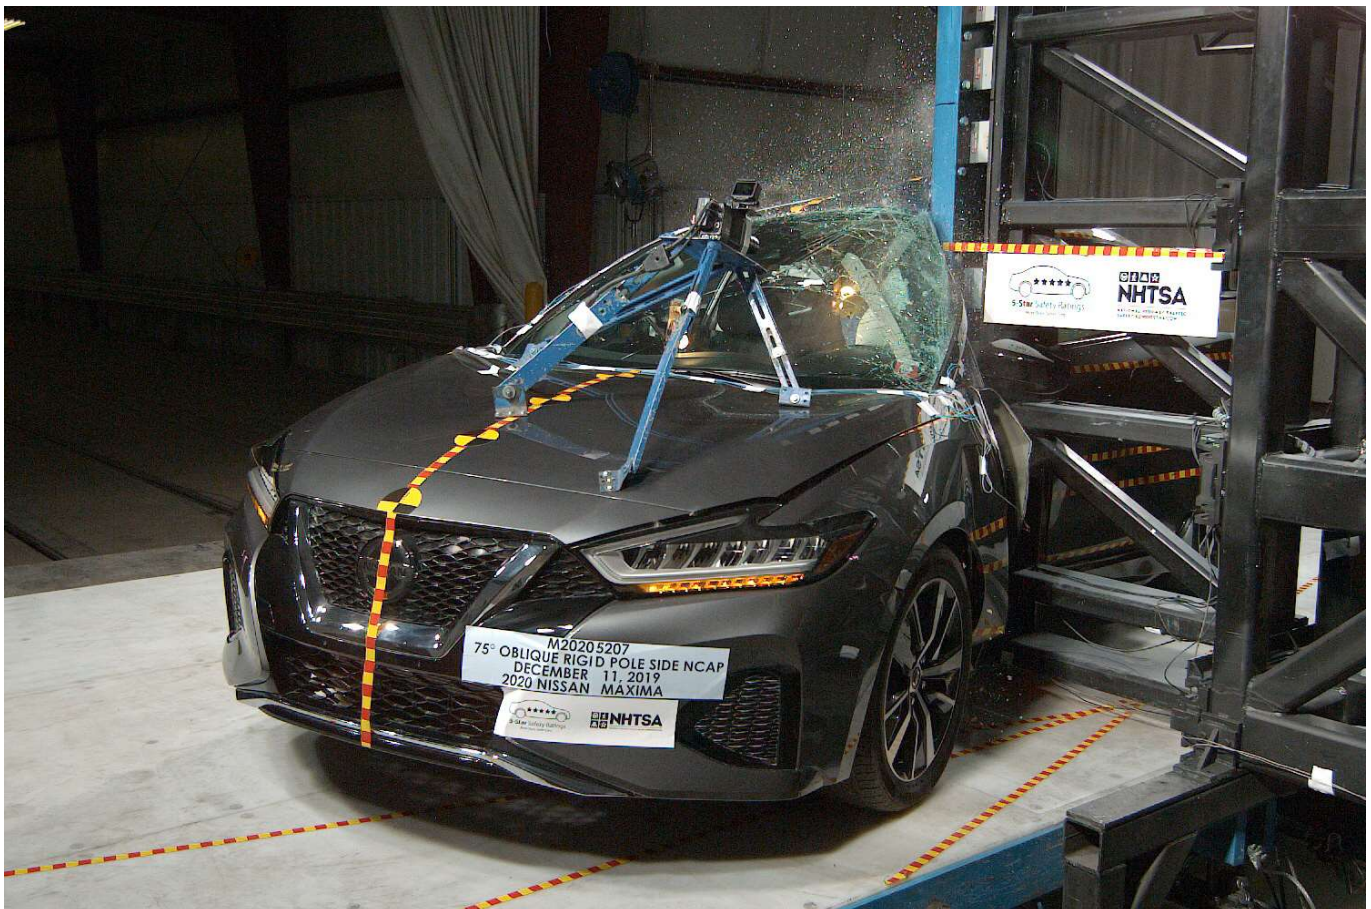
Photo No. 068 - Impact Event

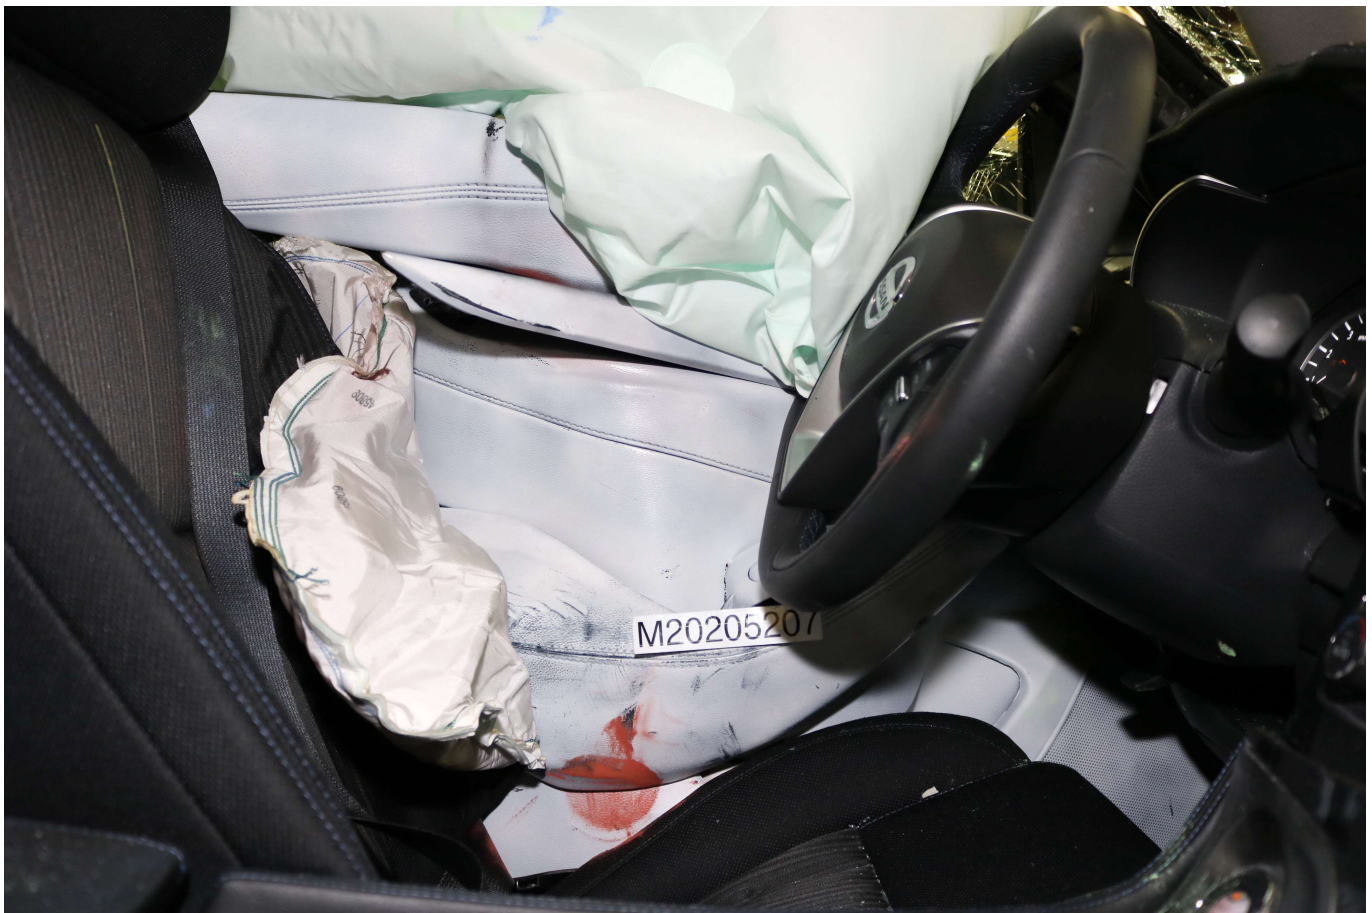
Photo No. 071 - Post-Test View of Shattered Vehicle Inner Door Panel

| Critical Areas of Performance | Observations and Conclusions |
|---|---|
| Side Window Damage | LF window cracked |
