**REPORT NUMBER: SPNCAP-MGA-20-013**

**NEW CAR ASSESSMENT PROGRAM (NCAP)  
Side Impact Pole Test**

**HYUNDAI MOTOR COMPANY  
2020 Hyundai Accent SE 4-Door Sedan  
NHTSA No.: M20204201**

**FINAL REPORT**

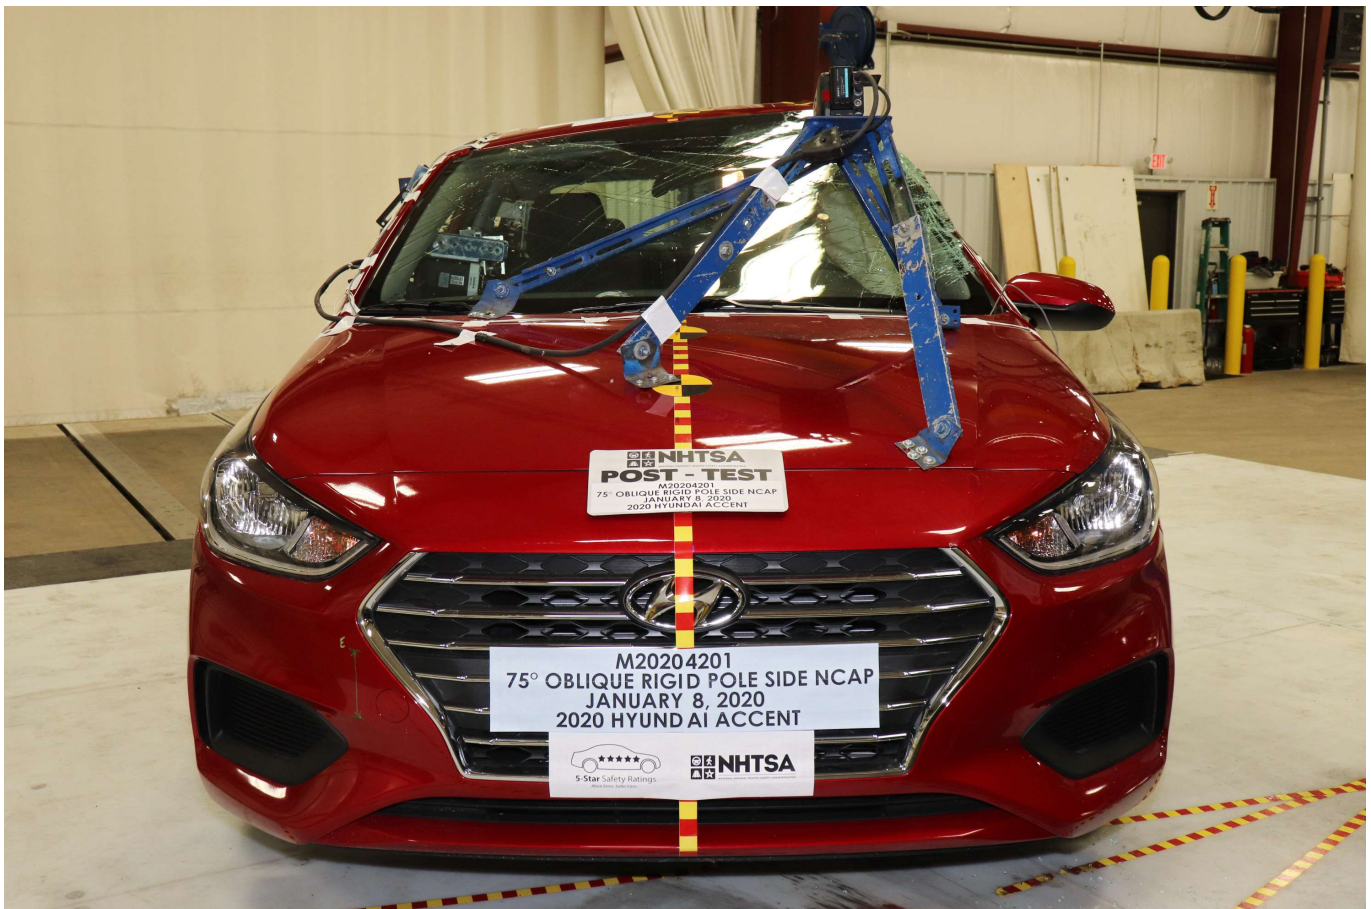
Photo No. 004 - Post-Test Frontal View of Test Vehicle

| Critical Areas of Performance | Observations and Conclusions |
|---|---|
| Windshield Damage | Cracked |

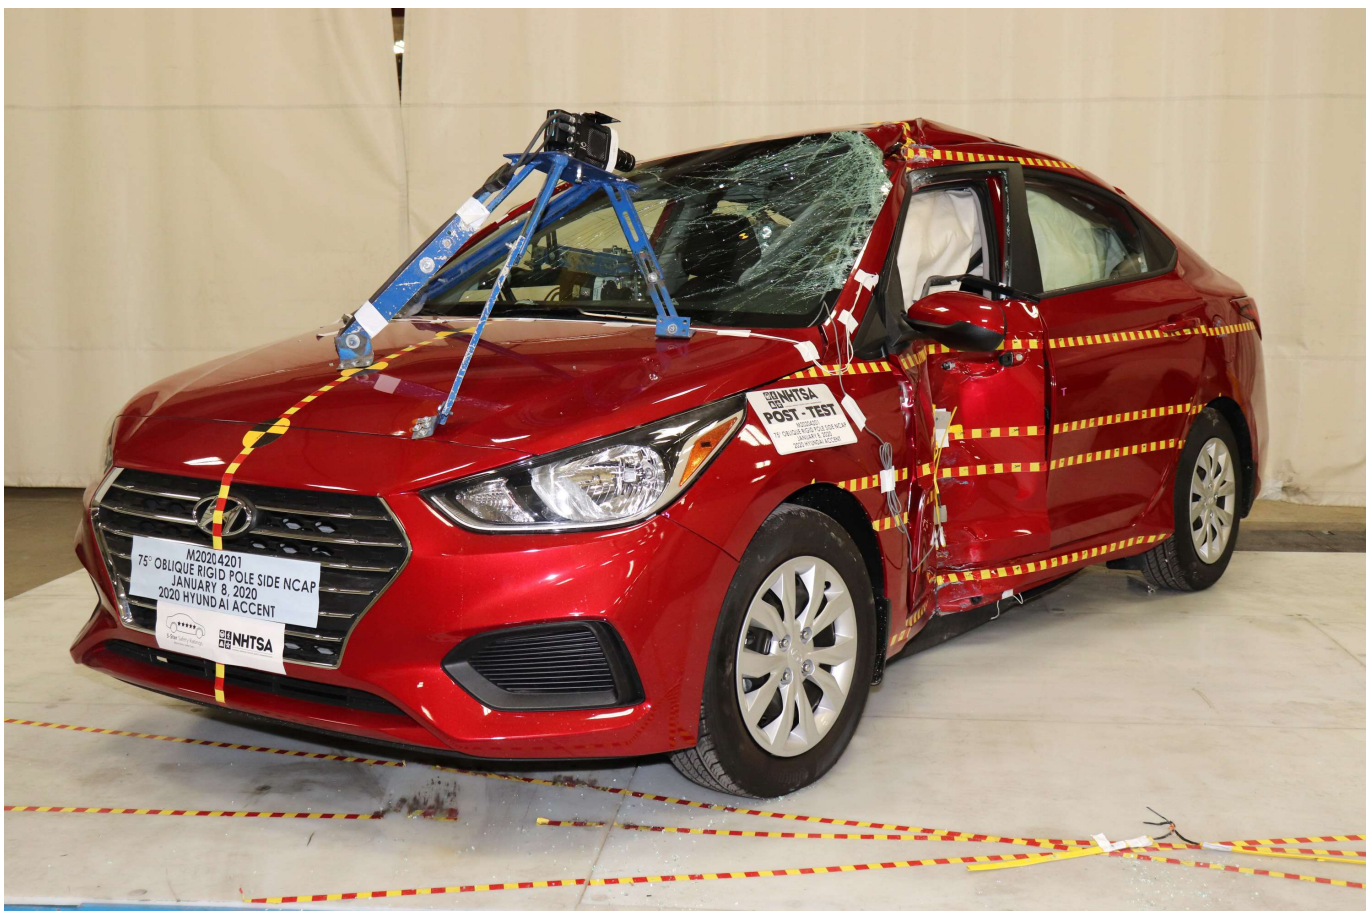
Photo No. 006 - Post-Test Left Front Three-Quarter View of Test Vehicle

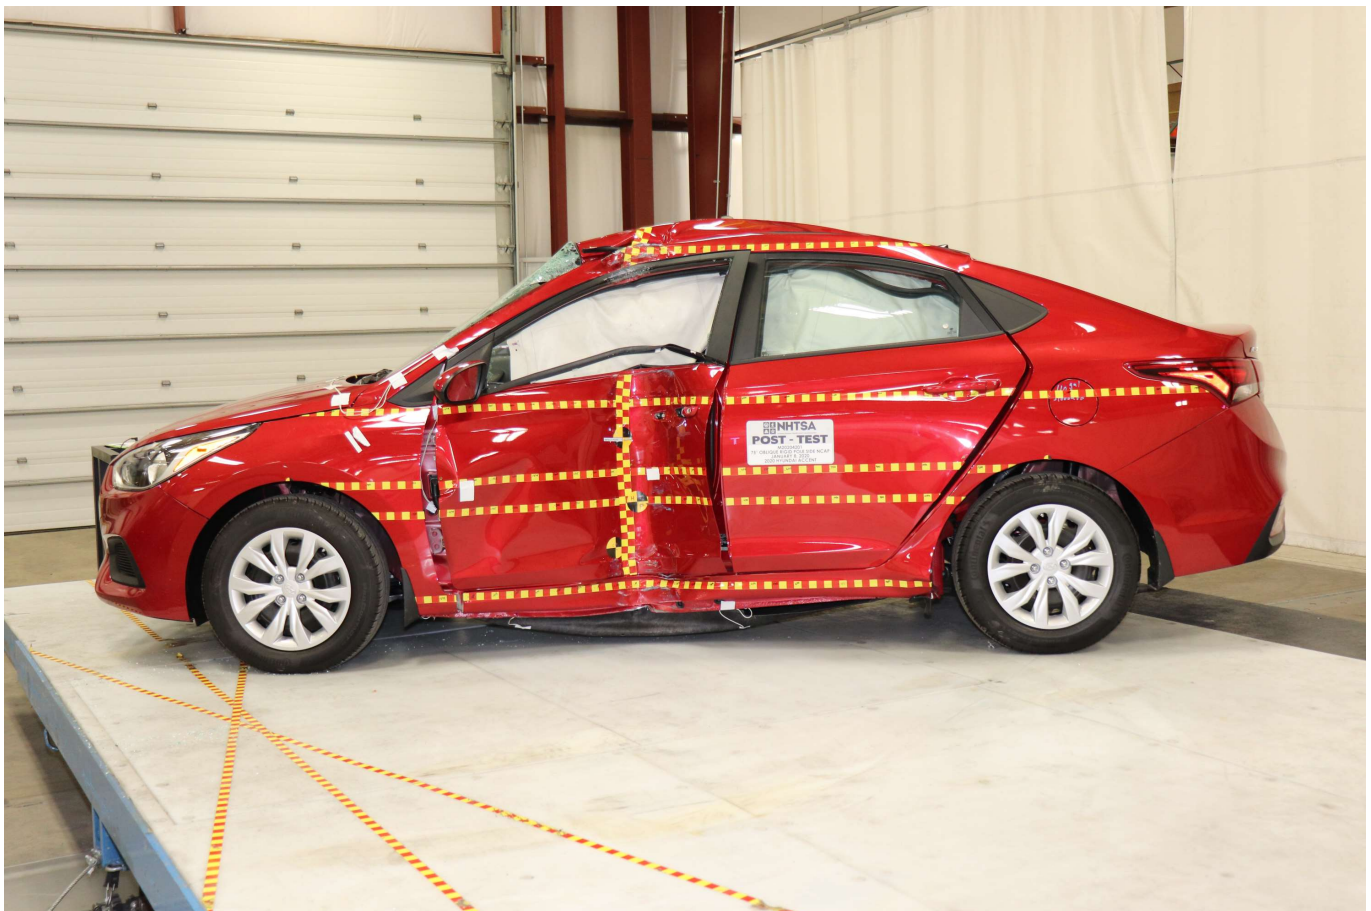
Photo No. 008 - Post-Test Left Side View of Test Vehicle

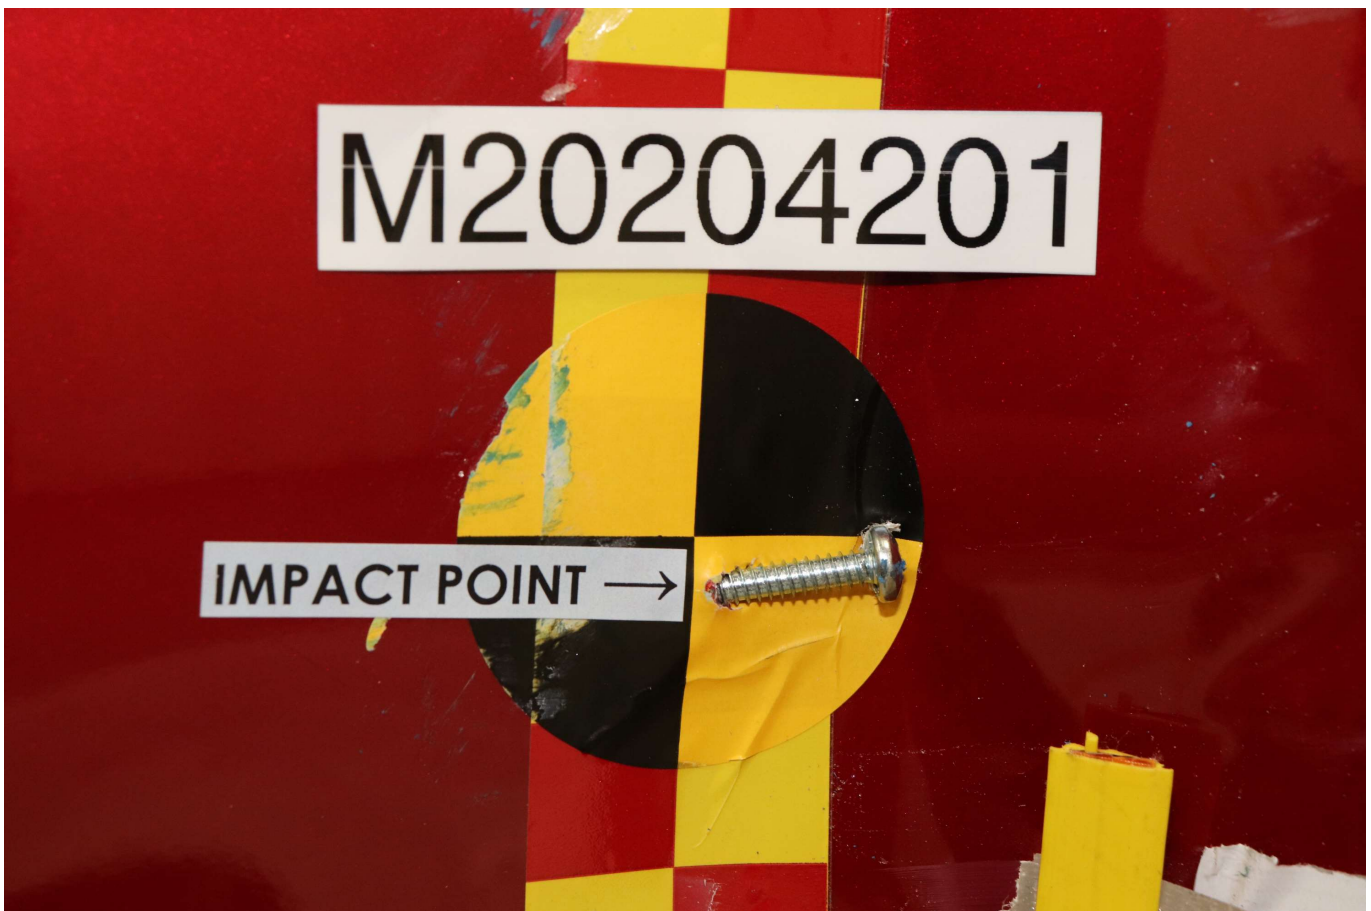
Photo No. 020 - Post-Test Close-Up View of Impact Point Target Showing Impact Location

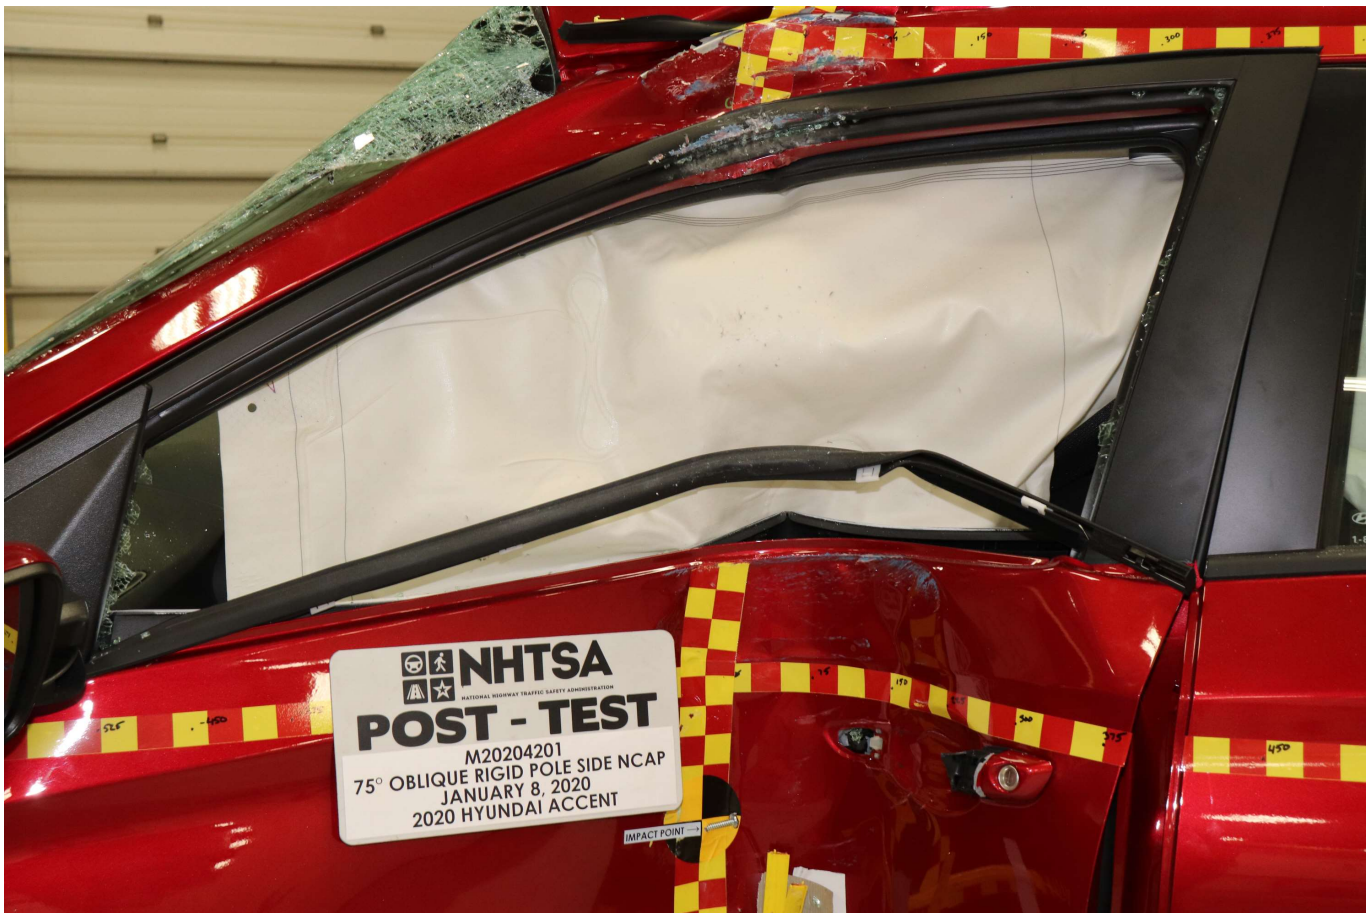
Photo No. 025 - Post-Test Left Side View of Dummy Shoulder and Door Top View

| Critical Areas of Performance | Observations and Conclusions |
|---|---|
| Side Window Damage | LF window broken |

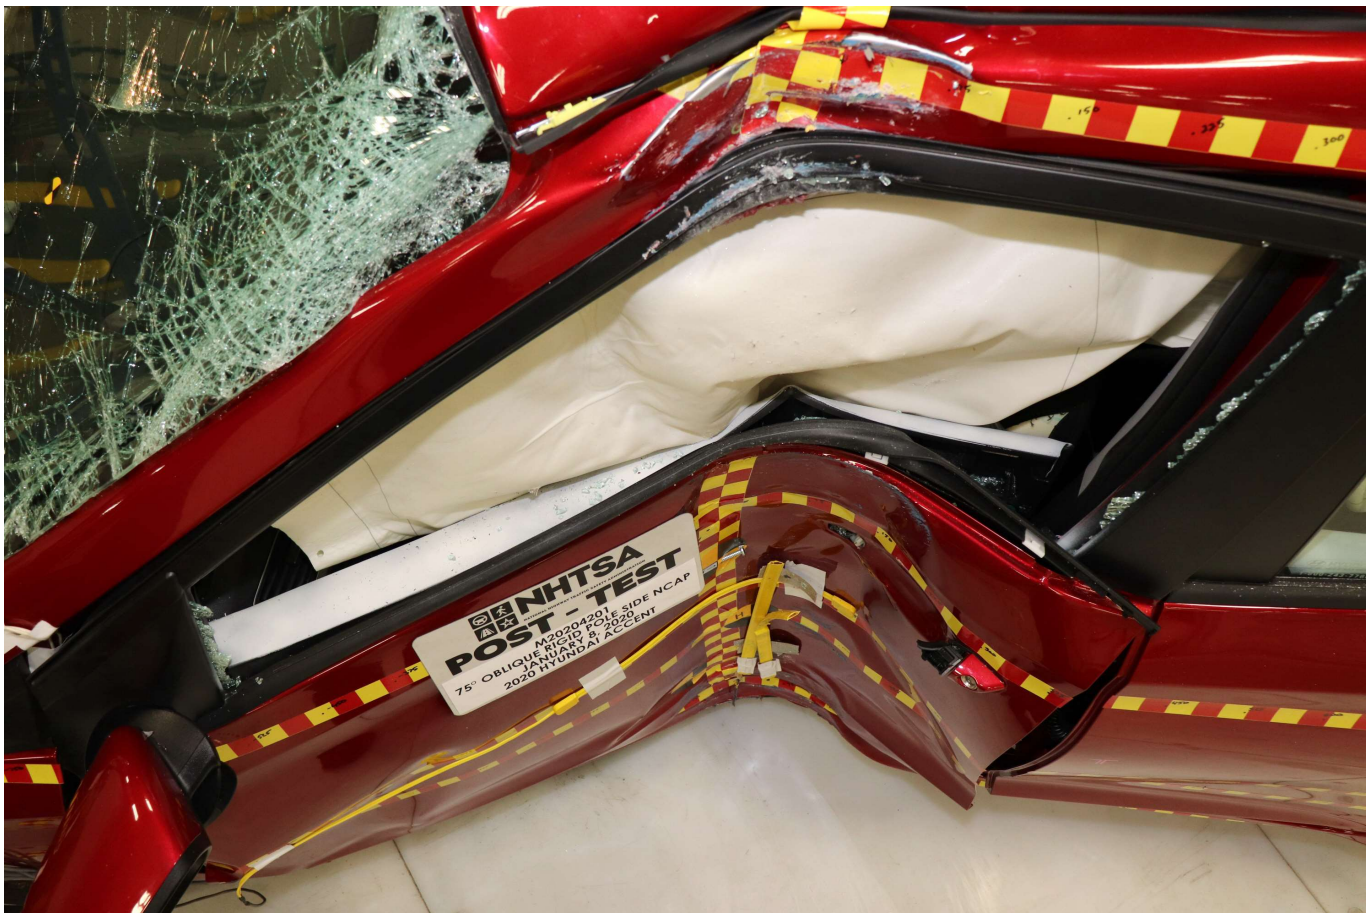
Photo No. 041 - Post-Test Dummy and Door Clearance View

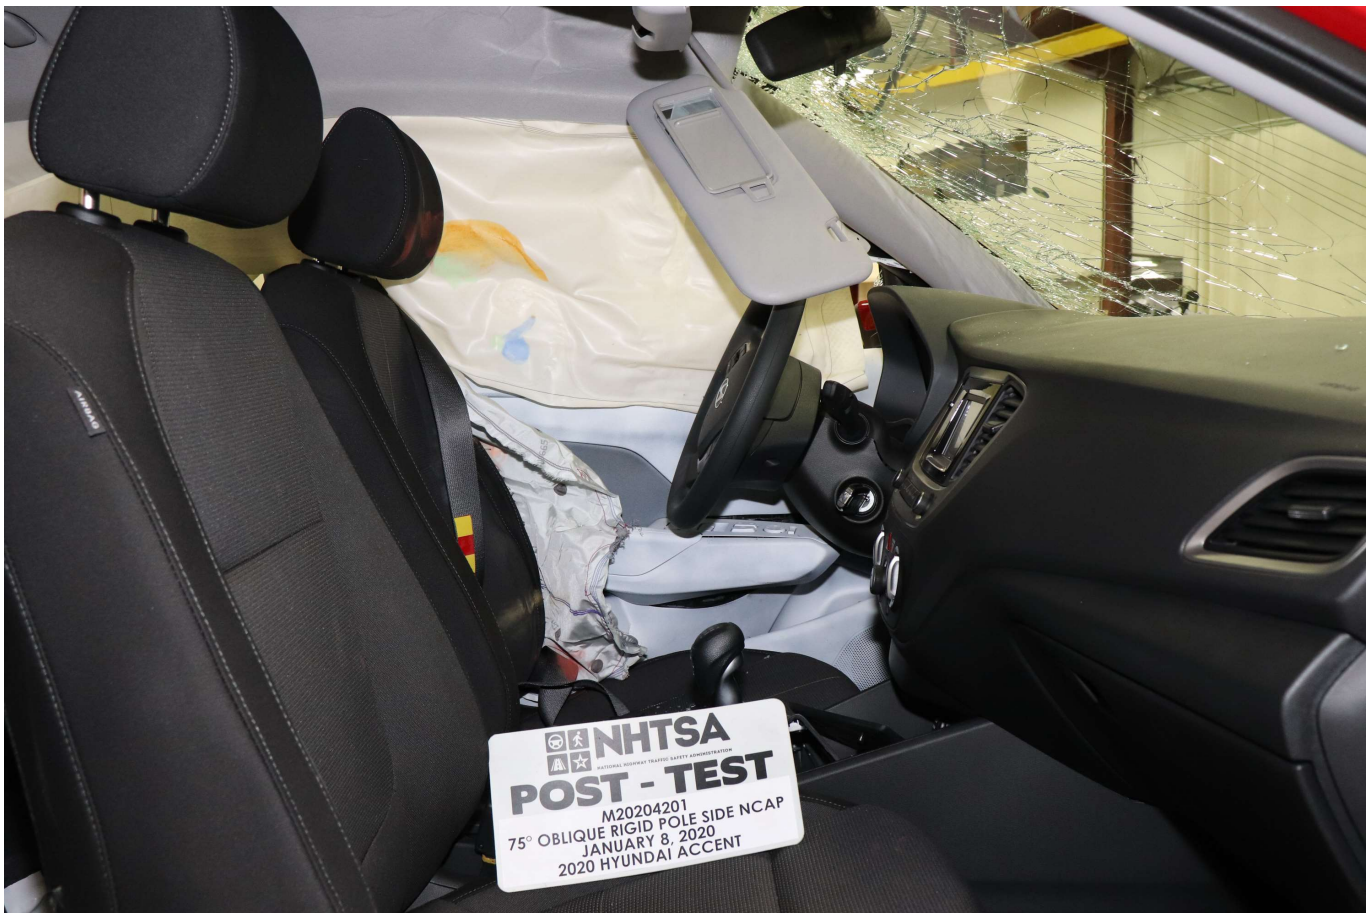
Photo No. 045 - Post-Test Inner Door Panel View Showing Dummy Contact Location

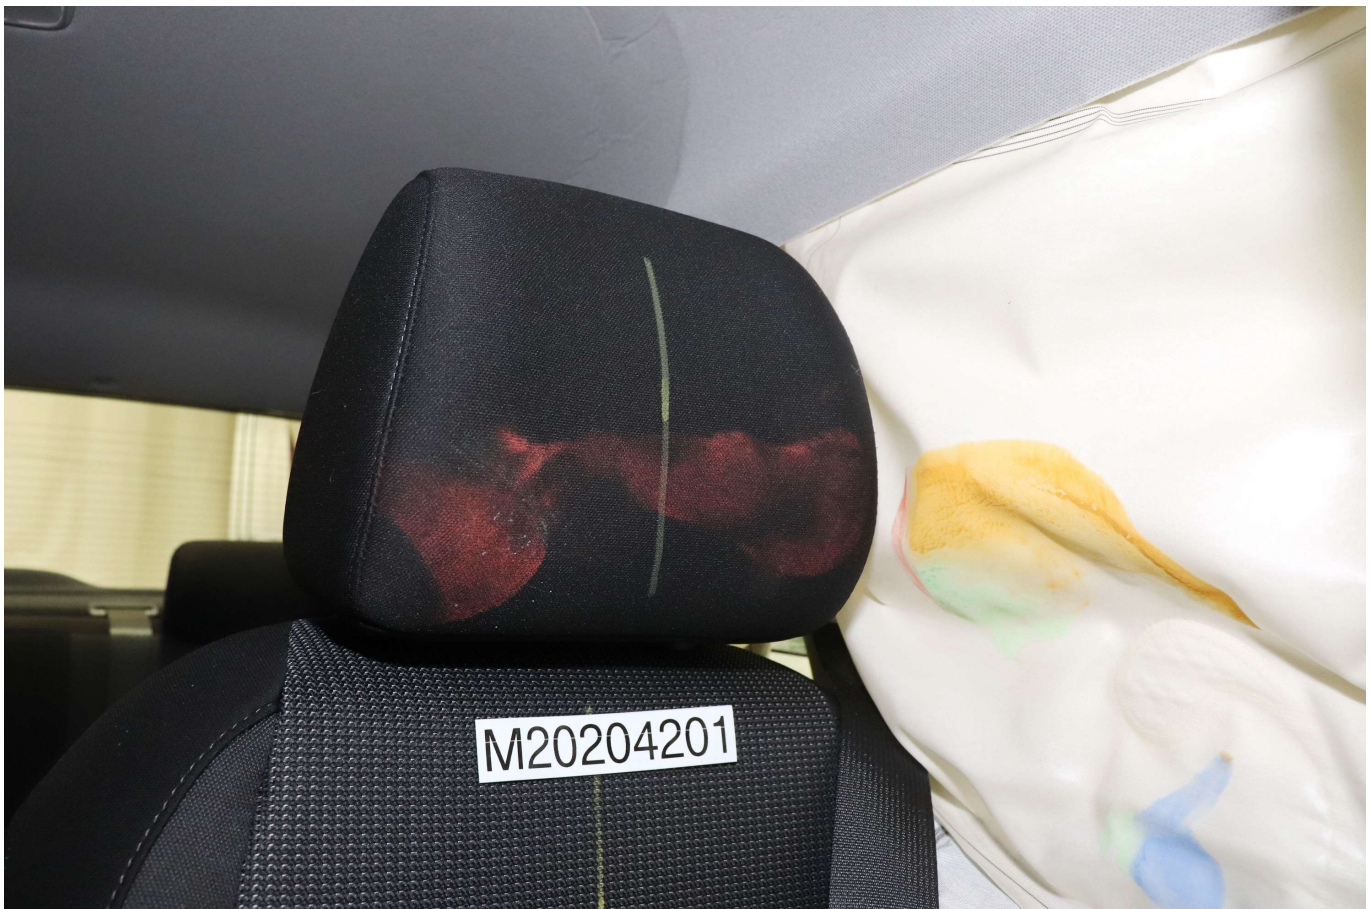
Photo No. 046 - Post-Test Dummy Close-Up Head Contact with Vehicle Interior View

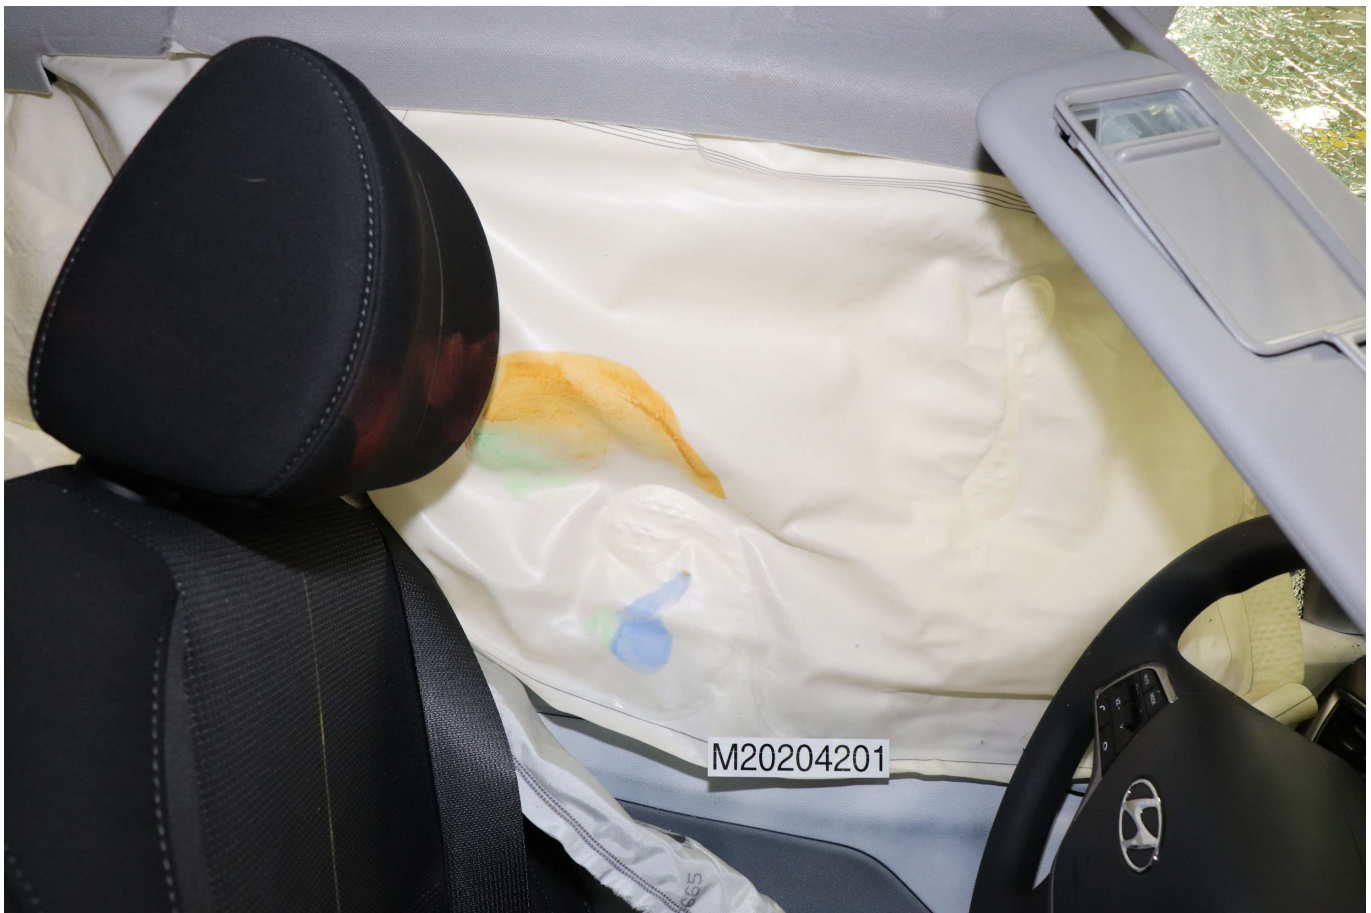
Photo No. 047 - Post-Test Dummy Close-Up Head Contact with Side Air Bag View

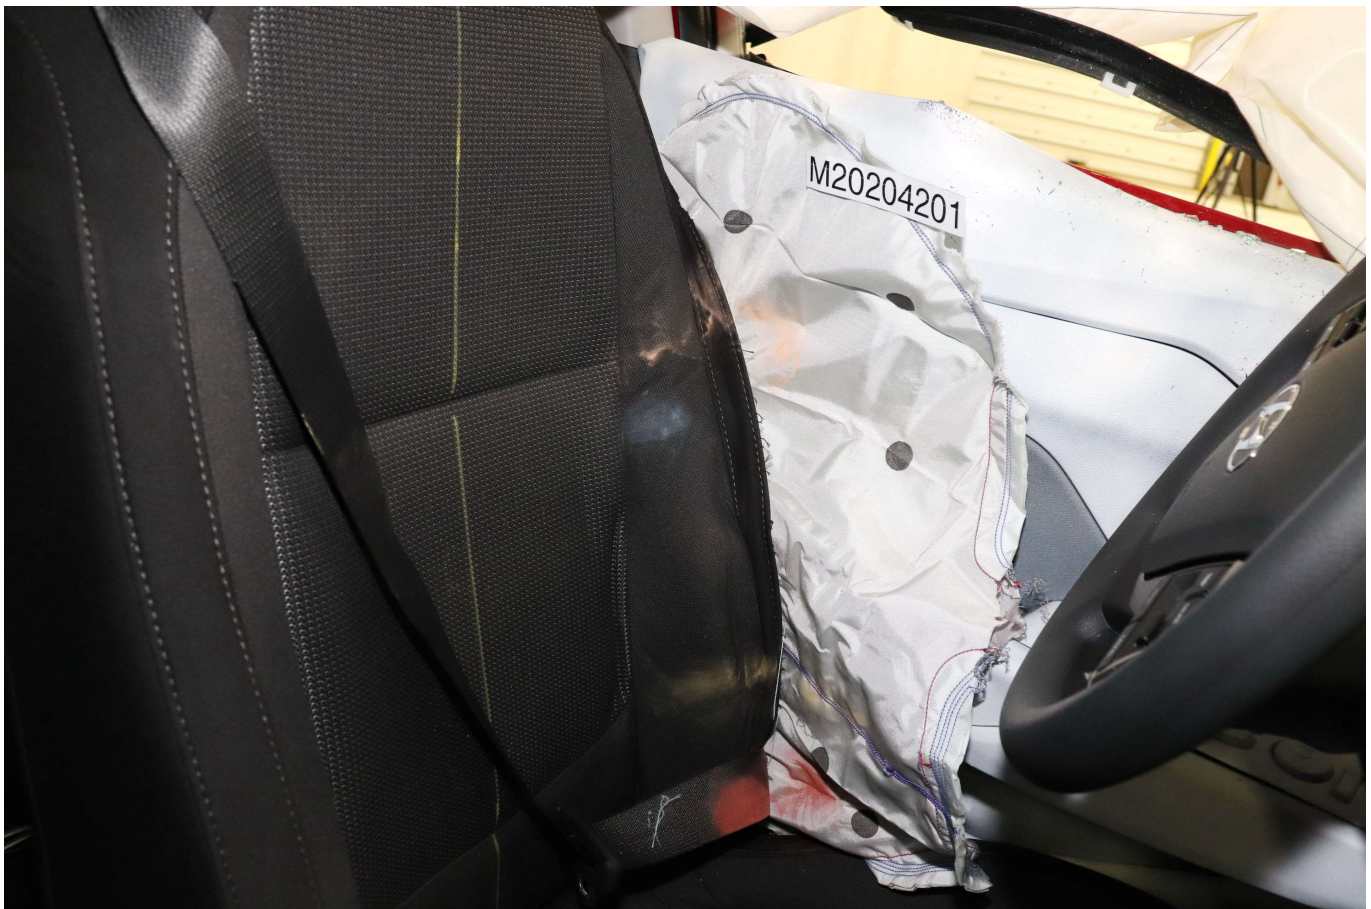
Photo No. 048 - Post-Test Dummy Close-Up Torso Contact with Vehicle Interior View

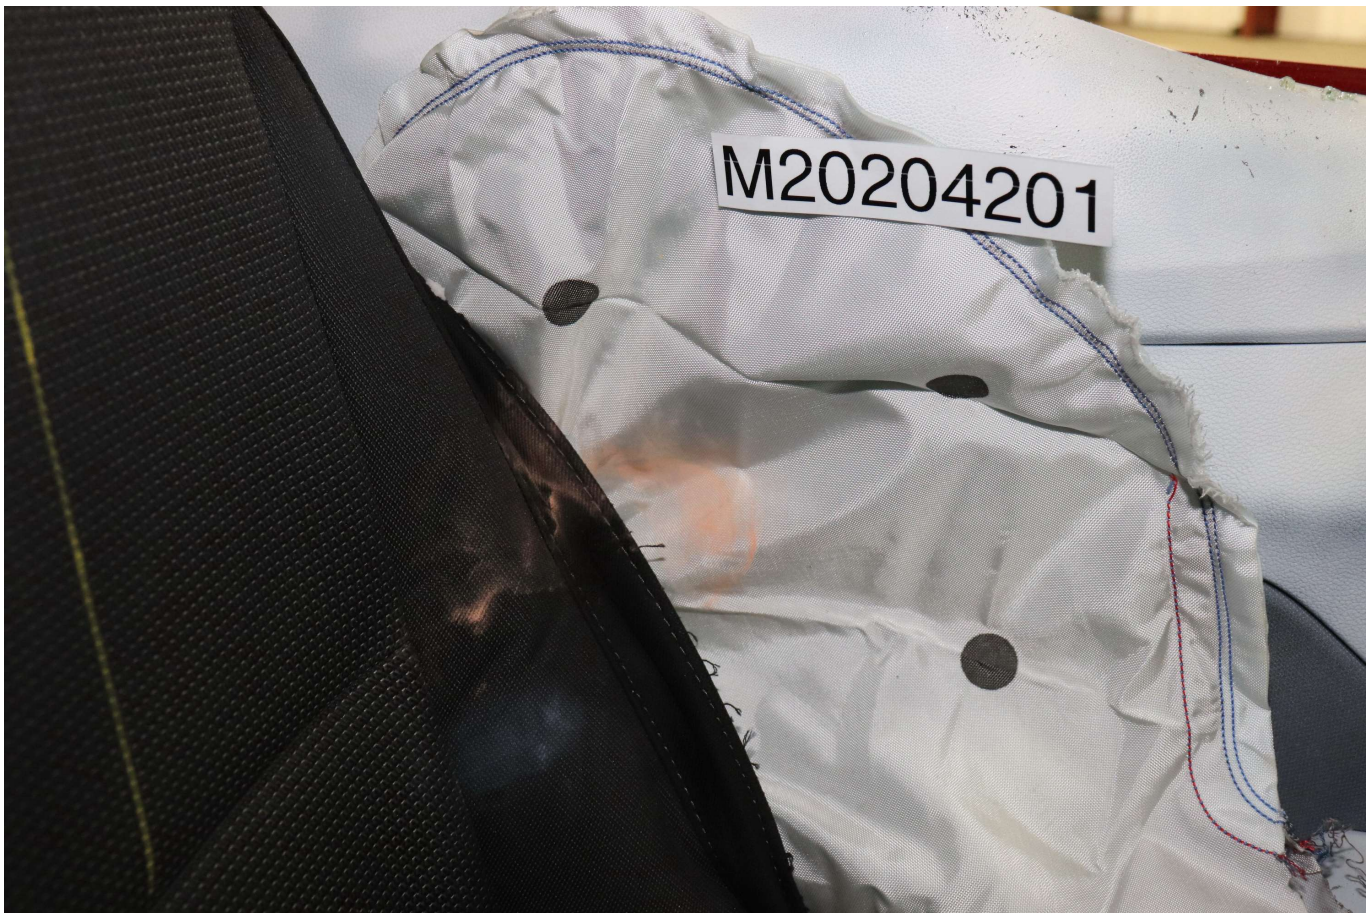
Photo No. 049 - Post-Test Dummy Close-Up Torso Contact with Side Air Bag View

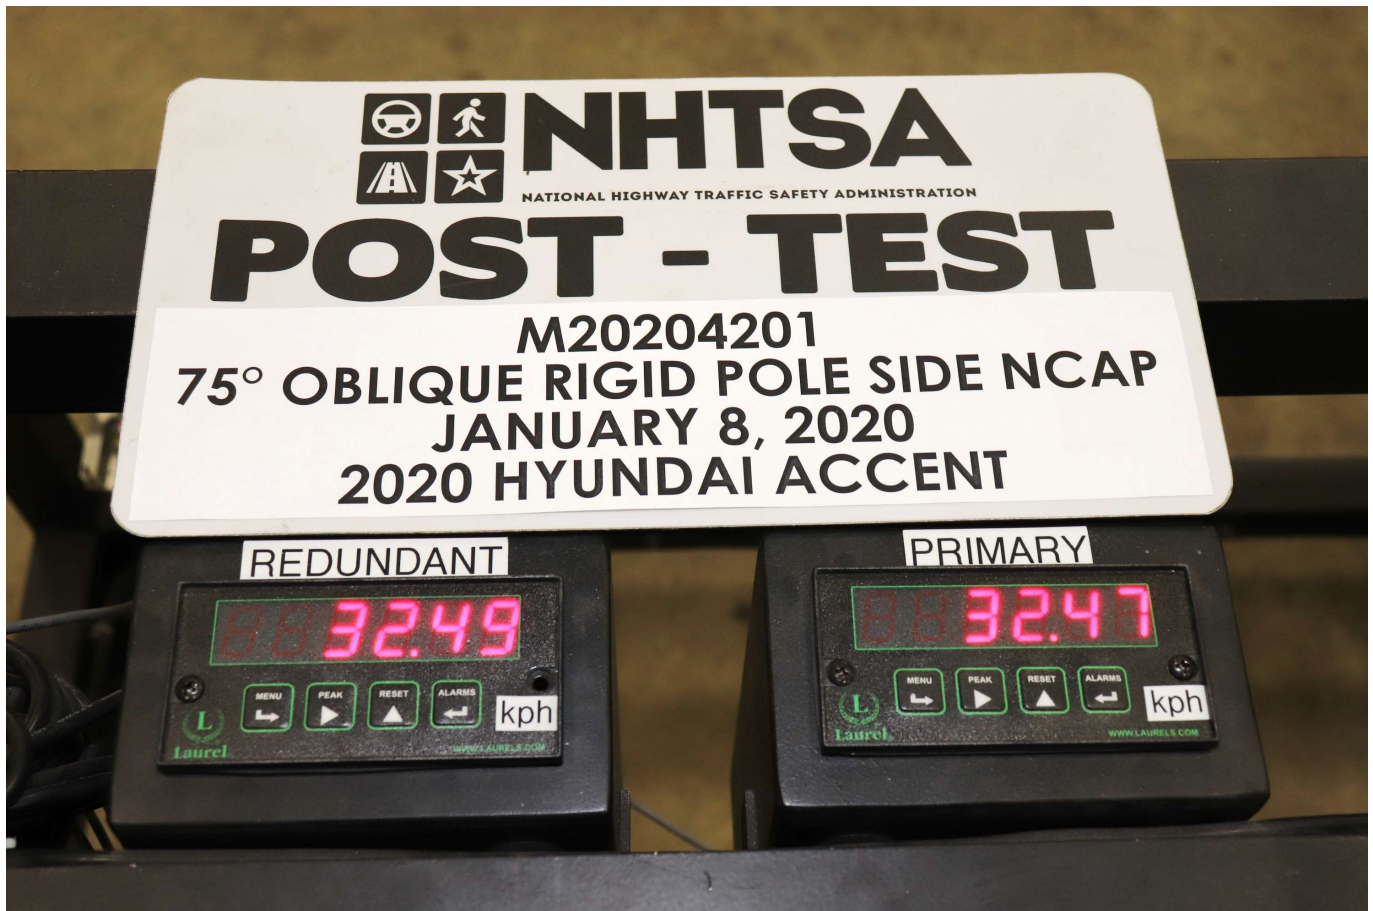
Photo No. 062 - Post-Test Primary and Redundant Speed Trap Read-Out

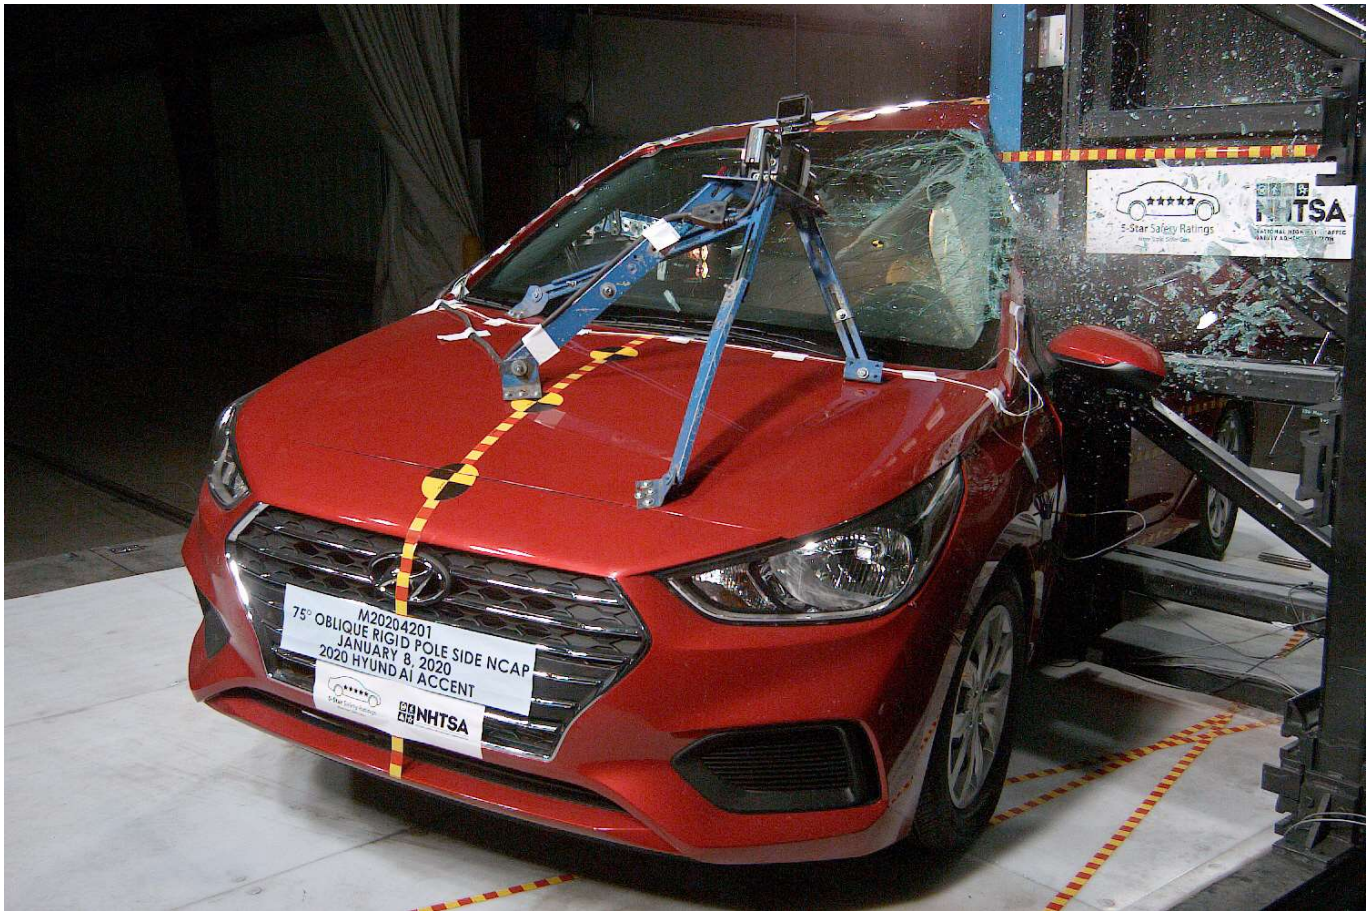
Photo No. 068 - Impact Event

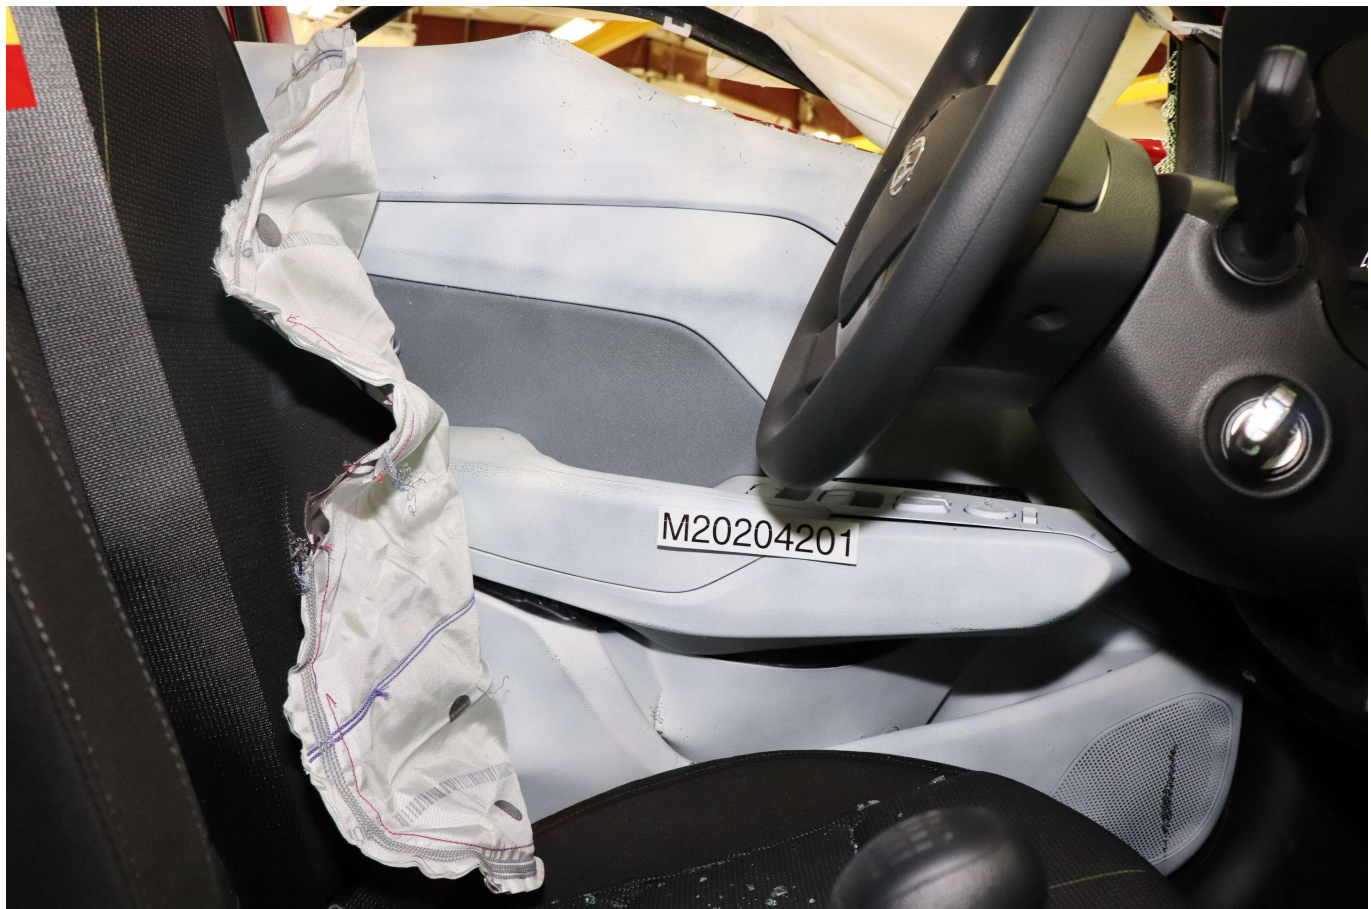
Photo No. 071 - Post-Test View of Shattered Vehicle Inner Door Panel
