**NEW CAR ASSESSMENT PROGRAM
CRASH IMMINENT BRAKE SYSTEM CONFIRMATION TEST
NCAP-DRI-CIB-20-01**

2020 Acura MDX Tech 7P

Final Report

1. Report No. NCAP-DRI-CIB-20-01	2. Government Accession No.	3. Recipient's Catalog No.	
4. Title and Subtitle Final Report of Crash Imminent Brake System Confirmation Test of a 2020 Acura MDX Tech 7P.		5. Report Date 17 February 2020

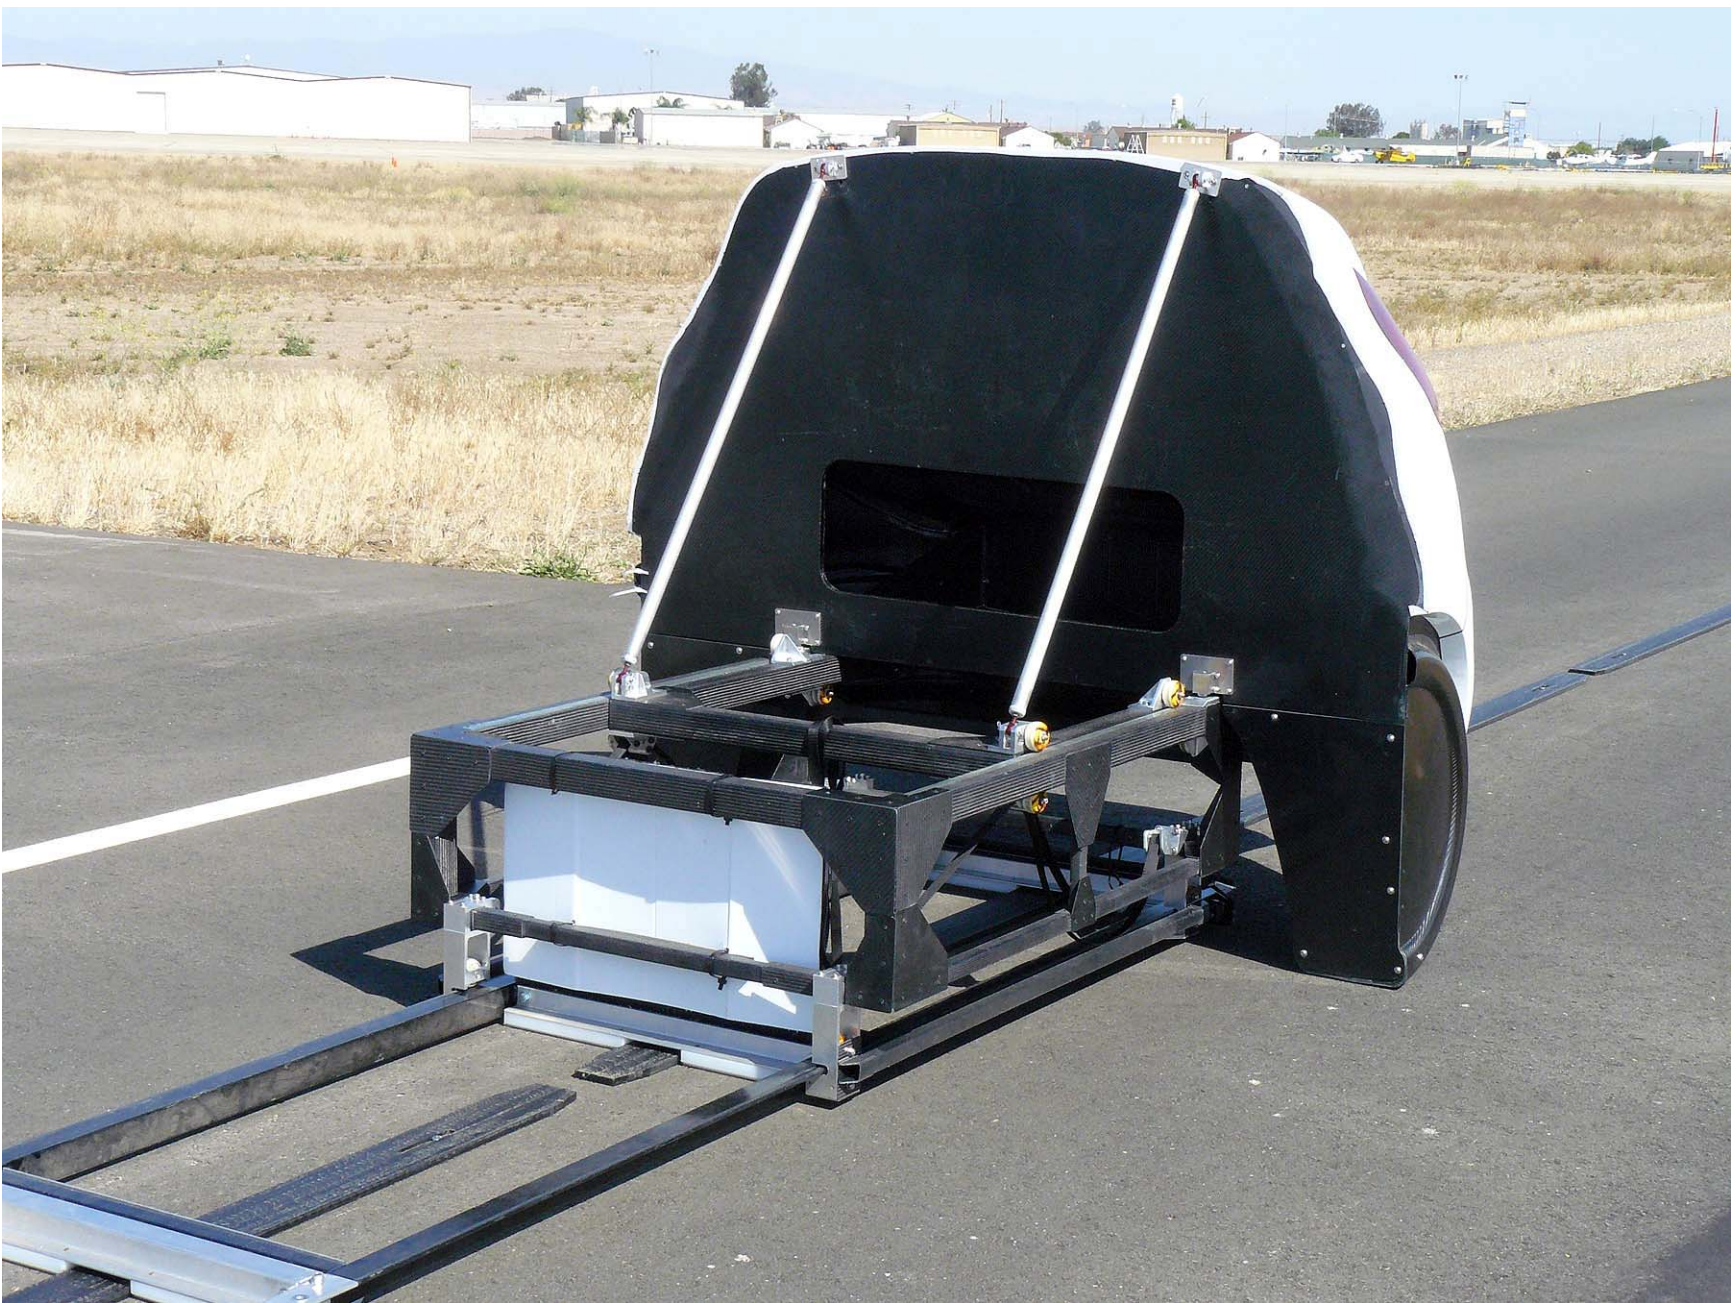
Figure A7. Load Frame/Slider of SSV

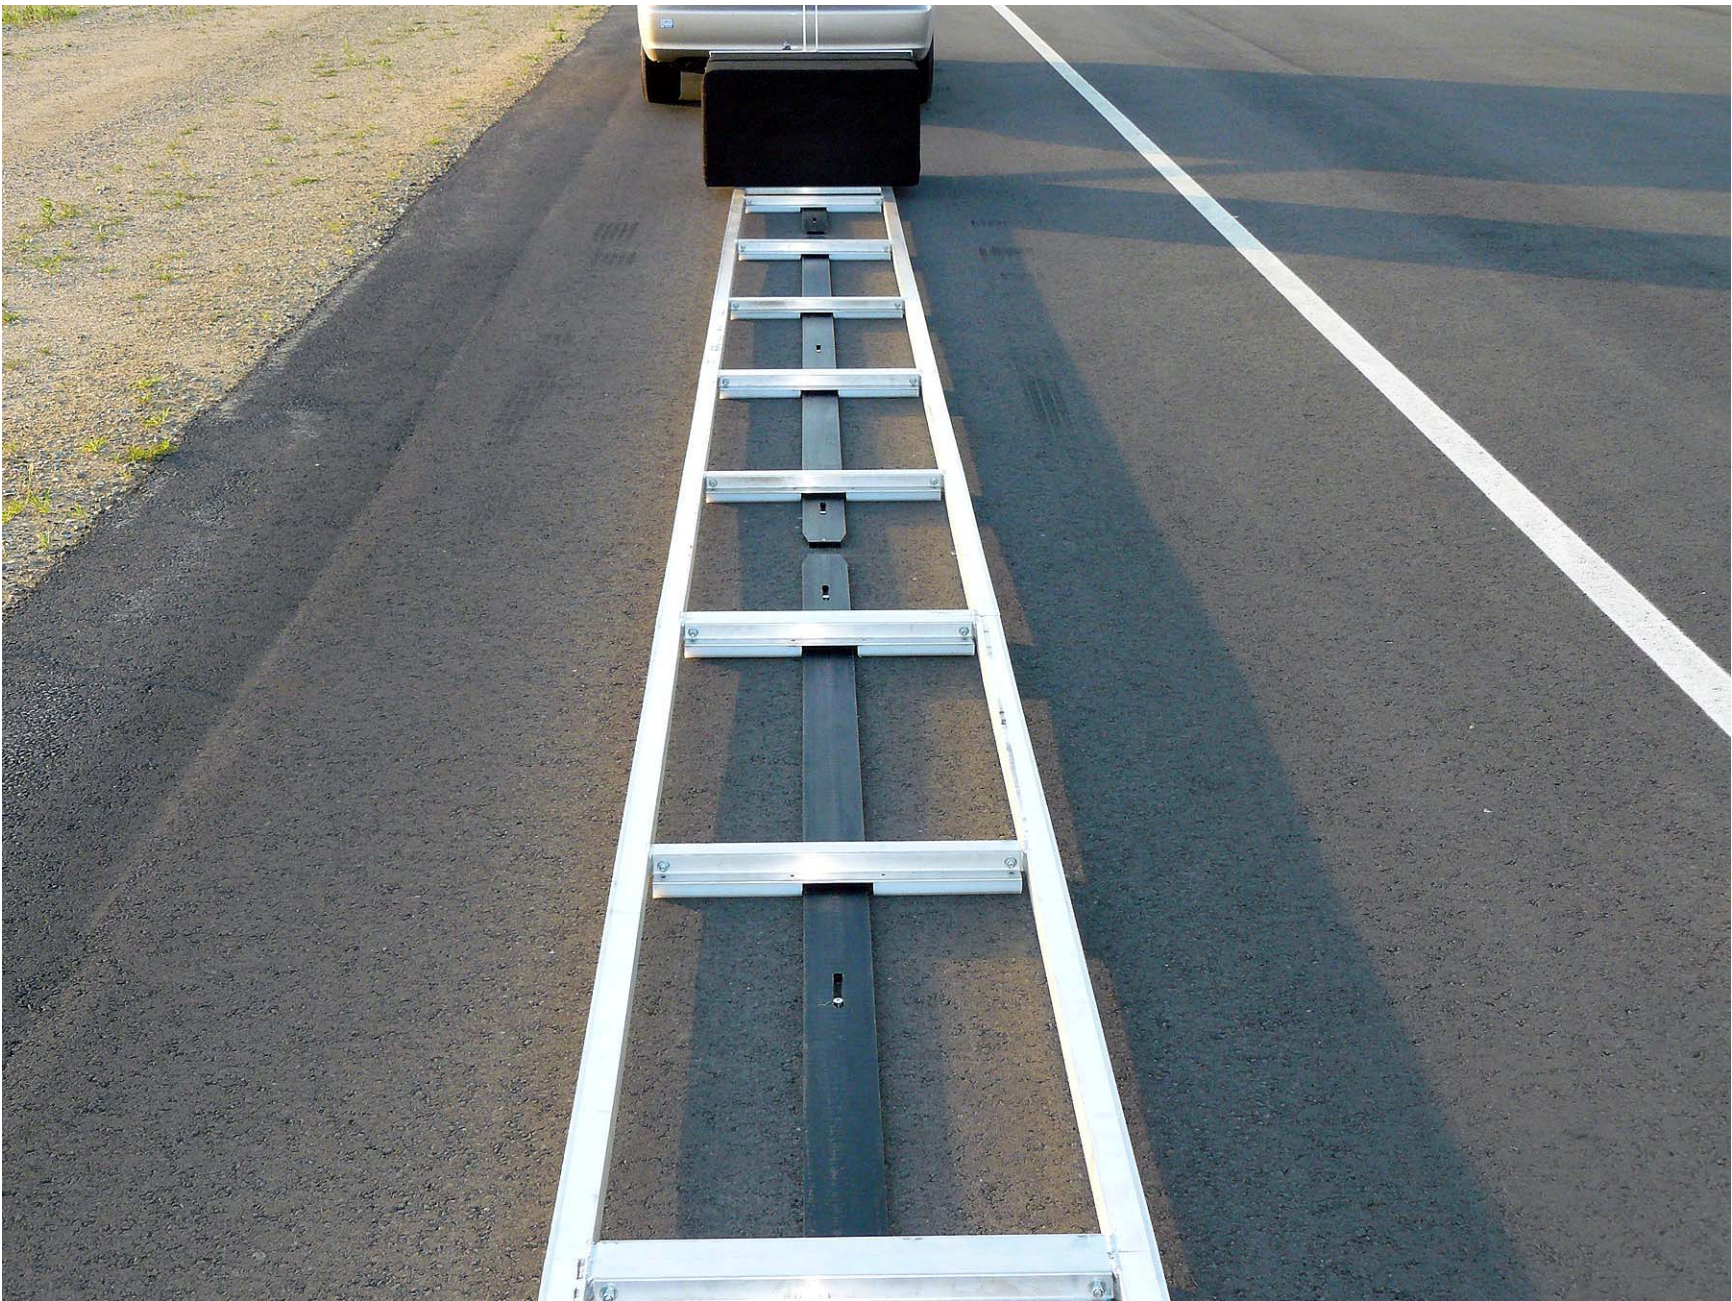
Figure A8. Two-Rail Track and Road-Based Lateral Restraint Track

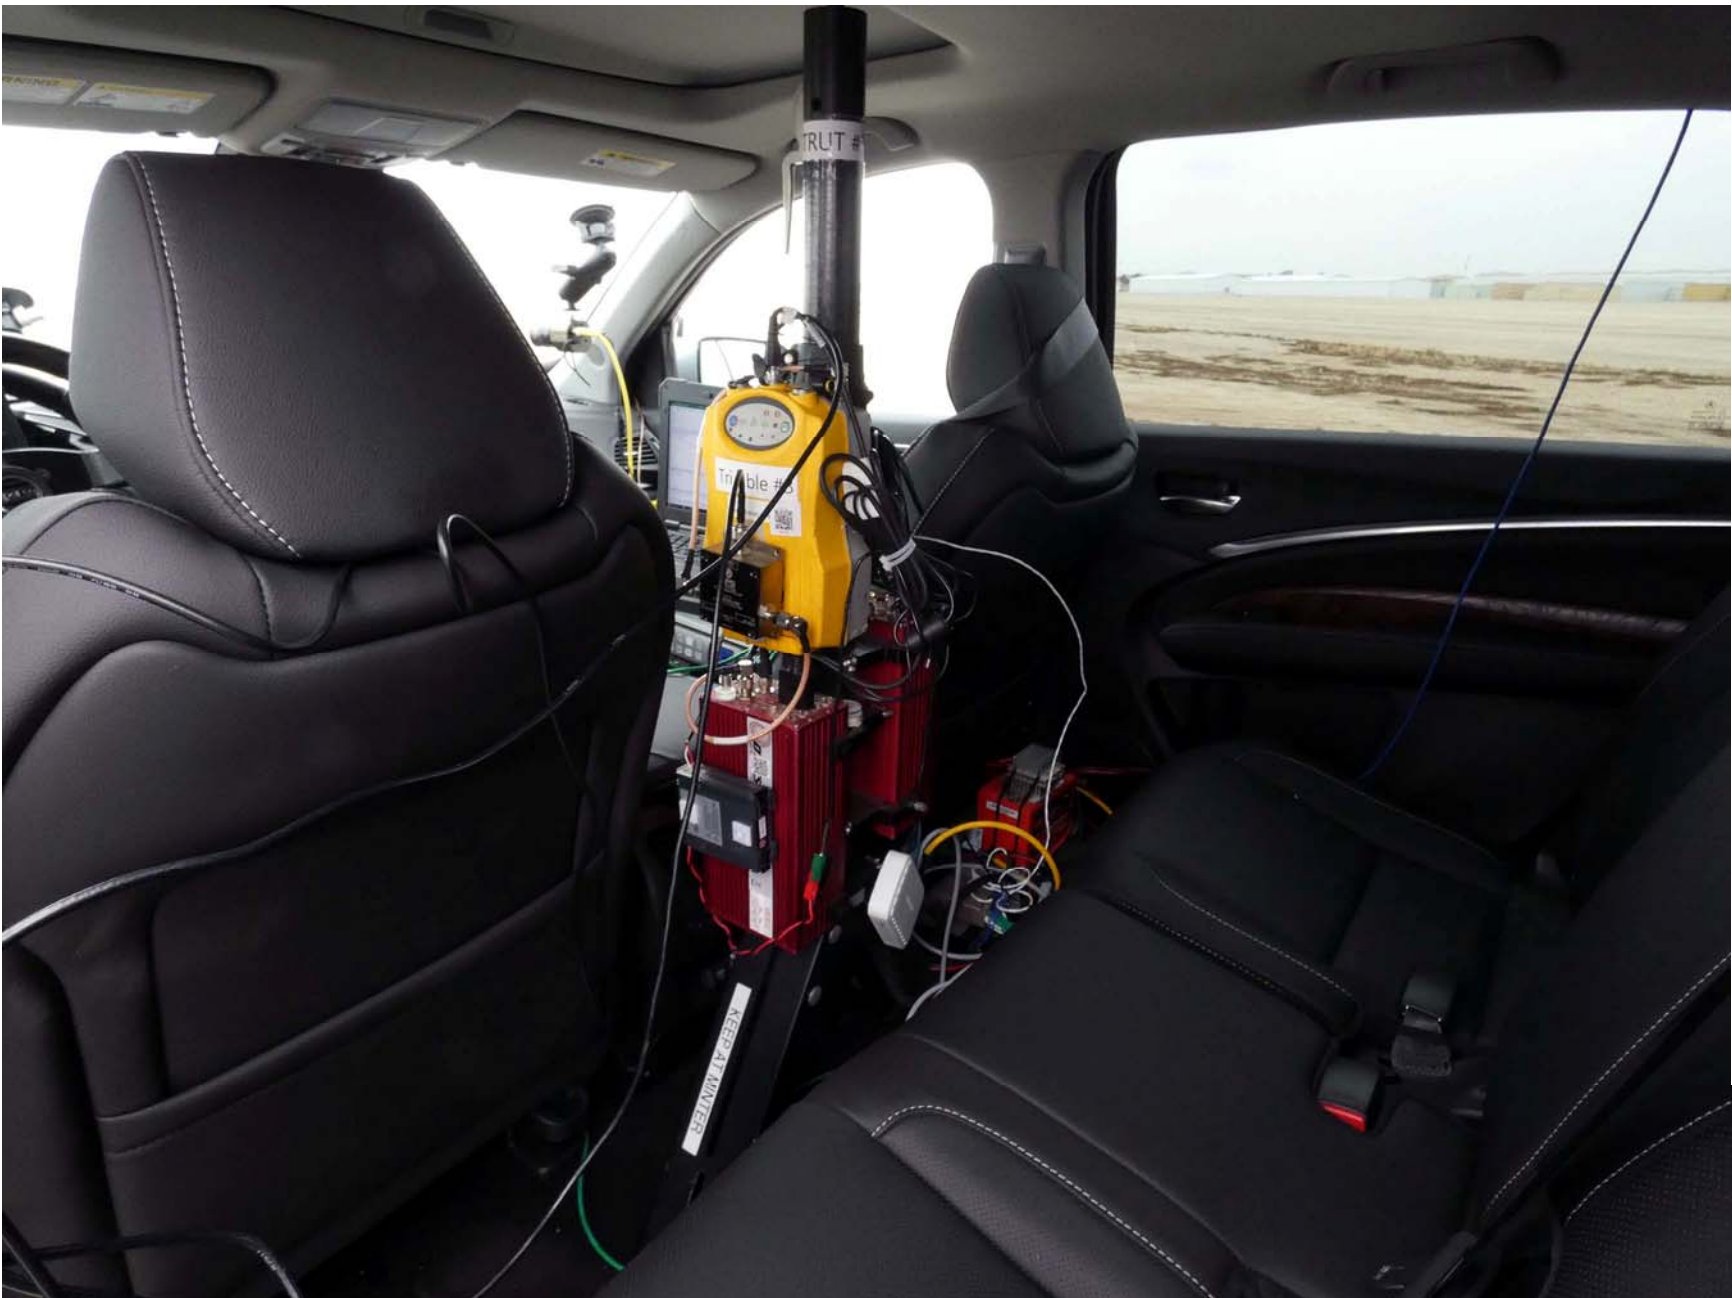
Figure A10. DGPS, Inertial Measurement Unit, and MicroAutoBox Installed in Subject Vehicle

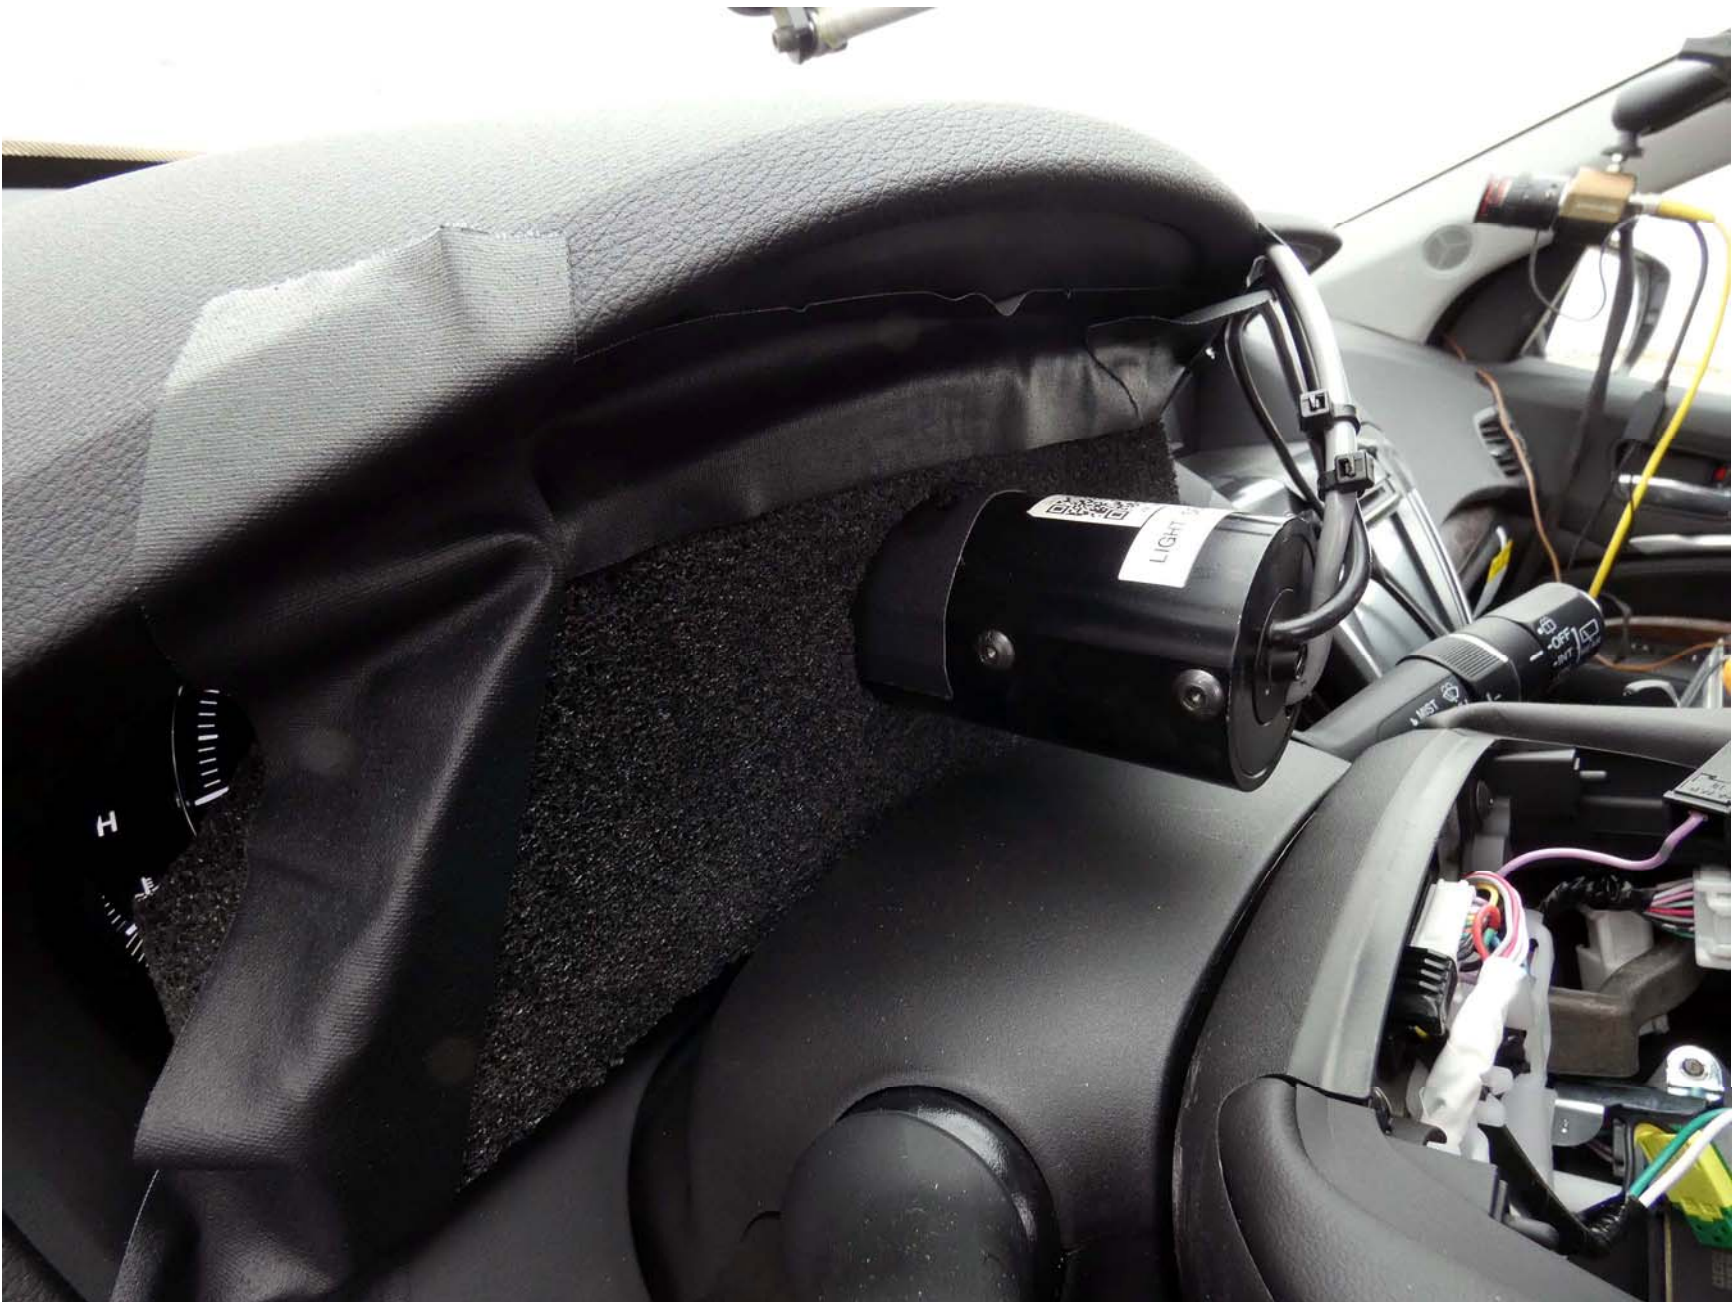
Figure A11. Sensor for Detecting Visual Alerts

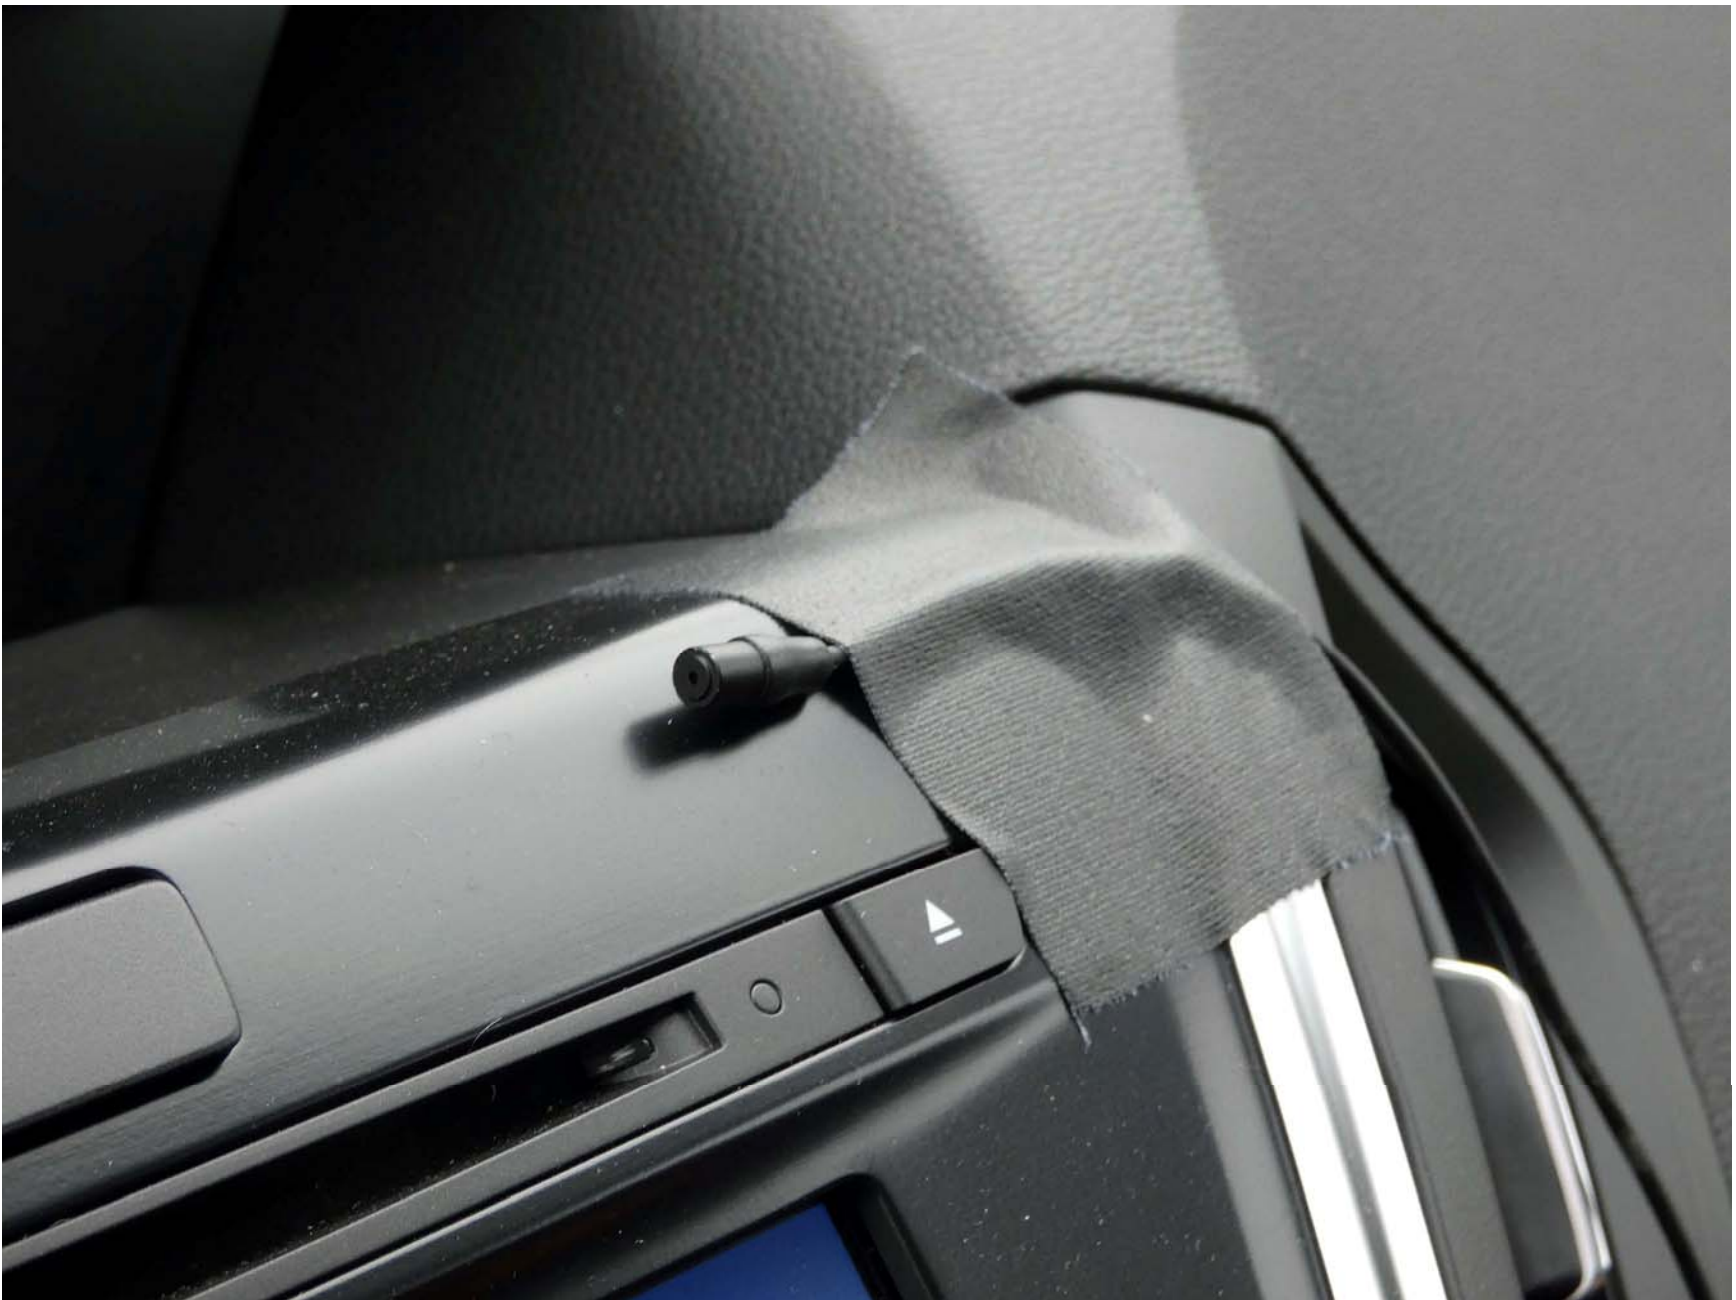
Figure A12. Sensor for Detecting Auditory Alerts

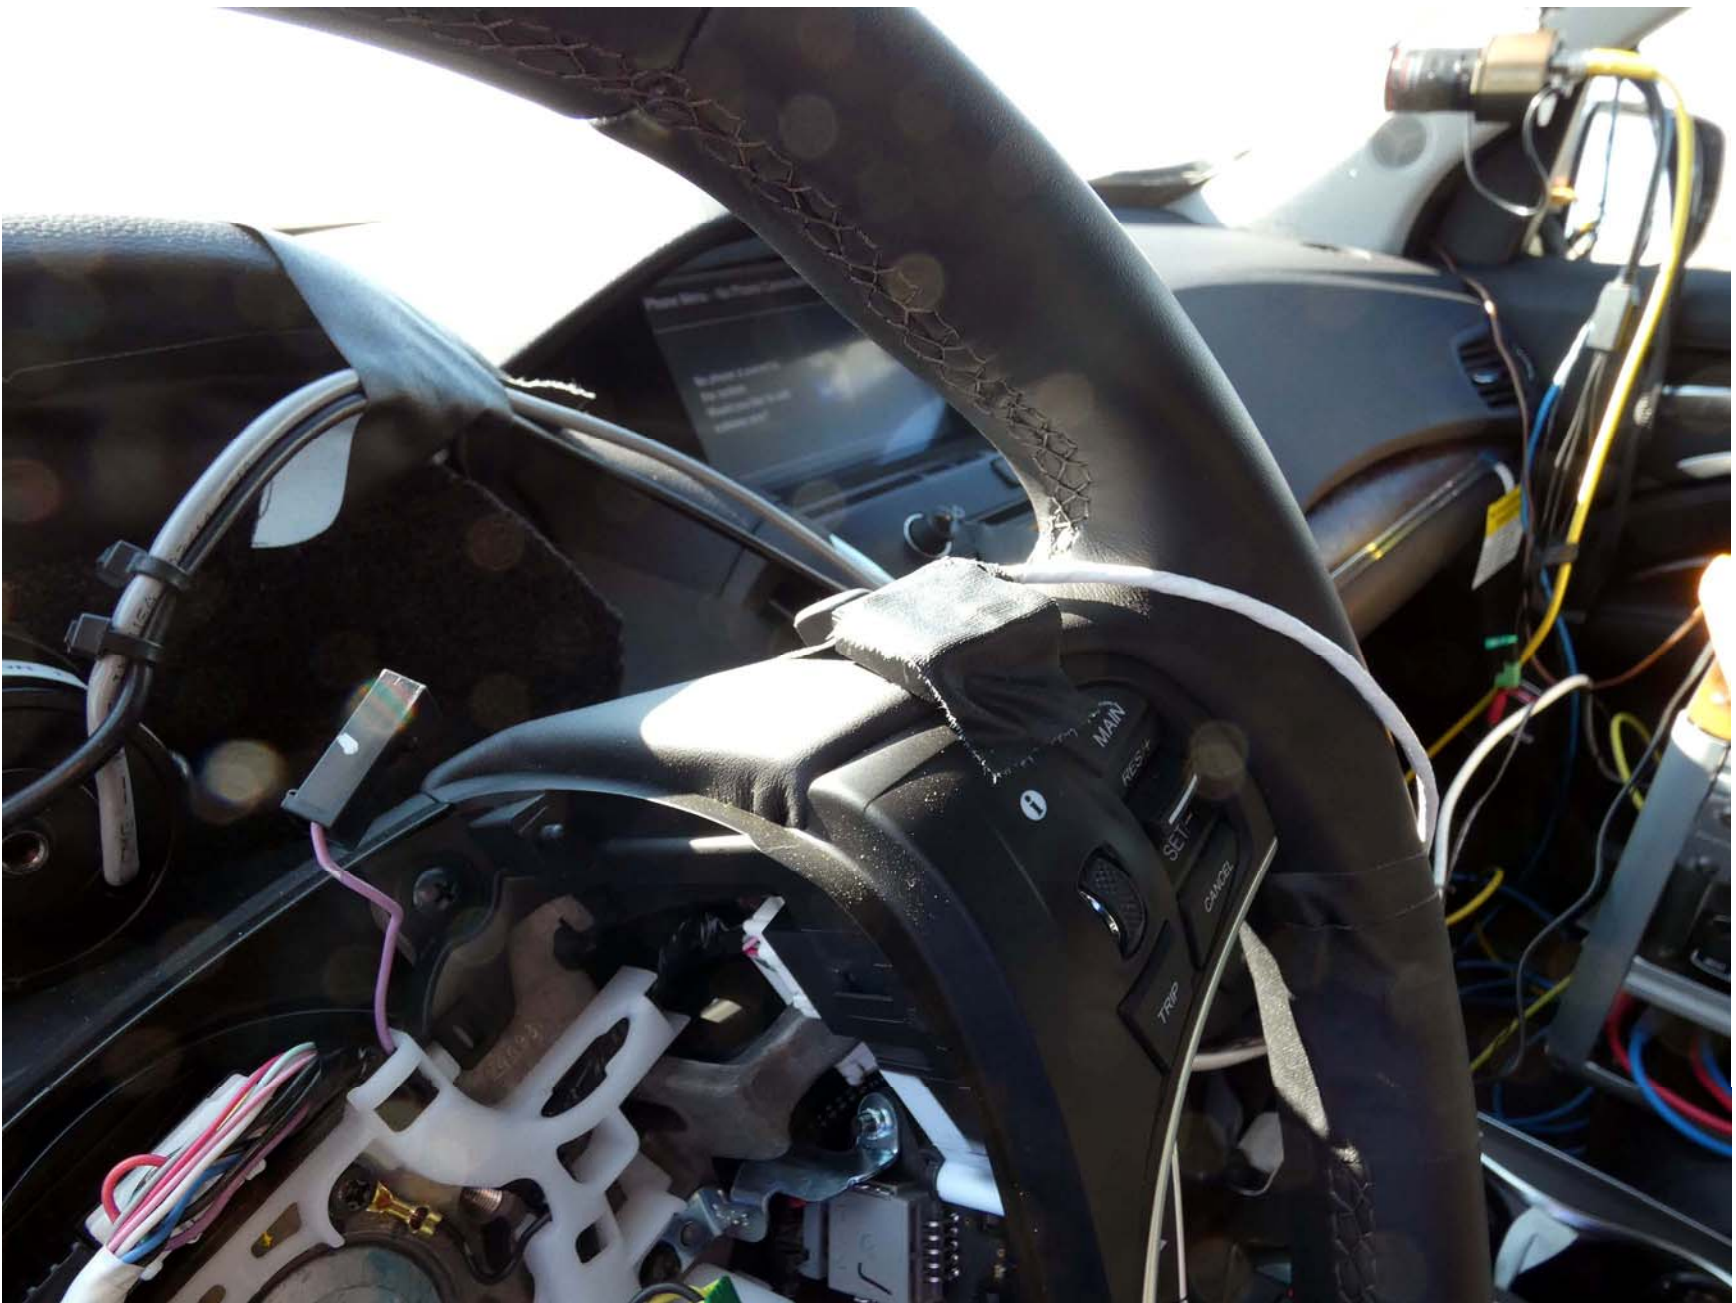
Figure A13. Sensor for Detecting Haptic Alerts

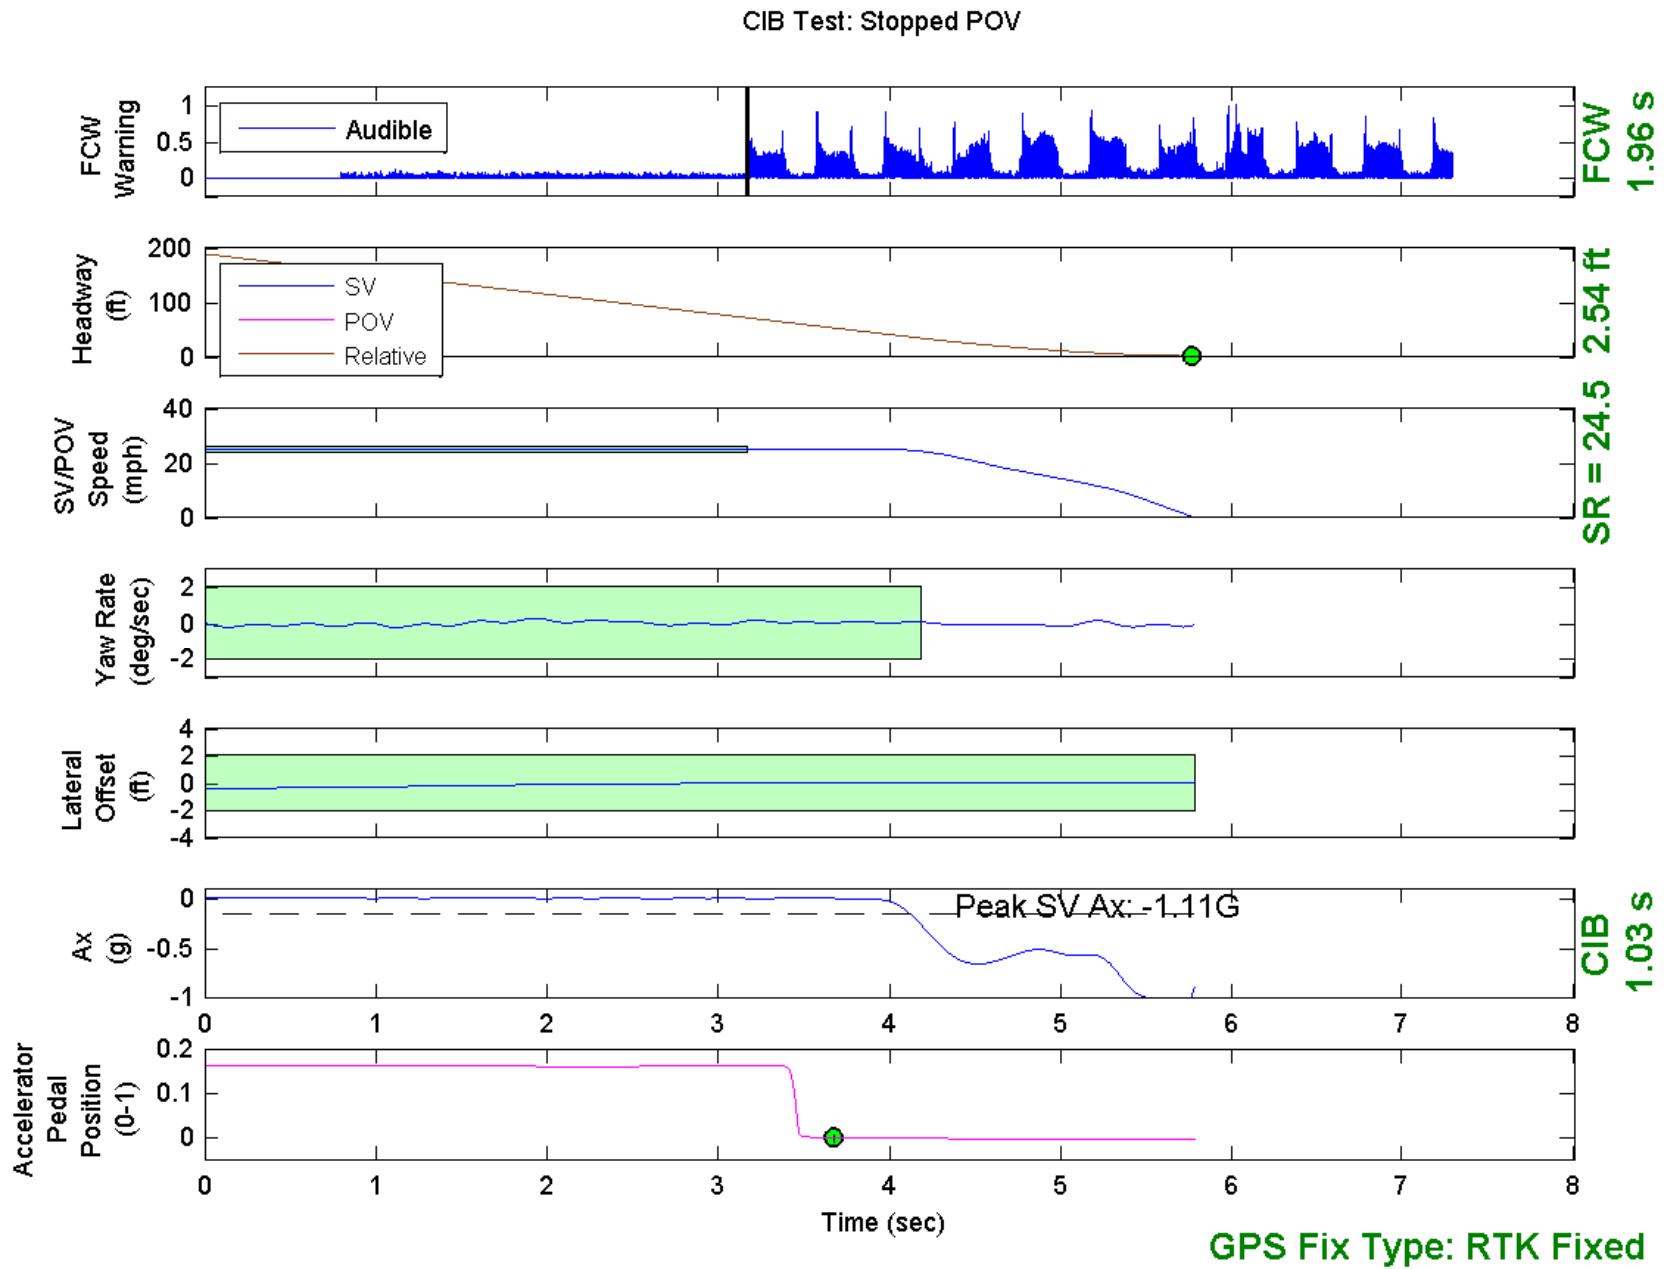
Figure D1. Example Time History for Stopped POV, Passing

Examples of time history plots for each test type (including passing, failing and invalid runs) are shown in Figure 1 through Figure 9. Figures 1 through 6 show passing runs for each of the 6 test types. Figures 7 and 8 show examples of invalid runs. Figure 9 shows an example of a valid test that failed the CIB requirements.

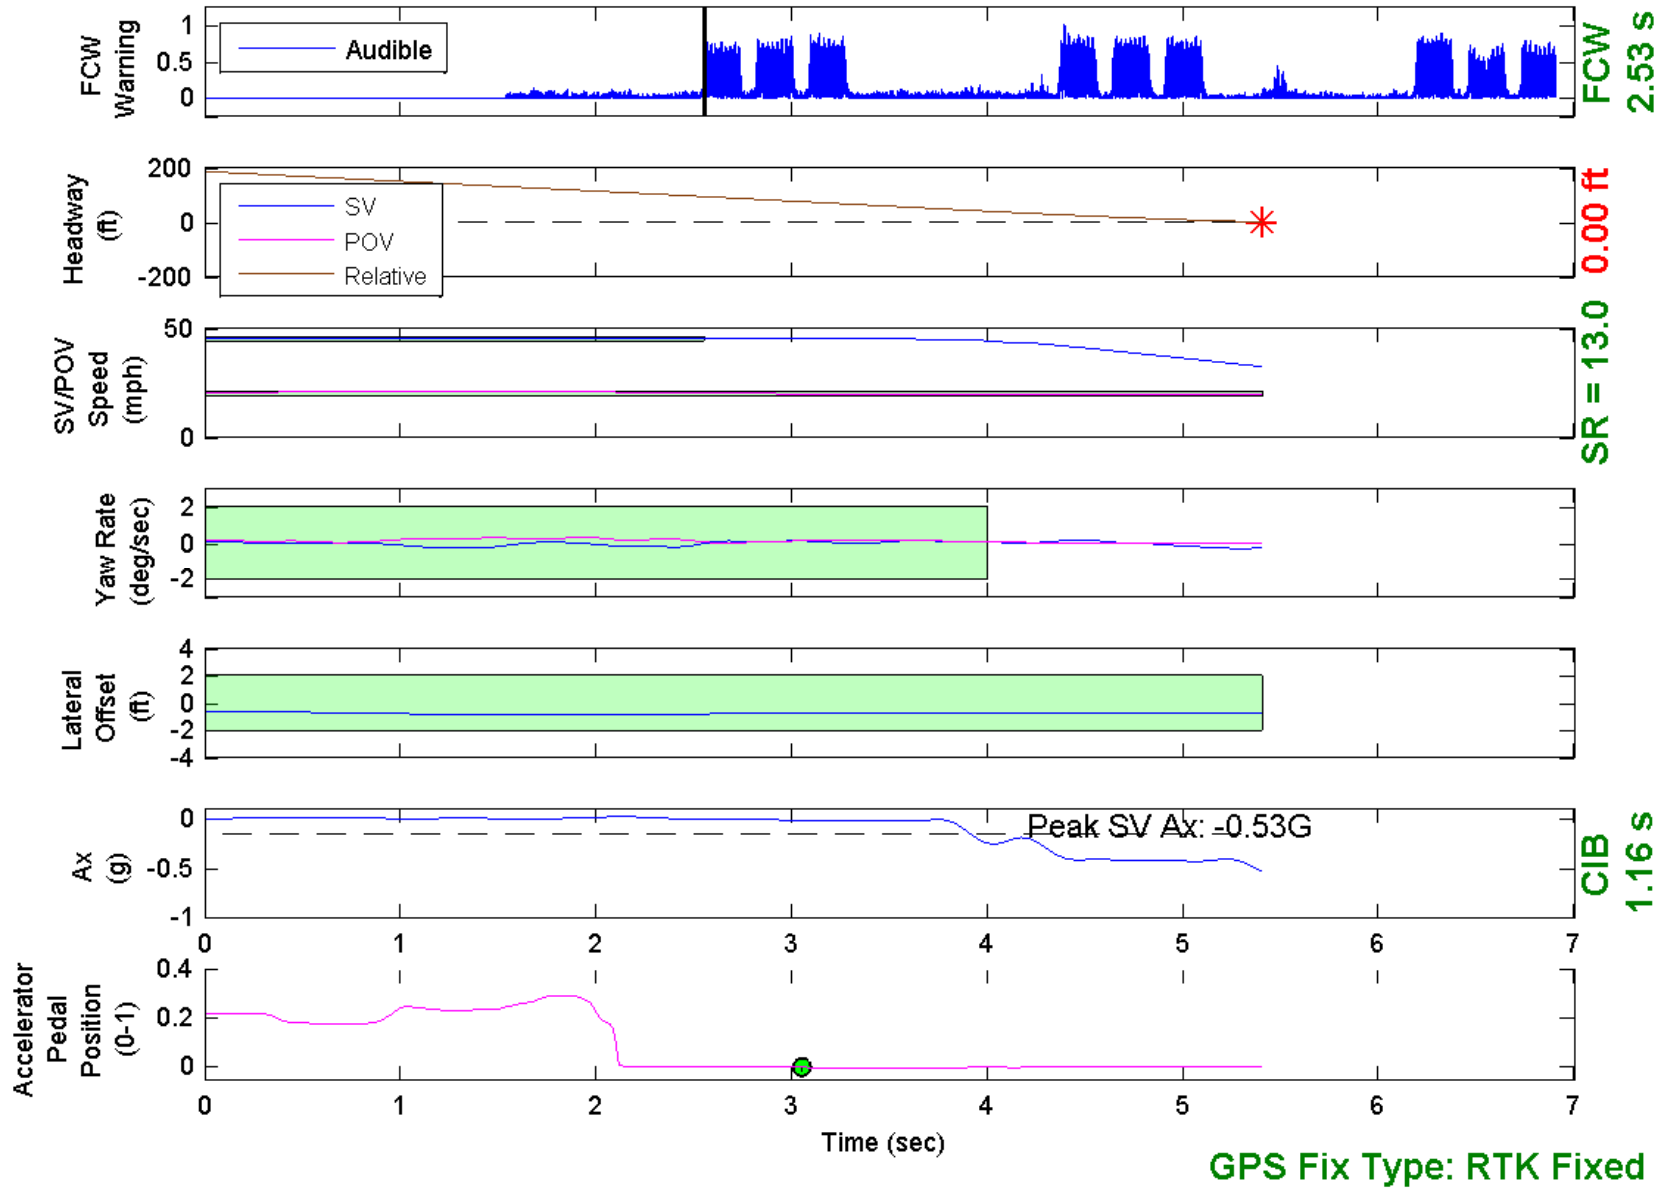
Figure D3. Example Time History for Slower POV 45 vs. 20, Passing

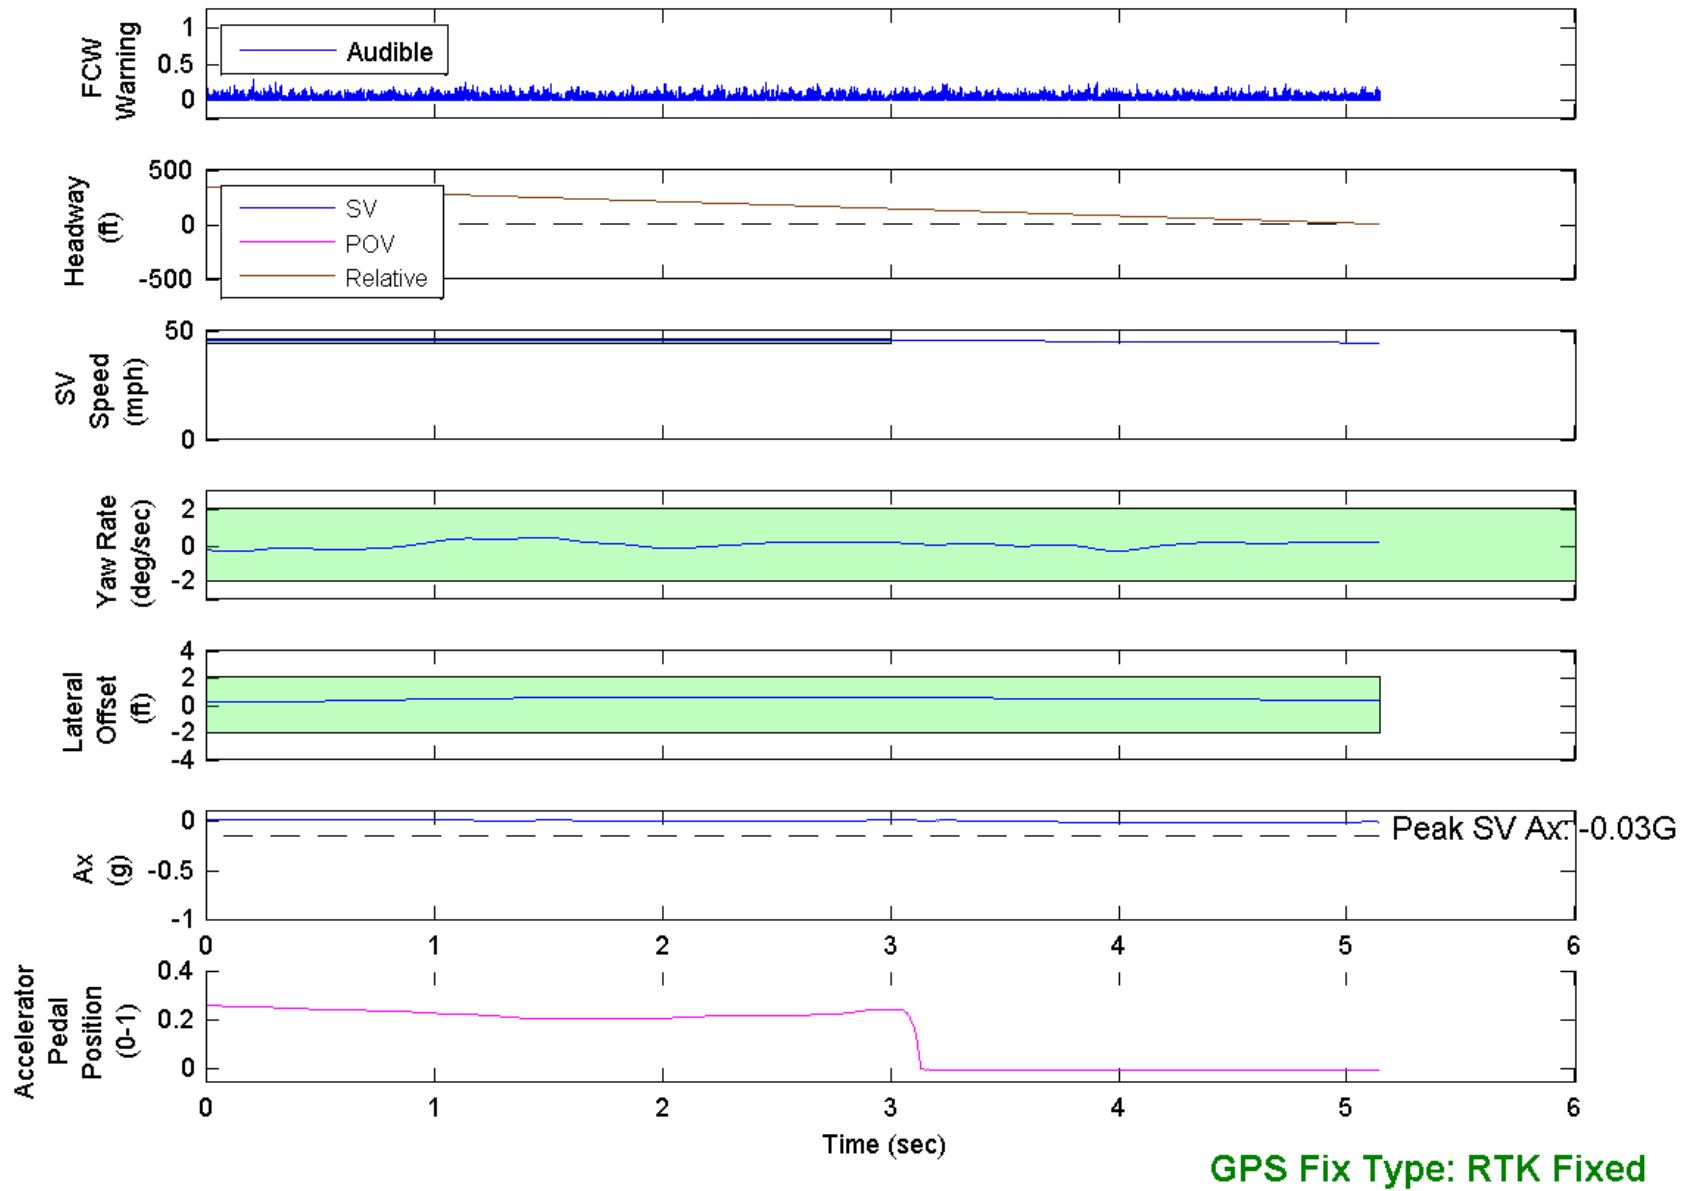
Figure D6. Example Time History for False Positive STP 45, Passing

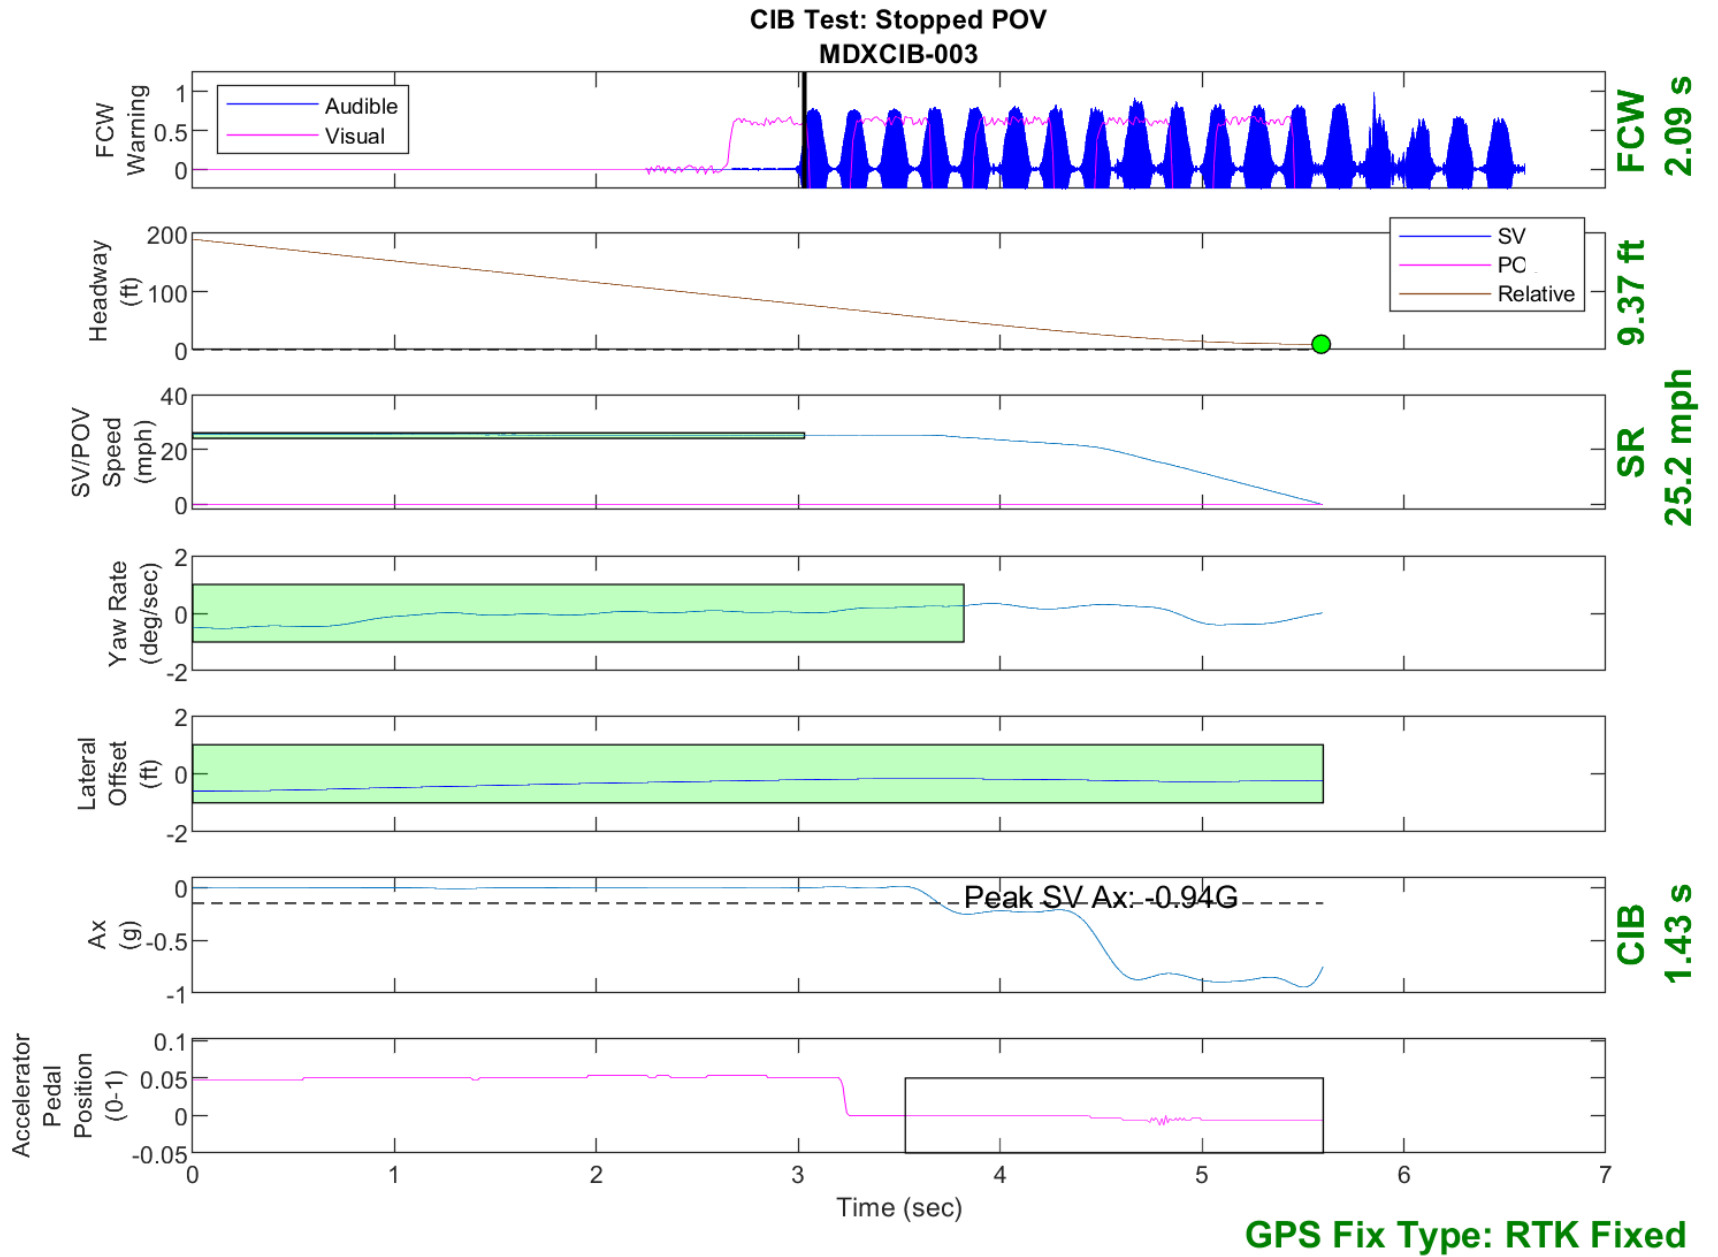
Figure D10. Time History for CIB Run 3, SV Encounters Stopped POV

Run	Test Type	Valid Run?	FCW TTC (s)	Min. Distance (ft)	Speed Reduction (mph)	Peak Decel. (g)	CIB TTC (s)	Pass/Fail	Notes
1	Static Run								
2	Stopped POV	N							Lost car to car communication
3		Y	2.09	9.37	25.2	0.94	1.43	Pass	
4		Y	1.98	10.32	25.4	0.95	1.40	Pass	
5		Y	2.12	9.13	24.8	0.95	1.44	Pass	
6		Y	1.92	9.50	24.9	0.98	1.45	Pass	
7		Y	2.08	9.90	25.3	0.97	1.43	Pass	
8		Y	2.07	9.21	24.9	0.95	1.44	Pass	
9		Y	2.03	8.75	25.7	0.92	1.45	Pass	
10	Static Run								
11	Slower POV, 25 vs 10	Y	1.90	4.88	15.6	0.91	1.27	Pass	
12		Y	1.88	4.92	14.8	0.95	1.22	Pass
