**NEW CAR ASSESSMENT PROGRAM
CRASH IMMINENT BRAKE SYSTEM CONFIRMATION TEST
NCAP-DRI-CIB-20-01**

2020 Acura MDX Tech 7P

Final Report

1. Report No. NCAP-DRI-CIB-20-01	2. Government Accession No.	3. Recipient's Catalog No.	
4. Title and Subtitle Final Report of Crash Imminent Brake System Confirmation Test of a 2020 Acura MDX Tech 7P.		5. Report Date 17 February 2020

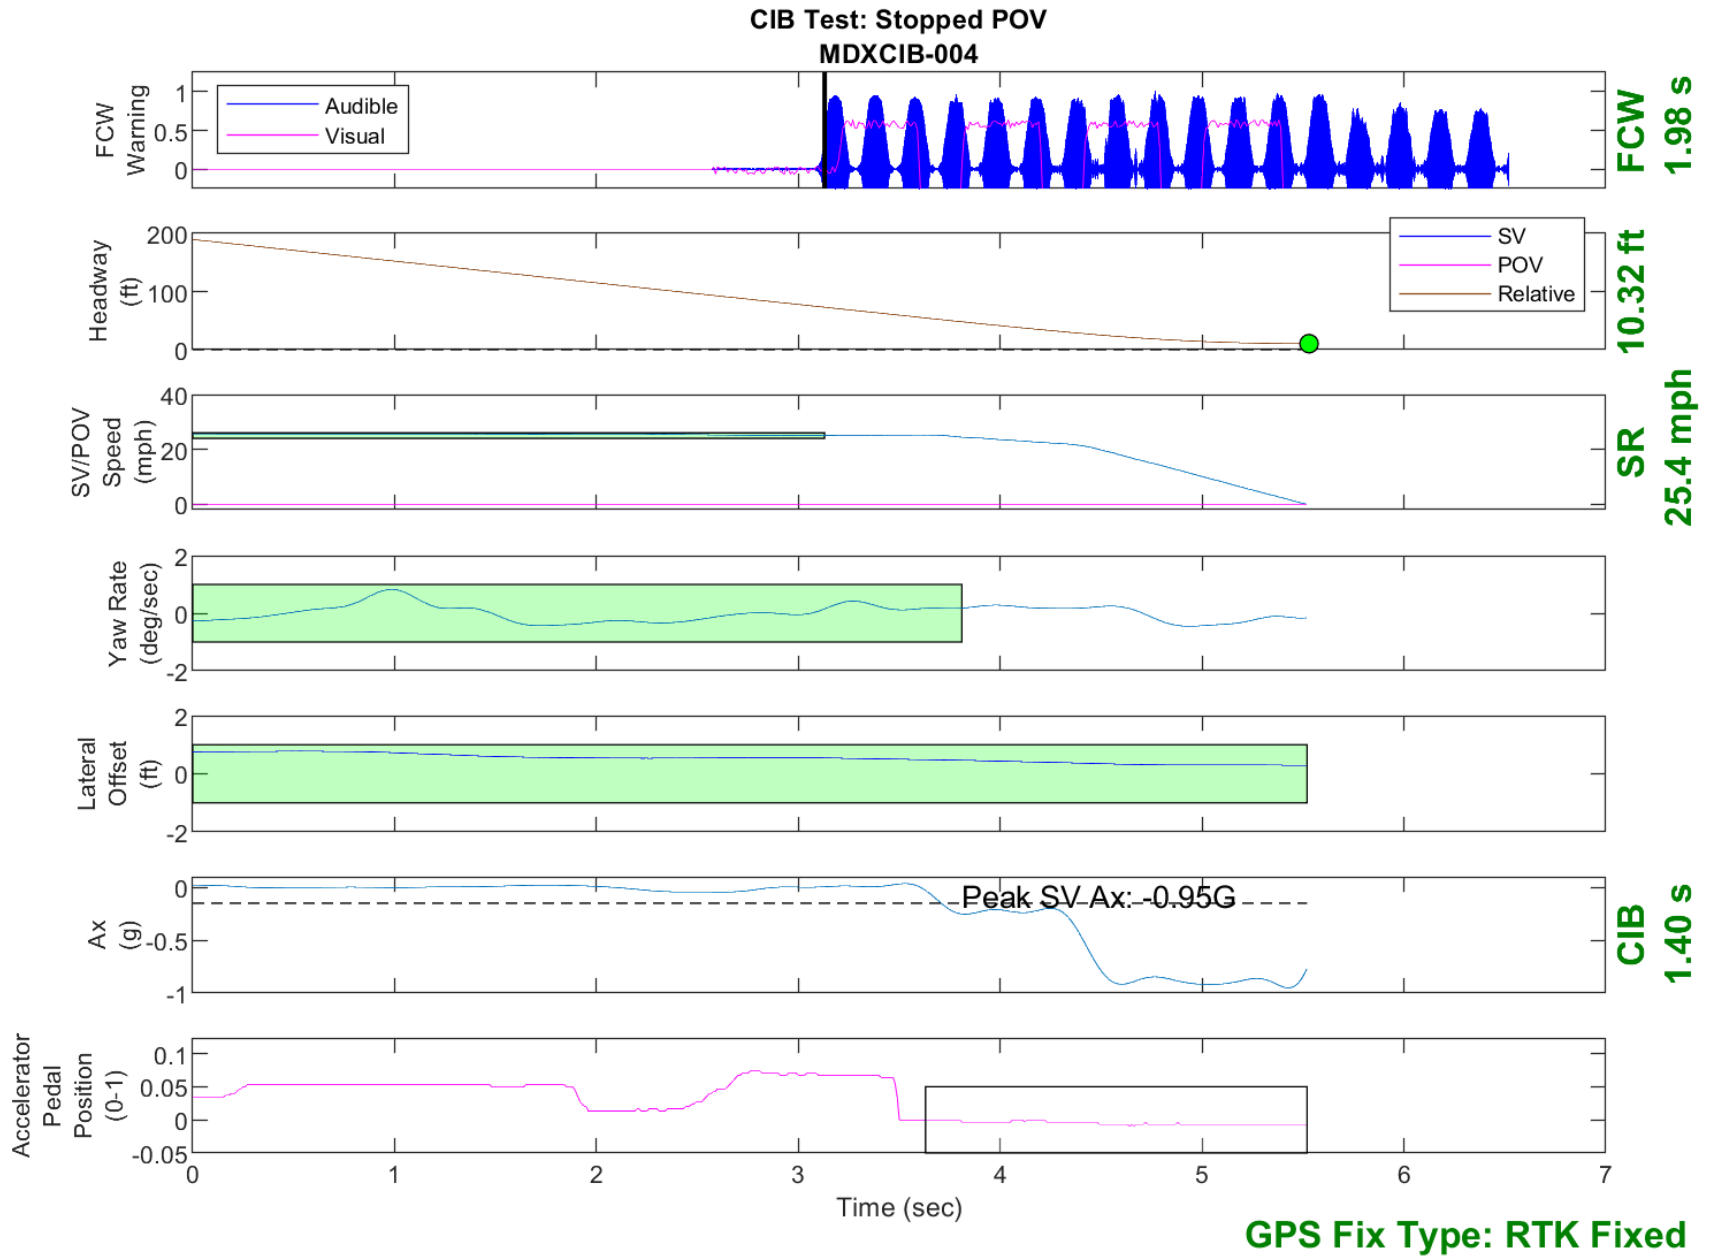
Figure D11. Time History for CIB Run 4, SV Encounters Stopped POV

Run	Test Type	Valid Run?	FCW TTC (s)	Min. Distance (ft)	Speed Reduction (mph)	Peak Decel. (g)	CIB TTC (s)	Pass/Fail	Notes
1	Static Run								
2	Stopped POV	N							Lost car to car communication
3		Y	2.09	9.37	25.2	0.94	1.43	Pass	
4		Y	1.98	10.32	25.4	0.95	1.40	Pass	
5		Y	2.12	9.13	24.8	0.95	1.44	Pass	
6		Y	1.92	9.50	24.9	0.98	1.45	Pass	
7		Y	2.08	9.90	25.3	0.97	1.43	Pass	
8		Y	2.07	9.21	24.9	0.95	1.44	Pass	
9		Y	2.03	8.75	25.7	0.92	1.45	Pass	
10	Static Run								
11	Slower POV, 25 vs 10	Y	1.90	4.88	15.6	0.91	1.27	Pass	
12		Y	1.88	4.92	14.8	0.95	1.22	Pass
