**REPORT NUMBER: SPNCAP-MGA-19-061**

**NEW CAR ASSESSMENT PROGRAM (NCAP)  
Side Impact Pole Test**

**AUDI AG  
2019 Audi A6 45 TFSI S tronic quattro 4-Door Sedan  
NHTSA No.: O20195807**

**FINAL REPORT**

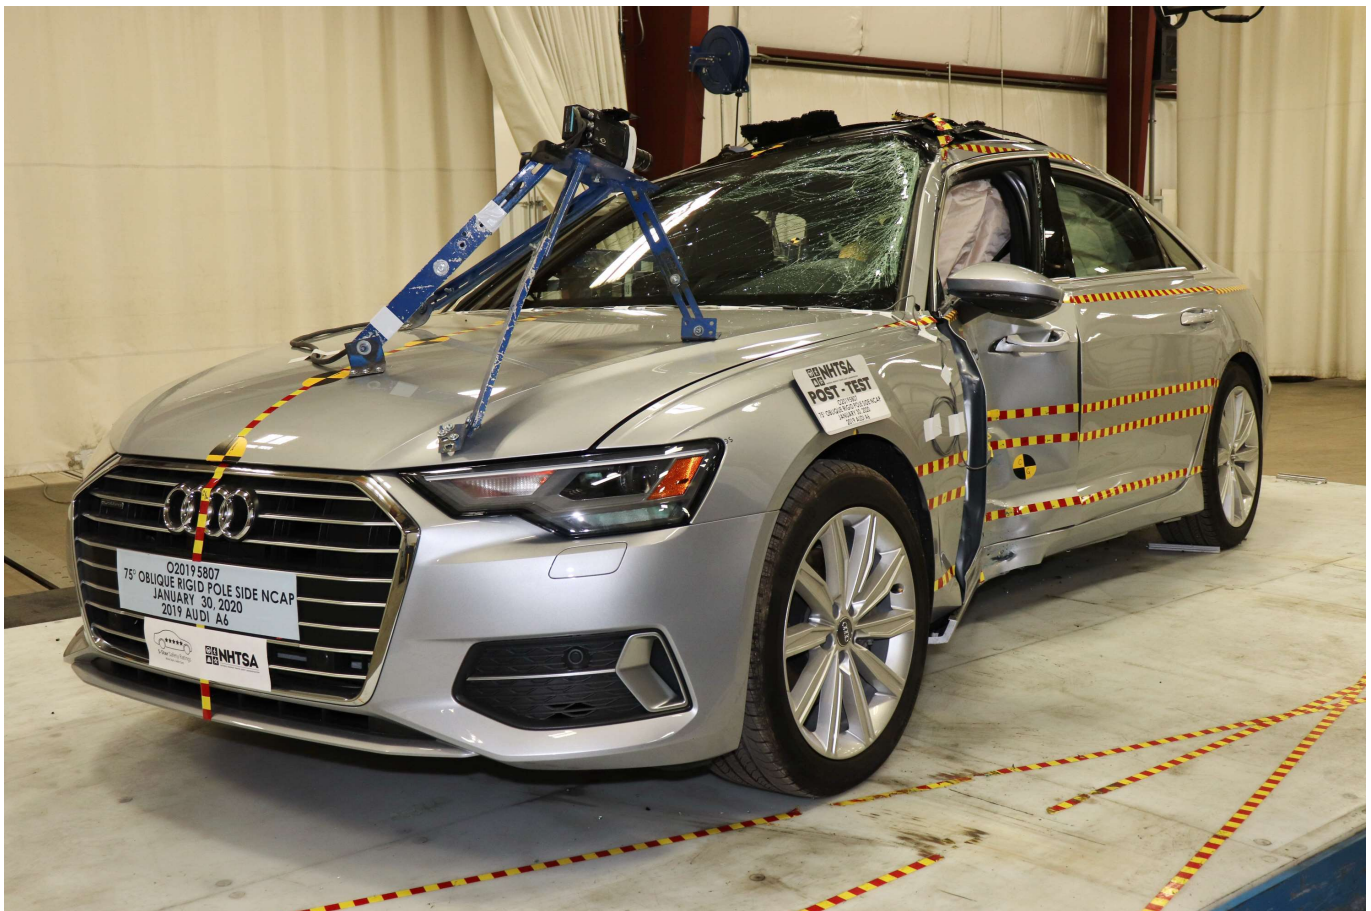
Photo No. 006 - Post-Test Left Front Three-Quarter View of Test Vehicle

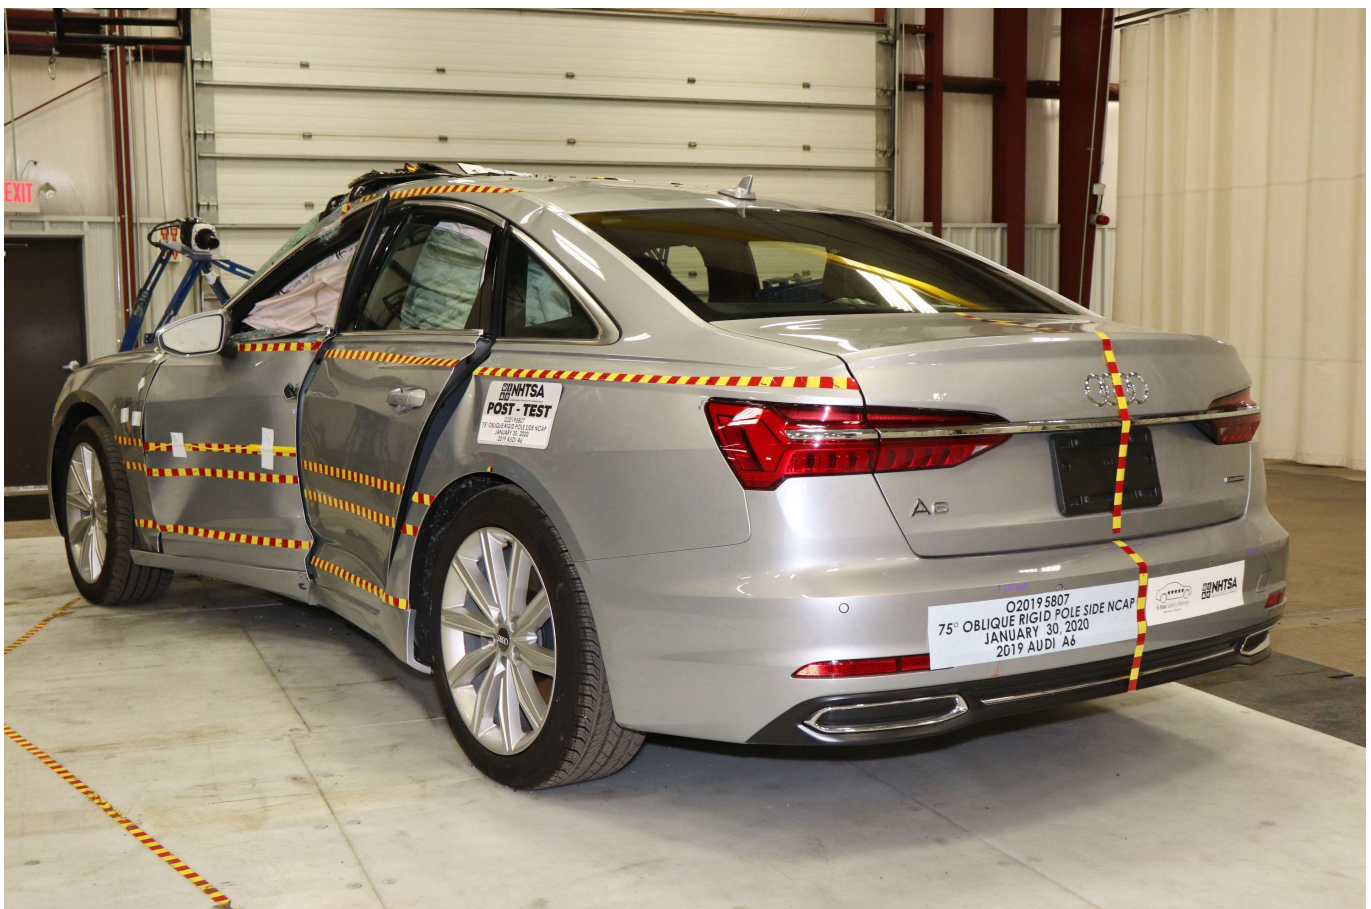
Photo No. 010 - Post-Test Left Rear Three-Quarter View of Test Vehicle

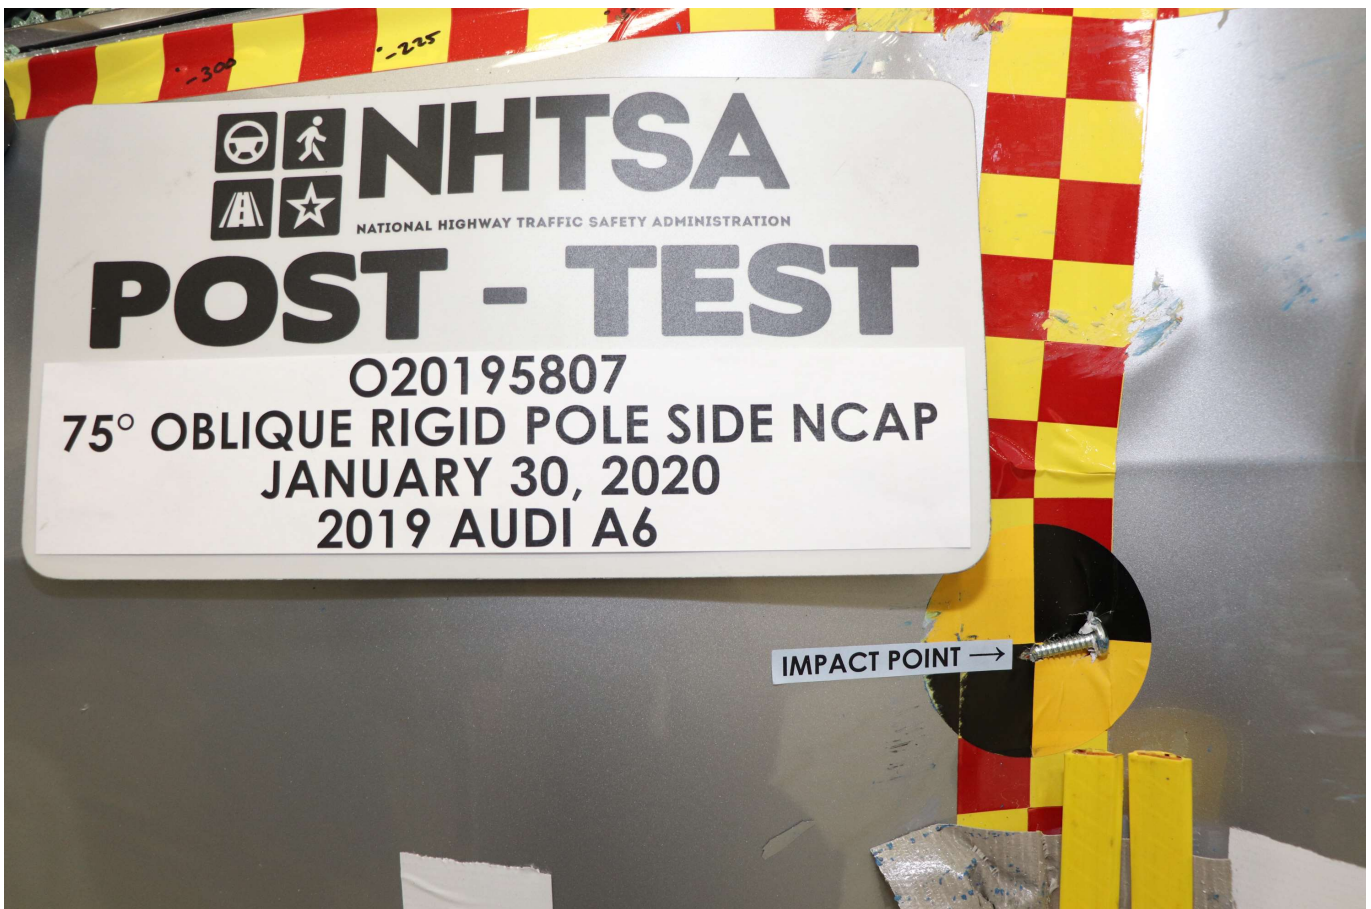
Photo No. 020 - Post-Test Close-Up View of Impact Point Target Showing Impact Location

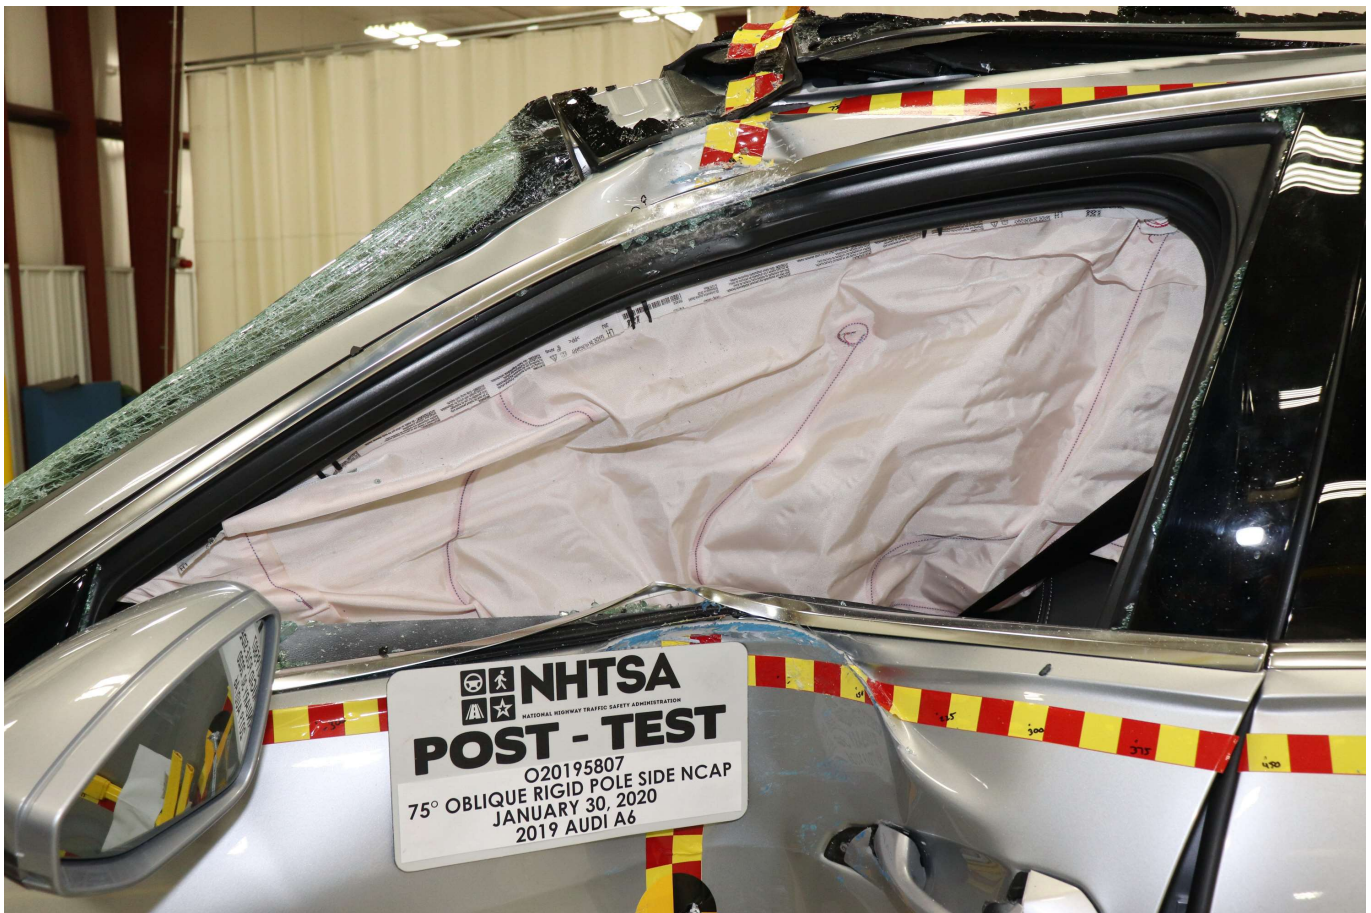
Photo No. 025 - Post-Test Left Side View of Dummy Shoulder and Door Top View

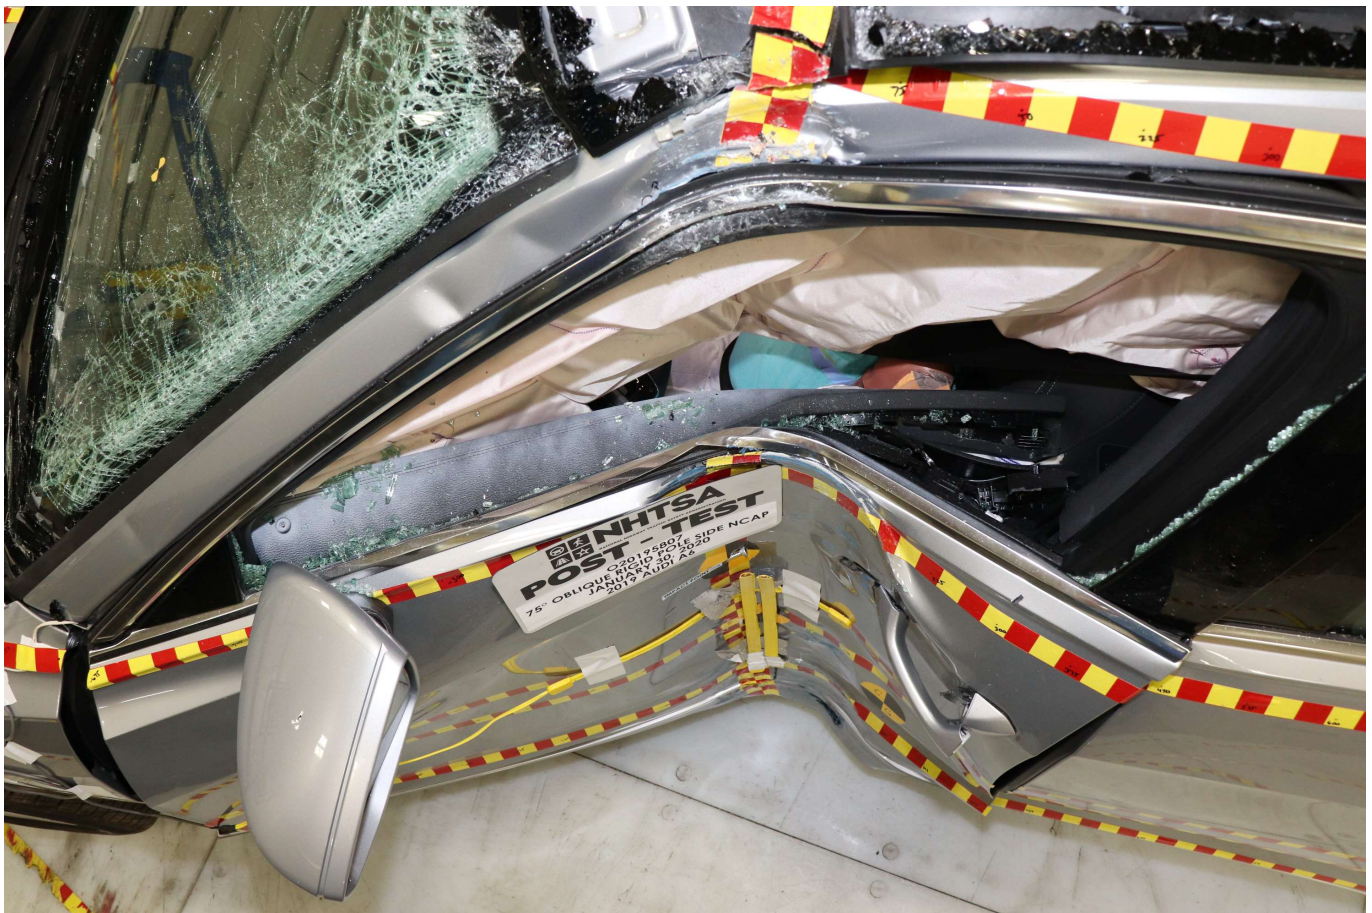
Photo No. 041 - Post-Test Dummy and Door Clearance View

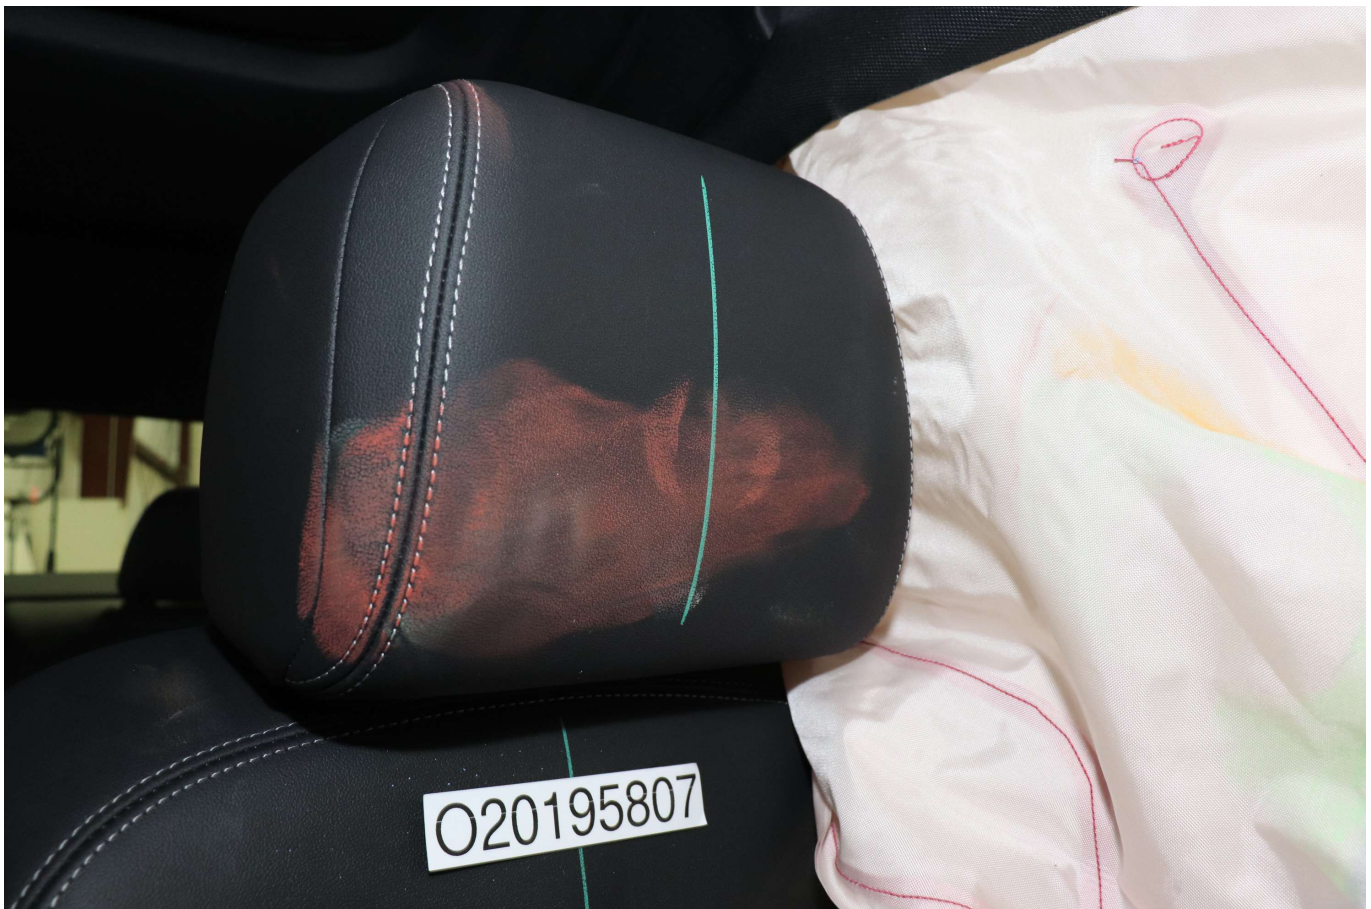
Photo No. 046 - Post-Test Dummy Close-Up Head Contact with Vehicle Interior View

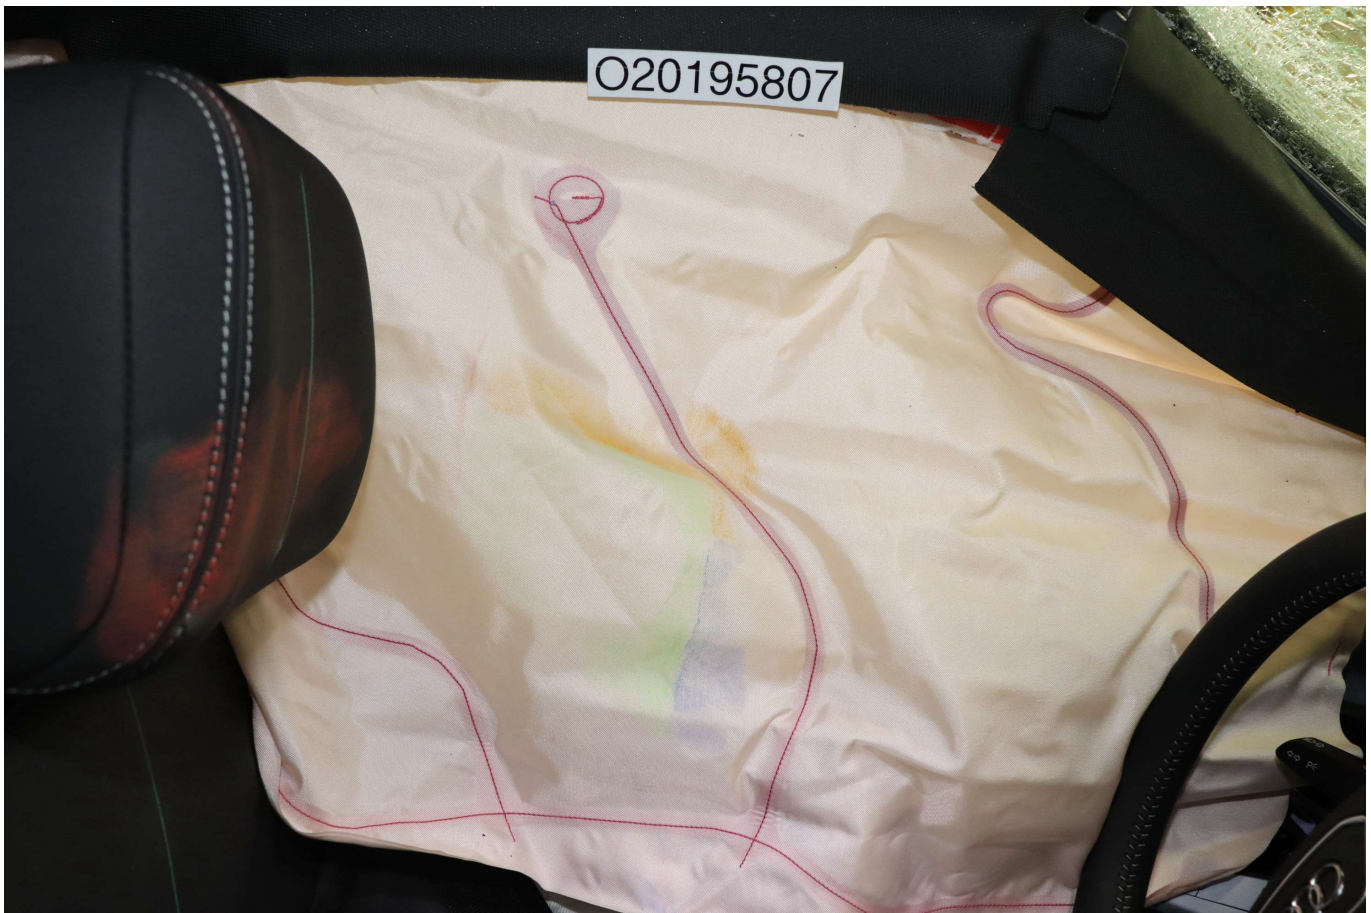
Photo No. 047 - Post-Test Dummy Close-Up Head Contact with Side Air Bag View

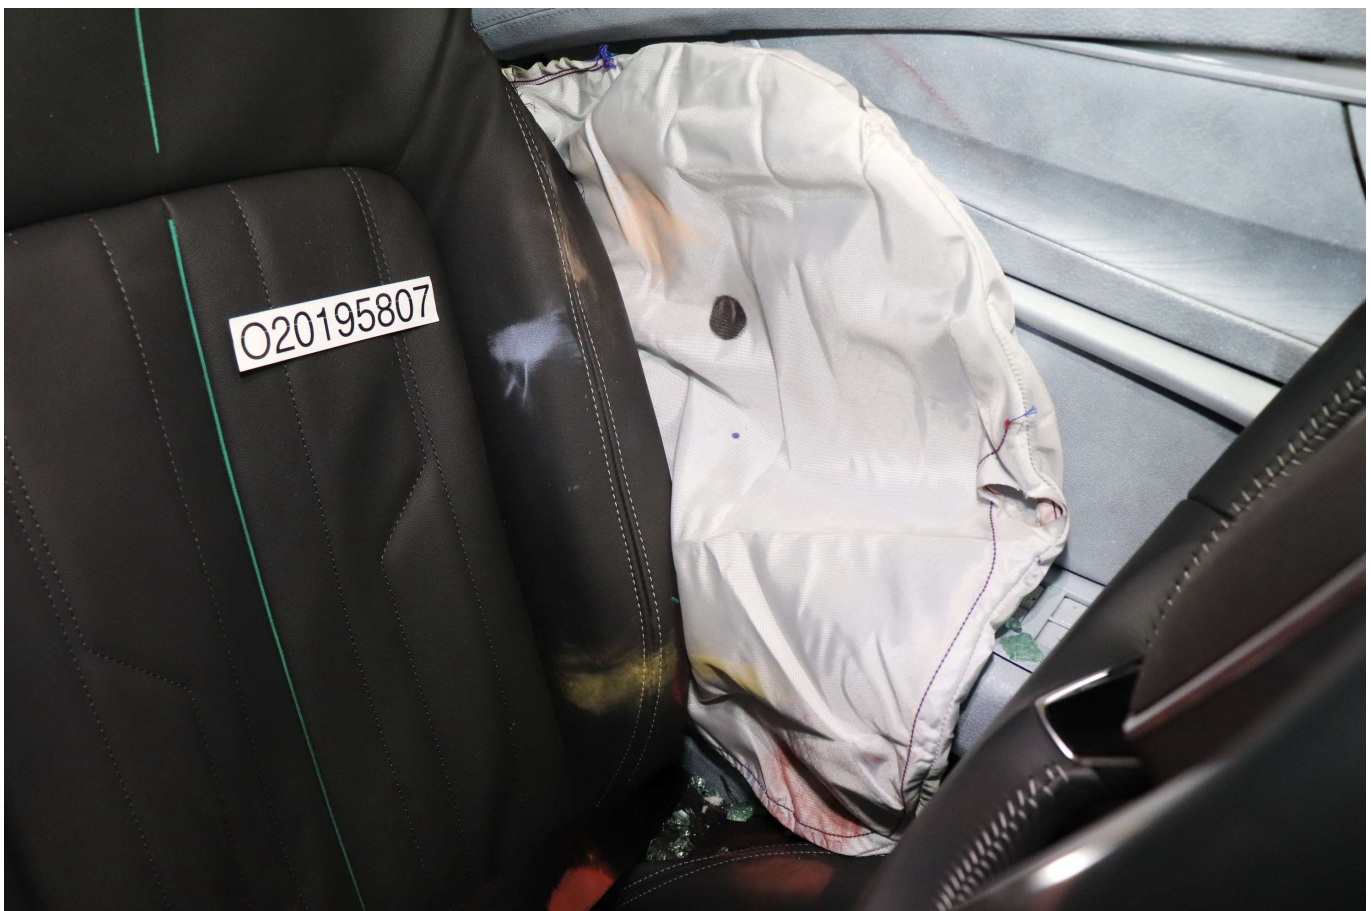
Photo No. 048 - Post-Test Dummy Close-Up Torso Contact with Vehicle Interior View

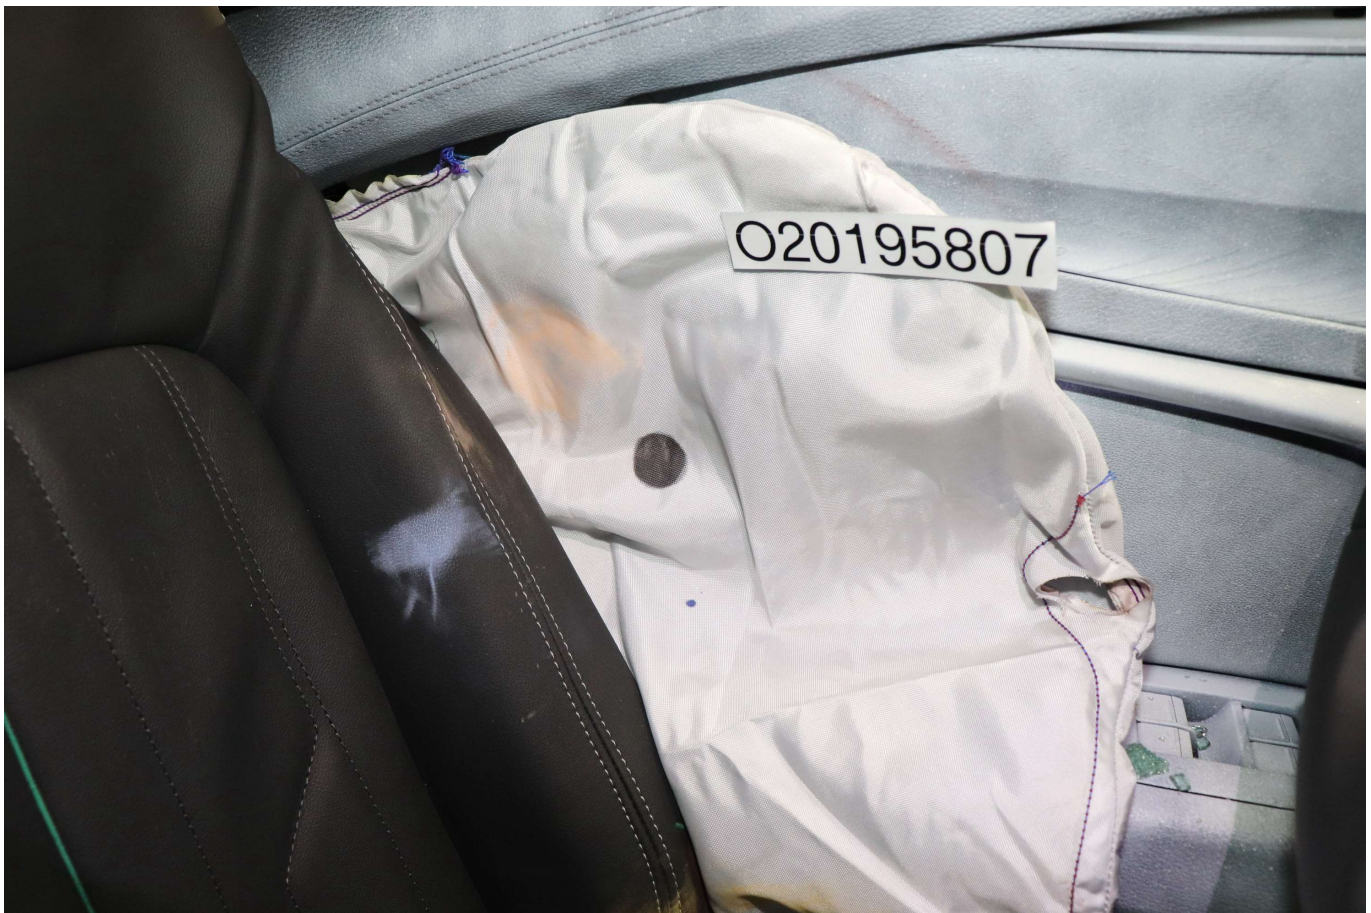
Photo No. 049 - Post-Test Dummy Close-Up Torso Contact with Side Air Bag View

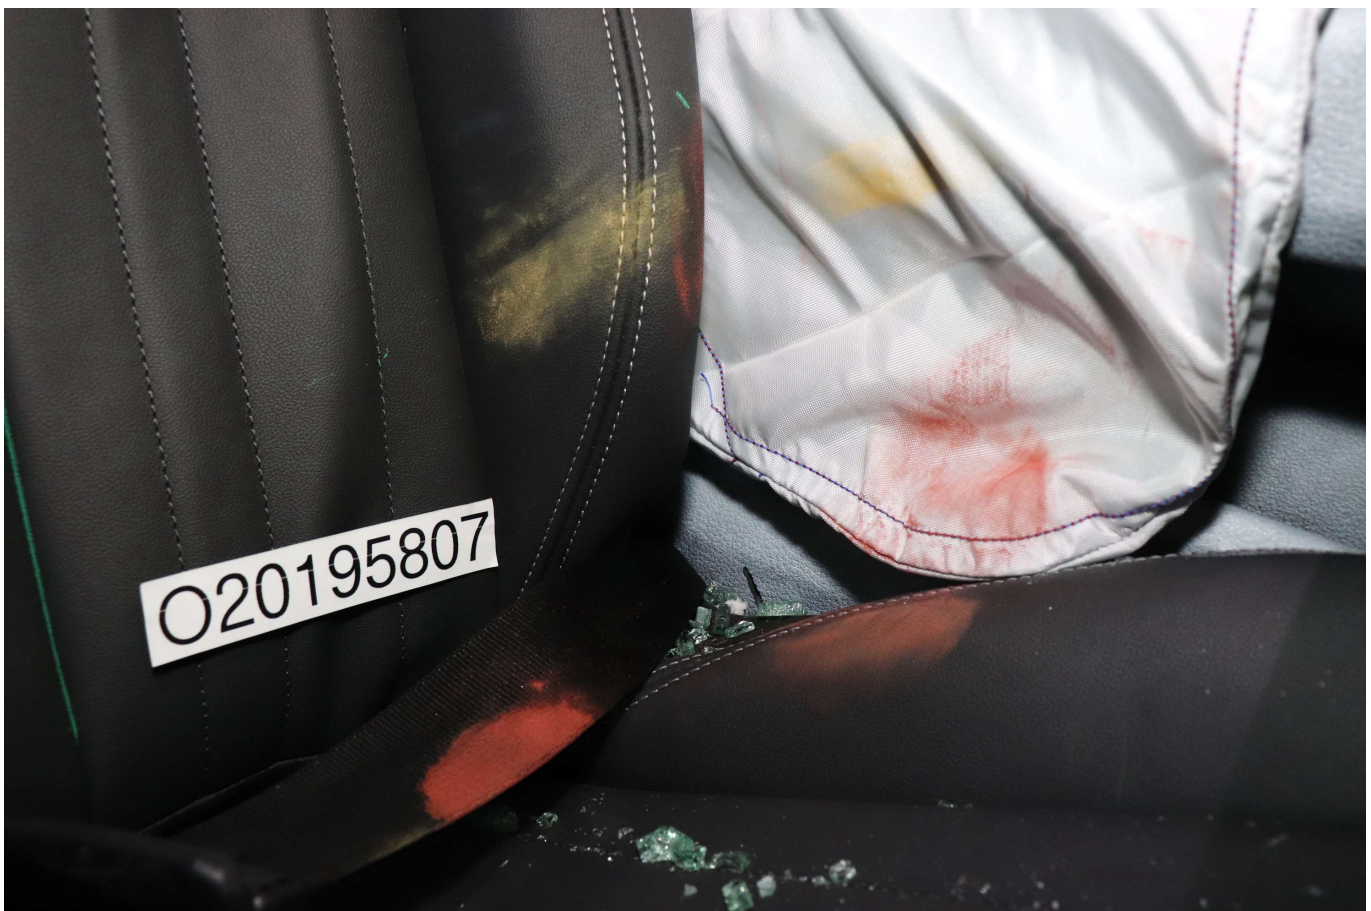
Photo No. 050 - Post-Test Dummy Close-Up Pelvis Contact with Vehicle Interior View

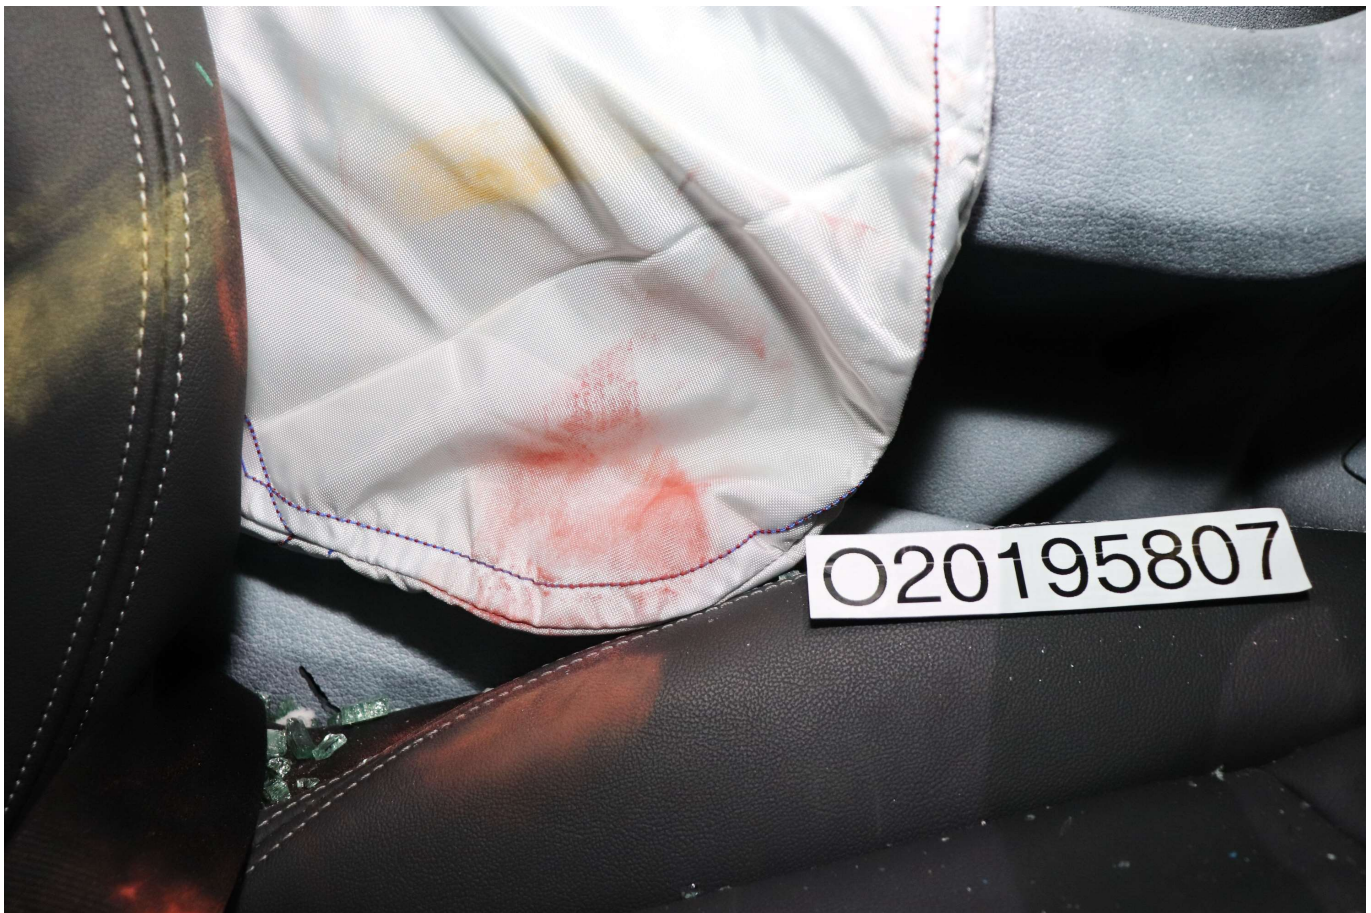
Photo No. 051 - Post-Test Dummy Close-Up Pelvis Contact with Side Air Bag View

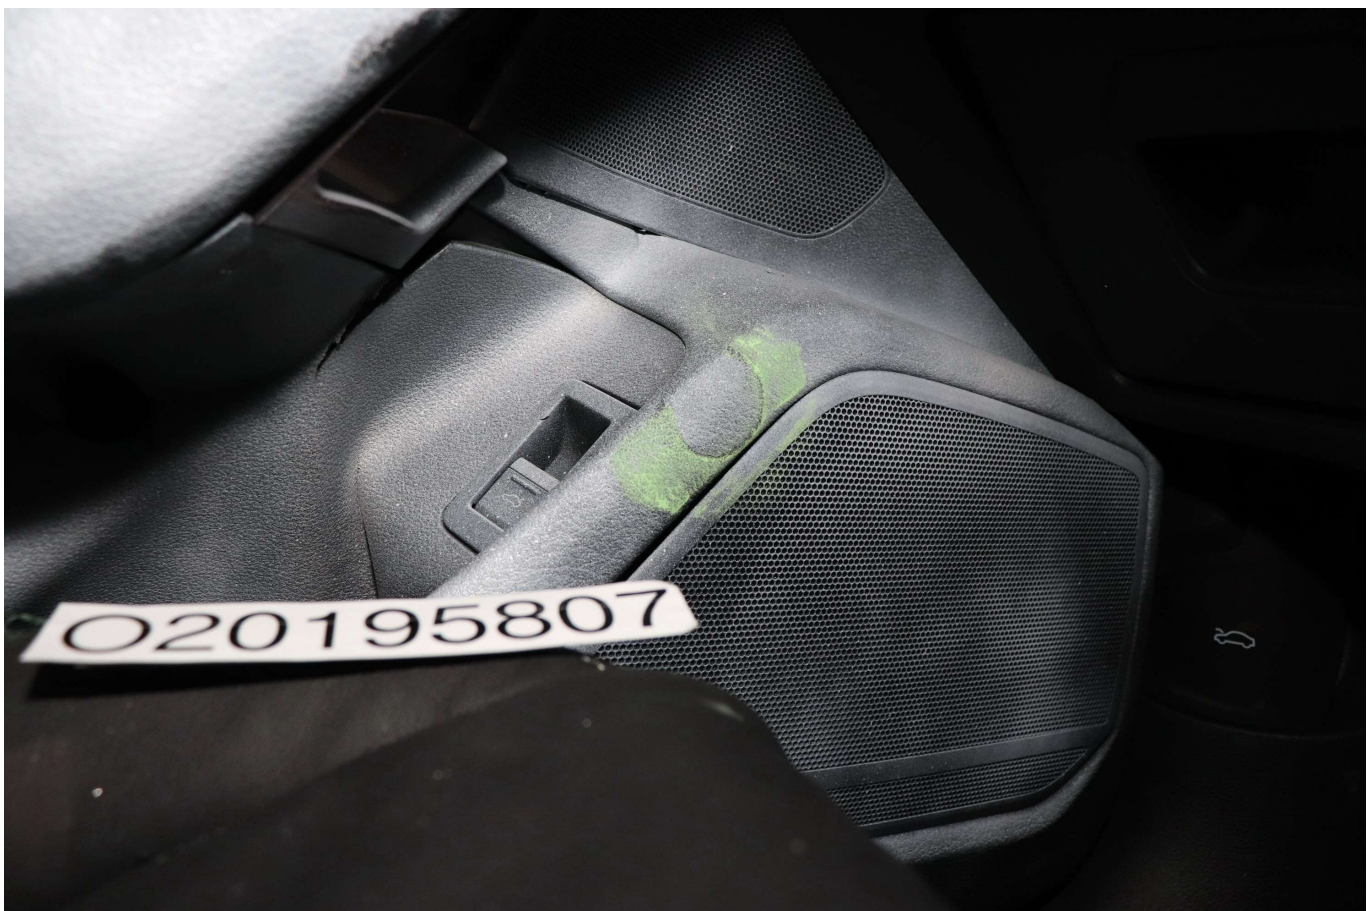
Photo No. 052 - Post-Test Dummy Close-Up Knee Contact with Vehicle Interior View

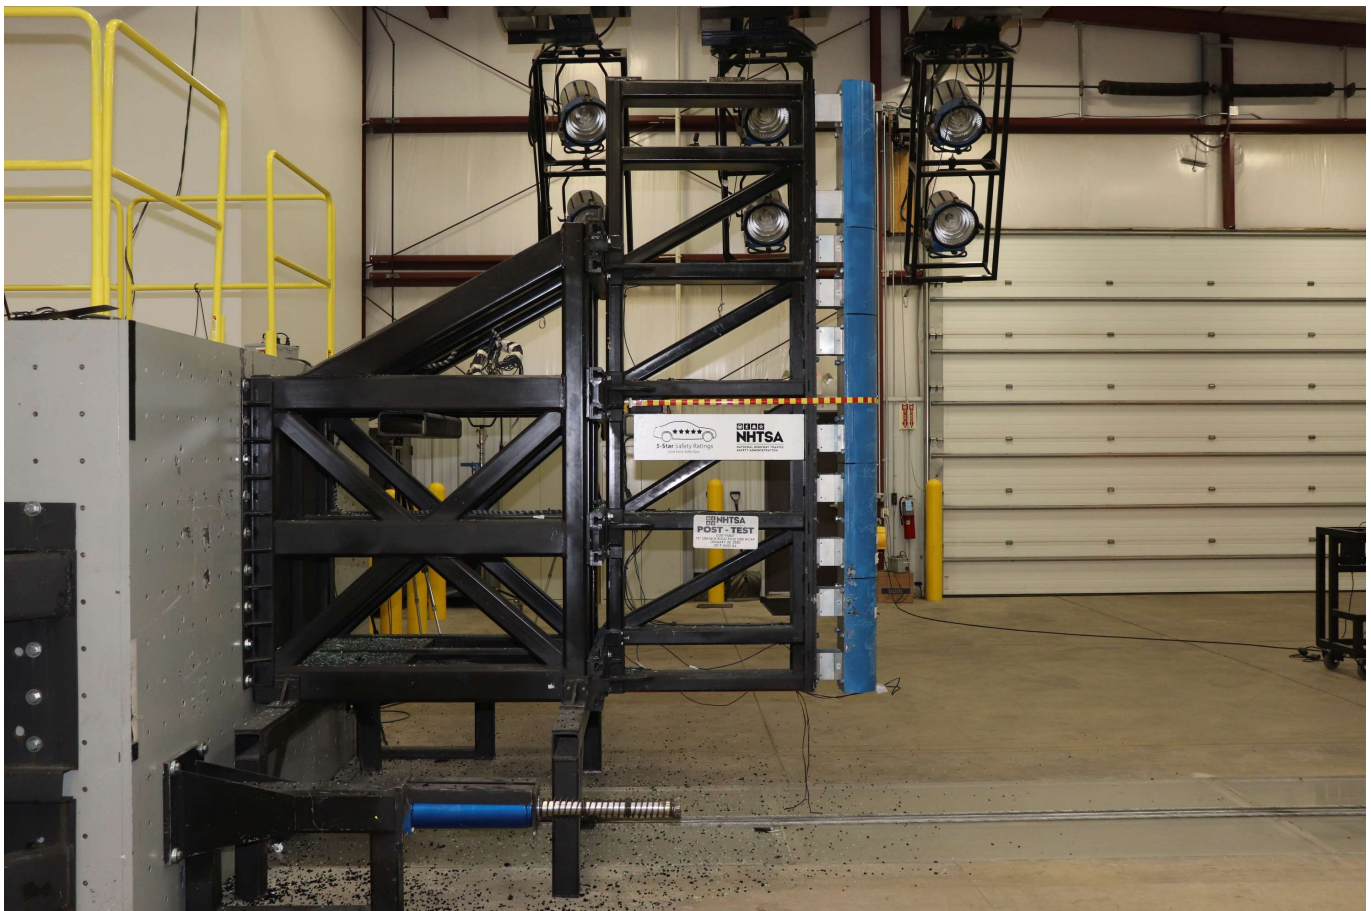
Photo No. 060 - Post-Test Pole Barrier Side View

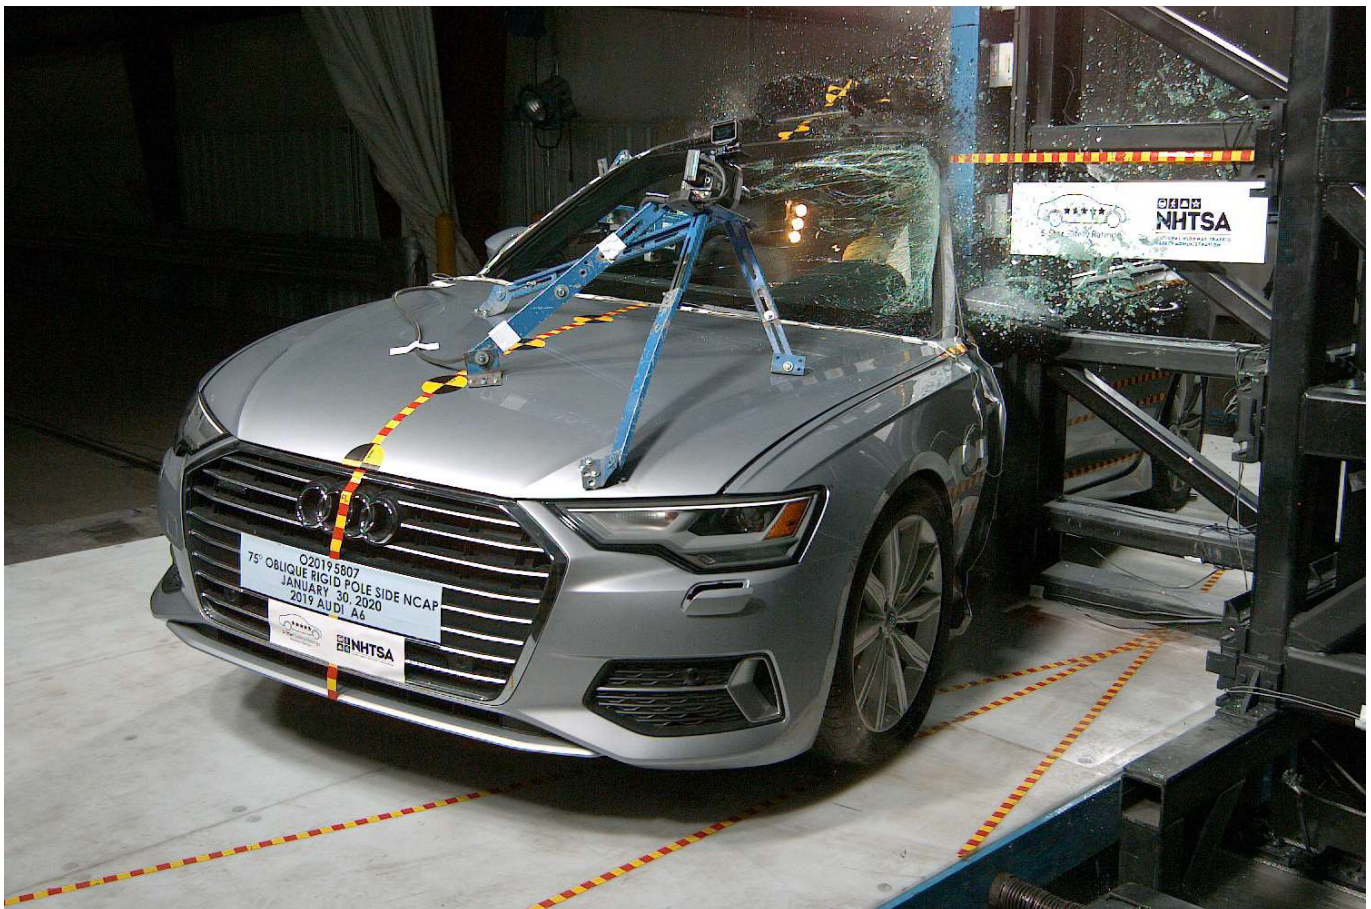
Photo No. 068 - Impact Event

A rigid pole side impact test was conducted on a 2019 Audi A6 45 TFSI S tronic quattro 4-Door Sedan. The subject vehicle was towed into the rigid pole at an angle of 75° and a velocity of 32.46 km/h. The test was conducted by MGA Research Corporation in Burlington, Wisconsin on January 30, 2020. Pre-test and post-test photographs of the test vehicle and side impact dummy (SID-IIs) are included in Appendix A of this report.

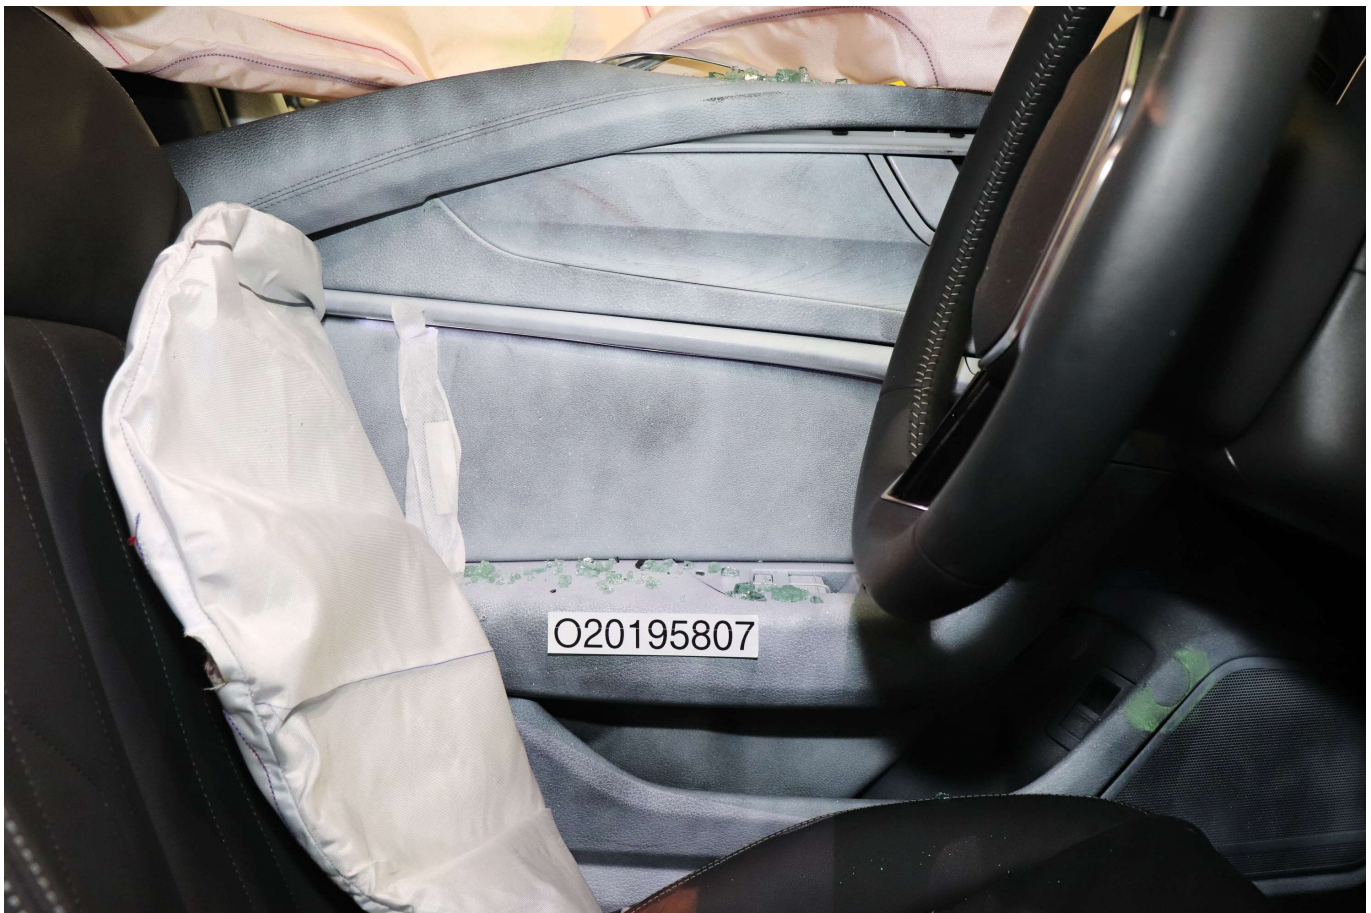
Photo No. 071 - Post-Test View of Shattered Vehicle Inner Door Panel
