Final Report Number: NCAP-TRC-20-004

**New Car Assessment Program (NCAP)
Frontal Barrier Impact Test**

**HYUNDAI MOTOR COMPANY
2020 Hyundai Venue 5-Door Hatchback
NHTSA Number: M20204209**

**PREPARED BY:
Transportation Research Center Inc.
10820 State Route 347
P. O. Box B-67
East Liberty, OH 43319**

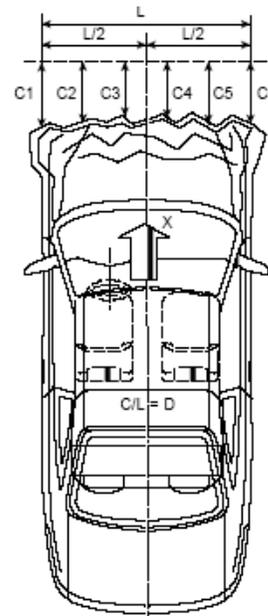
CRUSH PROFILE

Collision Deformation Classification: 12FDEW2
 Midpoint of Damage: Centerline
 Damage Region Length (mm): 1524
 Impact Mode: Frontal

No.	Measurement Description	Units	Pre-Test	Post-Test	Difference
C1	Crush zone 1 at left side	mm	3855	3496	359
C2	Crush zone 2 at left side	mm	3995	3501	494
C3	Crush zone 3 at left side	mm	4015	3513	502
C4	Crush zone 4 at right side	mm	4015	3515	500
C5	Crush zone 5 at right side	mm	3995	3510	485
C6	Crush zone 6 at right side	mm	3855	3509	346
L	C1 to C6	mm	1524	1155	369

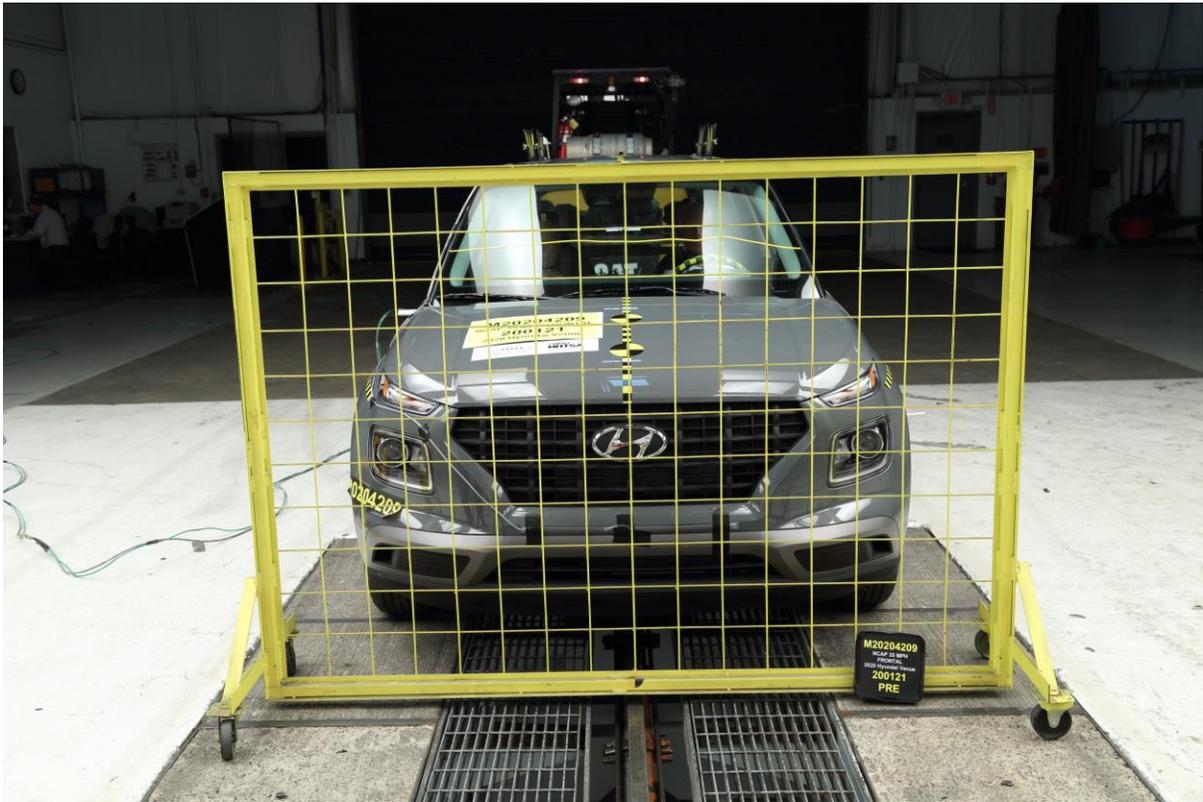
001 Load Cell Location

A load cell barrier consisting of 288 load cells was impacted by a 2020 Hyundai Venue 5-Door Hatchback at a velocity of 56.37 km/h. The test was performed at Transportation Research Center, Inc. on January 21, 2020. Pre- and post-test photographs of the vehicle and dummies can be found in Appendix A.

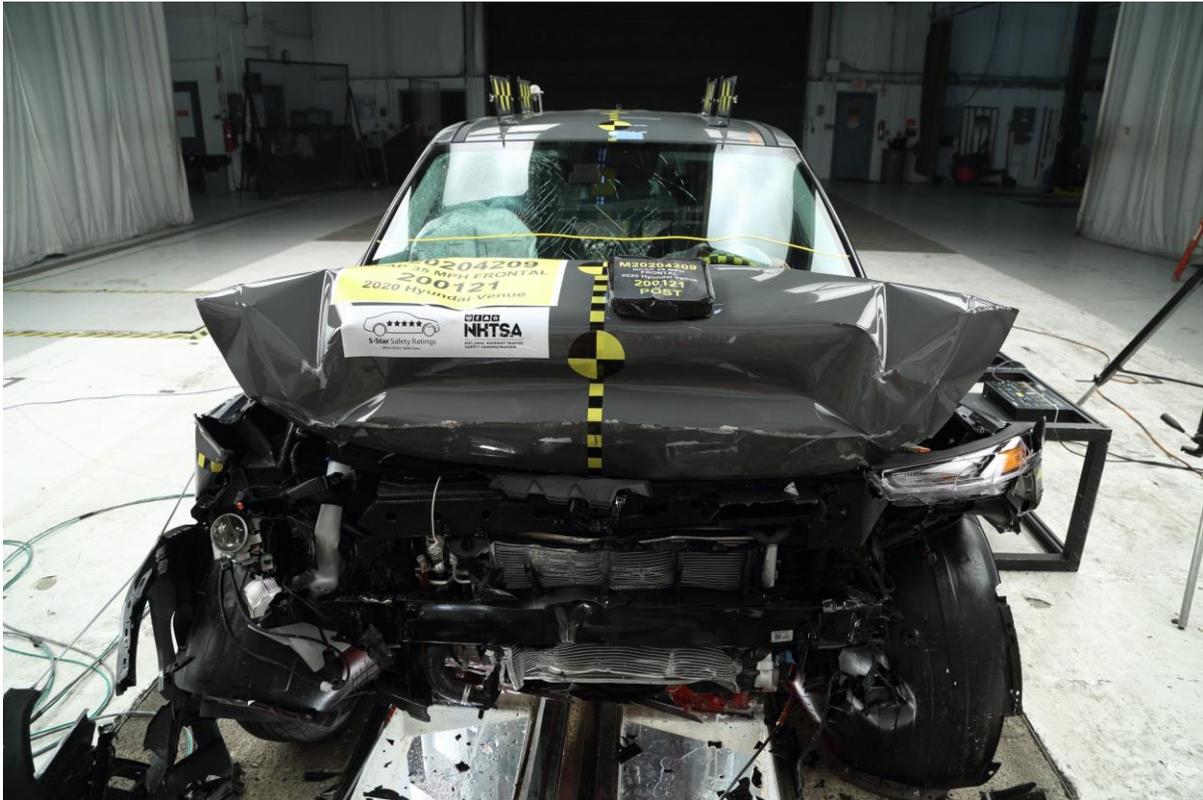
009 Post-Test Front View of Test Vehicle

The maximum static crush of the vehicle was 502 mm and both the driver and passenger side doors remained closed during the impact event and were operable after the impact.

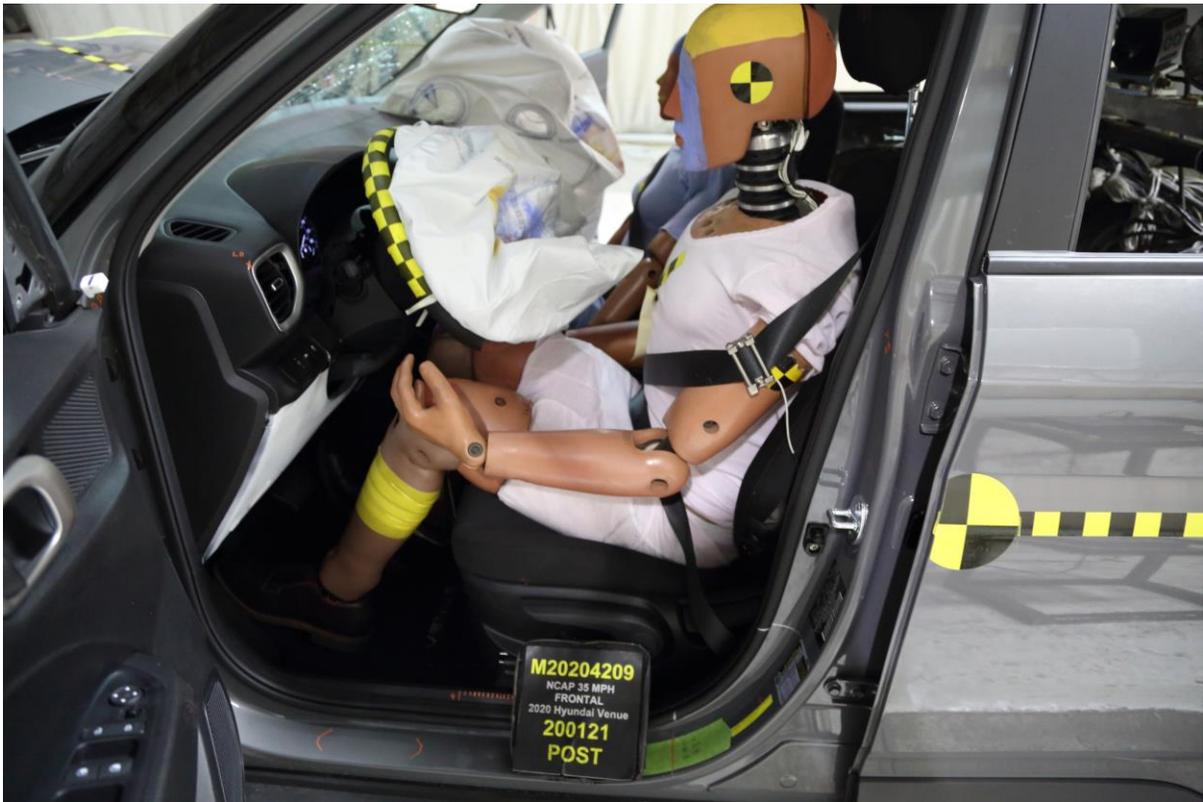
035 Post-Test Driver Dummy and Vehicle Interior View

The driver's visible contact points were as follows: front airbag, headrest and knee bolster. The passenger's visible contact points were as follows: front airbag, headrest and glove box.

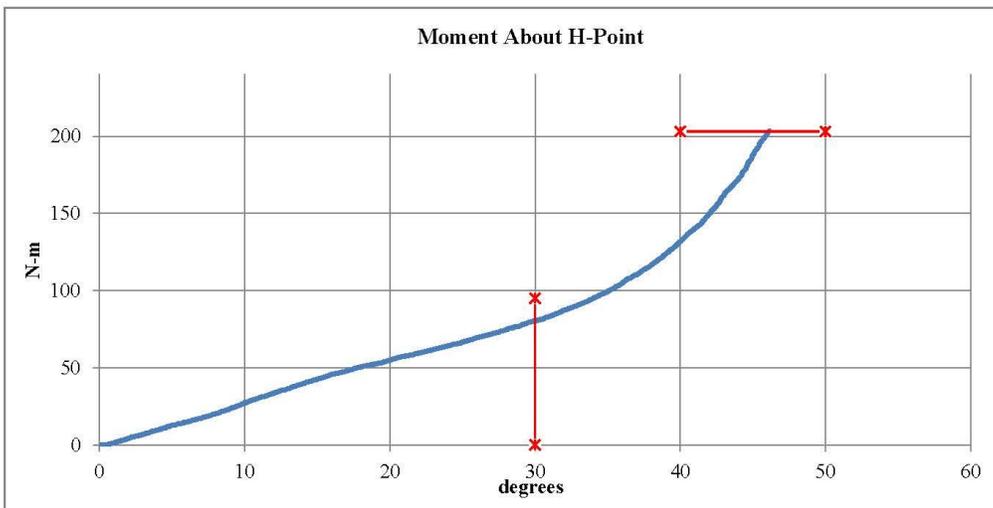
Serial Number: 037 Date: 13-Dec-2019
Side Tested: Left Hip Time: 10:43
Test Number: 1

TEST PARAMETER	SPECIFICATION	TEST RESULTS
Temperature	18.9 - 25.6	21.3 °C Pass
Humidity	10 - 70	39 % Pass
Moment at 30°	0 ≤ 94.9	80.33 N-m Pass
Angle at 203 Nm	40 - 50	46.13 deg Pass
Average Velocity	5 - 10	7.02 deg/sec Pass

Max: 8.29 deg/sec Min: 5.55 deg/sec

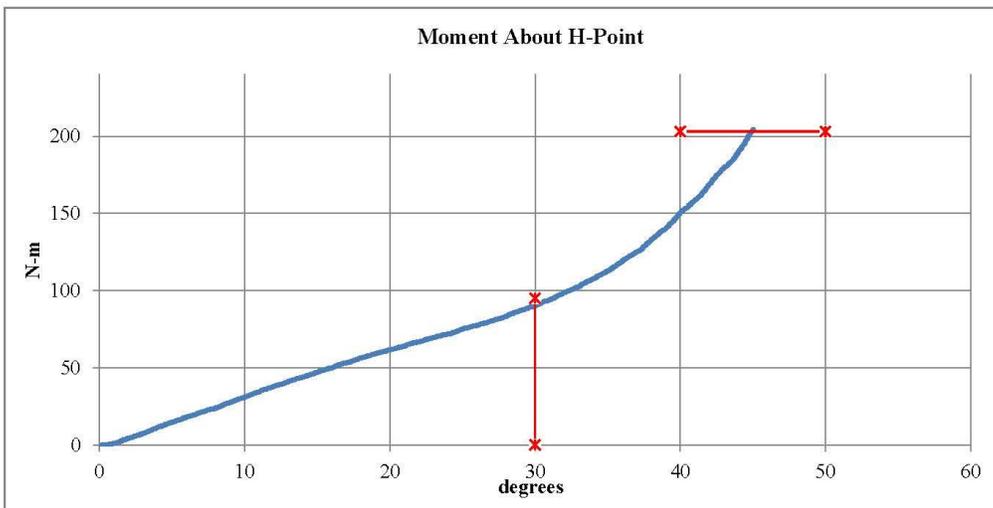
Serial Number: 037 Date: 13-Dec-2019
Side Tested: Right Hip Time: 12:37
Test Number: 1

TEST PARAMETER	SPECIFICATION	TEST RESULTS
Temperature	18.9 - 25.6	21.3 °C Pass
Humidity	10 - 70	39 % Pass
Moment at 30°	0 ≤ 94.9	90.45 N-m Pass
Angle at 203 Nm	40 - 50	45.02 deg Pass
Average Velocity	5 - 10	7.12 deg/sec Pass

Max: 8.33 deg/sec Min: 5.29 deg/sec

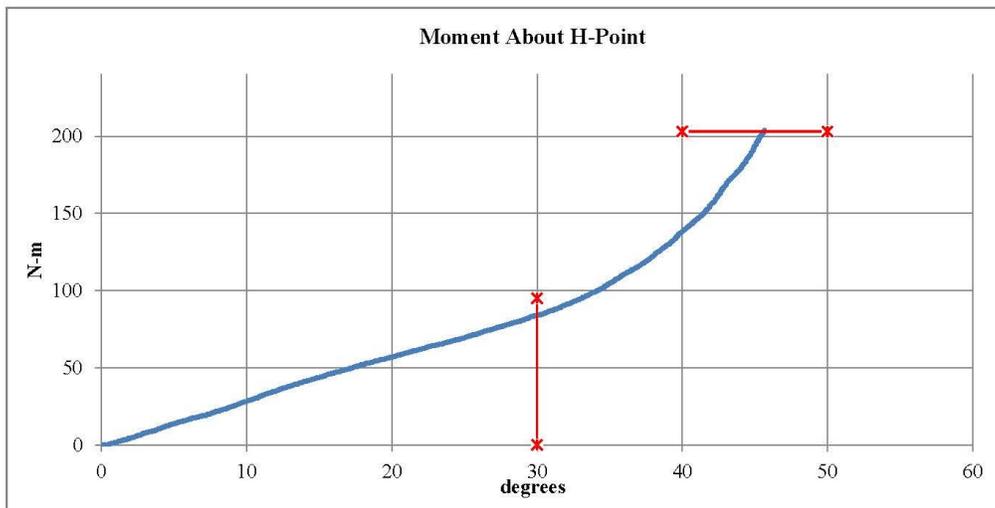
Serial Number: 037 Date: 22-Jan-2020
Side Tested: Left Hip Time: 8:31
Test Number: 1

TEST PARAMETER	SPECIFICATION	TEST RESULTS
Temperature	18.9 - 25.6	21.8 °C Pass
Humidity	10 - 70	40 % Pass
Moment at 30°	0 ≤ 94.9	84.2 N-m Pass
Angle at 203 Nm	40 - 50	45.66 deg Pass
Average Velocity	5 - 10	7.18 deg/sec Pass

Max: 7.93 deg/sec Min: 4.63 deg/sec

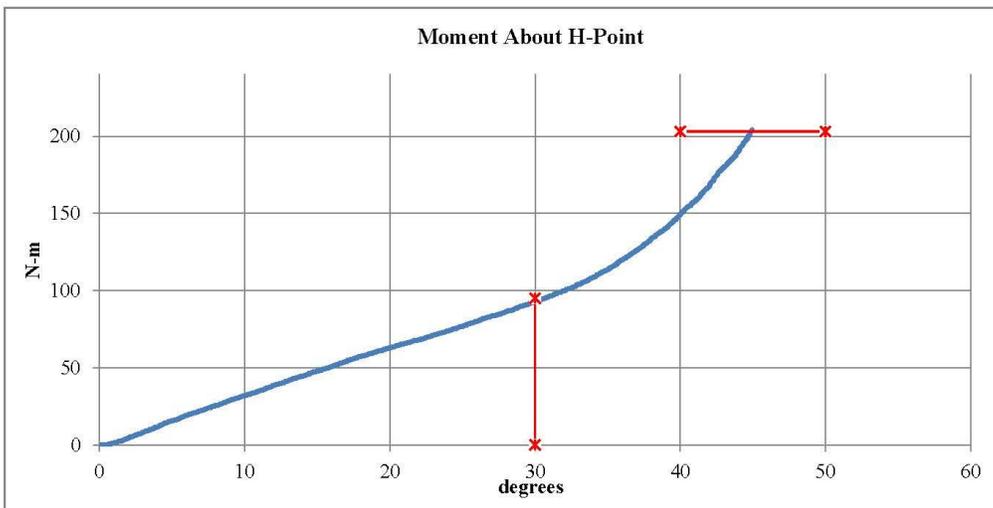
Serial Number: 037 Date: 22-Jan-2020
Side Tested: Right Hip Time: 9:51
Test Number: 1

TEST PARAMETER	SPECIFICATION	TEST RESULTS
Temperature	18.9 - 25.6	21.7 °C Pass
Humidity	10 - 70	39 % Pass
Moment at 30°	0 ≤ 94.9	92.83 N-m Pass
Angle at 203 Nm	40 - 50	44.94 deg Pass
Average Velocity	5 - 10	7.08 deg/sec Pass

Max: 7.93 deg/sec Min: 4.96 deg/sec

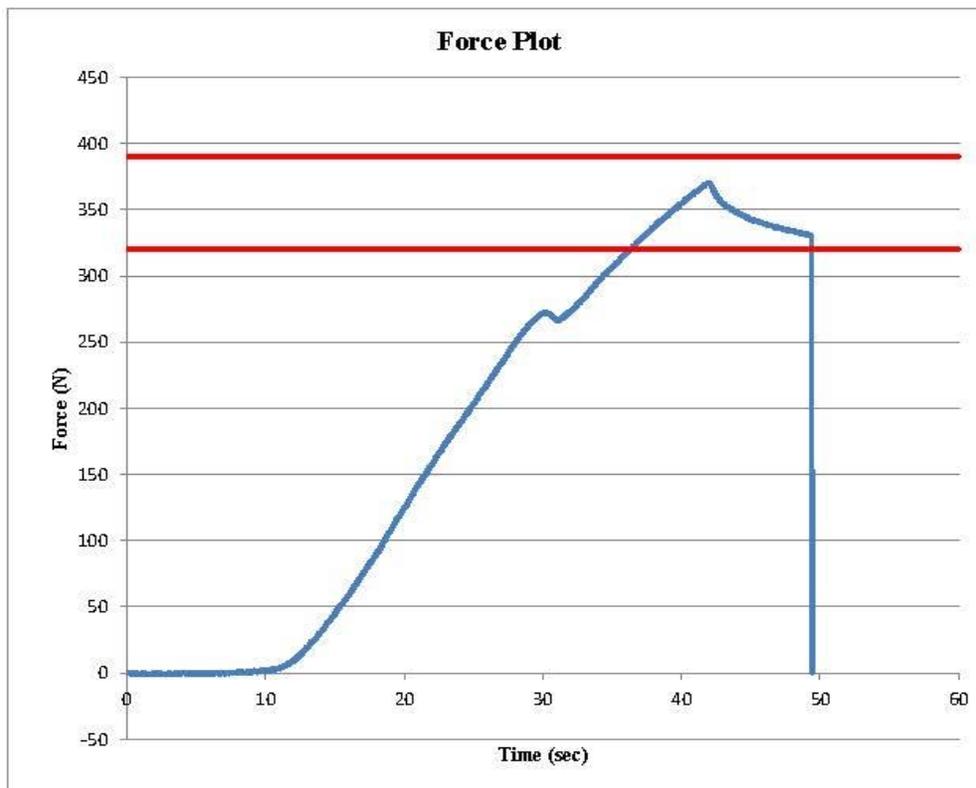
Lumbar S/N: 05060

Customer: NHTSA
 Serial Number: 070 Date: 1/15/2020
 Test Number: 1 Time: 10:03

TEST PARAMETER	SPECIFICATION	TEST RESULTS
Temperature	18.9 - 25.6	21.1 °C Pass
Humidity	10 - 70	41 % Pass
Average Angular Velocity	0.5 - 1.5	0.96 deg/sec Pass
Initial Angle	0 - 20	15.48 deg Pass
Peak Force at 45.29°	320 - 390	370.1 N Pass
Final Angle	-8 - 8	5.33 deg Pass

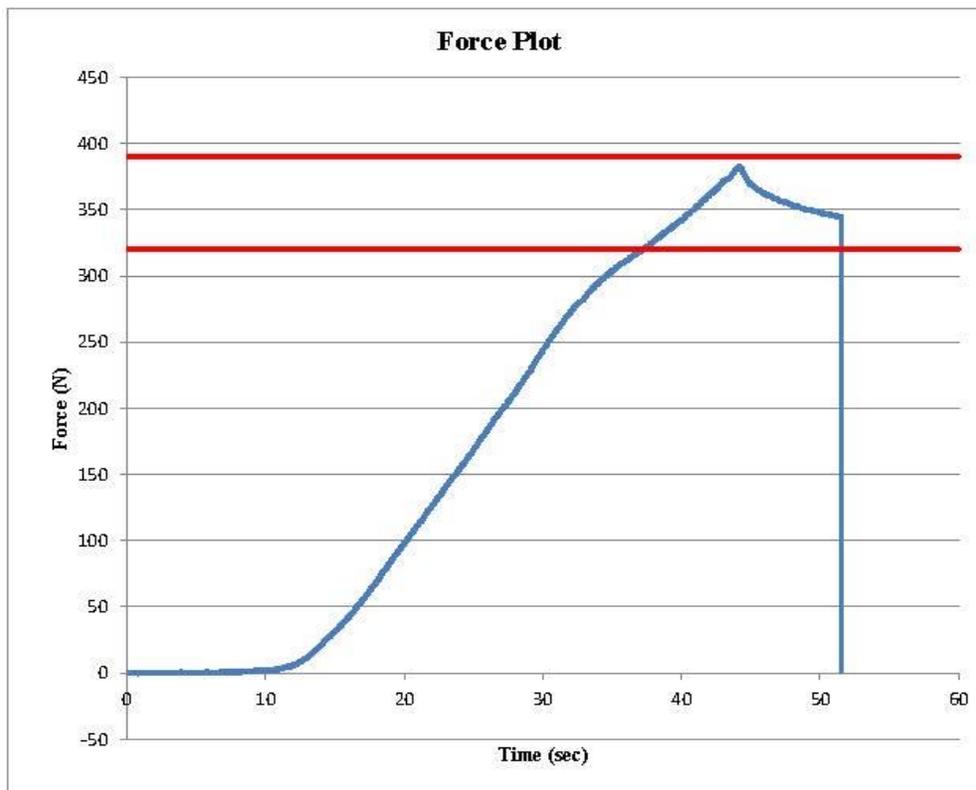
Lumbar S/N: 05060

Customer: NHTSA
Serial Number: 070 Date: 01/22/2020
Test Number: 1 Time: 10:33

TEST PARAMETER	SPECIFICATION	TEST RESULTS
Temperature	18.9 - 25.6	21.2 °C Pass
Humidity	10 - 70	40 % Pass
Average Angular Velocity	0.5 - 1.5	0.92 deg/sec Pass
Initial Angle	0 - 20	14.85 deg Pass
Peak Force at 45.39°	320 - 390	382.28 N Pass
Final Angle	-8 - 8	3.87 deg Pass
