#### FINAL REPORT NUMBER: SINCAP-TRC-20-001

#### NEW CAR ASSESSMENT PROGRAM (NCAP) MOVING DEFORMABLE BARRIER SIDE IMPACT TEST

KIA MOTORS CORPORATION 2020 Kia Soul 5-DR SUV NHTSA NUMBER: M20204214

PREPARED BY: Transportation Research Center Inc. 10820 State Route 347 P. O. Box B-67 East Liberty, OH 43319

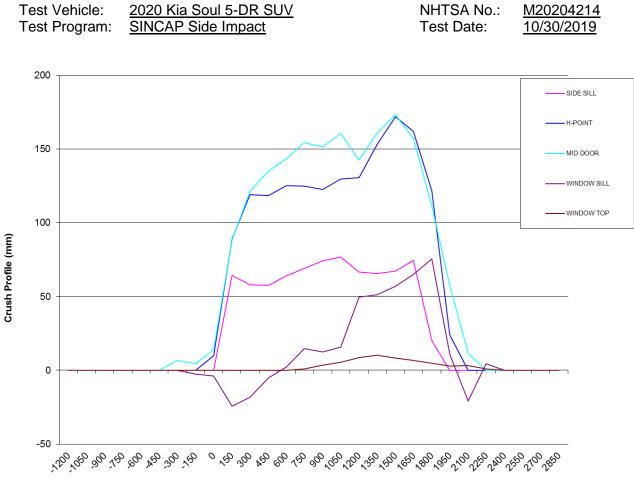
## DATA SHEET NO. 11 (CONTINUED) TEST VEHICLE EXTERIOR CRUSH MEASUREMENTS

**NOTE:** Pre-test measurements are taken when the vehicle is in the "As Tested" weight condition. Vehicle measurements forward of the vertical impact reference line are negative. The crush profile grid is established prior to the test based on an estimated impact point.

Distance from Impact Point (mm)

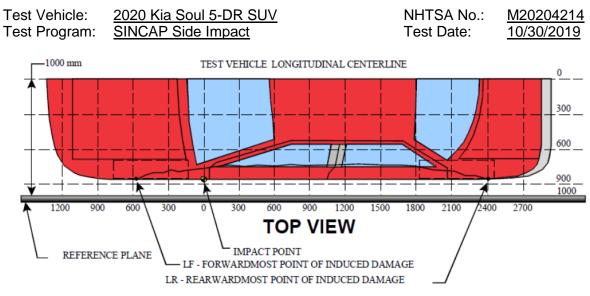
#### DATA SHEET NO. 13 VEHICLE AND MDB DAMAGE PROFILE DISTANCES

MEASUREMENT CONVENTIONS: Forward of the impact point (towards front of vehicle) is considered negative (—). Rearward of the impact point (toward rearend of vehicle) is considered positive (+).

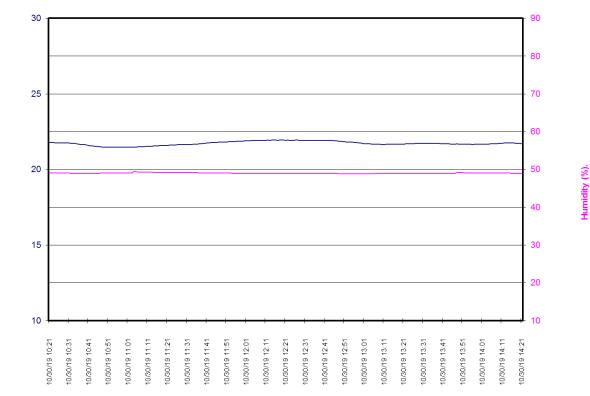
### DATA SHEET NO. 15 DUMMY/VEHICLE TEMPERATURE AND HUMIDITY STABILIZATION DATA

M202042142020 Kia Soul 5-DR SUV Left MDB Impact 191030: Test Time 14:21
