REPORT NUMBER: SINCAP-CAL-20-004

**NEW CAR ASSESSMENT PROGRAM (NCAP)
MOVING DEFORMABLE BARRIER SIDE IMPACT TEST**

**Mazda Motor Manufacturing de Mexico S.A. de C.V.
2020 Mazda CX-30
Five Door SUV**

NHTSA No: M20205402

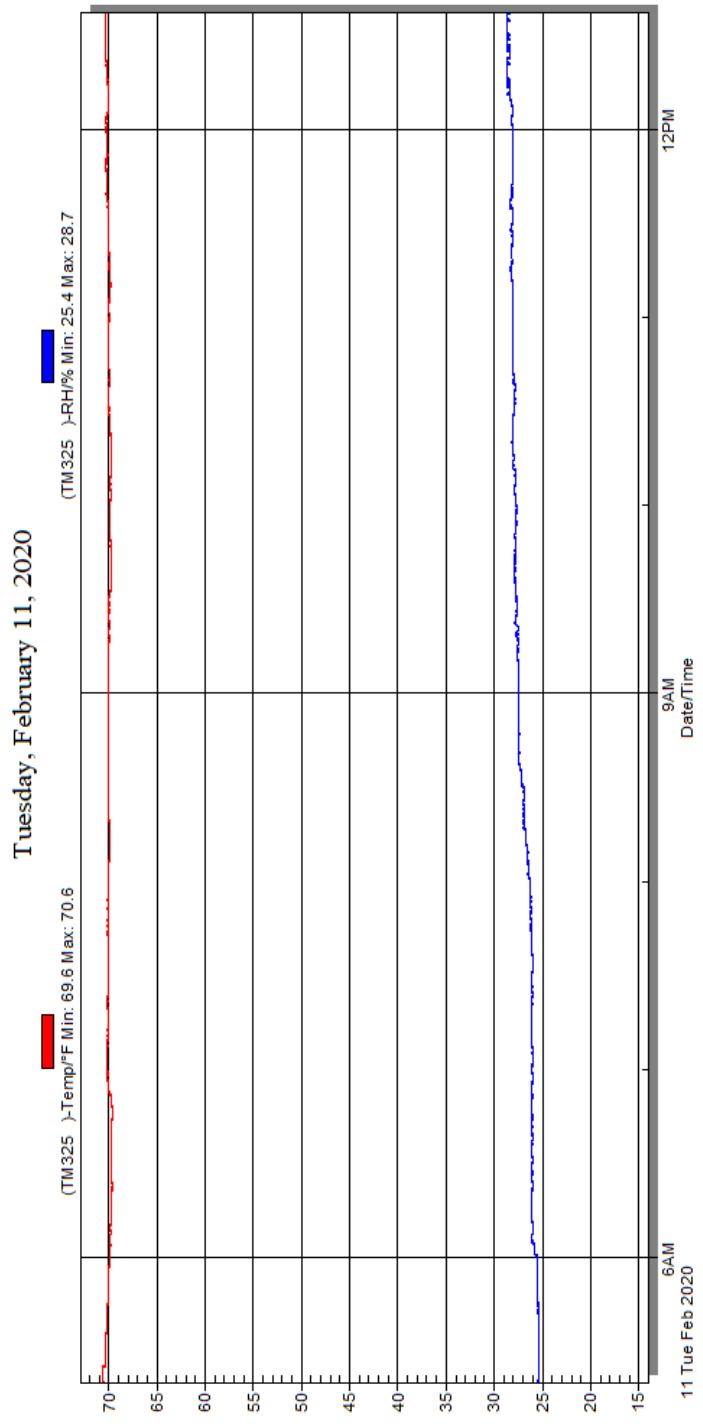
DATA SHEET NO. 15
DUMMY/VEHICLE TEMPERATURE AND HUMIDITY STABILIZATION DATA

Temperature and Humidity Stabilization Chart/Data for Dummies and Test Vehicle

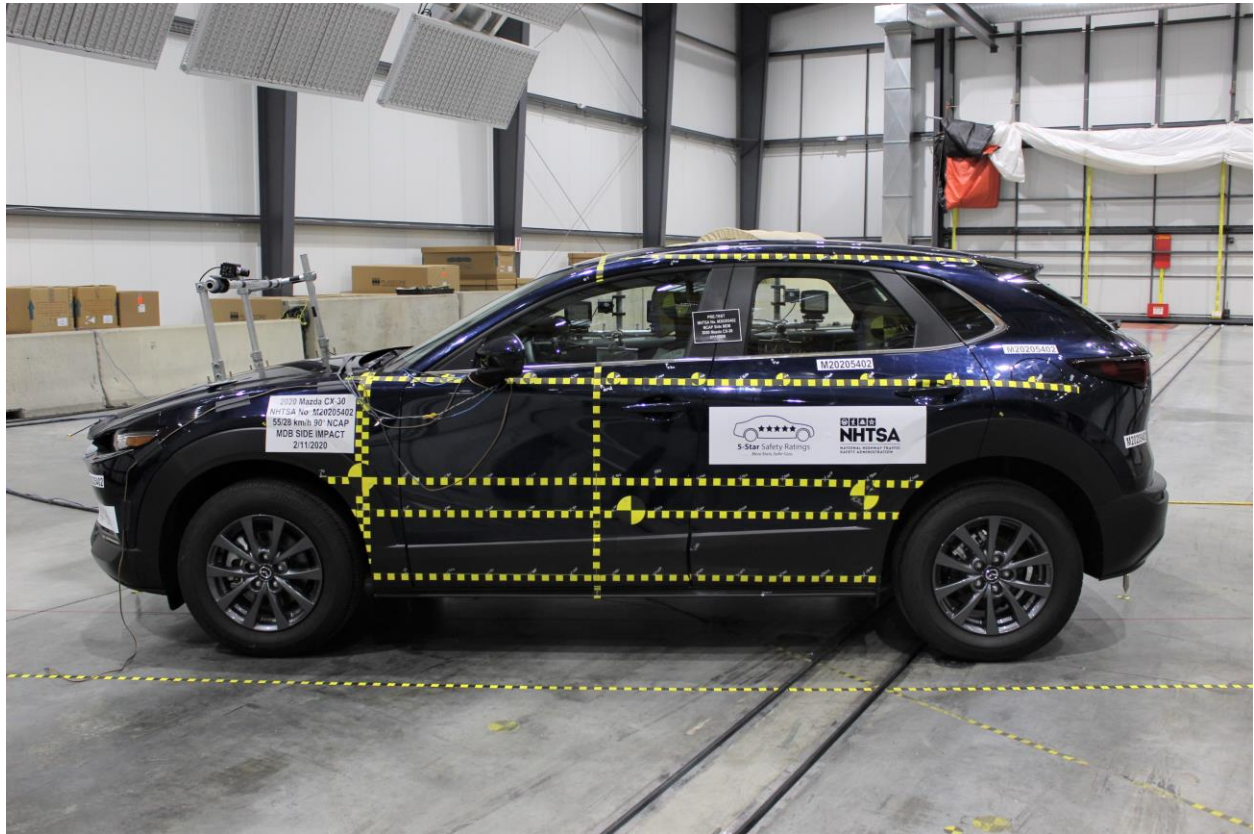
Figure A-6: Post-Test Left Front ¾ View of Test Vehicle

Critical Areas of Performance	Observations and Conclusions
Pillar Performance	B-Pillar & C-Pillar Buckled
Sill Separation	None
Windshield Damage	None
Side Window Damage	None
Other Notable Effects	None

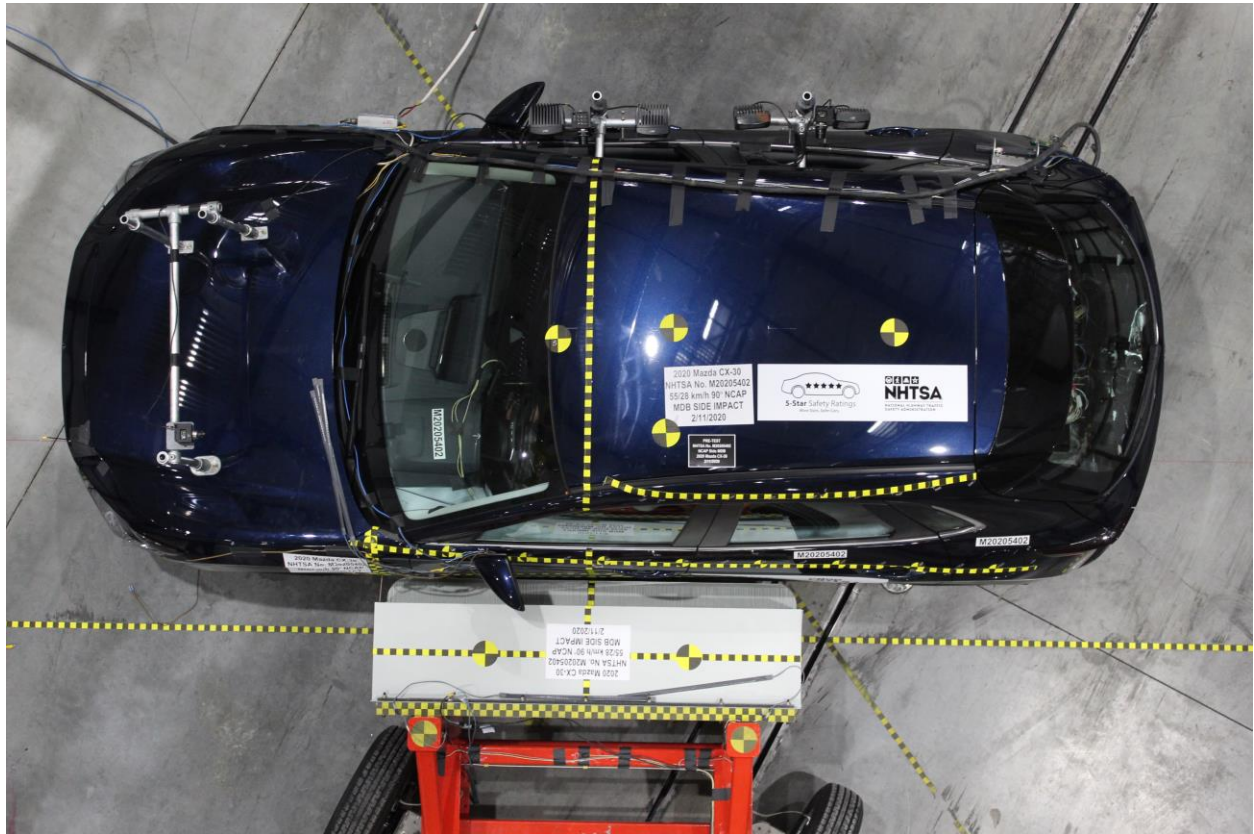
Figure A-14: Post-Test Right Side View of Test Vehicle
