REPORT NUMBER: SINCAP-KAR-20-010

**NEW CAR ASSESSMENT PROGRAM (NCAP)
MOVING DEFORMABLE BARRIER SIDE IMPACT TEST**

**MAZDA MOTOR MANUFACTURING DE MEXICO S.A. DE C.V.
2020 MAZDA3 4-DOOR SEDAN**

NHTSA No: M20205405

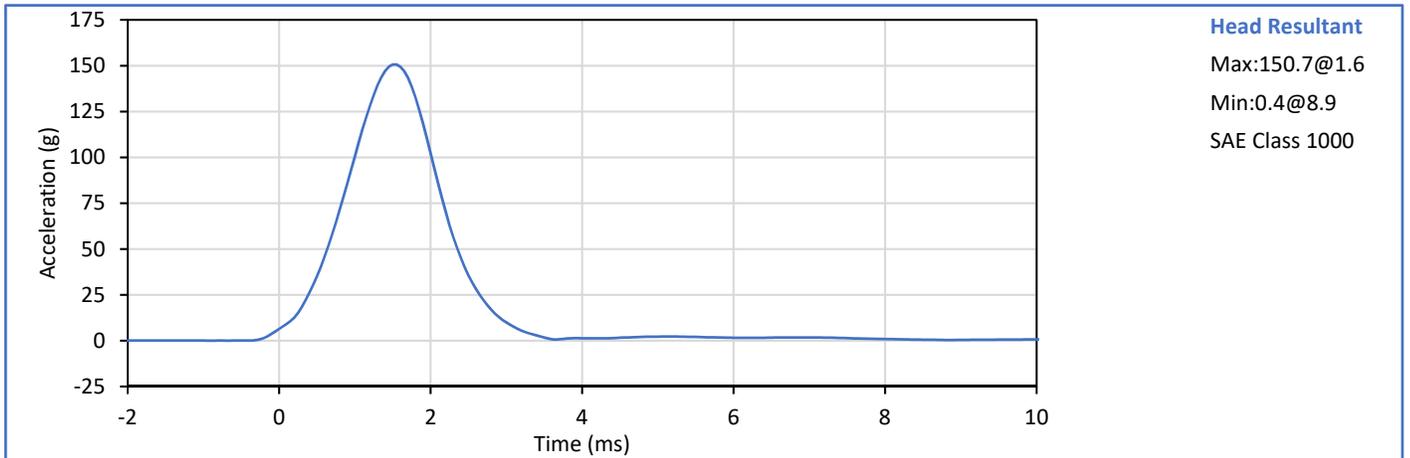
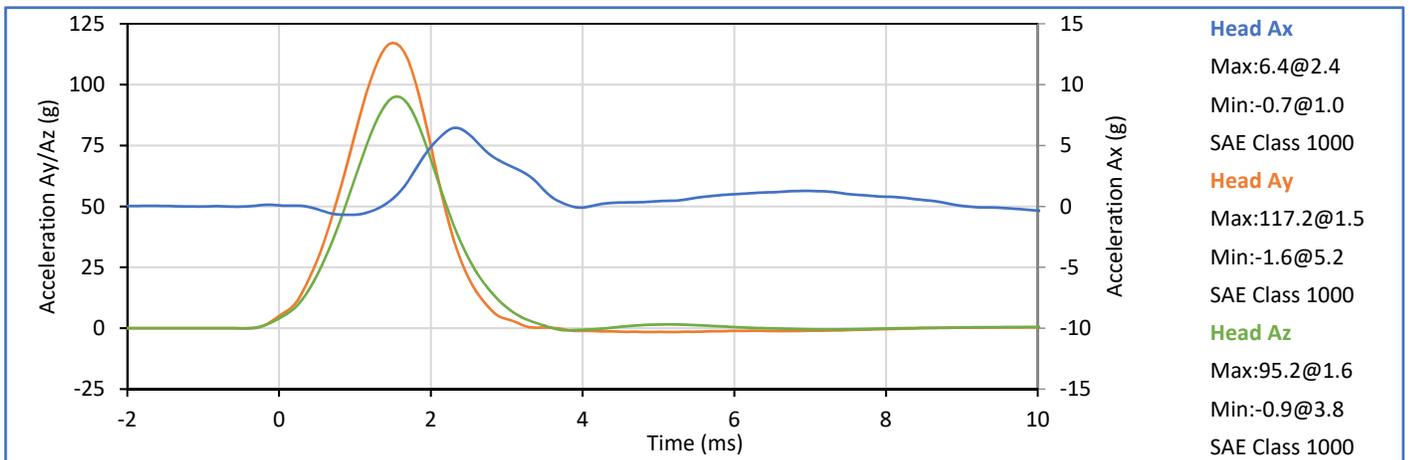
Tested Parameter	Units	Spec. Low	Spec. High	Result	Pass/Fail
Laboratory Temperature	°C	18.9	25.6	21.1	Pass
Laboratory Humidity	%	10	70	32	Pass
Peak Resultant Acceleration	g	125.0	155.0	150.7	Pass
Peak Head Ax	g	-15.0	15.0	6.4	Pass
Oscillations After Main Pulse	%	0.0	15.0	1.3	Pass
Is Acceleration Unimodal?	Yes/No	Yes		Yes	Pass
Overall Test Results					Pass

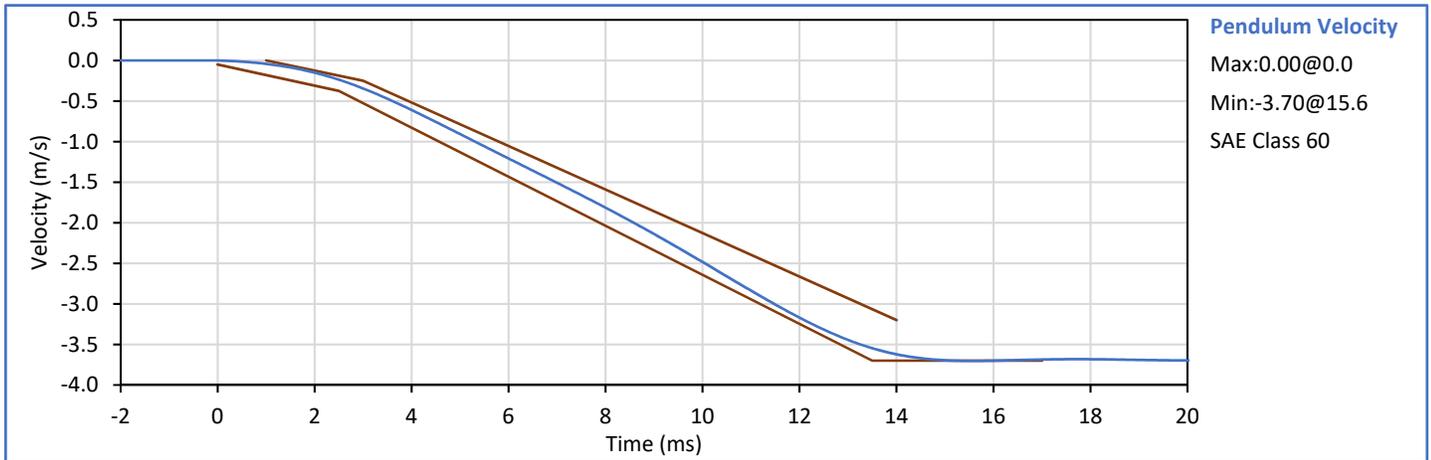
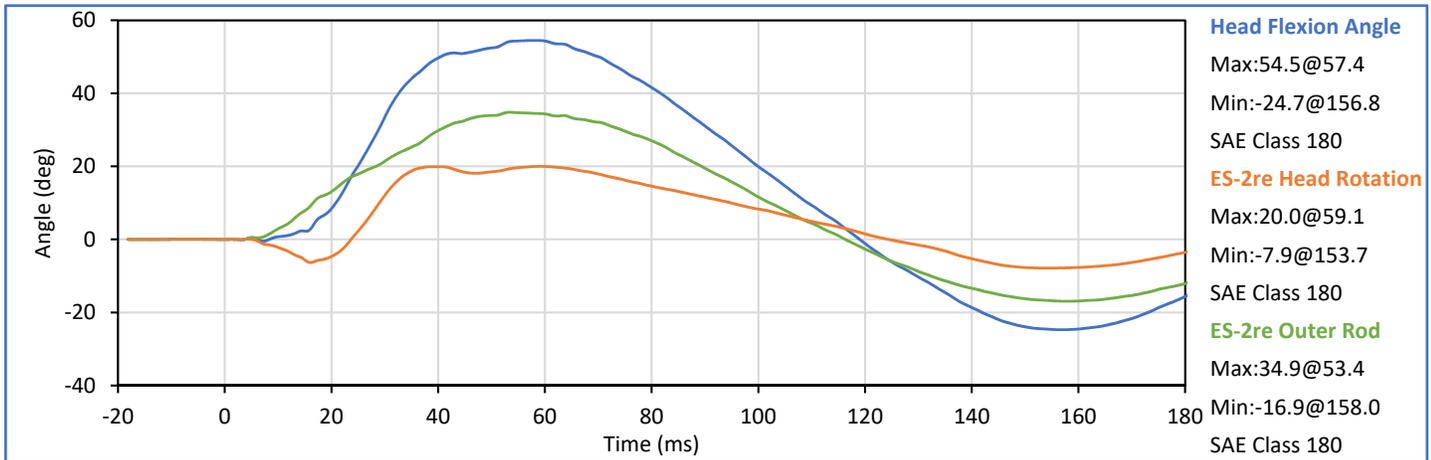
Tested Parameter	Units	Spec. Low	Spec. High	Result	Pass/Fail
Laboratory Temperature	°C	20.6	22.2	21.1	Pass
Laboratory Humidity	%	10	70	30	Pass
Pendulum Velocity	m/s	3.30	3.50	3.46	Pass
Peak Headform Flexion	deg	49.0	59.0	54.5	Pass
Time of Peak Headform Flexion	ms	54.0	66.0	57.4	Pass
Flexion Decay (Peak to zero)	ms	53.0	88.0	61.6	Pass
Overall Test Results					Pass

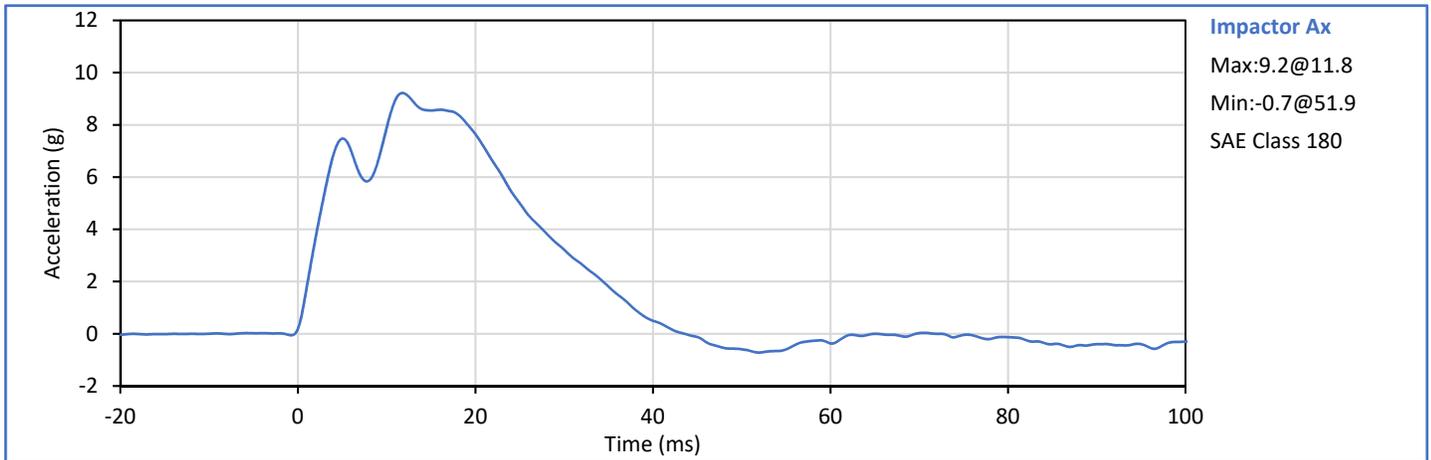
Tested Parameter	Units	Spec. Low	Spec. High	Result	Pass/Fail
Laboratory Temperature	°C	20.6	22.2	21.1	Pass
Laboratory Humidity	%	10	70	32	Pass
Impactor Velocity	m/s	4.20	4.40	4.36	Pass
Peak Impactor Ax	g	7.5	10.5	9.2	Pass
Overall Test Results					Pass

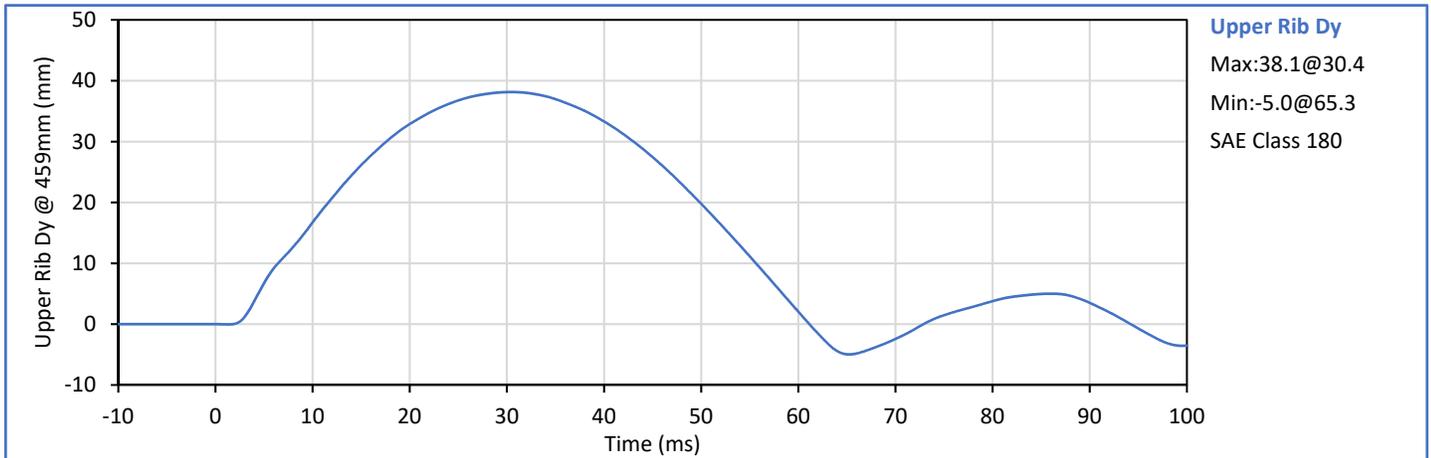
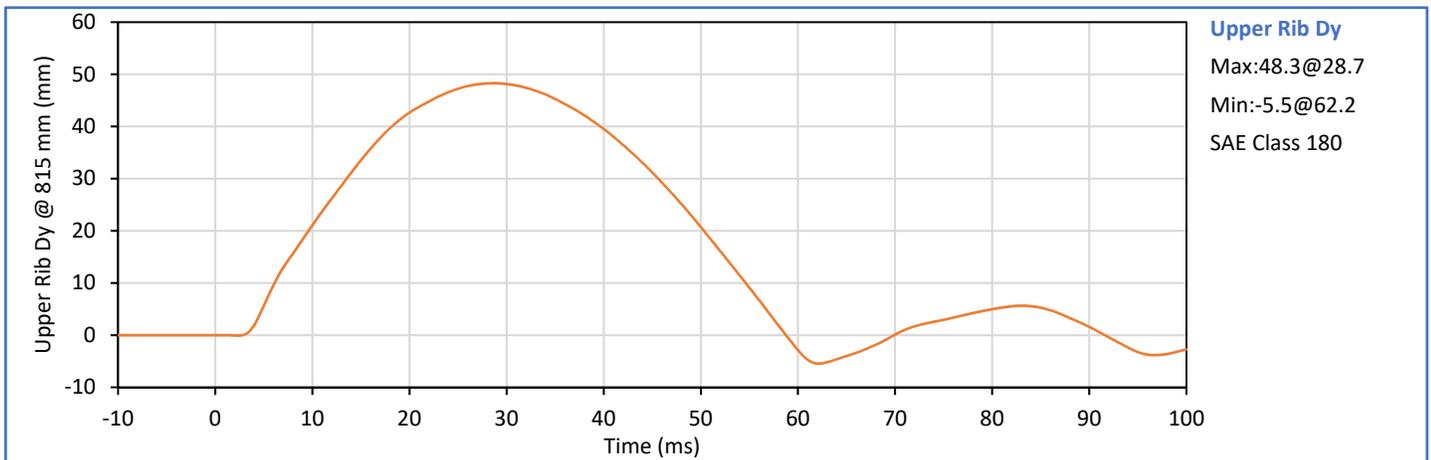
Tested Parameter	Units	Spec. Low	Spec. High	Result	Pass/Fail
Laboratory Temperature	°C	20.6	22.2	21.1	Pass
Laboratory Humidity	%	10	70	33	Pass
Upper Rib Dy @ 459mm	mm	36.0	40.0	38.1	Pass
Upper Rib Dy @ 815mm	mm	46.0	51.0	48.3	Pass
Overall Test Results					Pass

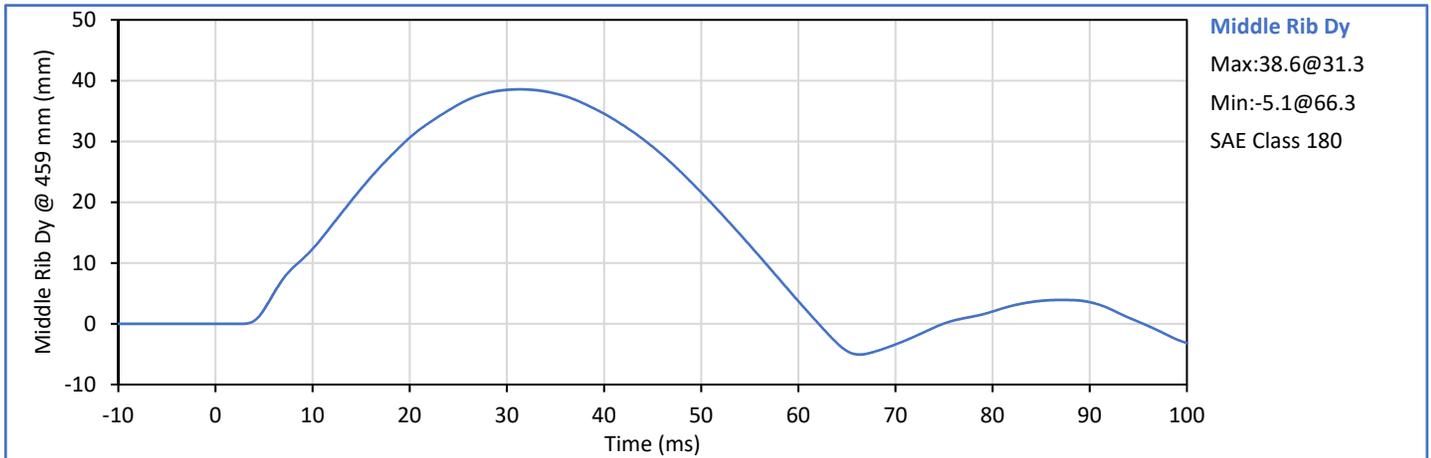
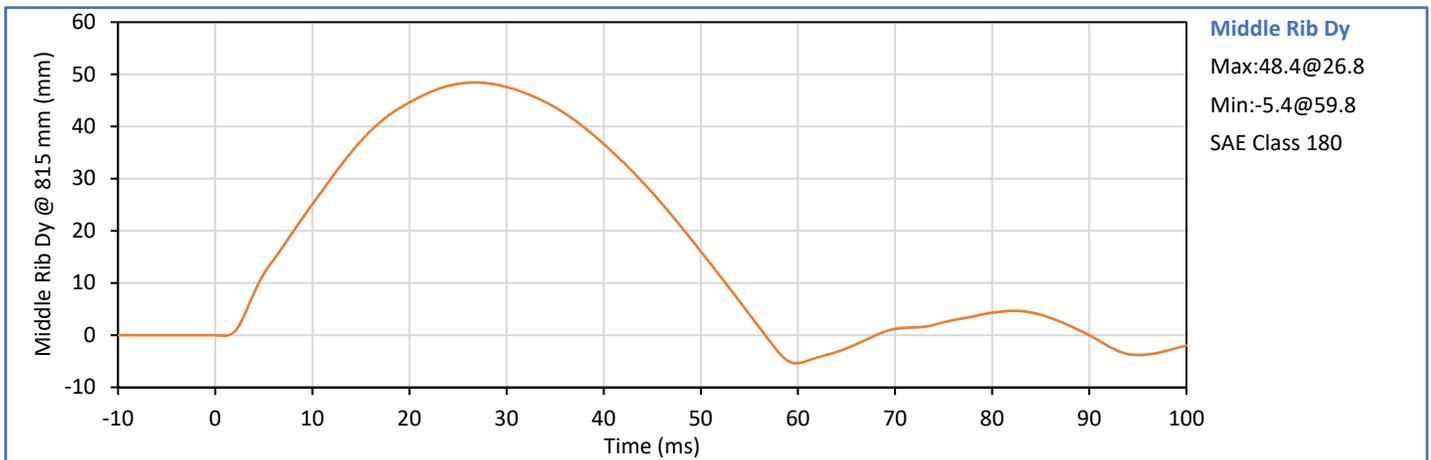
Tested Parameter	Units	Spec. Low	Spec. High	Result	Pass/Fail
Laboratory Temperature	°C	20.6	22.2	21.1	Pass
Laboratory Humidity	%	10	70	33	Pass
Middle Rib Dy @ 459mm	mm	36.0	40.0	38.6	Pass
Middle Rib Dy @ 815mm	mm	46.0	51.0	48.4	Pass
Overall Test Results					Pass

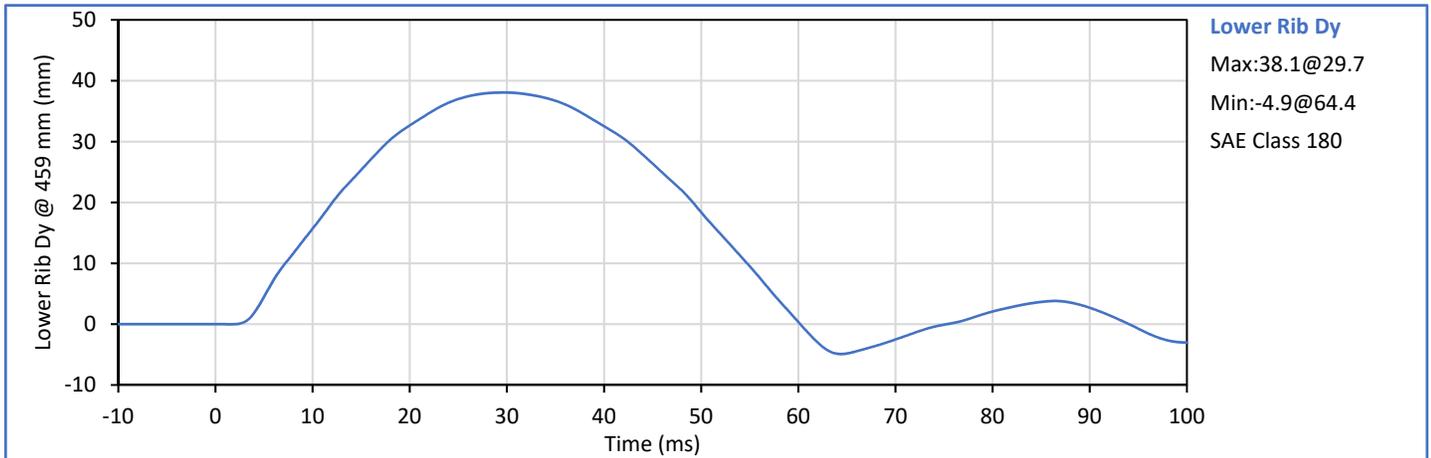
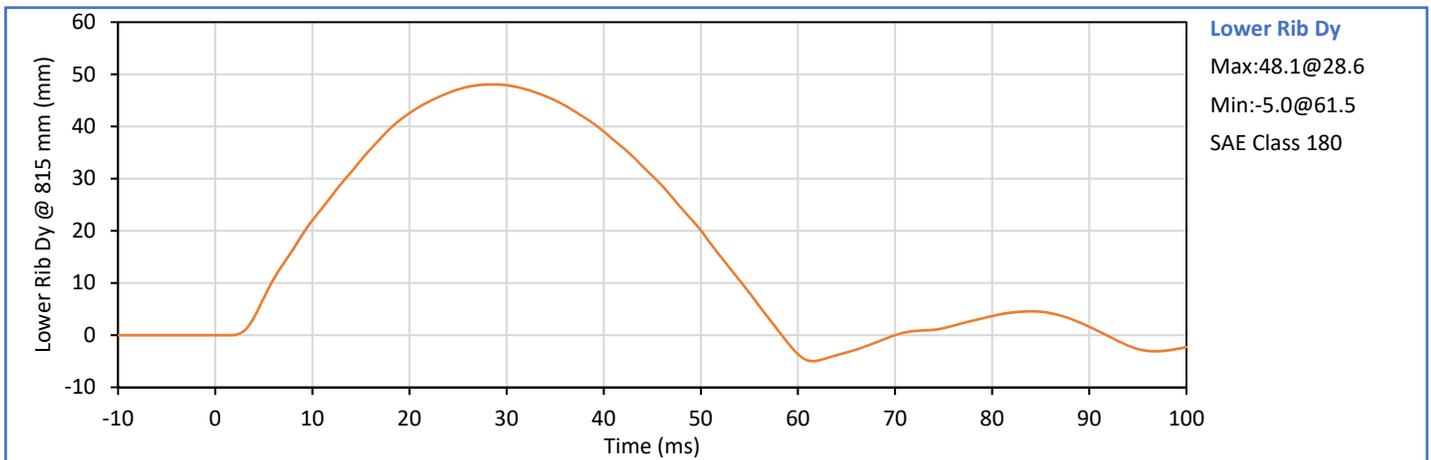
Tested Parameter	Units	Spec. Low	Spec. High	Result	Pass/Fail
Laboratory Temperature	°C	20.6	22.2	21.1	Pass
Laboratory Humidity	%	10	70	33	Pass
Lower Rib Dy @ 459mm	mm	36.0	40.0	38.1	Pass
Lower Rib Dy @ 815mm	mm	46.0	51.0	48.1	Pass
Overall Test Results					Pass

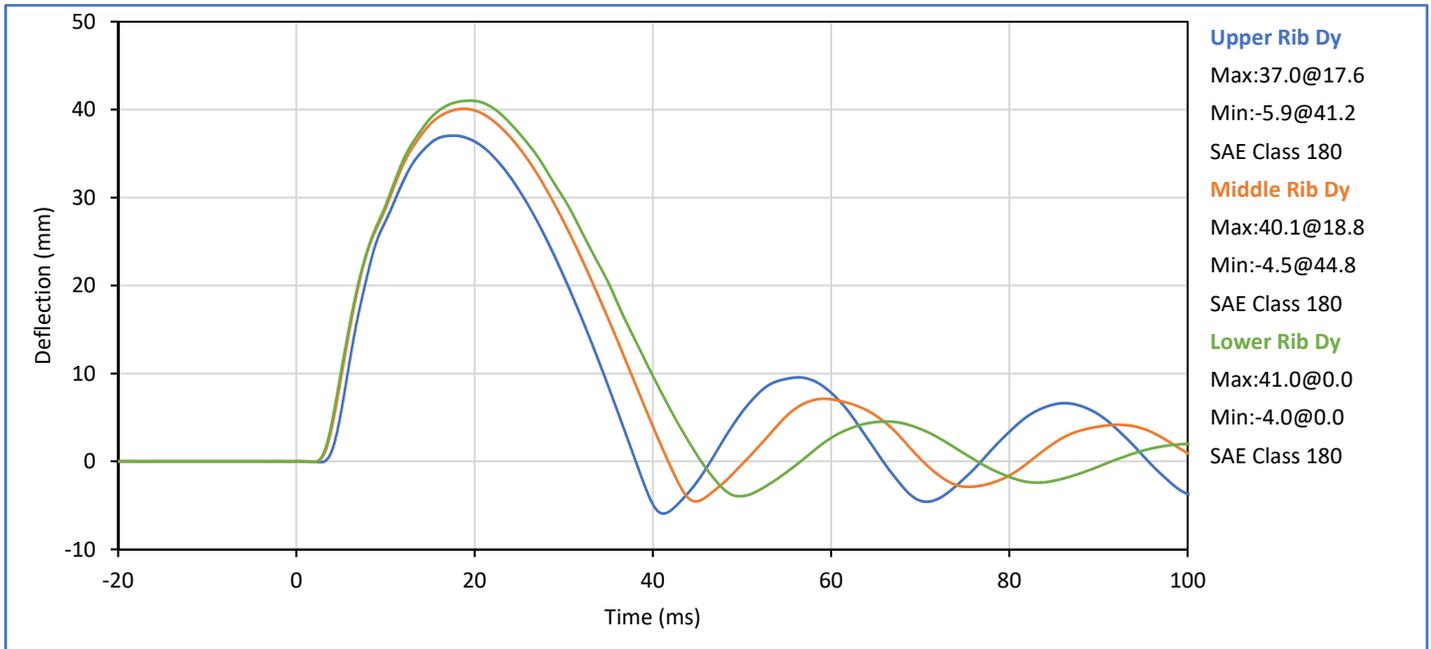
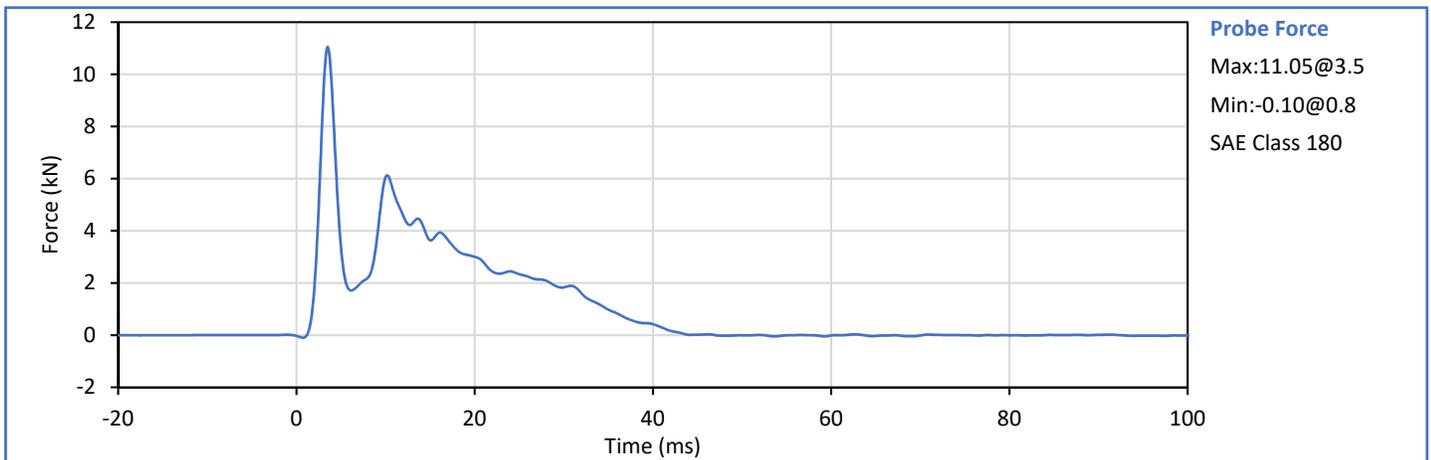
Tested Parameter	Units	Spec. Low	Spec. High	Result	Pass/Fail
Laboratory Temperature	°C	20.6	22.2	21.1	Pass
Laboratory Humidity	%	10	70	32	Pass
Impactor Velocity	m/s	5.40	5.60	5.50	Pass
Peak Upper Rib Dy	mm	34.0	41.0	37.0	Pass
Peak Middle Rib Dy	mm	37.0	45.0	40.1	Pass
Peak Lower Rib Dy	mm	37.0	44.0	41.0	Pass
Peak Impactor Force After 6 ms	kN	5.10	6.20	6.13	Pass
Overall Test Results					Pass

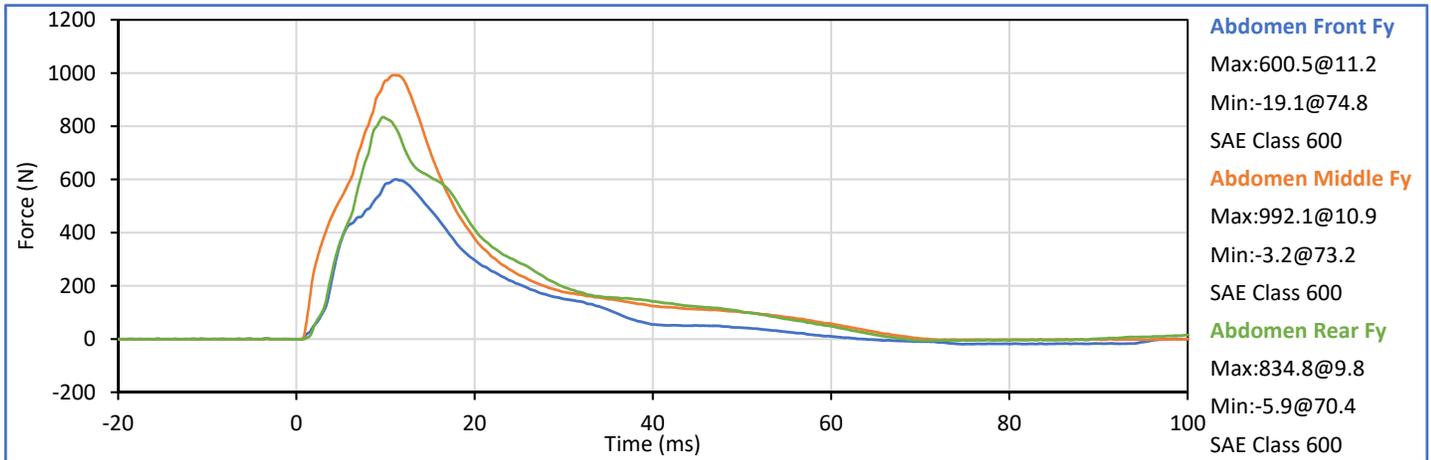
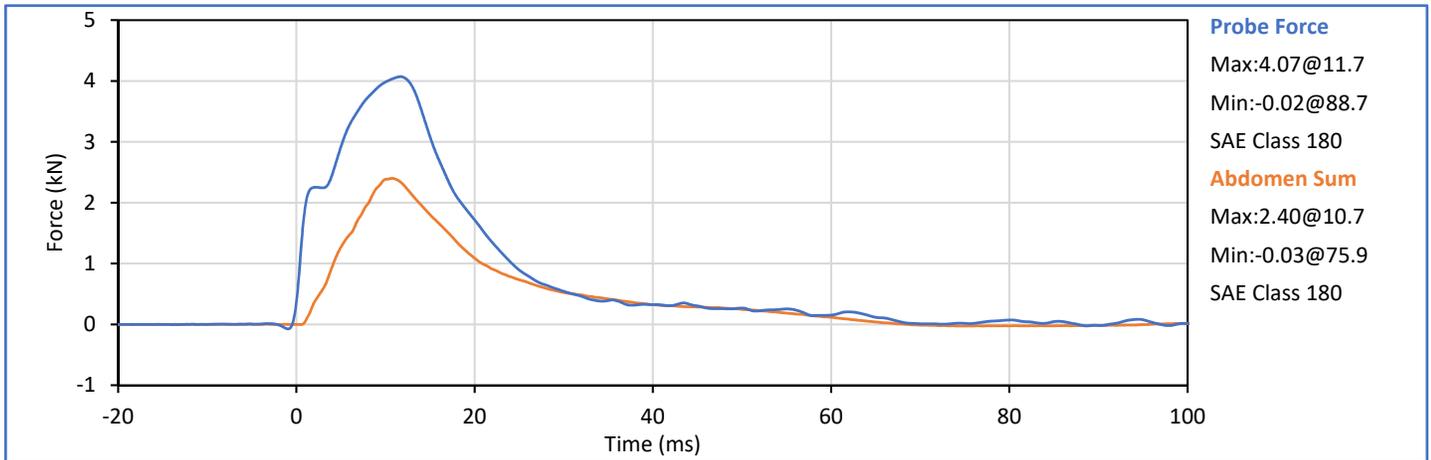
Tested Parameter	Units	Spec. Low	Spec. High	Result	Pass/Fail
Laboratory Temperature	°C	20.6	22.2	21.1	Pass
Laboratory Humidity	%	10	70	32	Pass
Impactor Velocity	m/s	3.90	4.10	3.98	Pass
Peak Impactor Force	kN	4.00	4.80	4.07	Pass
Time of Peak Impactor Force	ms	10.6	13.0	11.7	Pass
Sum of Abdomen Forces	kN	2.20	2.70	2.40	Pass
Time of Peak Sum Abdomen Force	ms	10.0	12.3	10.7	Pass
Overall Test Results					Pass

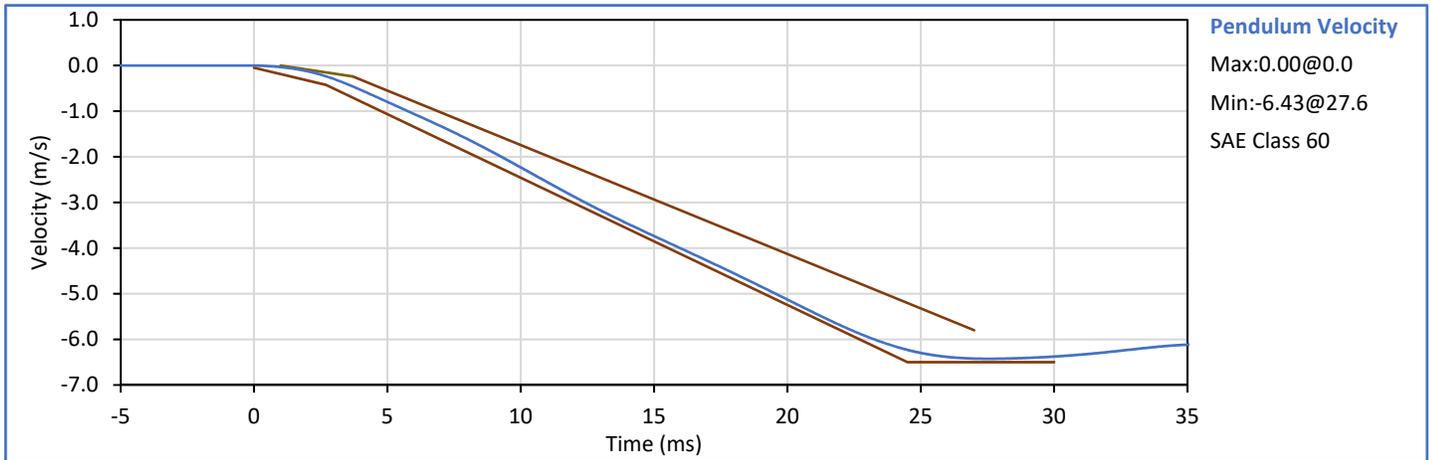
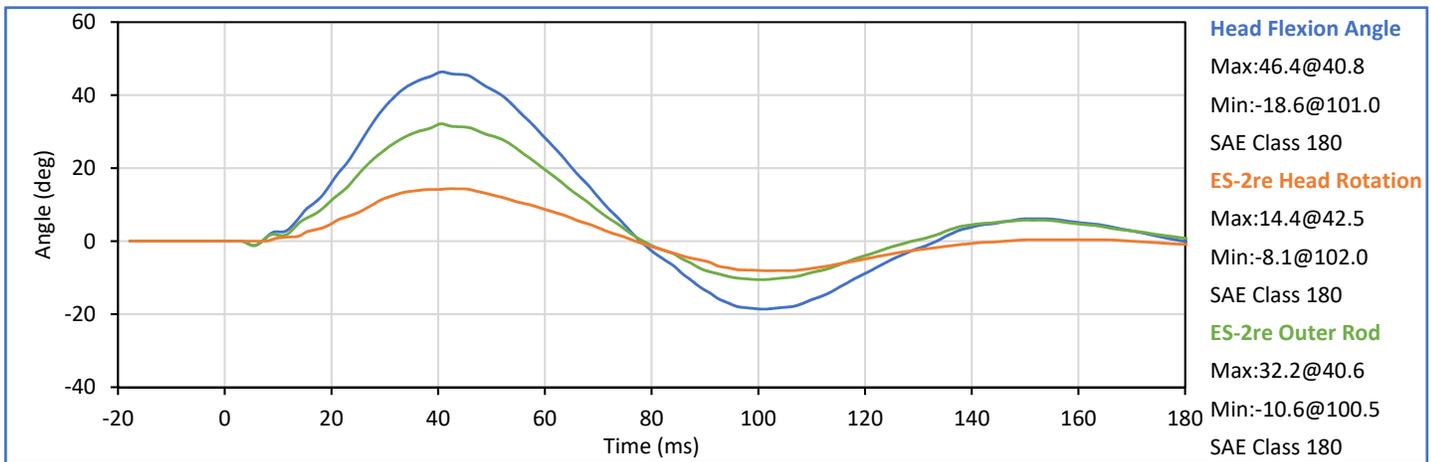
Tested Parameter	Units	Spec. Low	Spec. High	Result	Pass/Fail
Laboratory Temperature	°C	20.6	22.2	21.1	Pass
Laboratory Humidity	%	10	70	31	Pass
Pendulum Velocity	m/s	5.95	6.15	6.08	Pass
Peak Headform Flexion	deg	45.0	55.0	46.4	Pass
Time of Peak Headform Flexion	ms	39.0	53.0	40.8	Pass
Flexion Decay (Peak to zero)	ms	37.0	57.0	37.2	Pass
Overall Test Results					Pass

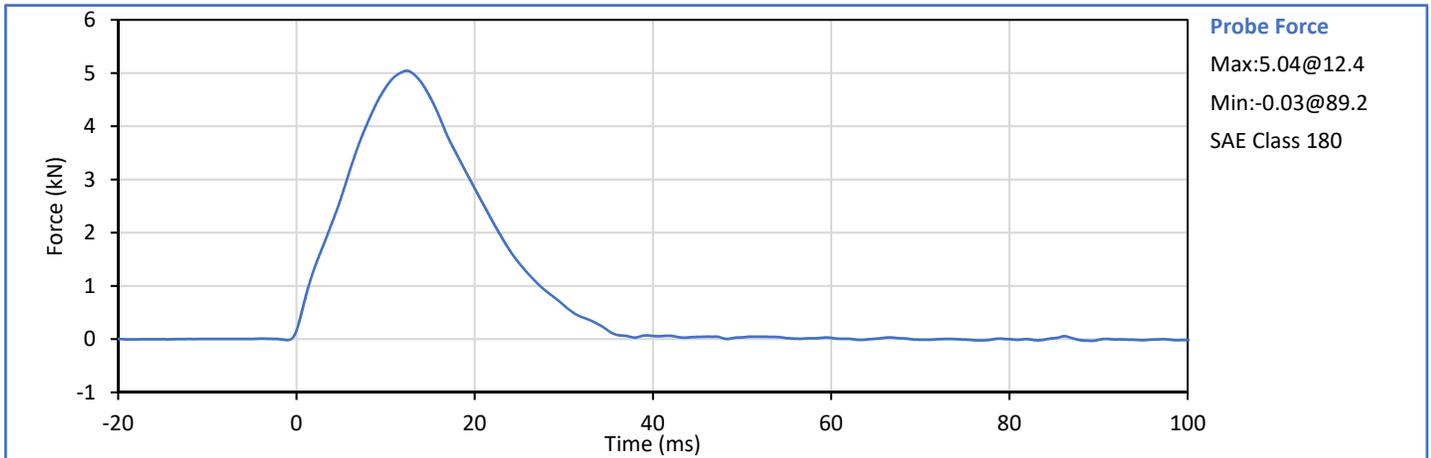
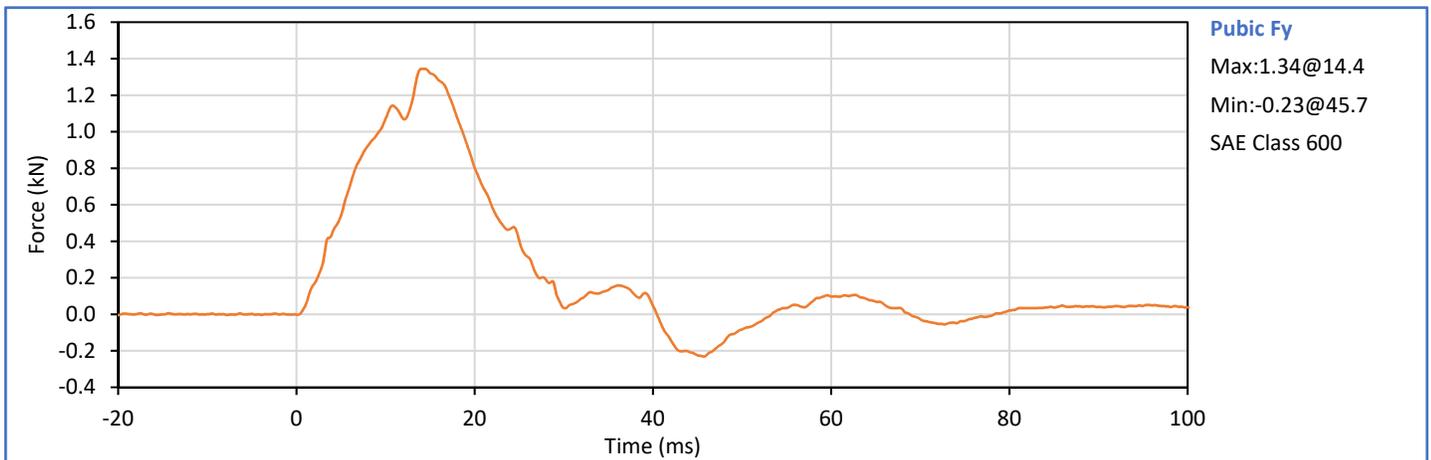
Tested Parameter	Units	Spec. Low	Spec. High	Result	Pass/Fail
Laboratory Temperature	°C	20.6	22.2	21.1	Pass
Laboratory Humidity	%	10	70	32	Pass
Impactor Velocity	m/s	4.20	4.40	4.32	Pass
Peak Impactor Force	kN	4.70	5.40	5.04	Pass
Time of Peak Impactor Force	ms	11.8	16.1	12.4	Pass
Pubic Symphysis Fy	kN	1.23	1.59	1.34	Pass
Time of Peak Pubic Symphysis Fy	ms	12.2	17.0	14.4	Pass
Overall Test Results					Pass

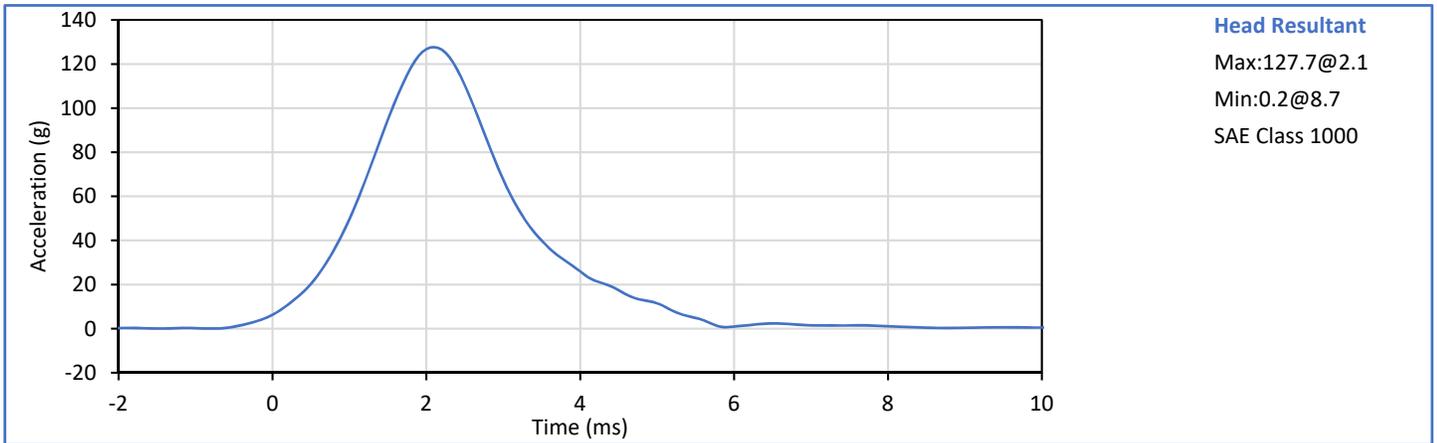
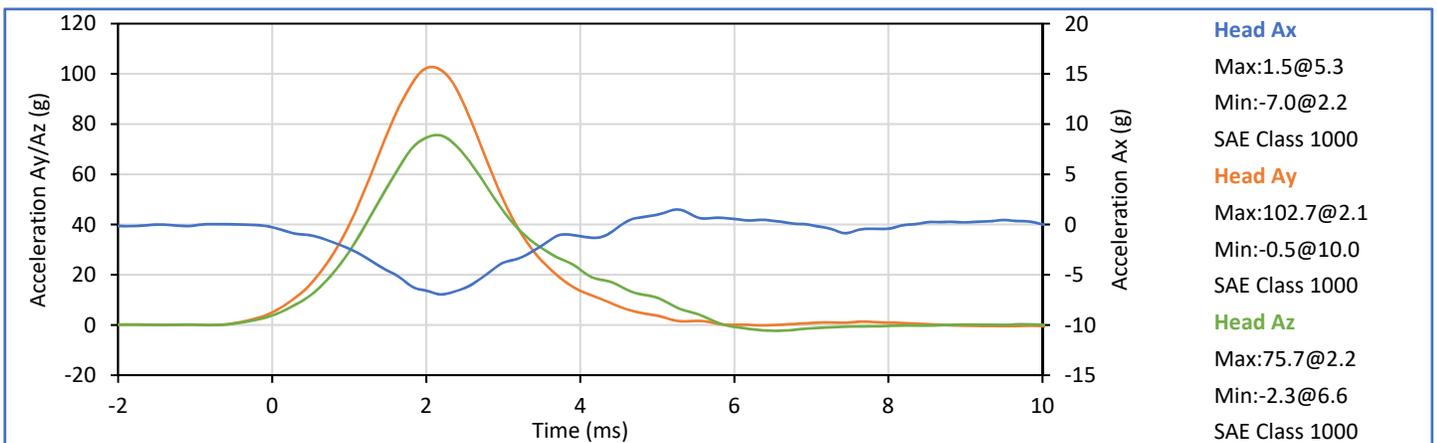
Tested Parameter	Units	Spec. Low	Spec. High	Result	Pass/Fail
Laboratory Temperature	°C	18.9	25.6	21.1	Pass
Laboratory Humidity	%	10	70	39	Pass
Peak Resultant Acceleration	g	115.0	137.0	127.7	Pass
Peak Head Ax	g	-15.0	15.0	-7.0	Pass
Oscillations After Main Pulse	%	0.0	15.0	1.8	Pass
Is Acceleration Unimodal?	Yes/No	Yes		Yes	Pass
Overall Test Results					Pass

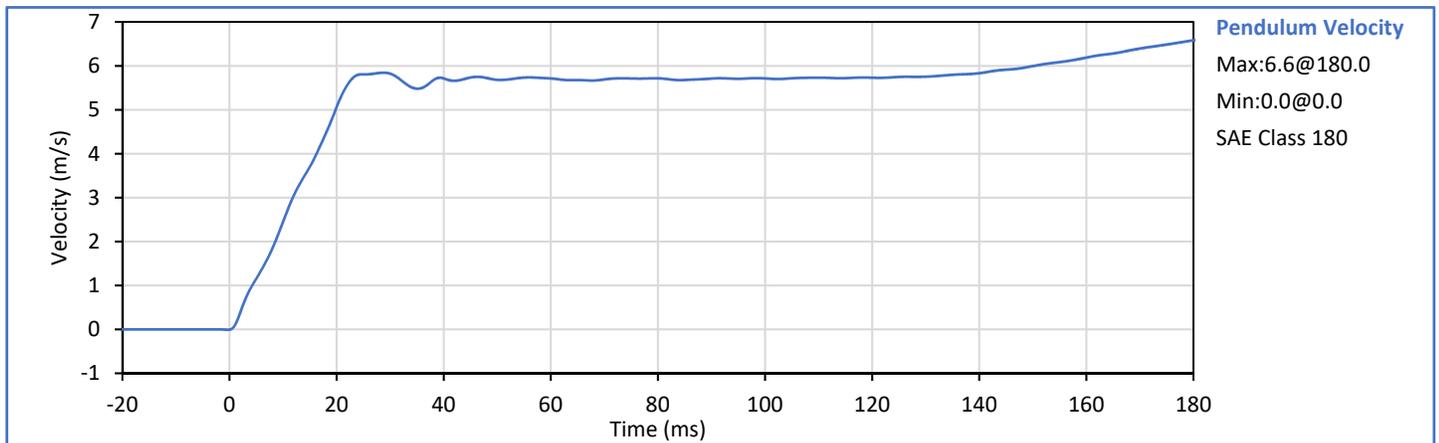
Tested Parameter	Units	Spec. Low	Spec. High	Result	Pass/Fail
Laboratory Temperature	°C	20.6	22.2	21.1	Pass
Laboratory Humidity	%	10	70	34	Pass
Pendulum Velocity	m/s	5.51	5.63	5.59	Pass
Pendulum Decel at 10 ms	m/s	2.20	2.80	2.45	Pass
Pendulum Decel at 15 ms	m/s	3.30	4.10	3.70	Pass
Pendulum Decel at 20 ms	m/s	4.40	5.40	5.06	Pass
Pendulum Decel at 25 ms	m/s	5.40	6.10	5.81	Pass
Pendulum Decel from 25-100 ms	m/s	5.50	6.20	5.84	Pass
Peak "D" Plane Rotation	deg	71.0	81.0	73.5	Pass
Time of Peak "D" Plane Rotation	ms	50.0	70.0	66.1	Pass
Peak Occ. Condyle Moment	Nm	-44.0	-36.0	-41.7	Pass
Time of Moment Decay to 0 Nm	ms	102.0	126.0	111.2	Pass
Overall Test Results					Pass

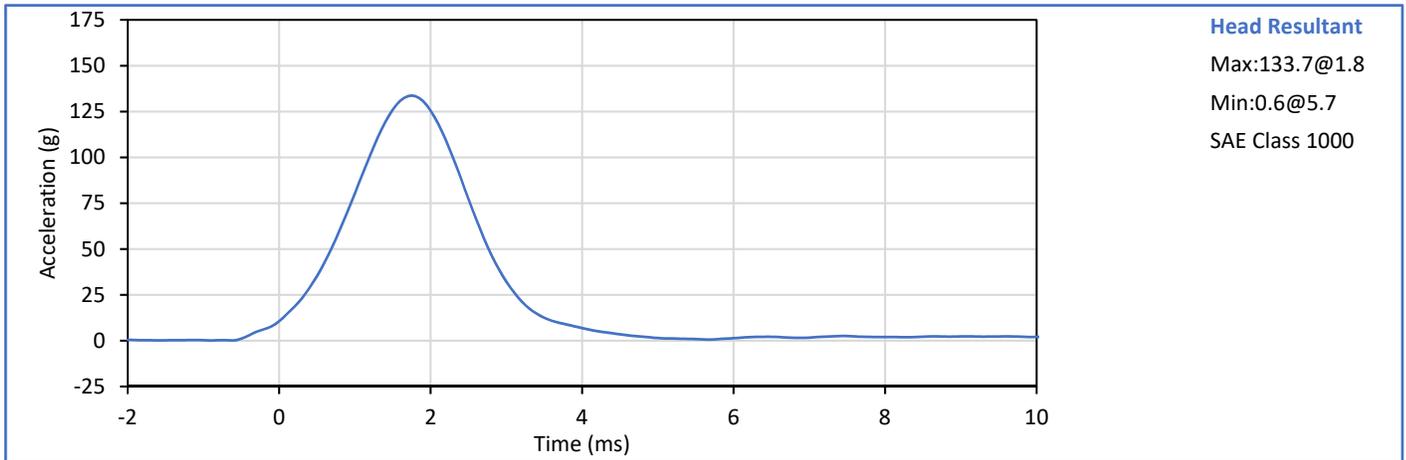
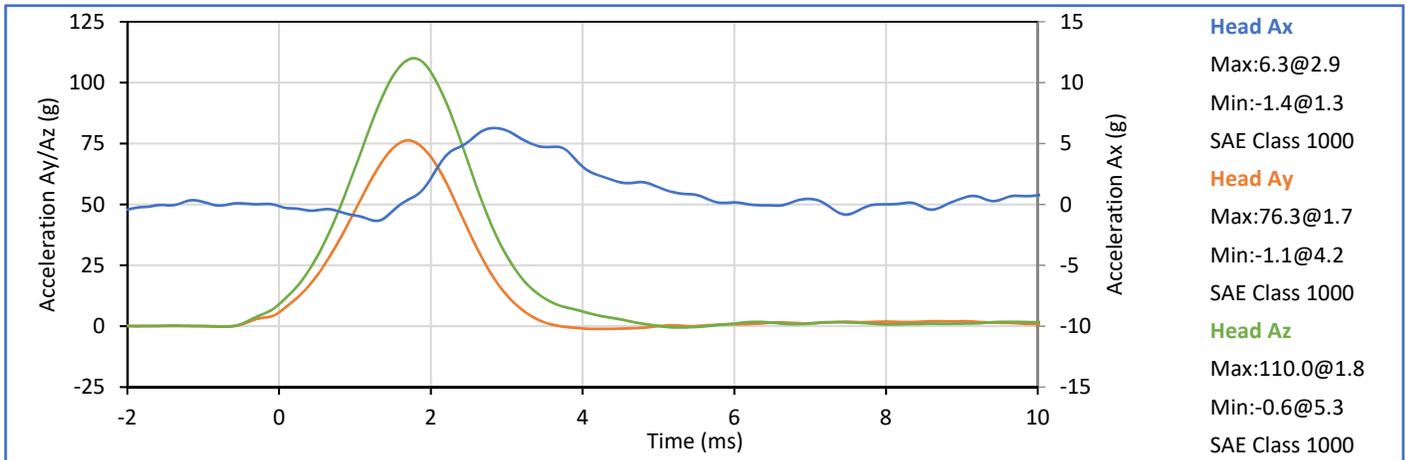
Tested Parameter	Units	Spec. Low	Spec. High	Result	Pass/Fail
Laboratory Temperature	°C	18.9	25.6	21.1	Pass
Laboratory Relative Humidity	%	10	70	23	Pass
Peak Resultant Acceleration	g	125.0	155.0	133.7	Pass
Peak Head Ax	g	-15.0	15.0	6.3	Pass
Oscillations After Main Pulse	%	0.0	15.0	1.9	Pass
Is Acceleration Unimodal?	Yes/No	Yes		Yes	Pass
Overall Test Results					Pass

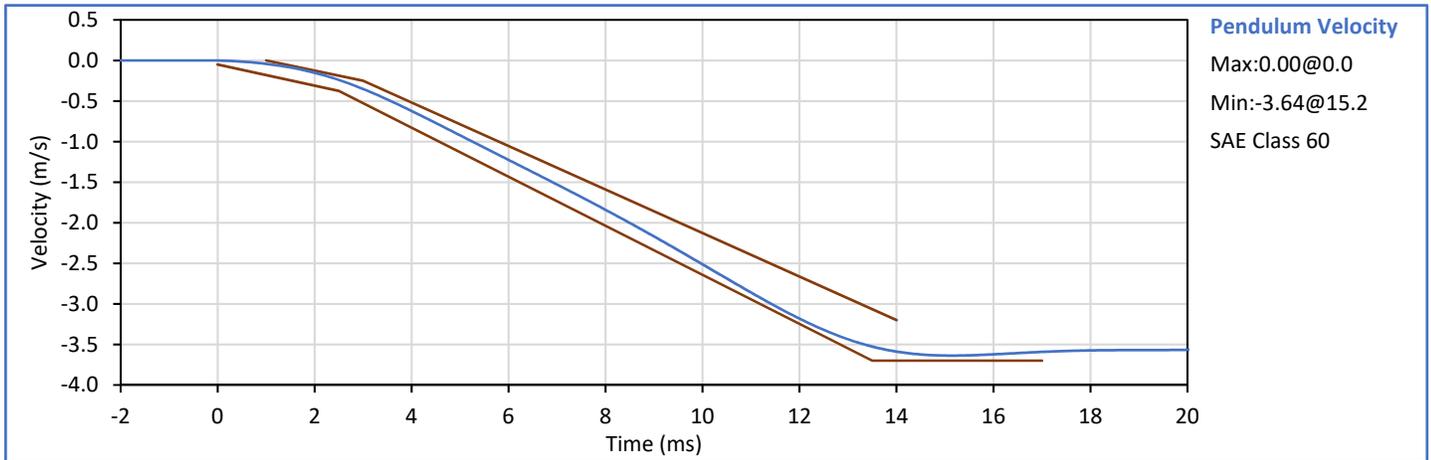
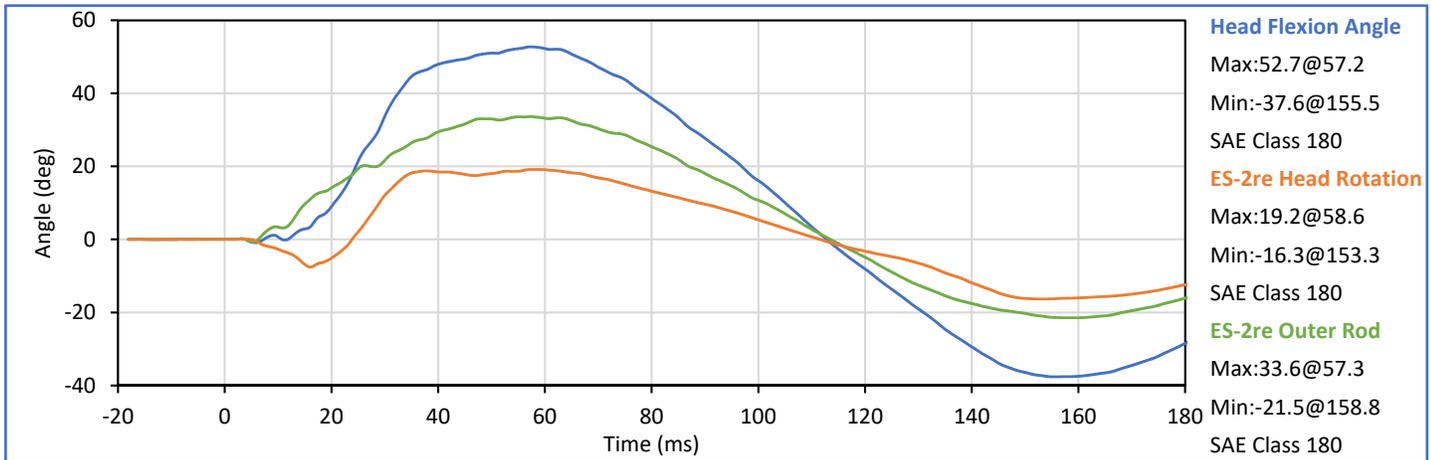
Tested Parameter	Units	Spec. Low	Spec. High	Result	Pass/Fail
Laboratory Temperature	°C	20.6	22.2	21.1	Pass
Laboratory Relative Humidity	%	10	70	30	Pass
Pendulum Velocity	m/s	3.30	3.50	3.46	Pass
Peak Headform Flexion	deg	49.0	59.0	52.7	Pass
Time of Peak Headform Flexion	ms	54.0	66.0	57.2	Pass
Flexion Decay (Peak to zero)	ms	53.0	88.0	55.6	Pass
Overall Test Results					Pass

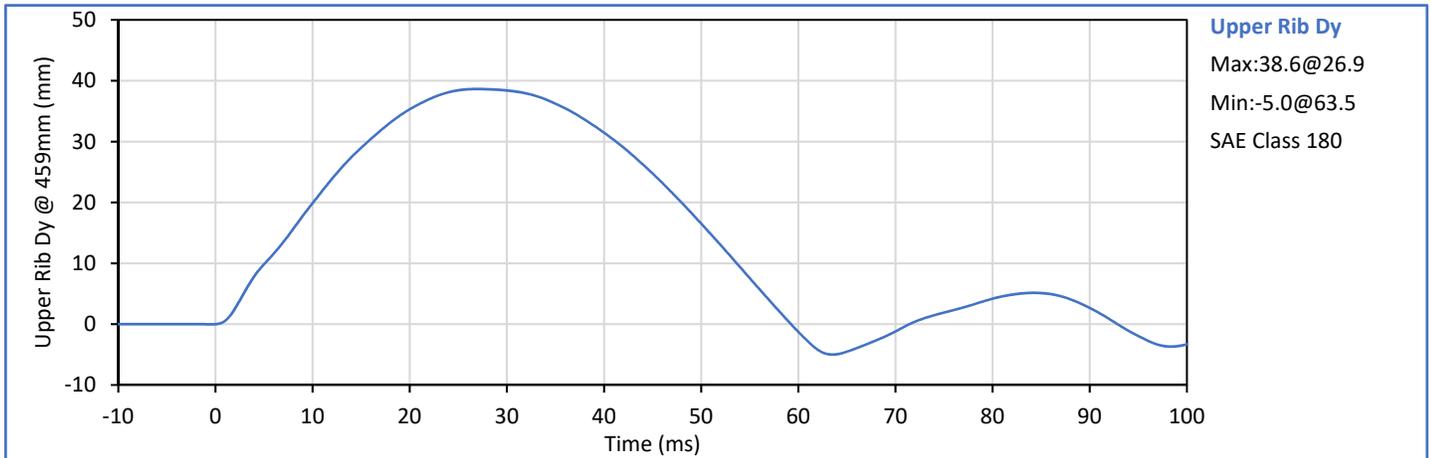
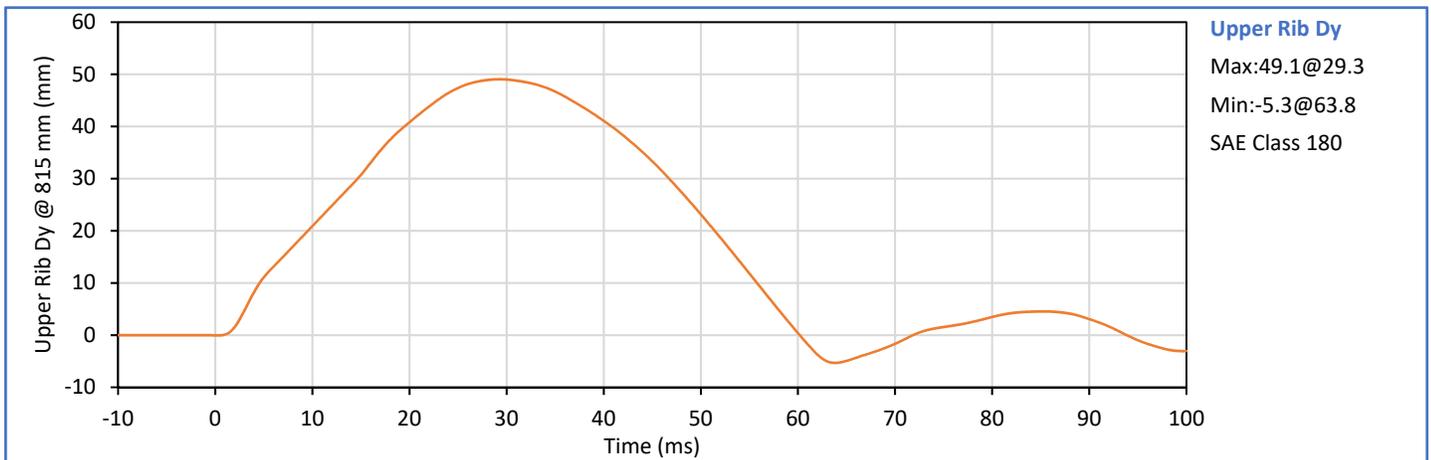
Tested Parameter	Units	Spec. Low	Spec. High	Result	Pass/Fail
Laboratory Temperature	°C	20.6	22.2	21.1	Pass
Laboratory Relative Humidity	%	10	70	32	Pass
Upper Rib Dy @ 459mm	mm	36.0	40.0	38.6	Pass
Upper Rib Dy @ 815mm	mm	46.0	51.0	49.1	Pass
Overall Test Results					Pass

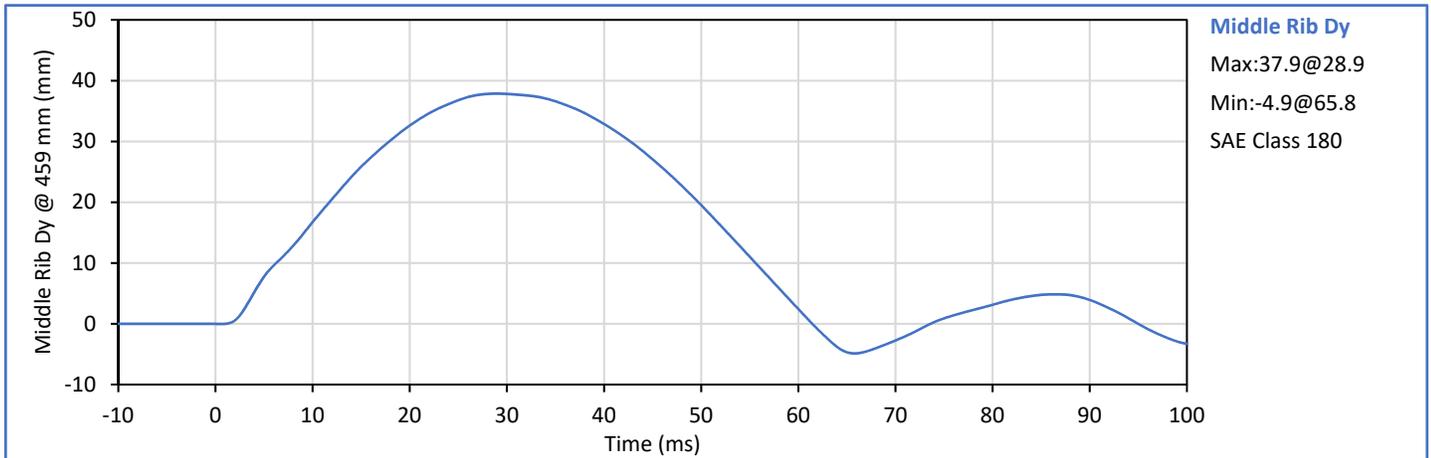
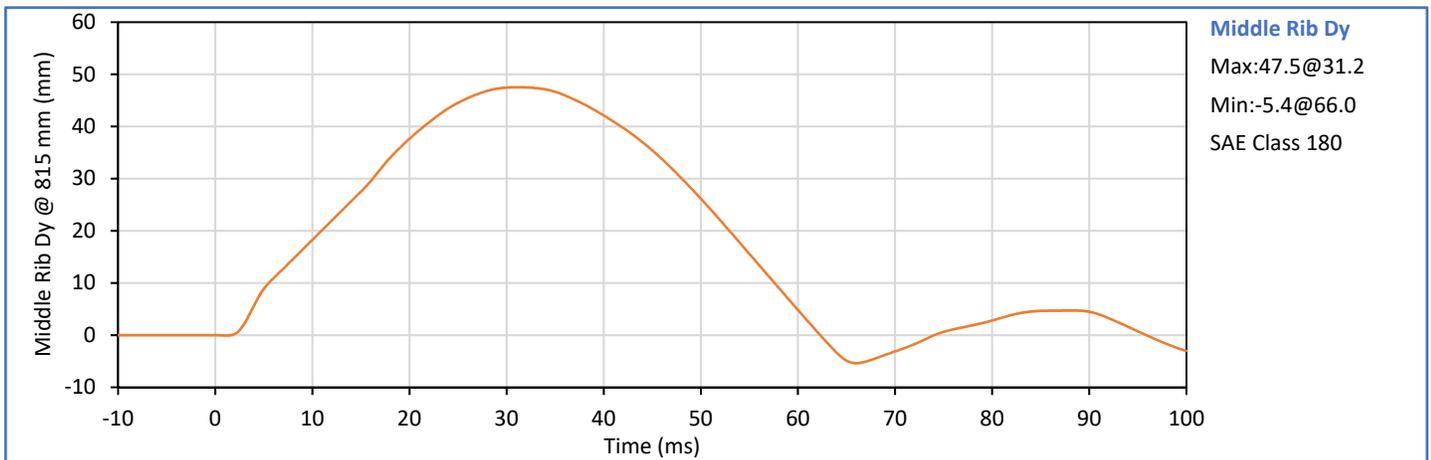
Tested Parameter	Units	Spec. Low	Spec. High	Result	Pass/Fail
Laboratory Temperature	°C	20.6	22.2	21.1	Pass
Laboratory Relative Humidity	%	10	70	32	Pass
Middle Rib Dy @ 459mm	mm	36.0	40.0	37.9	Pass
Middle Rib Dy @ 815mm	mm	46.0	51.0	47.5	Pass
Overall Test Results					Pass

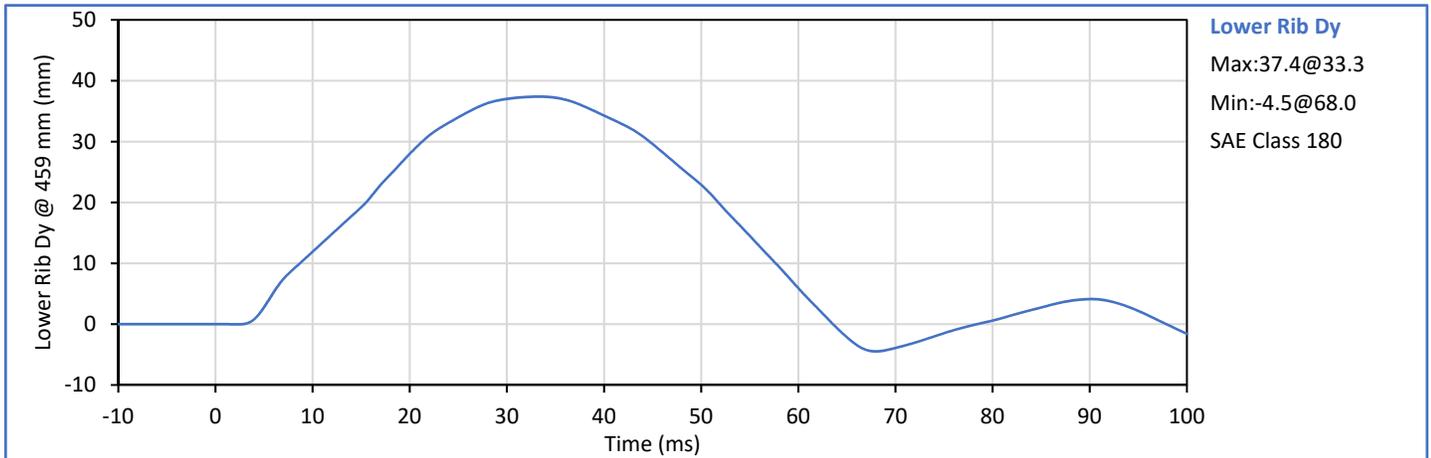
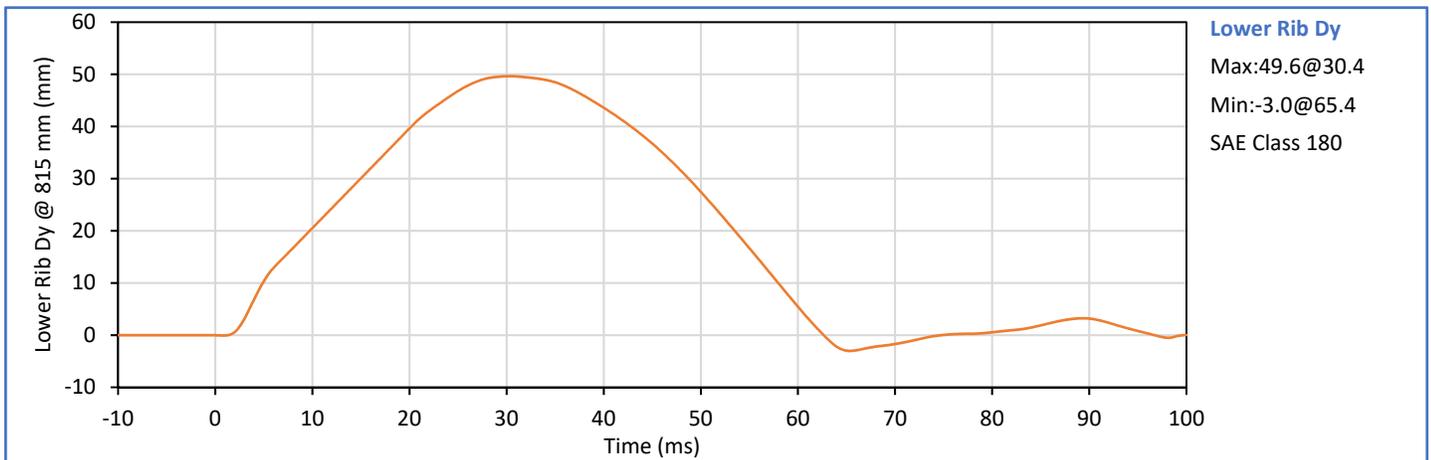
Tested Parameter	Units	Spec. Low	Spec. High	Result	Pass/Fail
Laboratory Temperature	°C	20.6	22.2	21.1	Pass
Laboratory Relative Humidity	%	10	70	32	Pass
Lower Rib Dy @ 459mm	mm	36.0	40.0	37.4	Pass
Lower Rib Dy @ 815mm	mm	46.0	51.0	49.6	Pass
Overall Test Results					Pass
