**REPORT NUMBER: NCAP-KAR-20-009**

**NEW CAR ASSESSMENT PROGRAM (NCAP)  
FRONTAL BARRIER IMPACT TEST**

**MAZDA MOTOR MANUFACTURING DE MEXICO S.A. DE C.V.  
2020 MAZDA3 AWD 4-DOOR SEDAN**

**NHTSA NUMBER: M20205403**

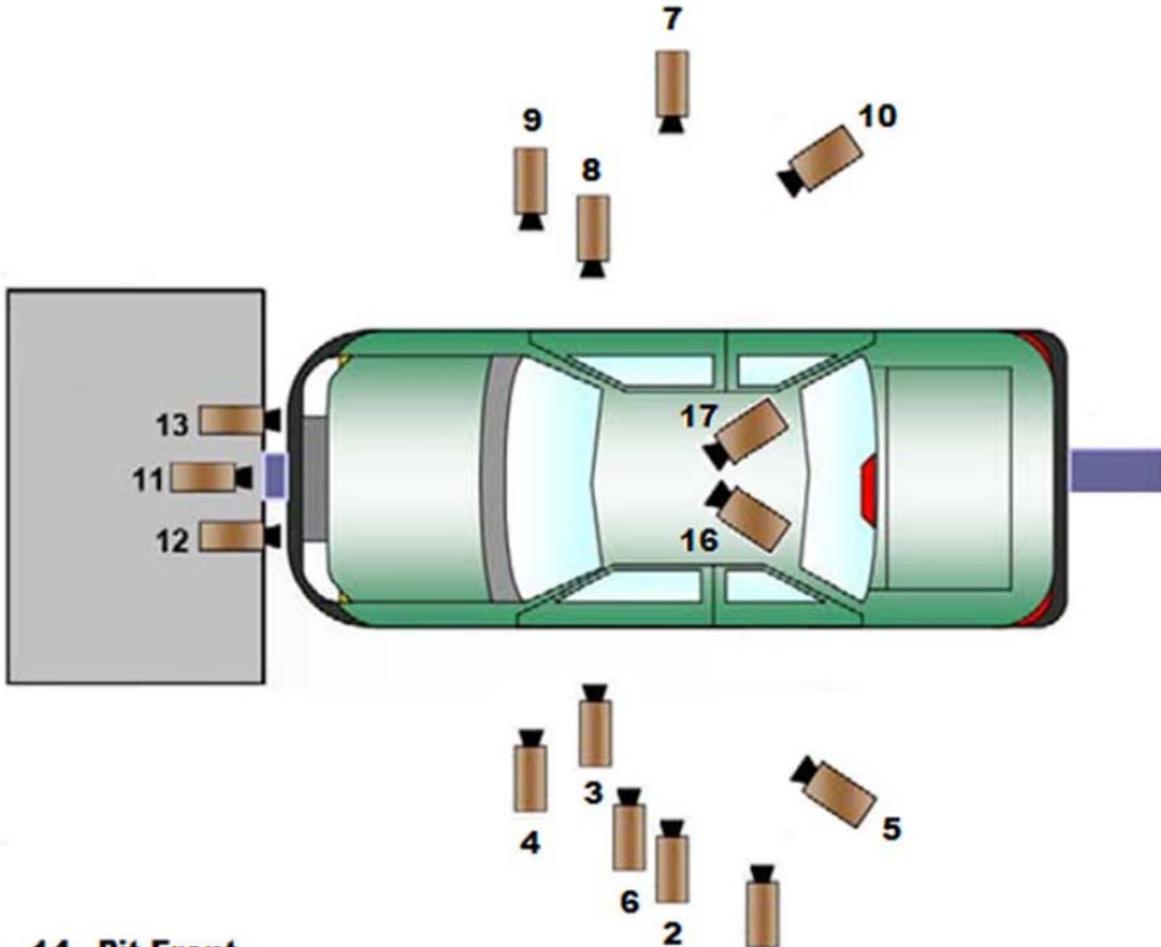
CAMERA POSITIONS FOR FRONTAL IMPACTS

14 - Pit Front

15 - Pit Rear

One (1) real-time cameras and sixteen (16) high-speed cameras were used to document the frontal barrier impact event. Camera locations and other pertinent camera information can be found in Data Sheet 6 of this report.

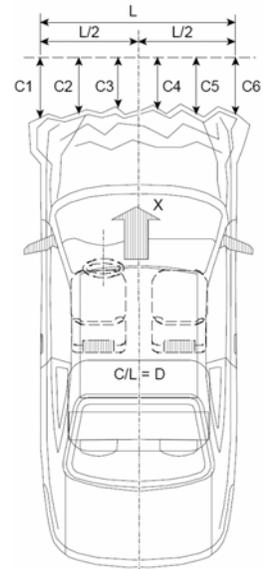
**CRUSH PROFILE**

Collision Deformation Classification: 12FDEW2  
 Midpoint of Damage: Vehicle Centerline  
 Damage Region Length (mm): 1385  
 Impact Mode: Full Frontal

No.	Measurement Description	Units	Pre-Test	Post-Test	Difference
C1	Crush Zone 1 at Left Side	mm	205	460	255
C2	Crush Zone 2 at Left Side	mm	98	440	342
C3	Crush Zone 3 at Left Side	mm	38	415	377
C4	Crush Zone 4 at Right Side	mm	38	440	402
C5	Crush Zone 5 at Right Side	mm	98	440	342
C6	Crush Zone 6 at Right Side	mm	205	470	265
L	C1 to C6	mm	1385

The maximum static crush was 432 mm at the vehicle's centerline and both the driver and passenger side doors remained closed during the impact event and were operable after the impact. The Engine Top Acceleration X channel failed at 84.1 milliseconds.

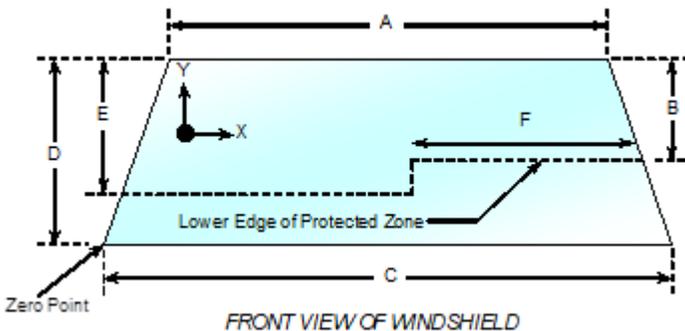
**WINDSHIELD PERIPHERY MEASUREMENTS**

Measurement	Pre-Test (mm)	Post-Test (mm)	% Retention
Left Side	2306	2306	100.0%
Right Side	2306	2306	100.0%
Total	4612	4612	100.0%

Item	Units	Value
A	mm	1238
B	mm	340
C	mm	1461
D	mm	956
E	mm	479
F	mm	535

There was 100 percent windshield retention and no intrusion into the protected zone of the windshield during the event. There was no Stoddard solvent leakage after the event or during any phase of the static rollover.
