**REPORT NUMBER: SPNCAP-KAR-20-011  
NEW CAR ASSESSMENT PROGRAM (NCAP)  
SIDE IMPACT POLE TEST**

**MAZDA MOTOR MANUFACTURING DE MEXICO S.A. DE C.V.  
2020 MAZDA3 4-DOOR SEDAN**

**NHTSA No: M20205404**

**FINAL REPORT**

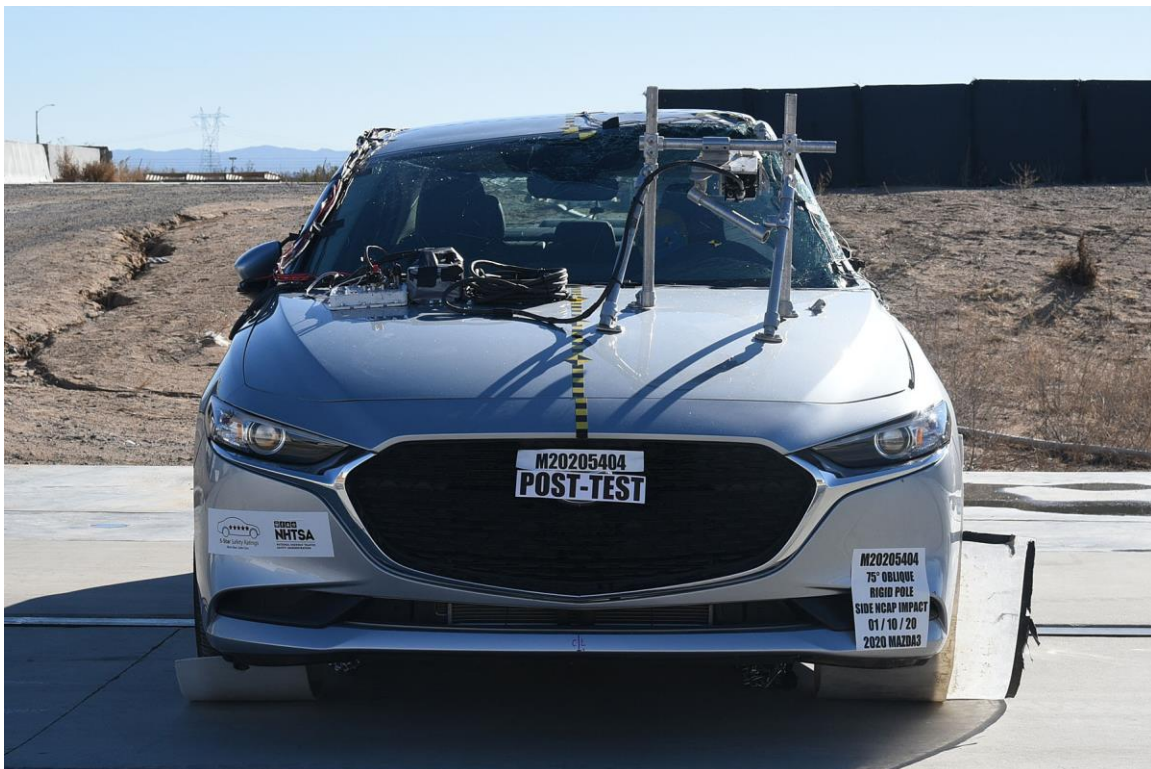
FIGURE 4. Post-Test Frontal View of Test Vehicle

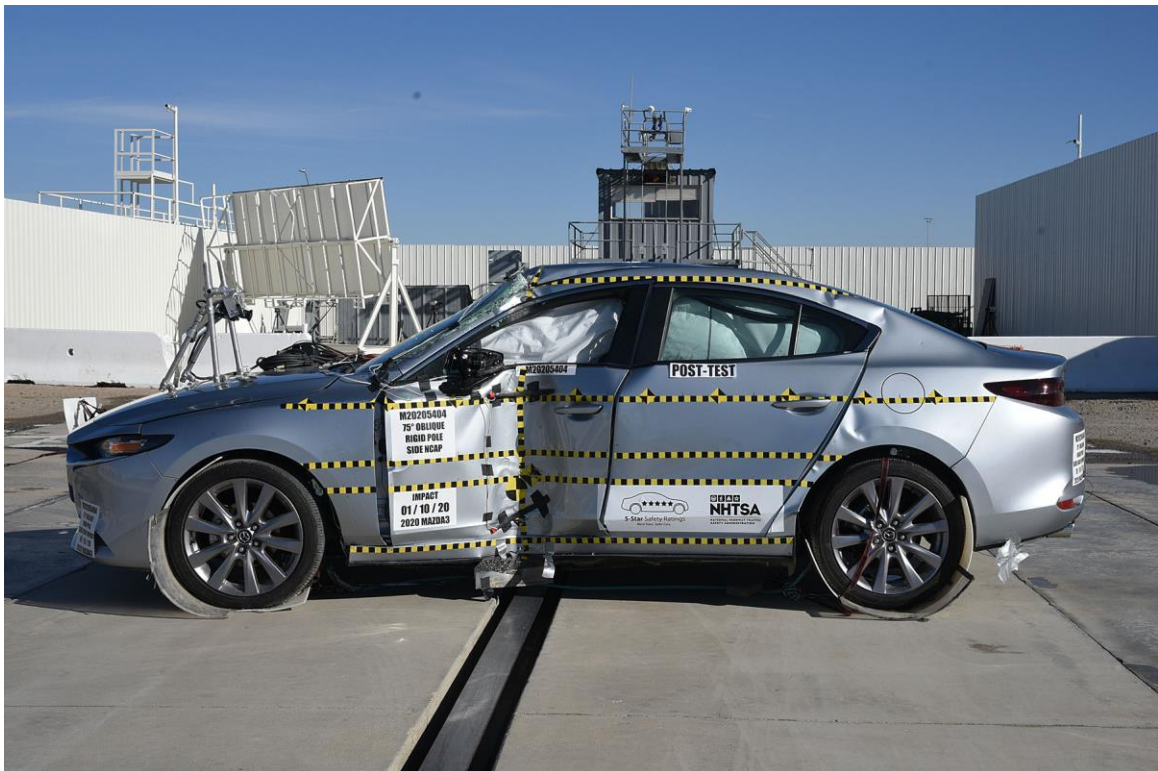
FIGURE 8. Post-Test Left Side View of Test Vehicle

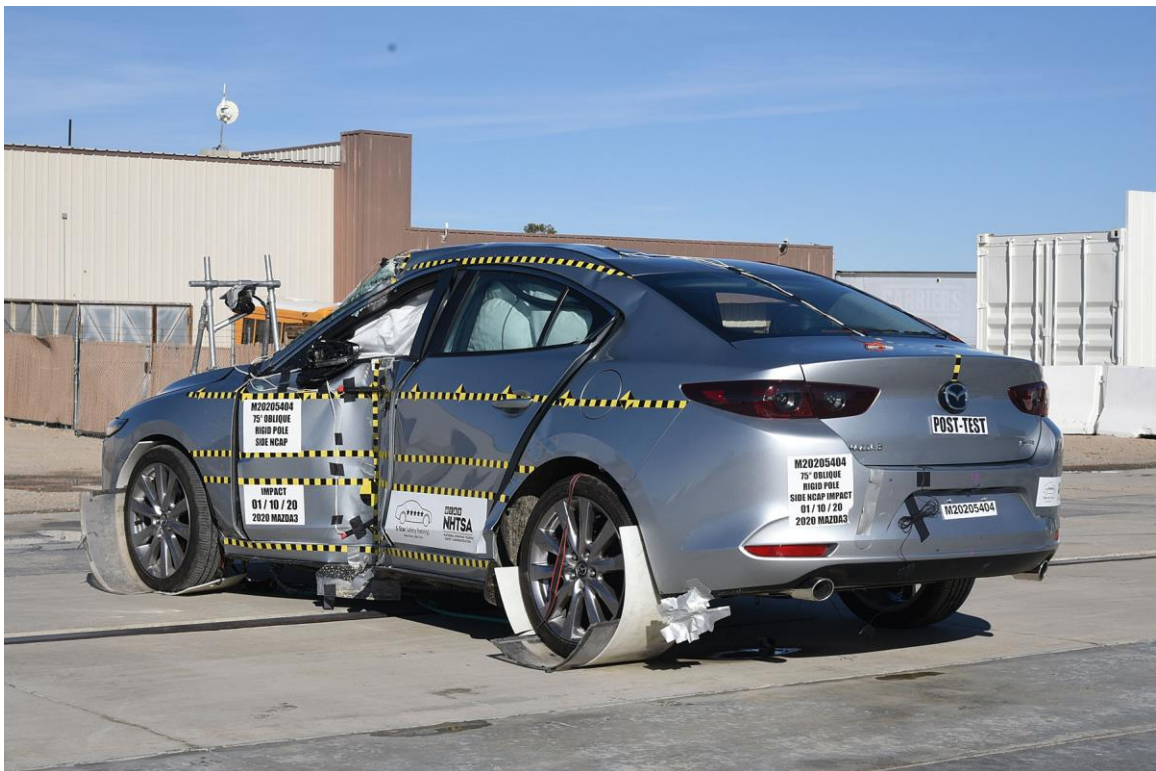
FIGURE 10. Post-Test Left Rear  $\frac{3}{4}$  View of Test Vehicle

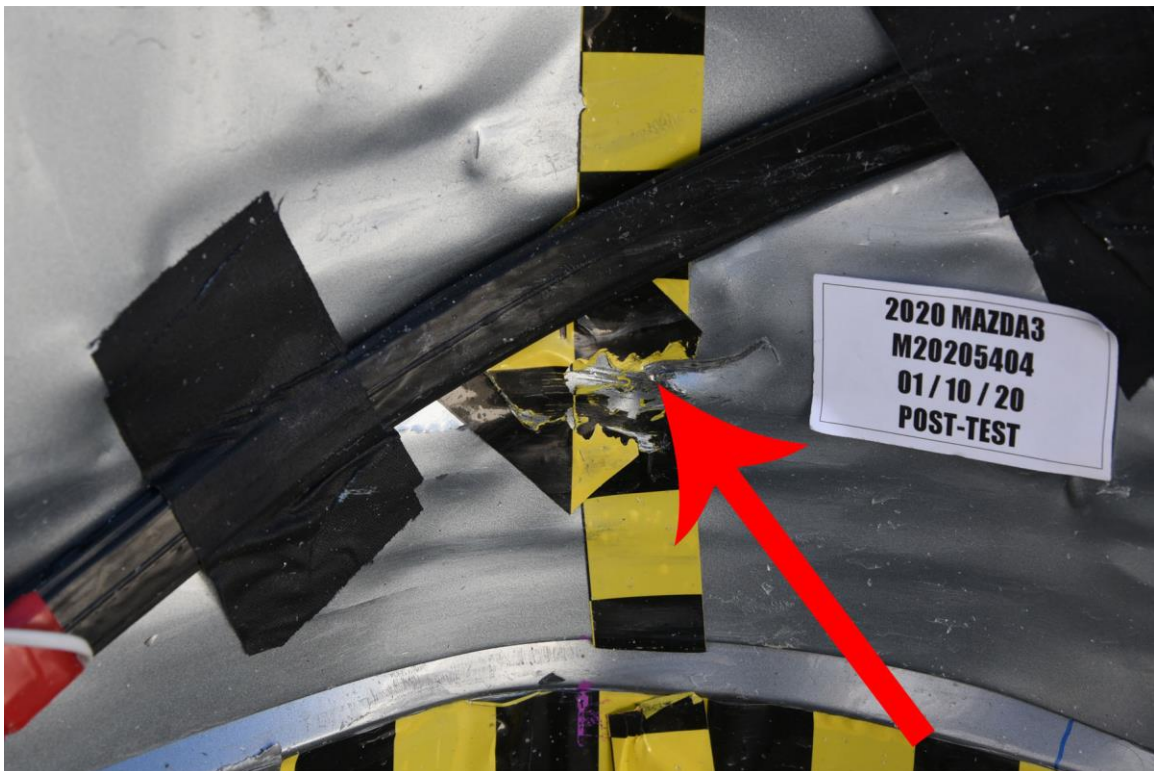
FIGURE 20. Post-Test Close-Up View of Impact Point Target Showing Impact Location

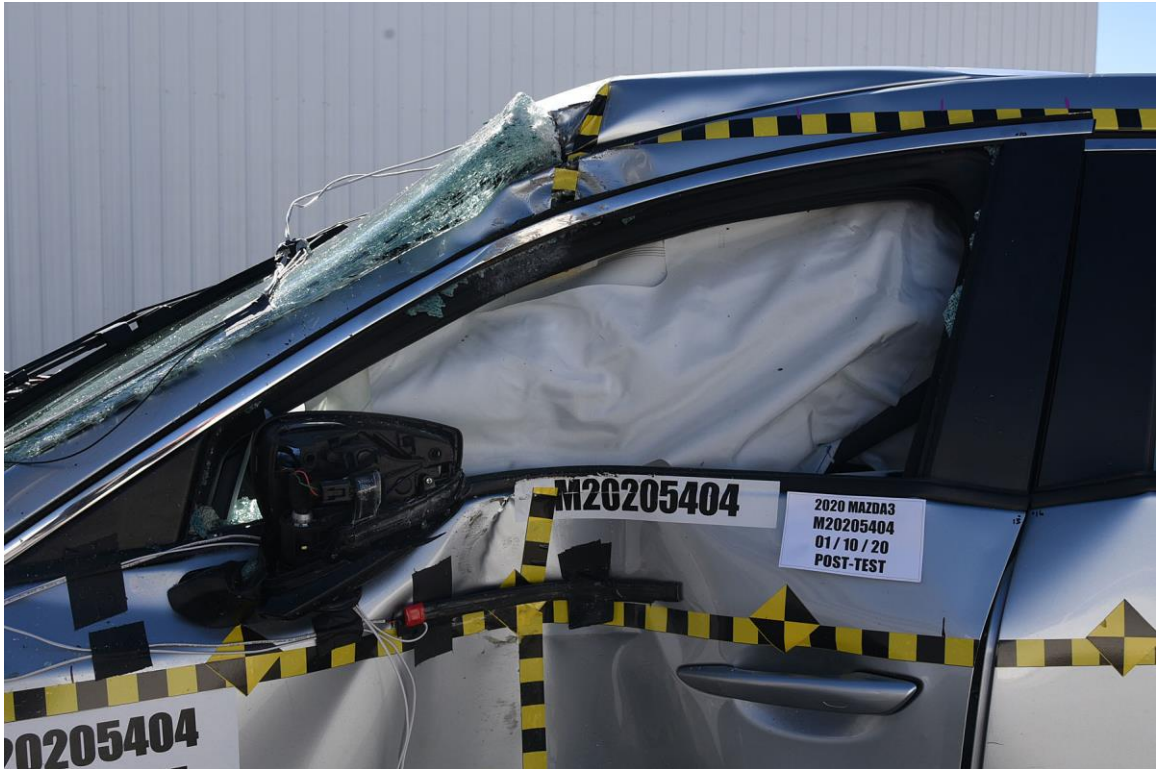
FIGURE 25. Post-Test Left Side View of Dummy Shoulder and Door Top View

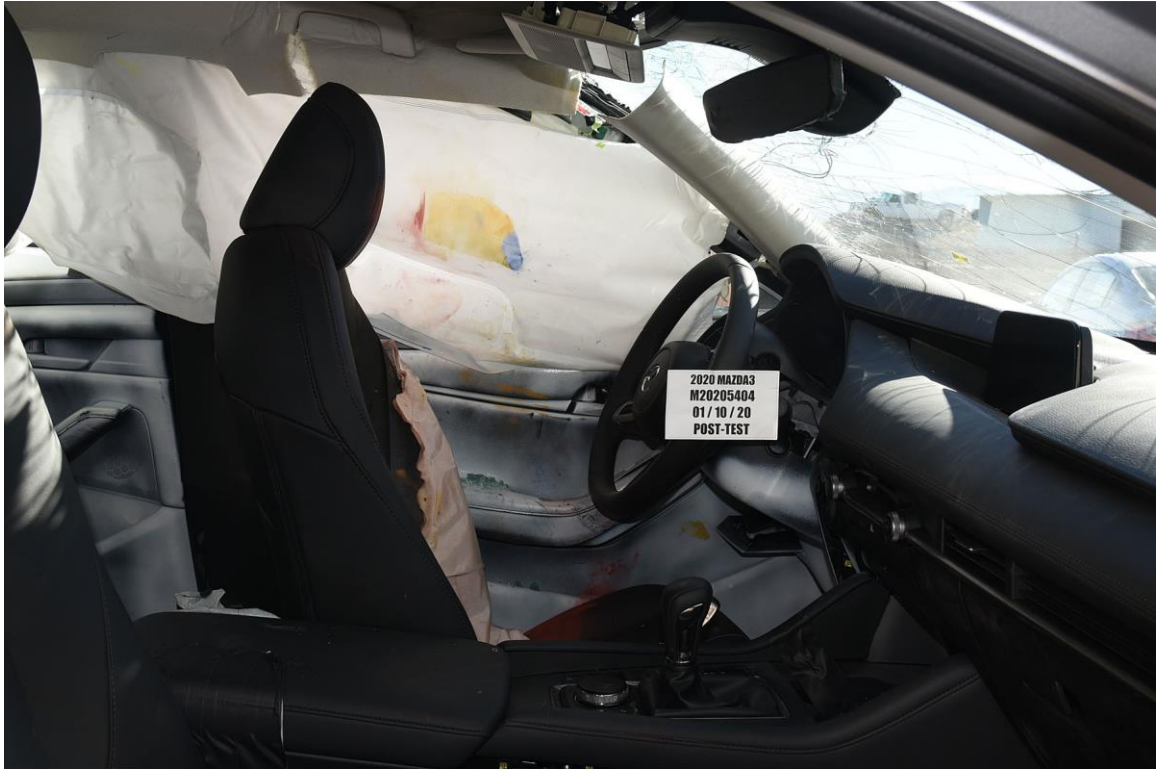
FIGURE 45. Post-Test Inner Door Panel View Showing Dummy Contact Locations

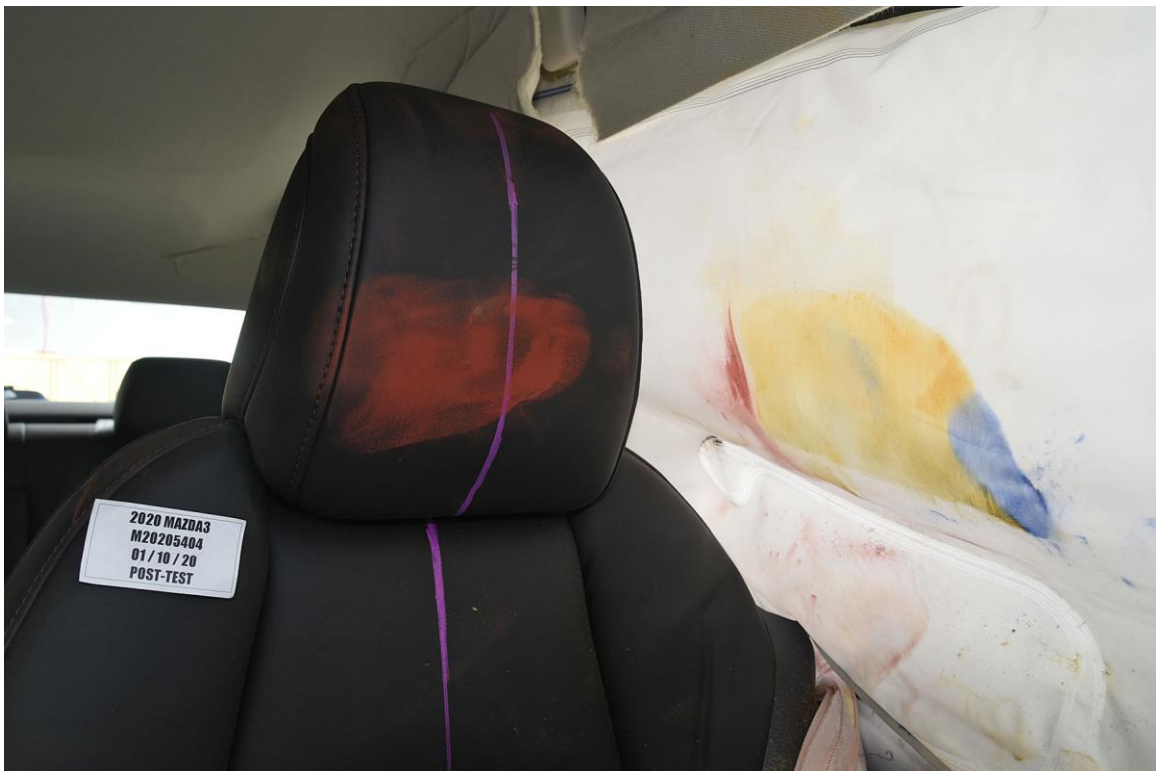
FIGURE 46. Post-Test Dummy Close-Up Head Contact with Vehicle Interior View

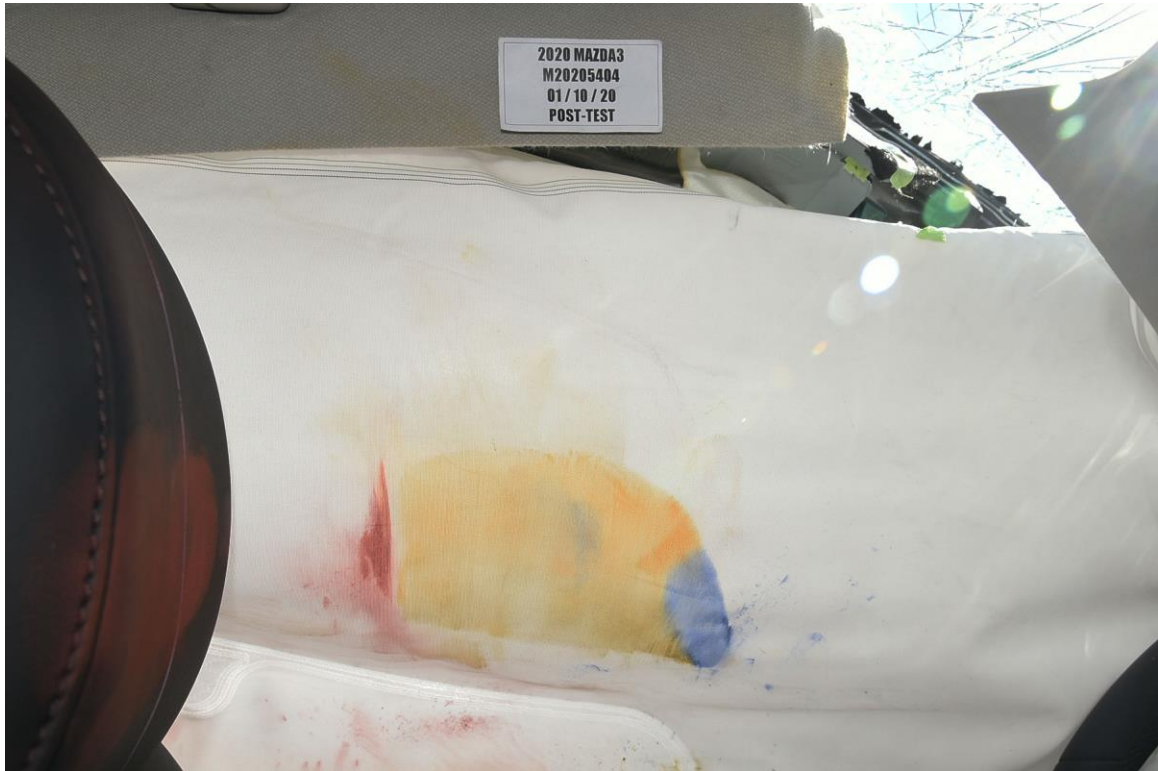
FIGURE 47. Post-Test Dummy Close-Up Head Contact With Side Airbag View

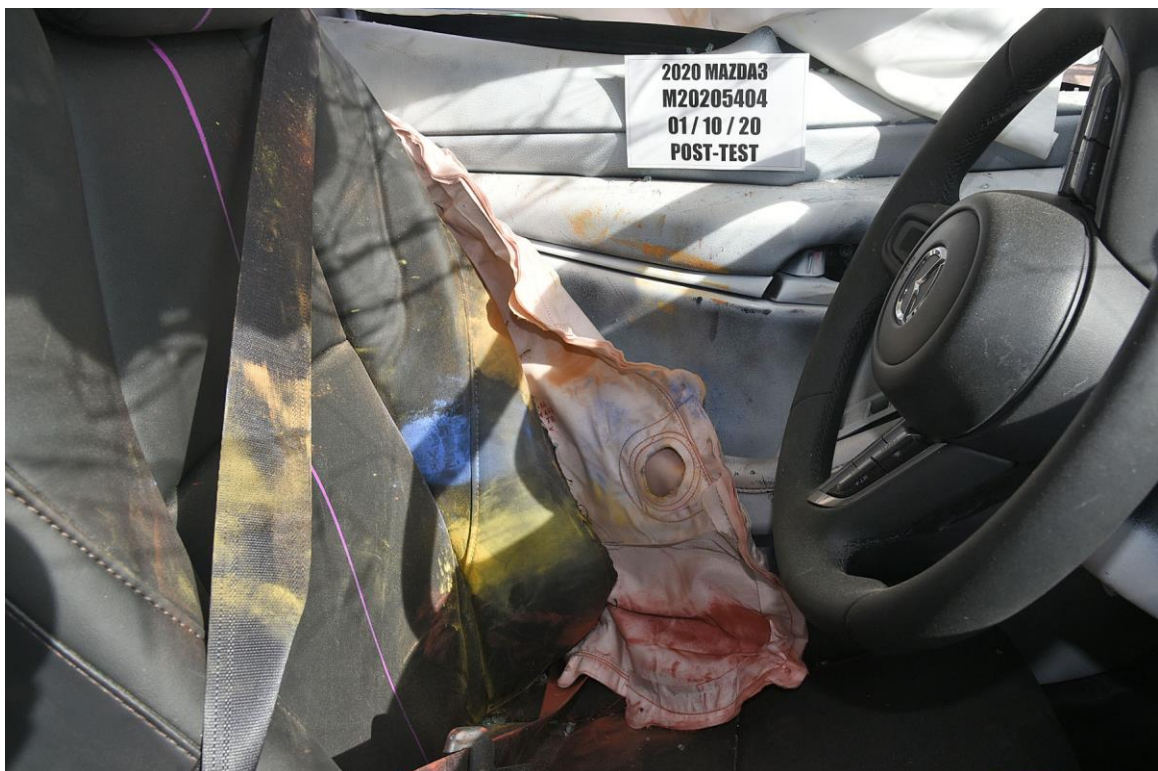
FIGURE 48. Post-Test Dummy Close-Up Torso Contact With Vehicle Interior View

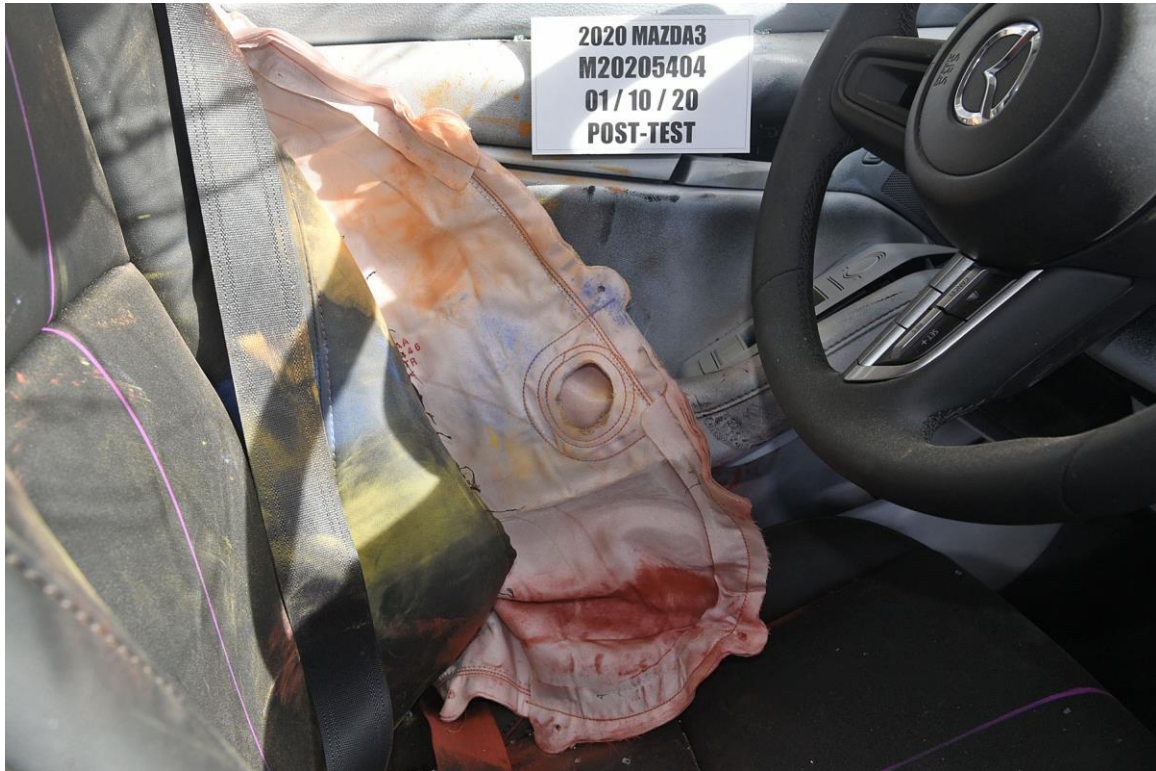
FIGURE 49. Post-Test Dummy Close-Up Torso Contact With Side Airbag View

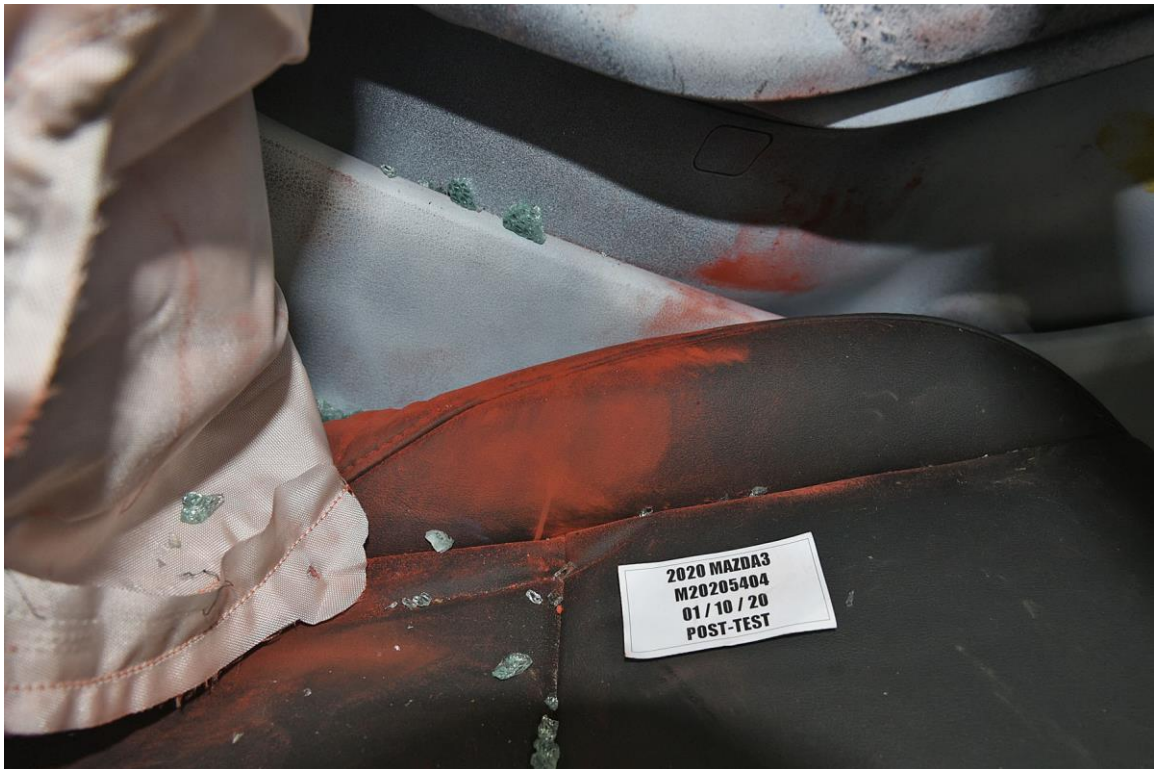
FIGURE 50. Post-Test Dummy Close-Up Pelvis Contact With Vehicle Interior View

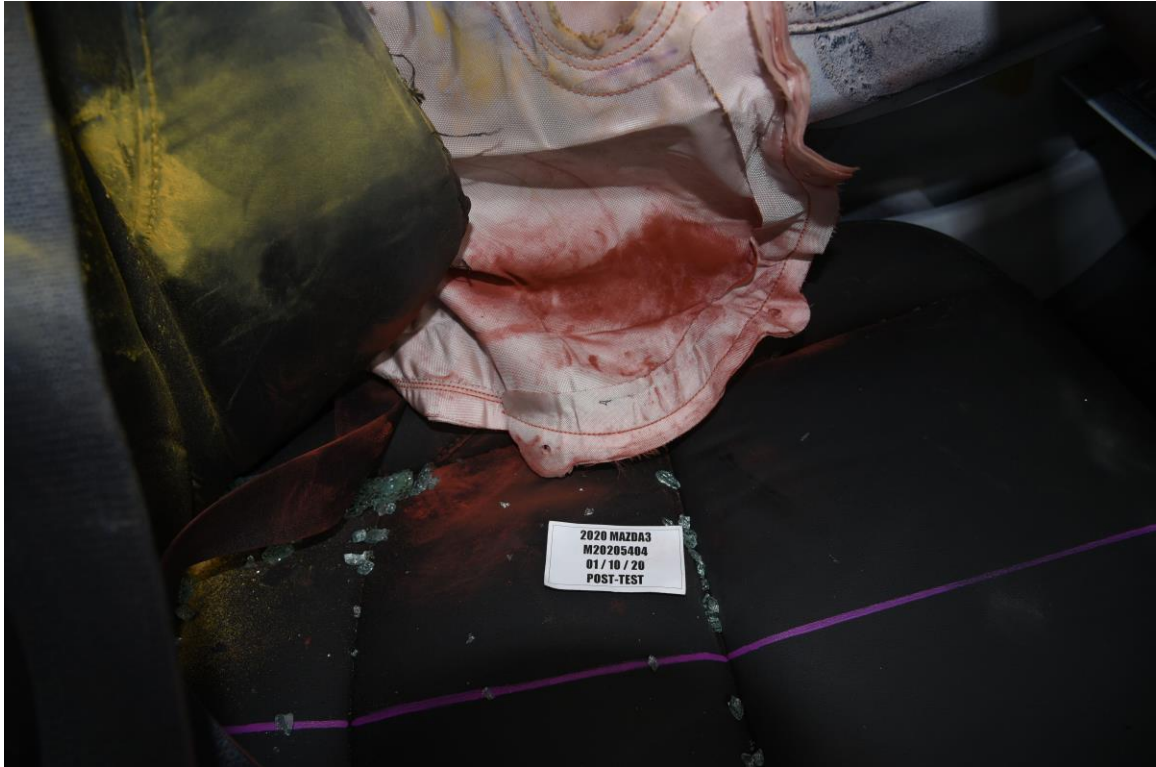
FIGURE 51. Post-Test Dummy Close-Up Pelvis Contact With Side Airbag View

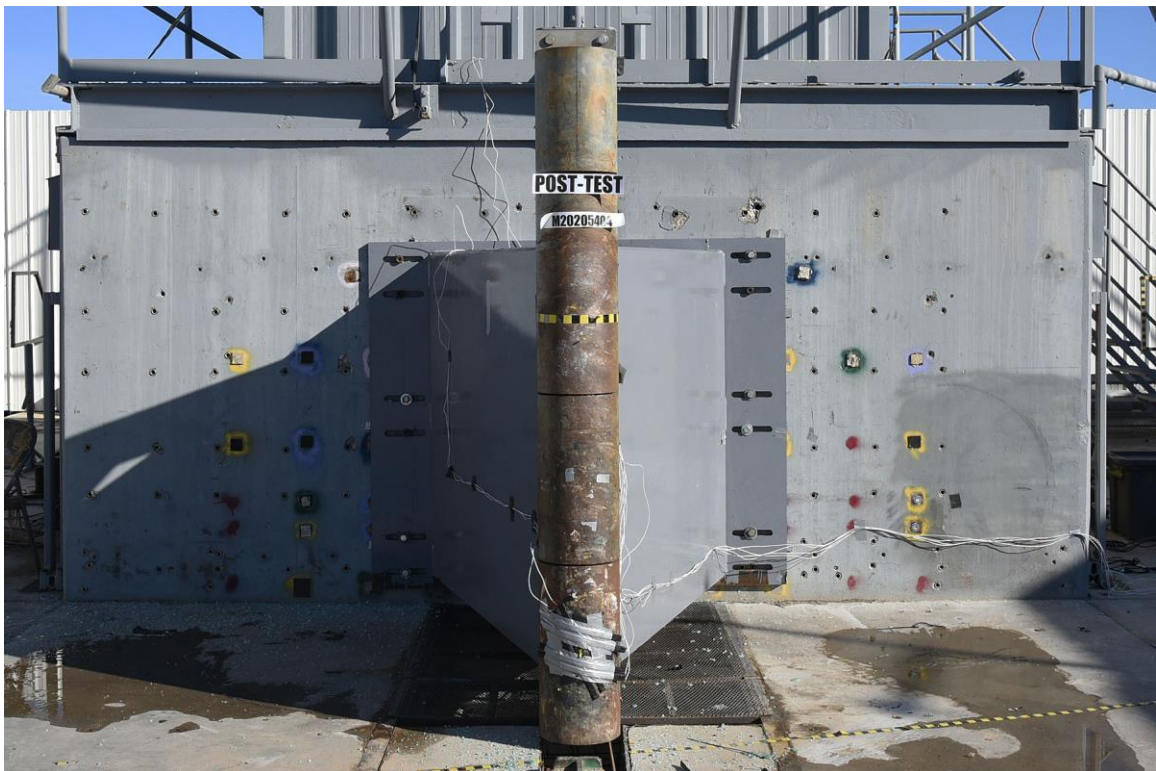
FIGURE 58. Post-Test Pole Barrier Front View

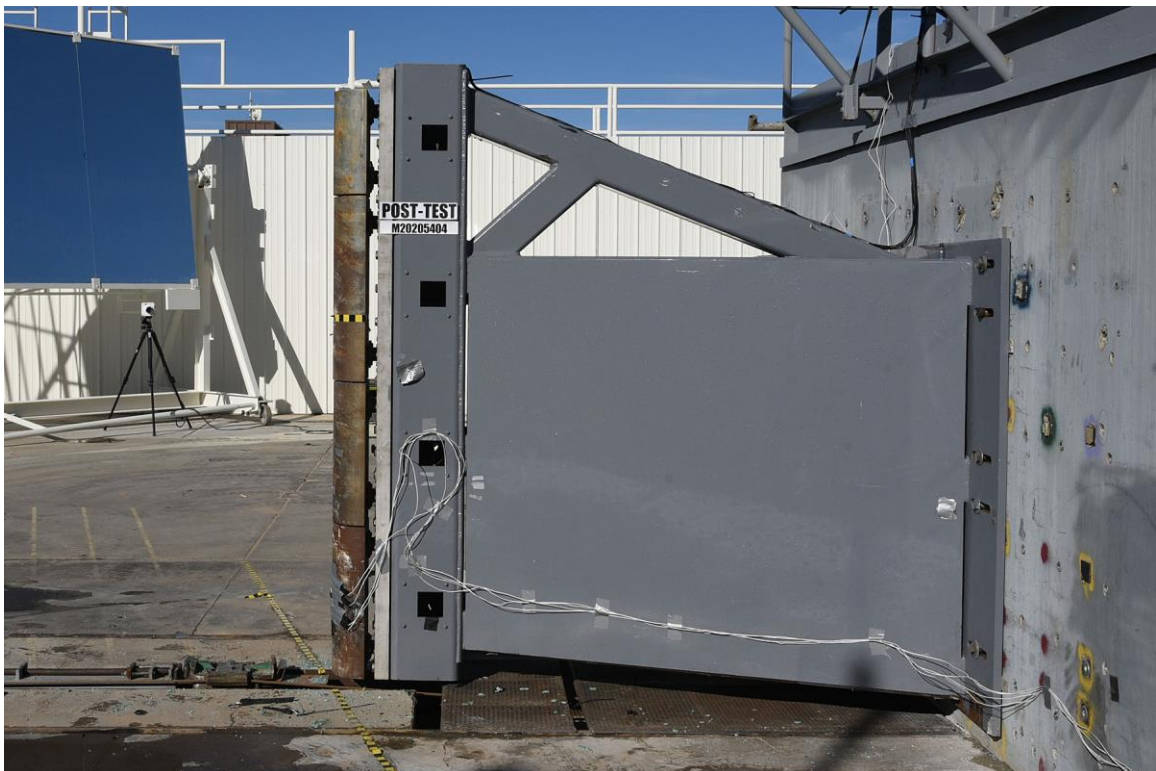
FIGURE 60. Post-Test Pole Barrier Side View

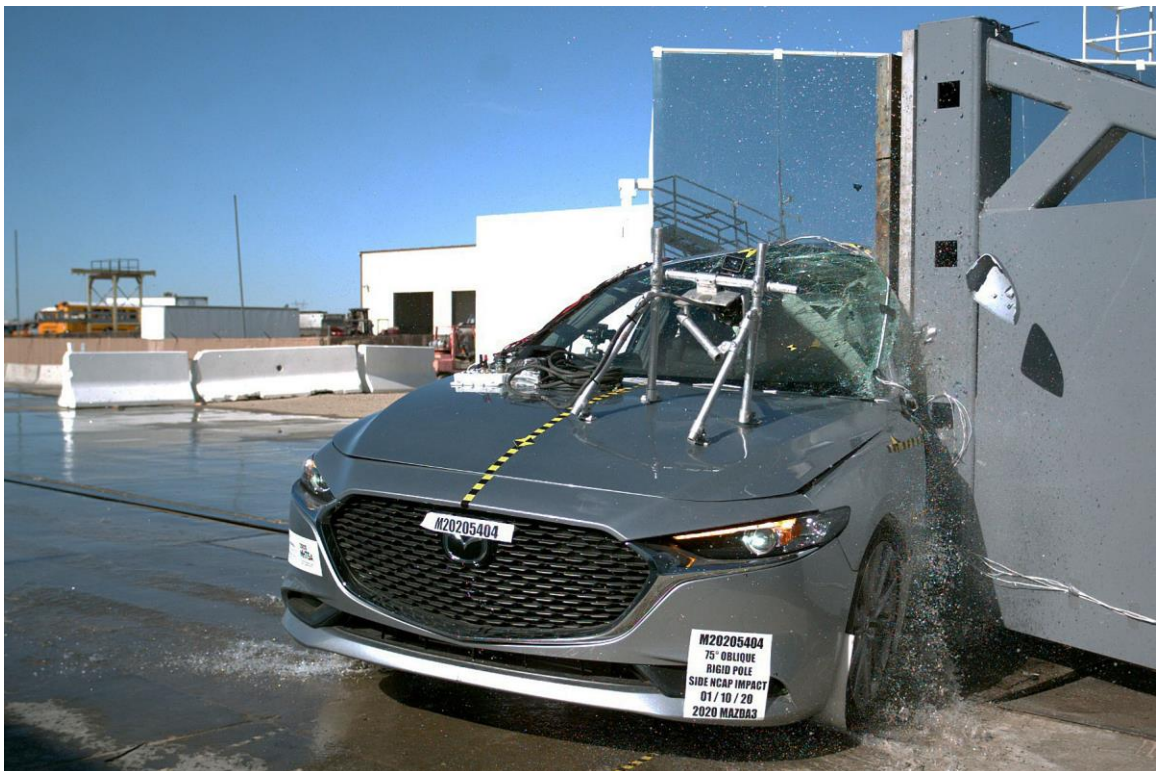
FIGURE 68. Impact Event

A rigid pole side impact test was conducted on a 2020 MAZDA3 4-door sedan. The subject vehicle was towed into the rigid pole at an angle of 75.5° and a velocity of 32.05 km/h. The test was conducted by Applus IDIADA KARCO Engineering, LLC. in Adelanto, California on January 10, 2020. Pre- and post-test photographs of the test vehicle and side impact dummy (SID-IIs) are included in Appendix A of this report.
