REPORT NUMBER: NCAP-KAR-20-017

**NEW CAR ASSESSMENT PROGRAM (NCAP)
FRONTAL BARRIER IMPACT TEST**

**HYUNDAI MOTOR COMPANY
2020 HYUNDAI PALISADE AWD 5-DOOR MPV**

NHTSA NUMBER: M20204203

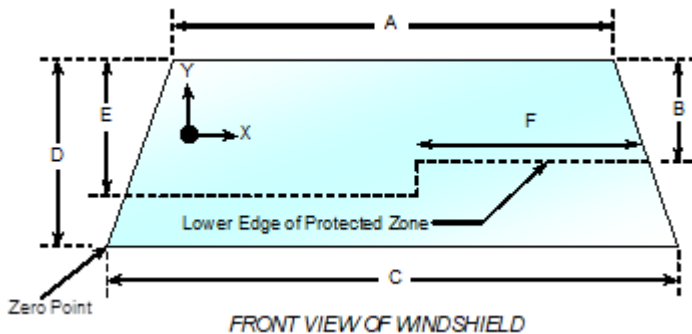
WINDSHIELD PERIPHERY MEASUREMENTS

Item	Units	Value
A	mm	1340
B	mm	355
C	mm	1593
D	mm	855
E	mm	436
F	mm	555
