REPORT NUMBER: SINCAP-CAL-20-006

**NEW CAR ASSESSMENT PROGRAM (NCAP)
MOVING DEFORMABLE BARRIER SIDE IMPACT TEST**

**Volvo Car Corporation
2020 Volvo S60
Four Door Sedan**

NHTSA No: M20205902

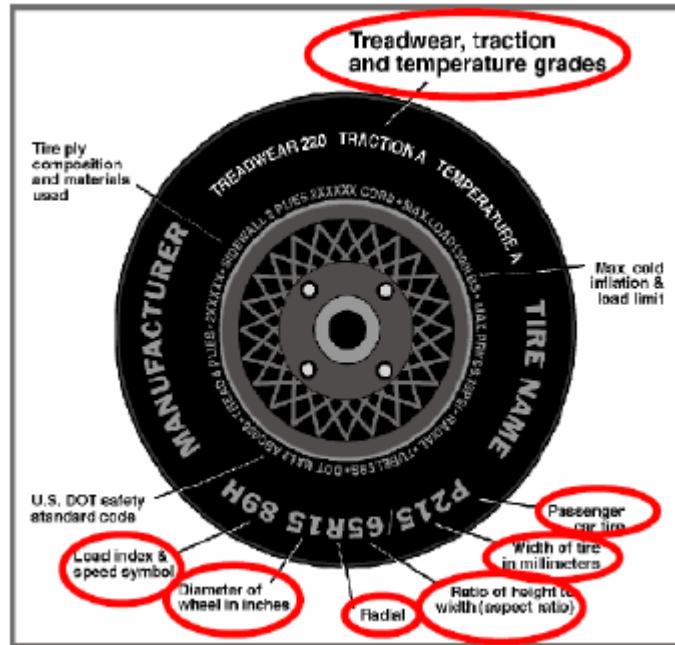
VEHICLE TIRE INFORMATION

Collected for year, make, model, & VIN, all items circled in red, tire manufacturer and tire name.

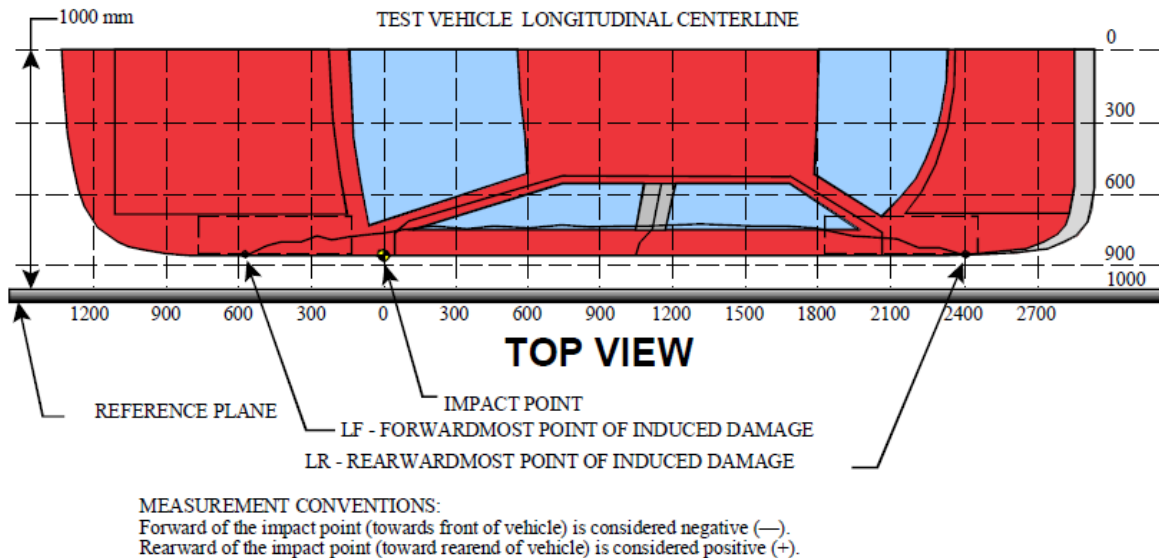
DATA SHEET NO. 13 **VEHICLE AND MDB DAMAGE PROFILE DISTANCES**

DPD	Distance From Impact Point (mm)	Level	Post-Test (mm)	Pre-Test (mm)	Crush (mm)
1	-150	3	110	84	26
2	270	3	213	90	123
3	690	3	277	87	190
4	1110	3	258	89	169
5	1530	3	287	98	189
6	1950	3	196	91	105
