REPORT NUMBER: SPNCAP-CAL-20-006

**NEW CAR ASSESSMENT PROGRAM (NCAP)
SIDE IMPACT POLE TEST**

**Volvo Car Corporation
2020 Volvo S60
Four Door Sedan**

FINAL REPORT

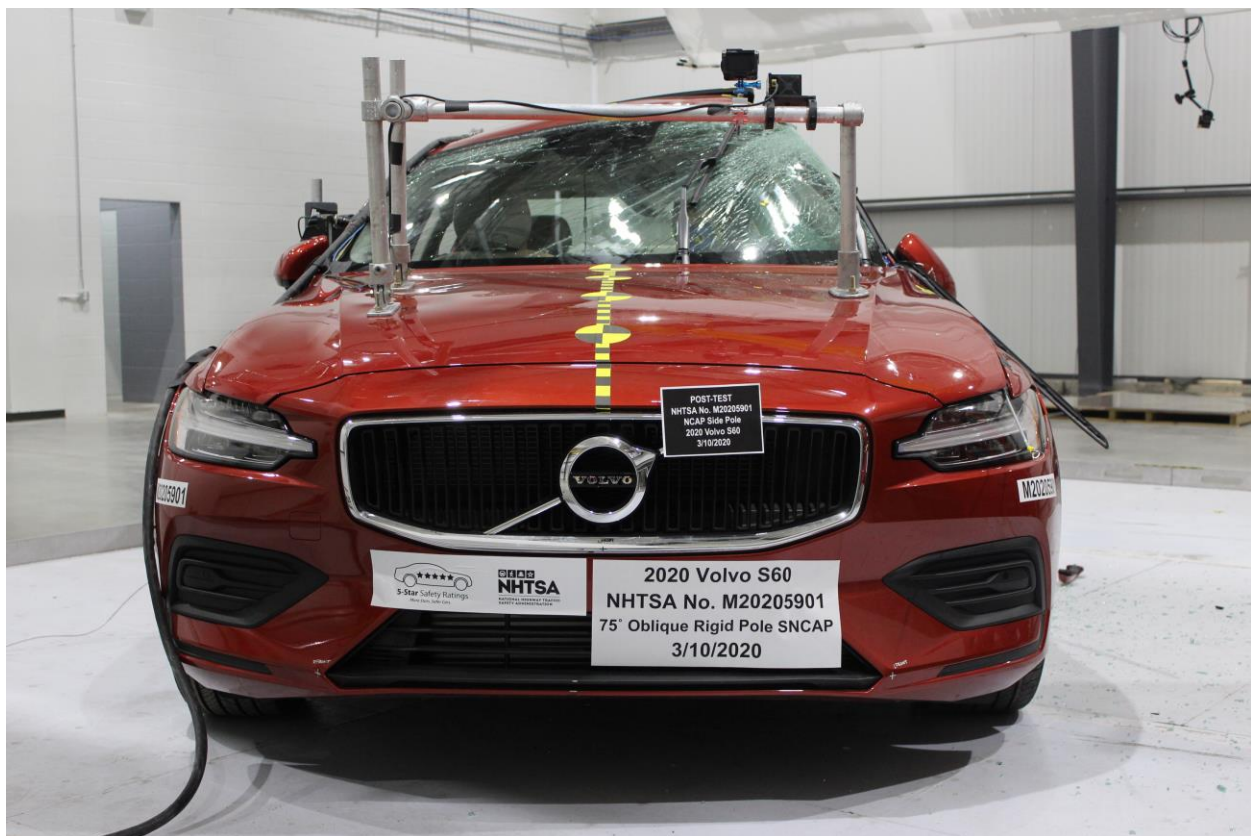
Figure A-4: Post-Test Frontal View of Test Vehicle

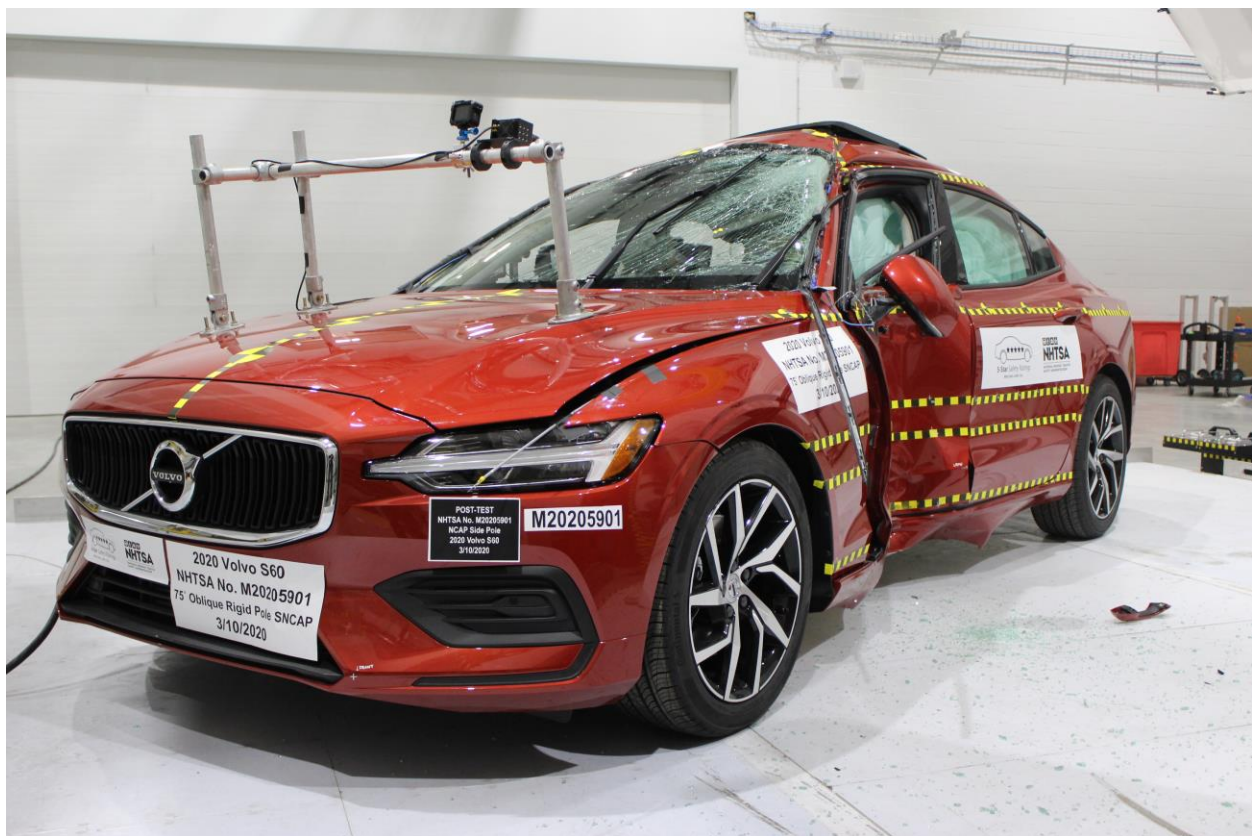
Figure A-6: Post-Test Left Front $\frac{3}{4}$ View of Test Vehicle

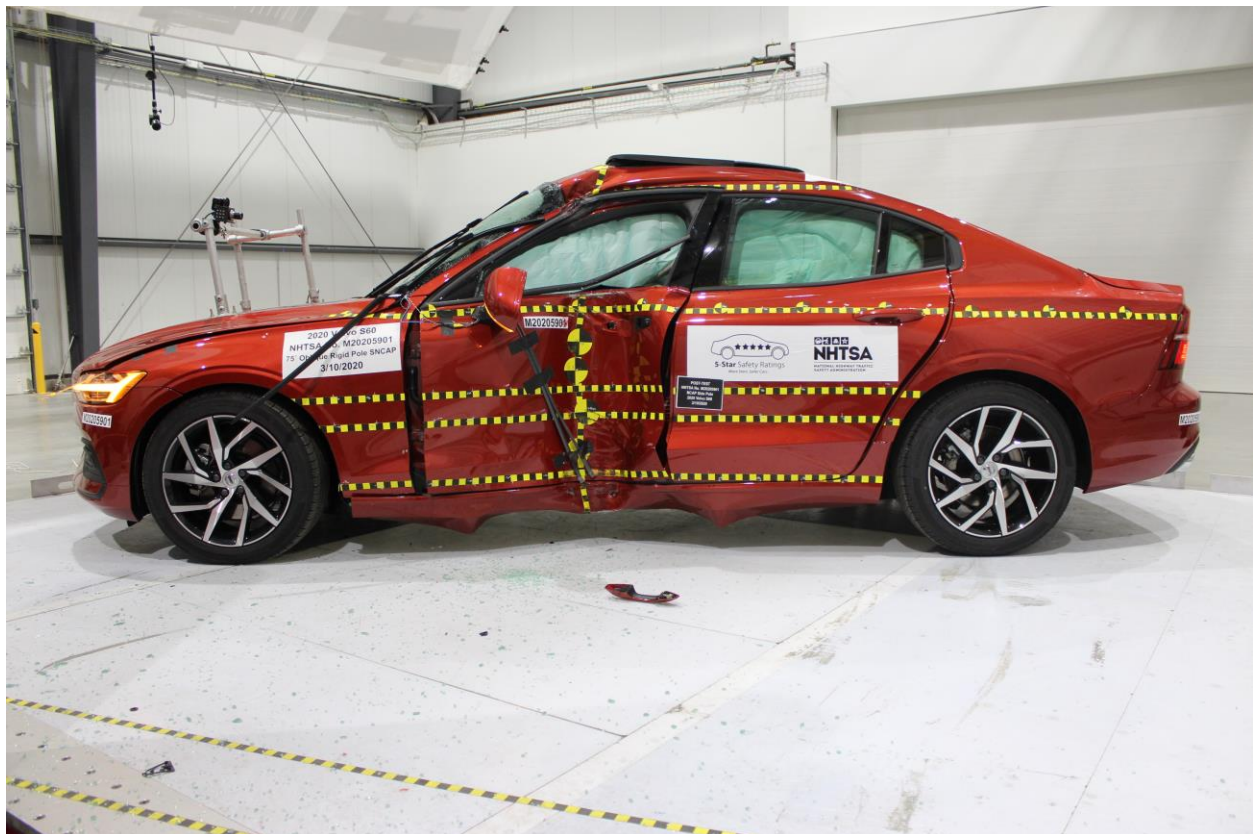
Figure A-8: Post-Test Left Side View of Test Vehicle

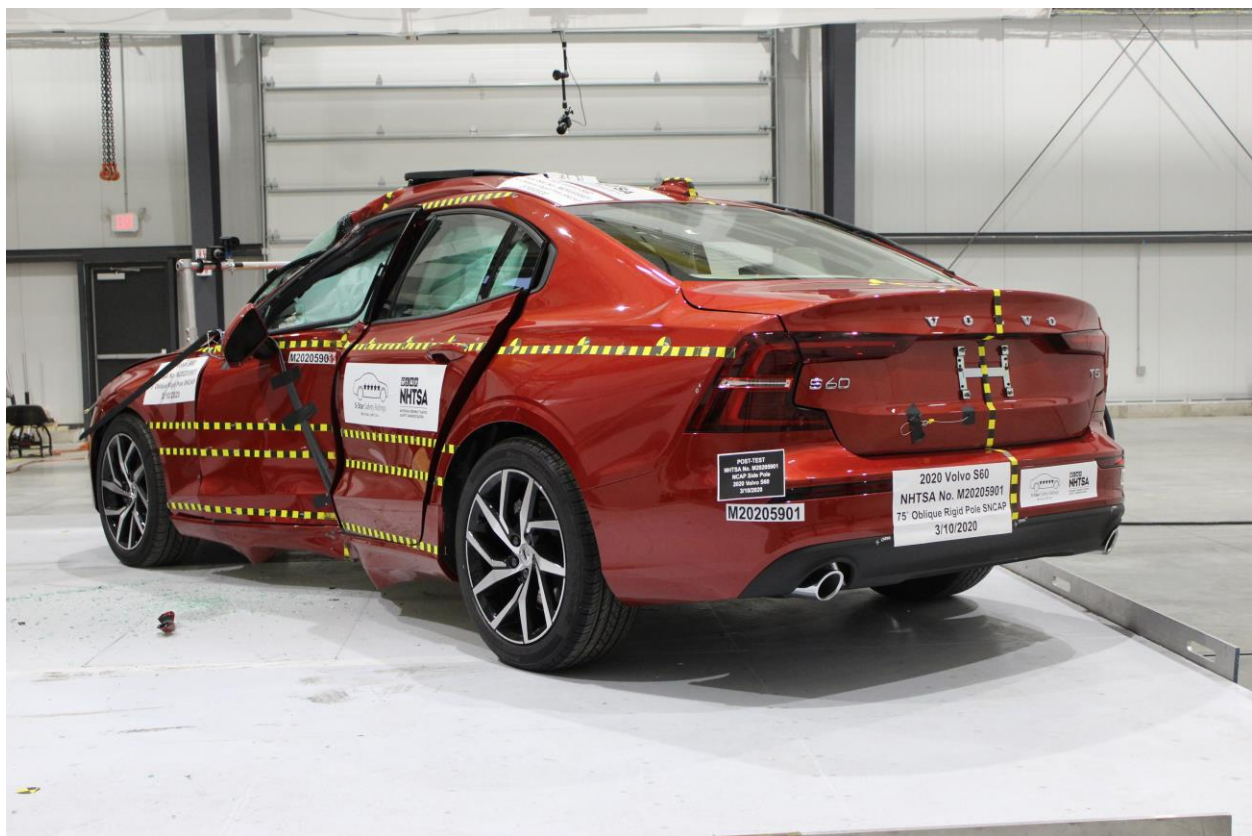
Figure A-10: Post-Test Left Rear $\frac{3}{4}$ View of Test Vehicle

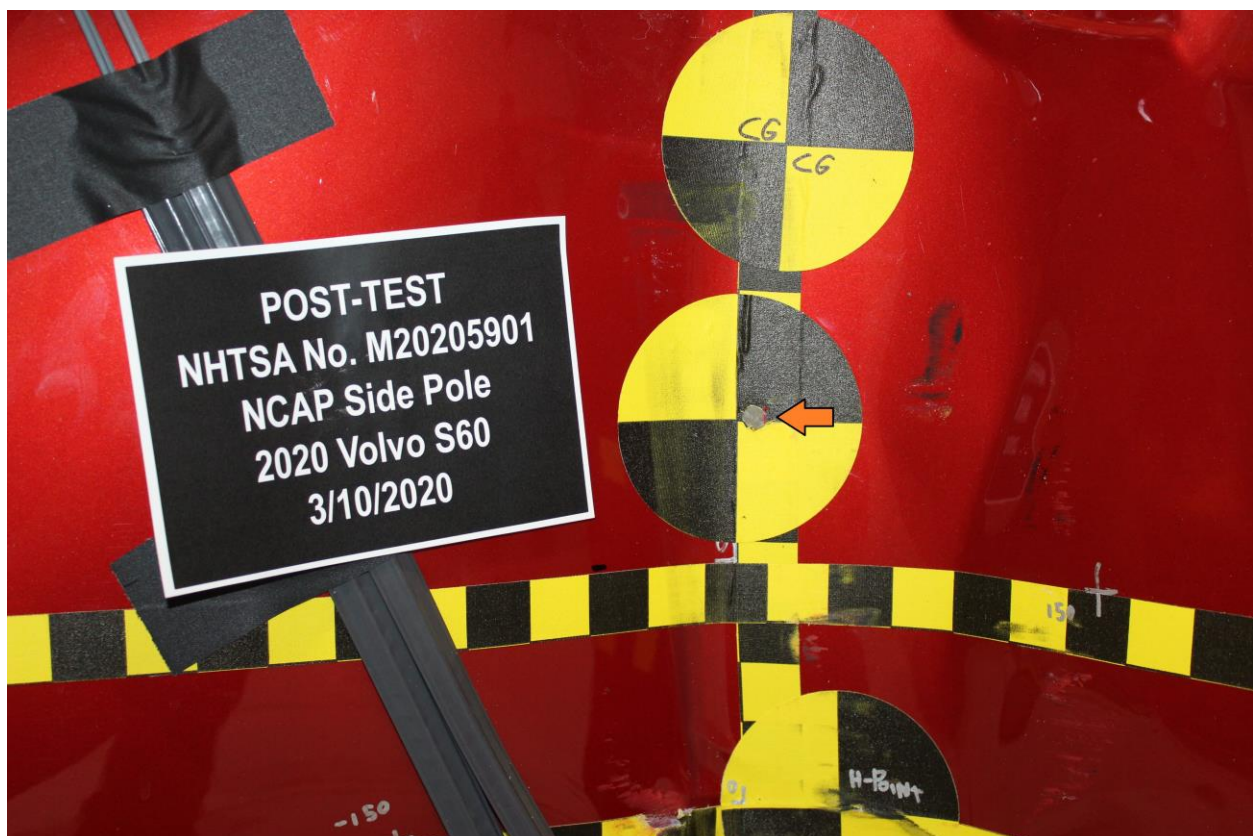
Figure A-20: Post-Test Close-Up View of Impact Point Target Showing Impact Location

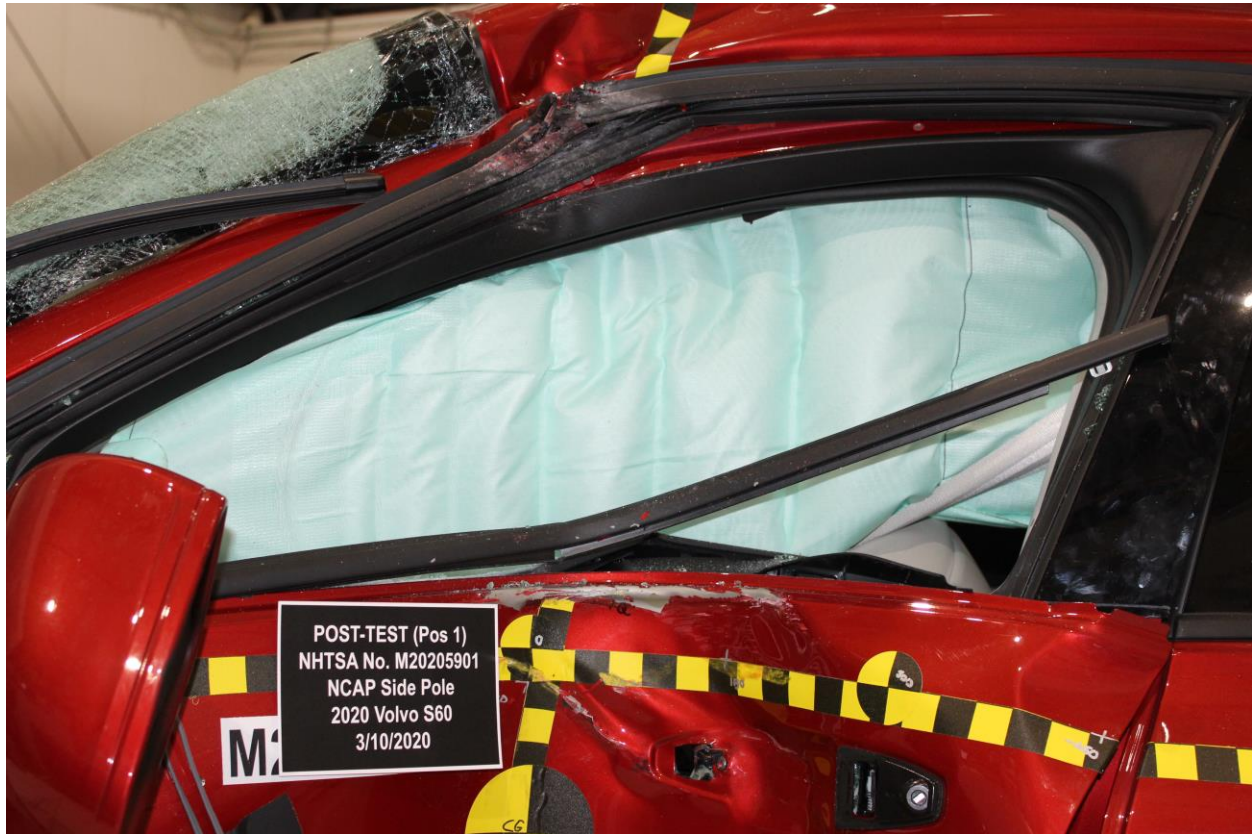
Figure A-25: Post-Test Left Side View of Dummy Shoulder and Door Top View

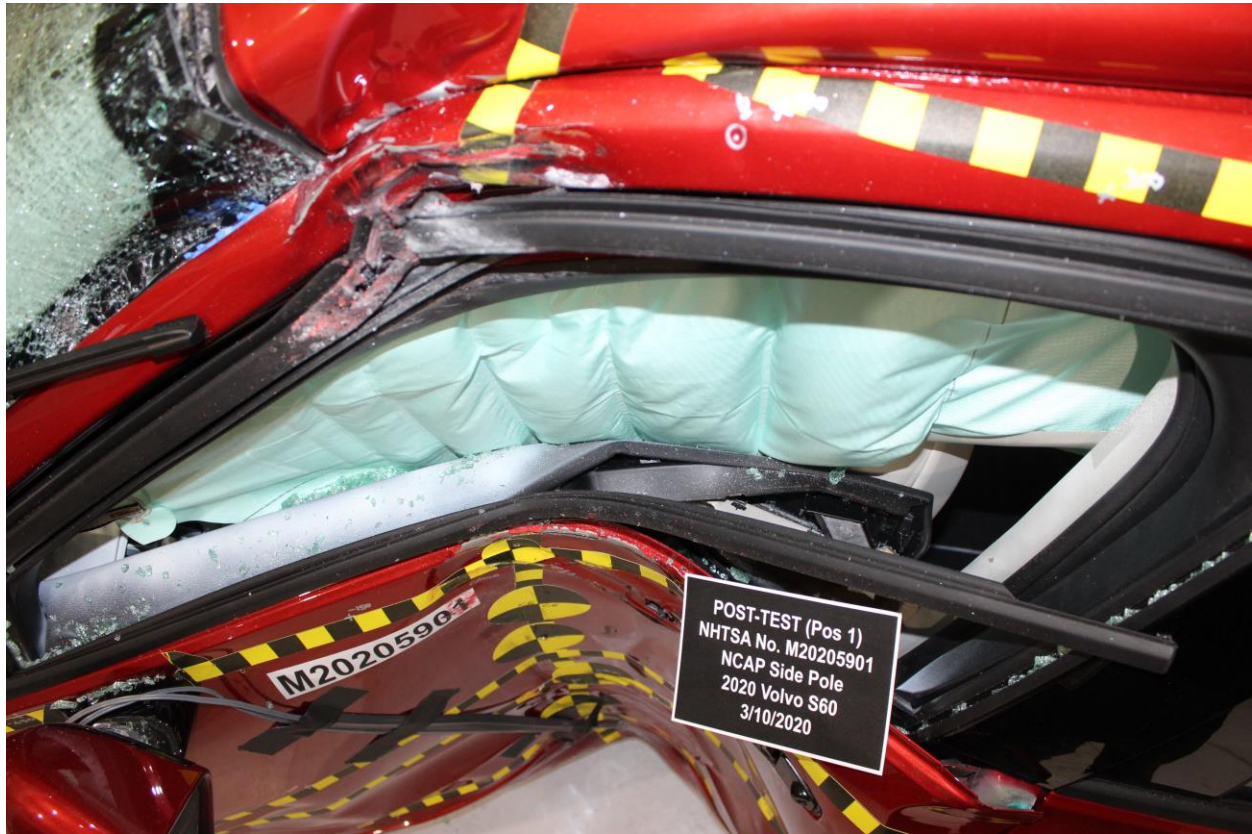
Figure A-41: Post-Test Dummy and Door Clearance View

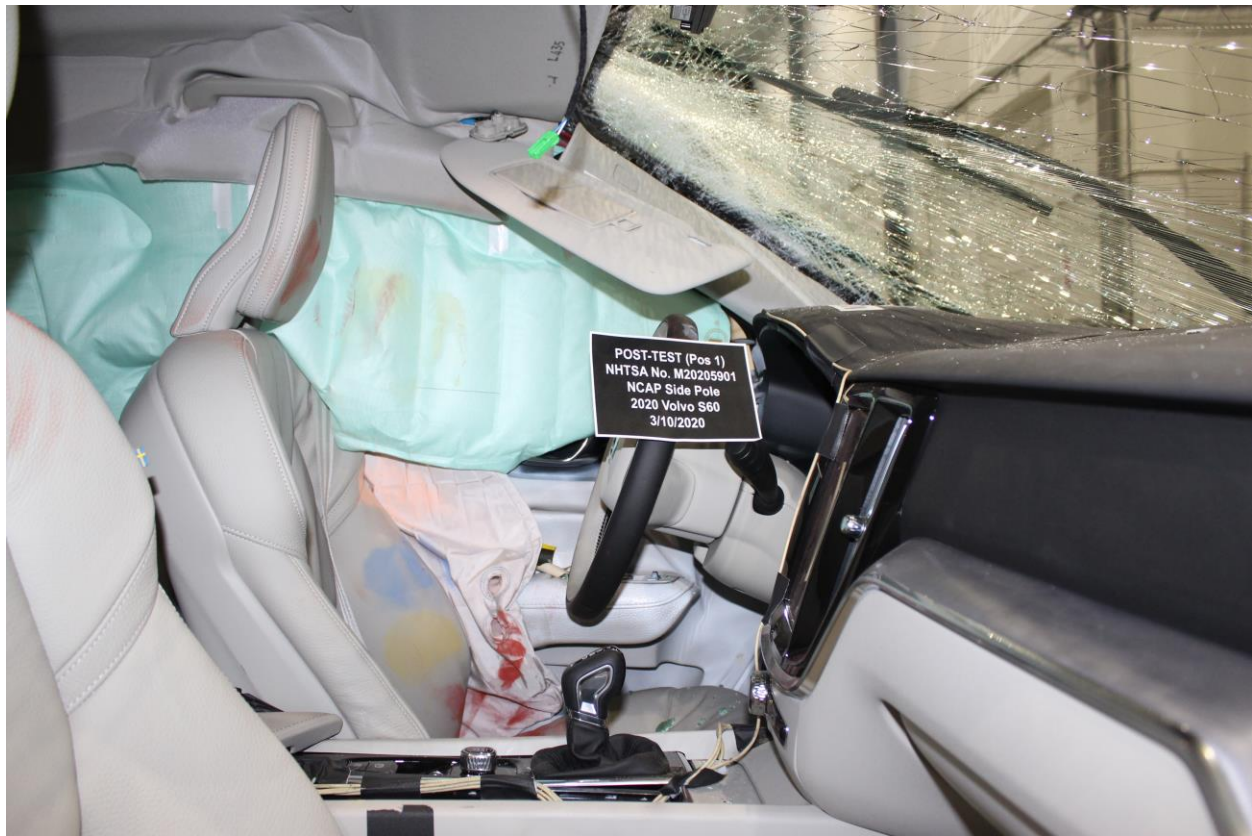
Figure A-45: Post-Test Inner Door Panel View Showing Dummy Contact Location

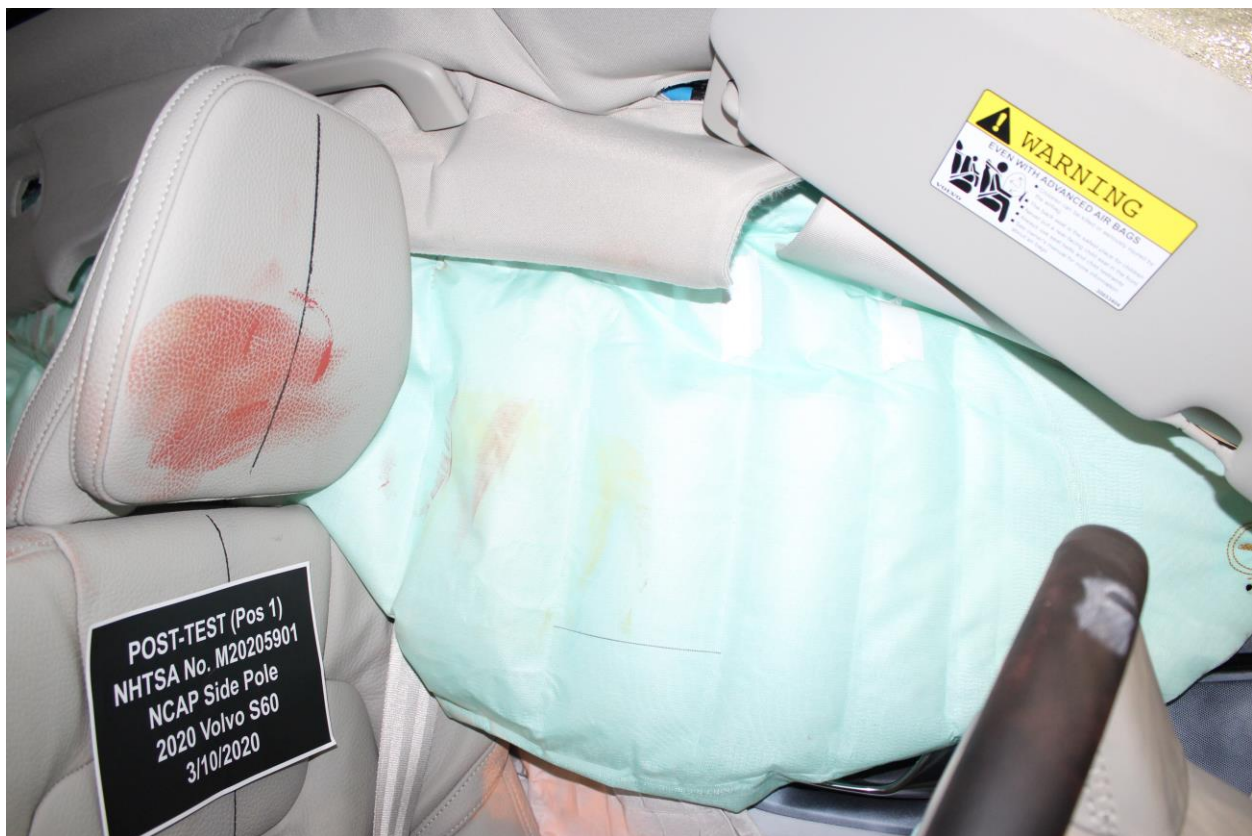
Figure A-46: Post-Test Dummy Close-Up Head Contact with Vehicle Interior View

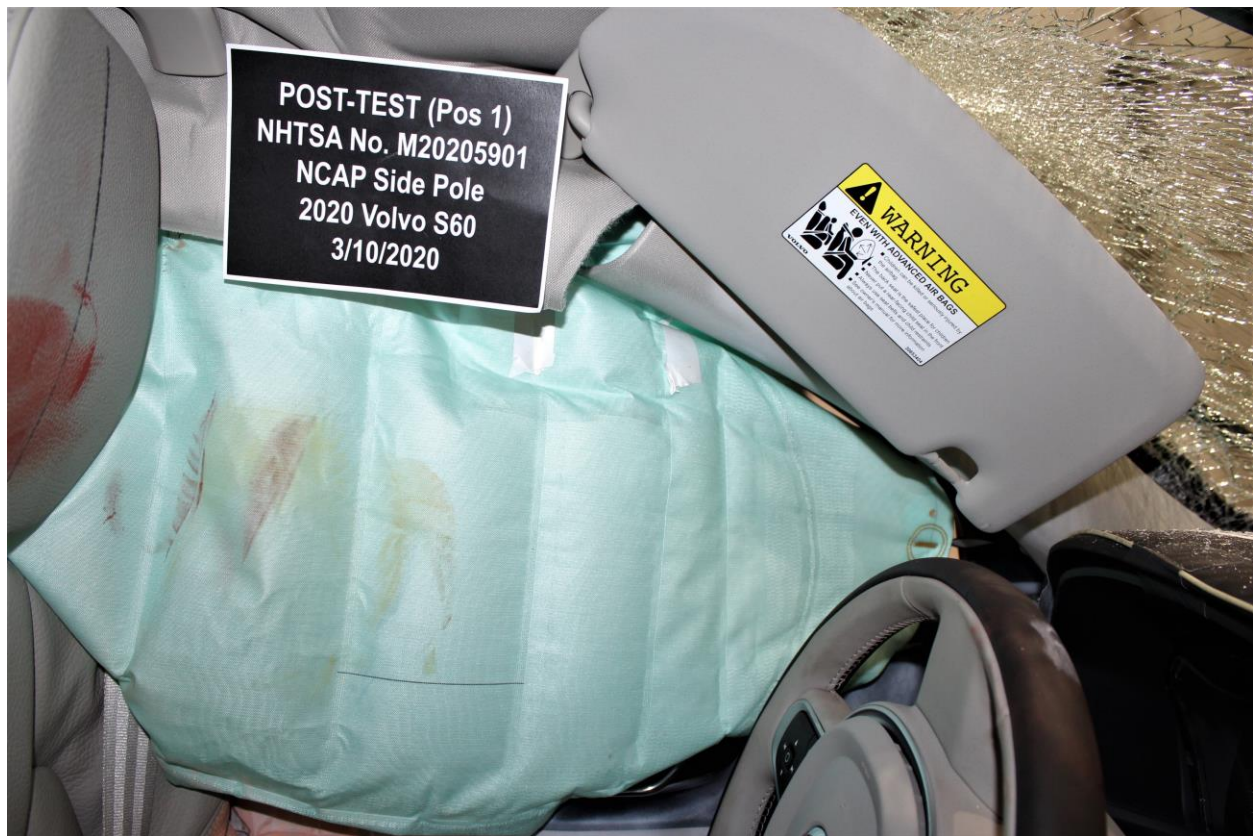
Figure A-47: Post-Test Dummy Close-Up Head Contact with Side Airbag View

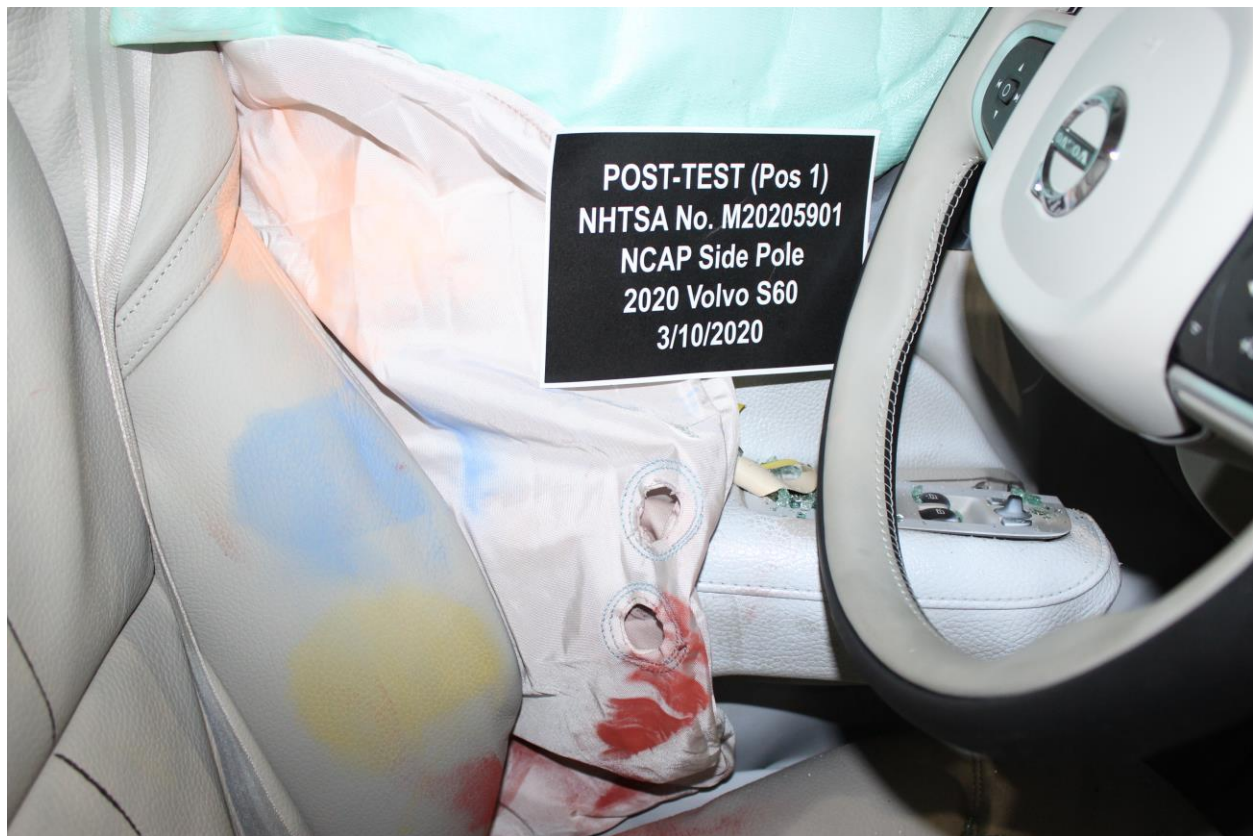
Figure A-49: Post-Test Dummy Close-Up Torso Contact with Side Airbag View

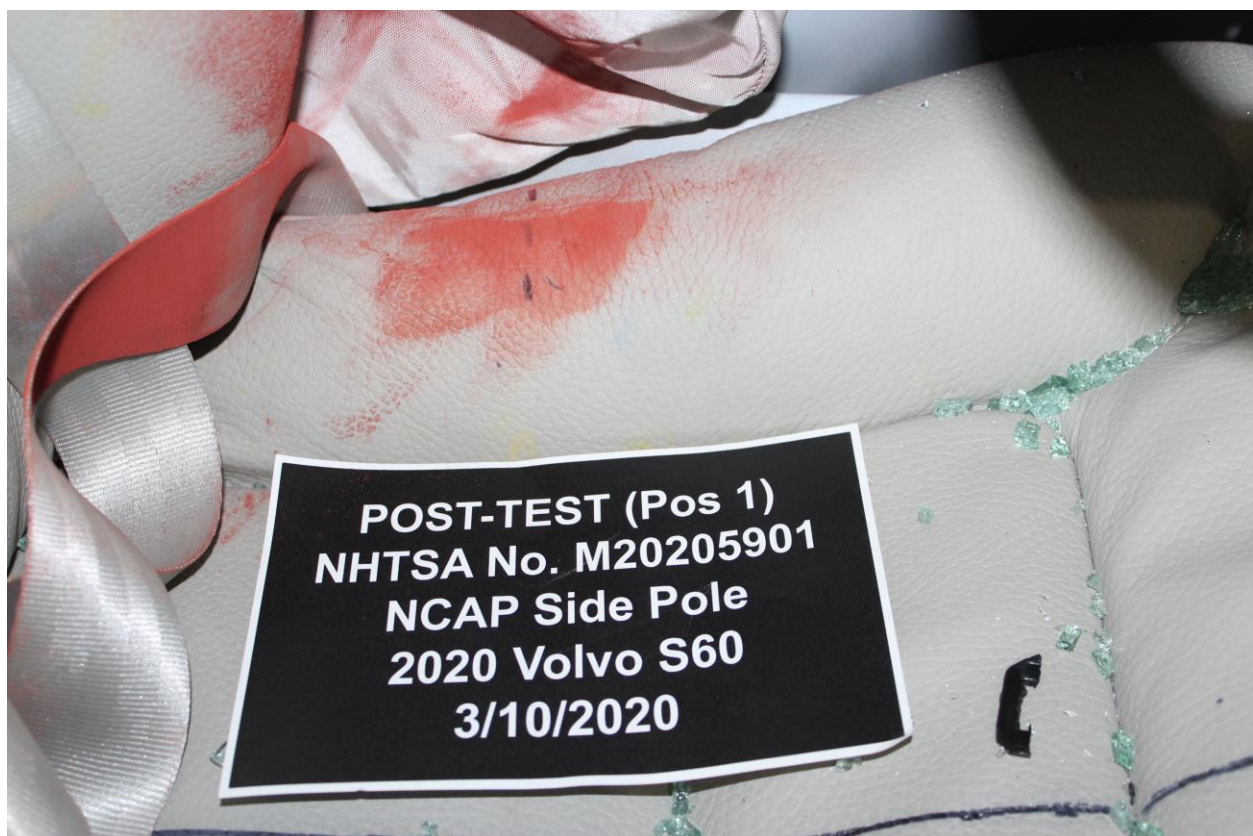
Figure A-50: Post-Test Dummy Close-Up Pelvis Contact with Vehicle Interior View

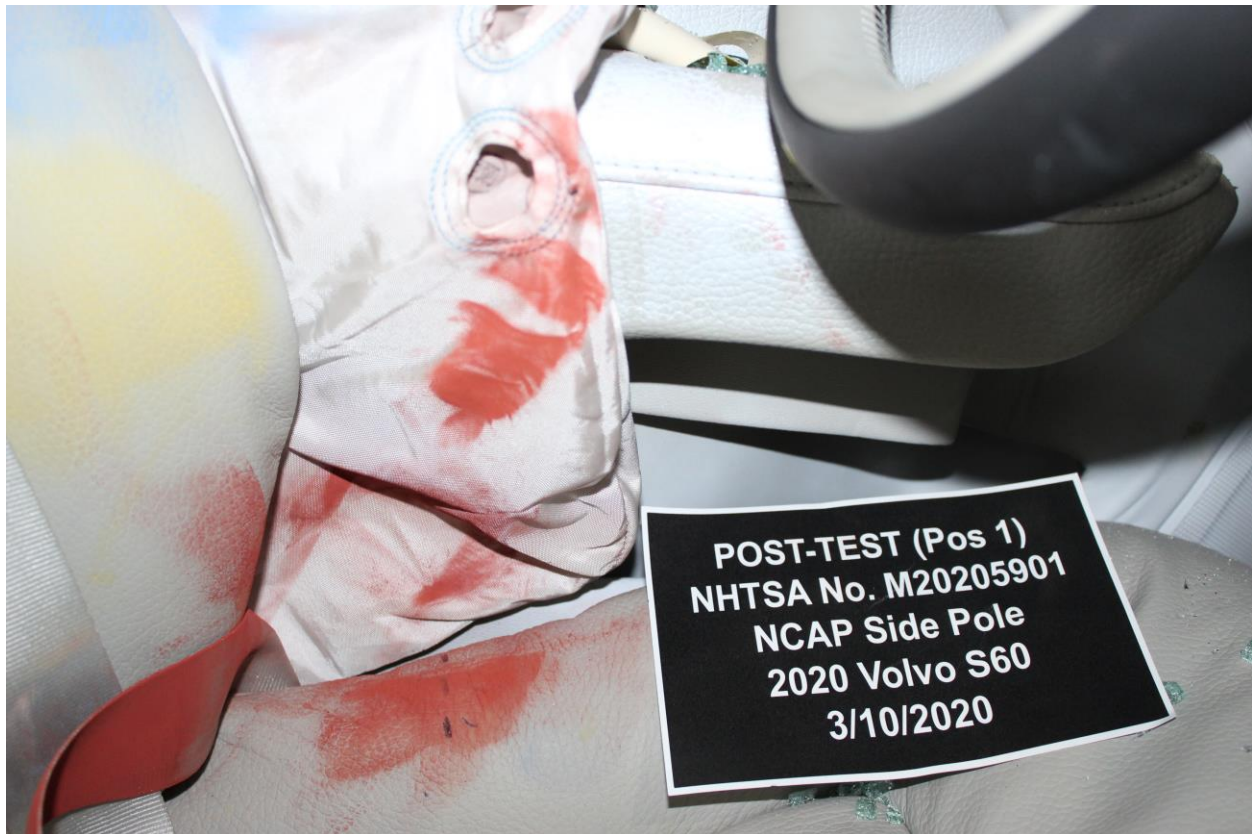
Figure A-51: Post-Test Dummy Close-Up Pelvis Contact with Side Airbag View

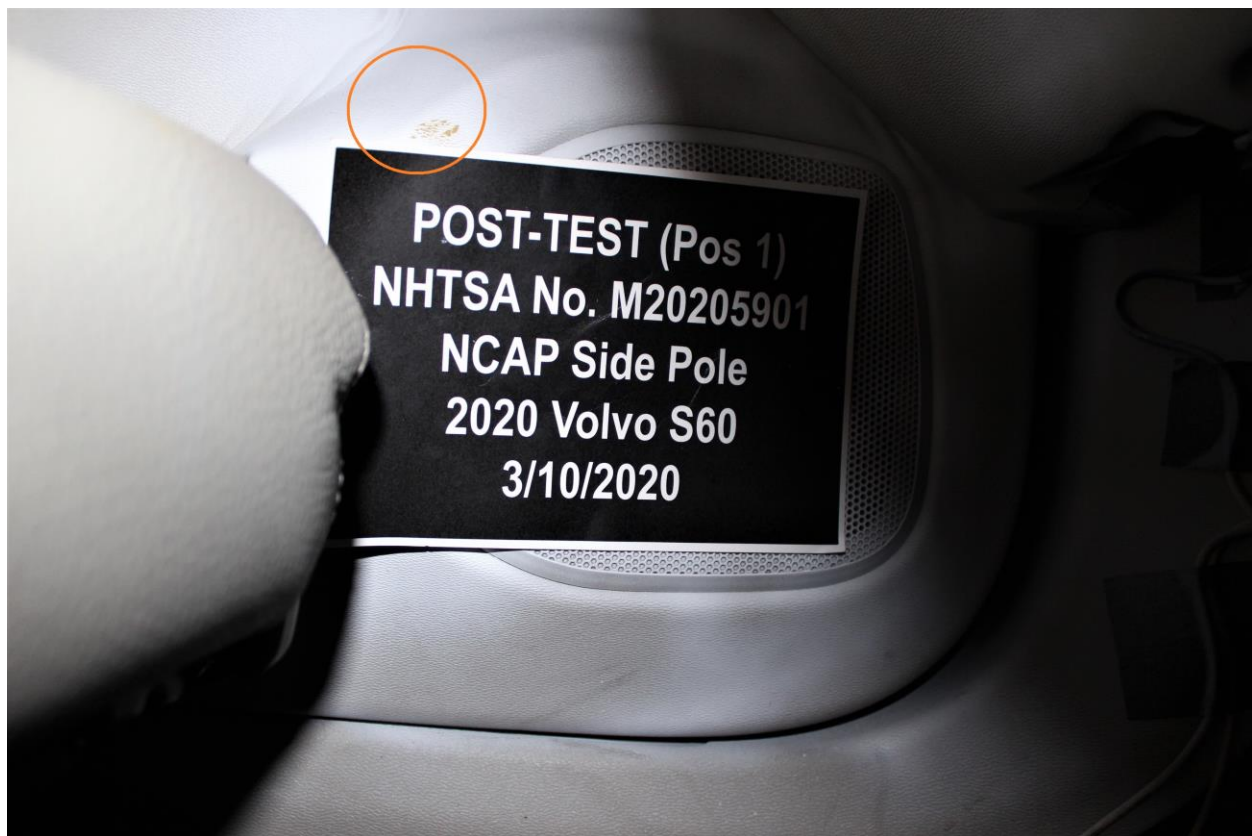
Figure A-52: Post-Test Dummy Close-Up Knee Contact with Vehicle Interior View

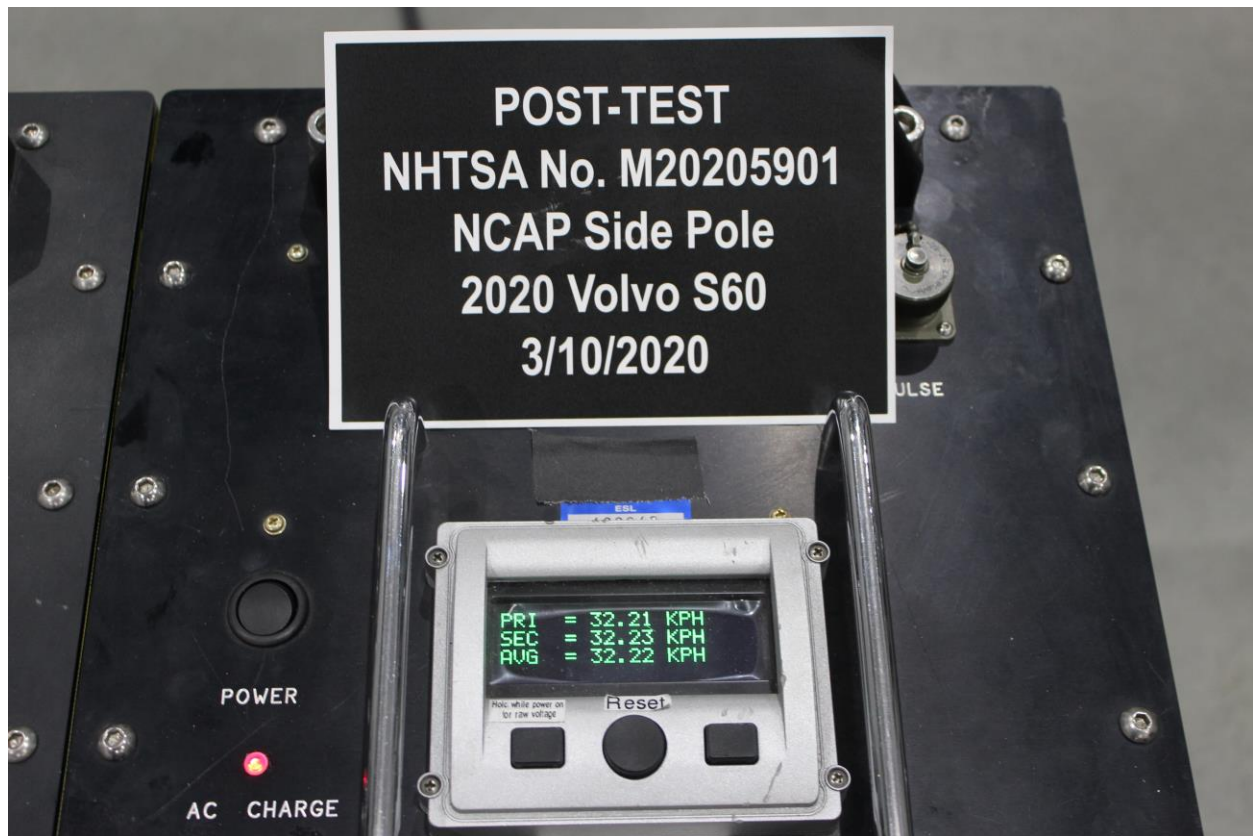
Figure A-62: Post-Test Primary and Redundant Speed Trap Read-Out

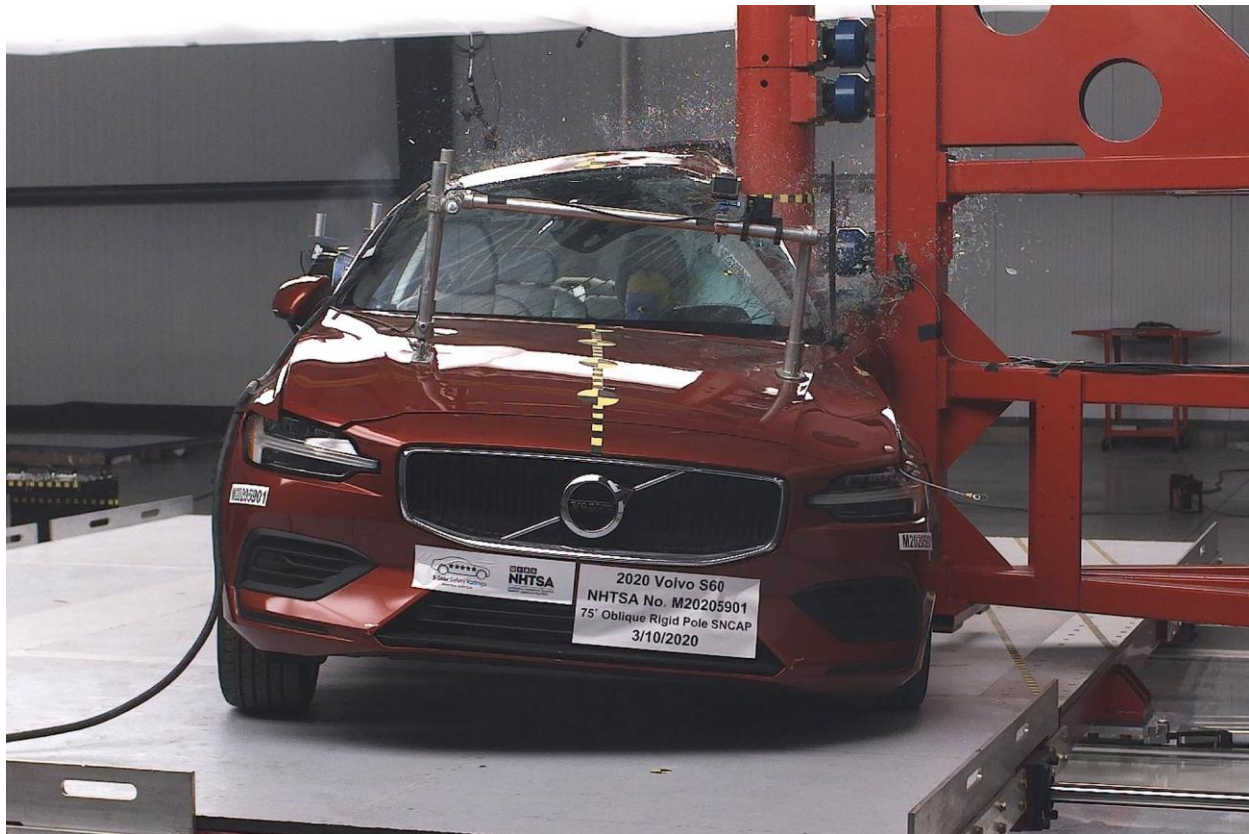
Figure A-68: Impact Event
