**REPORT NUMBER: NCAP-KAR-20-012**

**NEW CAR ASSESSMENT PROGRAM (NCAP)  
FRONTAL BARRIER IMPACT TEST**

**VOLVO CAR CORPORATION  
2020 VOLVO XC60 T5 AWD 5-DOOR MPV**

**FINAL REPORT**

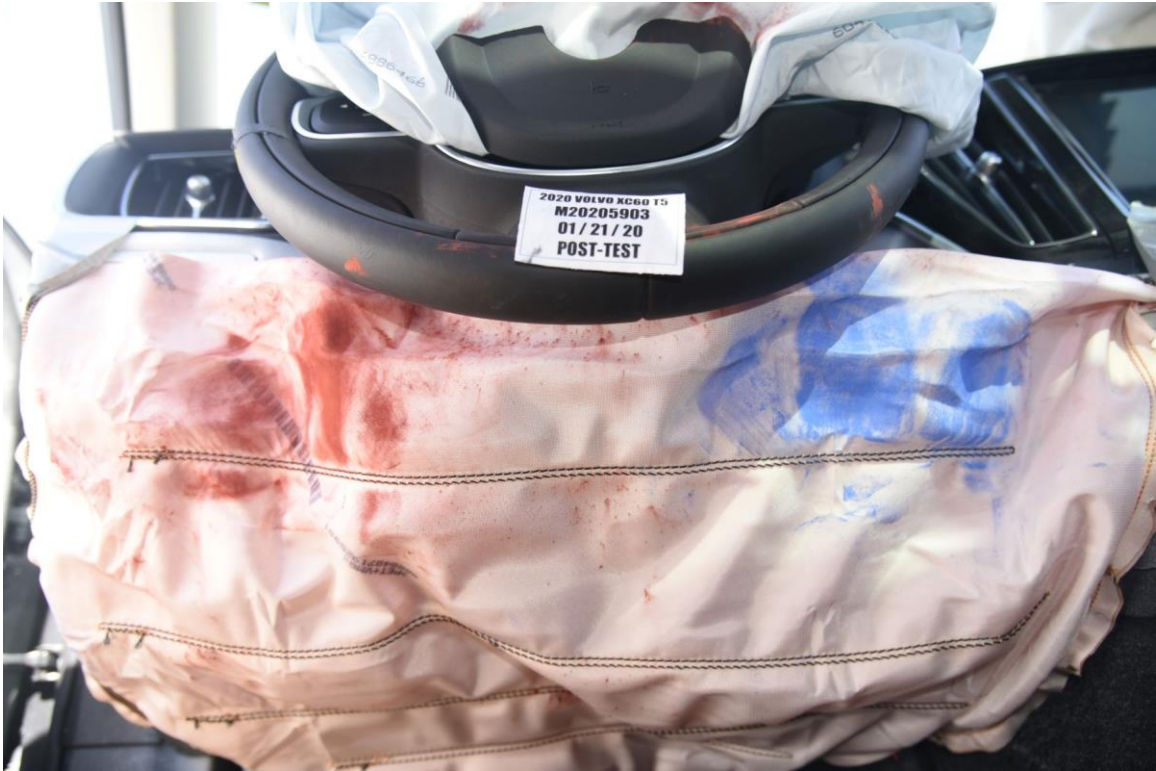
FIGURE 50. Post-Test Driver Dummy Contact with Headrest

The driver's visible contact points were as follows: the driver ATD's head contacted the frontal airbag and headrest. The upper torso contacted the frontal airbag. Both left and right knees contacted the knee airbag.
