**REPORT NUMBER: SPNCAP-KAR-20-014
NEW CAR ASSESSMENT PROGRAM (NCAP)
SIDE IMPACT POLE TEST**

**VOLVO CAR CORPORATION
2020 VOLVO XC60 T5 5-DOOR MPV**

NHTSA No: M20205904

**PREPARED BY:
APPLUS IDIADA KARCO ENGINEERING, LLC.
9270 HOLLY ROAD
ADELANTO, CA 92301**

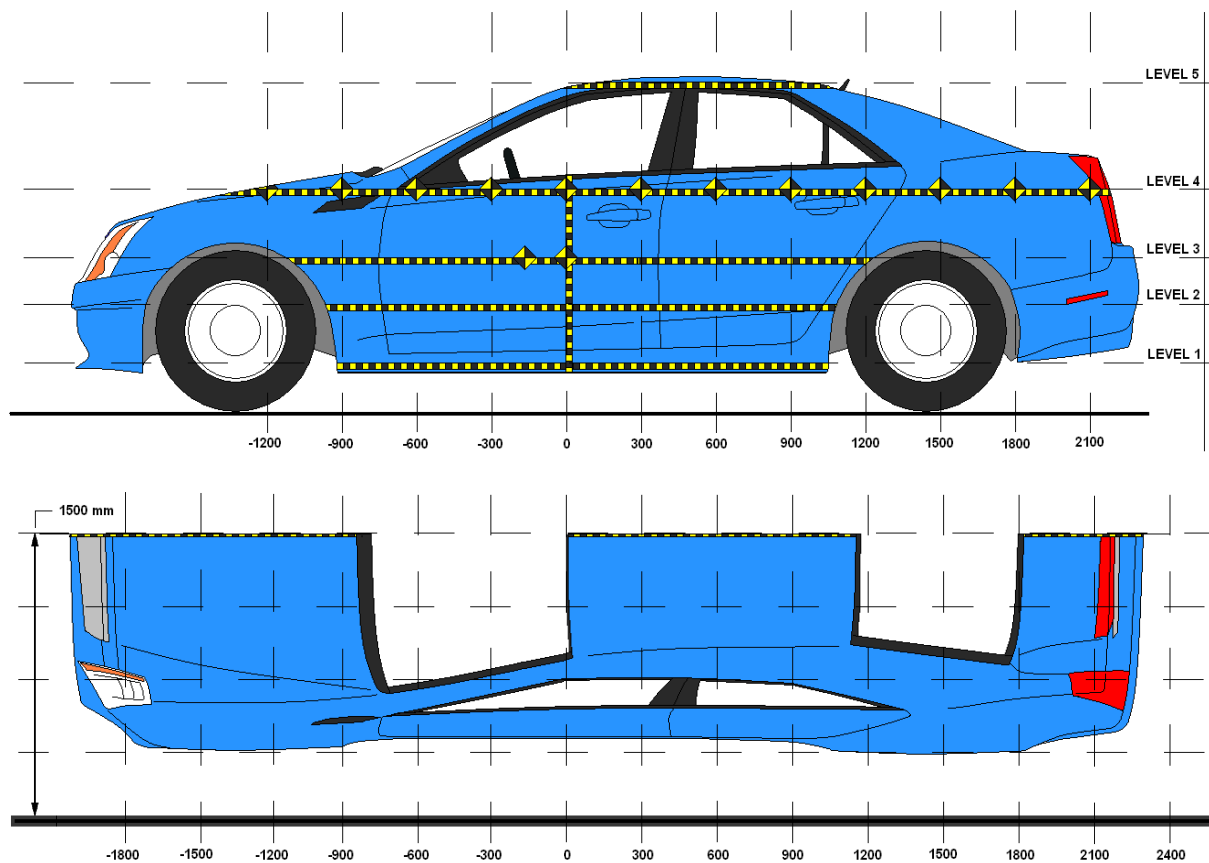
TEST VEHICLE EXTERIOR CRUSH MEASUREMENTS

NOTE: All measurements in mm with tolerance of $\pm 3\text{mm}$
