REPORT NUMBER: NCAP-MGA-20-014

**NEW CAR ASSESSMENT PROGRAM (NCAP)
Frontal Barrier Impact Test**

**GENERAL MOTORS LLC
2020 GMC Acadia AWD SLE 5-Door SUV
NHTSA No.: M20200111**

**MGA RESEARCH CORPORATION
5000 Warren Road
Burlington, WI 53105**

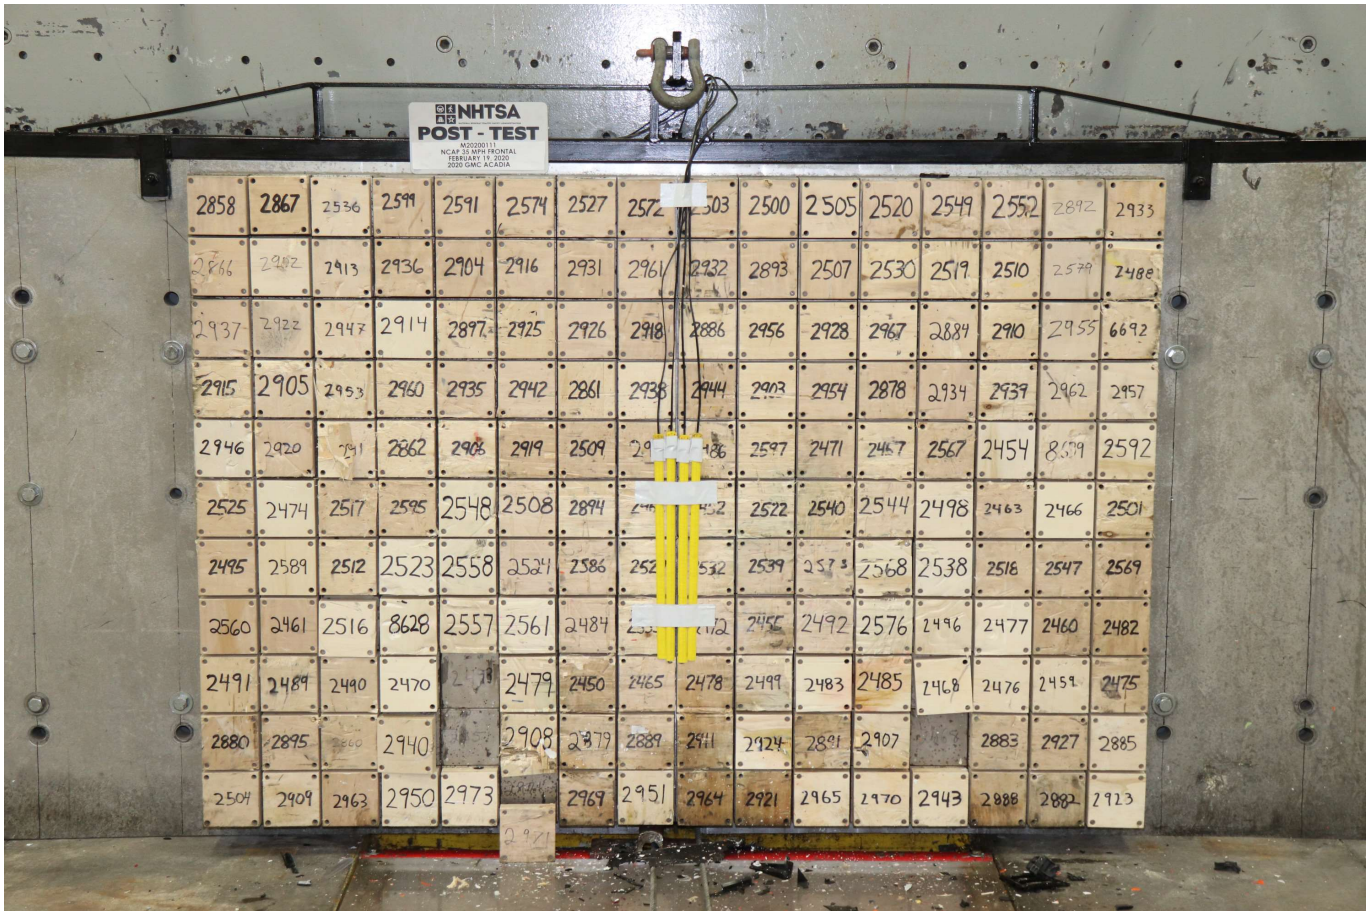
Photo No. 003 - Post-Test Load Cell Wall

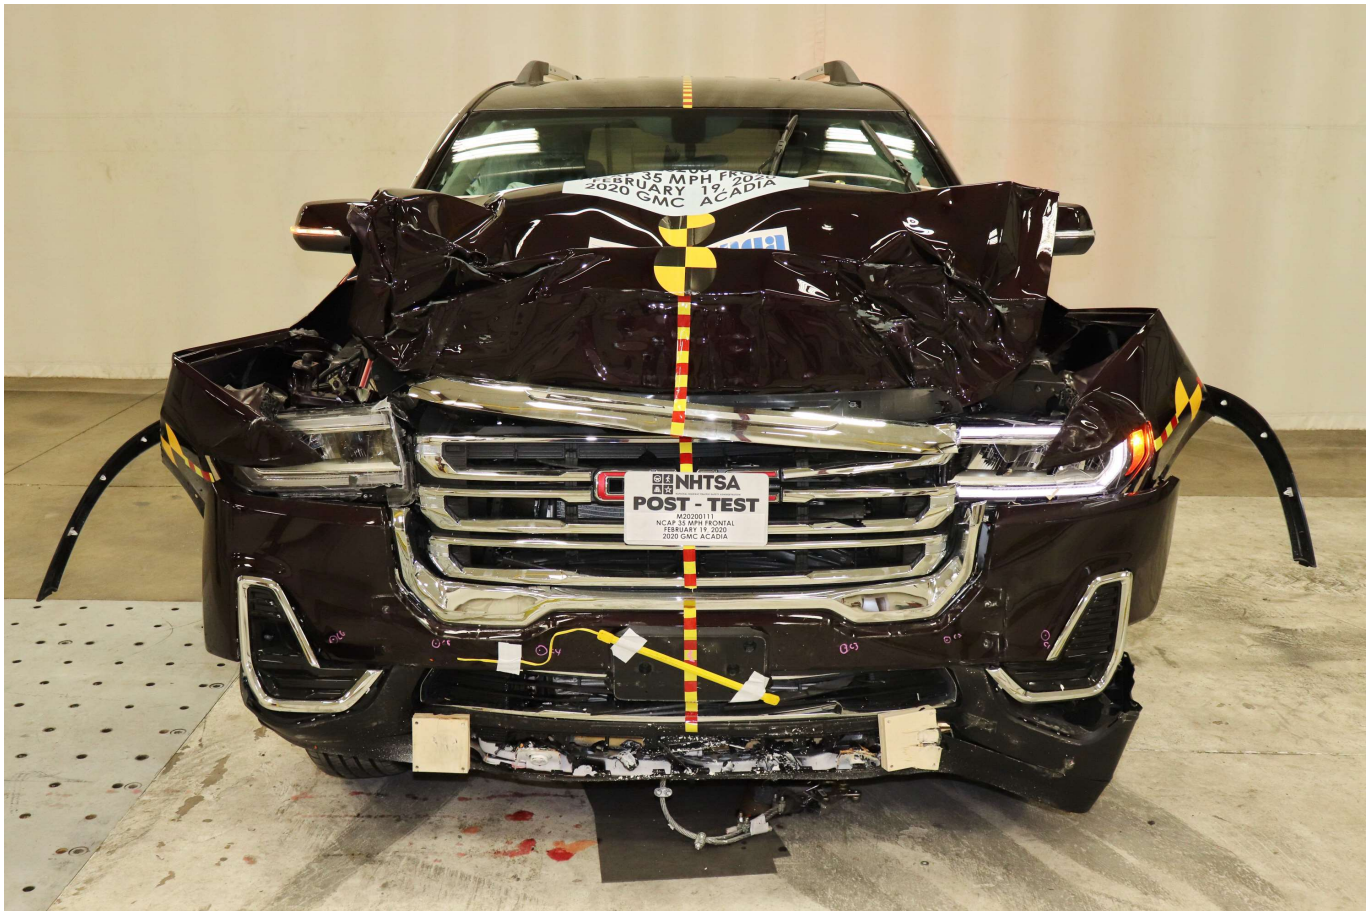
Photo No. 009 - Post-Test Front View of Test Vehicle

The maximum static crush of the vehicle was 478 mm located at the vehicle centerline and both the driver and passenger side doors remained closed during the impact event and were operable after the impact.

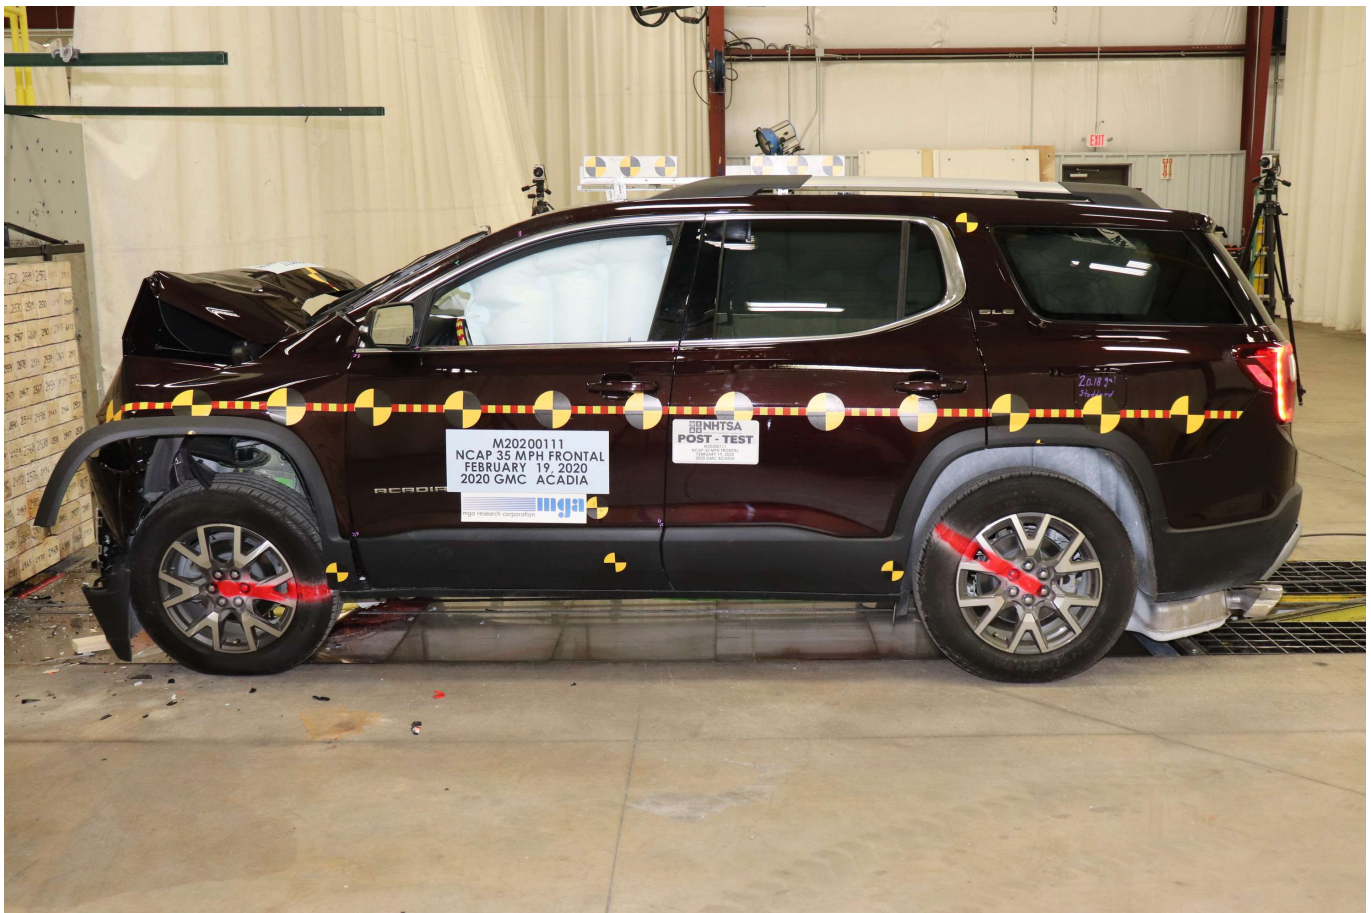
Photo No. 011 - Post-Test Left View of Test Vehicle

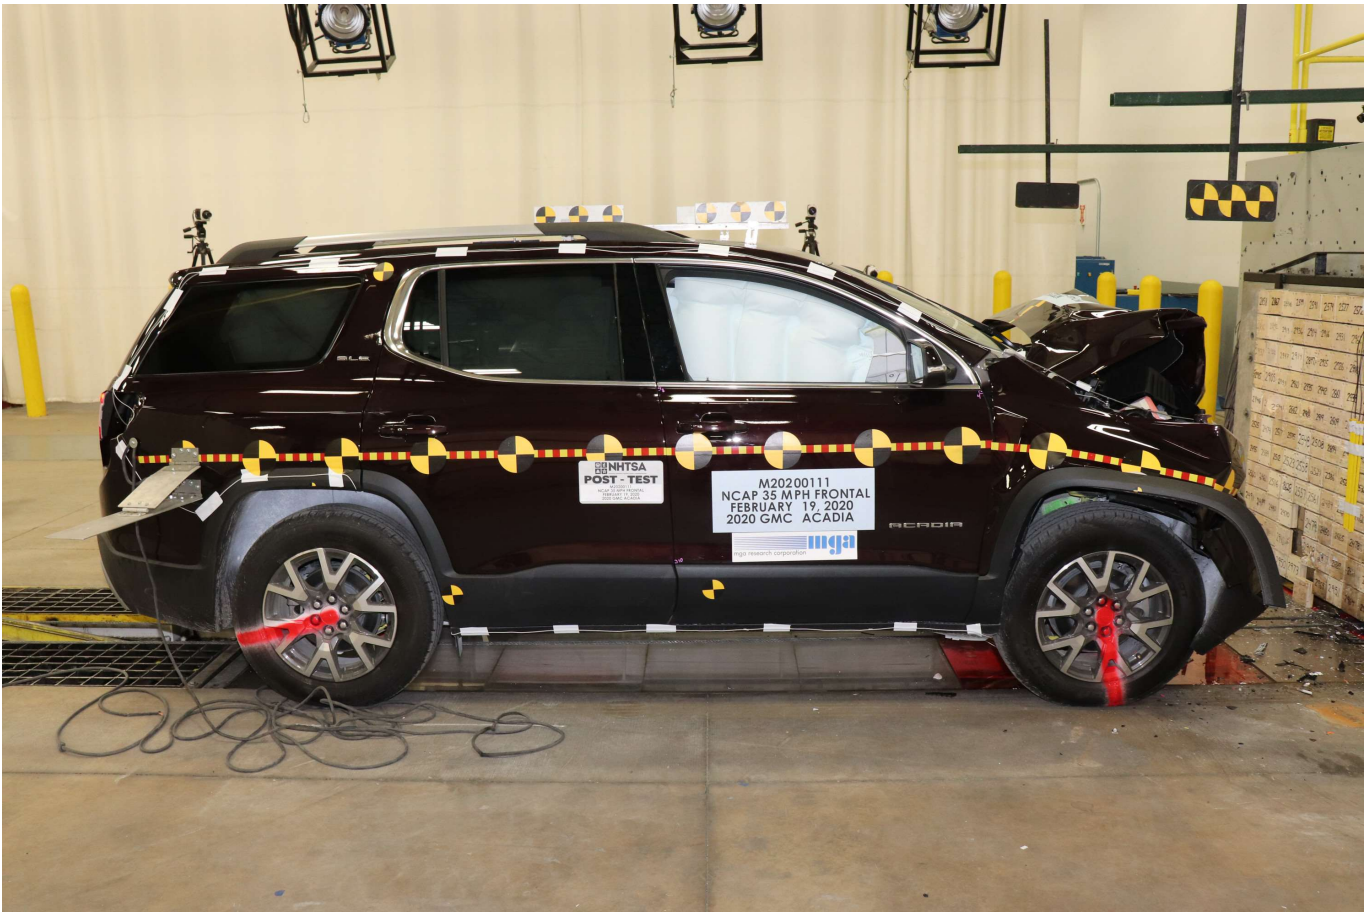
Photo No. 013 - Post-Test Right View of Test Vehicle

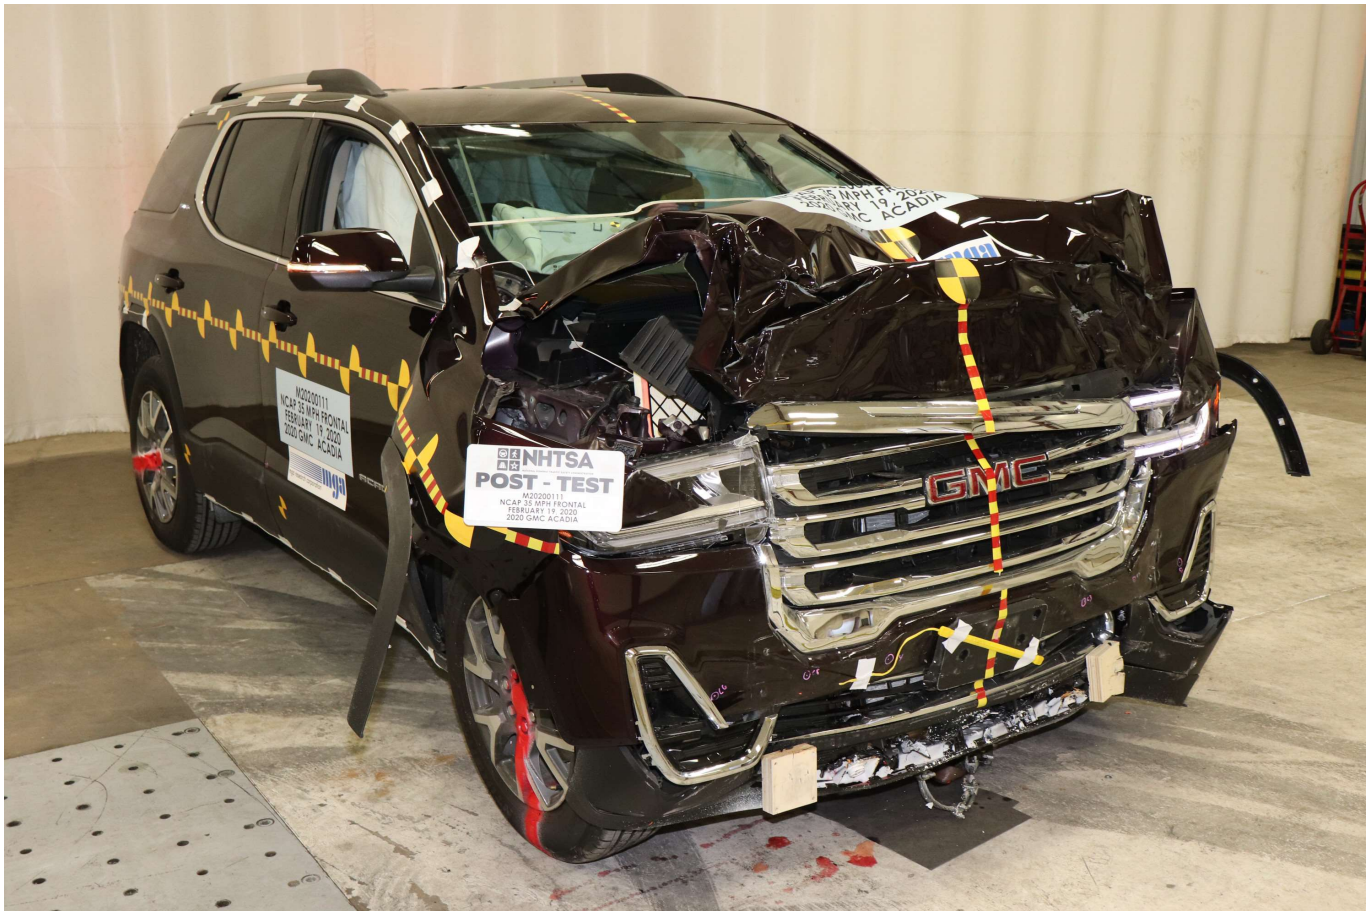
Photo No. 015 - Post-Test Right Front 3-4 View

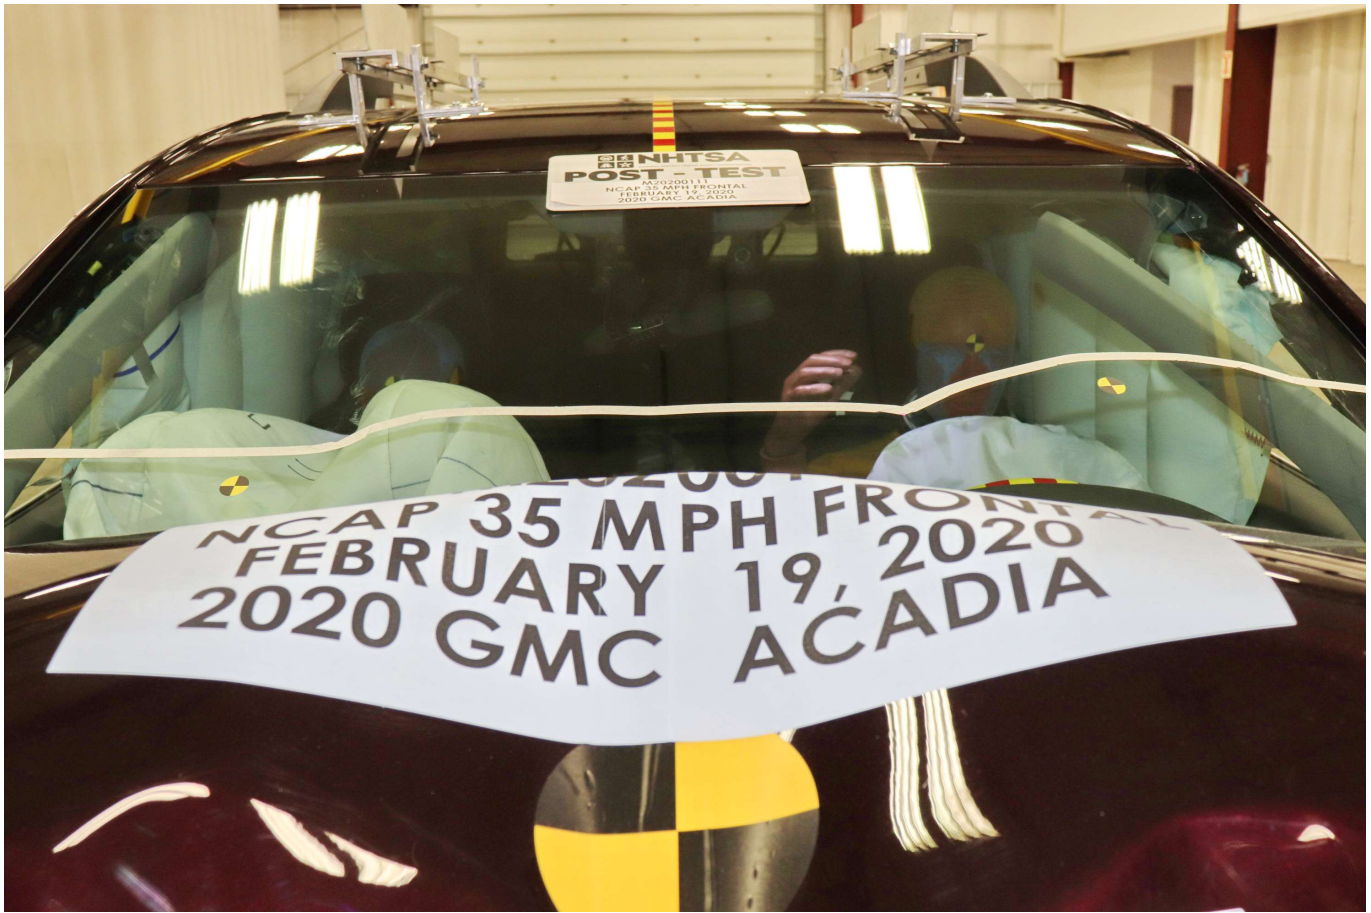
Photo No. 019 - Post-Test Windshield View

There was 100 percent windshield retention and no intrusion into the protected zone of the windshield during the event. There was no Stoddard Solvent leakage after the event or during any phase of the static rollover.

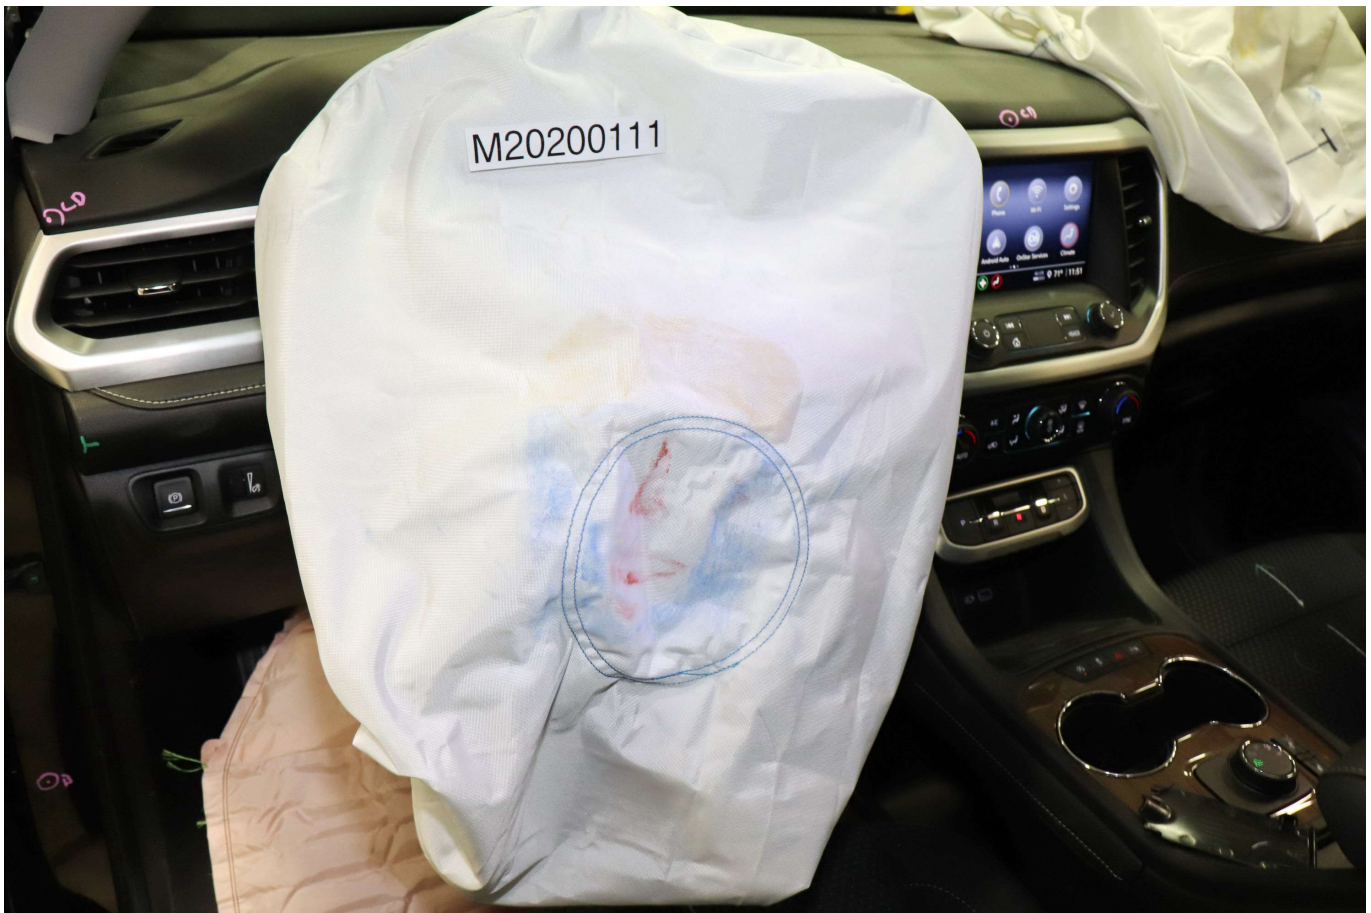
Photo No. 049 - Post-Test Driver Dummy Contact with Airbag

The driver's visible contact points were as follows: The driver's head contacted the airbag. The driver's head also contacted the headrest and curtain airbag. The driver's knees contacted the knee airbag. The passenger's visible contact points were as follows: The passenger's head contacted the airbag. The passenger's head also contacted the headrest. The passenger's knees contacted the glove box.
