**REPORT NUMBER: SPNCAP-MGA-20-015**

**NEW CAR ASSESSMENT PROGRAM (NCAP)  
Side Impact Pole Test**

**GENERAL MOTORS LLC  
2020 GMC Acadia SLE 5-Door SUV  
NHTSA No.: M20200112**

**FINAL REPORT**

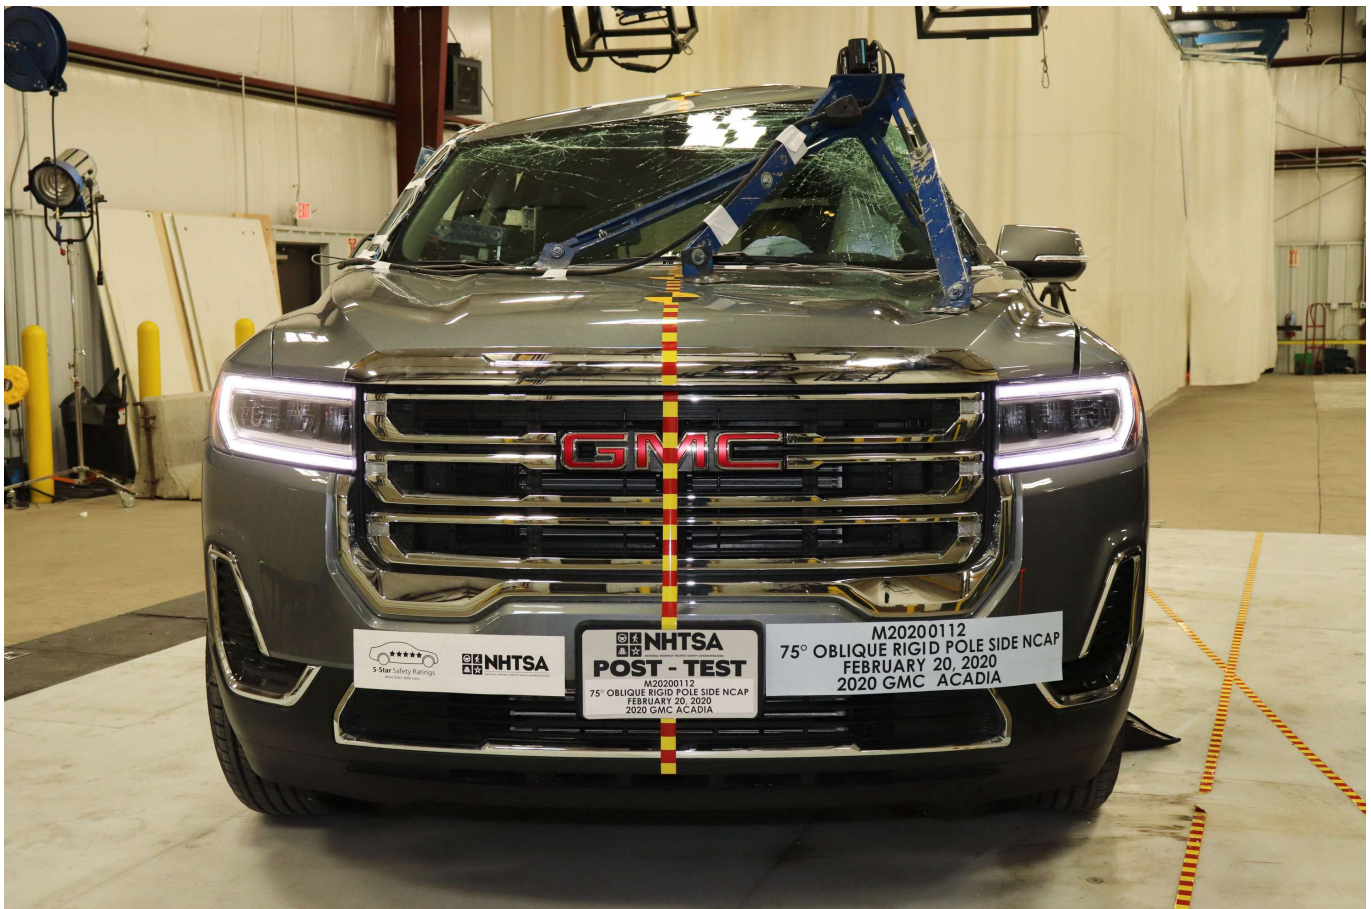
Photo No. 004 - Post-Test Frontal View of Test Vehicle

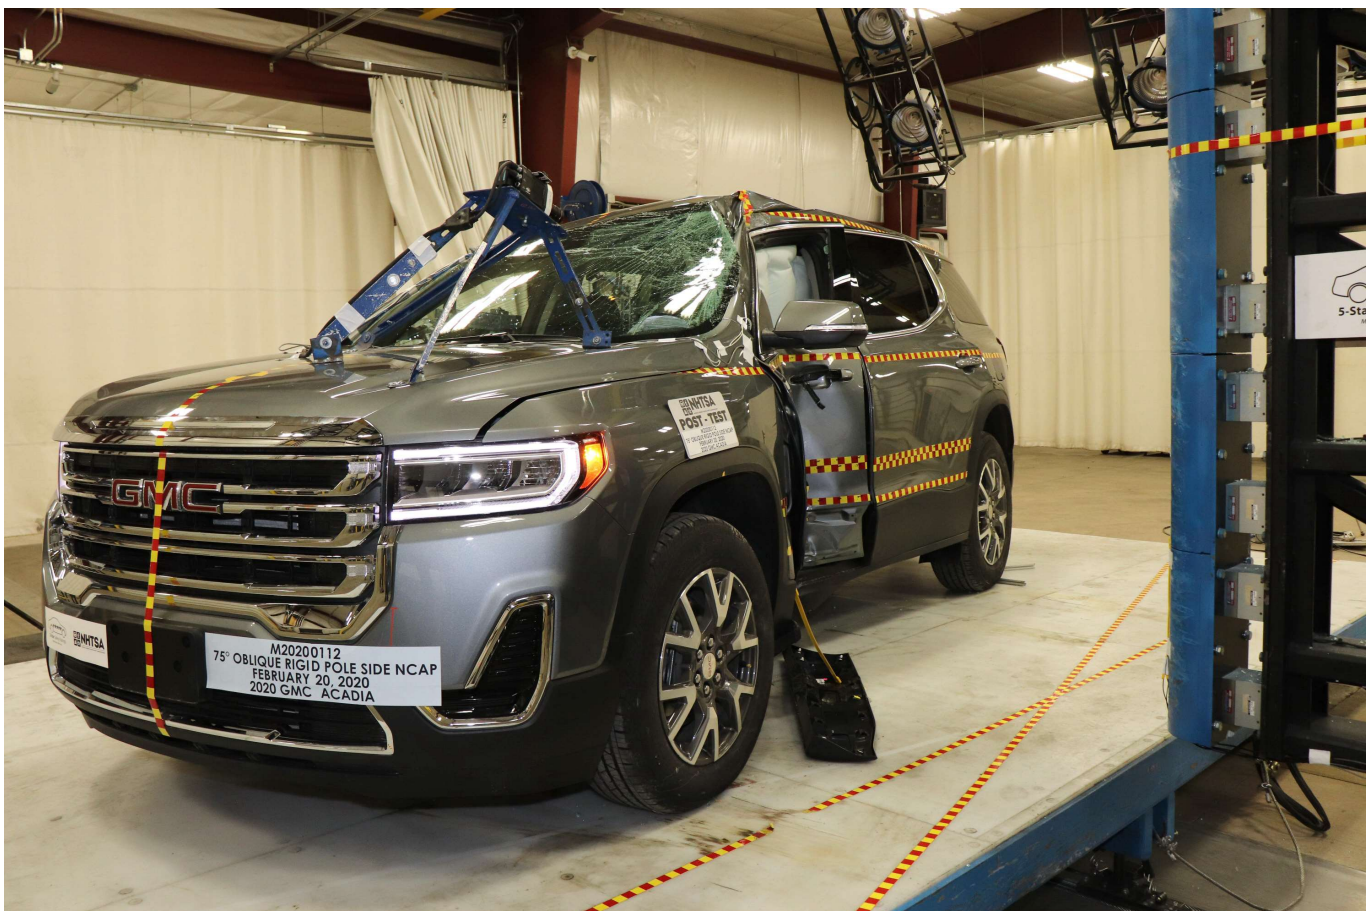
Photo No. 006 - Post-Test Left Front Three-Quarter View of Test Vehicle

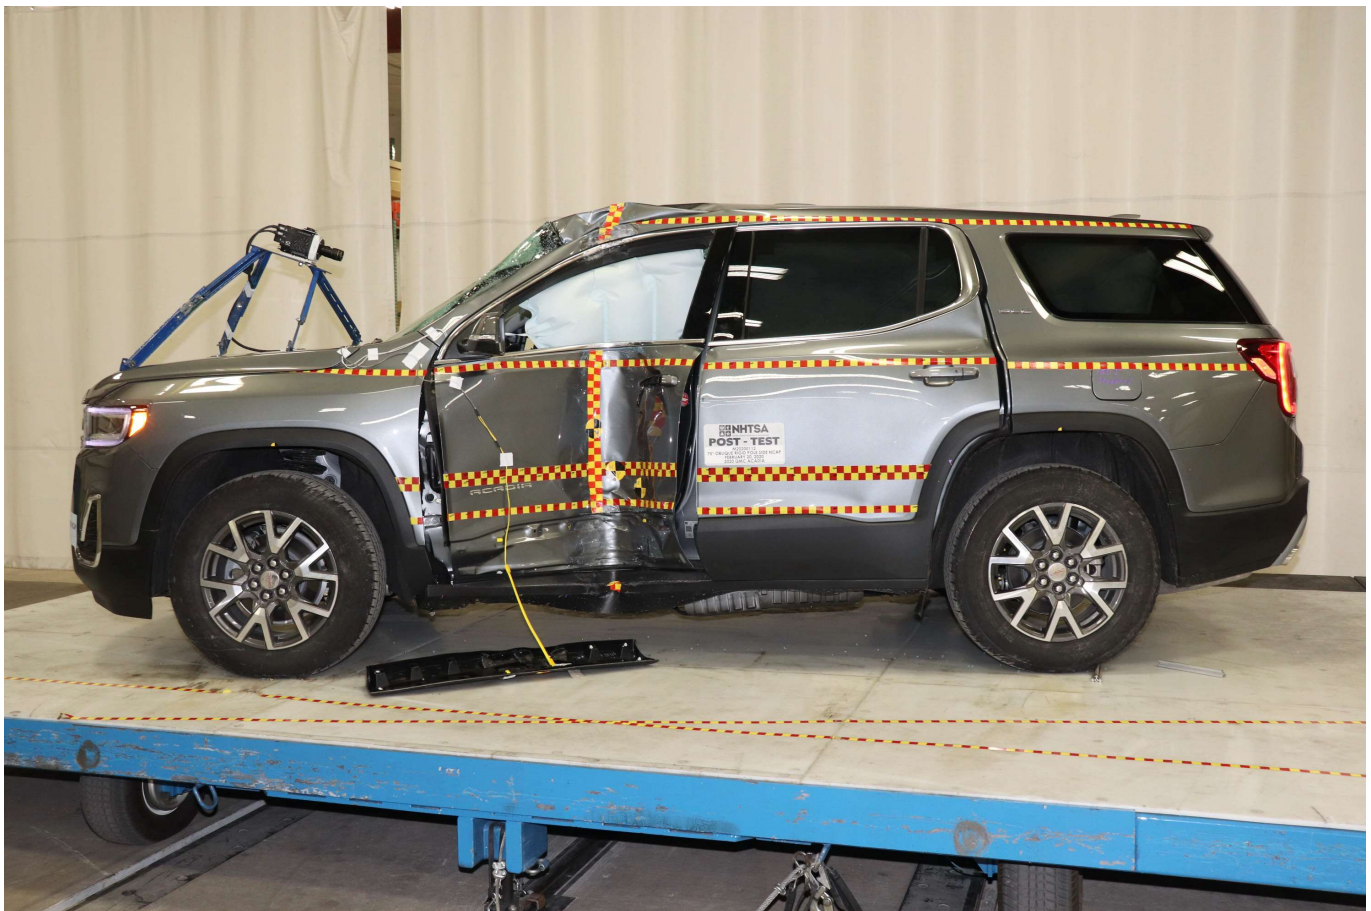
Photo No. 008 - Post-Test Left Side View of Test Vehicle

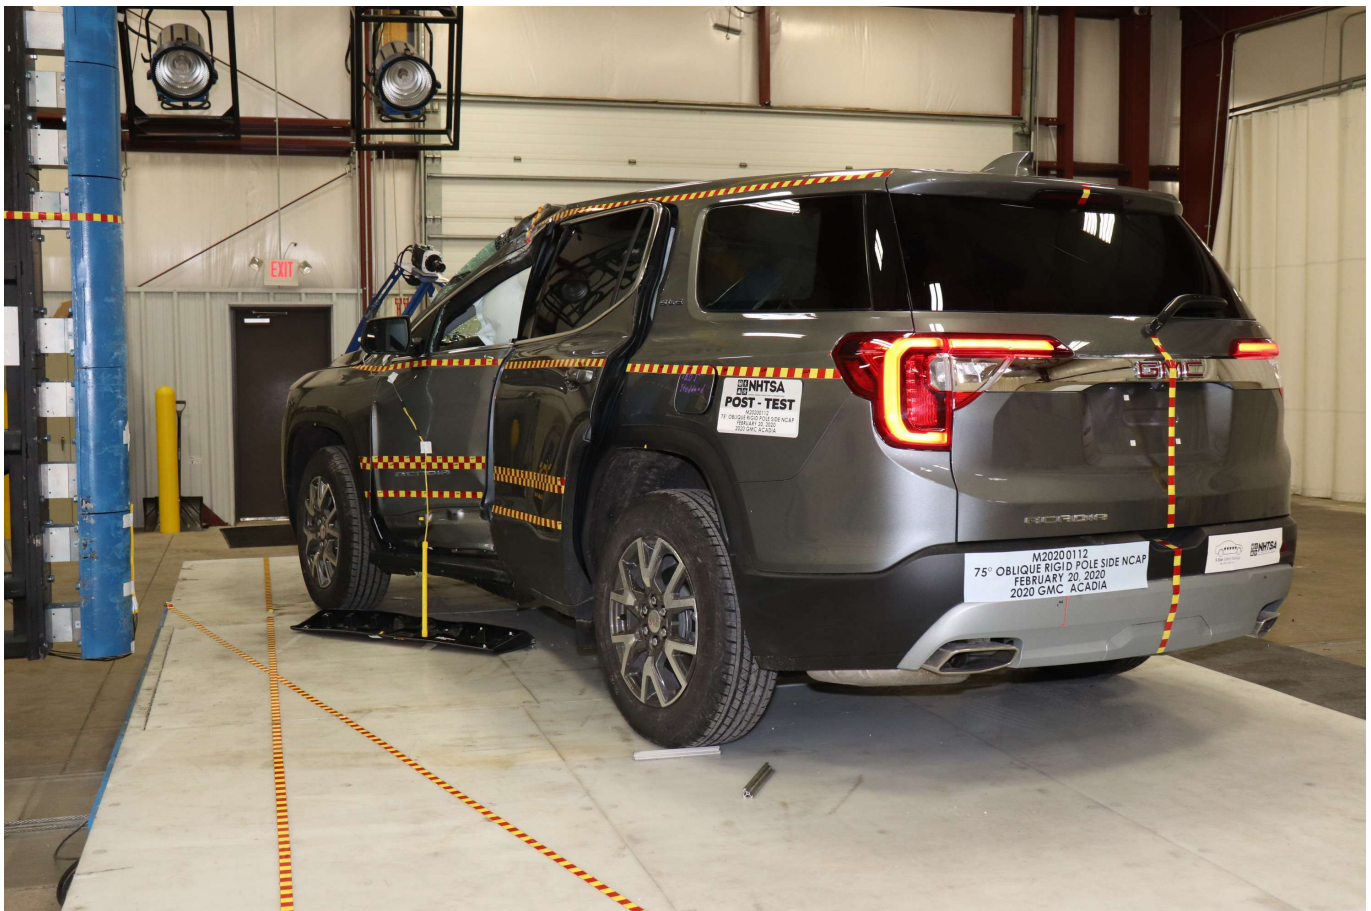
Photo No. 010 - Post-Test Left Rear Three-Quarter View of Test Vehicle

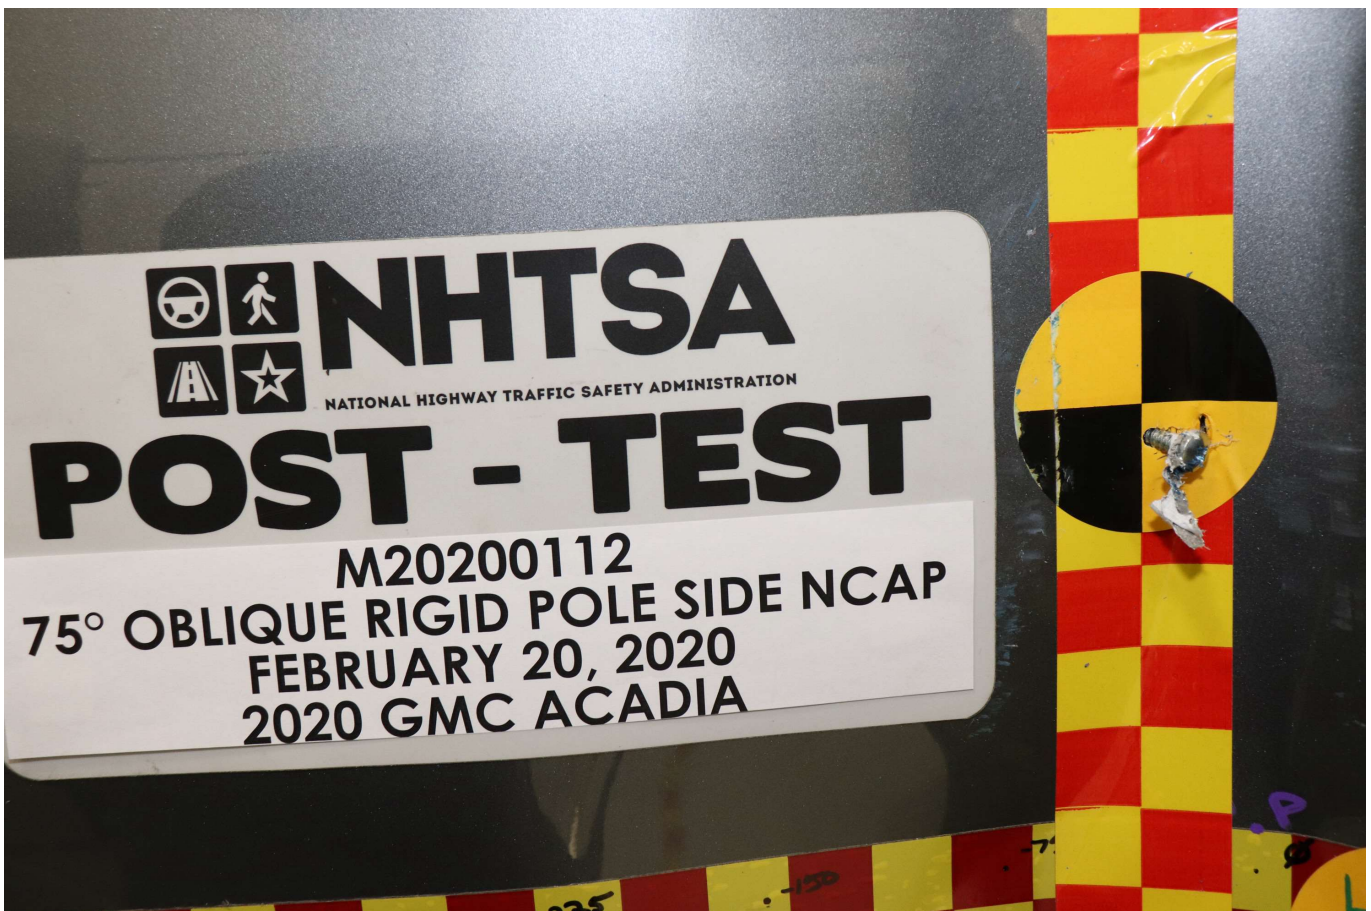
Photo No. 020 - Post-Test Close-Up View of Impact Point Target Showing Impact Location

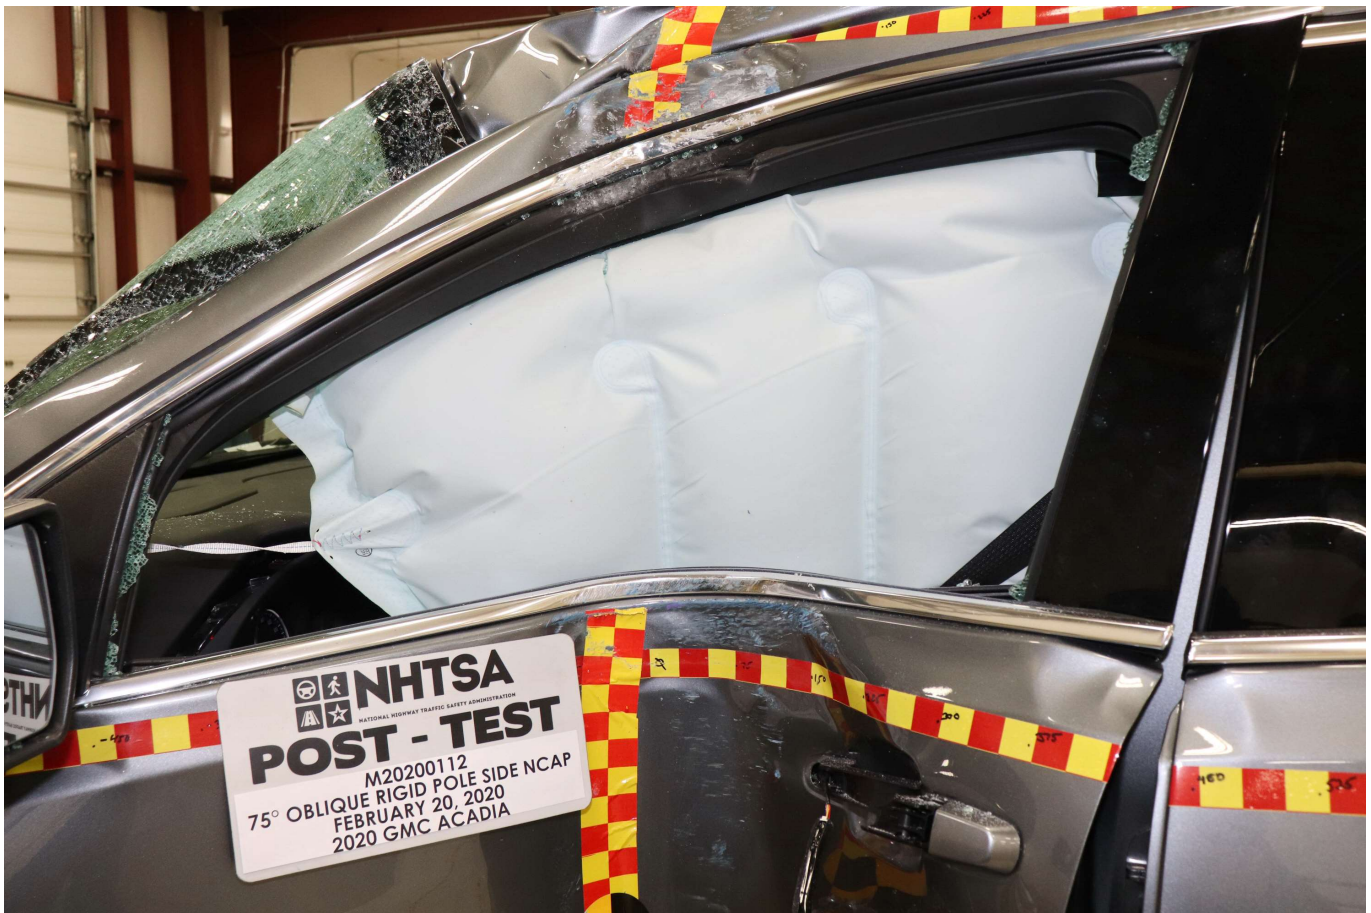
Photo No. 025 - Post-Test Left Side View of Dummy Shoulder and Door Top View

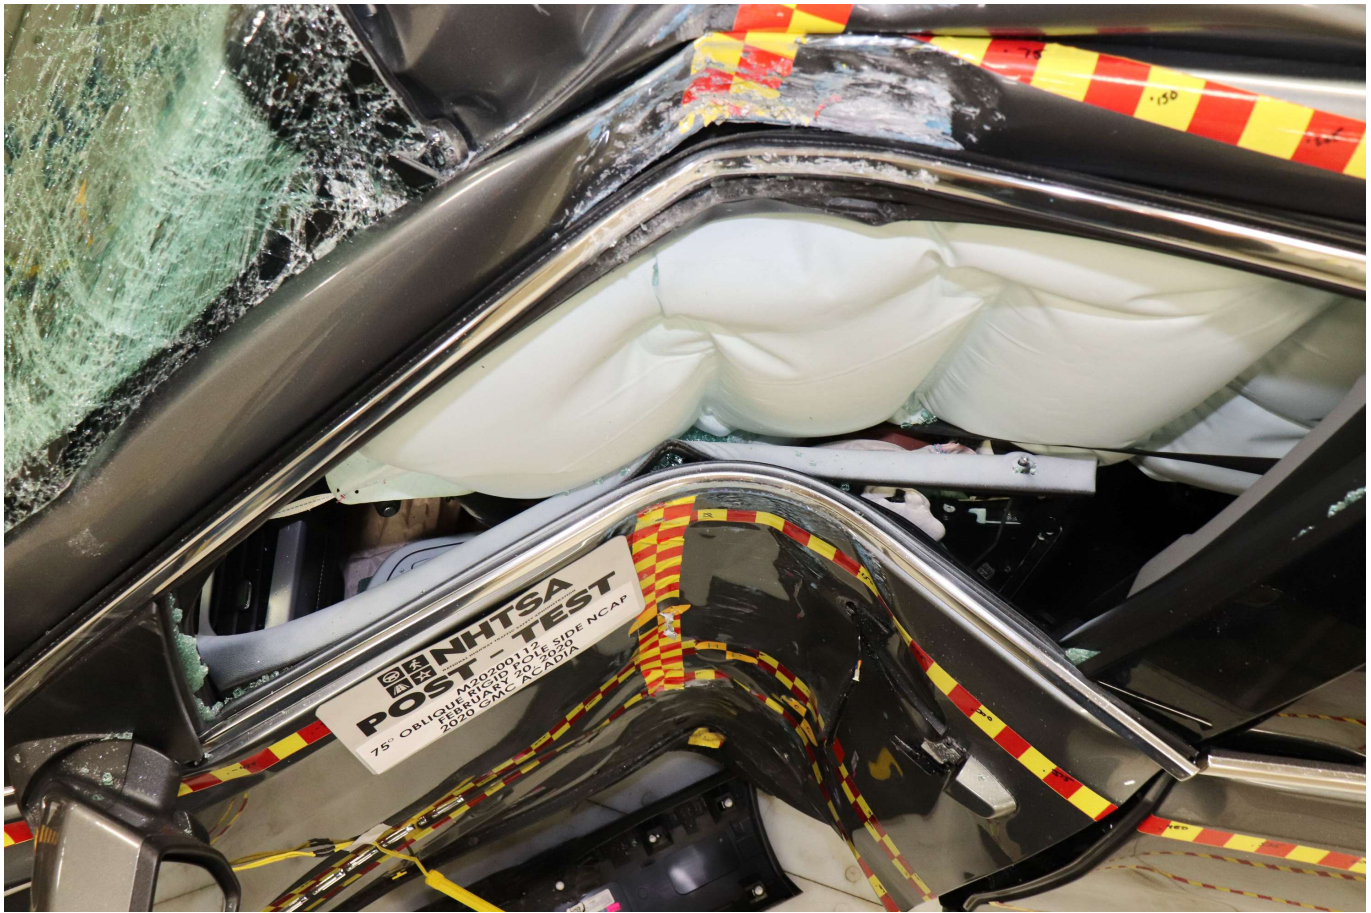
Photo No. 041 - Post-Test Dummy and Door Clearance View

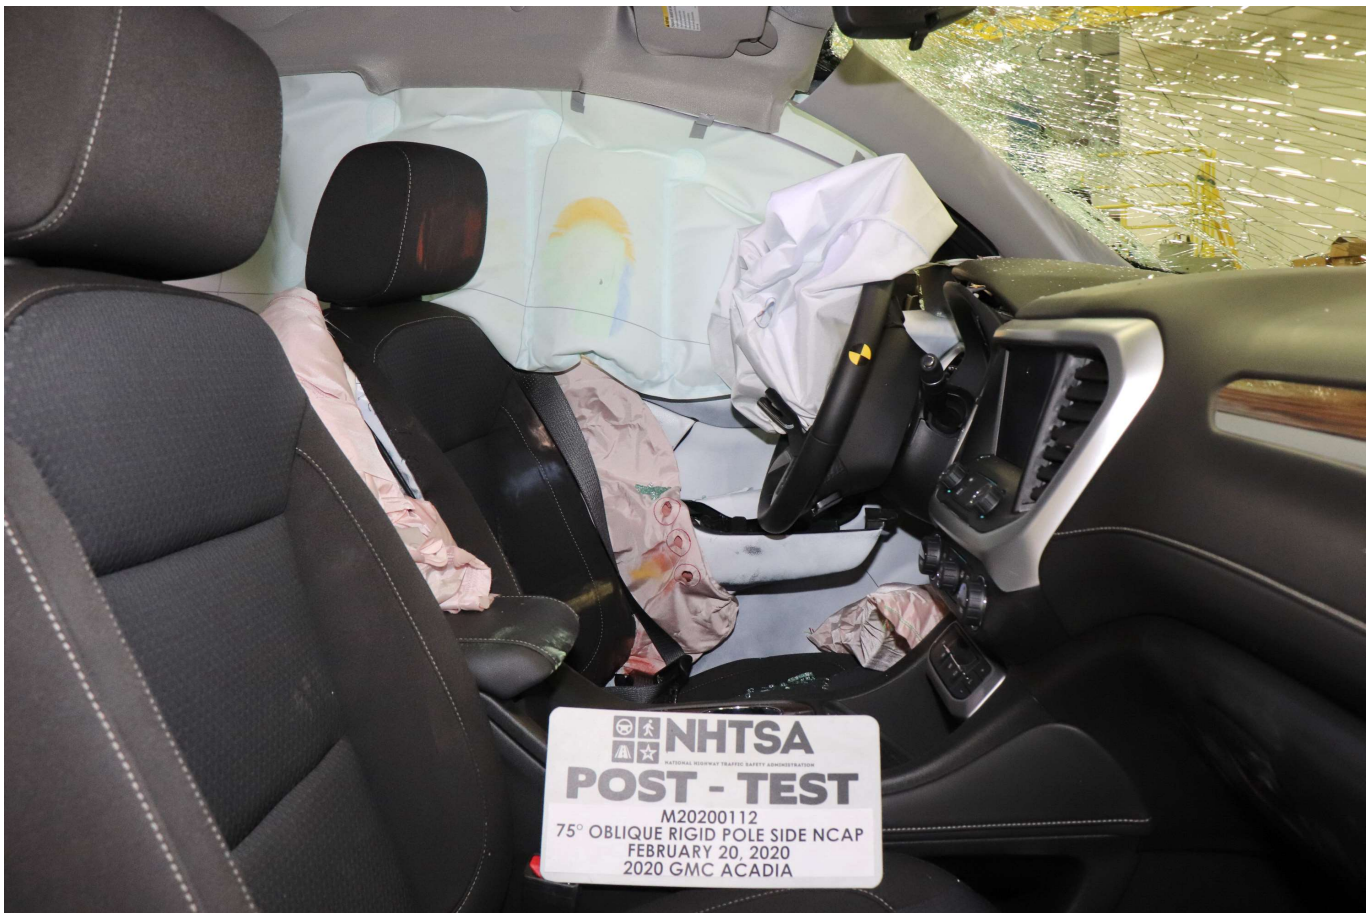
Photo No. 045 - Post-Test Inner Door Panel View Showing Dummy Contact Location

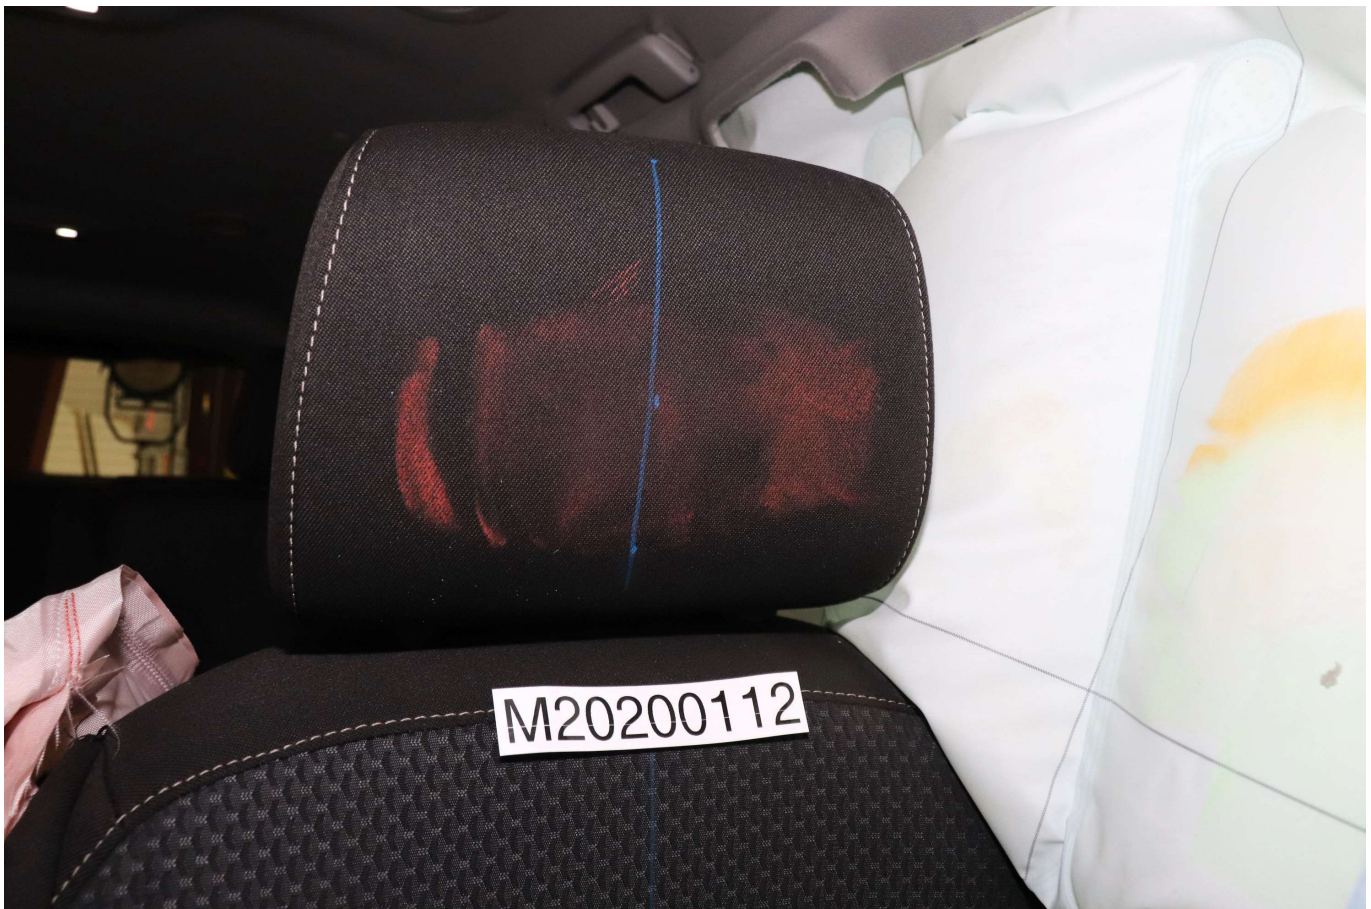
Photo No. 046 - Post-Test Dummy Close-Up Head Contact with Vehicle Interior View

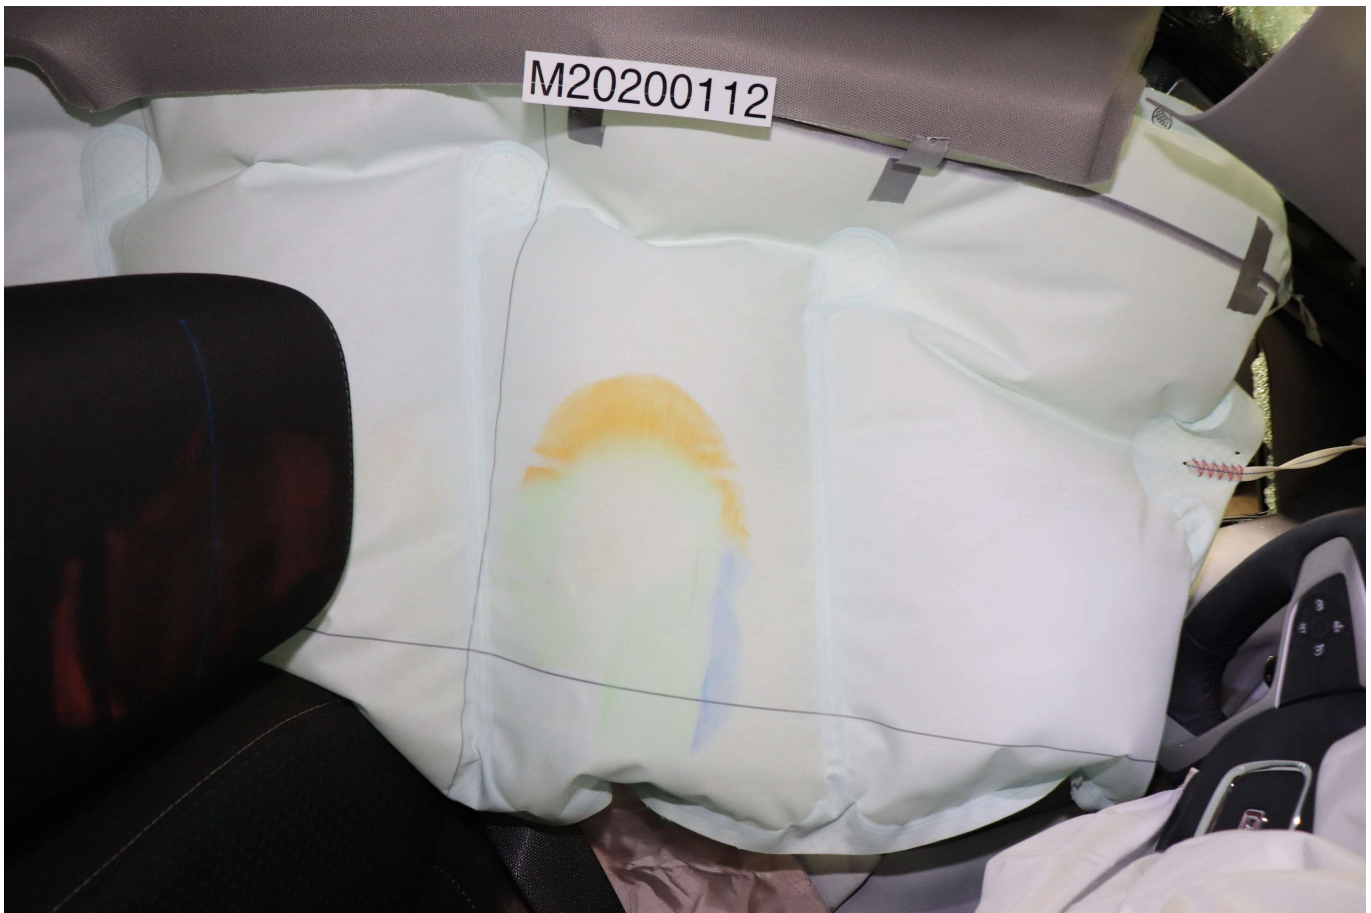
Photo No. 047 - Post-Test Dummy Close-Up Head Contact with Side Air Bag View

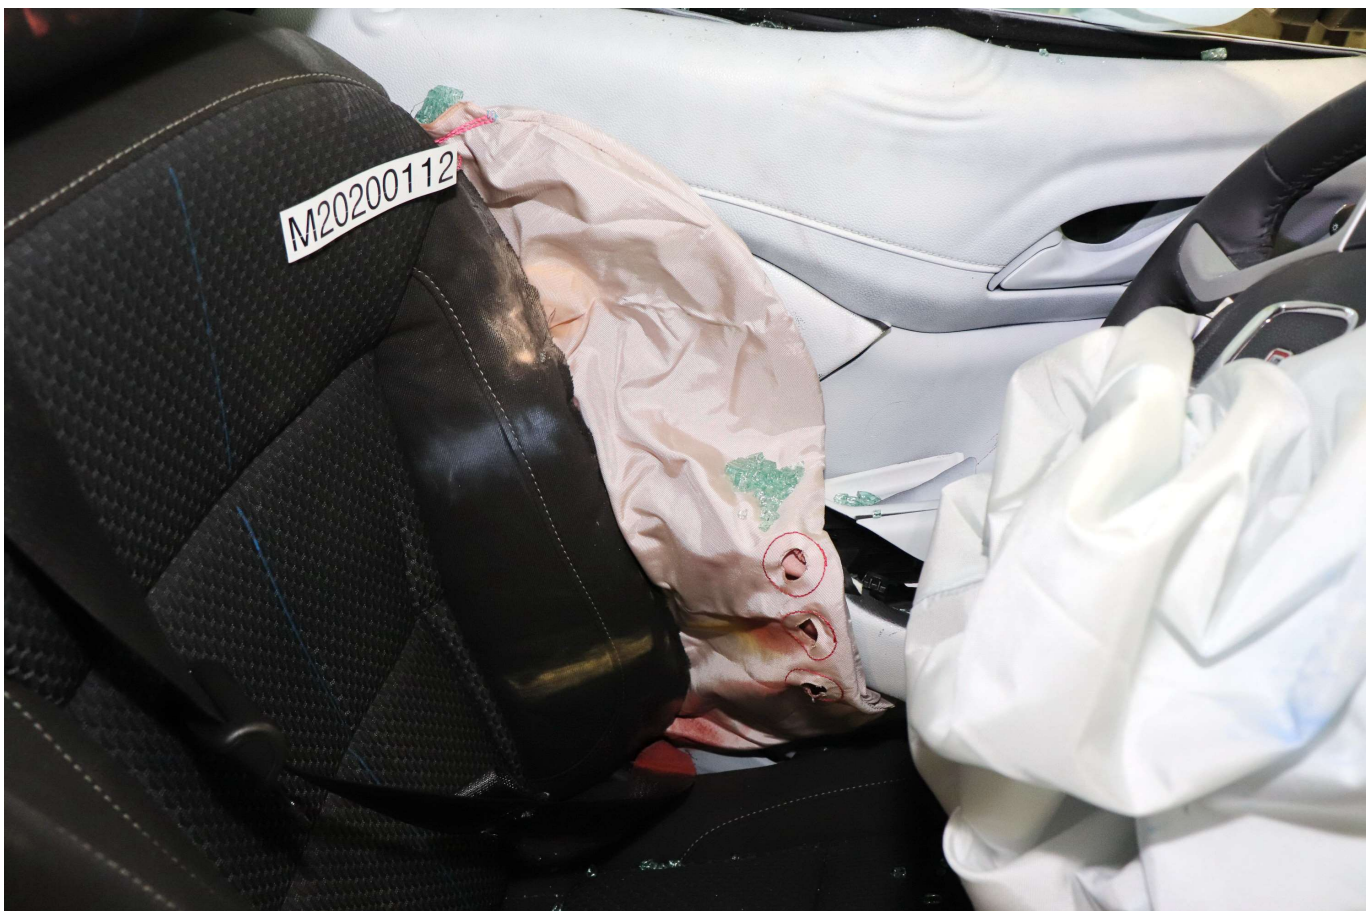
Photo No. 048 - Post-Test Dummy Close-Up Torso Contact with Vehicle Interior View

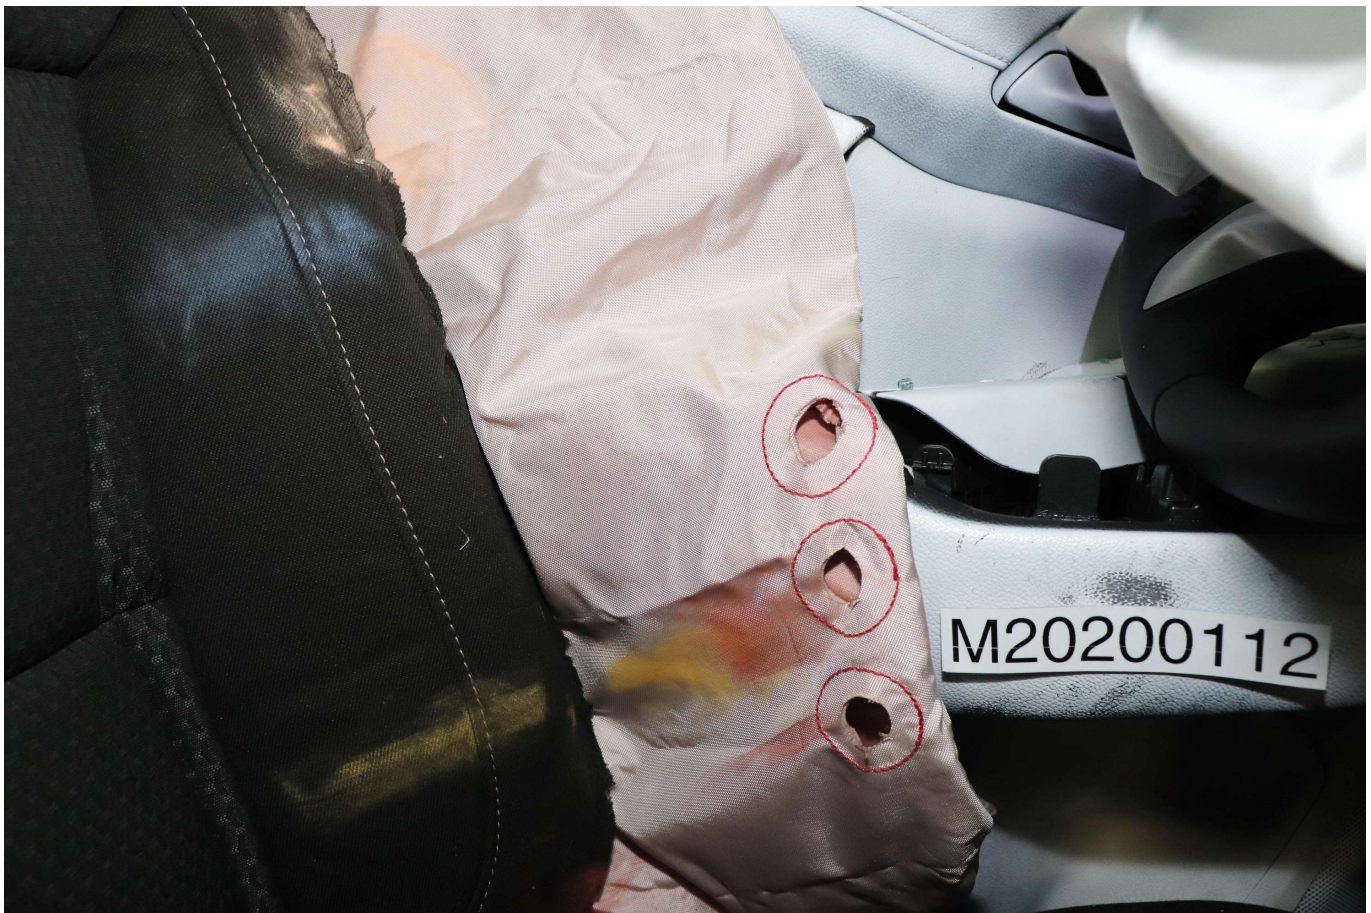
Photo No. 049 - Post-Test Dummy Close-Up Torso Contact with Side Air Bag View

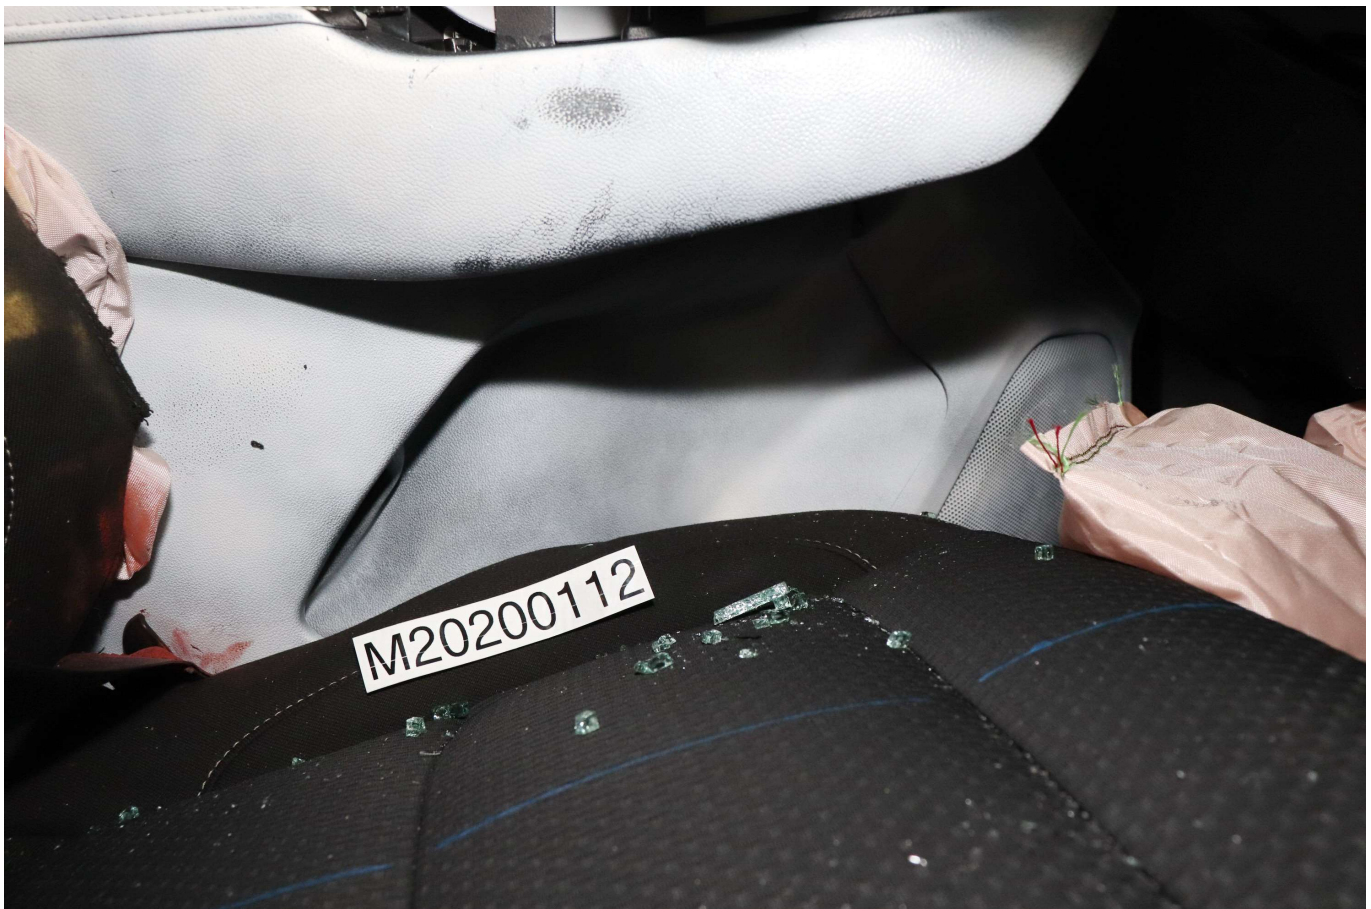
Photo No. 050 - Post-Test Dummy Close-Up Pelvis Contact with Vehicle Interior View

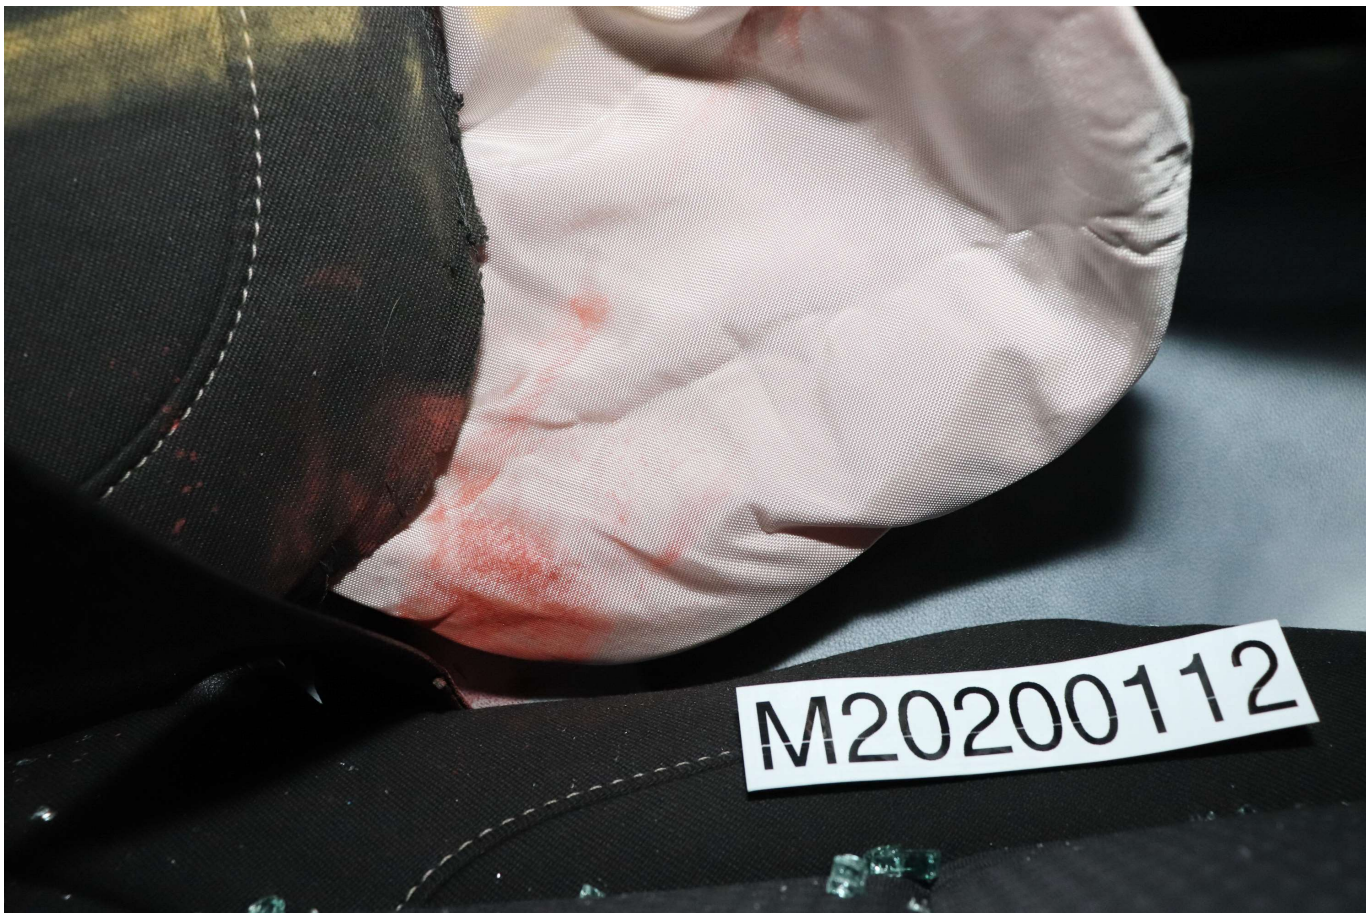
Photo No. 051 - Post-Test Dummy Close-Up Pelvis Contact with Side Air Bag View

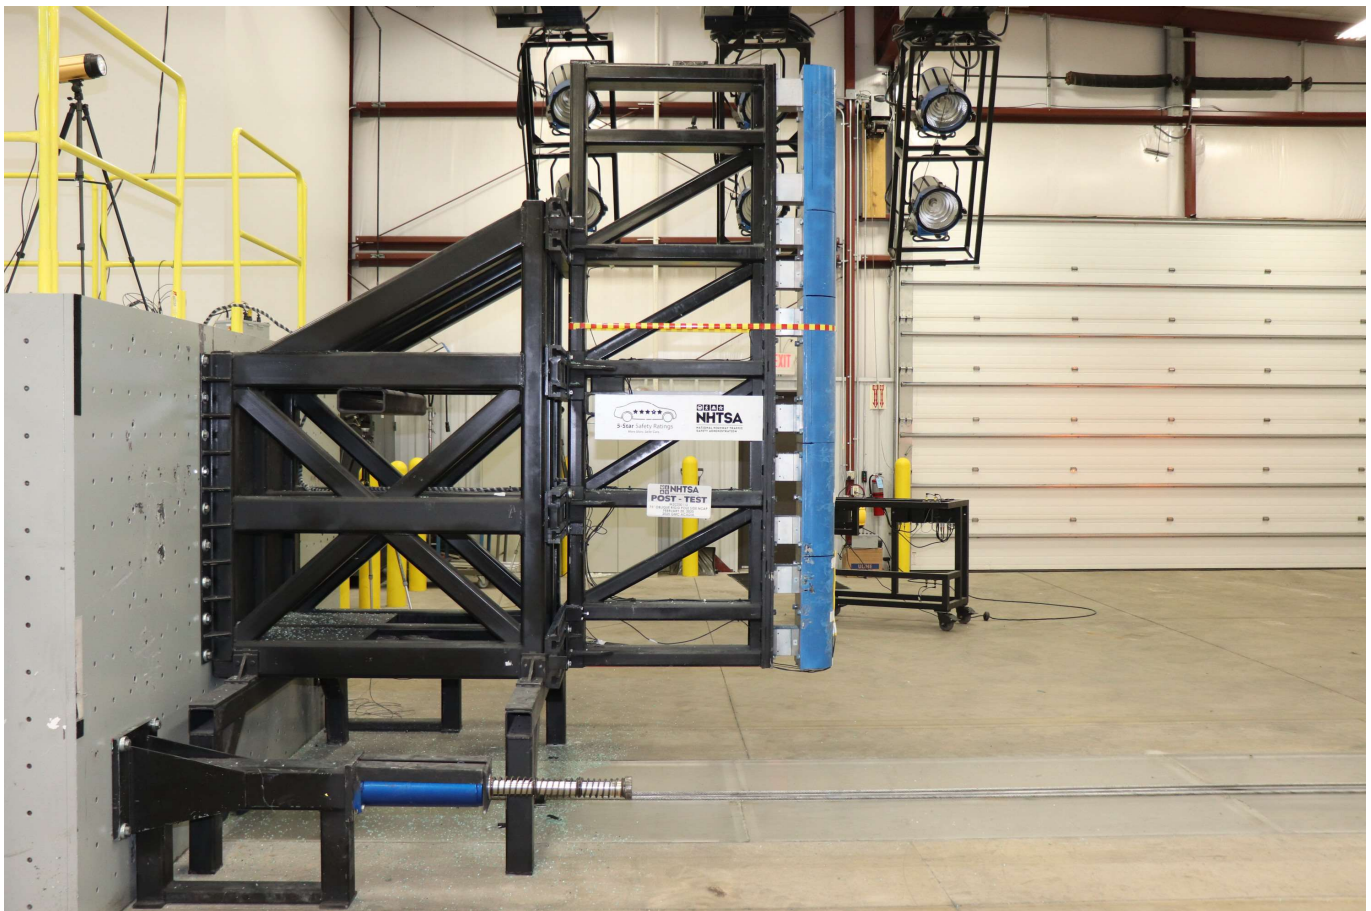
Photo No. 060 - Post-Test Pole Barrier Side View

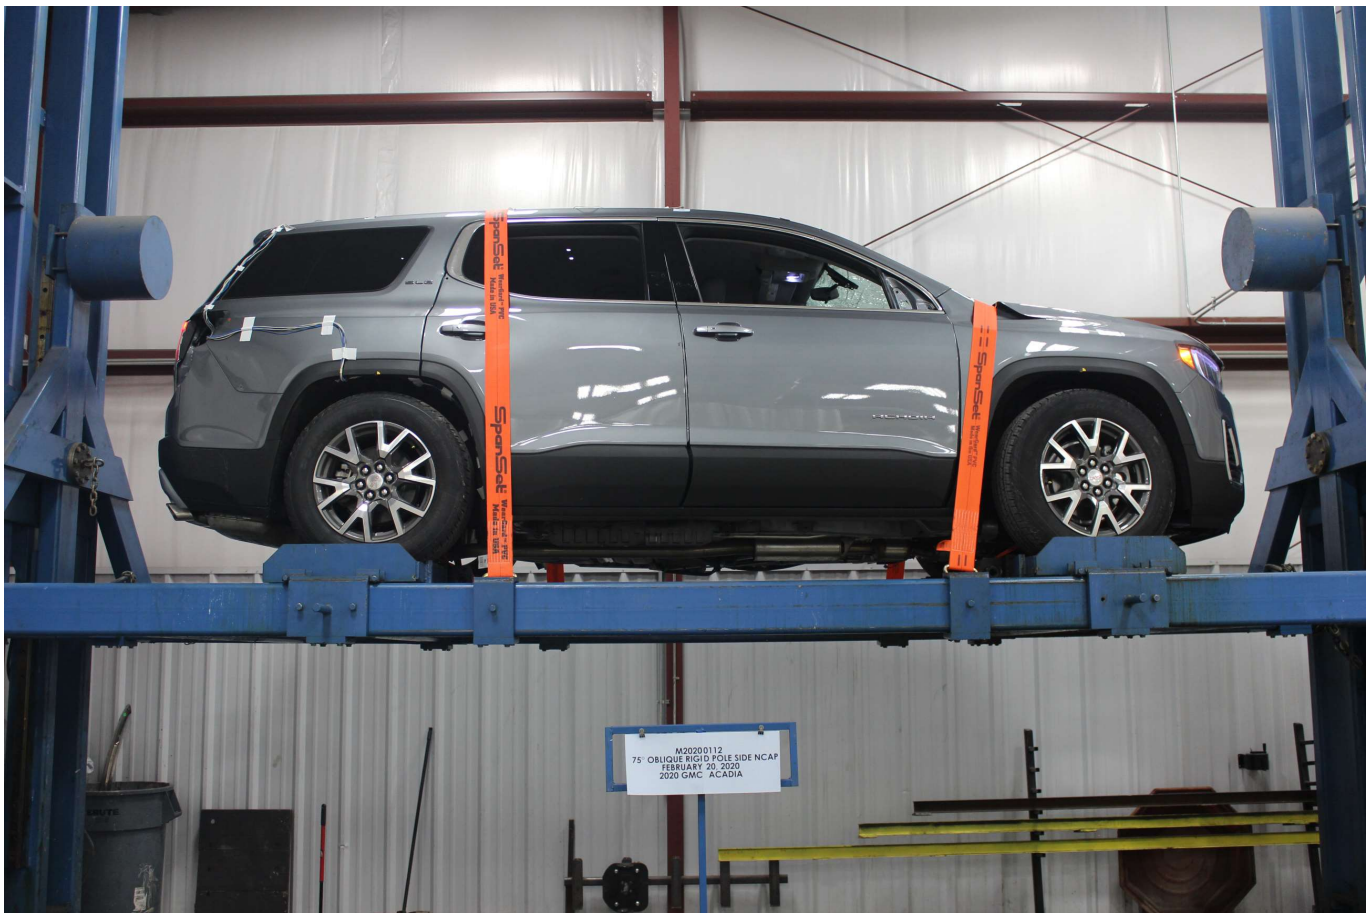
Photo No. 063 - FMVSS Photo No. 301 Static Rollover 0 Degrees

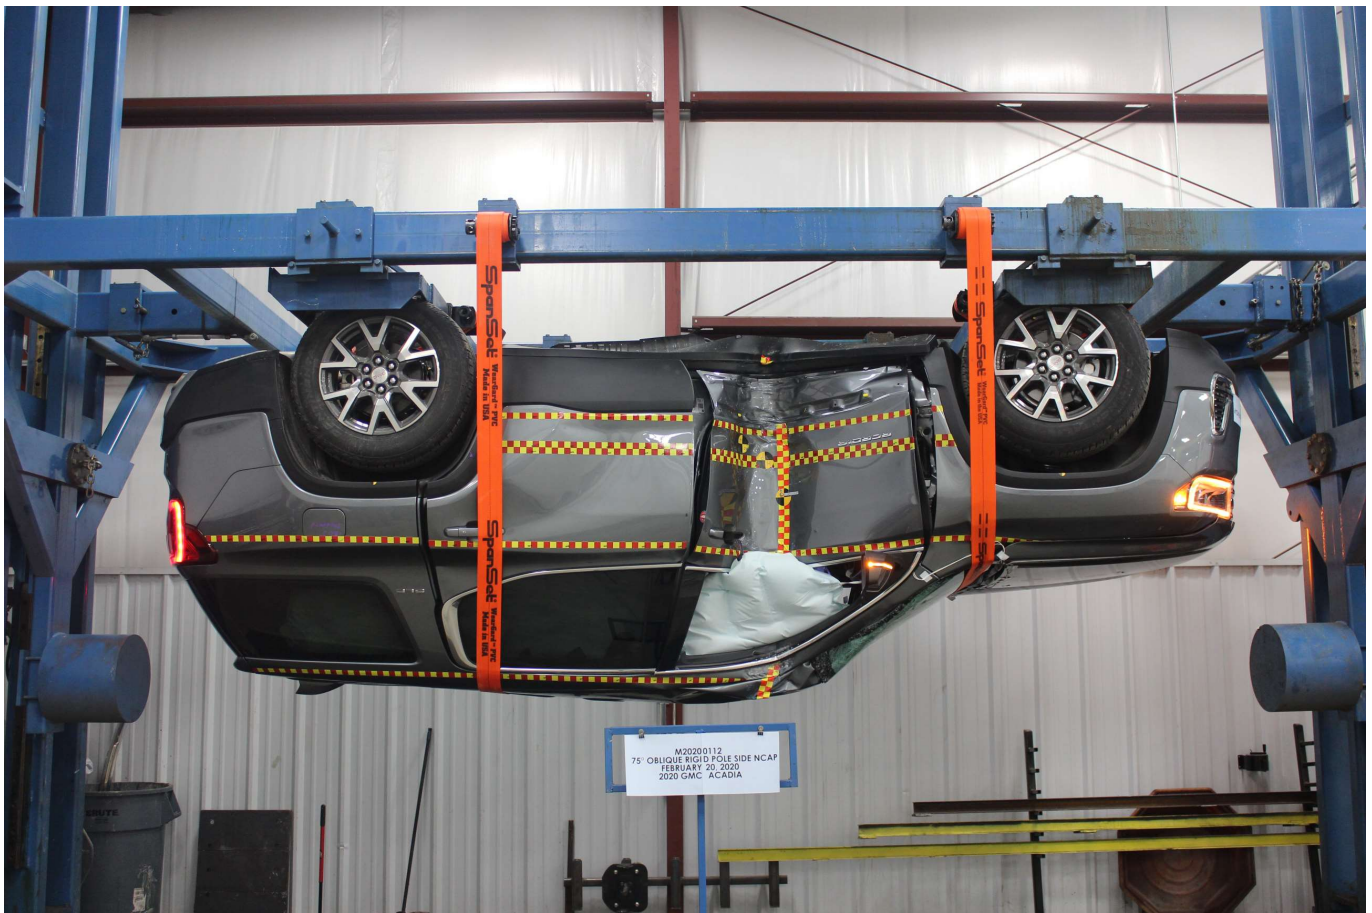
Photo No. 065 - FMVSS Photo No. 301 Static Rollover 180 Degrees

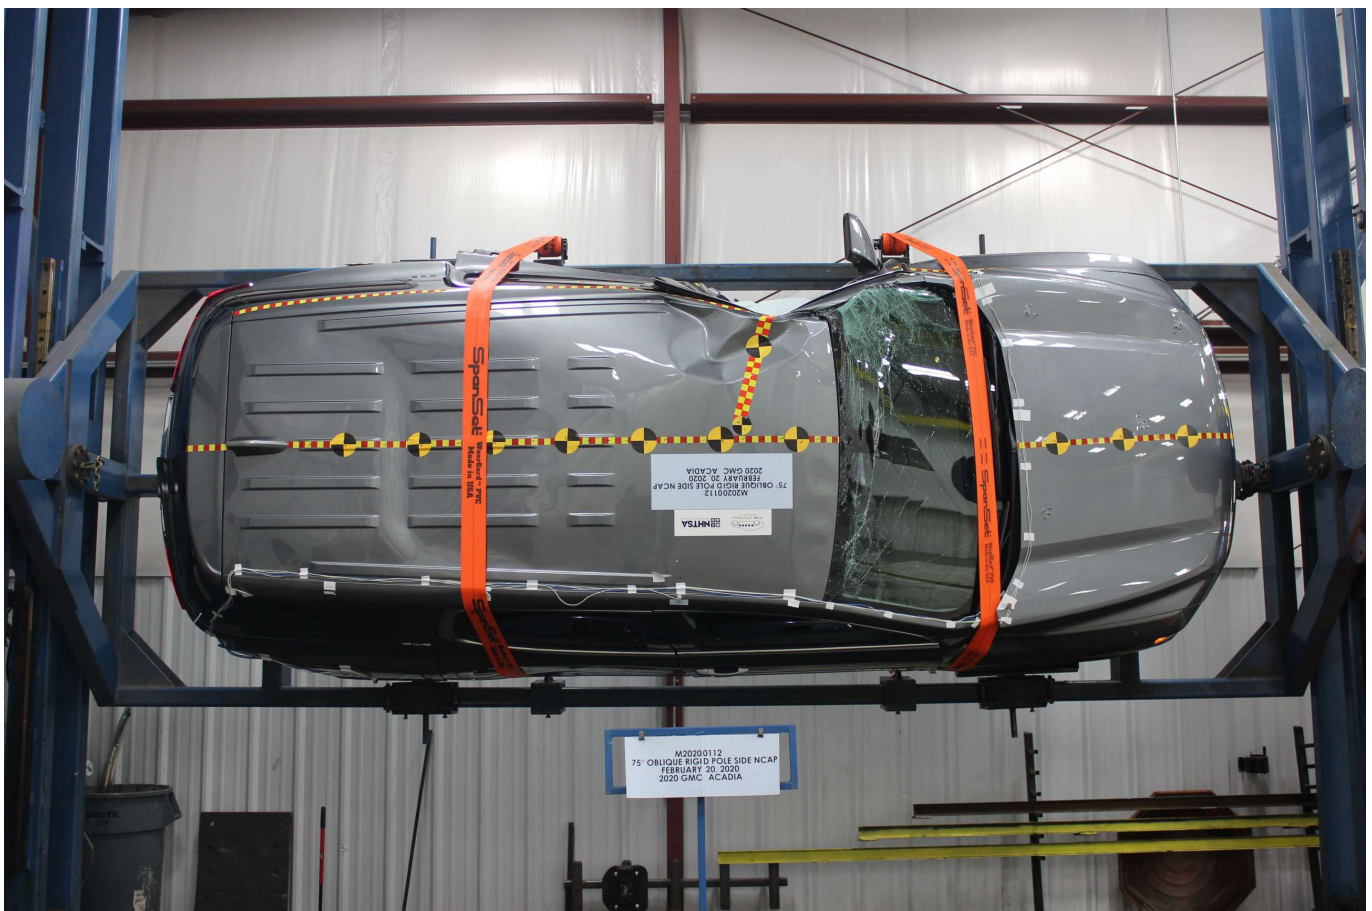
Photo No. 066 - FMVSS Photo No. 301 Static Rollover 270 Degrees
