**REPORT NUMBER: SPNCAP-MGA-20-015**

**NEW CAR ASSESSMENT PROGRAM (NCAP)  
Side Impact Pole Test**

**GENERAL MOTORS LLC  
2020 GMC Acadia SLE 5-Door SUV  
NHTSA No.: M20200112**

**FINAL REPORT**

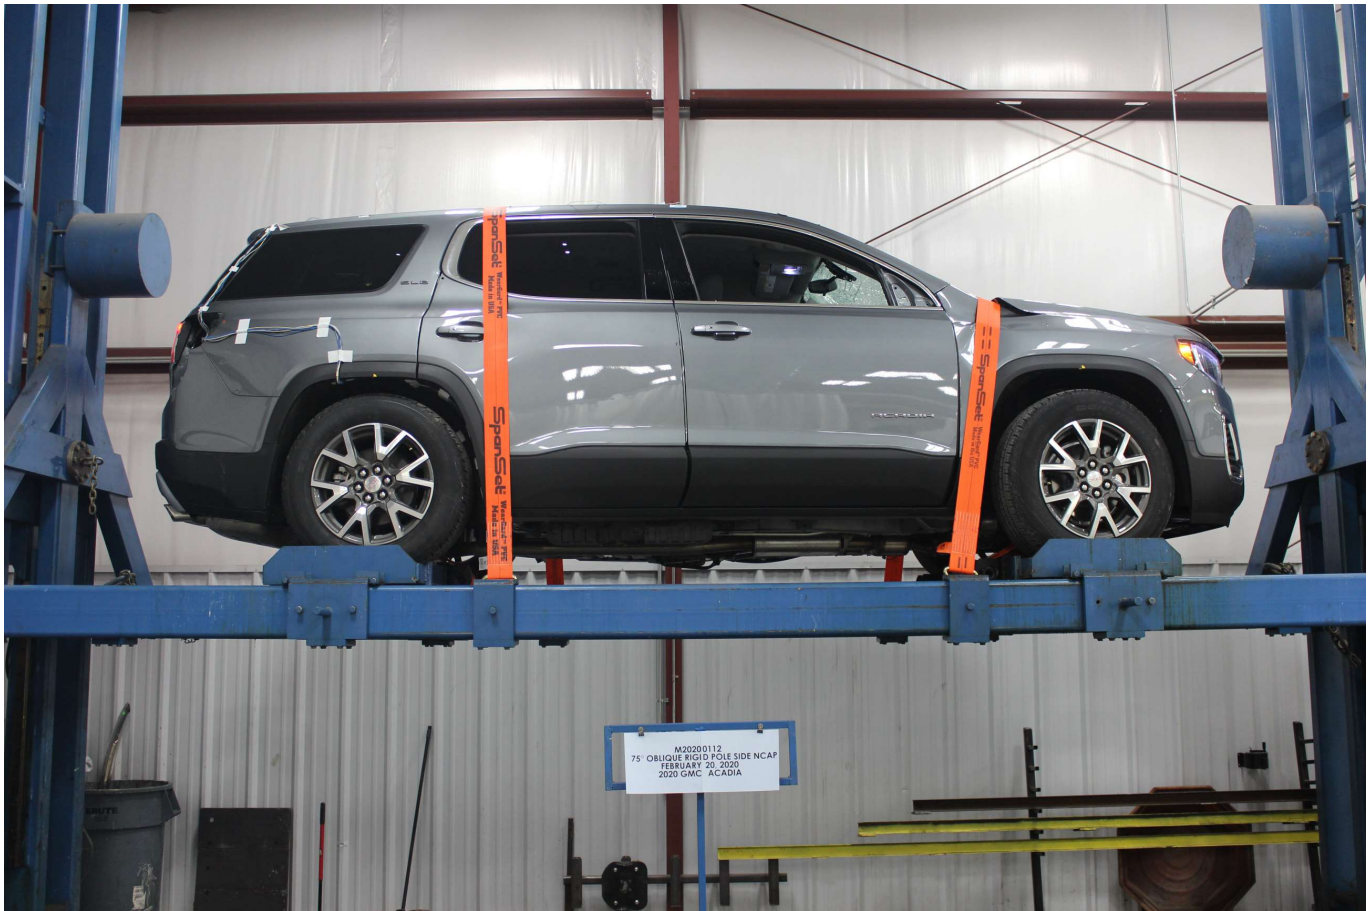
Photo No. 067 - FMVSS Photo No. 301 Static Rollover 360 Degrees

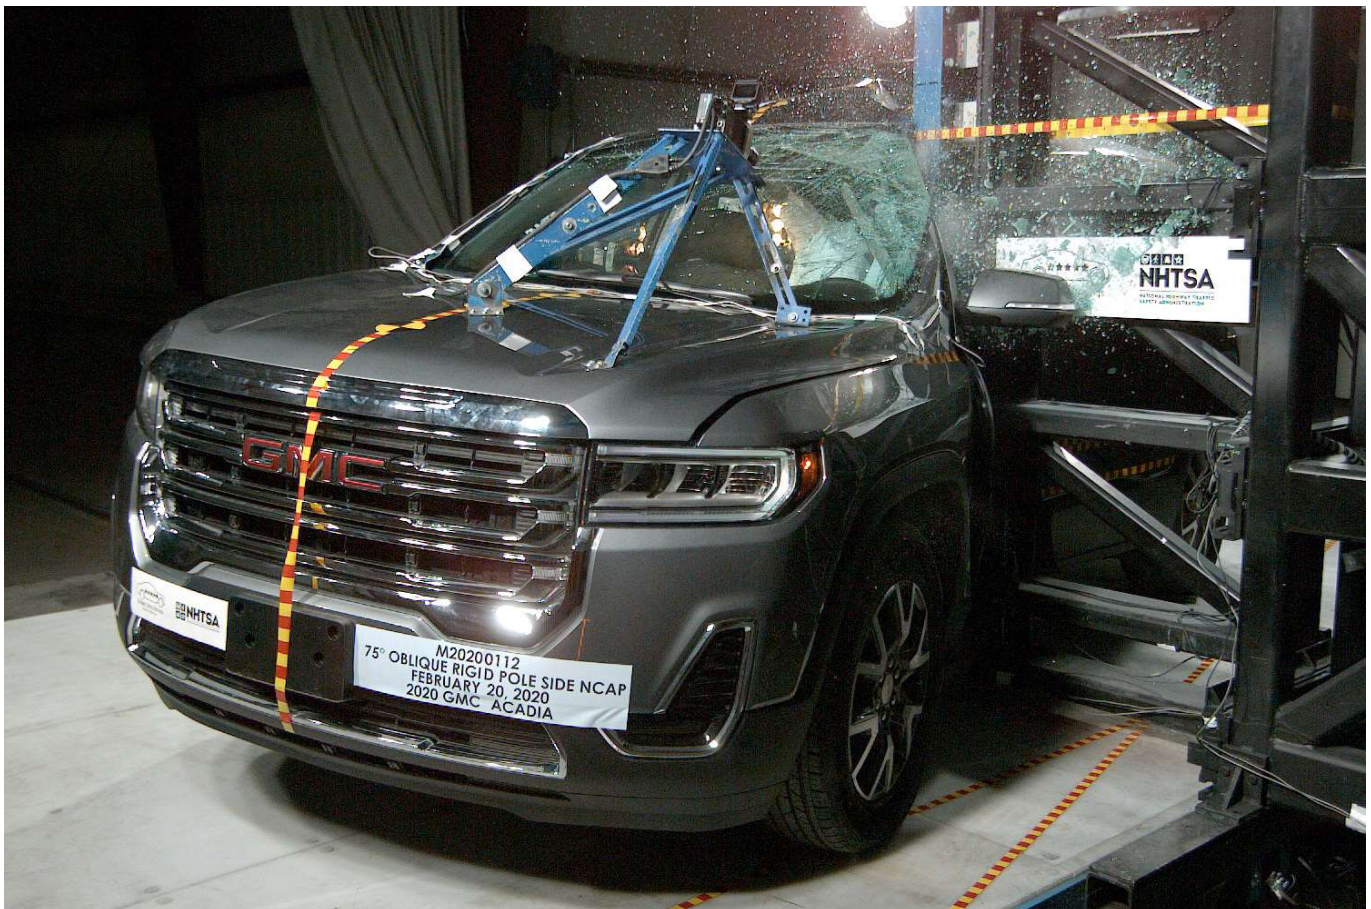
Photo No. 068 - Impact Event

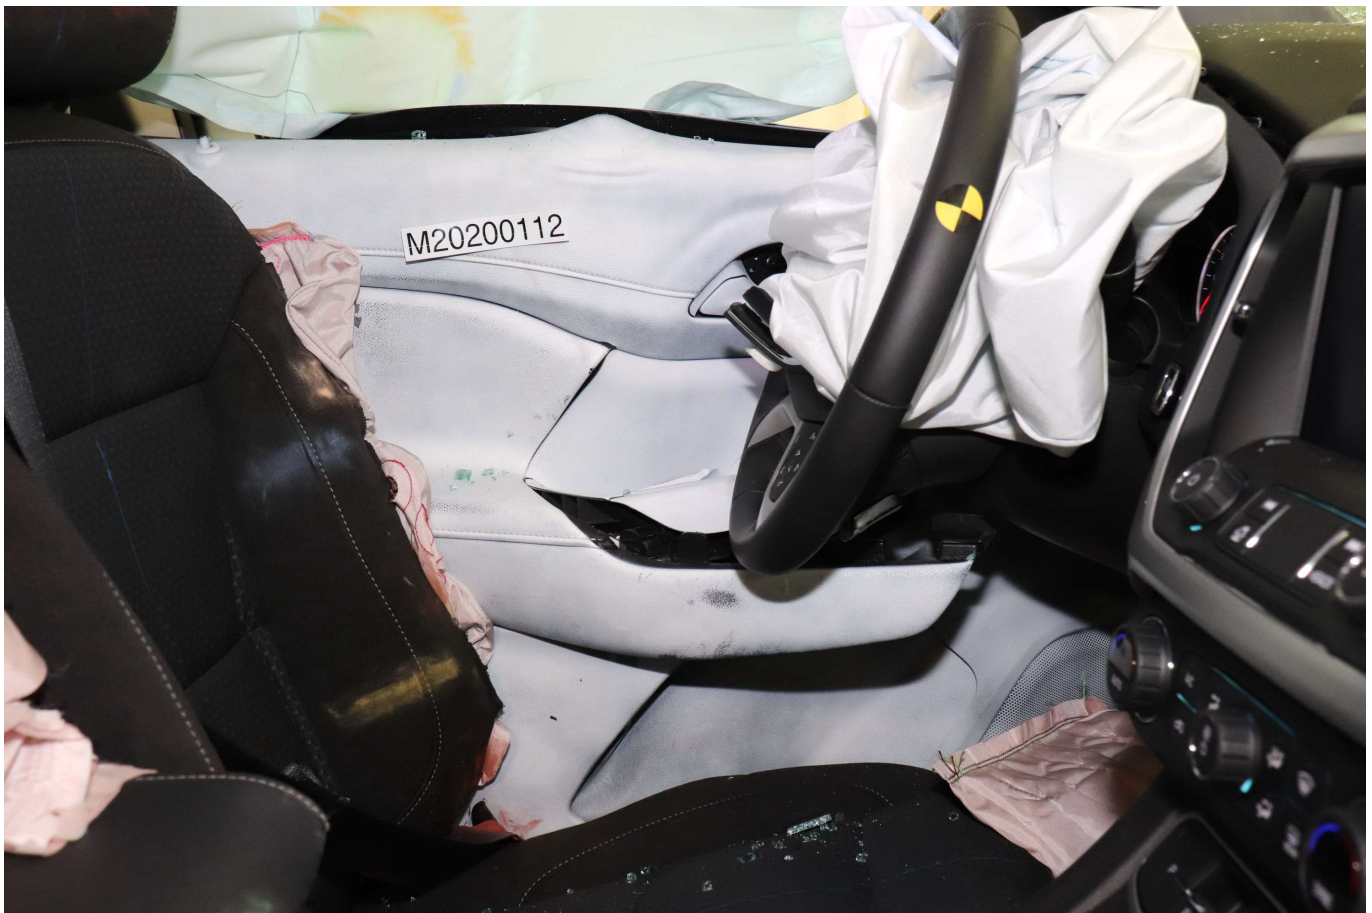
Photo No. 071 - Post-Test View of Shattered Vehicle Inner Door Panel

| Critical Areas of Performance | Observations and Conclusions |
|---|---|
| Side Window Damage | LF window broken |
