**REPORT NUMBER: SPNCAP-KAR-20-015
NEW CAR ASSESSMENT PROGRAM (NCAP)
SIDE IMPACT POLE TEST**

**HYUNDAI MOTOR COMPANY
2020 HYUNDAI PALISADE 5-DOOR MPV**

NHTSA No: M20204204

**PREPARED BY:
APPLUS IDIADA KARCO ENGINEERING, LLC.
9270 HOLLY ROAD
ADELANTO, CA 92301**

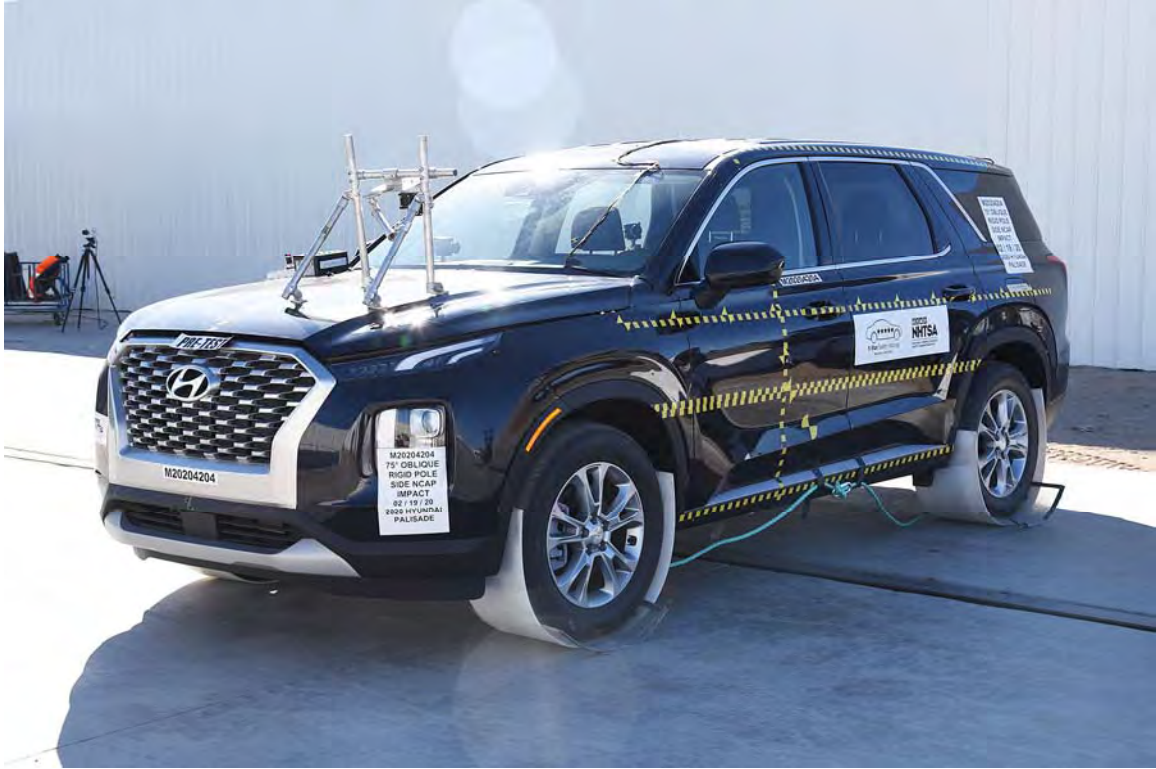
FIGURE 4. Post-Test Frontal View of Test Vehicle

The struck side doors of the vehicle were jammed shut. There was no separation at the hinges or latches. The remaining doors remained closed and latched. There were no ATD values that exceeded limits. The Left Lower A-Post Acceleration Y channel failed at 25.5 milliseconds. The Vehicle CG Acceleration X channel failed and no data was collected. The Left Front Sill Y channel failed and no data was collected.

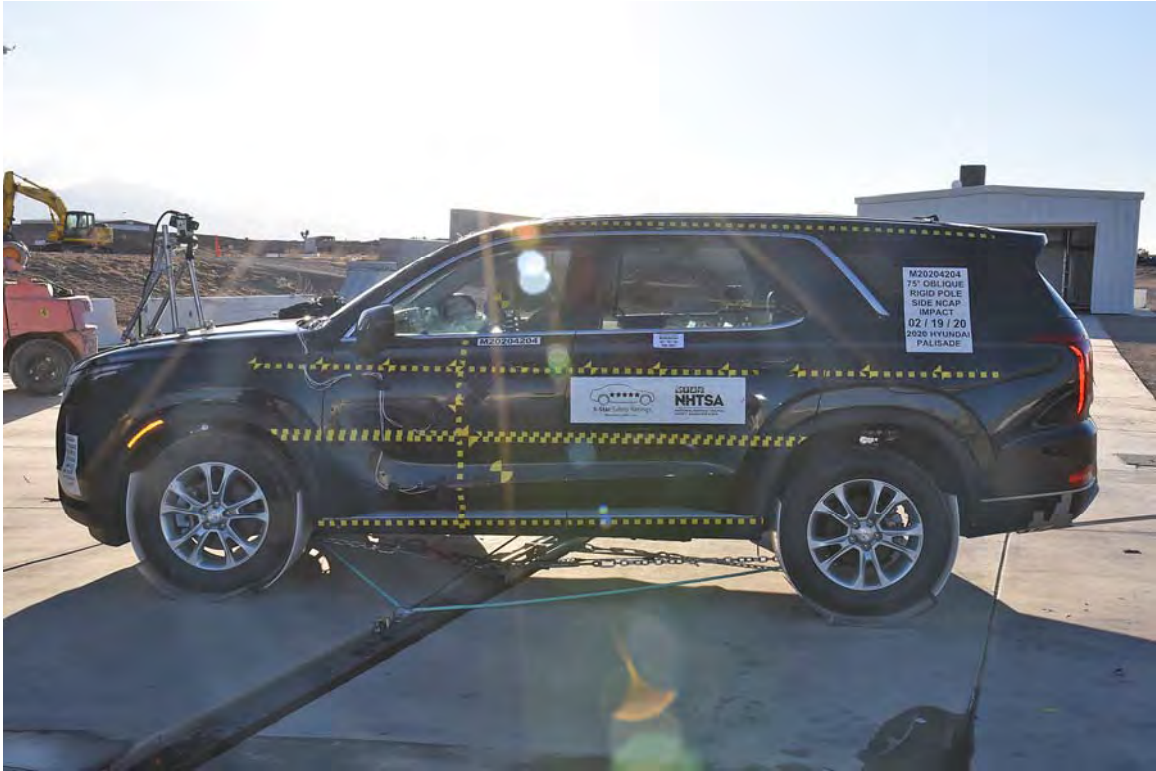
FIGURE 6. Post-Test Left Front $\frac{3}{4}$ View of Test Vehicle

Critical Areas of Performance	Observations and Conclusions
Pillar Performance	No separation occurred
Sill Separation	No separation occurred
Windshield Damage	Broken
Side Window Damage	Left front window broken
Other Notable Effects	None

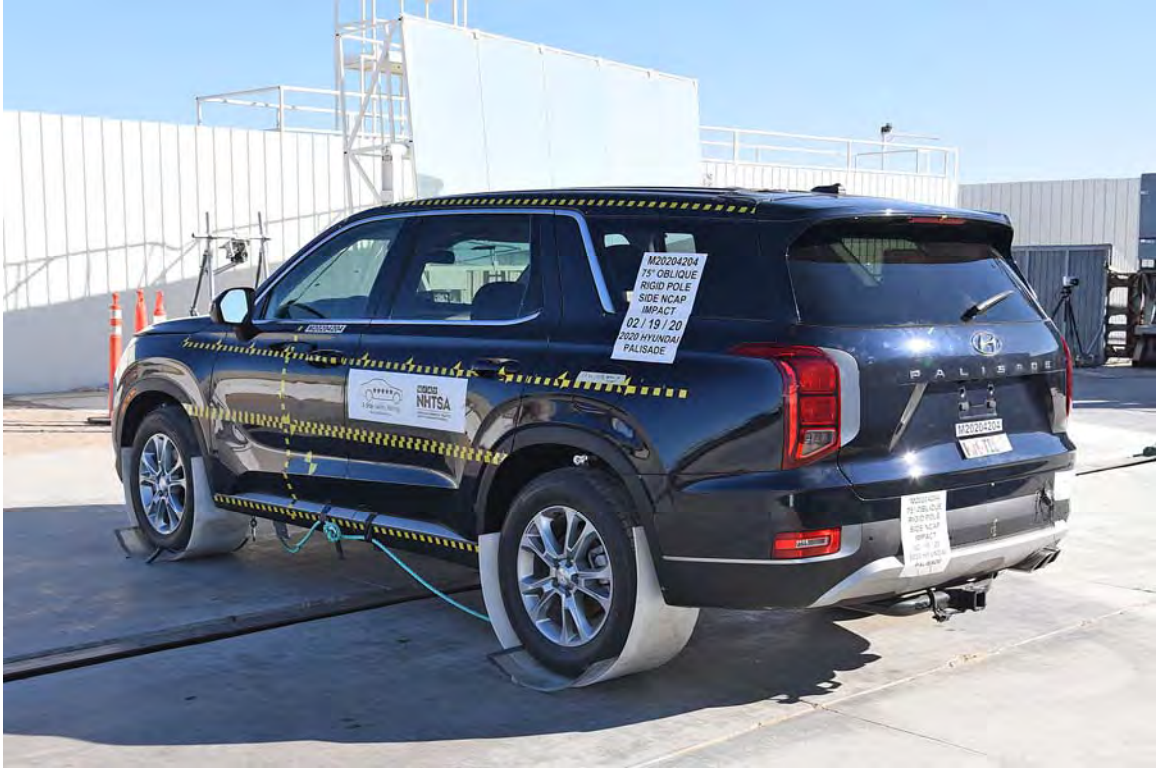
FIGURE 8. Post-Test Left Side View of Test Vehicle

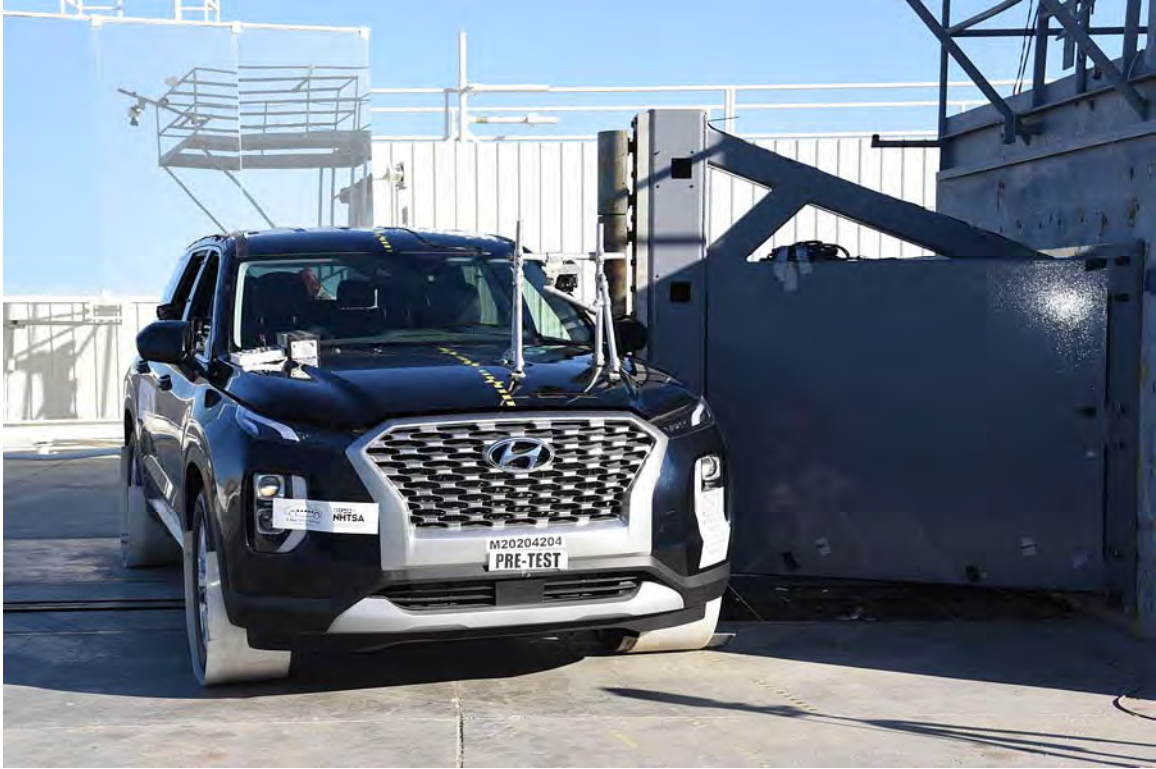
FIGURE 17. Pre-Test Left Side View of Pole Positioned Against Side of Vehicle

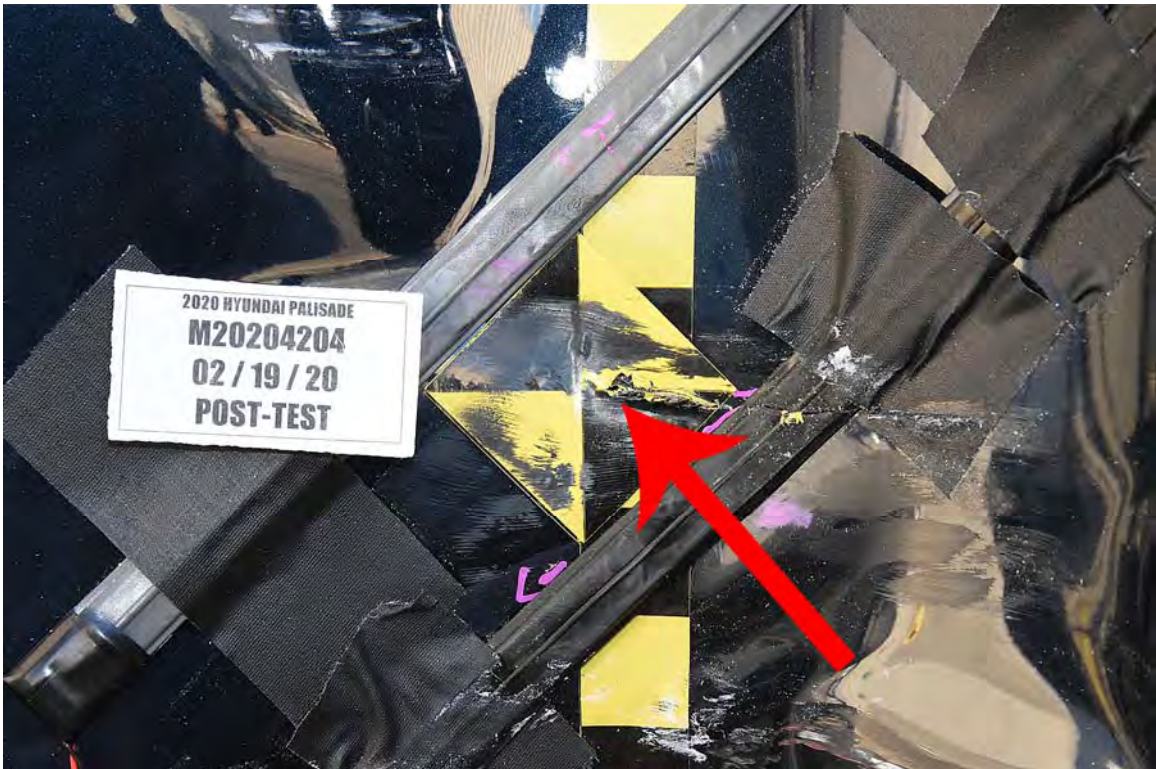
FIGURE 20. Post-Test Close-Up View of Impact Point Target Showing Impact Location

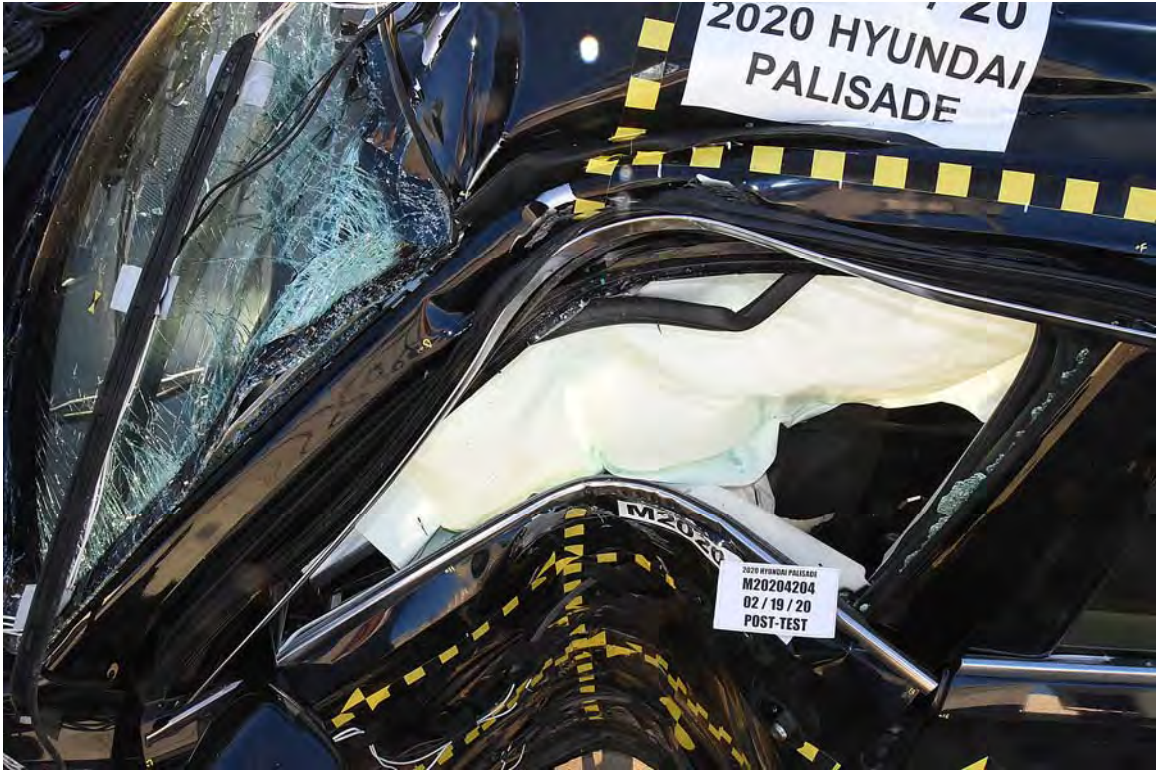
FIGURE 41. Post-Test Dummy and Door Clearance View

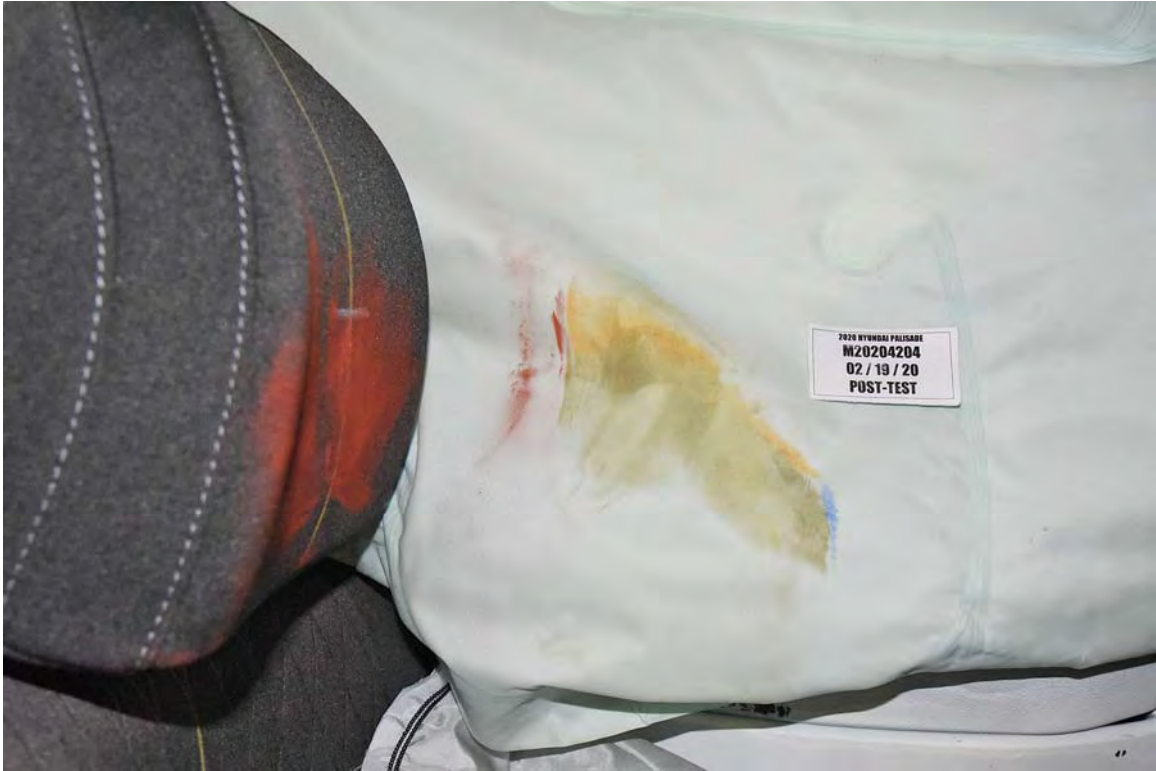
FIGURE 47. Post-Test Dummy Close-Up Head Contact With Side Airbag View
