REPORT NUMBER: NCAP-CAL-20-010

**NEW CAR ASSESSMENT PROGRAM (NCAP)
FRONTAL BARRIER IMPACT TEST**

**Volvo Car Corporation
2020 Volvo S60
Four Door Sedan**

NHTSA No: M20205900

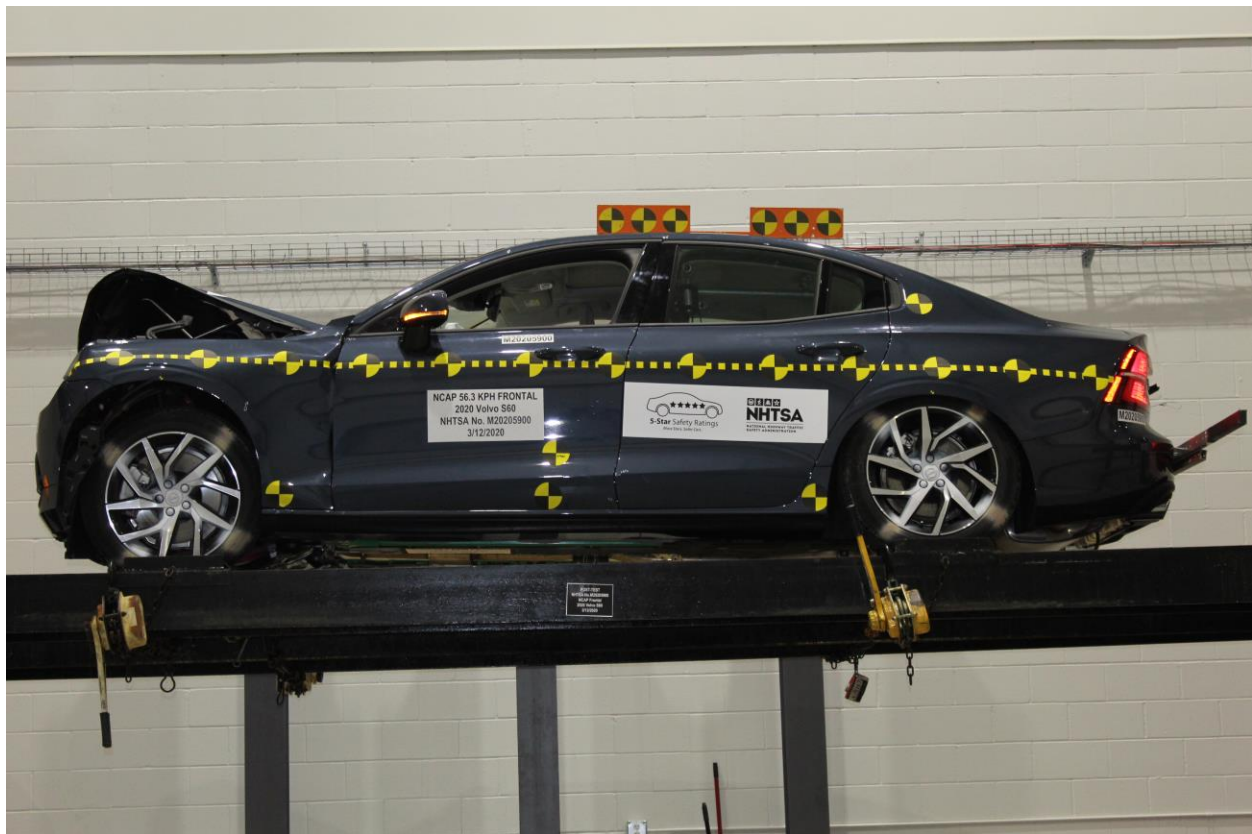
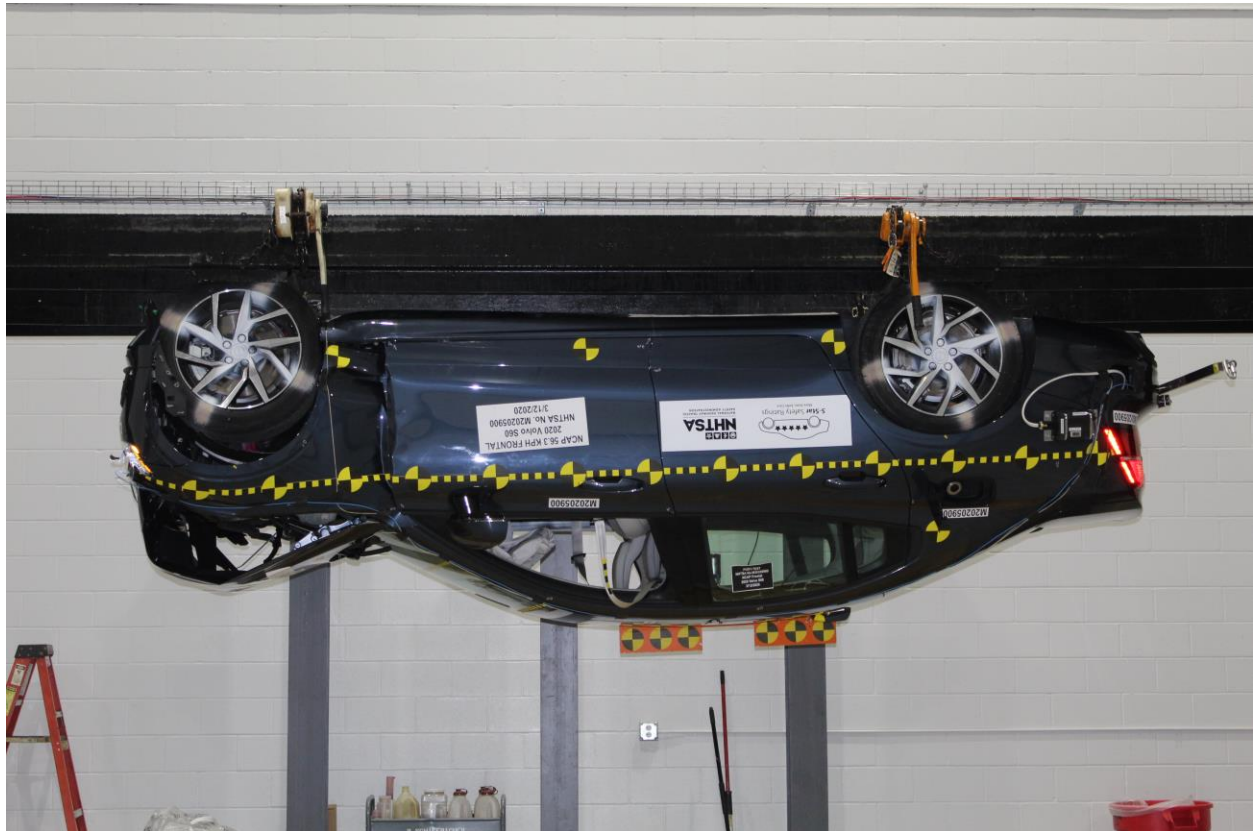
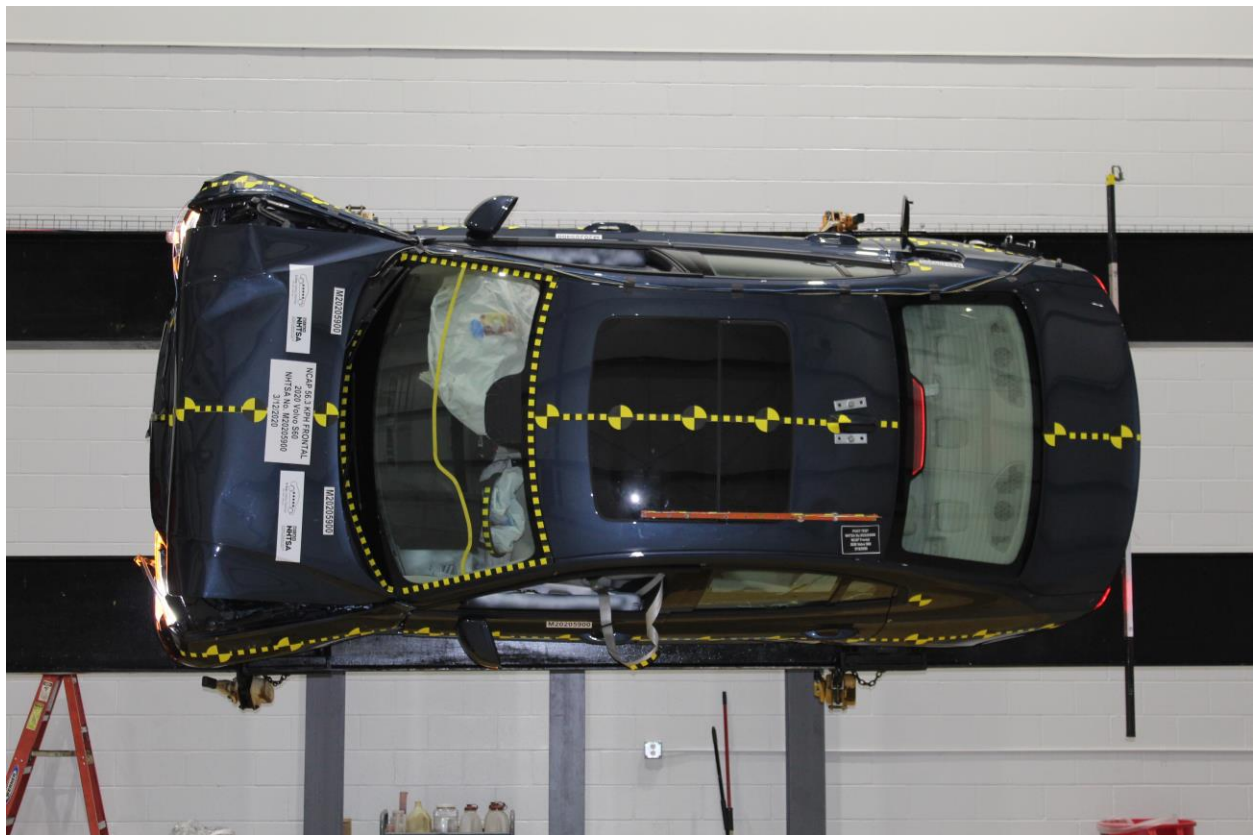
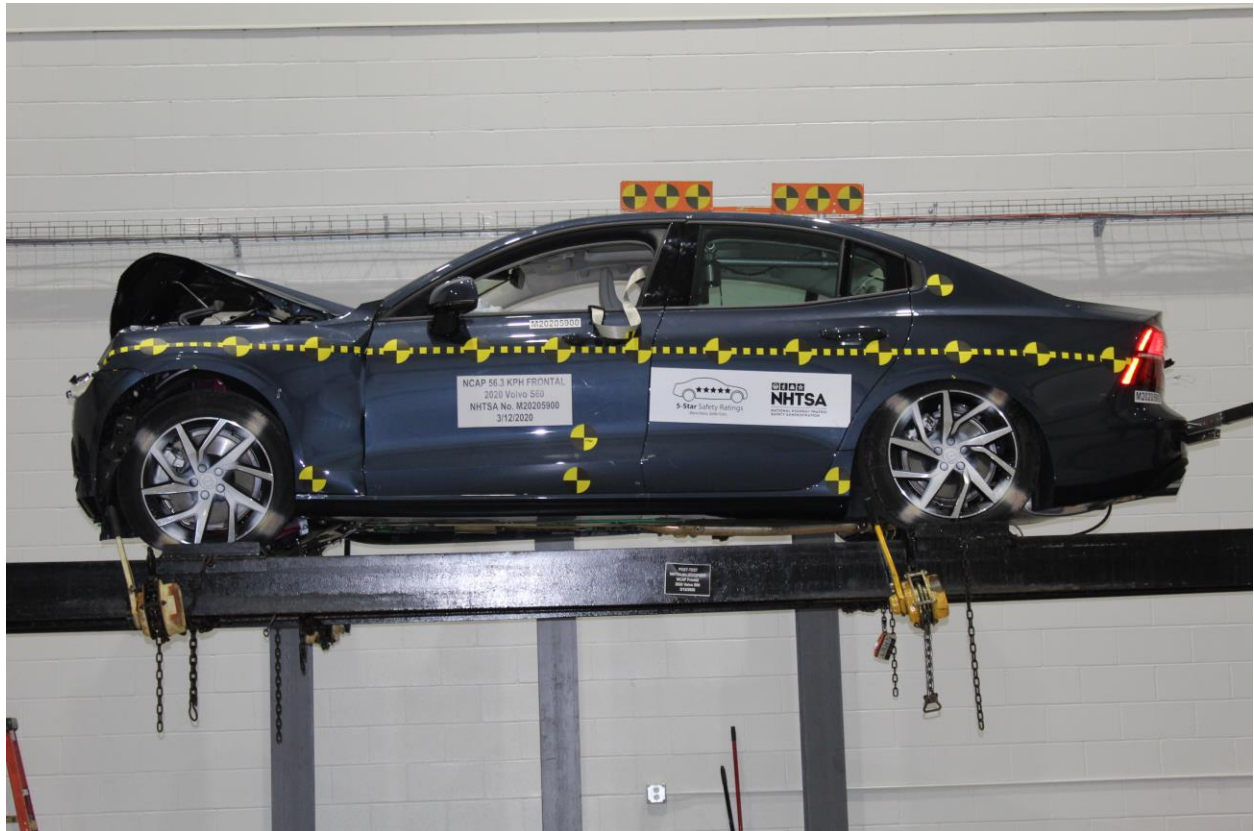
Figure A-77: Vehicle at 0° on Static Rollover Device

Figure A-78: Vehicle at 90° on Static Rollover Device

Figure A-79: Vehicle at 180° on Static Rollover Device

Figure A-80: Vehicle at 270° on Static Rollover Device

Figure A-81: Vehicle at 360° on Static Rollover Device

There was 100 percent windshield retention and no intrusion into the protected zone of the windshield during the event. There was a total of 0.0 grams of stoddard solvent leakage after the event or during any phase of the static rollover. The maximum static crush of the vehicle was 409 mm and both driver and passenger side doors remained closed during the impact event and were operable after the impact.
