**REPORT NUMBER: SINCAP-KAR-20-013**

**NEW CAR ASSESSMENT PROGRAM (NCAP)  
MOVING DEFORMABLE BARRIER SIDE IMPACT TEST**

**VOLVO CAR CORPORATION  
2020 VOLVO XC60 T5 5-DOOR MPV**

**NHTSA No: M20205905**

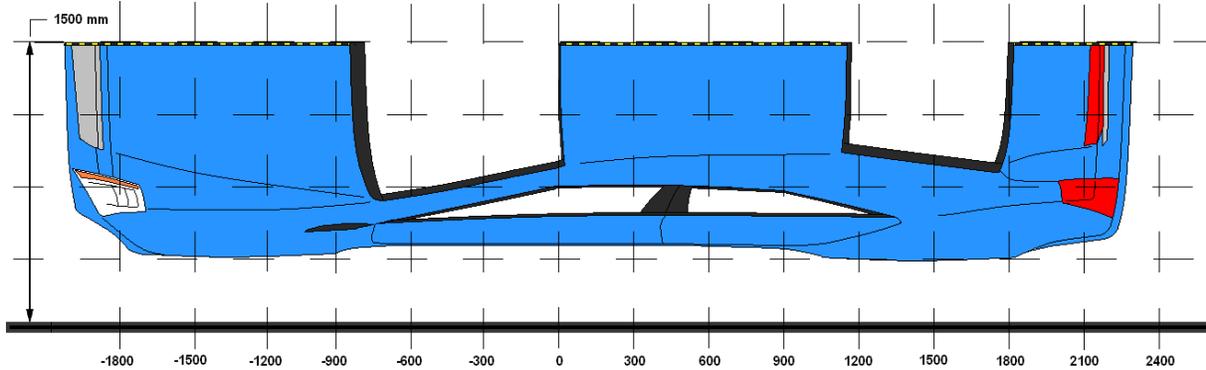
**VEHICLE AND MDB DAMAGE PROFILE DISTANCES**

DPD	Distance From Impact Point (mm)	Level	Pre-Test (mm)	Post-Test (mm)	Crush (mm)
1	2400	4	603	605	2
2	1950	3	558	627	69
3	1350	2	569	719	150
4	750	3	559	727	168
5	150	2	562	650	88
6	-300	4	666	651	-15
