REPORT NUMBER: SPNCAP-MGA-20-019

**NEW CAR ASSESSMENT PROGRAM (NCAP)
Side Impact Pole Test**

**HYUNDAI MOTOR MANUFACTURING ALABAMA, LLC
2020 Hyundai Sonata SE 4-Door Sedan
NHTSA No.: O20204207**

FINAL REPORT

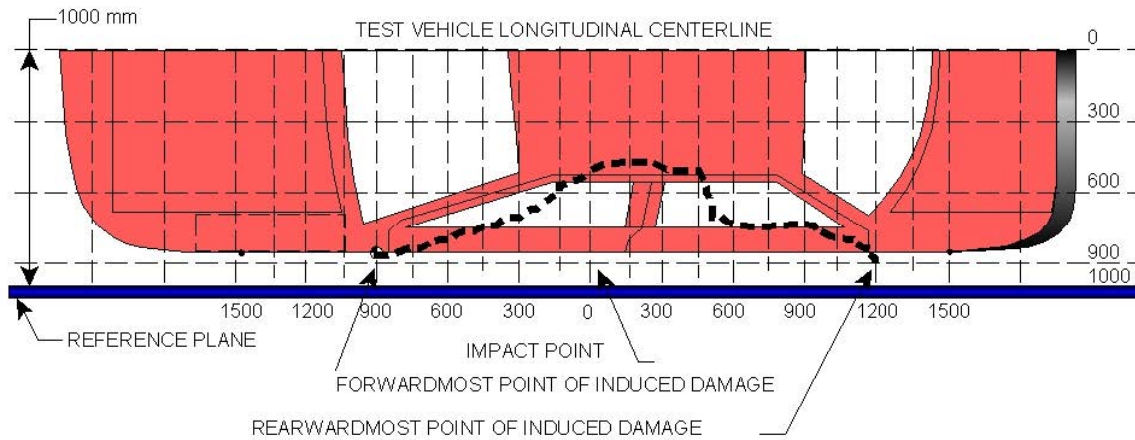
VEHICLE DAMAGE PROFILE DISTANCES

Pre-test measurements are taken when the vehicle is in the “As Tested” weight condition. Vehicle measurements forward of the vertical impact reference line are negative. The crush profile grid is established prior to the test based on an estimated impact point.

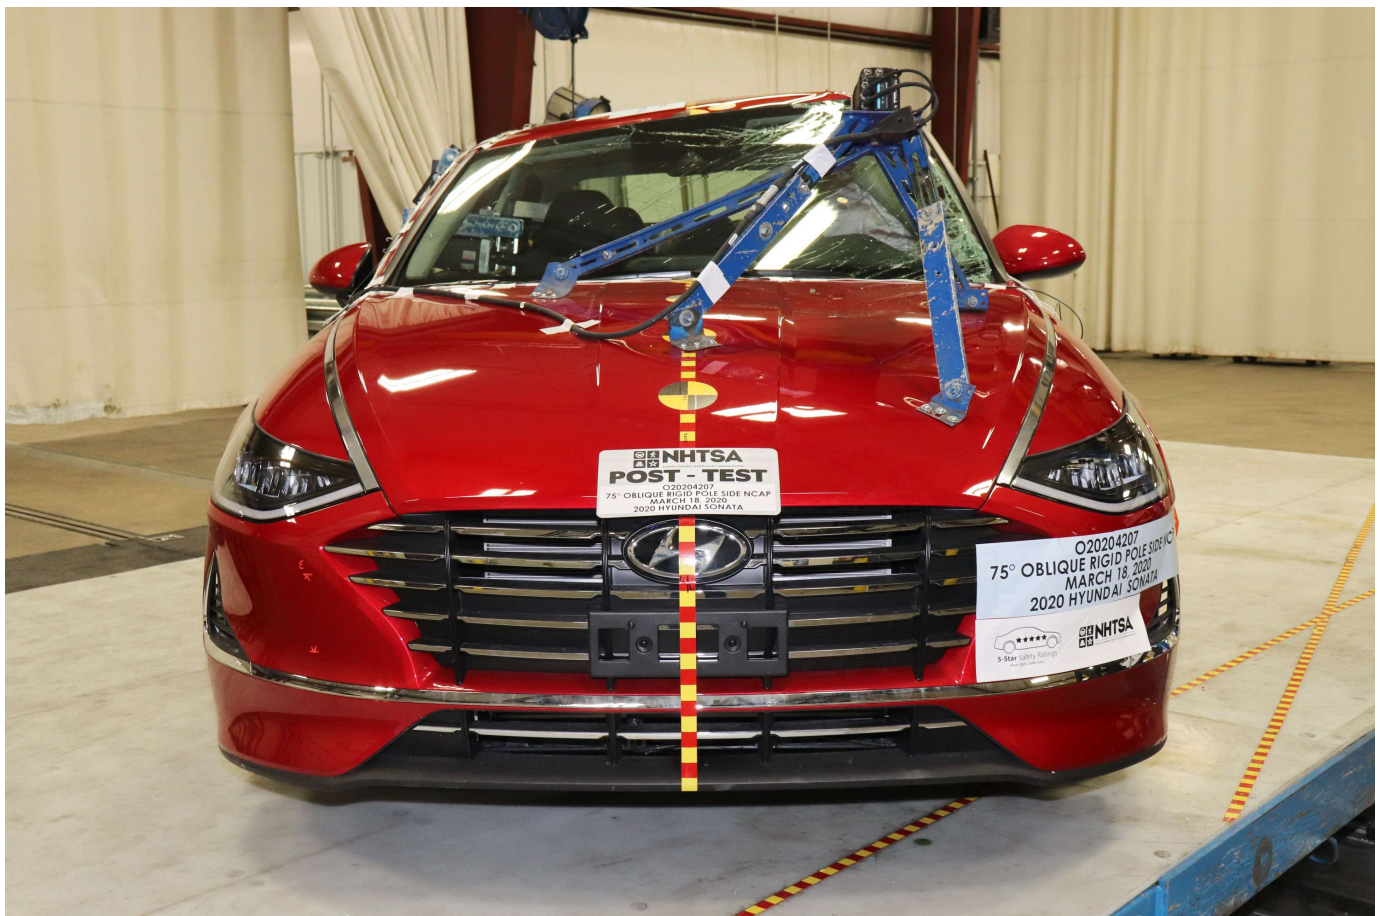
Photo No. 004 - Post-Test Frontal View of Test Vehicle

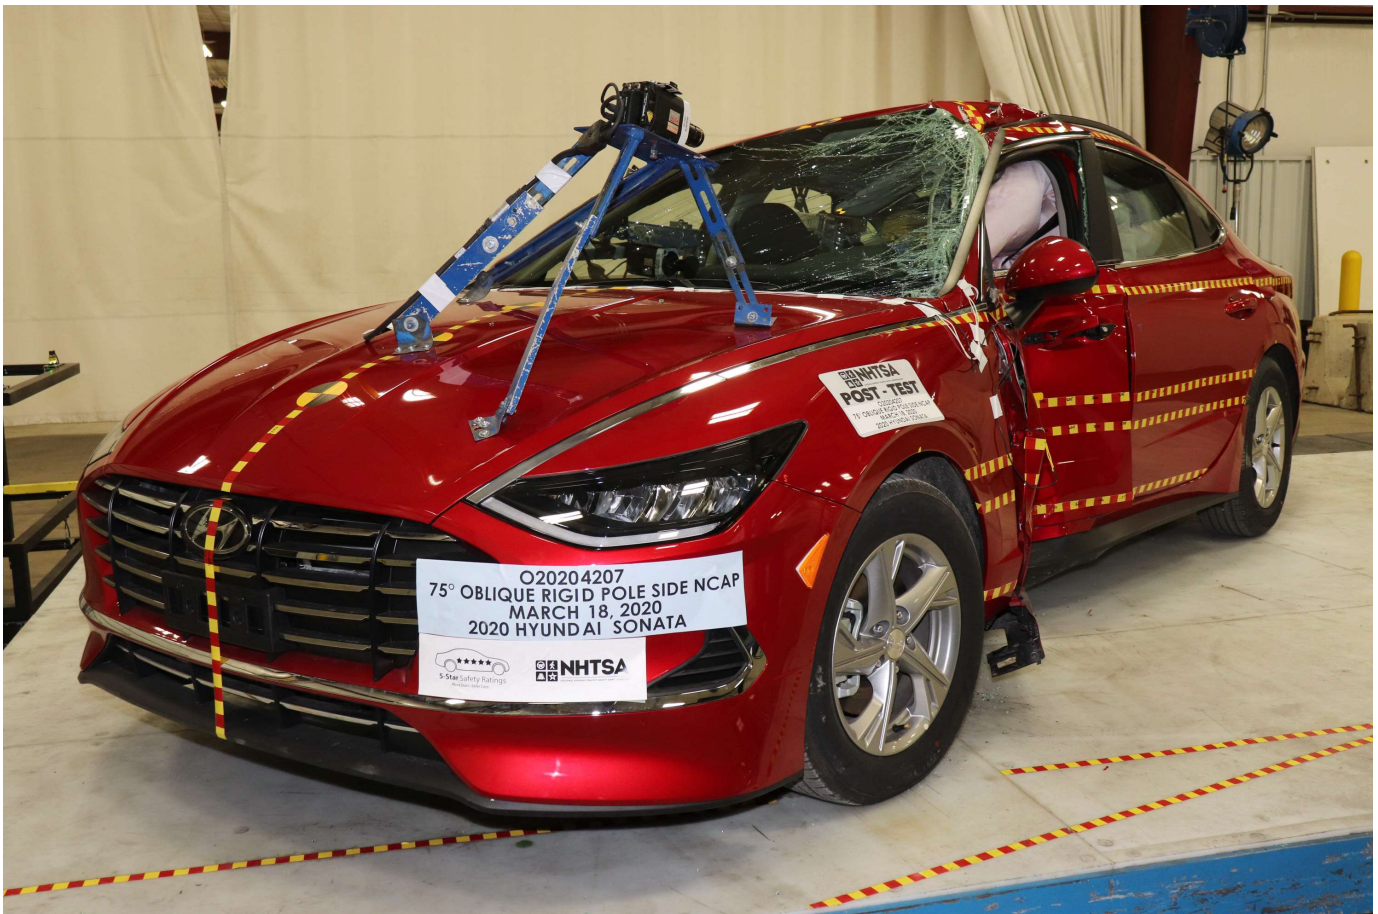
Photo No. 006 - Post-Test Left Front Three-Quarter View of Test Vehicle

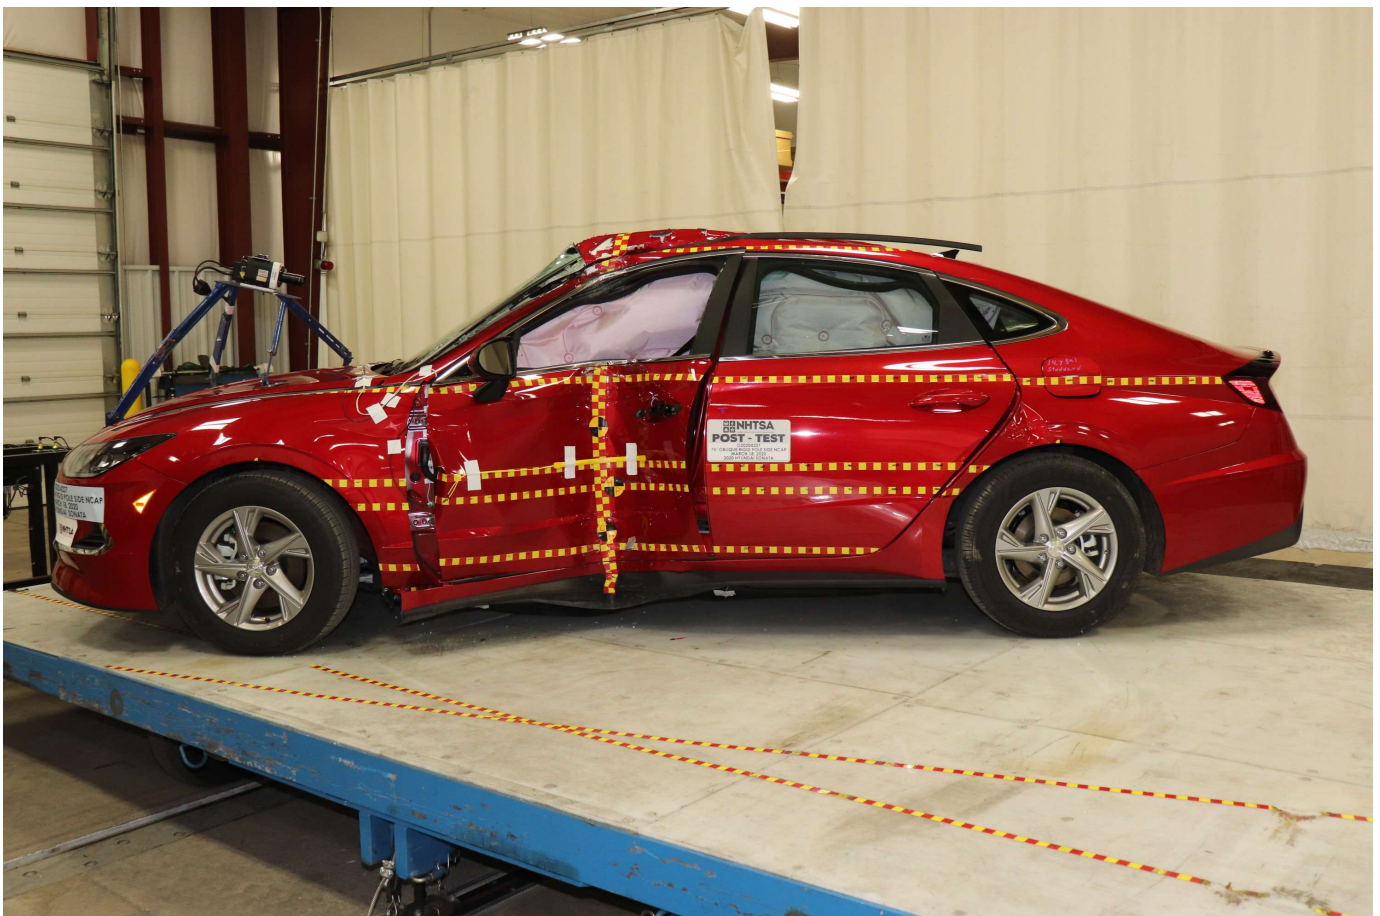
Photo No. 008 - Post-Test Left Side View of Test Vehicle

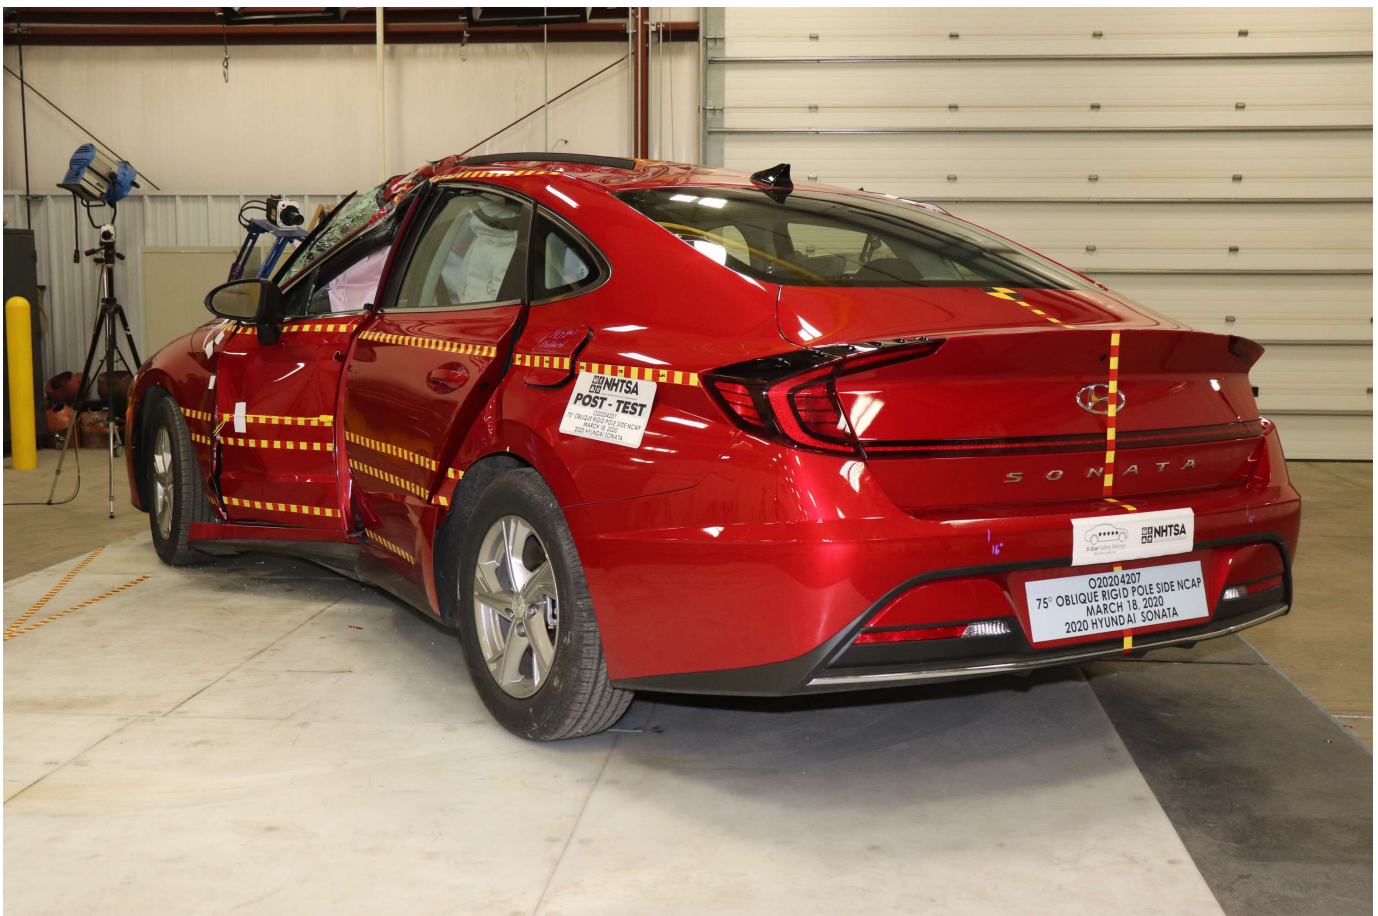
Photo No. 010 - Post-Test Left Rear Three-Quarter View of Test Vehicle

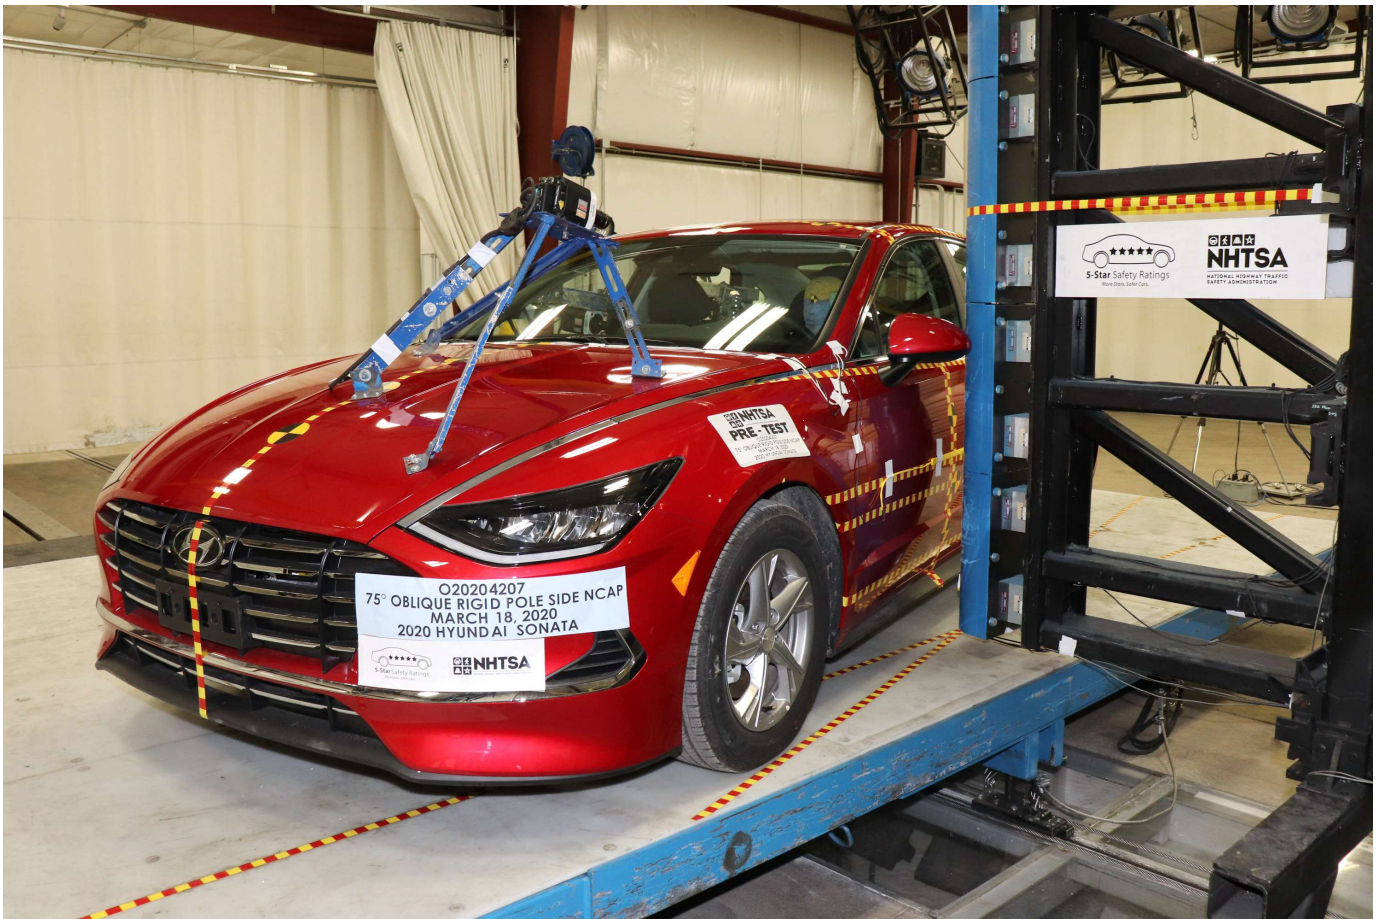
Photo No. 017 - Pre-Test Left Side View of Pole Positioned Against Side of Vehicle

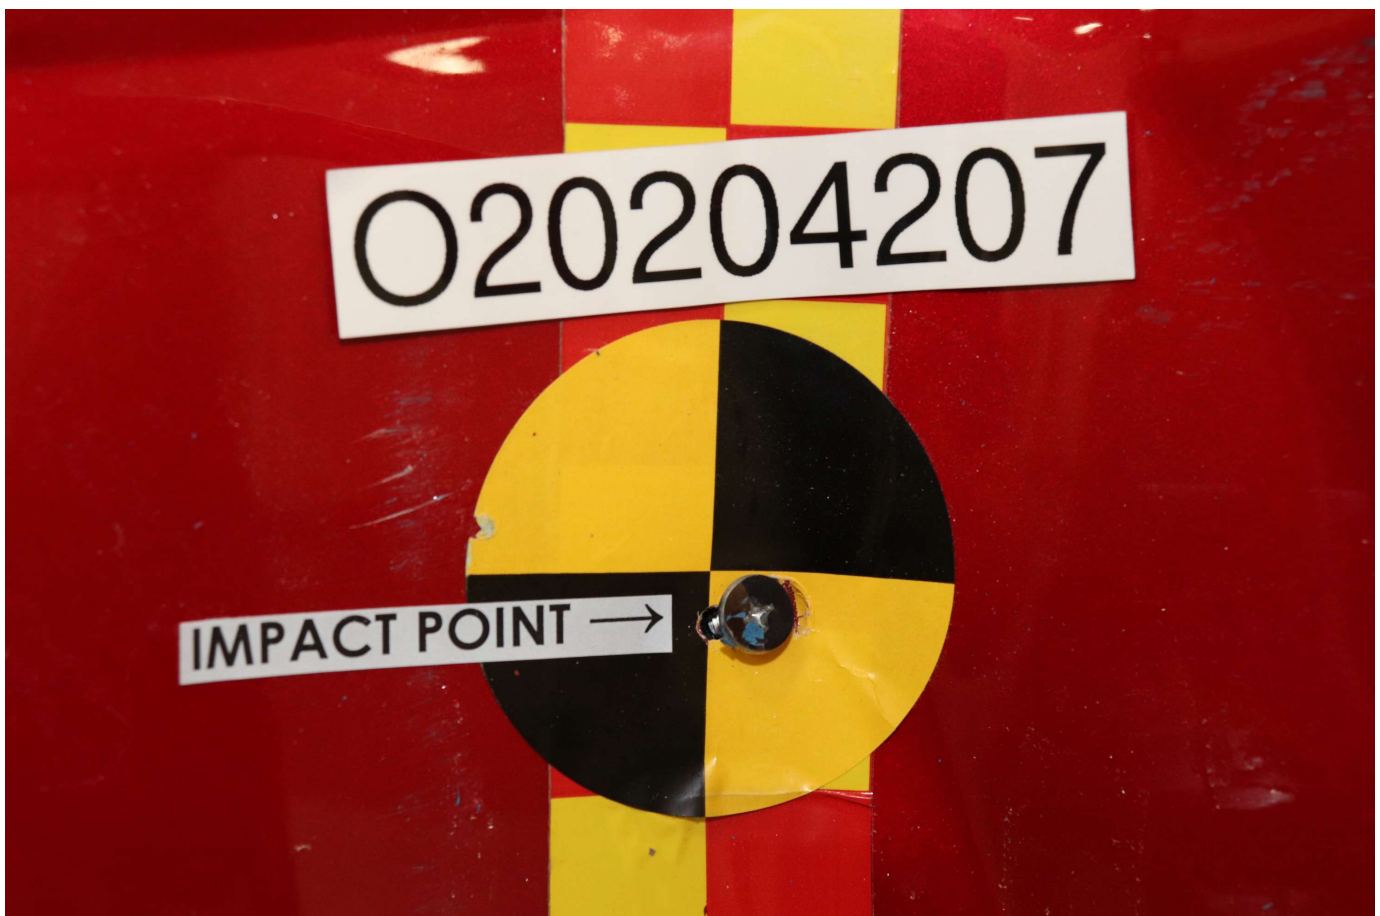
Photo No. 020 - Post-Test Close-Up View of Impact Point Target Showing Impact Location

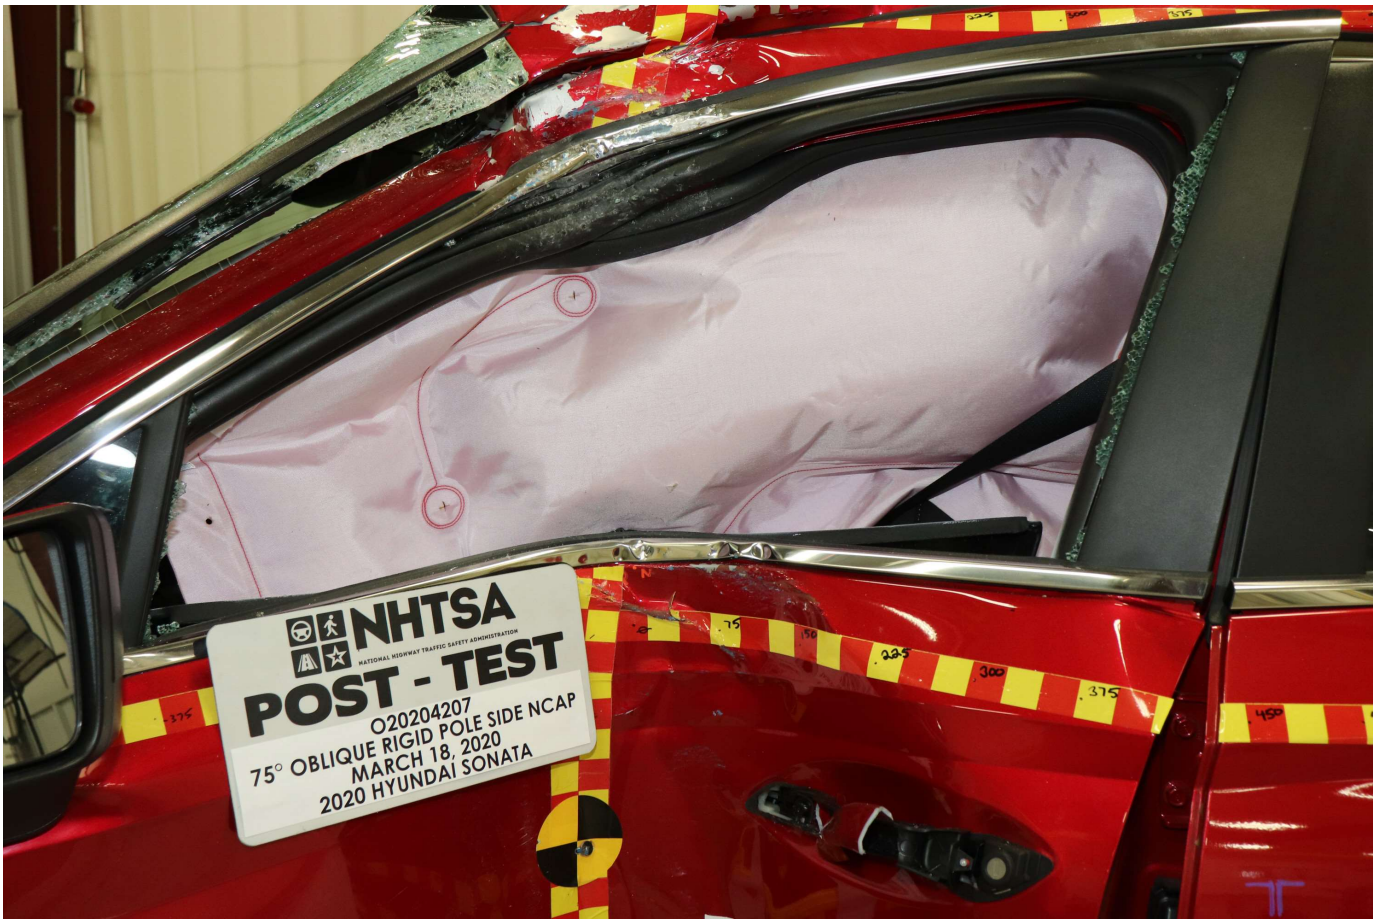
Photo No. 025 - Post-Test Left Side View of Dummy Shoulder and Door Top View

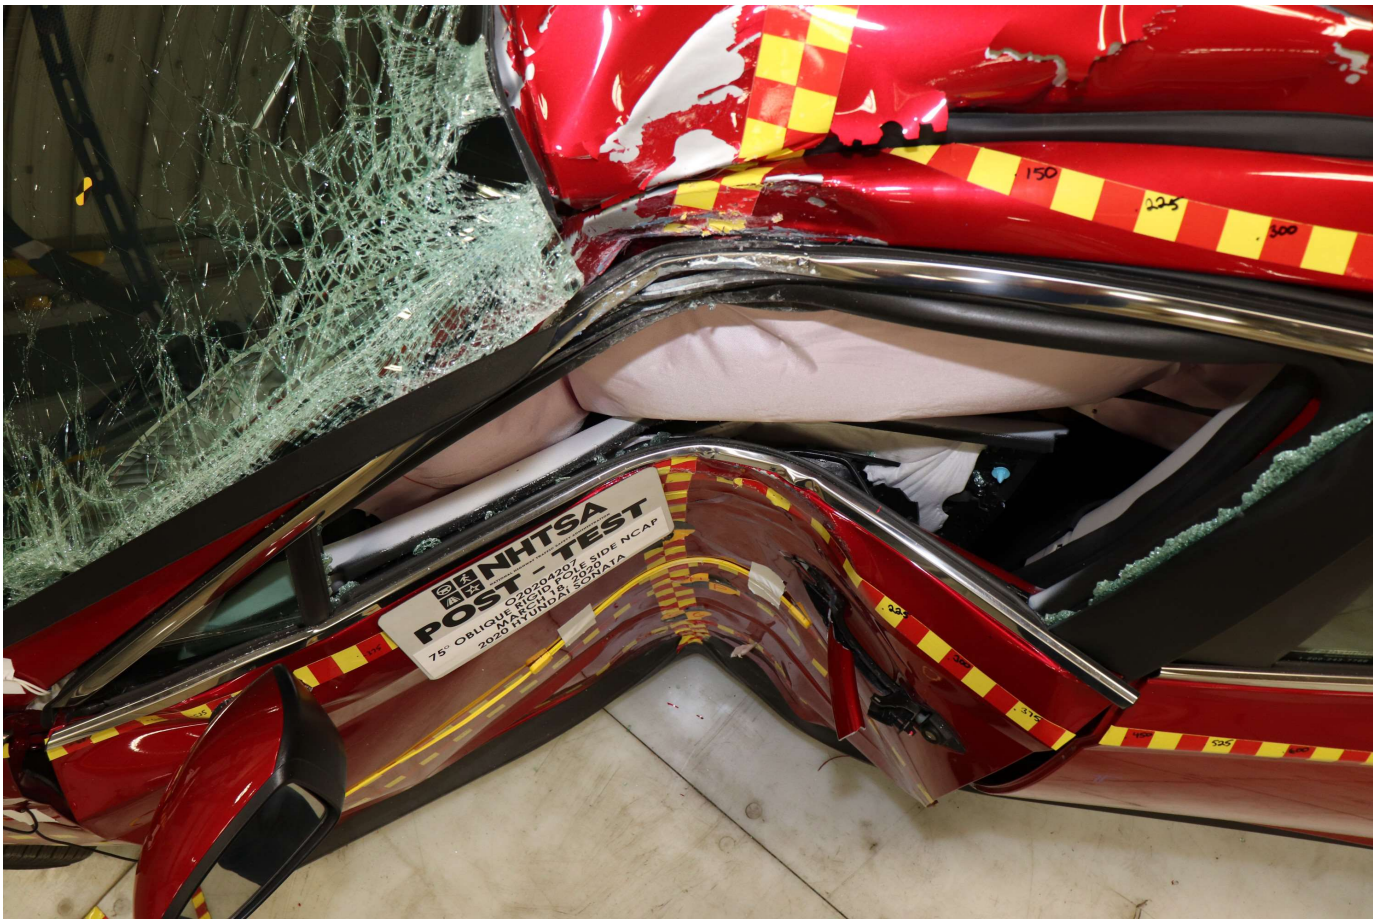
Photo No. 041 - Post-Test Dummy and Door Clearance View

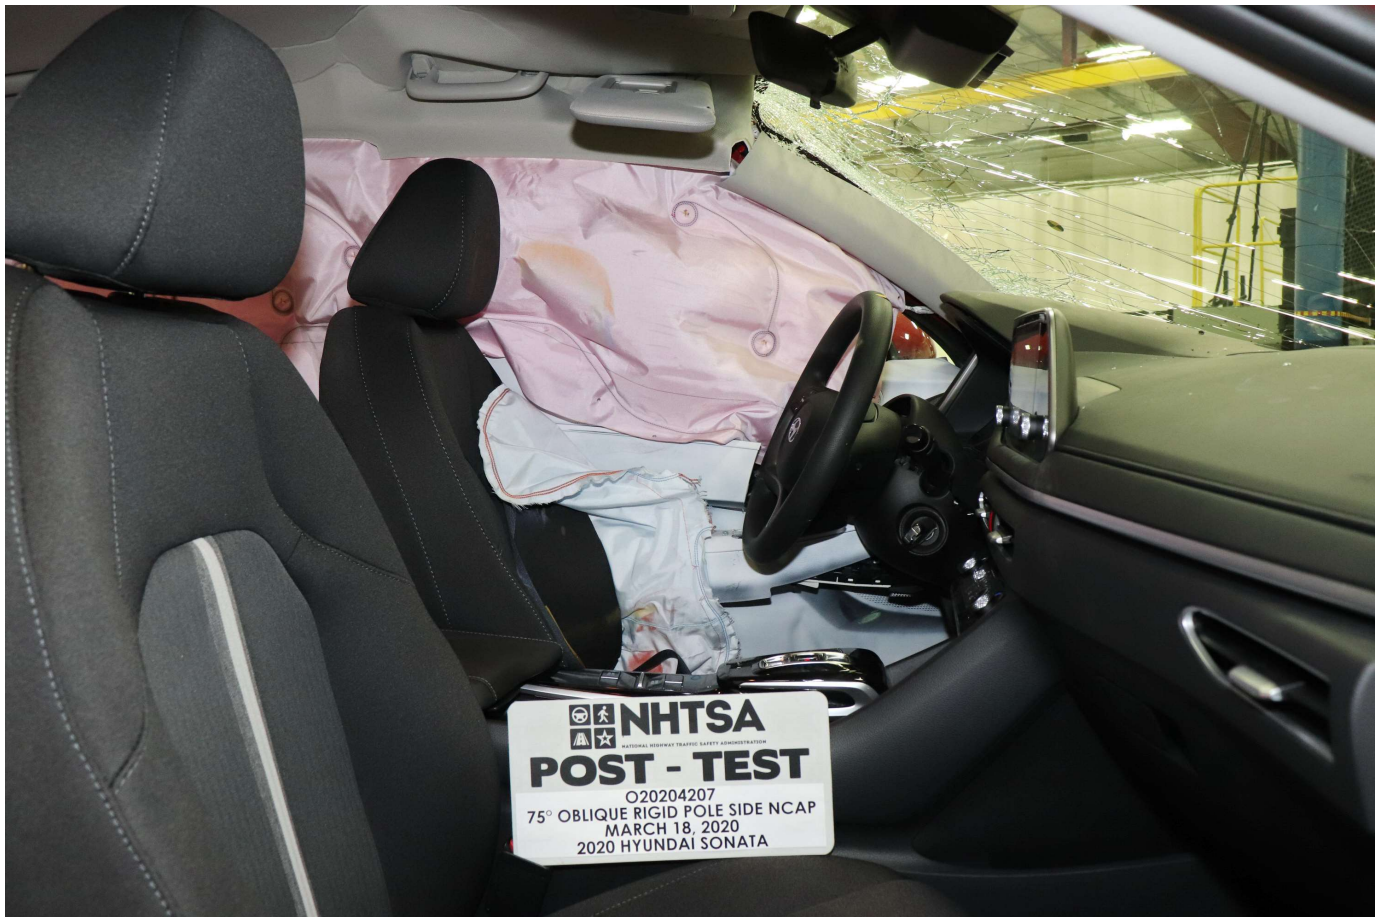
Photo No. 045 - Post-Test Inner Door Panel View Showing Dummy Contact Location

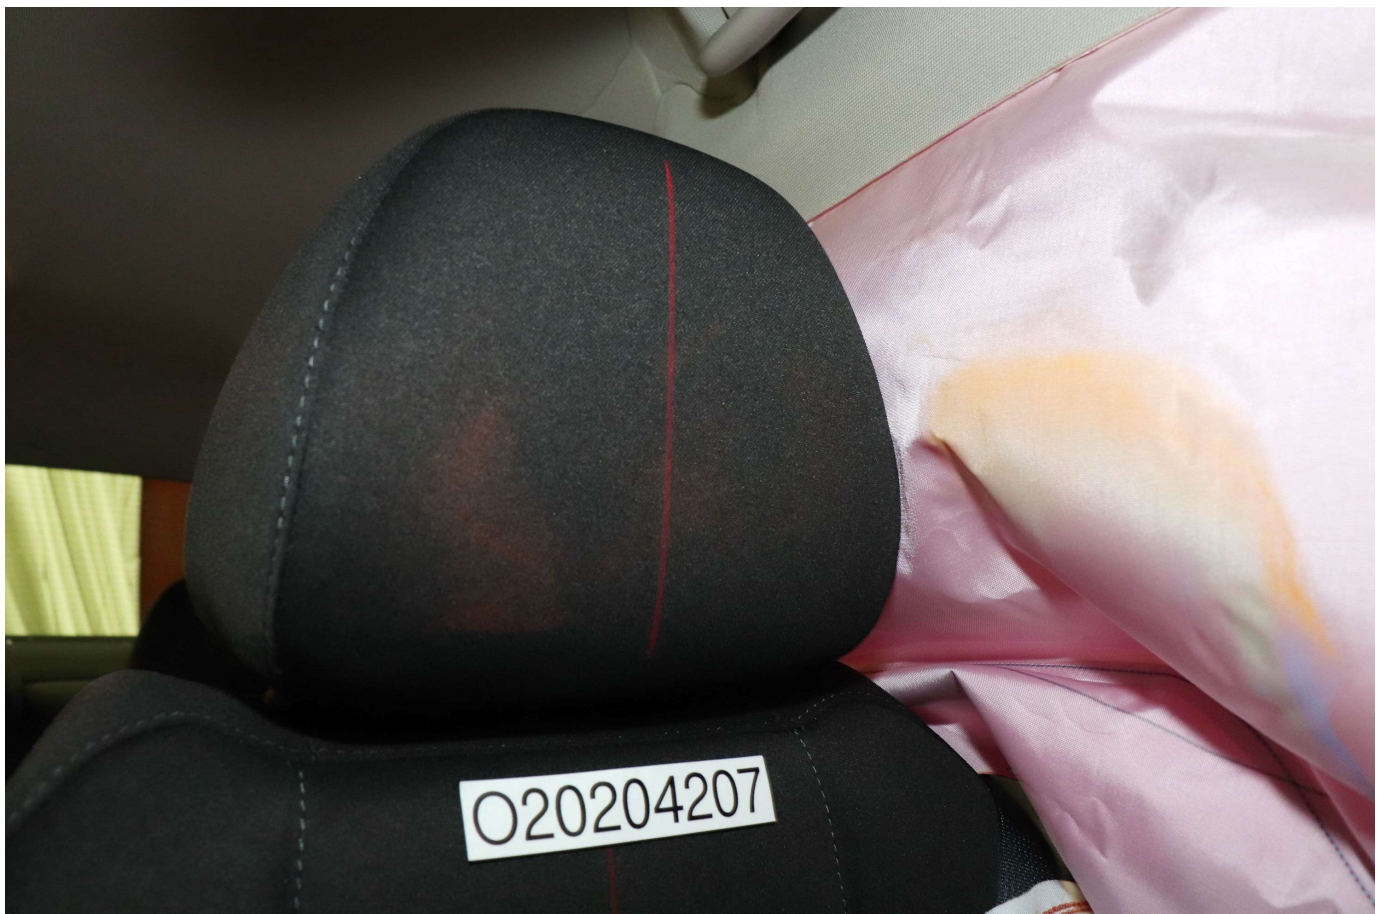
Photo No. 046 - Post-Test Dummy Close-Up Head Contact with Vehicle Interior View

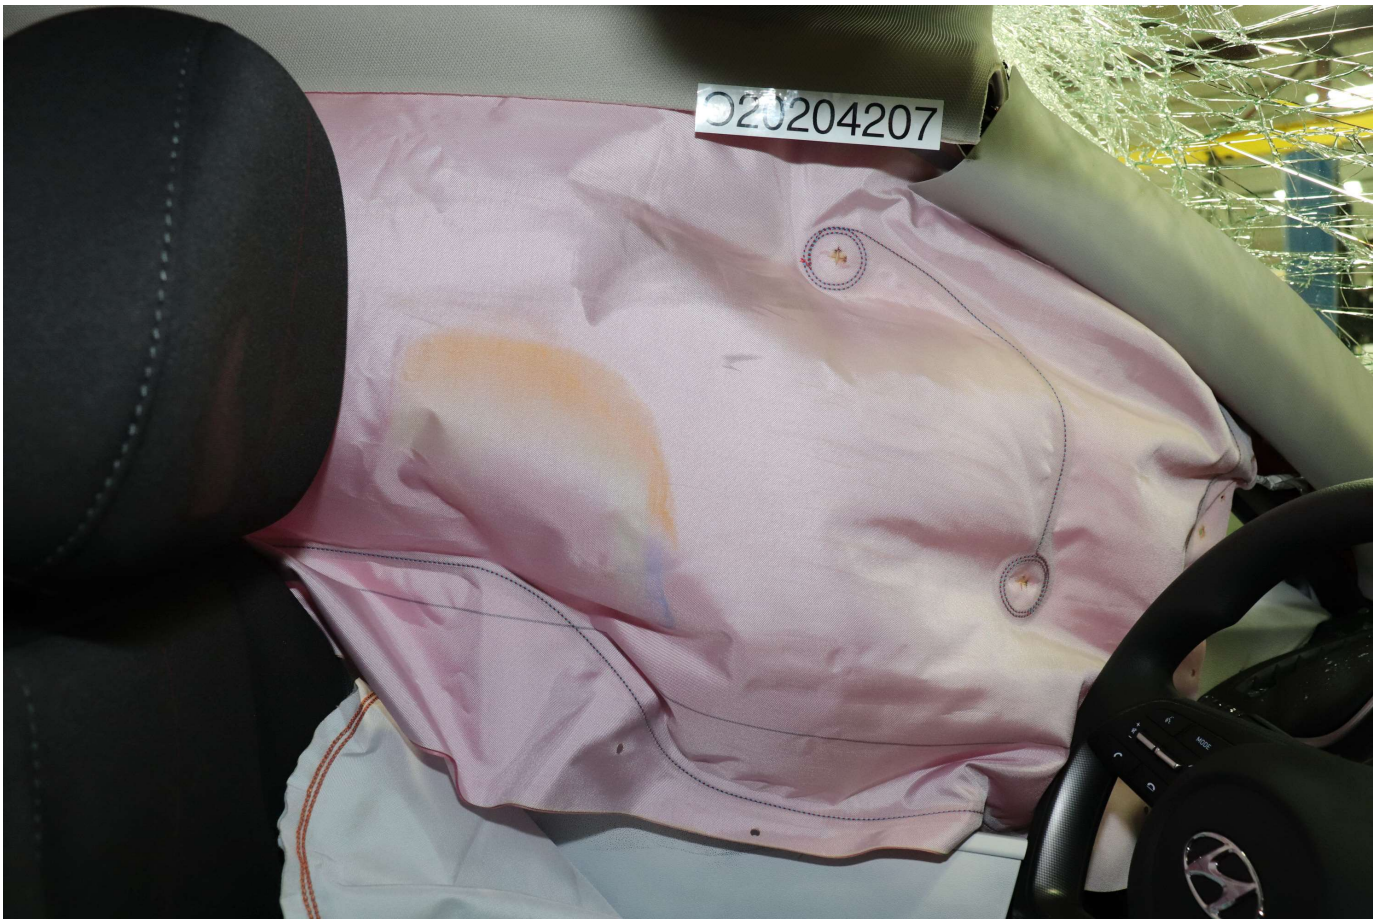
Photo No. 047 - Post-Test Dummy Close-Up Head Contact with Side Air Bag View

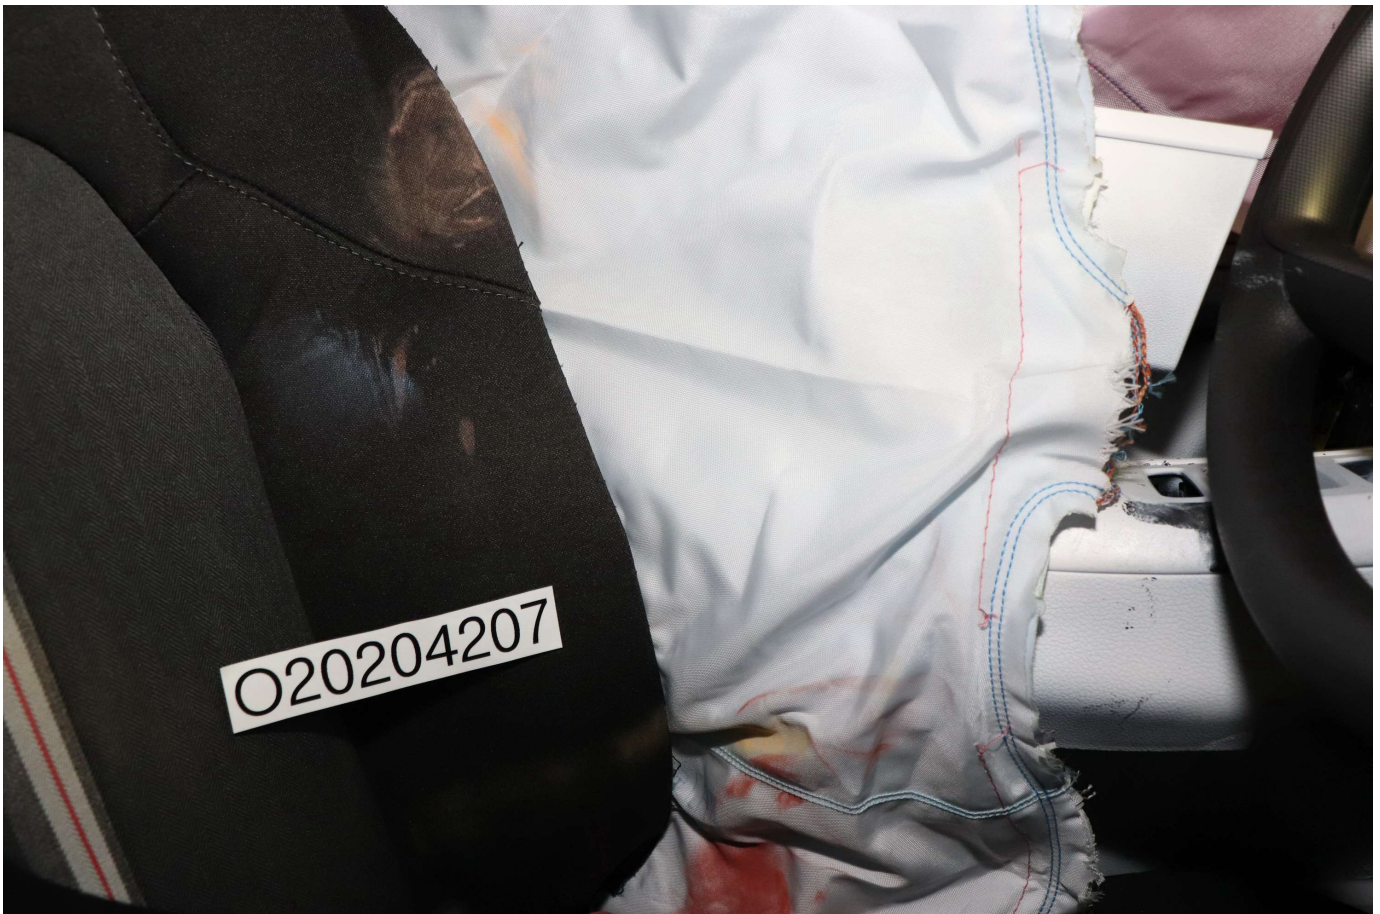
Photo No. 048 - Post-Test Dummy Close-Up Torso Contact with Vehicle Interior View

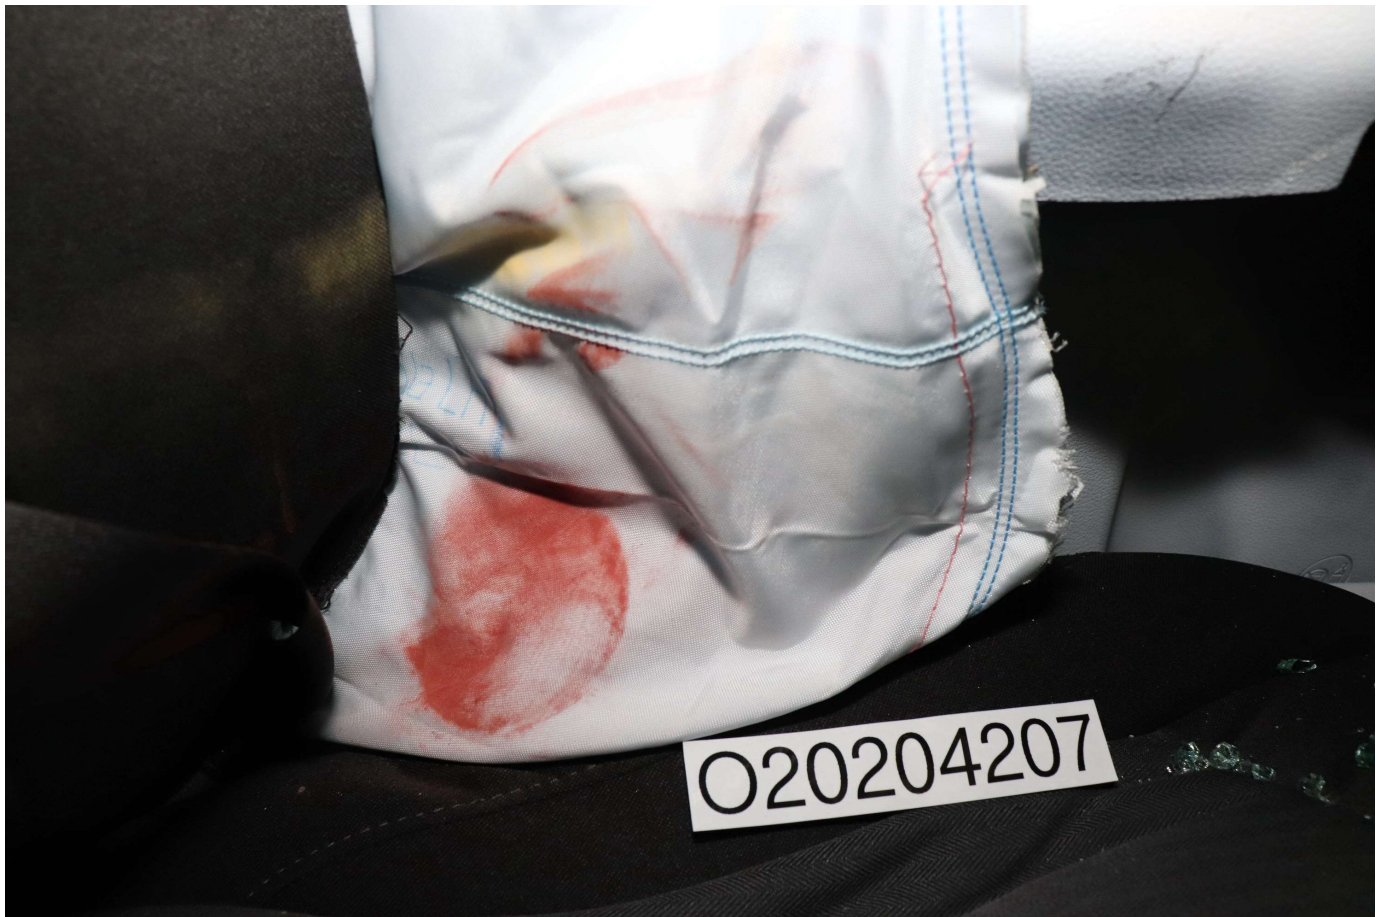
Photo No. 051 - Post-Test Dummy Close-Up Pelvis Contact with Side Air Bag View

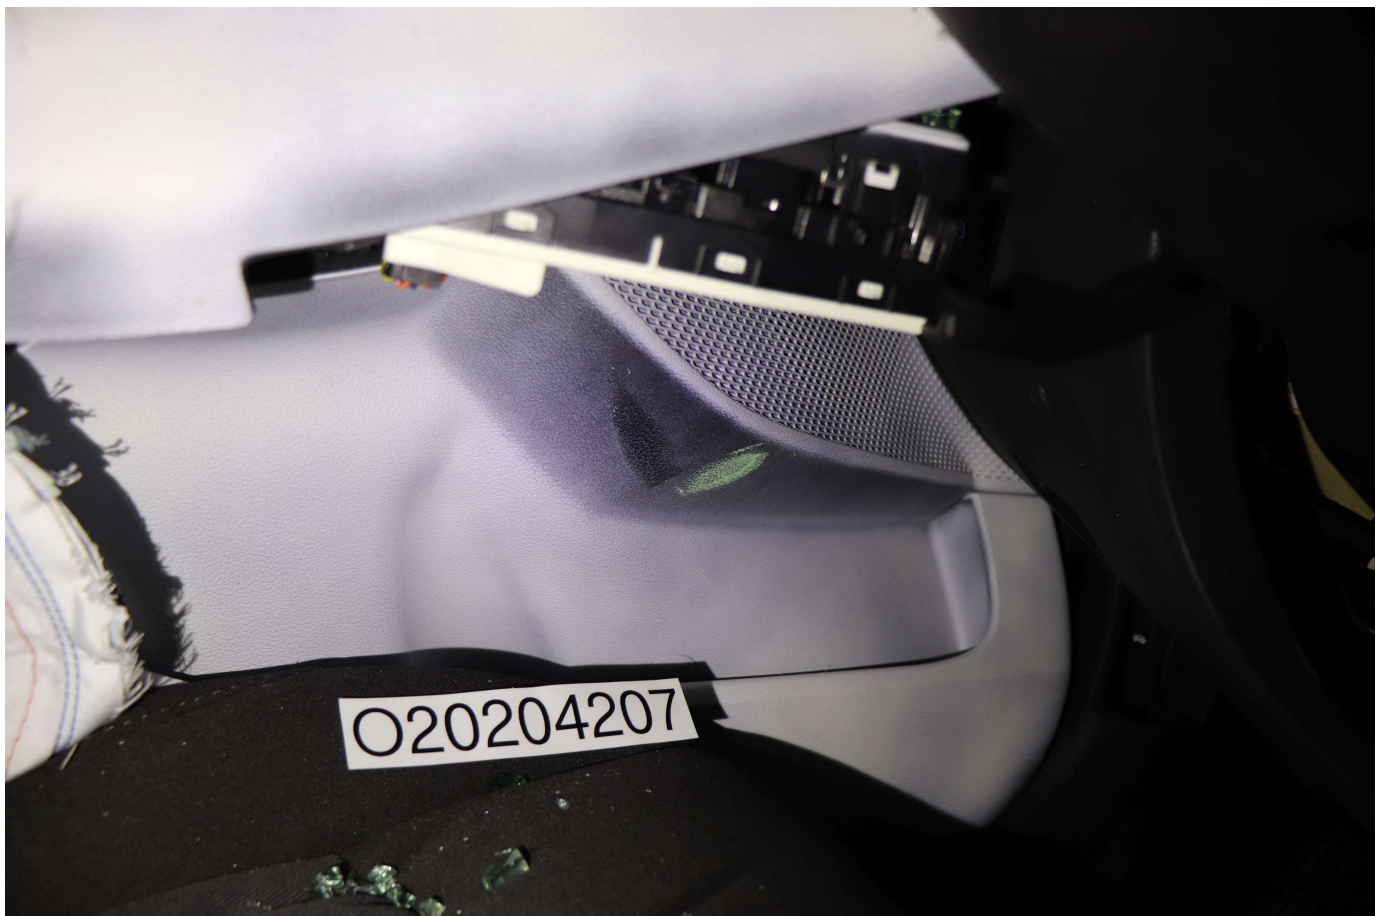
Photo No. 052 - Post-Test Dummy Close-Up Knee Contact with Vehicle Interior View

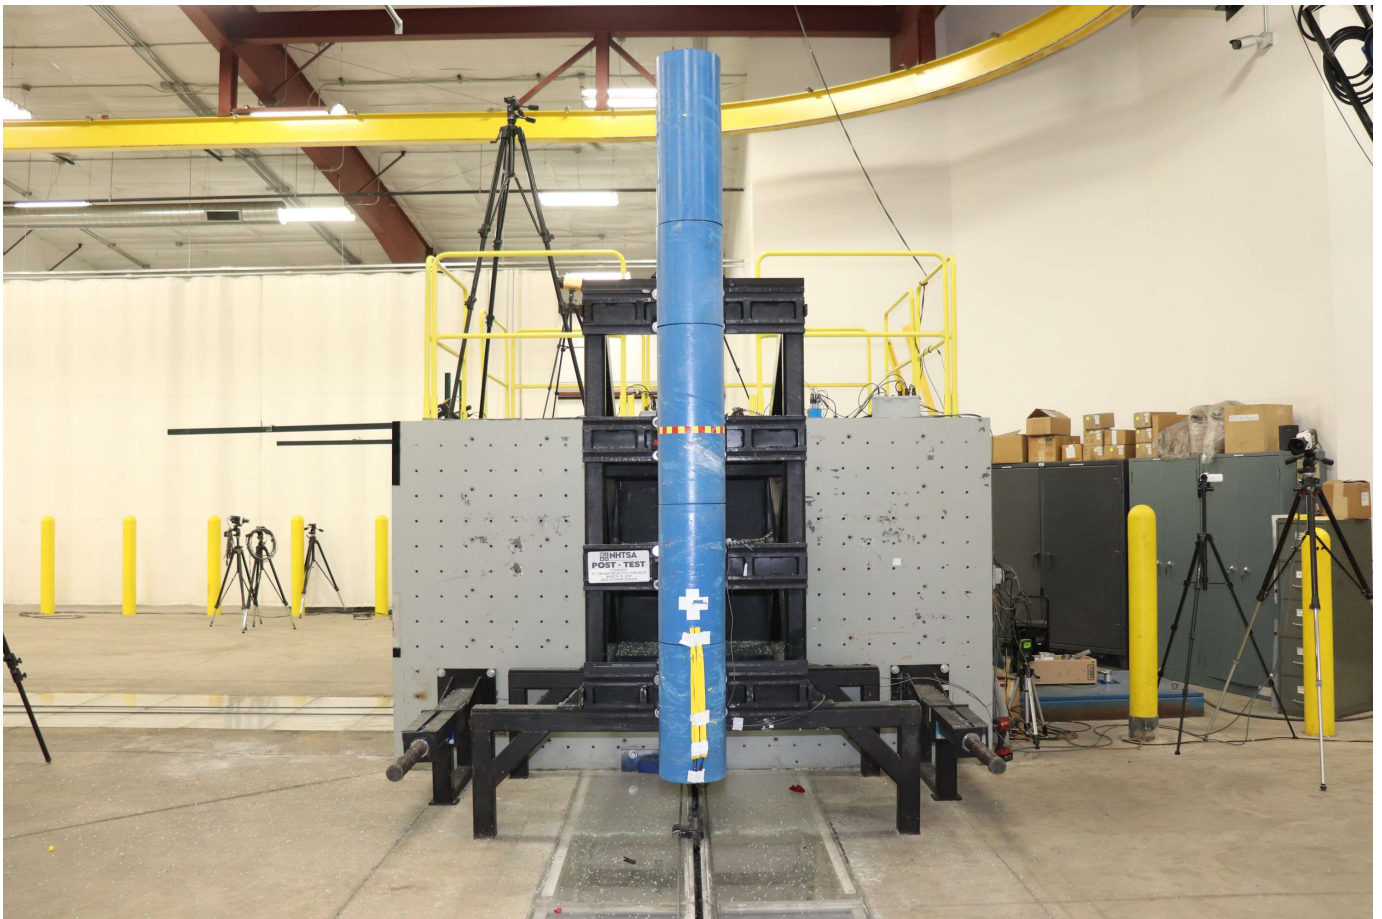
Photo No. 058 - Post-Test Pole Barrier Front View

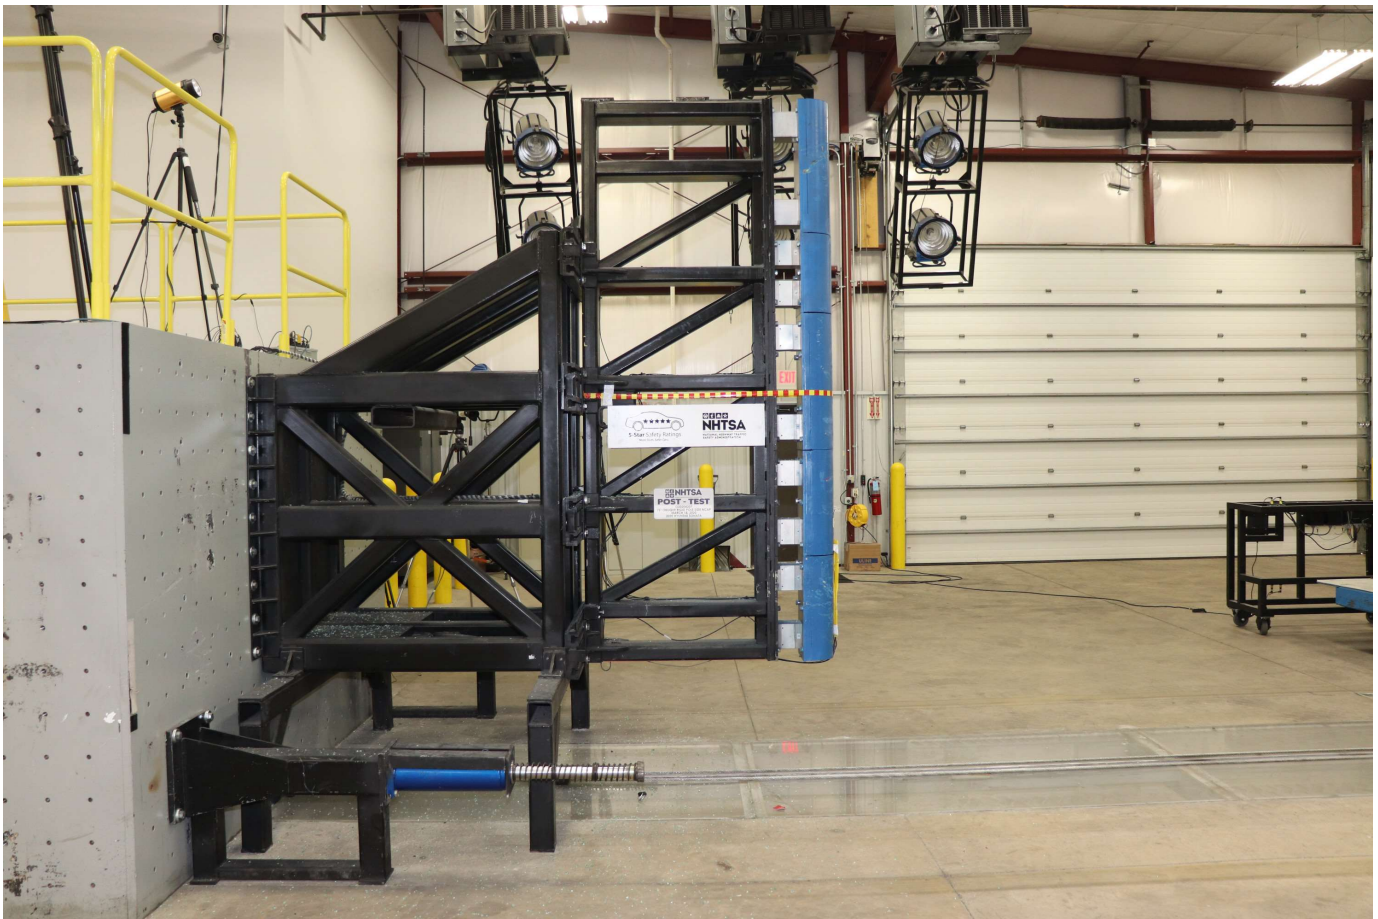
Photo No. 060 - Post-Test Pole Barrier Side View

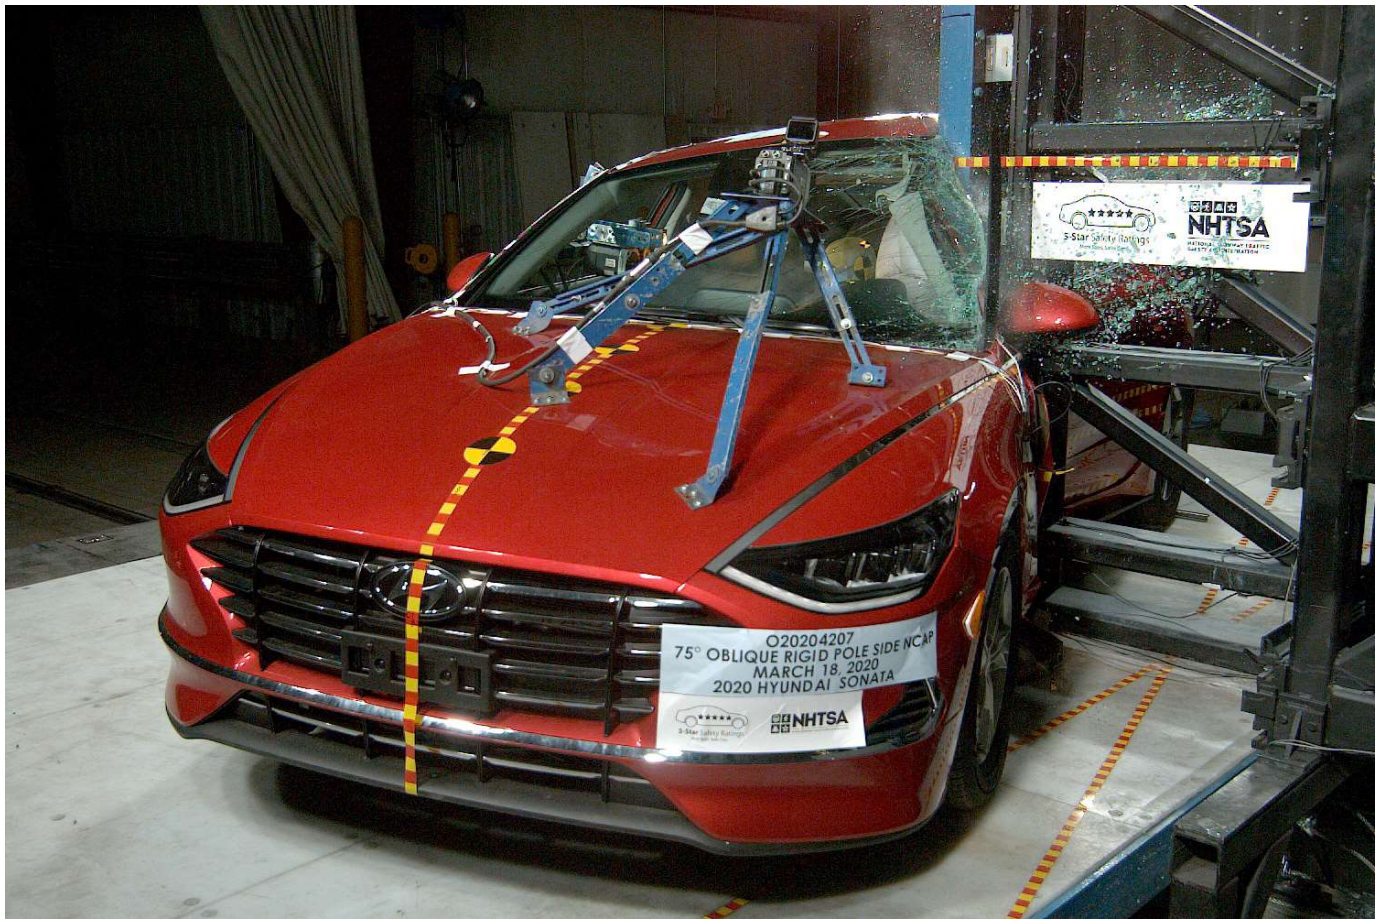
Photo No. 068 - Impact Event
