**REPORT NUMBER: SINCAP-MGA-20-018**

**NEW CAR ASSESSMENT PROGRAM (NCAP)  
Moving Deformable Barrier Side Impact Test**

**HYUNDAI MOTOR MANUFACTURING ALABAMA, LLC  
2020 Hyundai Sonata SE 4-Door Sedan  
NHTSA No.: O20204208**

**MGA RESEARCH CORPORATION  
5000 Warren Road  
Burlington, WI 53105**

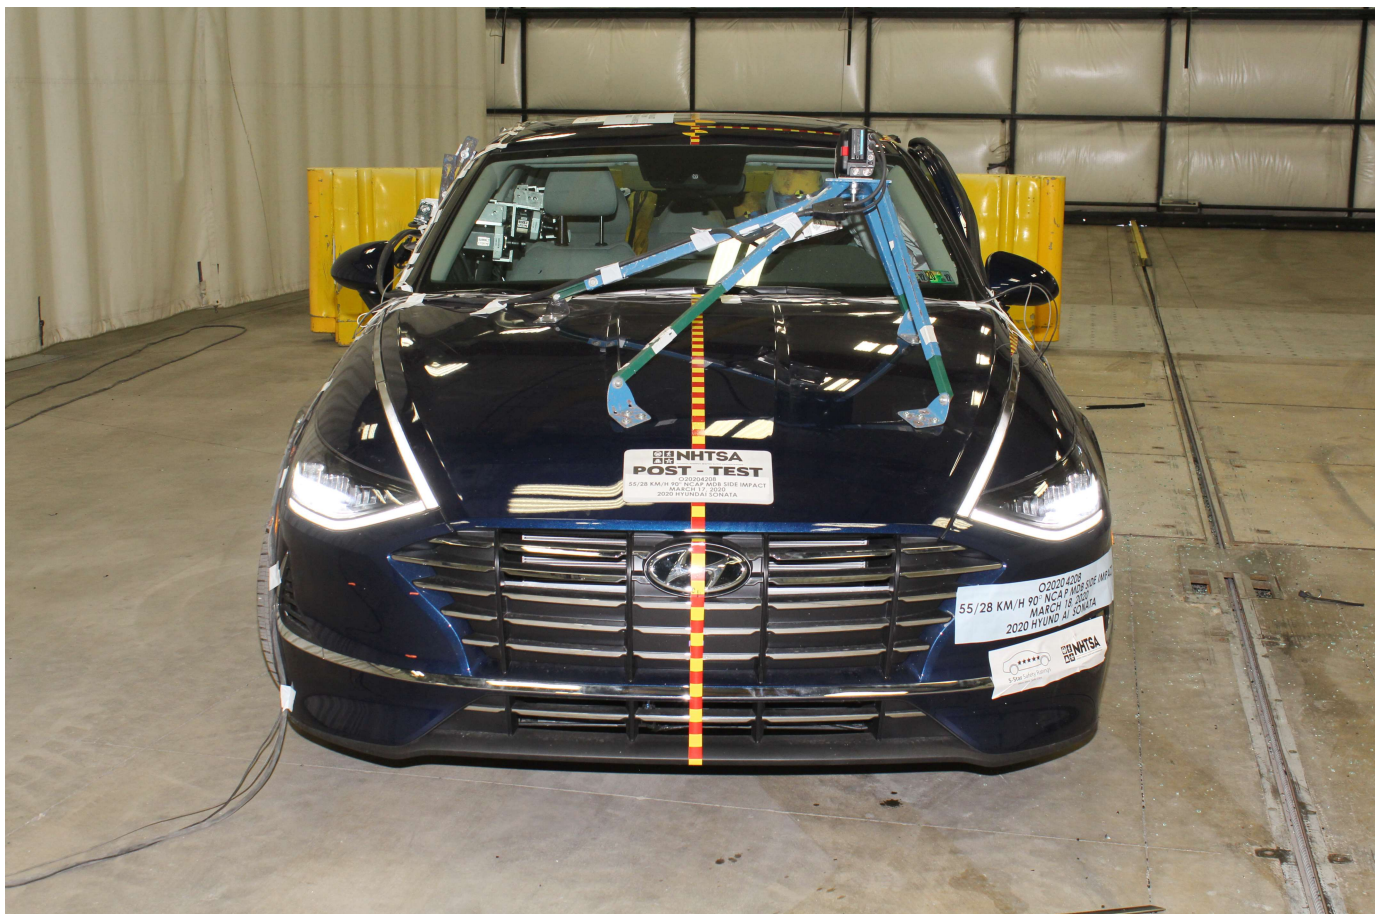
Photo No. 004 - Post-Test Frontal View of Test Vehicle

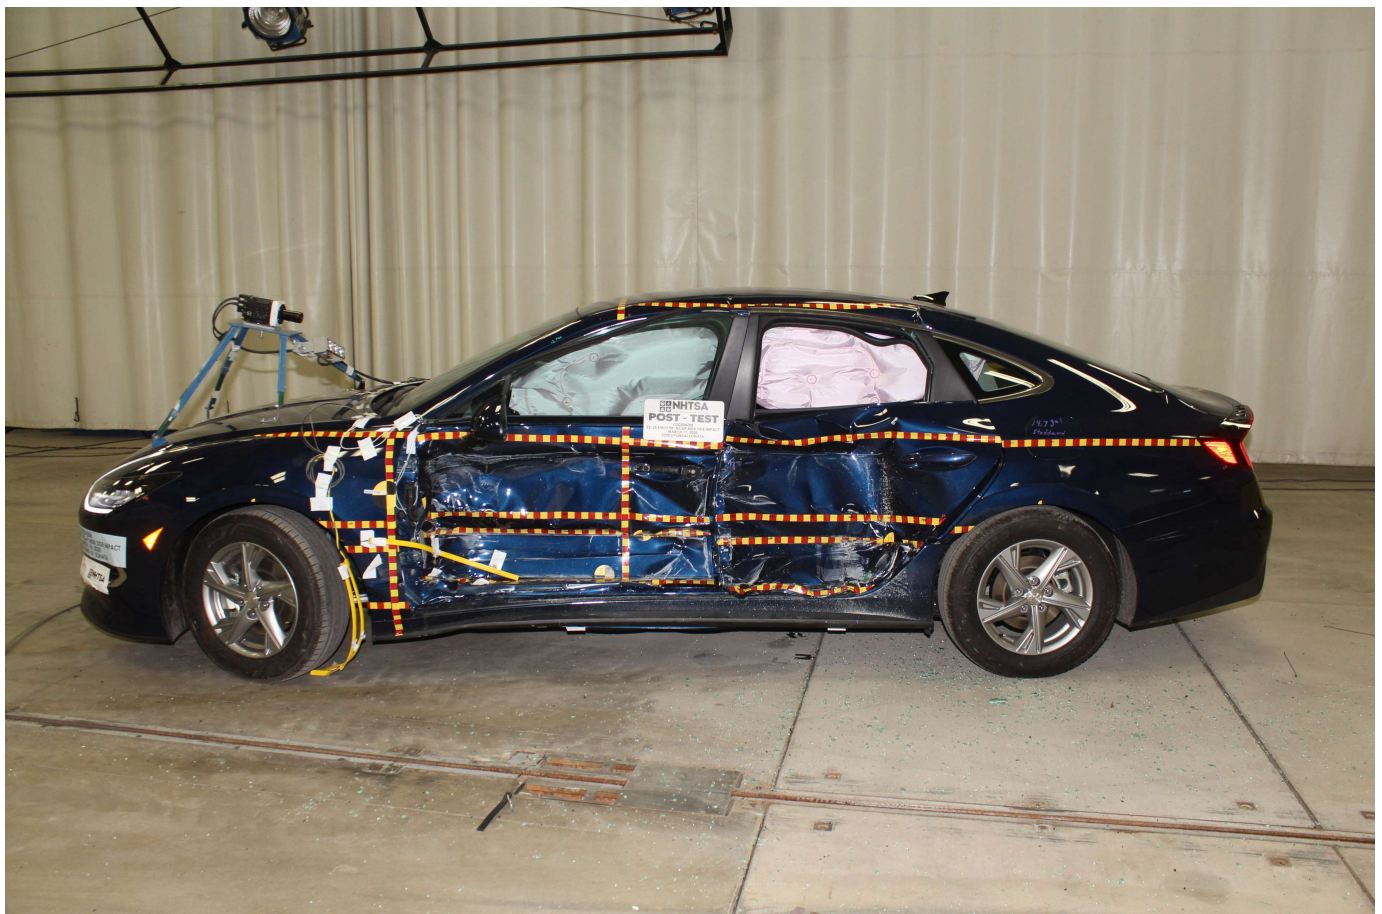
Photo No. 008 - Post-Test Left Side View of Test Vehicle

The doors on the struck side of the vehicle did not separate from the body at the hinges or latches and the opposite doors did not open during the side impact event.

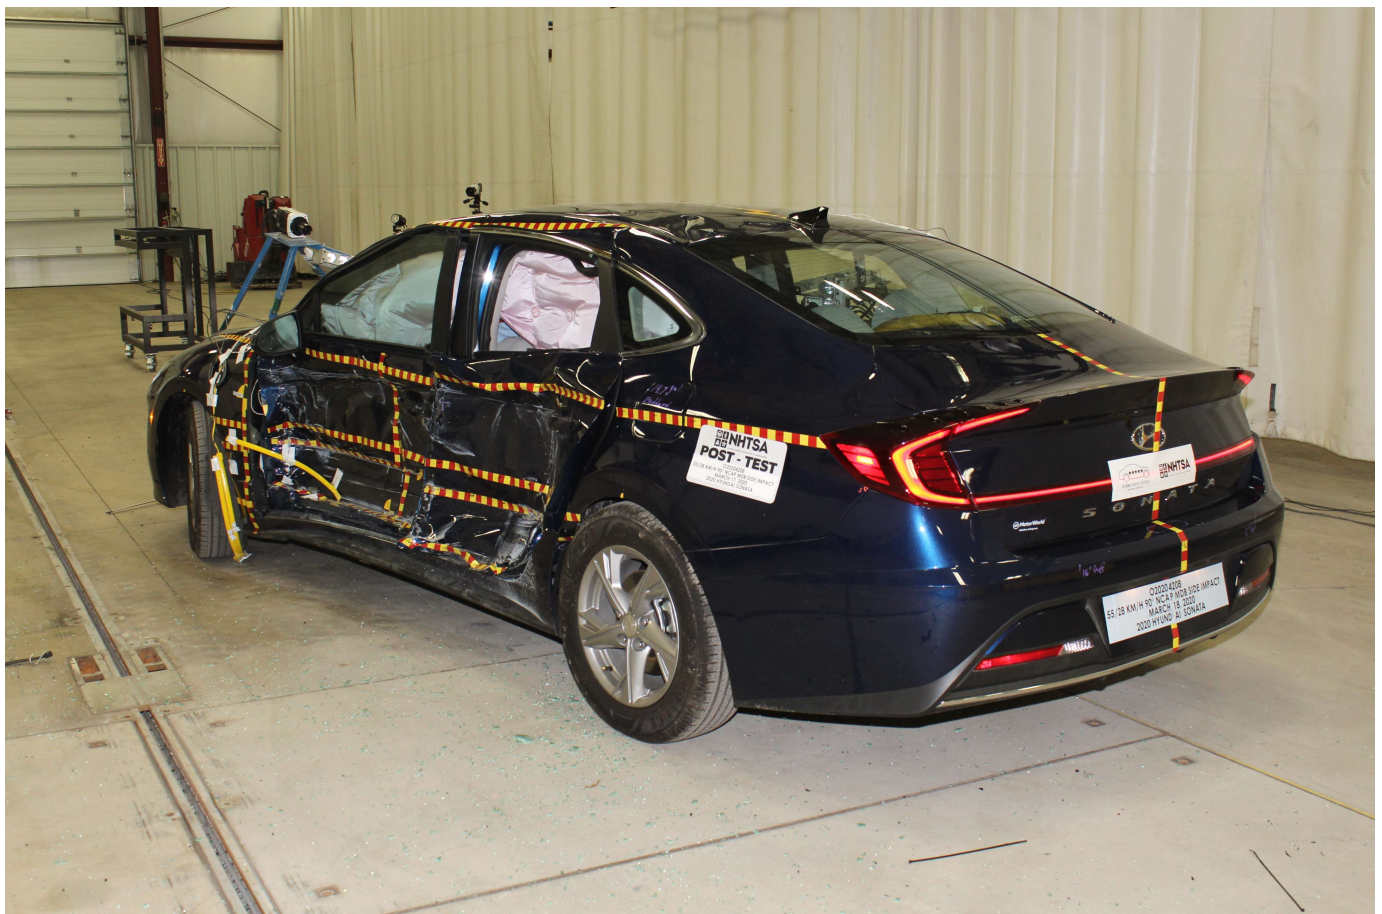
Photo No. 010 - Post-Test Left Three-Quarter Rear View of Test Vehicle

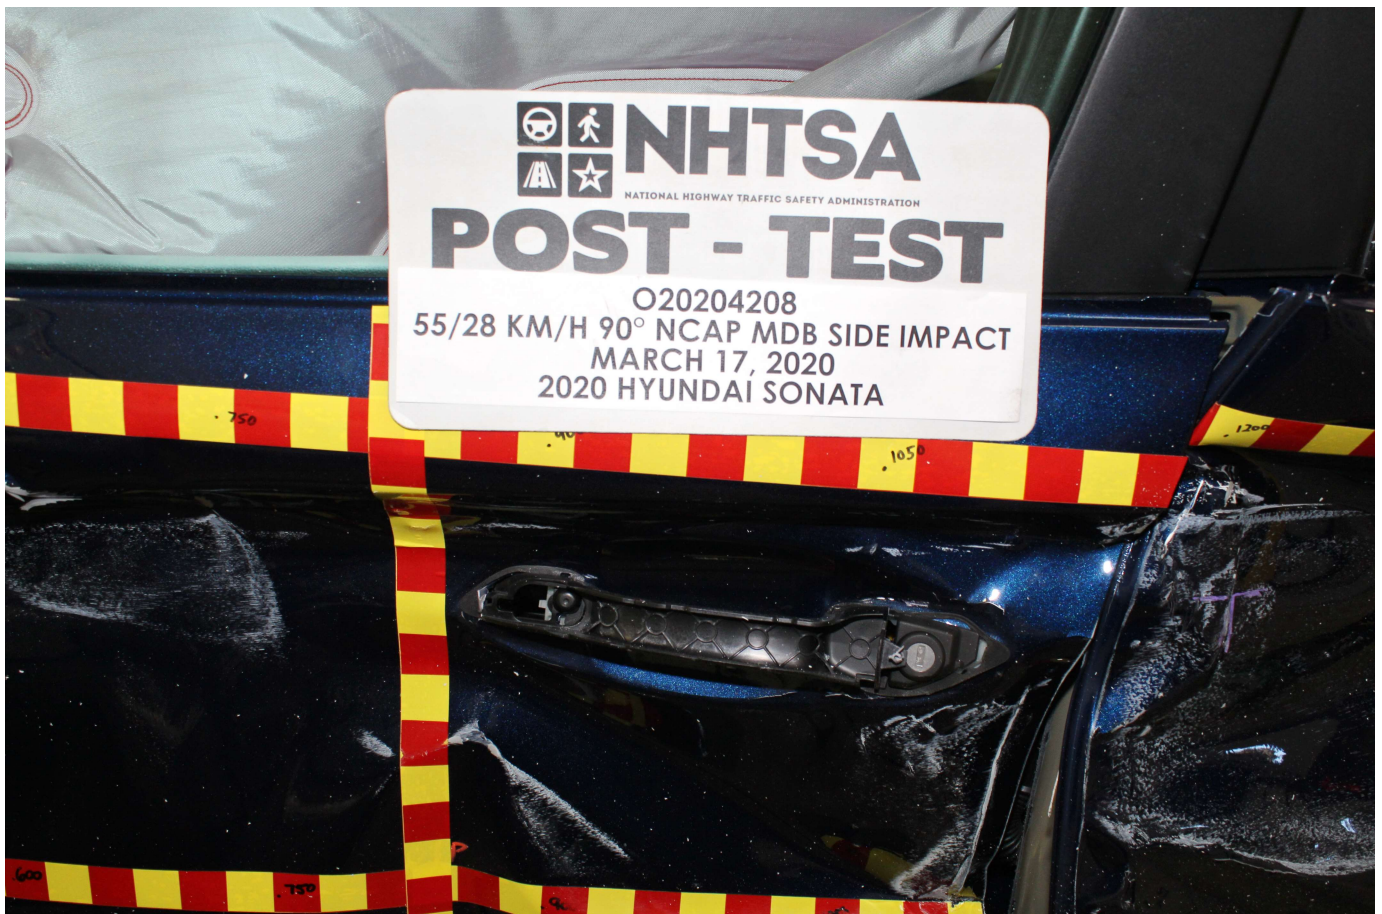
Photo No. 022 - Post-Test Left Front Door Latch Close-Up

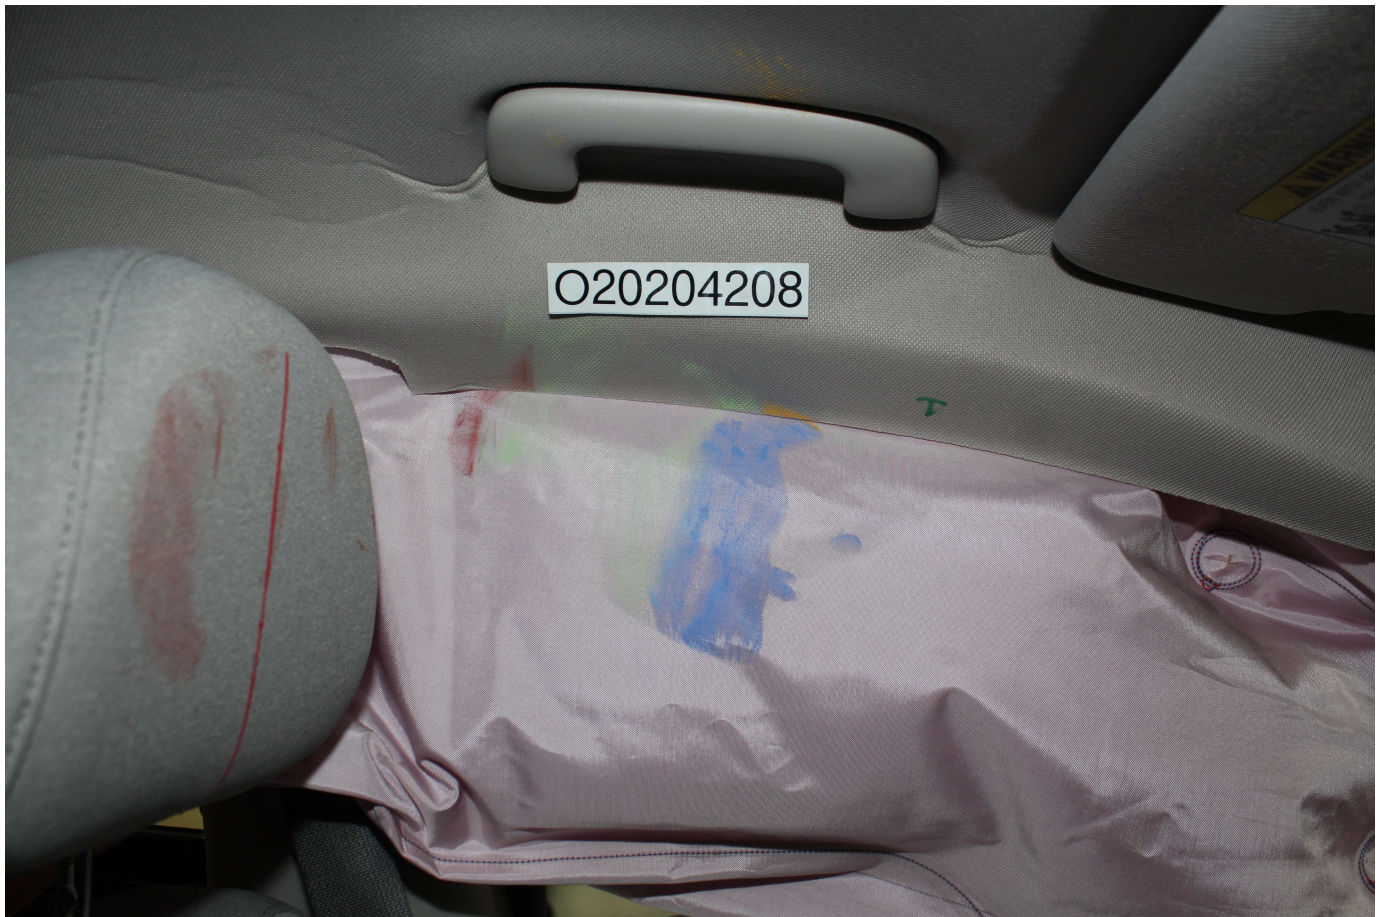
Photo No. 049 - Post-Test Driver Dummy Close-up Head Contact with Side Airbag View

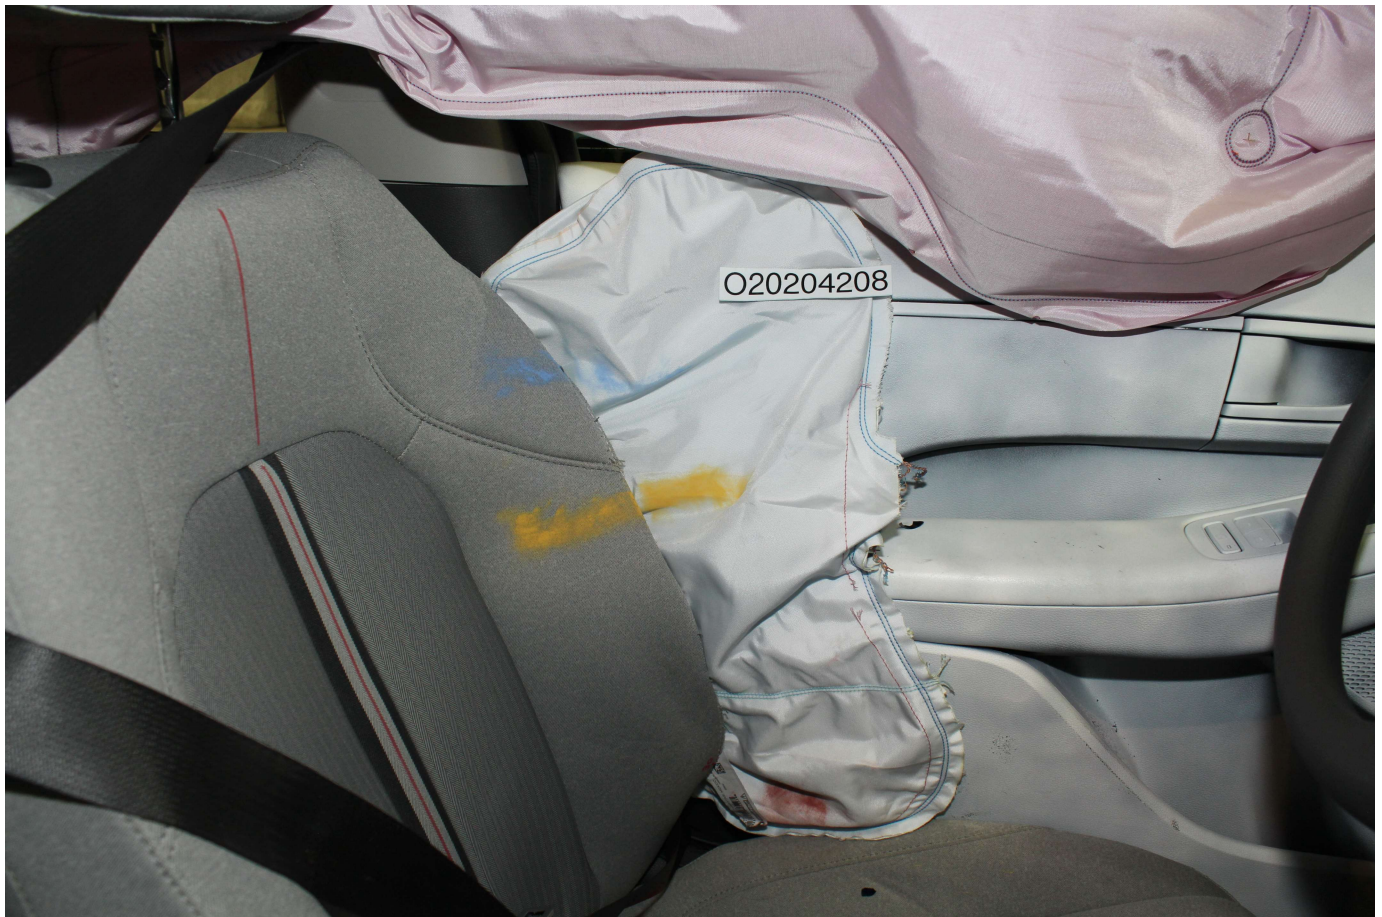
Photo No. 051 - Post-Test Driver Dummy Close-up Torso Contact with Side Airbag View

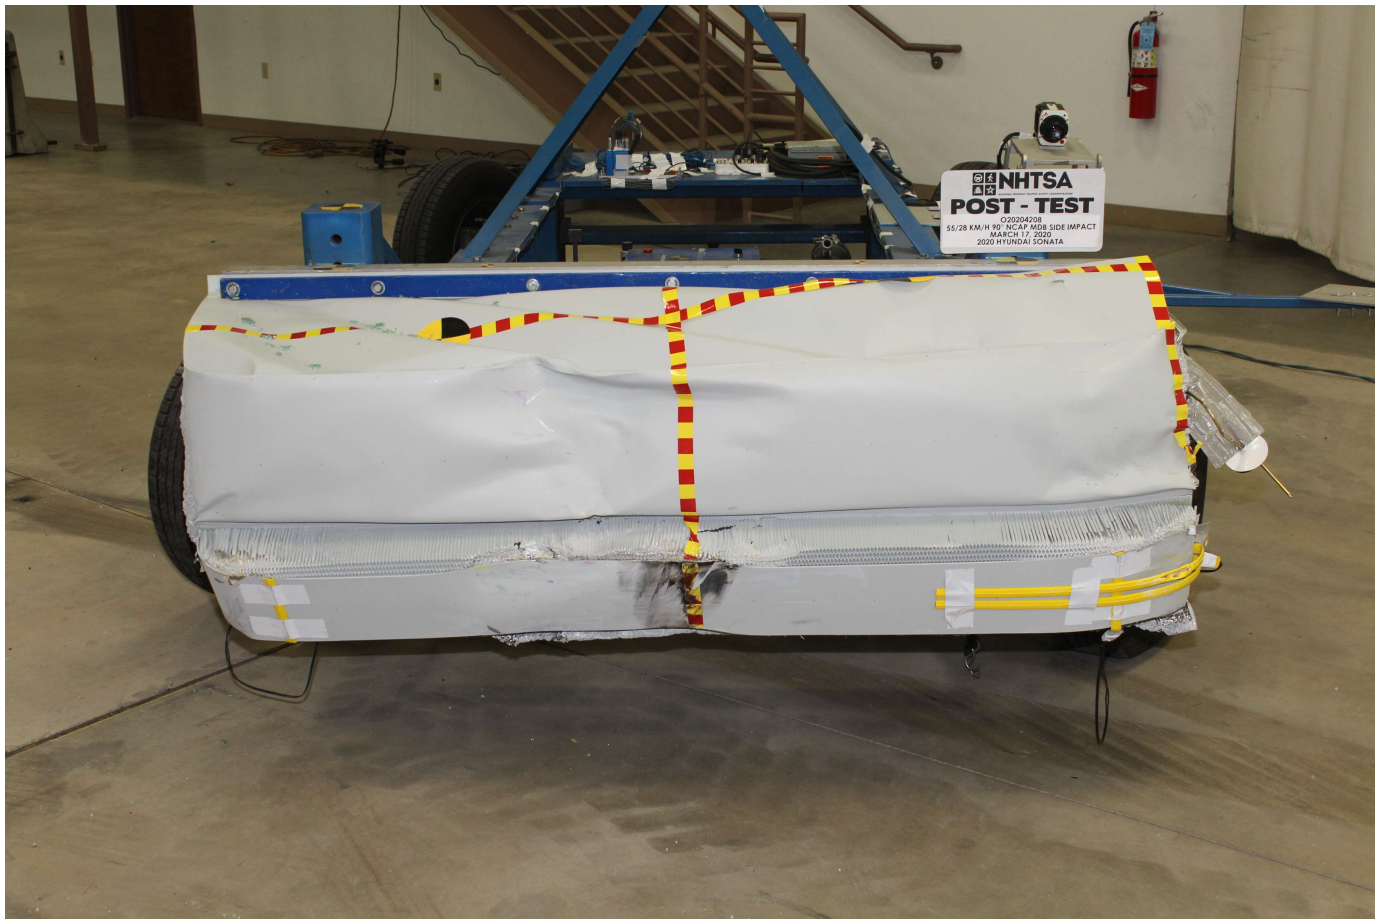
Photo No. 085 - Post-Test Front View of MDB Impactor Face

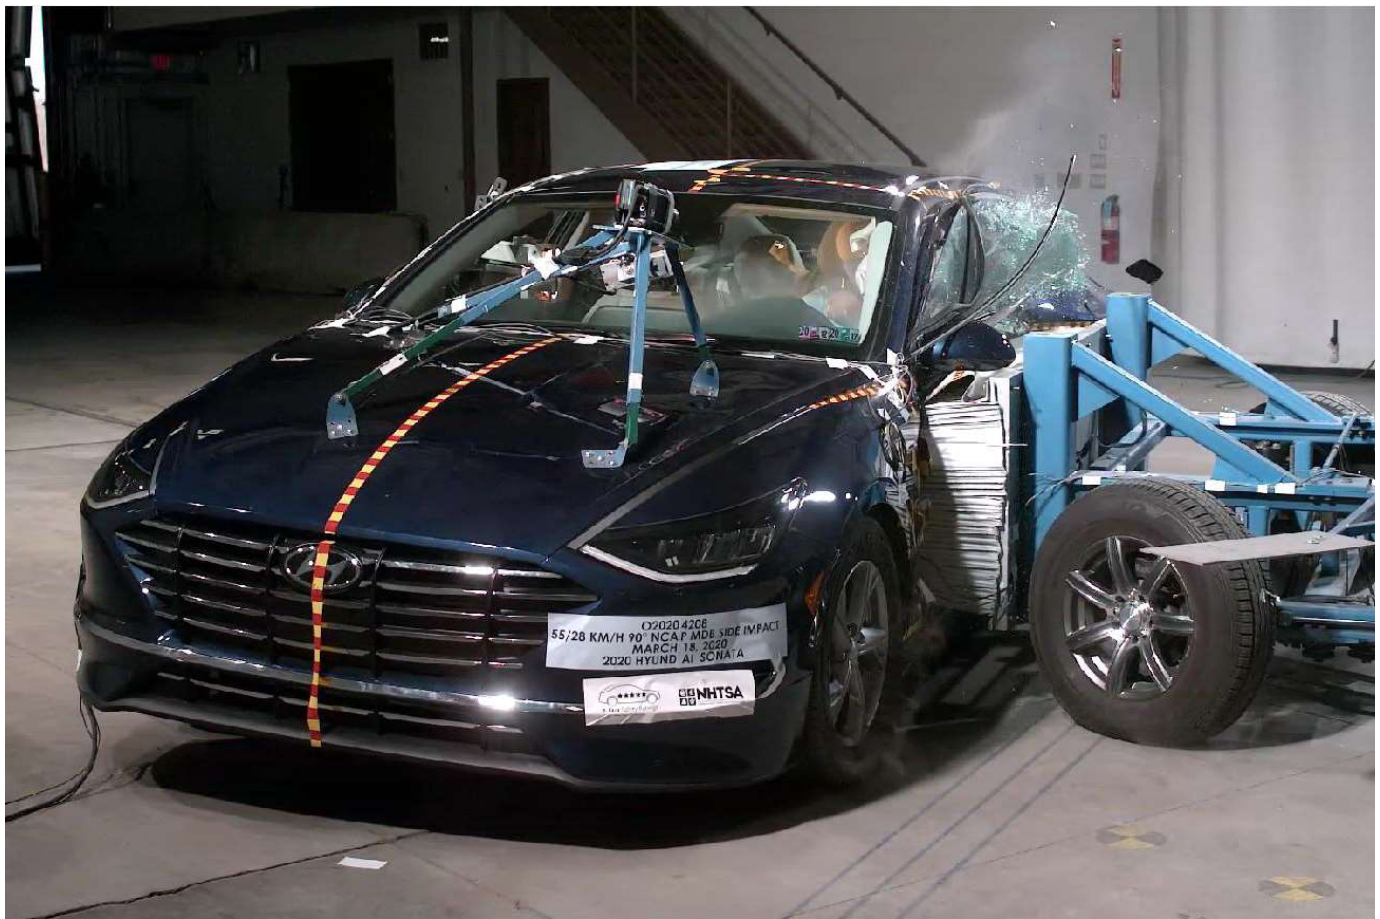
Photo No. 101 - Impact Event
