REPORT NUMBER: SPNCAP-CAL-20-007

**NEW CAR ASSESSMENT PROGRAM (NCAP)
SIDE IMPACT POLE TEST**

**Ford Motor CO.
2020 Ford Explorer Hybrid
SUV**

FINAL REPORT

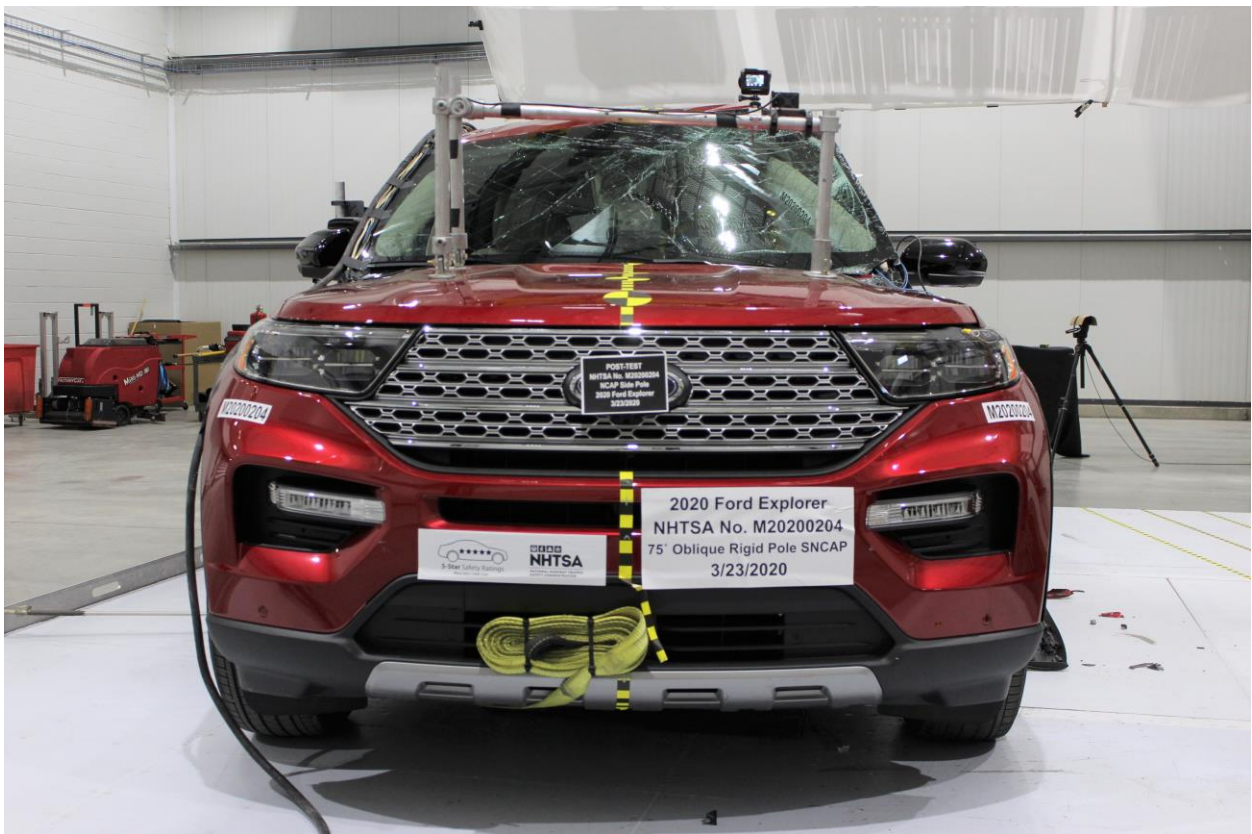
Figure A-4: Post-Test Frontal View of Test Vehicle

Critical Areas of Performance	Observations and Conclusions
Pillar Performance	A-Pillar & C-Pillar Buckled
Sill Separation	None
Windshield Damage	Cracks throughout with separation along Driver's A-Pillar, roof and lower edge
Side Window Damage	Driver window has cracks throughout
Other Notable Effects	None

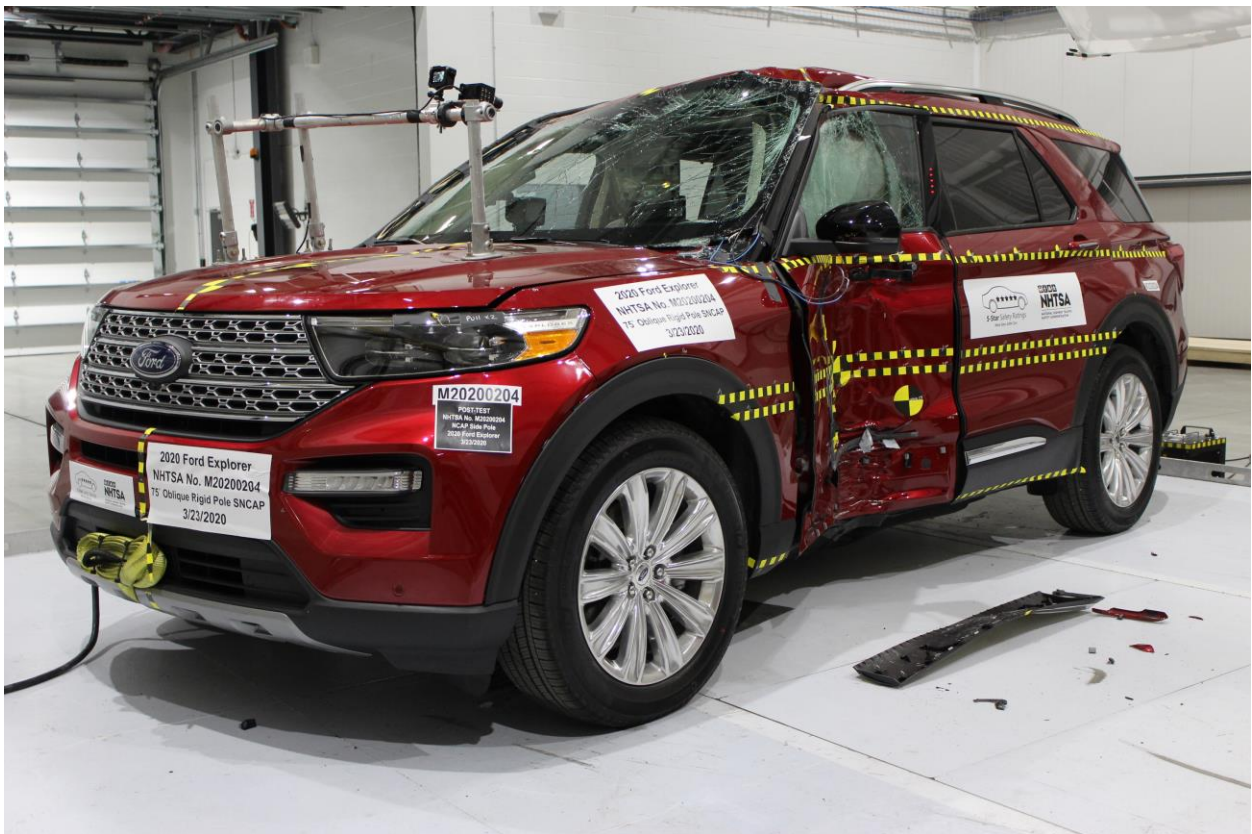
Figure A-6: Post-Test Left Front ¾ View of Test Vehicle

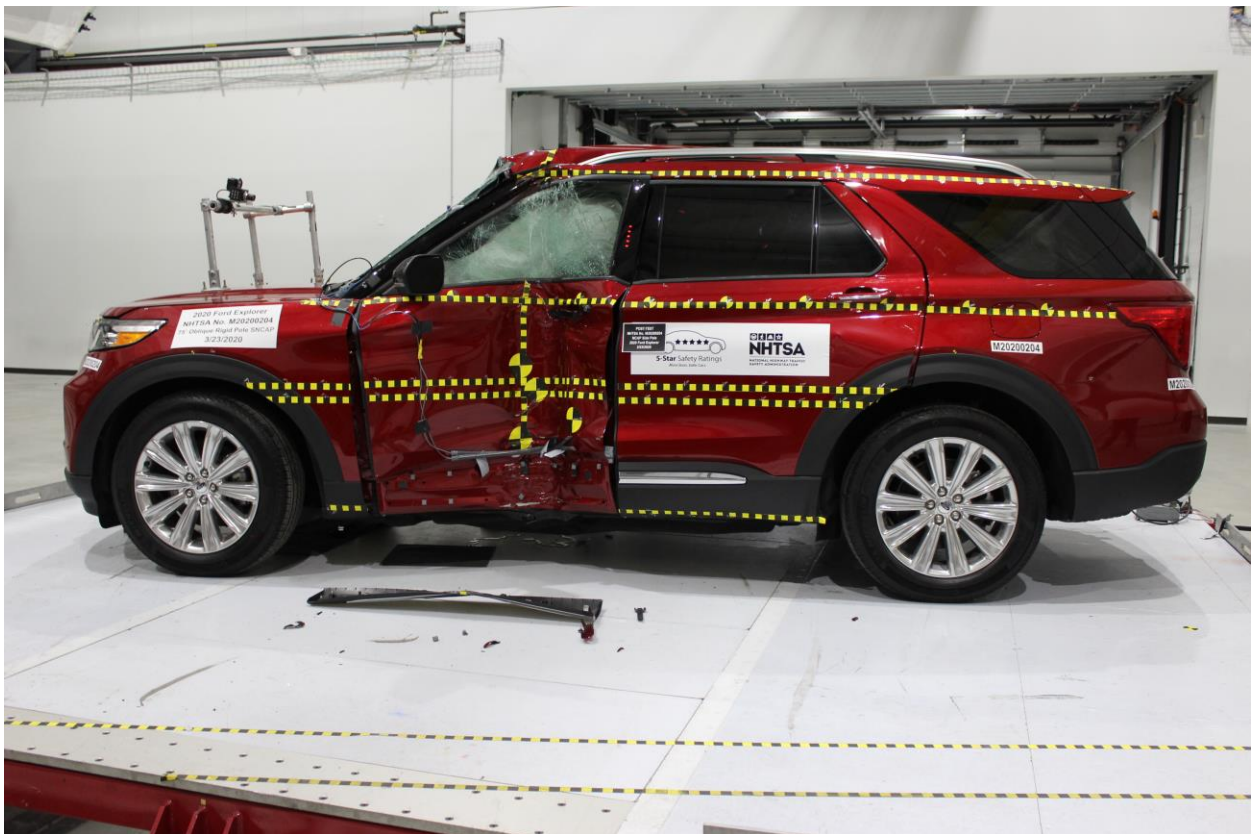
Figure A-8: Post-Test Left Side View of Test Vehicle

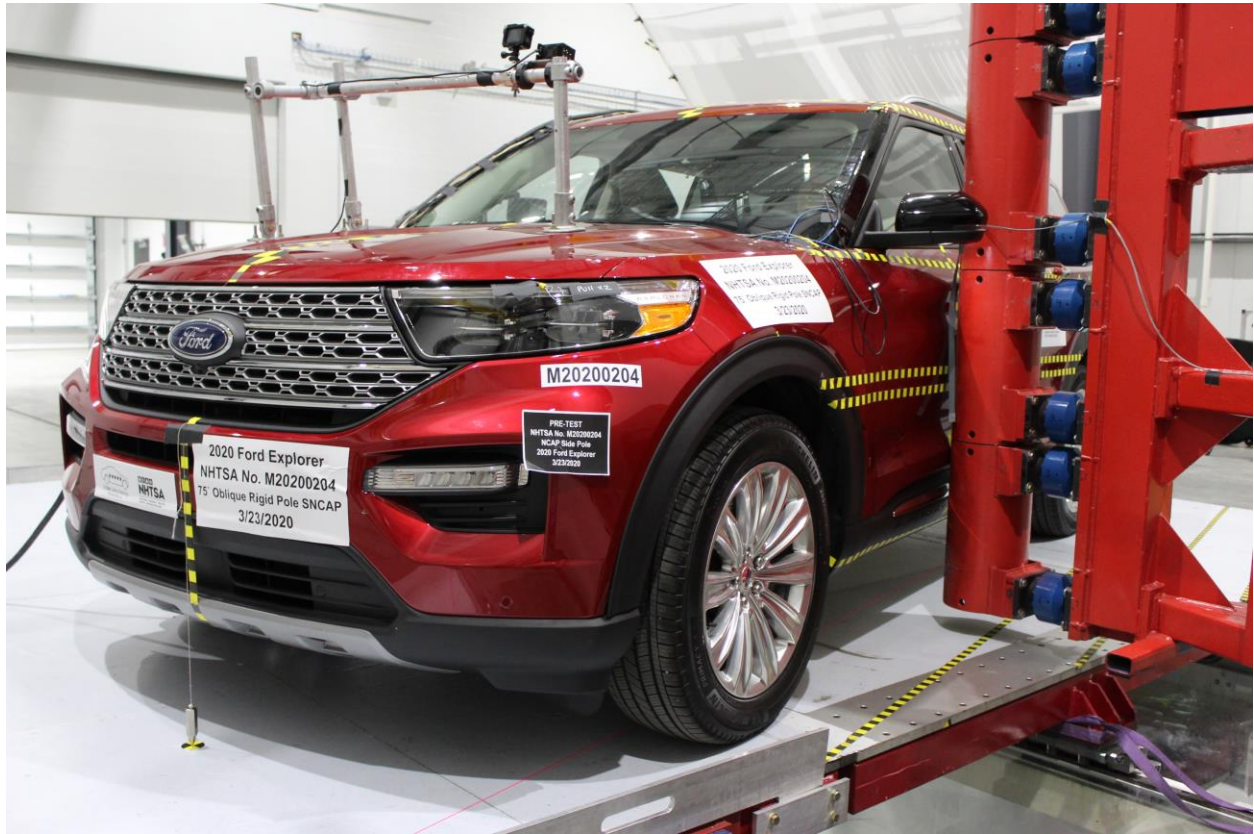
Figure A-17: Pre-Test Left Side View of Pole Positioned Against Side of Vehicle

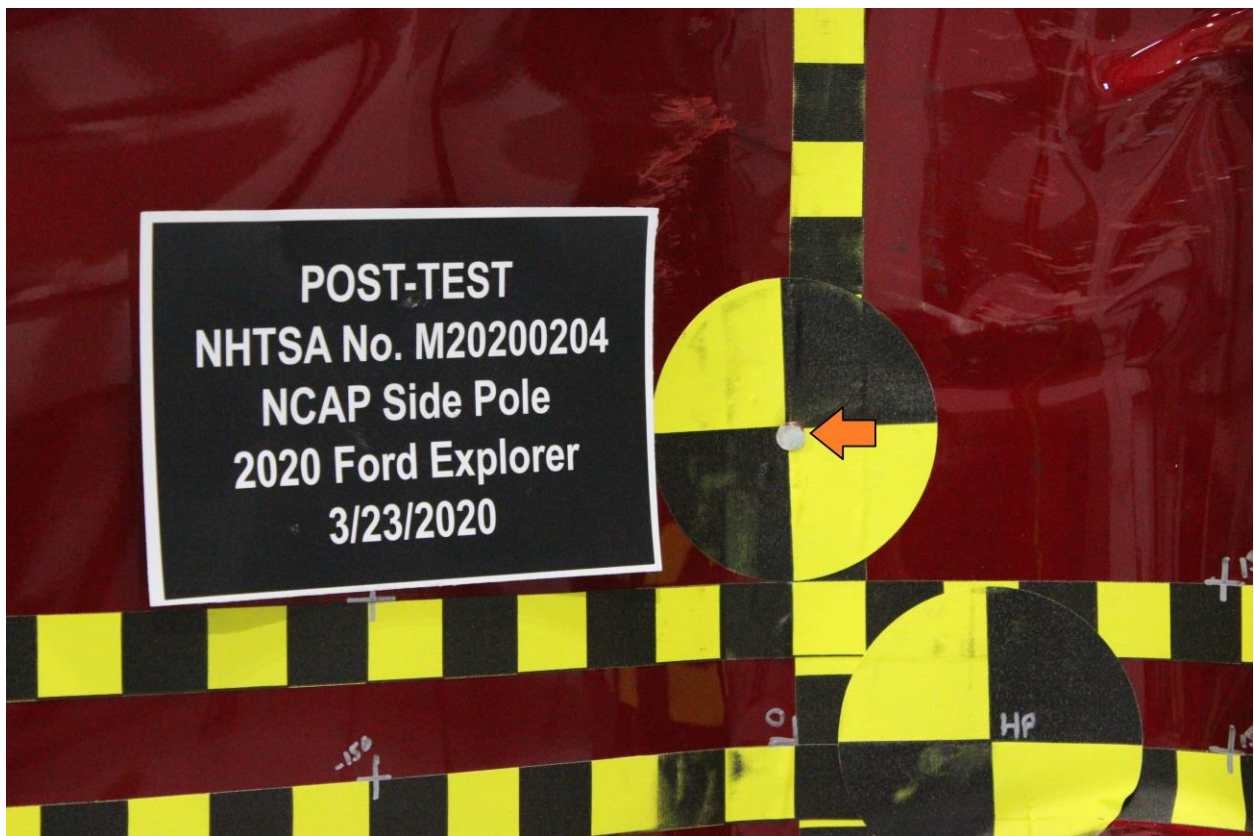
Figure A-20: Post-Test Close-Up View of Impact Point Target Showing Impact Location

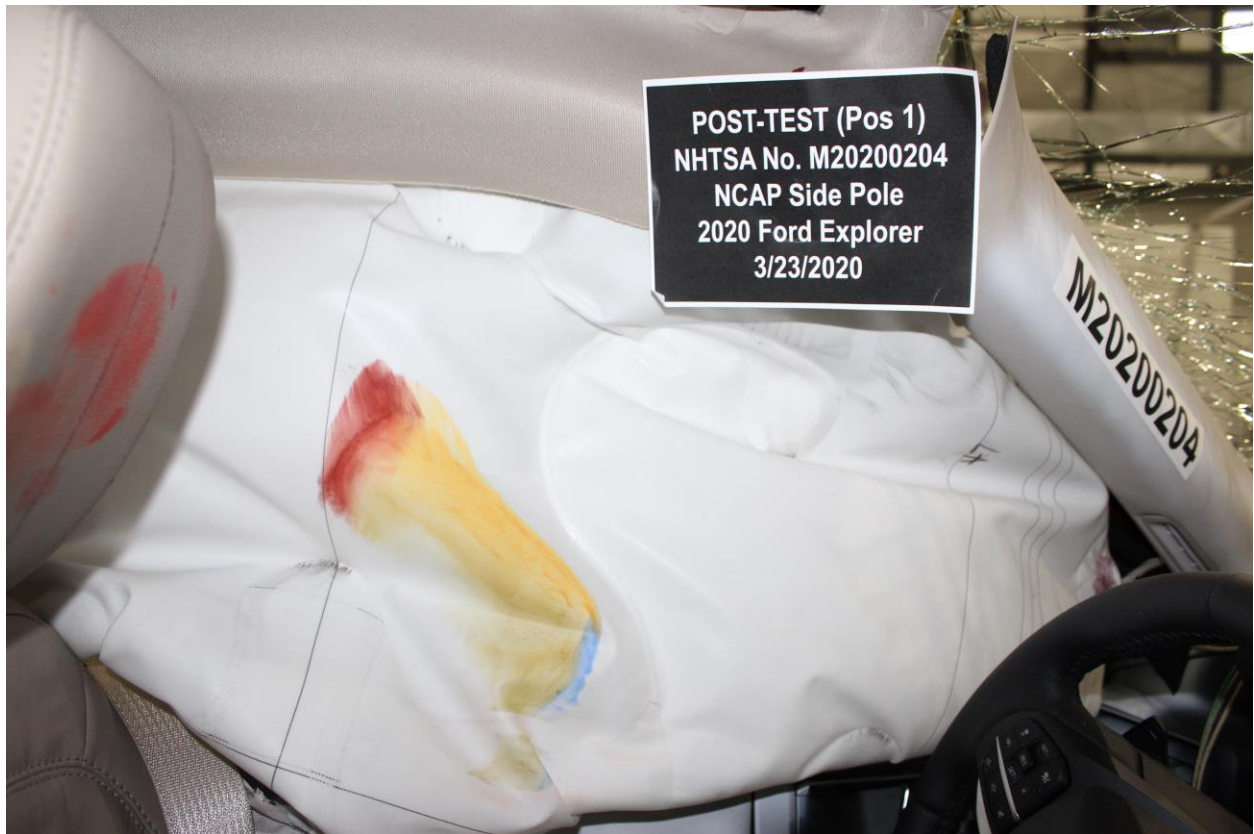
Figure A-47: Post-Test Dummy Close-Up Head Contact with Side Airbag View

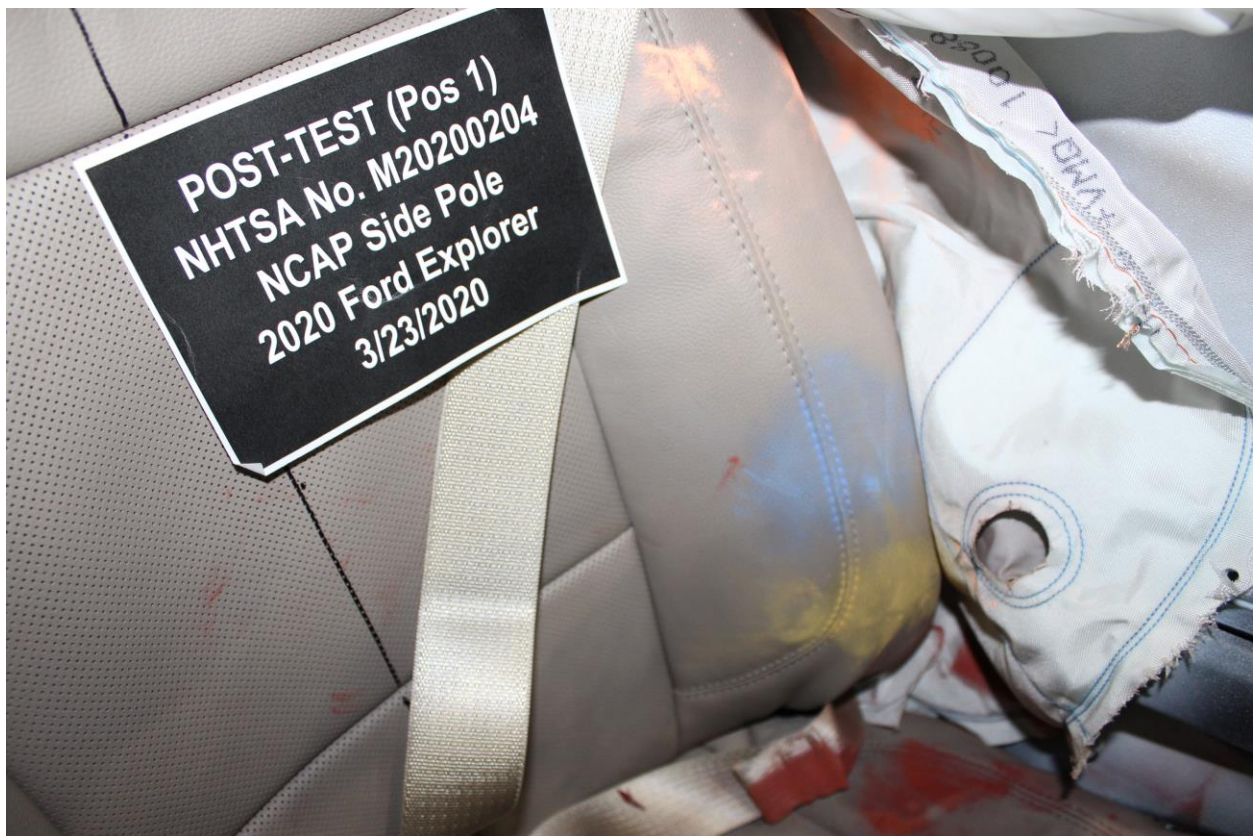
Figure A-48: Post-Test Dummy Close-Up Torso Contact with Vehicle Interior View

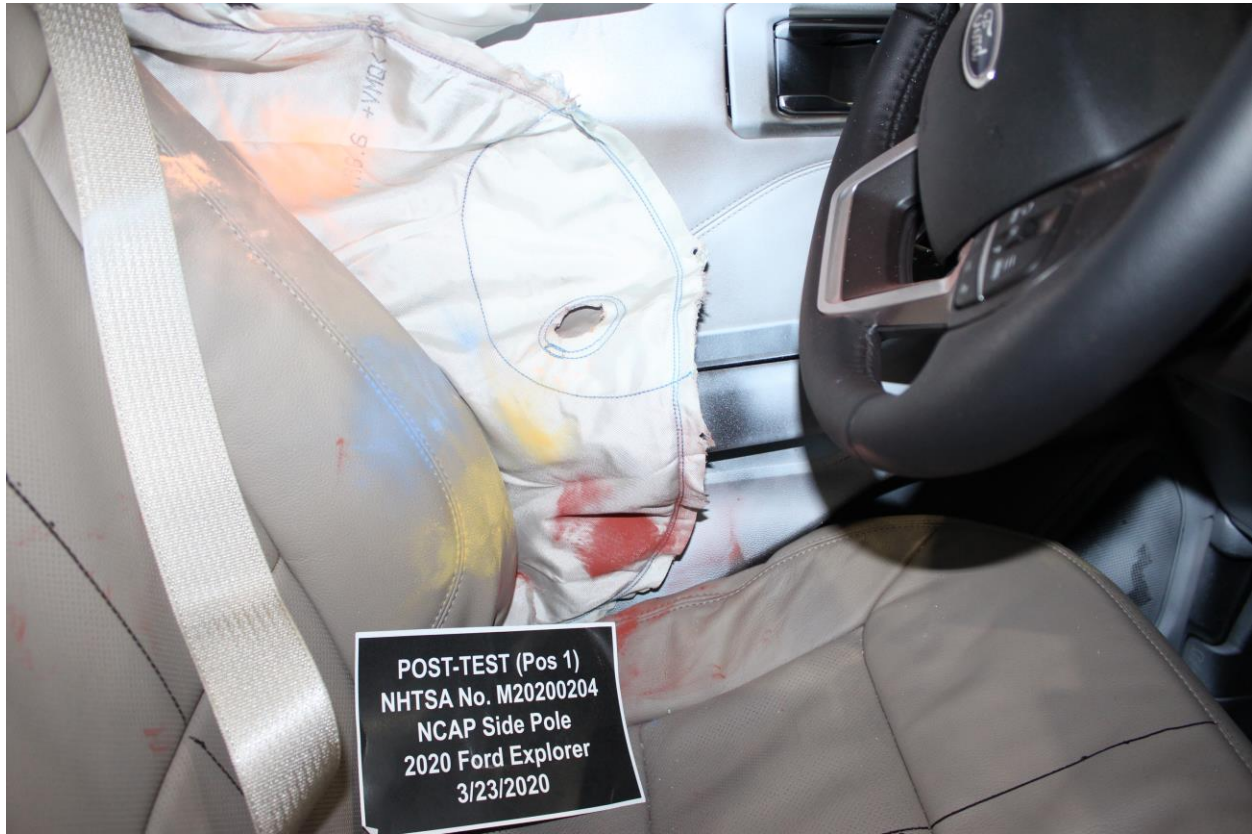
Figure A-49: Post-Test Dummy Close-Up Torso Contact with Side Airbag View

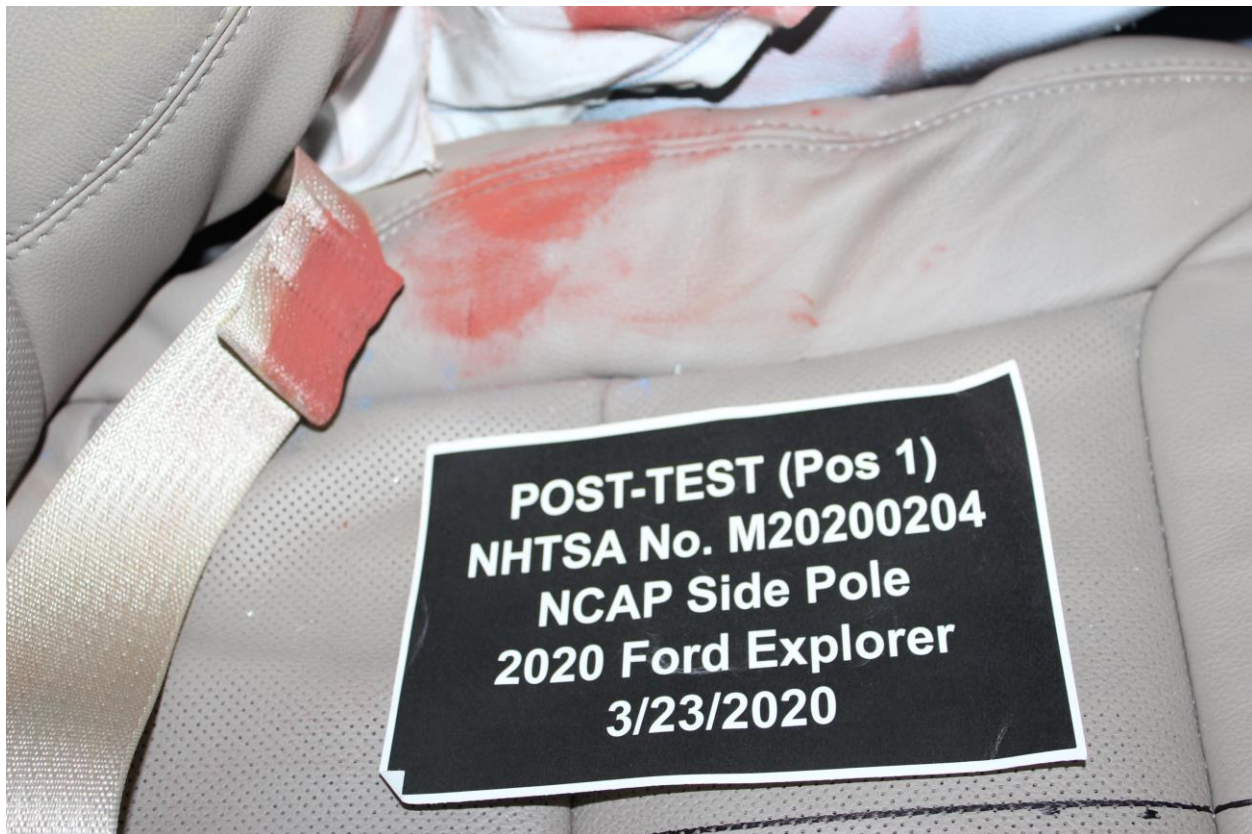
Figure A-50: Post-Test Dummy Close-Up Pelvis Contact with Vehicle Interior View

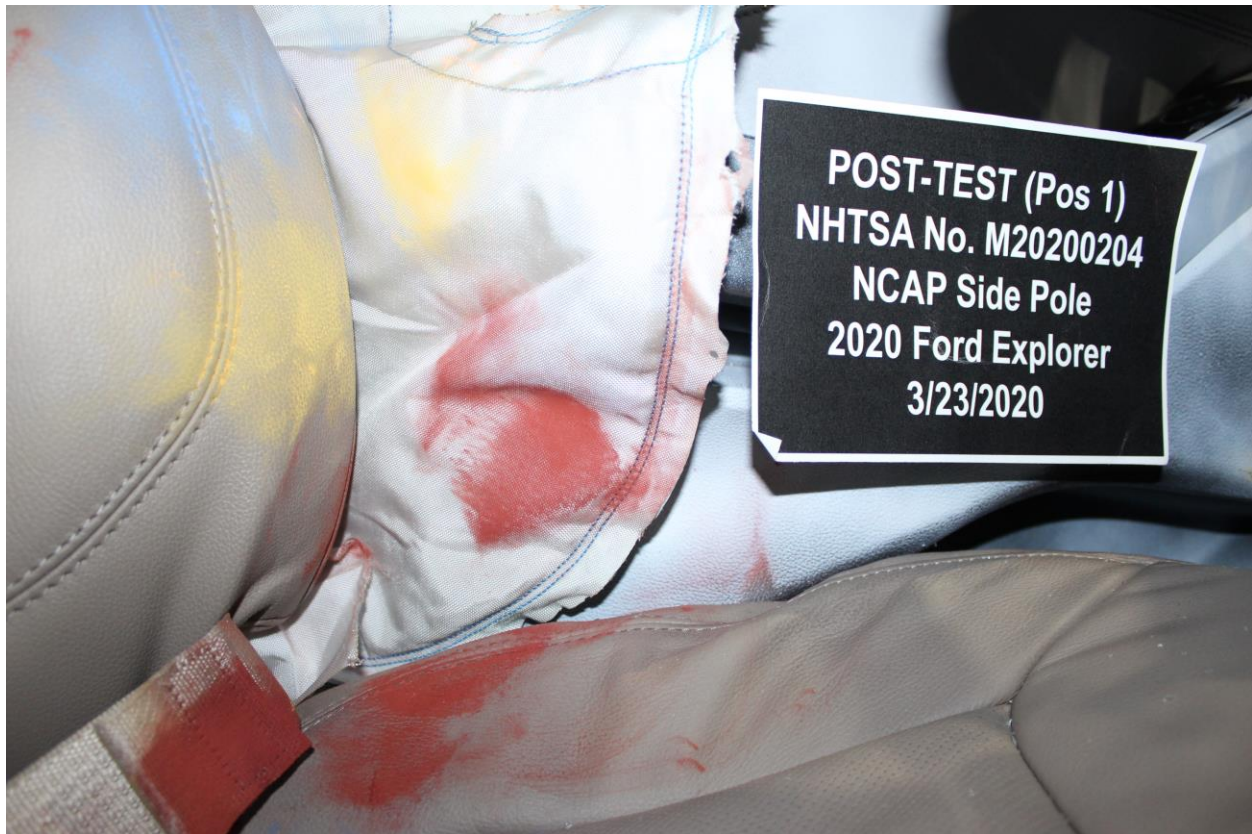
Figure A-51: Post-Test Dummy Close-Up Pelvis Contact with Side Airbag View

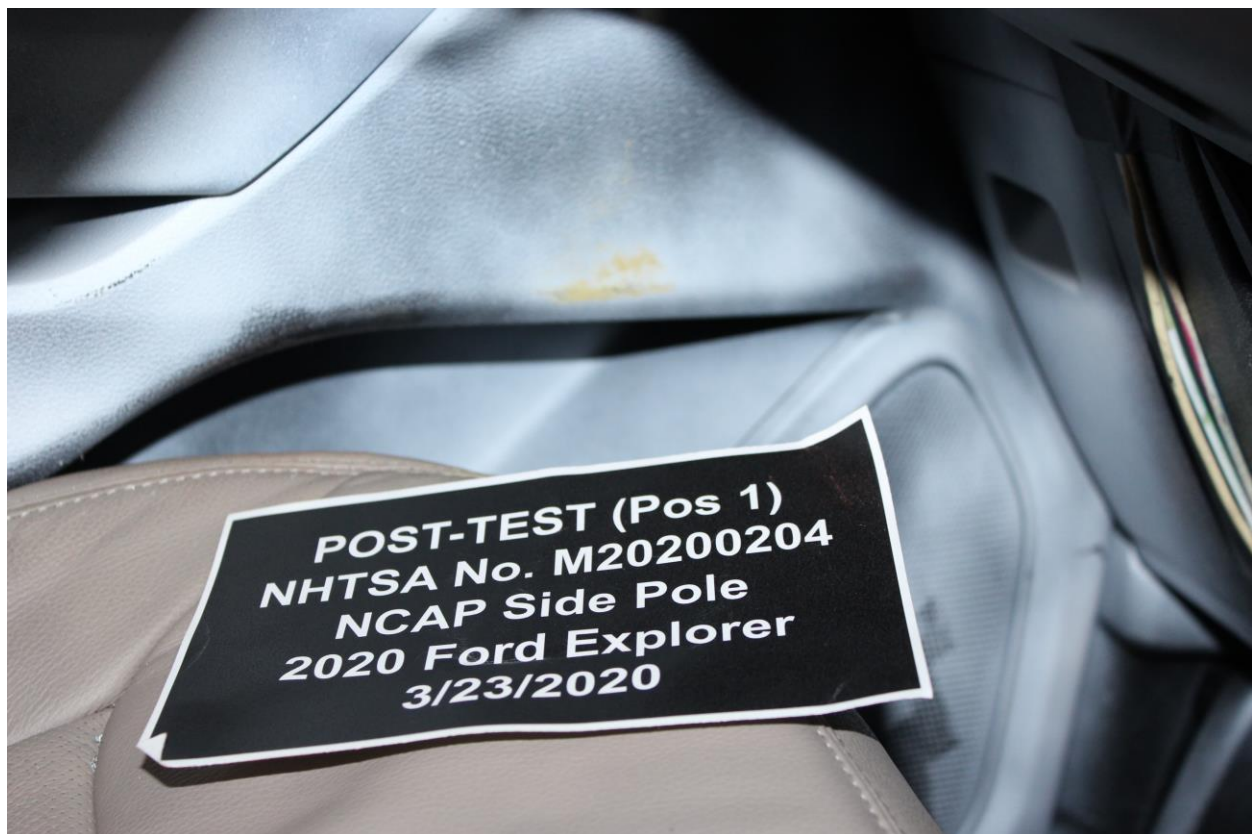
Figure A-52: Post-Test Dummy Close-Up Knee Contact with Vehicle Interior View

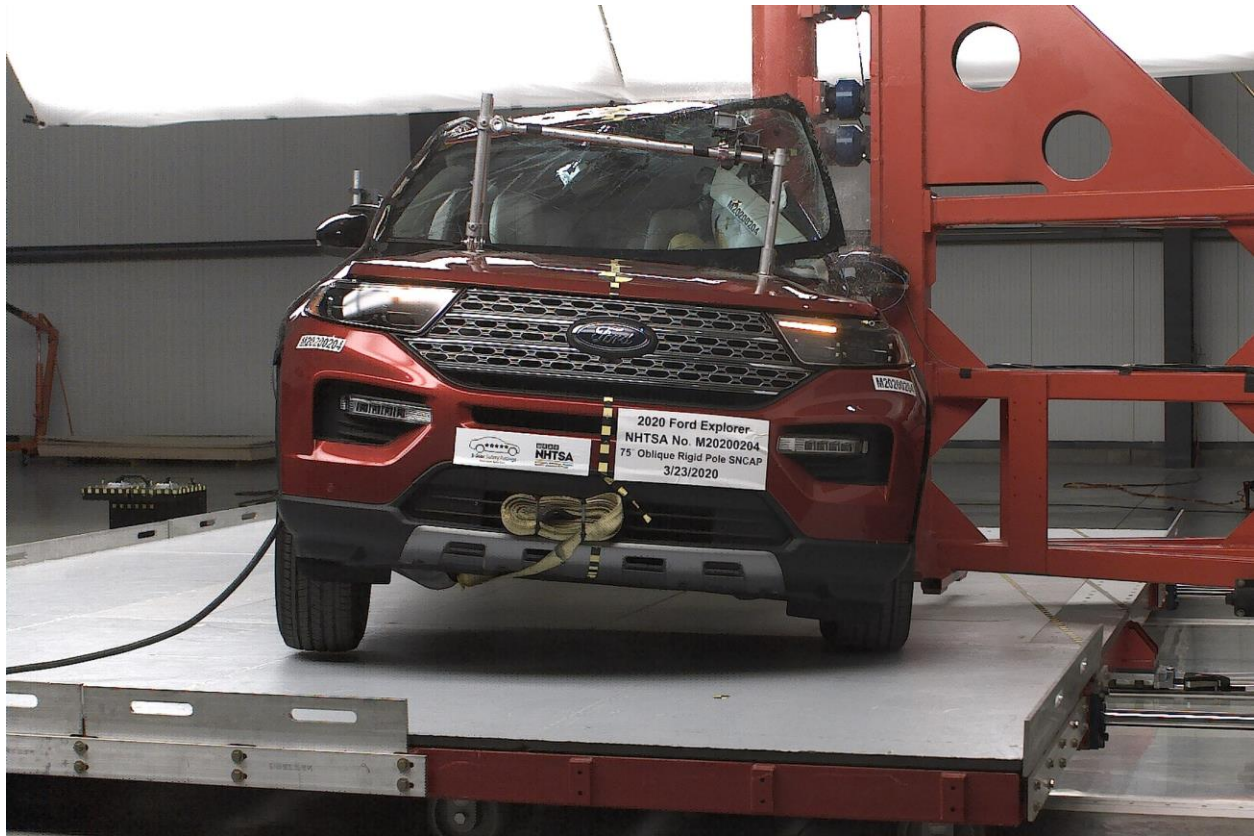
Figure A-68: Impact Event

A rigid pole side impact test was conducted on a 2020 Ford Explorer Hybrid SUV. The subject vehicle was towed into the rigid pole at an angle of 75° and a velocity of 32.53 km/h. The test was conducted by Calspan Corporation's Transportation Test Operations facility in Buffalo, New York on March 23, 2020. Pre-test and post-test photographs of the test vehicle and side impact dummy (SID-IIs) are included in Appendix A of this report.

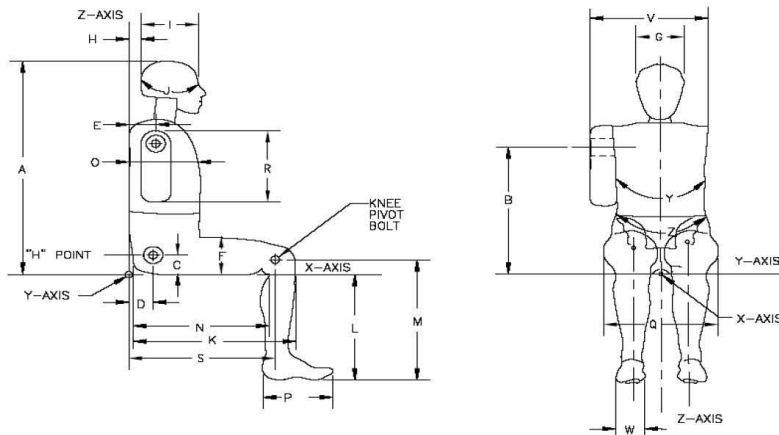
Symbol	Description	Specification (mm)		Result (mm)	Pass/Fail
A	Sitting Height	772	788	779	Pass
B	Shoulder Pivot Height	437	453	446	Pass
C	H-point Height	79	89	85	Pass
D	H-point from seatback	141	151	146	Pass
E	Shoulder Pivot from Backline	97	107	103	Pass
F	Thigh Clearance	119	135	126	Pass
G	Head Breadth	140	148	144	Pass
H	Head Back from Backline	40	46	44	Pass
I	Head Depth	178	188	185	Pass
J	Head Circumference	541	551	547	Pass
K	Buttock to Knee Length	514	540	532	Pass
L	Popliteal Height	343	369	357	Pass
M	Knee Pivot to floor height	392	409	404	Pass
N	Buttock Popliteal Length	416	442	433	Pass
O	Chest Depth w/o jacket	195	211	205	Pass
P	Foot Length	216	232	224	Pass
Q	Hip Breadth (w/pelvic plugs)	313	323	318	Pass
R	Arm Length	249	259	255	Pass
S	Knee Joint to seatback	477	493	486	Pass
V	Shoulder Width	341	357	345	Pass
W	Foot Width	78	94	85	Pass
Y	Chest Circumference w/jacket	851	881	867	Pass
Z	Waist Circumference	761	791	781	Pass
