**NEW CAR ASSESSMENT PROGRAM  
FORWARD COLLISION WARNING CONFIRMATION TEST  
OCAS-DRI-FCW-20-17**

**2020 Ram 1500 Crew Cab**

**Final Report**

1. Report No. OCAS-DRI-FCW-20-17	2. Government Accession No.	3. Recipient's Catalog No.	
4. Title and Subtitle Final Report of Forward Collision Warning Confirmation Testing of a 2020 Ram 1500 Crew Cab.		5. Report Date 8 January 2020

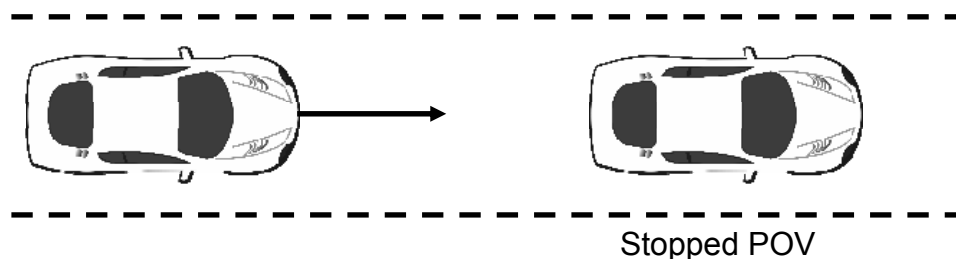
This test evaluates the ability of the FCW function to detect a stopped lead vehicle, as depicted in Figure 1.

Figure 1. Depiction of Test 1

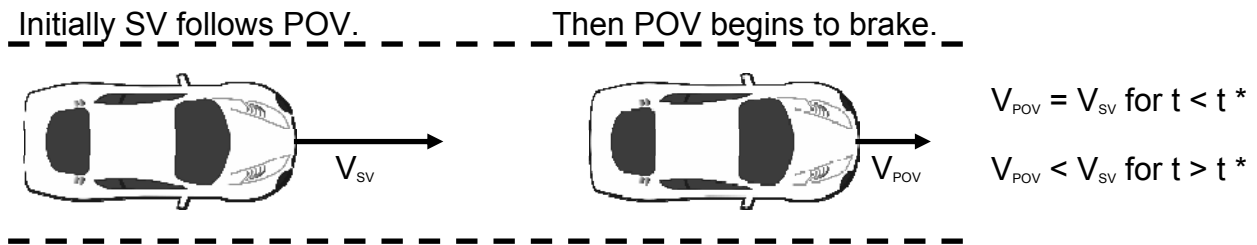
The SV in this test initially followed the POV at a constant time gap, and then the POV suddenly decelerated, as depicted in Figure 2. The test evaluates the ability of the FCW to recognize a decelerating lead vehicle and to issue an alert to SV driver in a timely manner.

Figure 2. Depiction of Test 2

The test began approximately 7 seconds before the driver of the POV started a braking maneuver in which the POV brakes were rapidly applied and modulated such that a constant deceleration of 0.3 g was achieved within 1.5 seconds after braking is initiated. The test ended when either of the following conditions was satisfied:

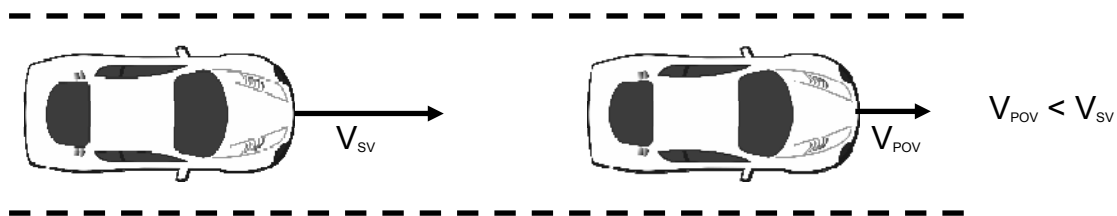
This test examines the ability of the FCW system to recognize a slower lead vehicle being driven with a constant speed and to issue a timely alert. As depicted in Figure 3, the scenario was conducted with a closing speed equal to 25.0 mph (40.2 kph).

Figure 3. Depiction of Test 3

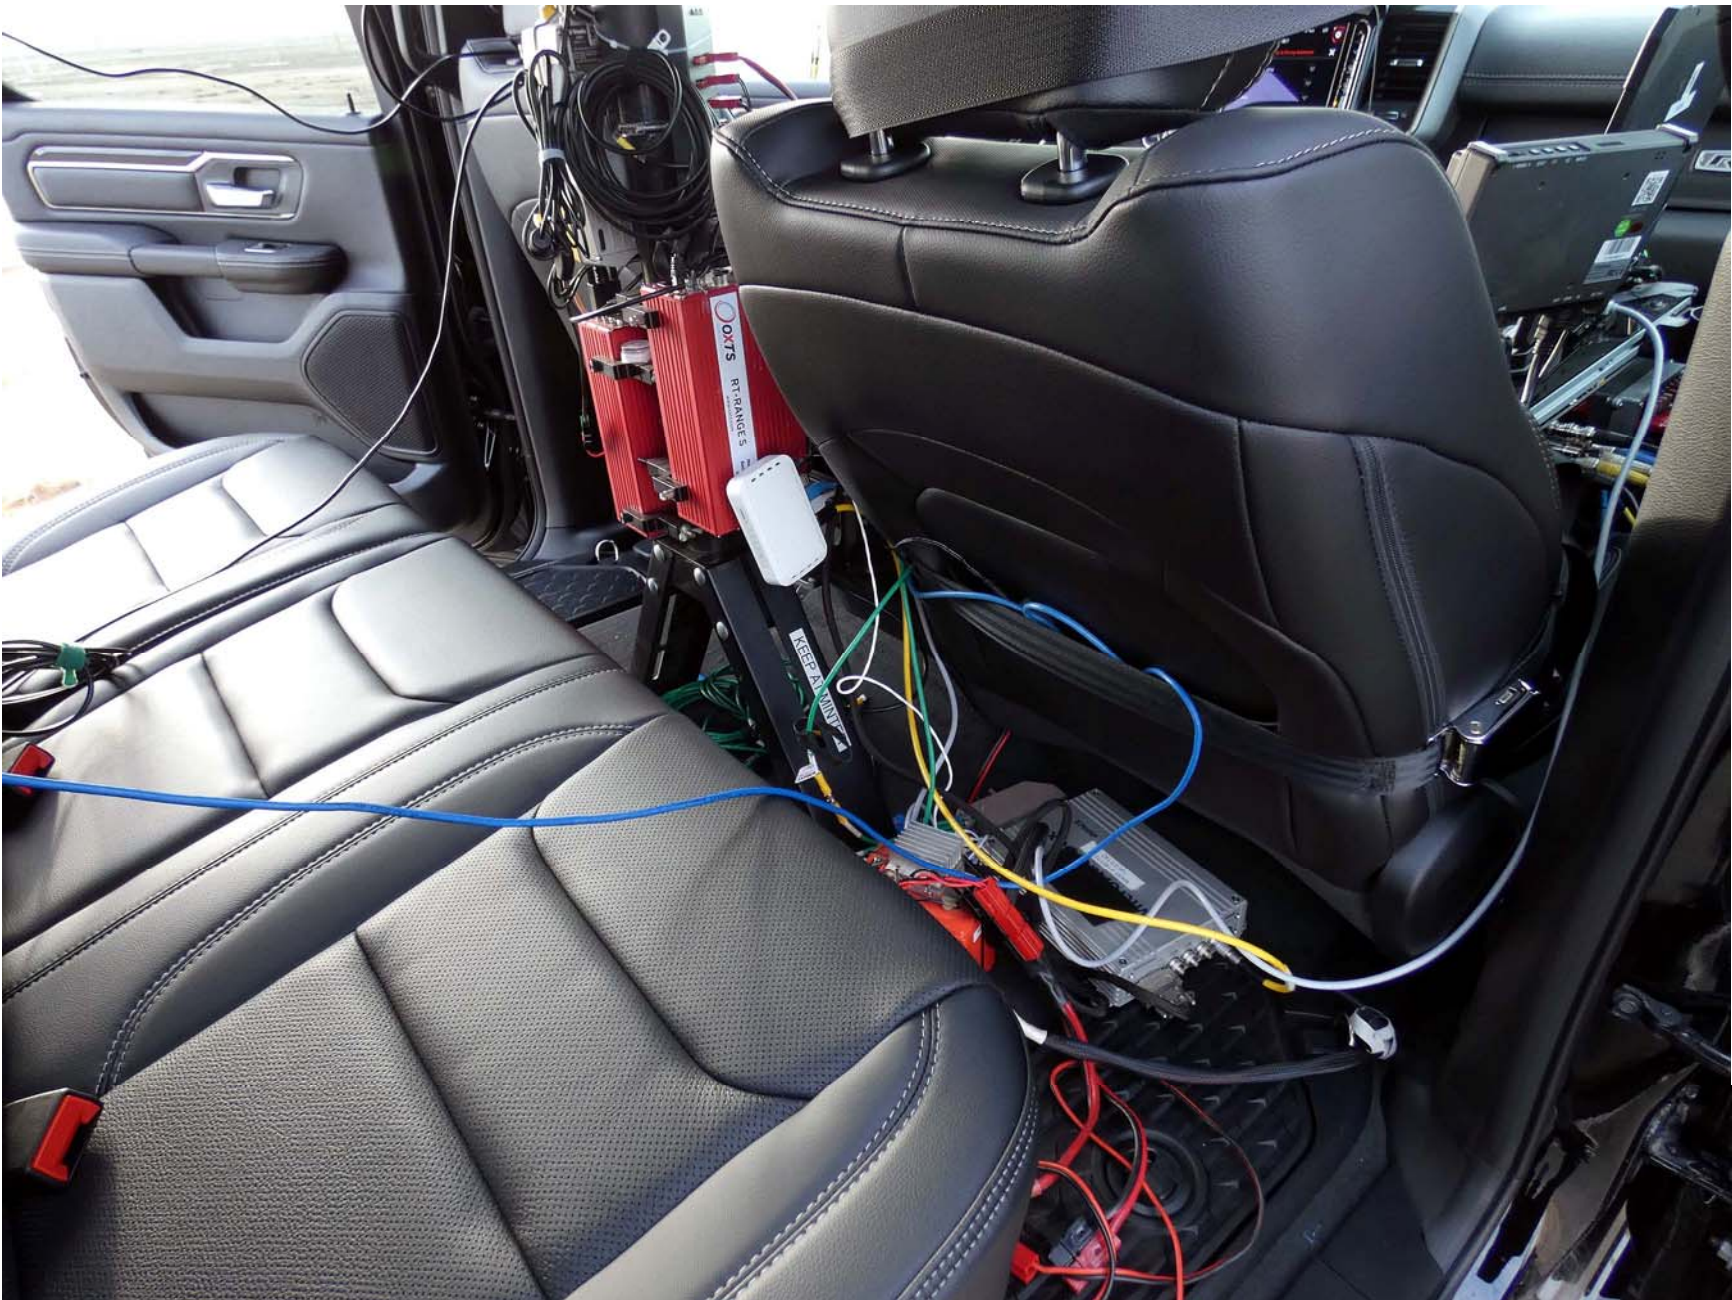
Figure A8. DGPS, Inertial Measurement Unit, and MicroAutoBox Installed in Subject Vehicle

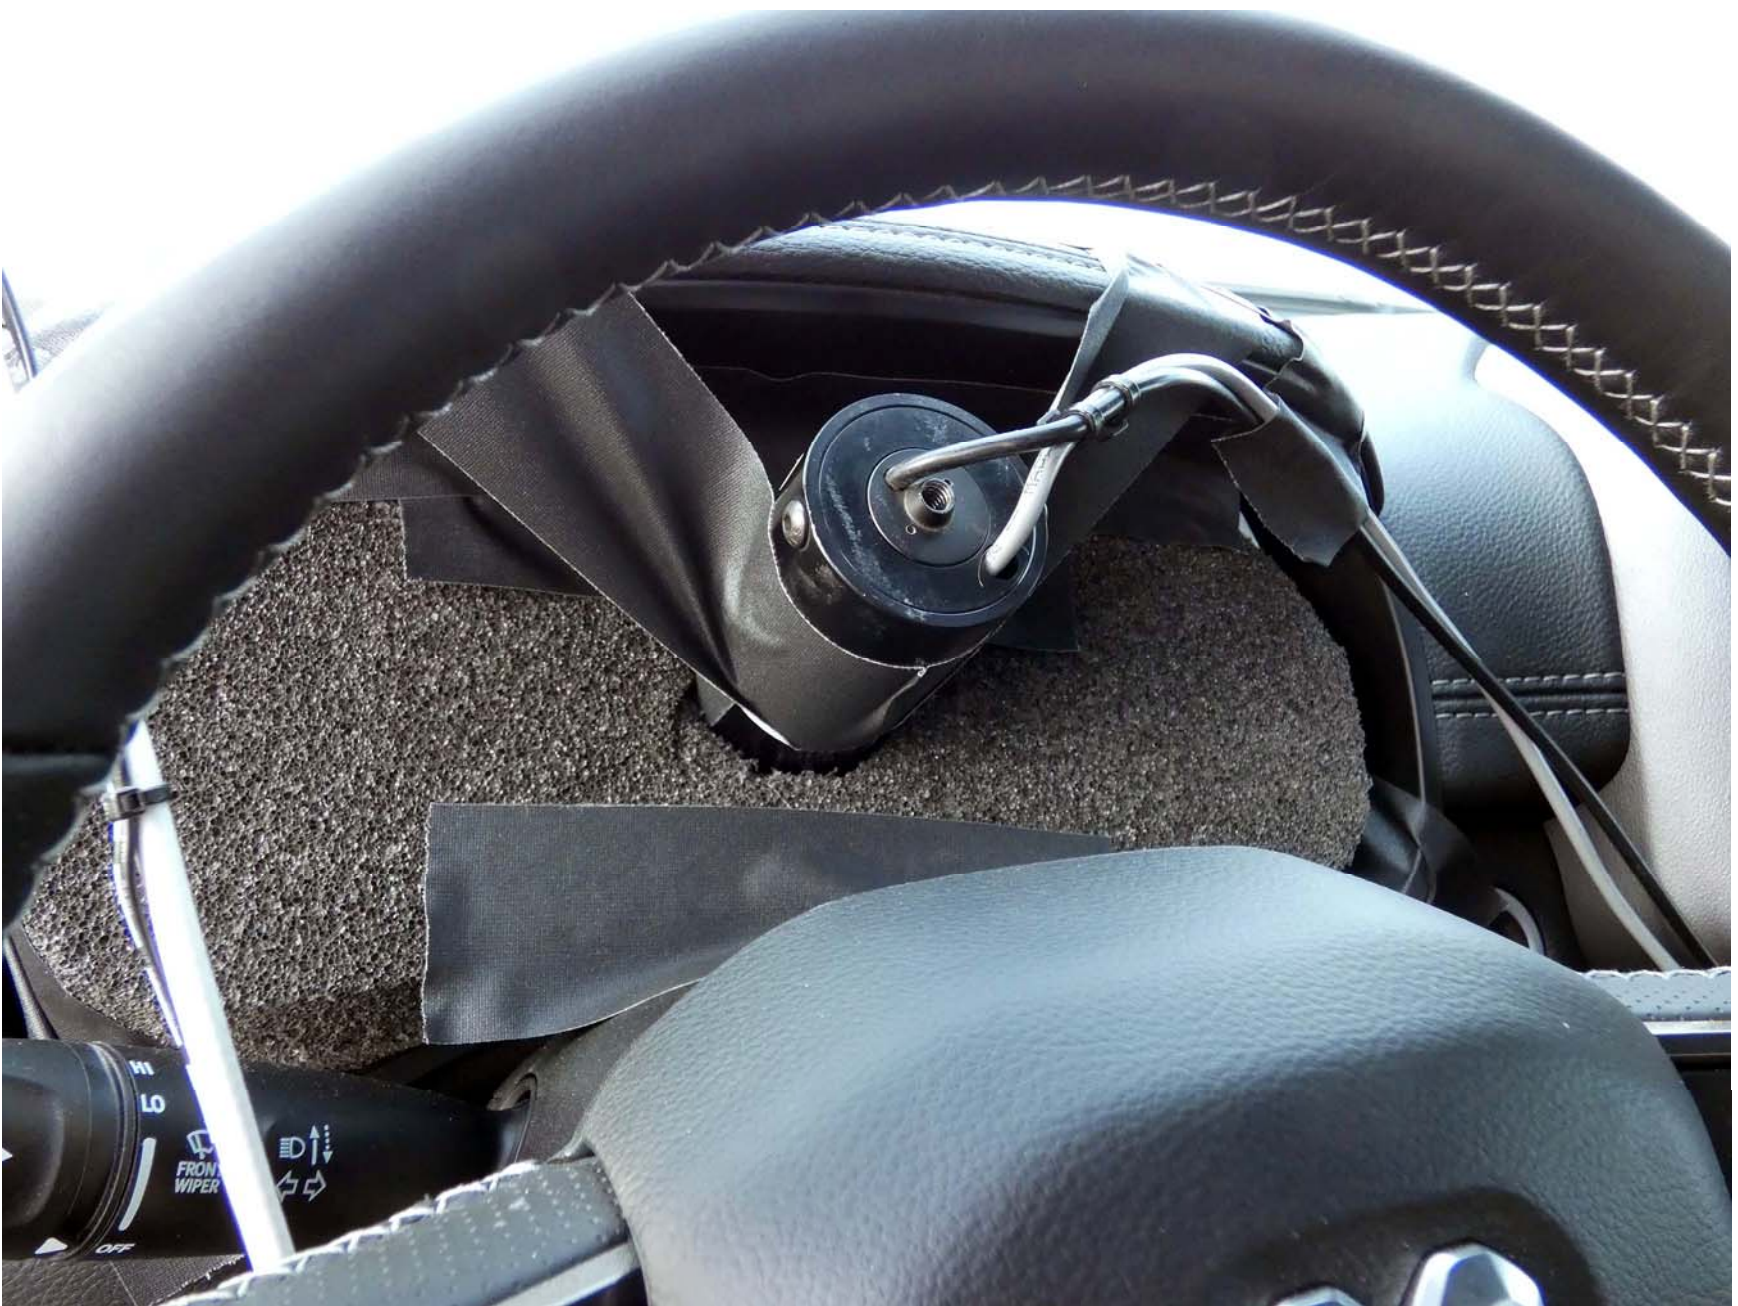
Figure A9. Sensor for Detecting Visual Alerts

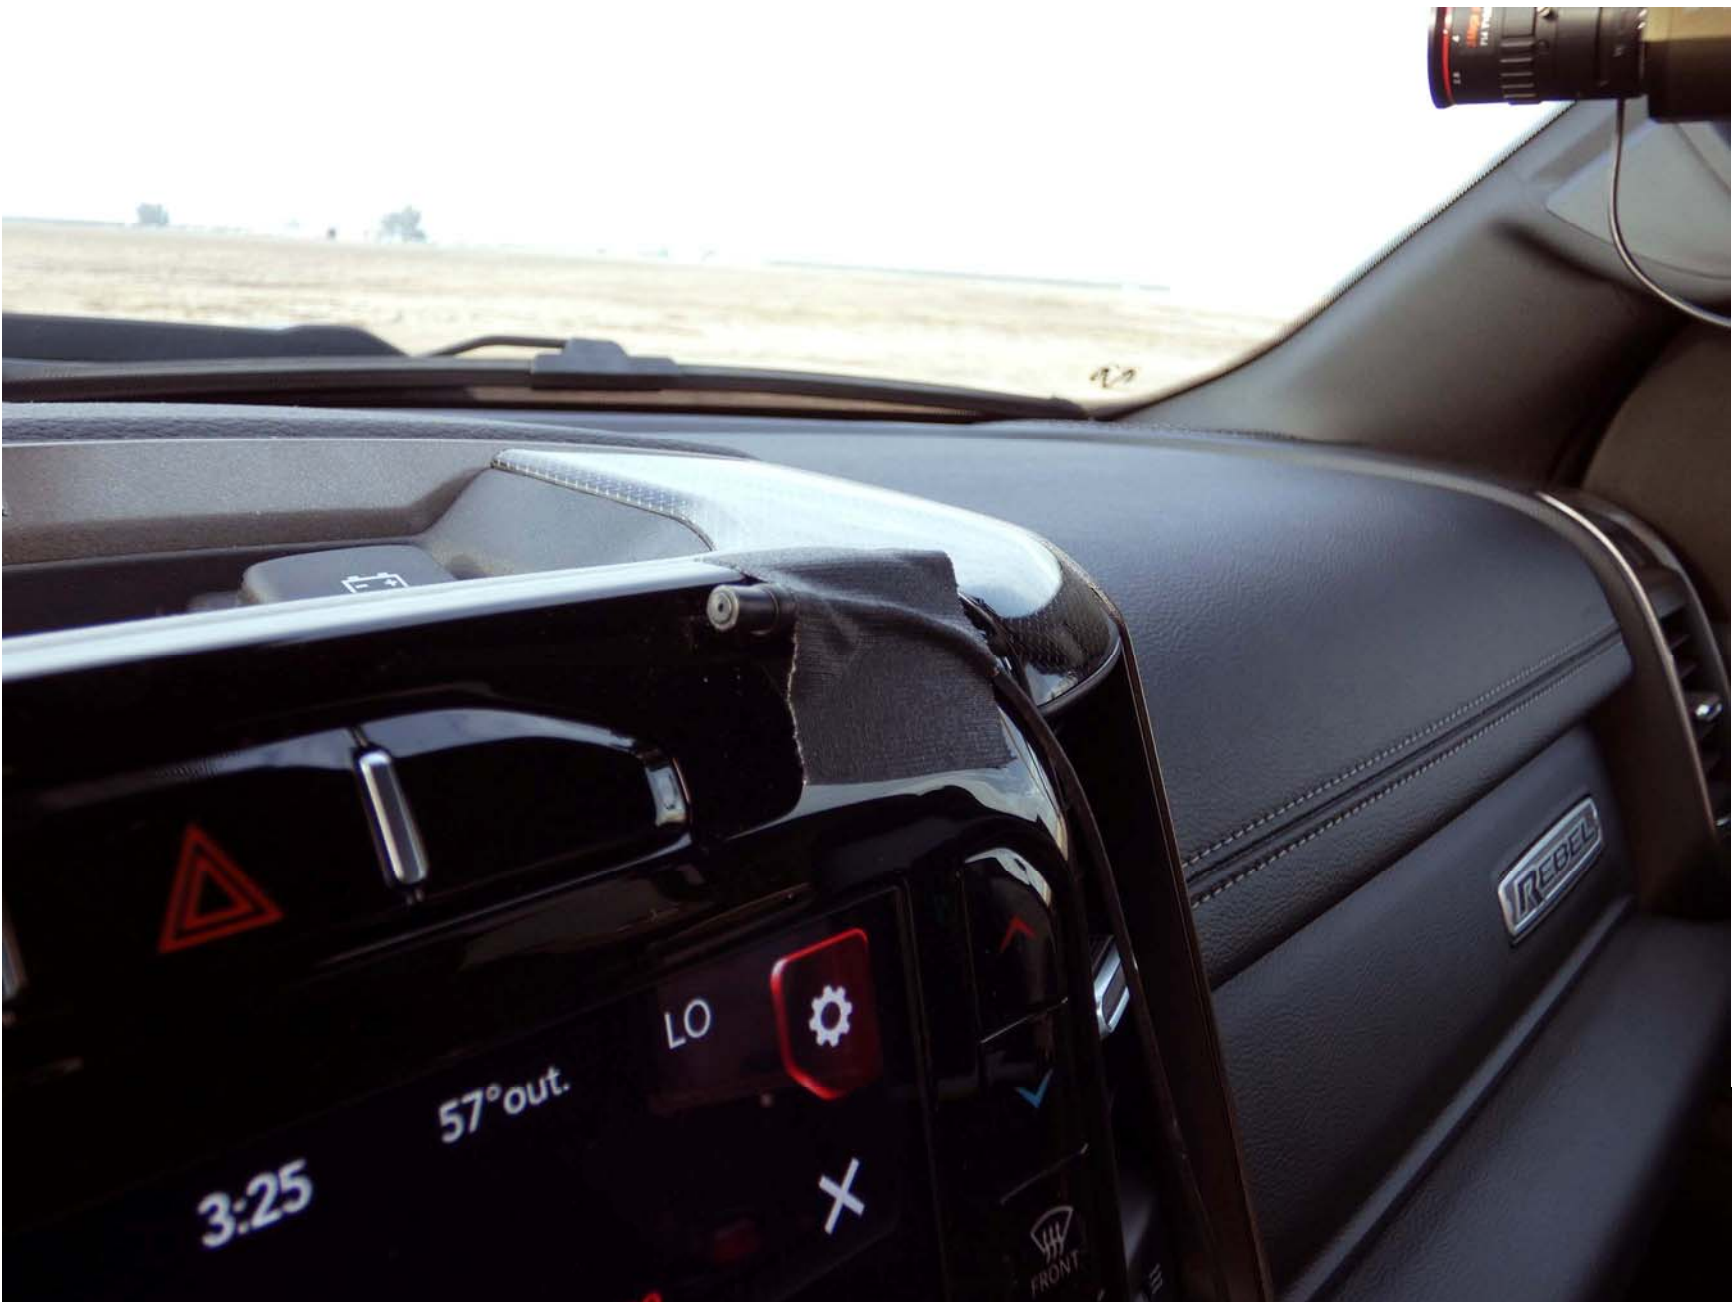
Figure A10. Sensor for Detecting Auditory Alerts

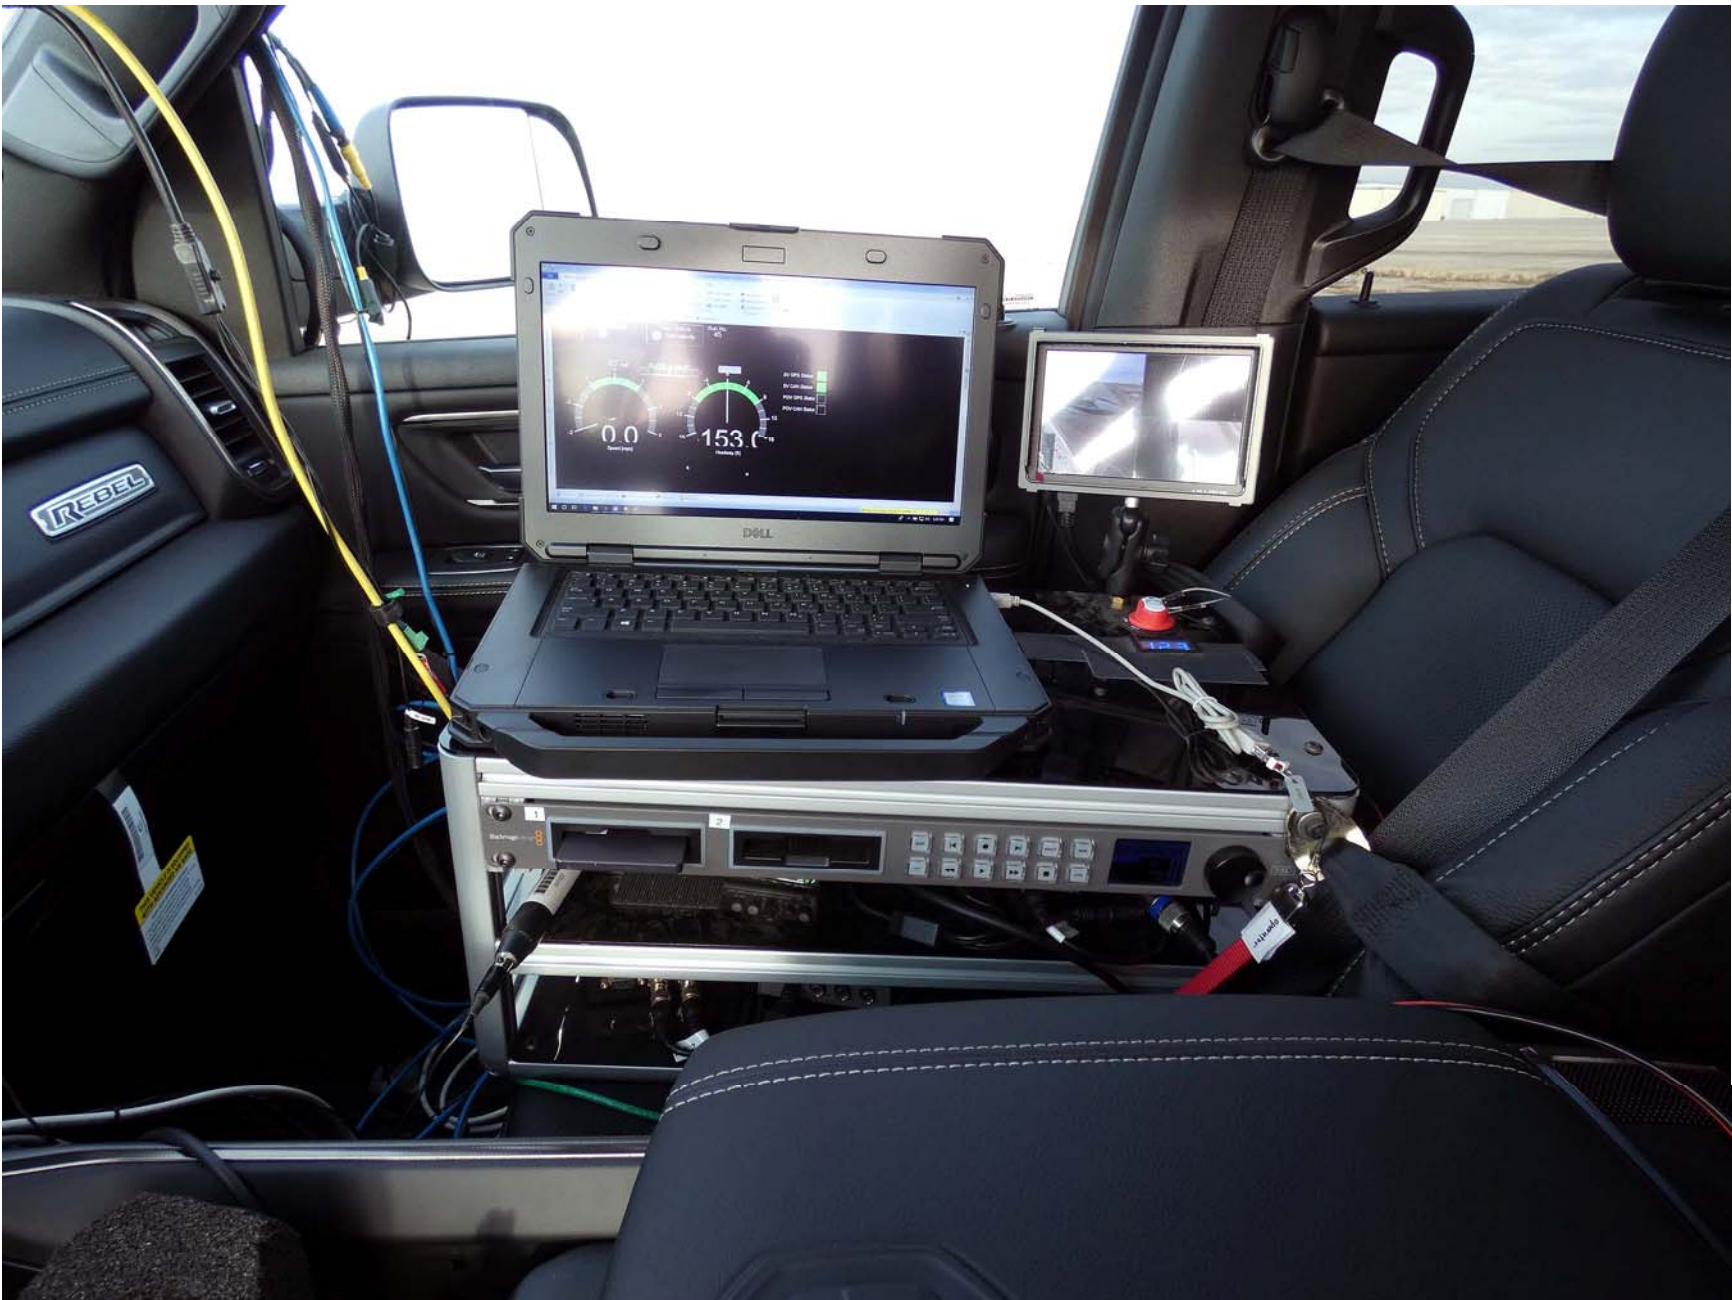
Figure A11. Computer Installed in Subject Vehicle

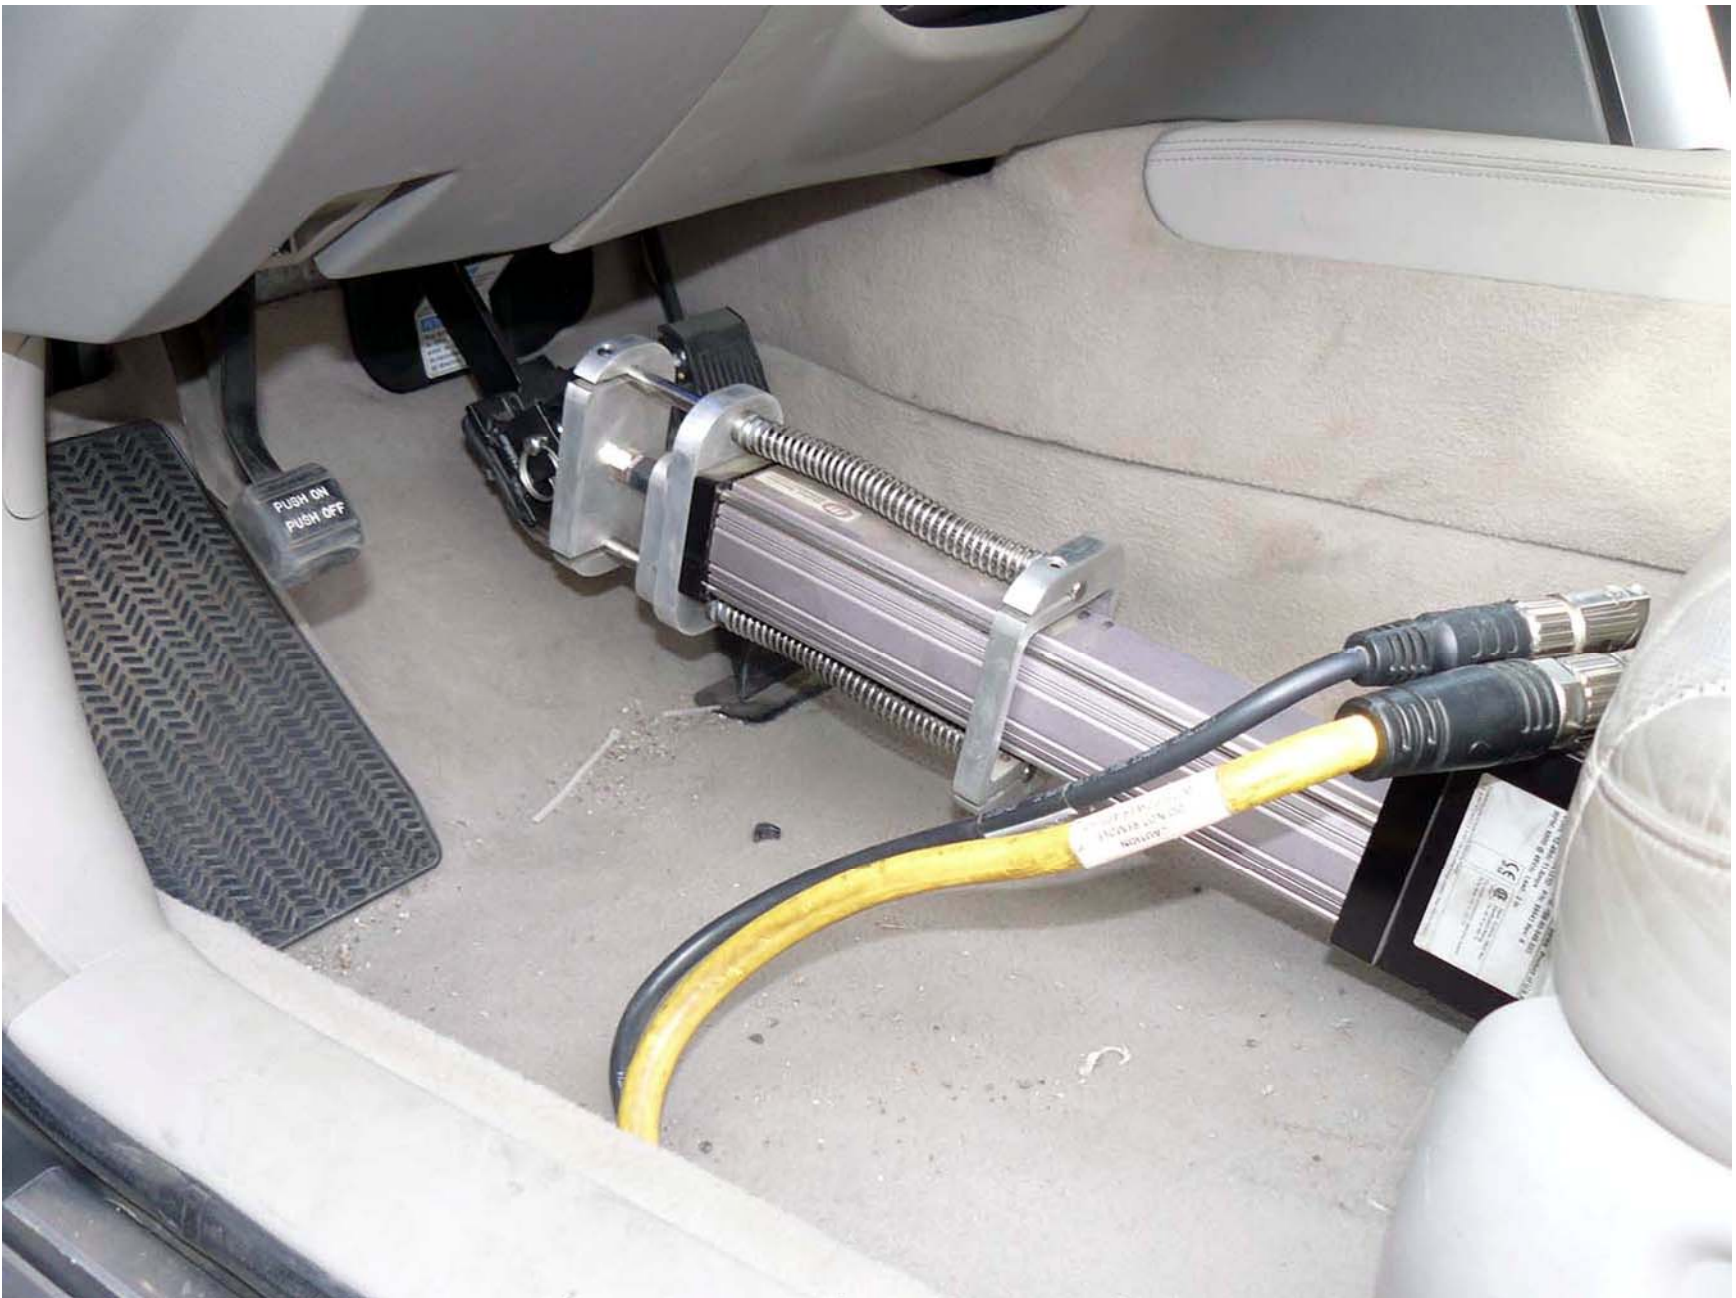
Figure A12. Brake Actuation System Installed in Principal Other Vehicle

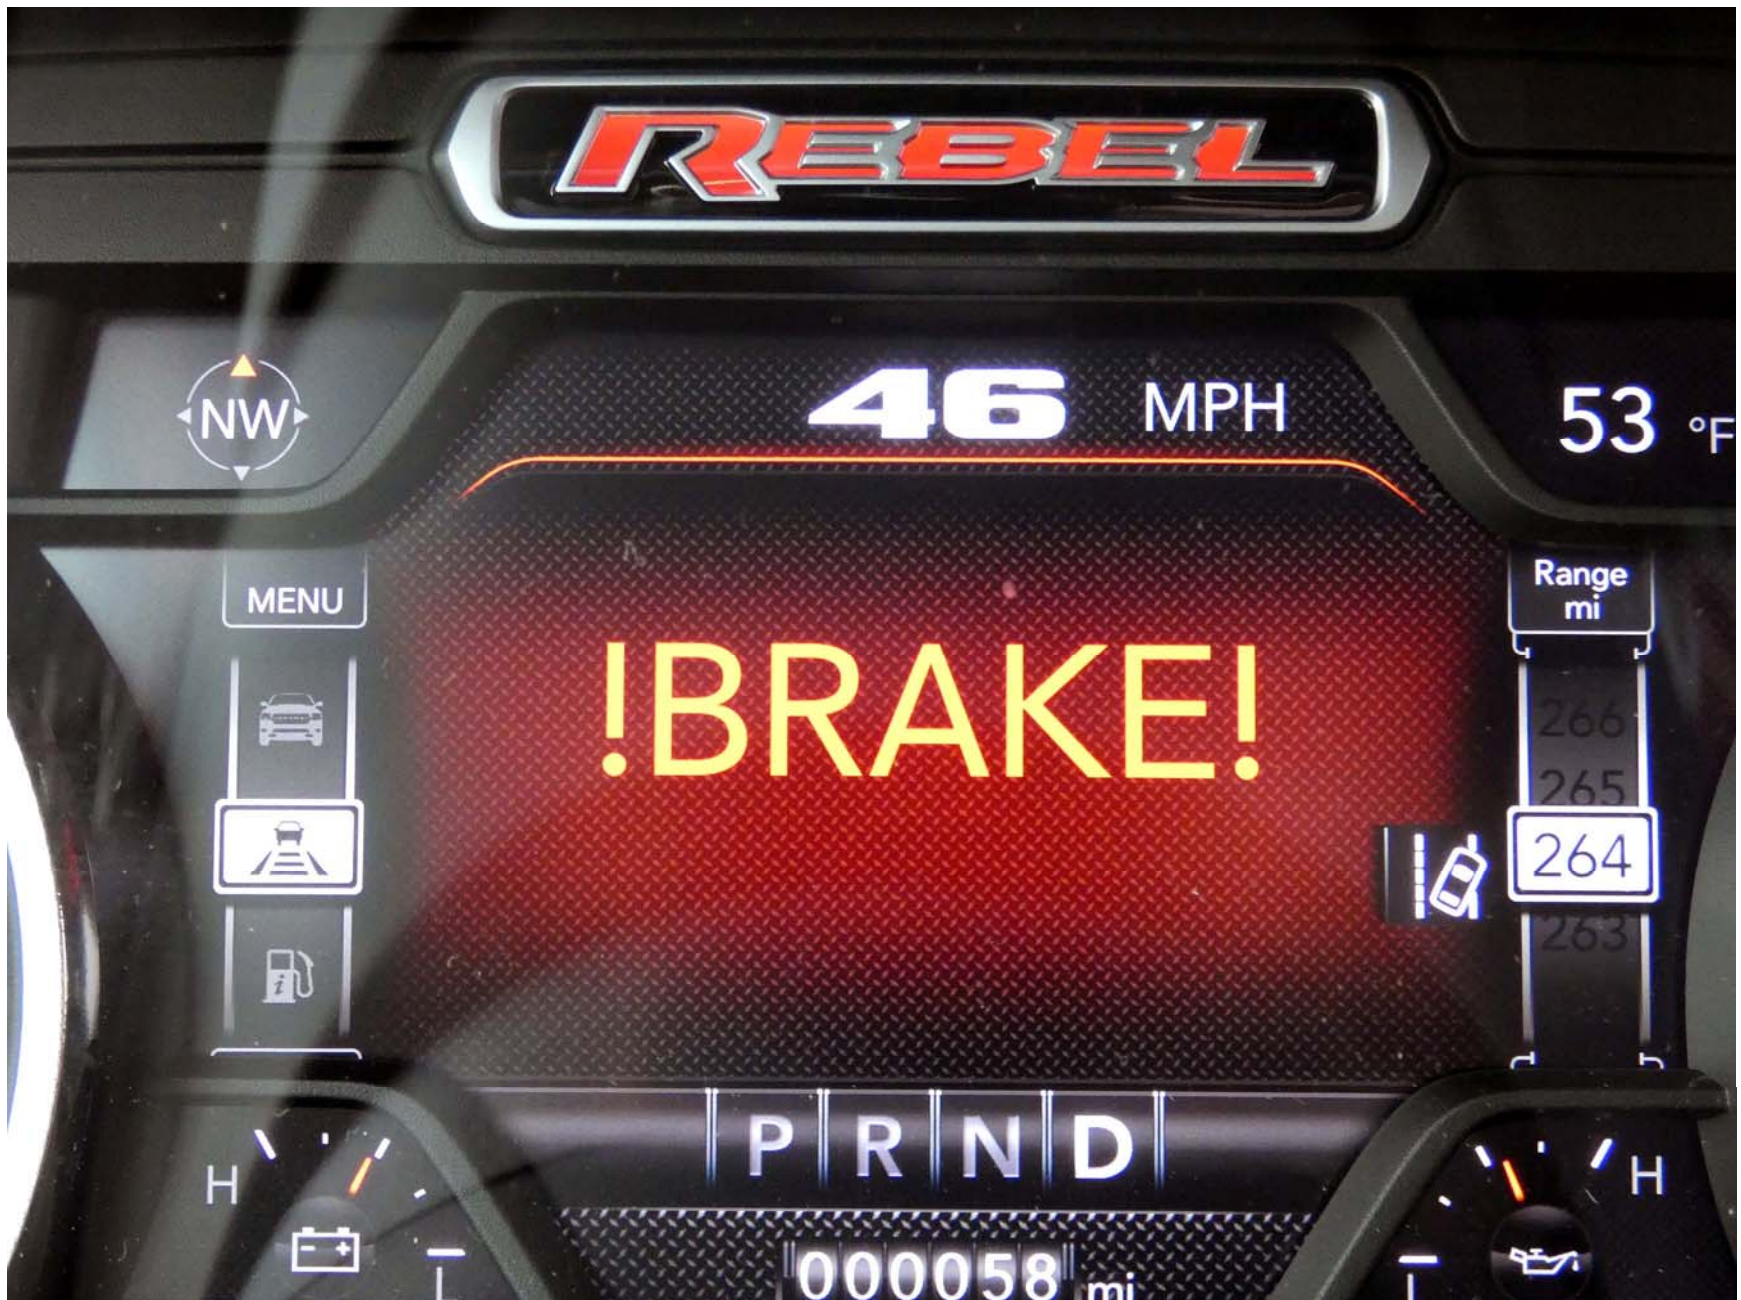
Figure A13. FCW Visual Alert

The visual warning is an orange !BRAKE! In the center display of the instrument panel (see Figure A13).

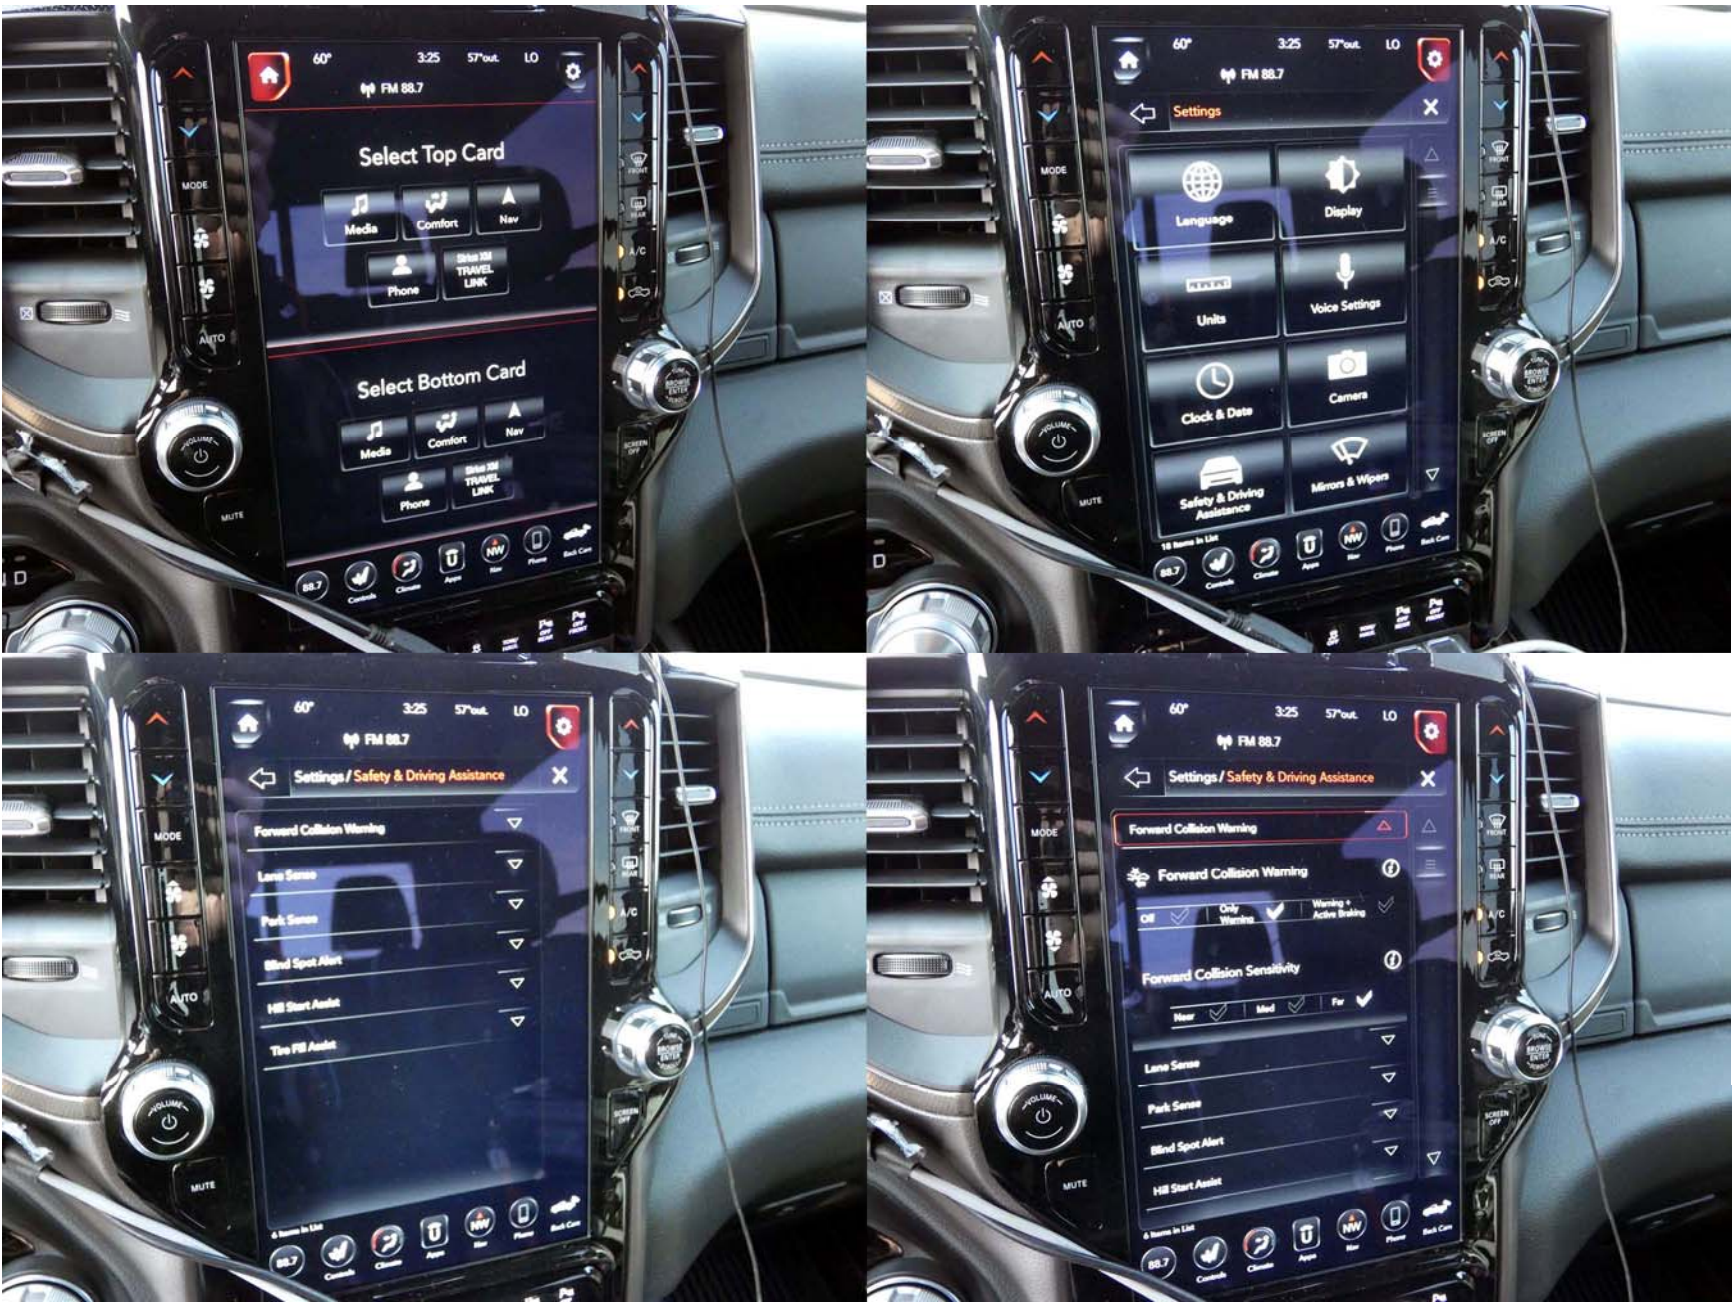
Figure A14. FCW System Setting Menus

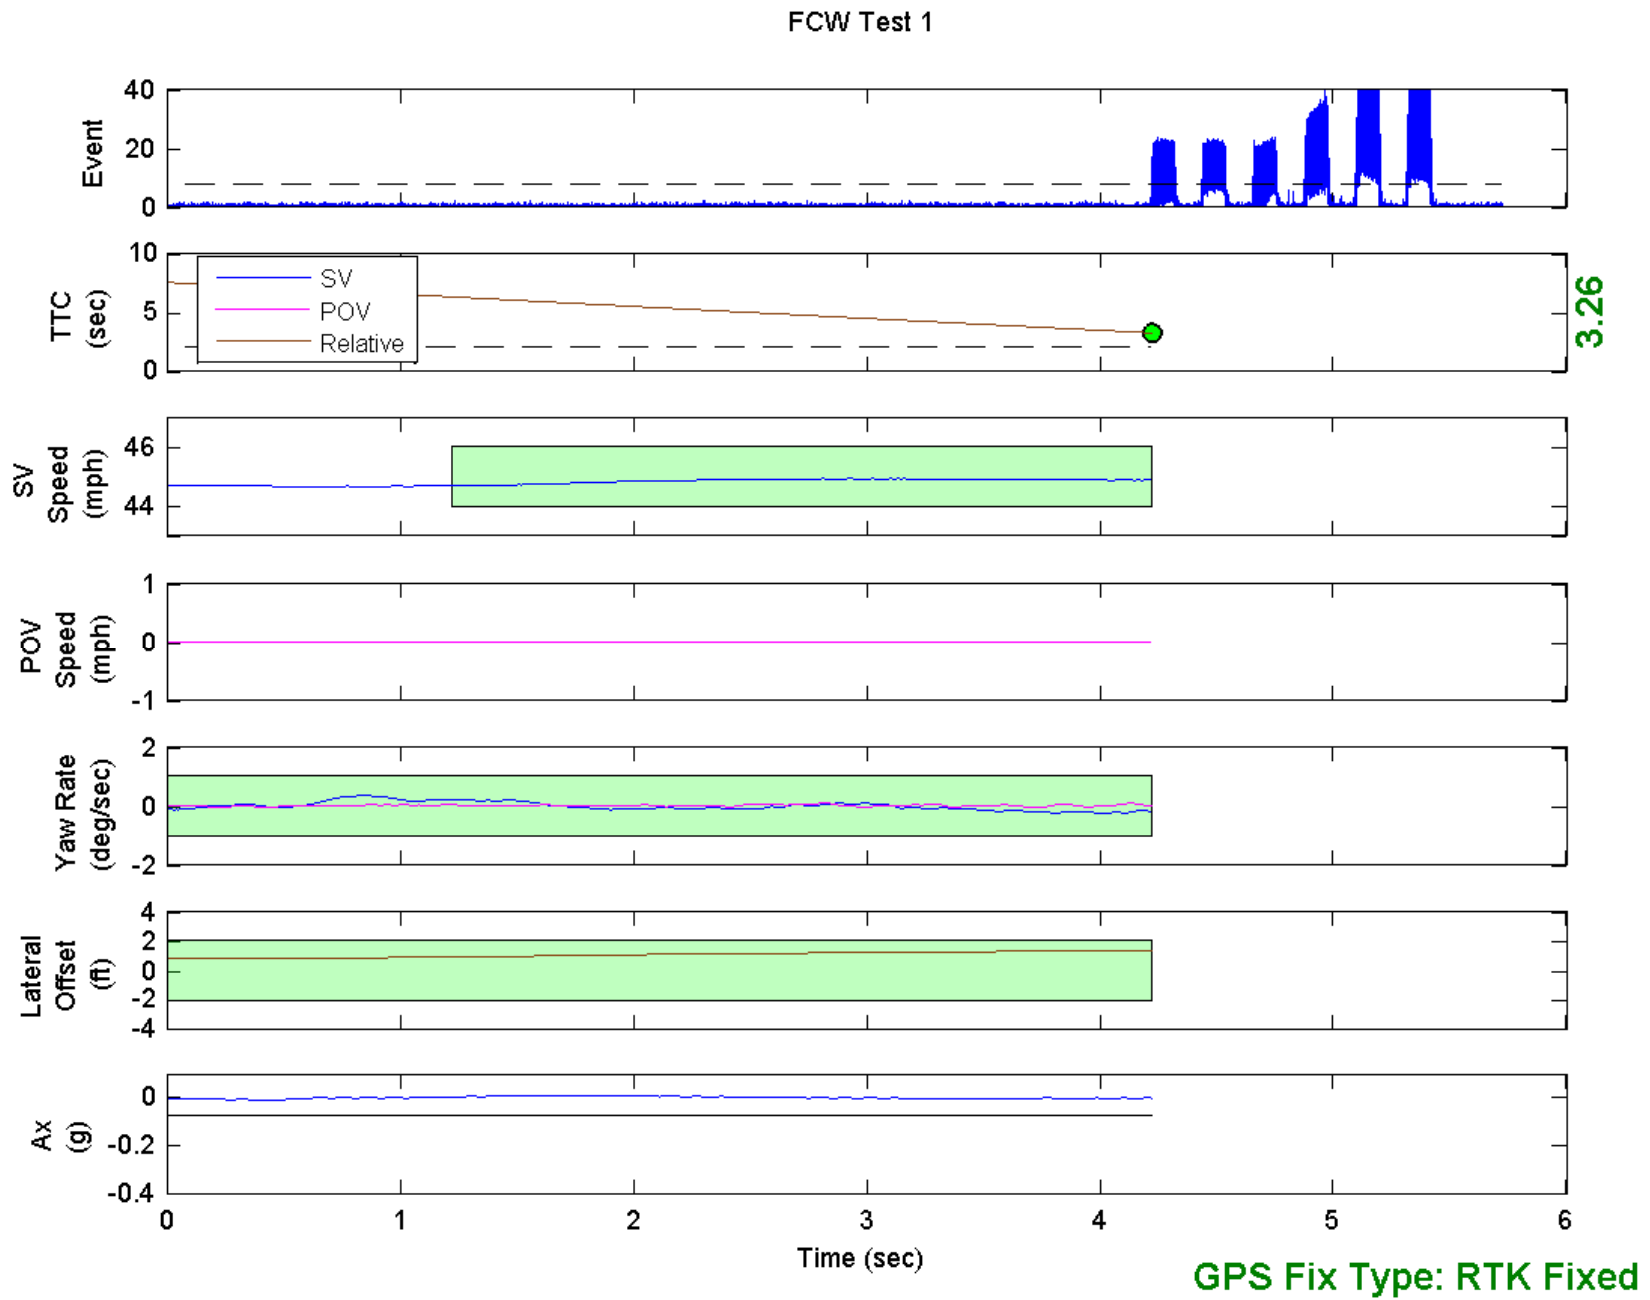
Figure D1. Example Time History for Test Type 1, Passing

Examples of time history plots for each test type (including passing, failing and invalid runs) are shown in Figure D1 through Figure D6. Actual time history data plots for the vehicle under consideration are provided subsequently.

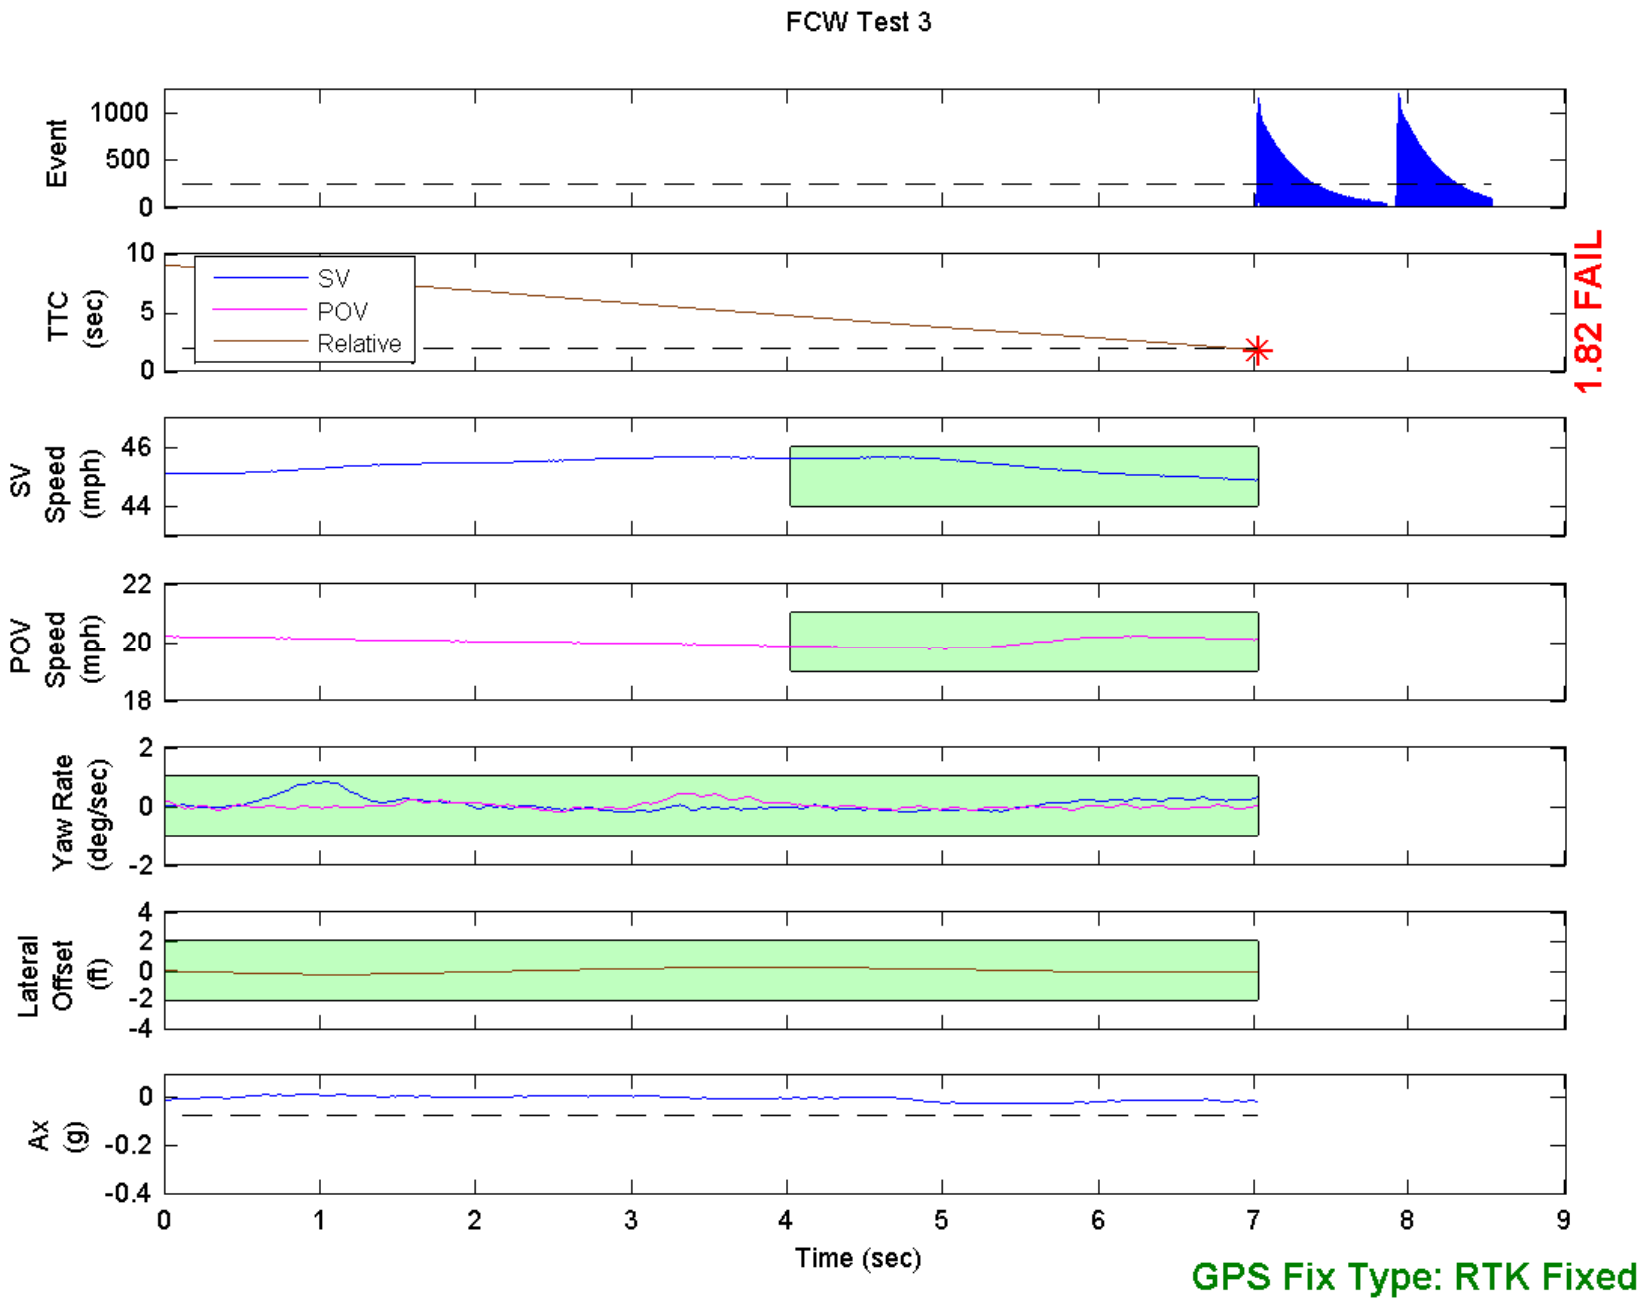
Figure D4. Example Time History for Test Type 3, Failing
