**NEW CAR ASSESSMENT PROGRAM  
FORWARD COLLISION WARNING CONFIRMATION TEST  
OCAS-DRI-FCW-20-17**

**2020 Ram 1500 Crew Cab**

**Final Report**

1. Report No. OCAS-DRI-FCW-20-17	2. Government Accession No.	3. Recipient's Catalog No.	
4. Title and Subtitle Final Report of Forward Collision Warning Confirmation Testing of a 2020 Ram 1500 Crew Cab.		5. Report Date 8 January 2020

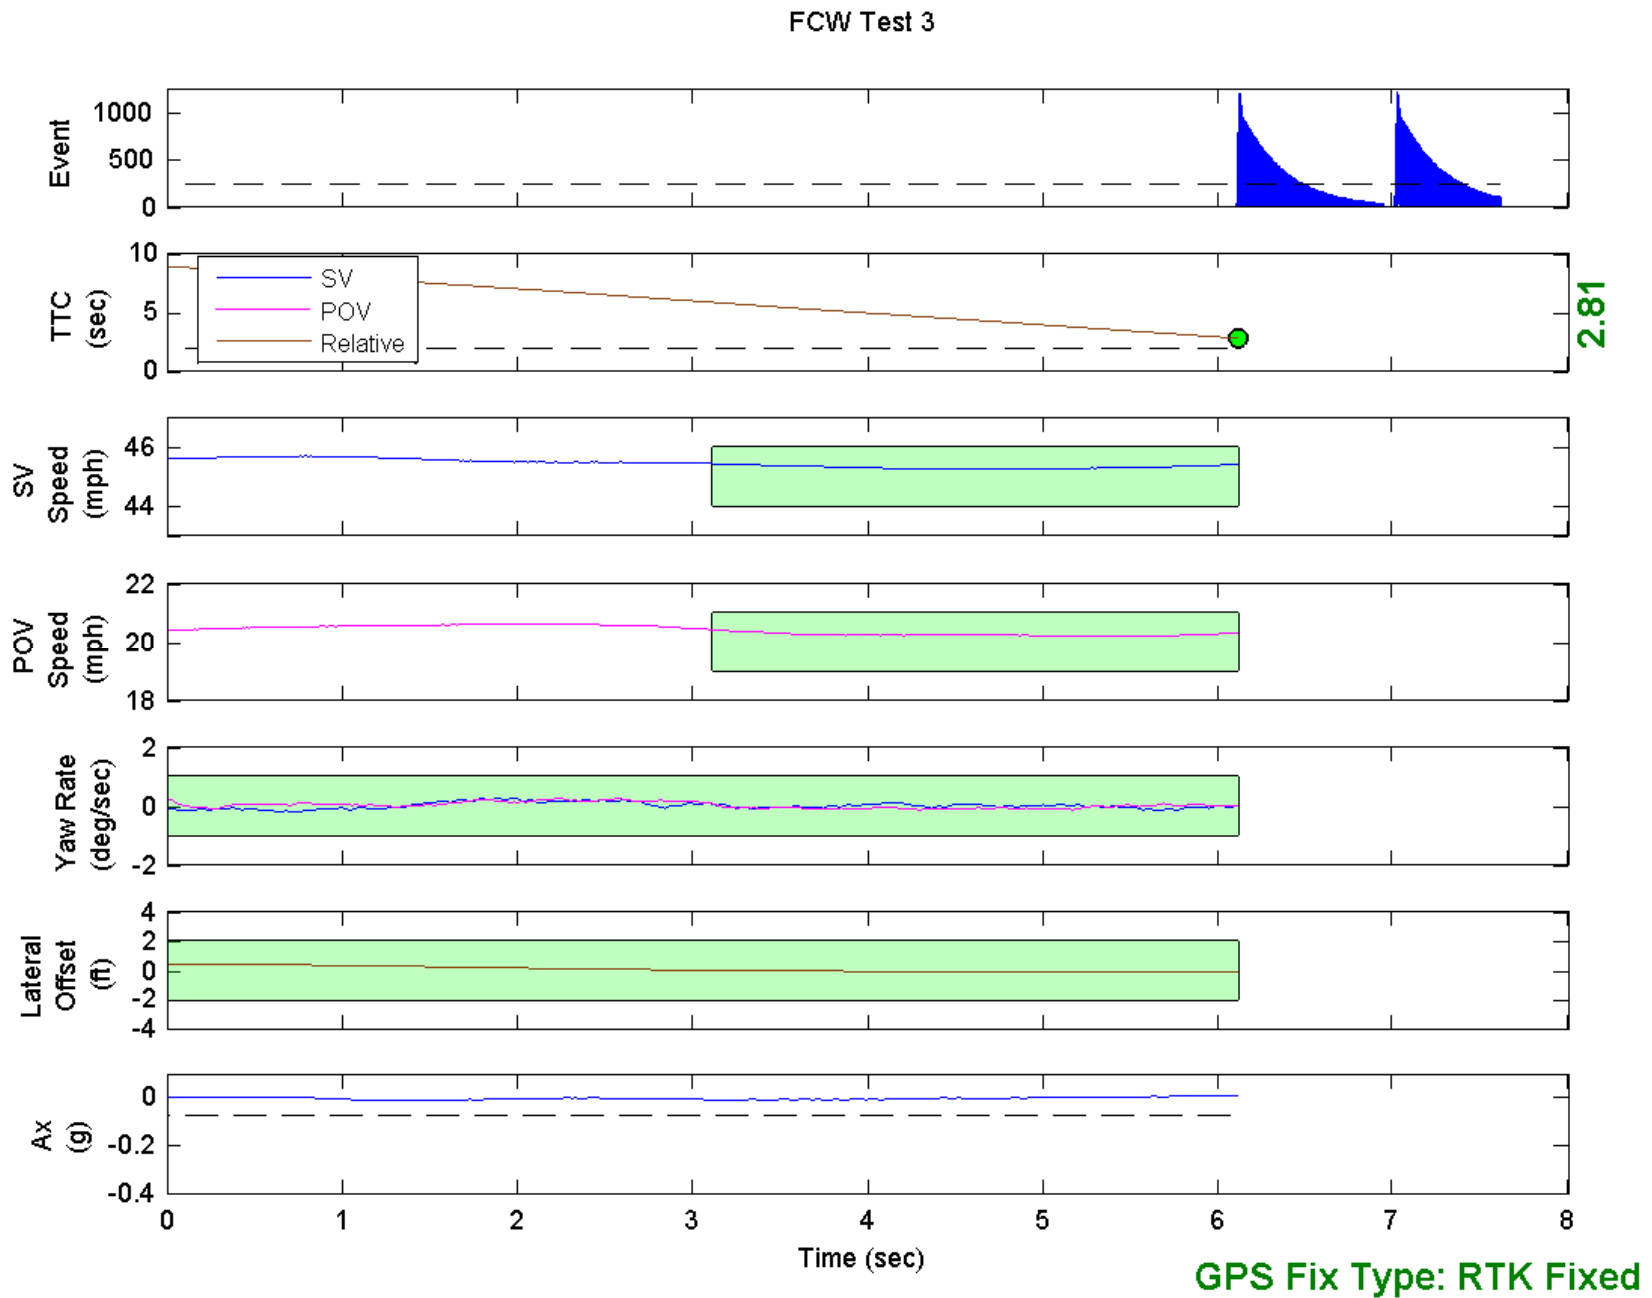
Figure D5. Example Time History for Test Type 3, Passing

Examples of time history plots for each test type (including passing, failing and invalid runs) are shown in Figure D1 through Figure D6. Actual time history data plots for the vehicle under consideration are provided subsequently.

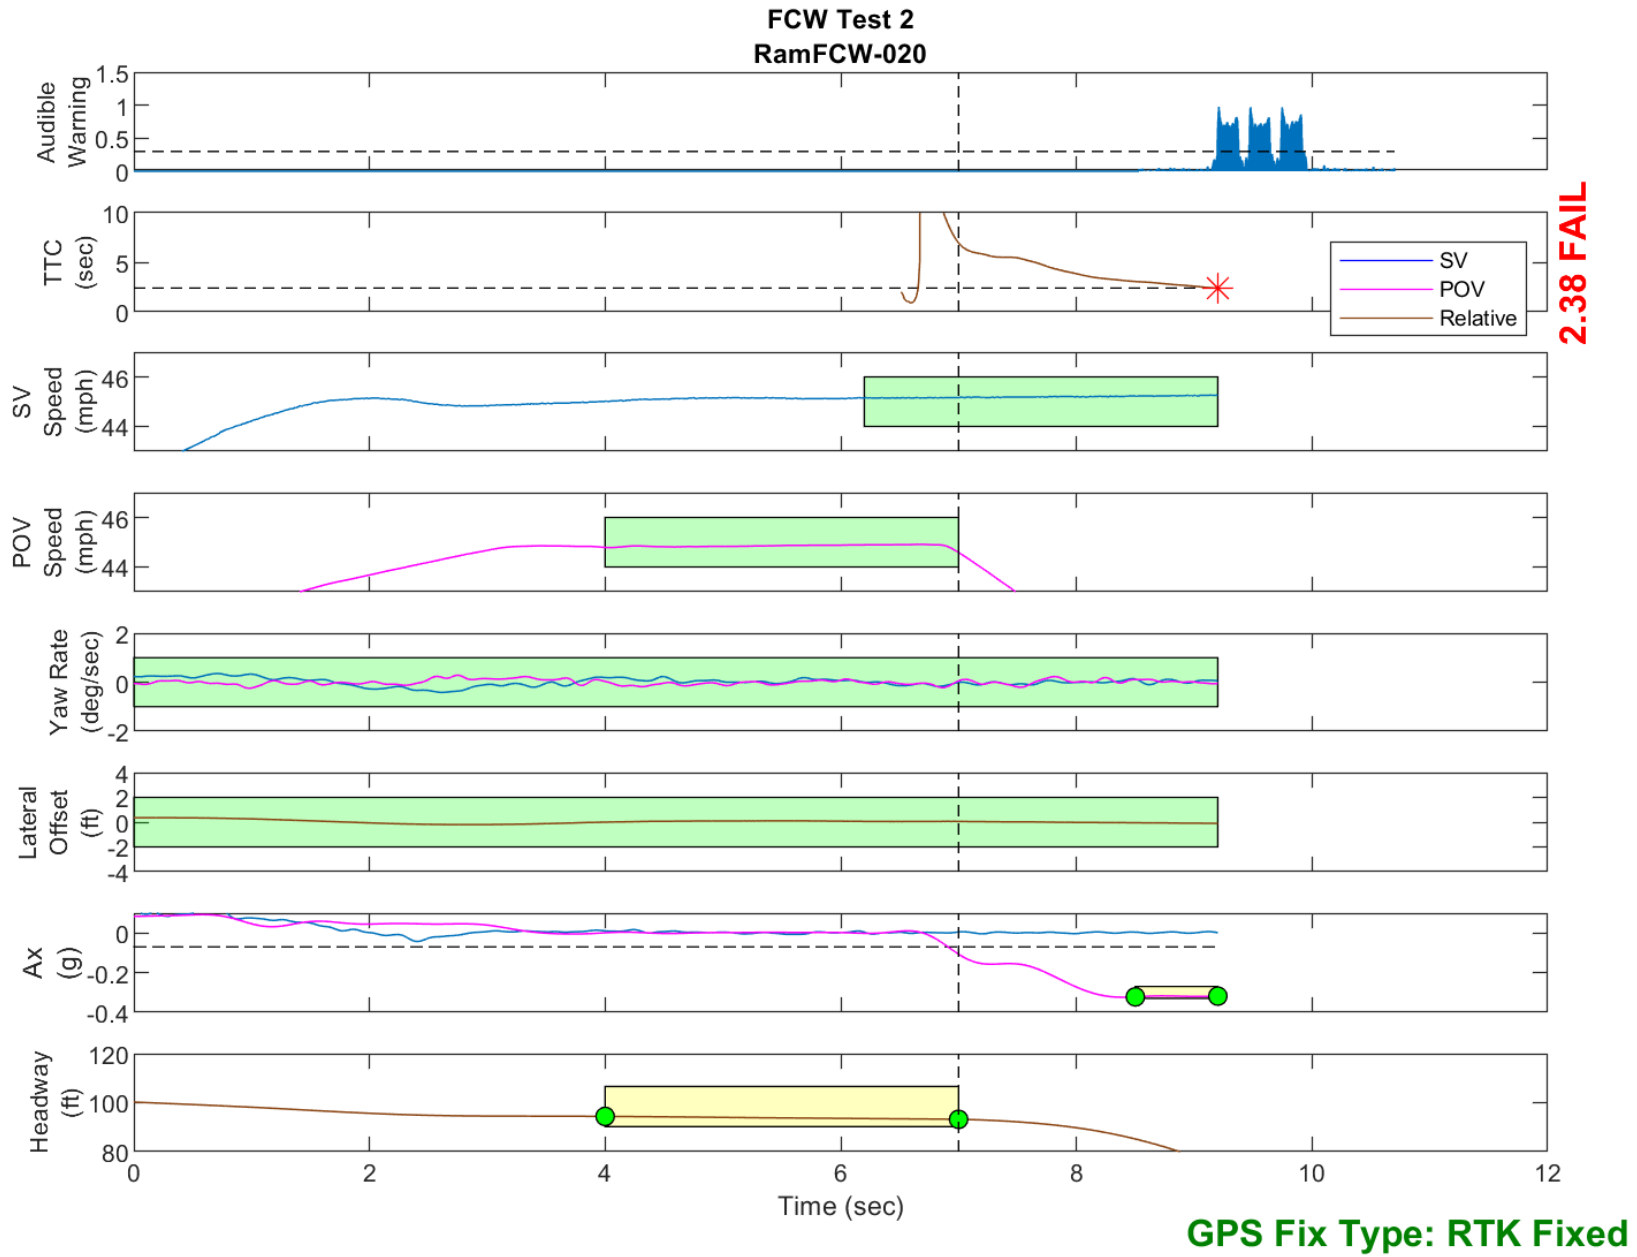
Figure D29. Time History for Run 20, FCW Test 2, Audible Warning

Run	Test Type	Valid Run?	TTCW Sound (sec)	TTCW Light (sec)	TTCW Margin (sec)	Pass/Fail	Notes
1	<b>Stopped POV</b>	Y	2.27	2.18	0.17	Pass	Reprocess for light signal drop
2		Y	2.36	2.34	0.26	Pass	
3		Y	2.33	2.28	0.23	Pass	
4		Y	2.36	2.31	0.26	Pass	
5		Y	2.42	2.38	0.32	Pass	Changed IP screen, light alert changed
6		Y	2.26	2.19	0.16	Pass	
7		Y	2.44	2.42	0.34	Pass	
15	<b>Decelerating POV, 45</b>	Y	2.55	2.50	0.15	Pass	
16		N					Yaw
17		Y	2.42	2.36	0.02	Pass	
18		Y	2.47	2.40	0.07	Pass	
19		Y	2.47	2.44	0.07	Pass	
20		Y	2.38	2.33	-0.02	Fail	
21		Y	2.39	2.32	-0.01	Fail	
22		Y	2.55	2.54	0.15	Pass

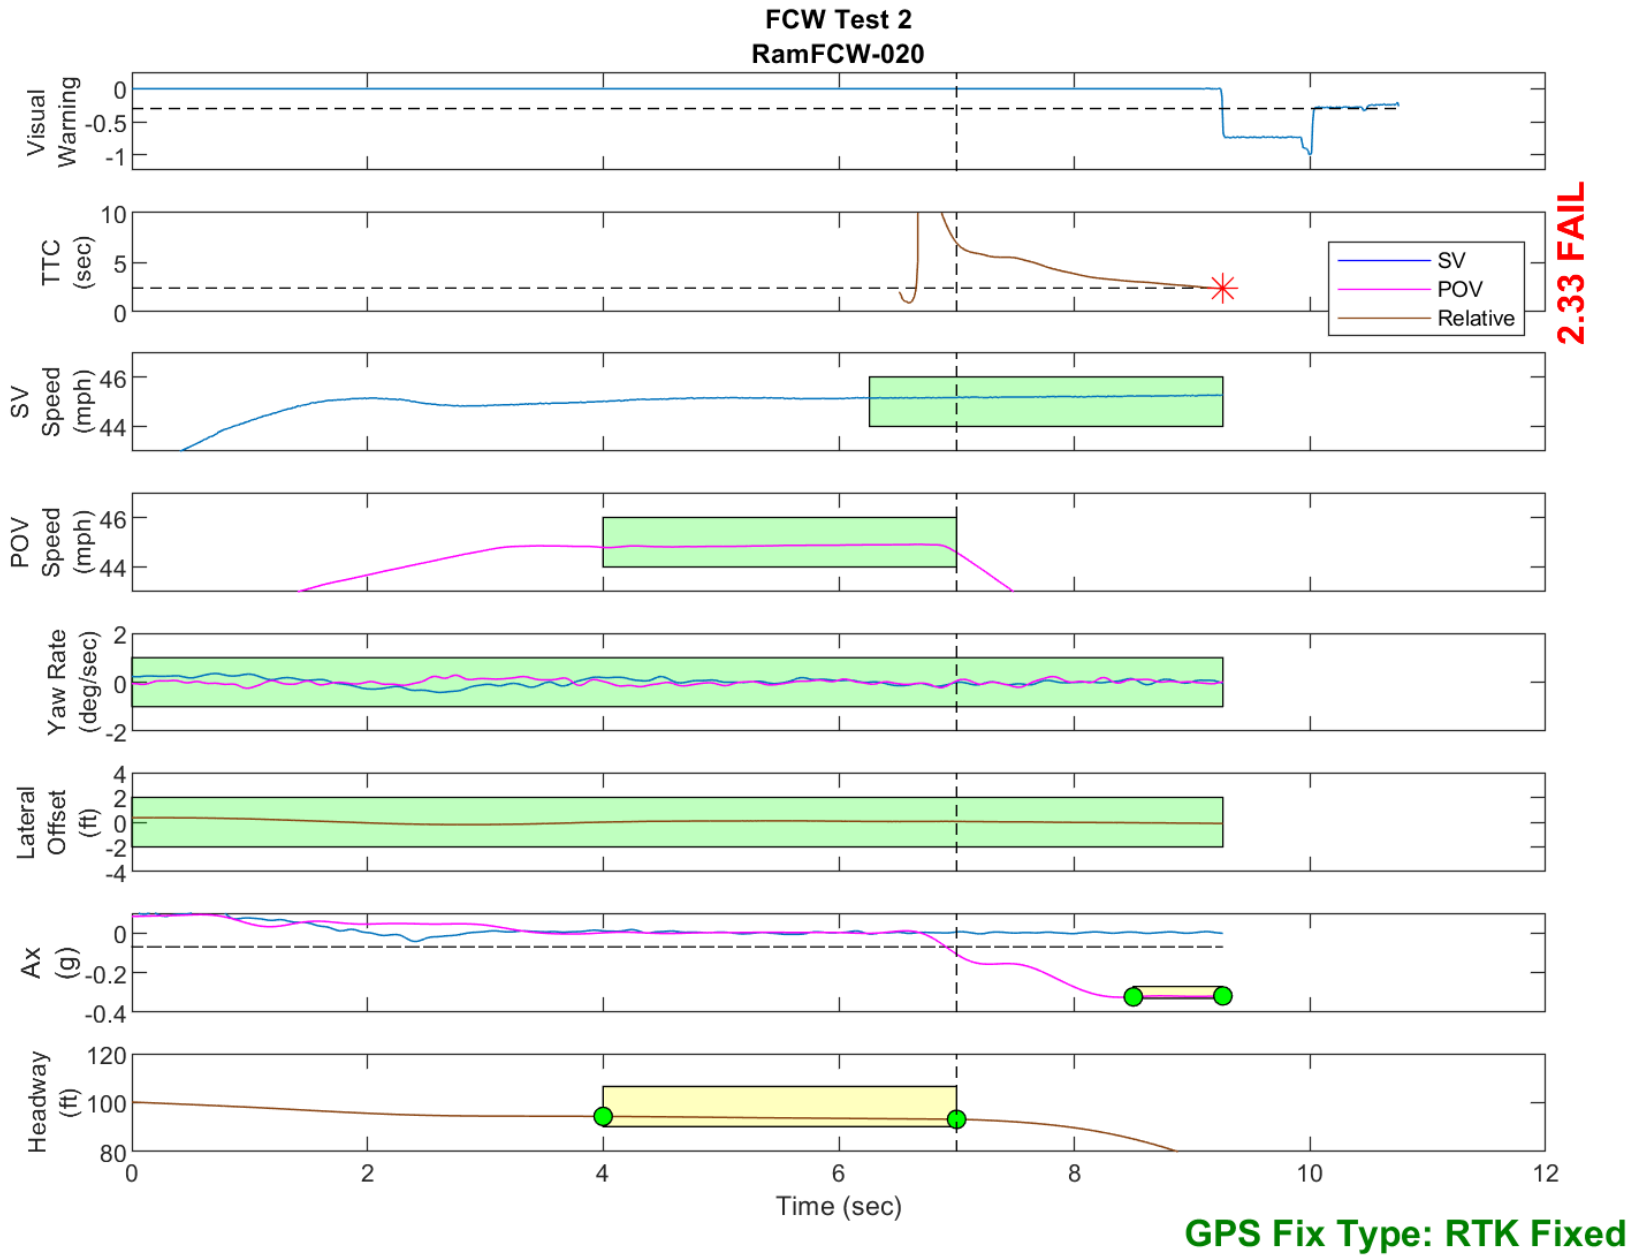
Figure D30. Time History for Run 20, FCW Test 2, Visual Warning

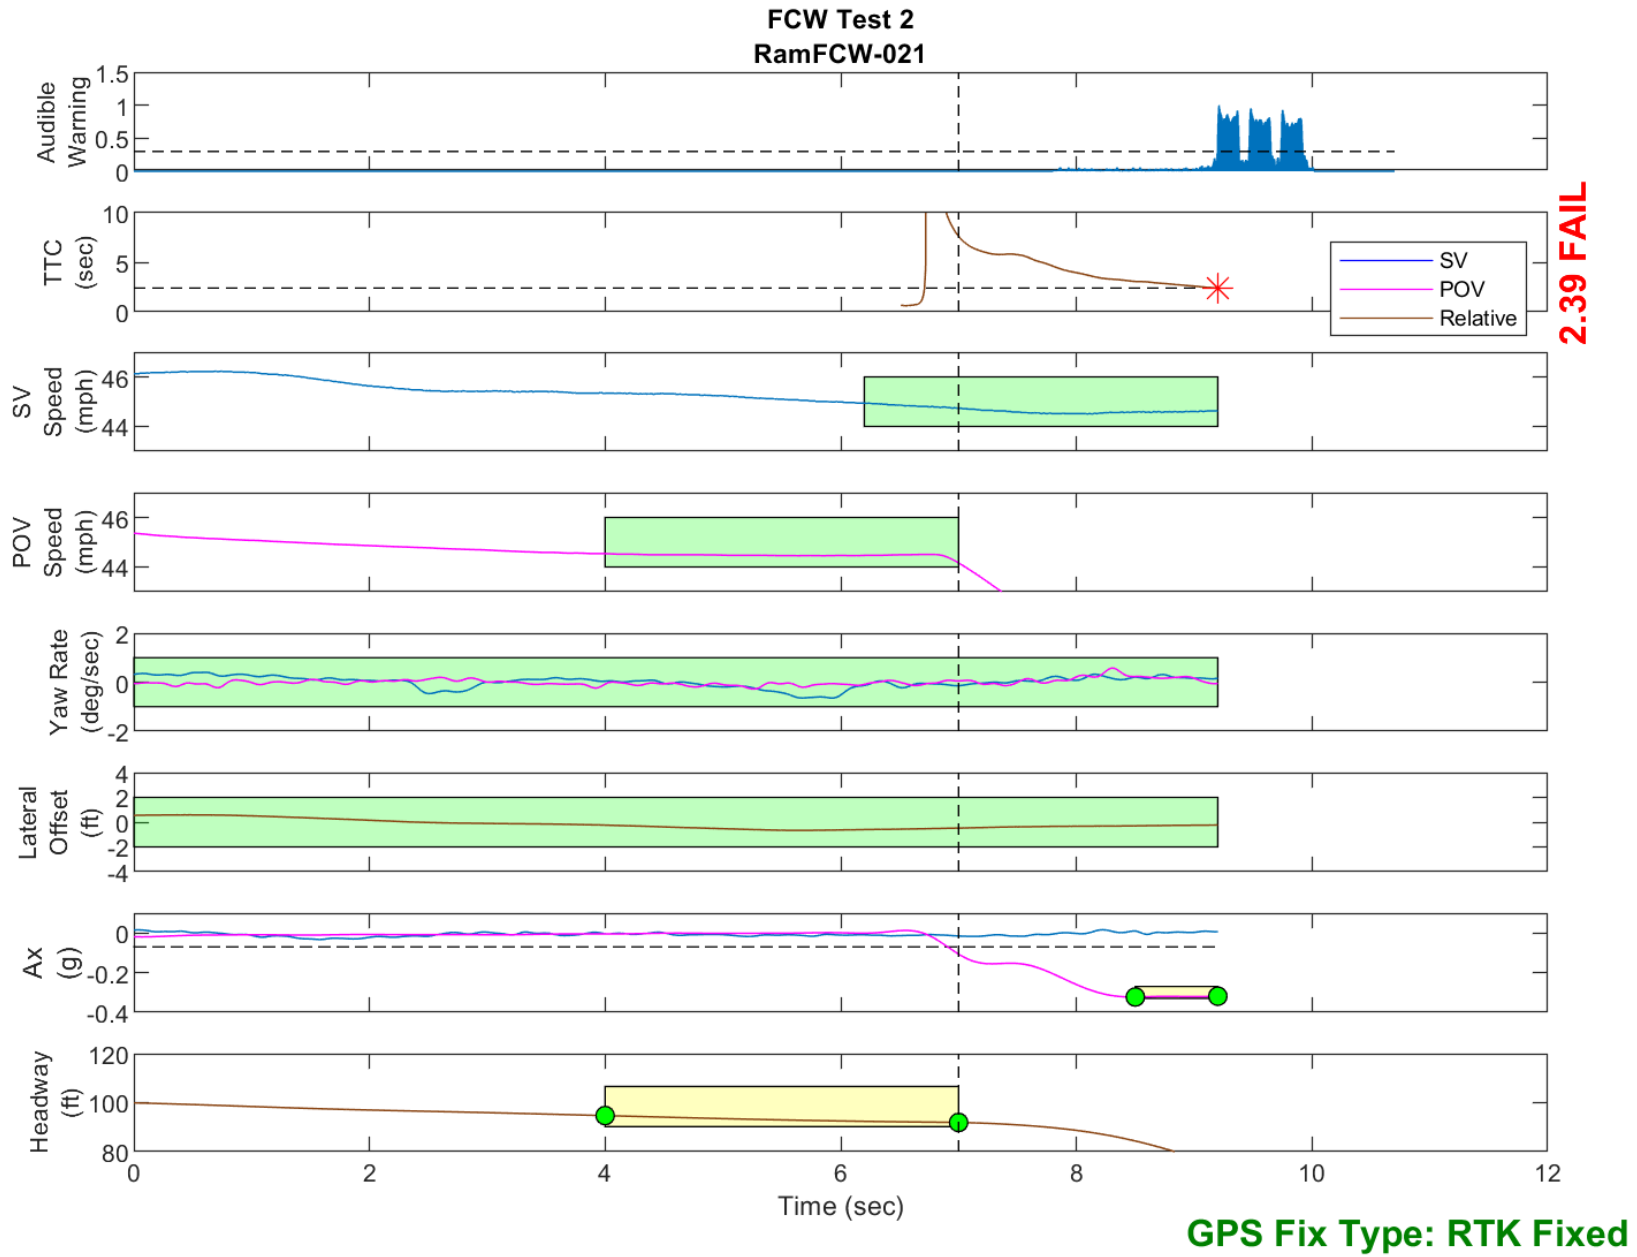
Figure D31. Time History for Run 21, FCW Test 2, Audible Warning

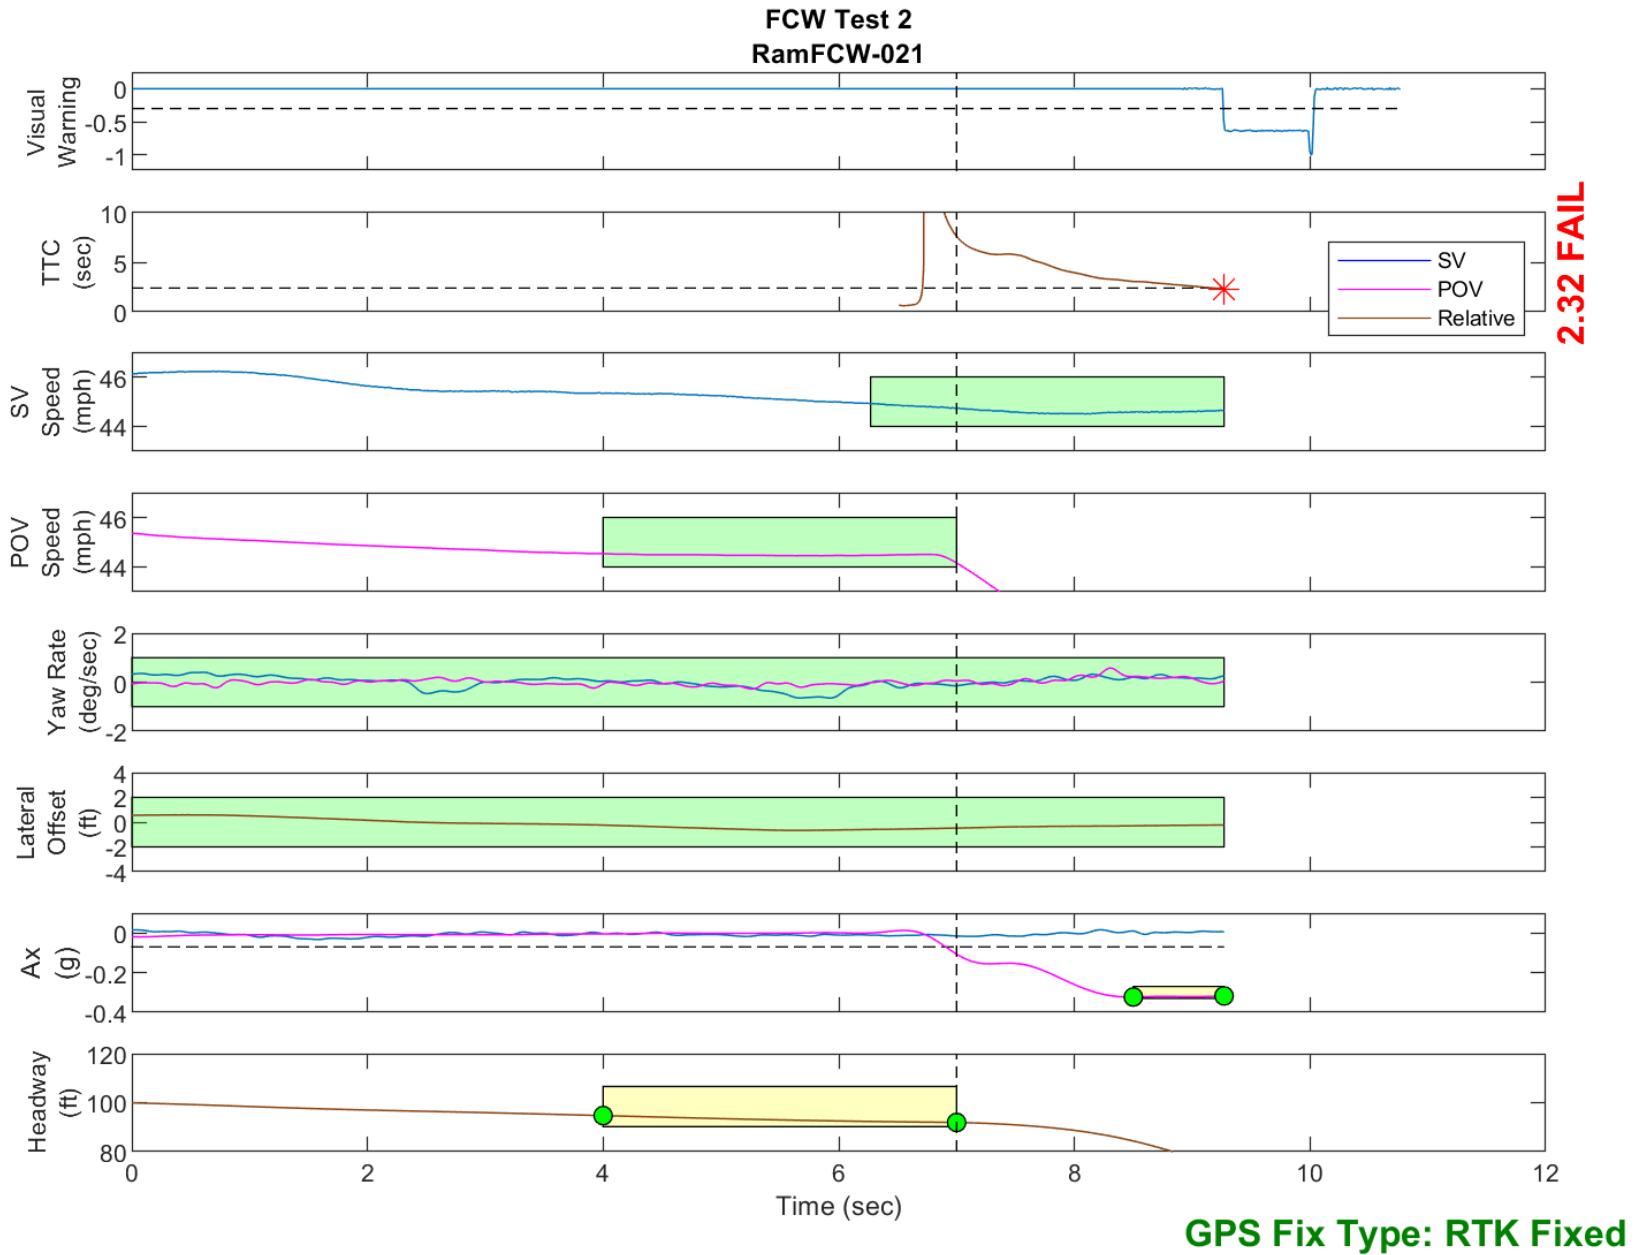
Figure D32. Time History for Run 21, FCW Test 2, Visual Warning
