**NEW CAR ASSESSMENT PROGRAM
CRASH IMMINENT BRAKING SYSTEM CONFIRMATION TEST
NCAP-DRI-CIB-20-12**

2020 Nissan Altima

Final Report

1. Report No. NCAP-DRI-CIB-20-12	2. Government Accession No.	3. Recipient's Catalog No.	
4. Title and Subtitle Final Report of Crash Imminent Braking System Confirmation Test of a 2020 Nissan Altima.		5. Report Date 12 May 2020

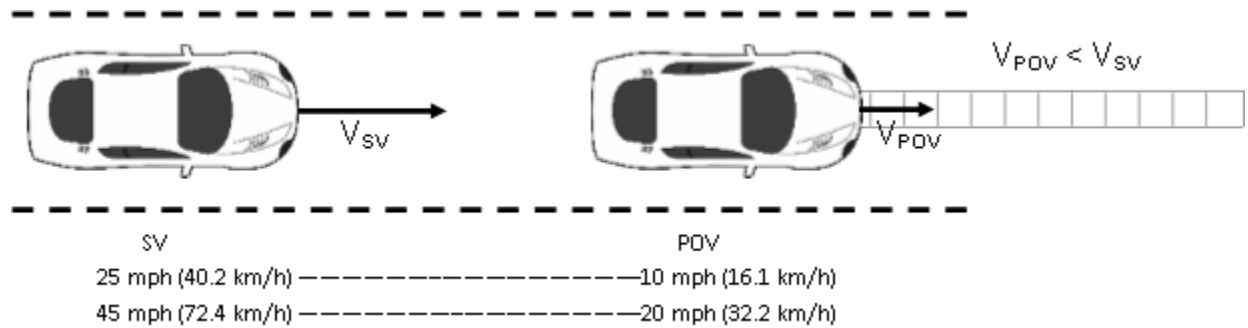
- This test evaluates the ability of the CIB system to detect and respond to a slower-moving lead vehicle traveling at a constant speed in the immediate forward path of the SV, as depicted in Figure 2.

Figure 2. Depiction of Test 2

The SV ignition was cycled prior to each test run. For this test scenario, both the POV and SV were driven at a constant 35.0 mph (56.3 km/h) in the center of the lane, with a headway of 45.3 ft (13.8 m) \pm 8 ft (2.4 m). Once these conditions were met, the POV tow vehicle brakes were applied to achieve 0.3 \pm 0.03 g of deceleration. The test concluded when either:

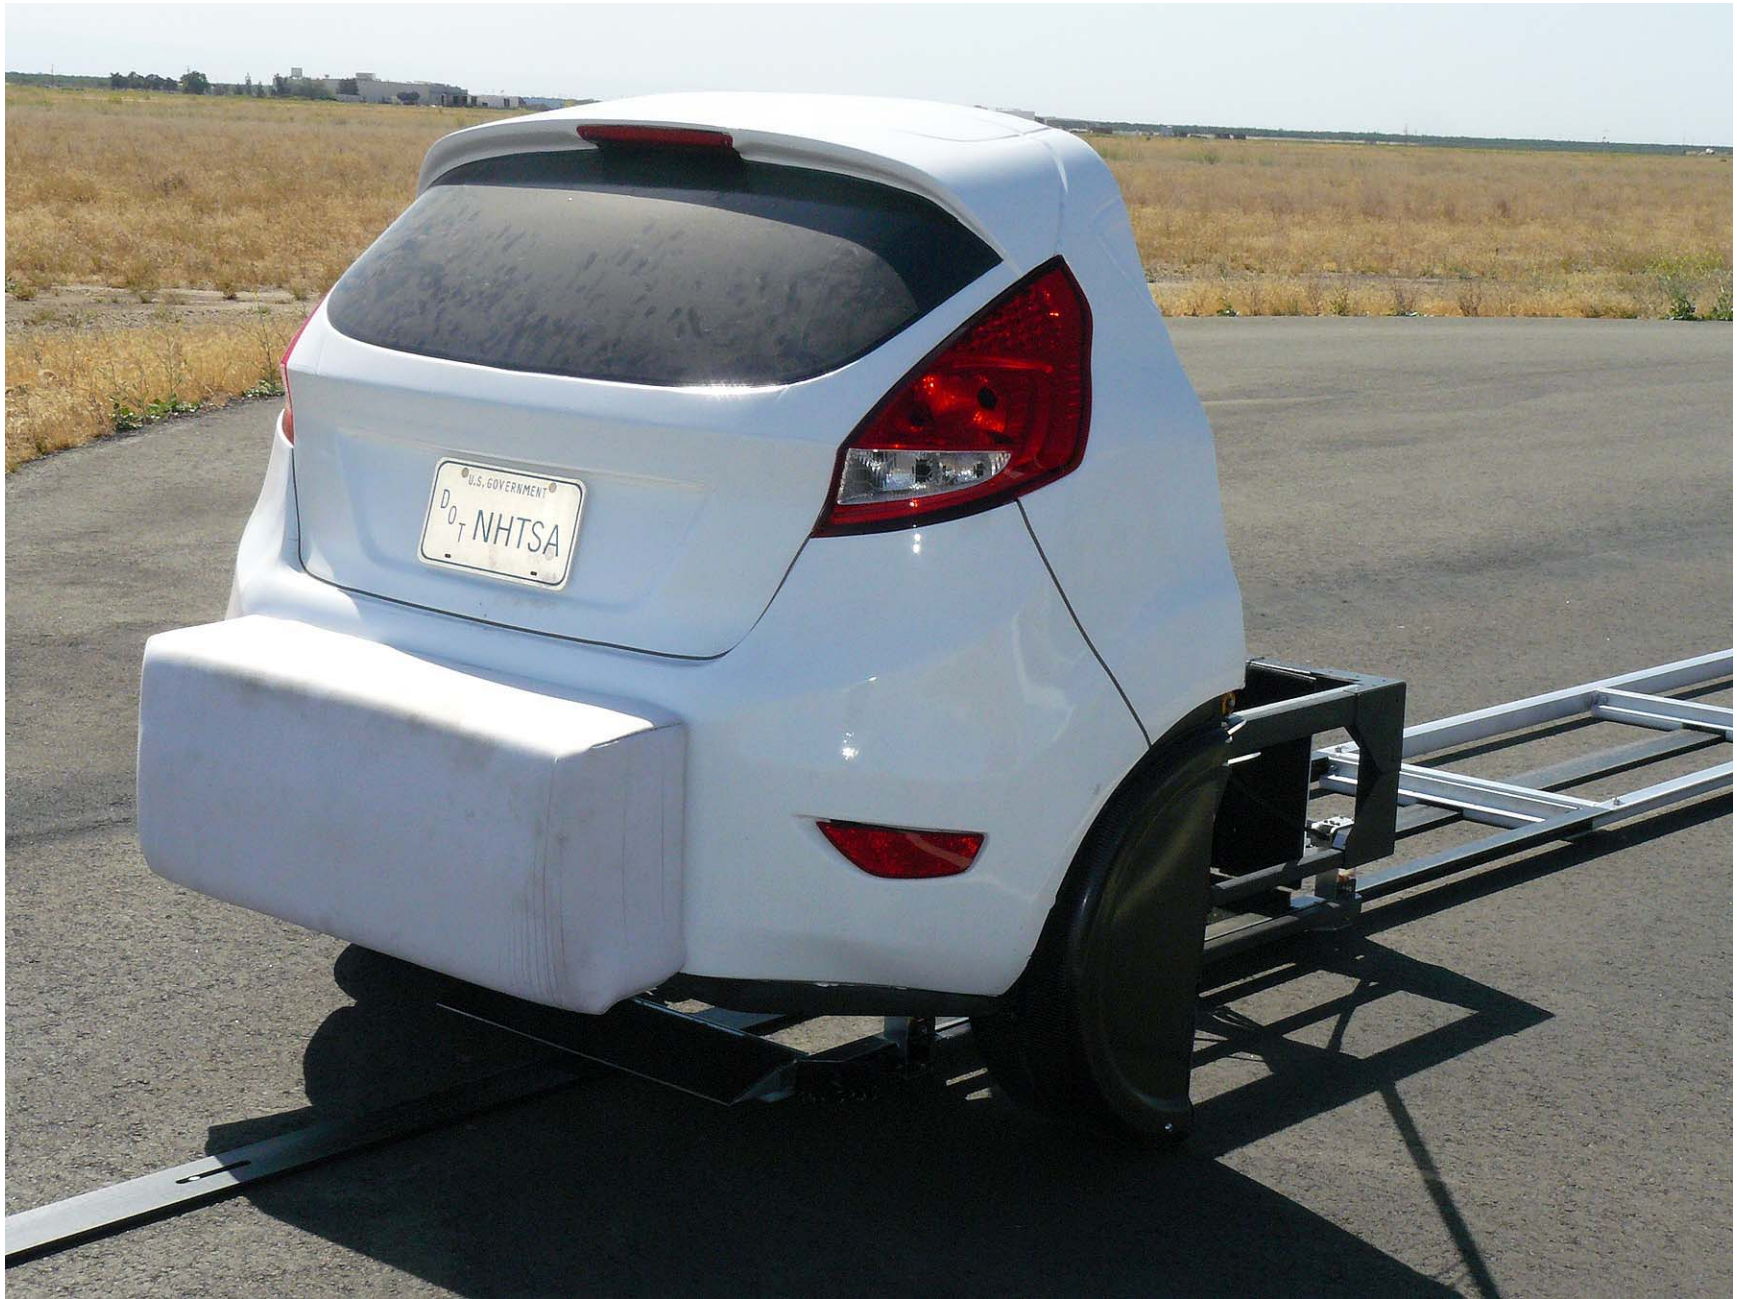
Figure A6. Rear View of Principal Other Vehicle (SSV)

CIB testing requires a POV that realistically represents typical vehicles, does not suffer damage or cause damage to a test vehicle in the event of collision, and can be accurately positioned and moved during the tests. The tests reported herein made use of the NHTSA developed Strikeable Surrogate Vehicle (SSV).

- Provide an accurate representation of a real vehicle to DBS sensors, including cameras and radar.
- Be resistant to damage and inflict little or no damage to the SV as a result of repeated SV-to-POV impacts.

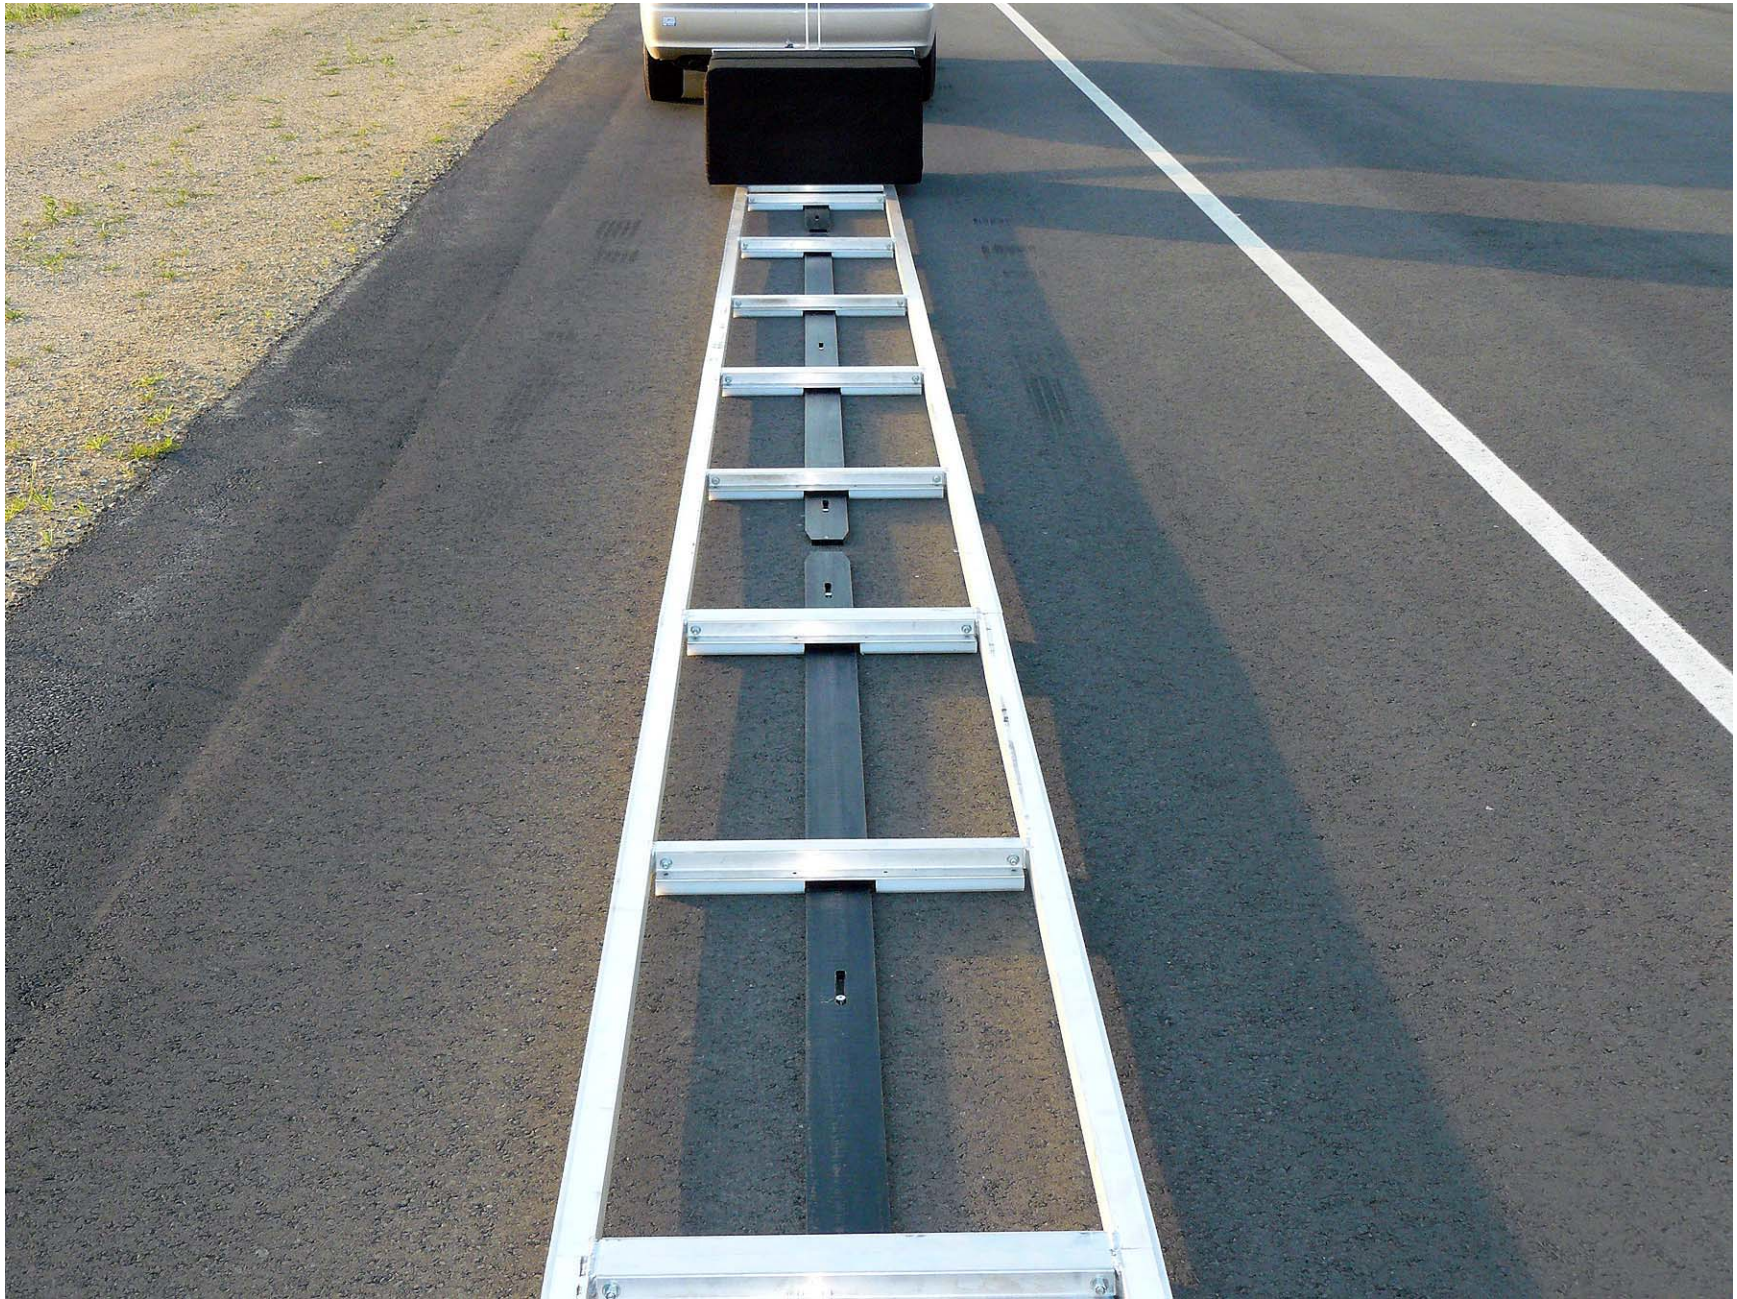
Figure A8. Two-Rail Track and Road-Based Lateral Restraint Track

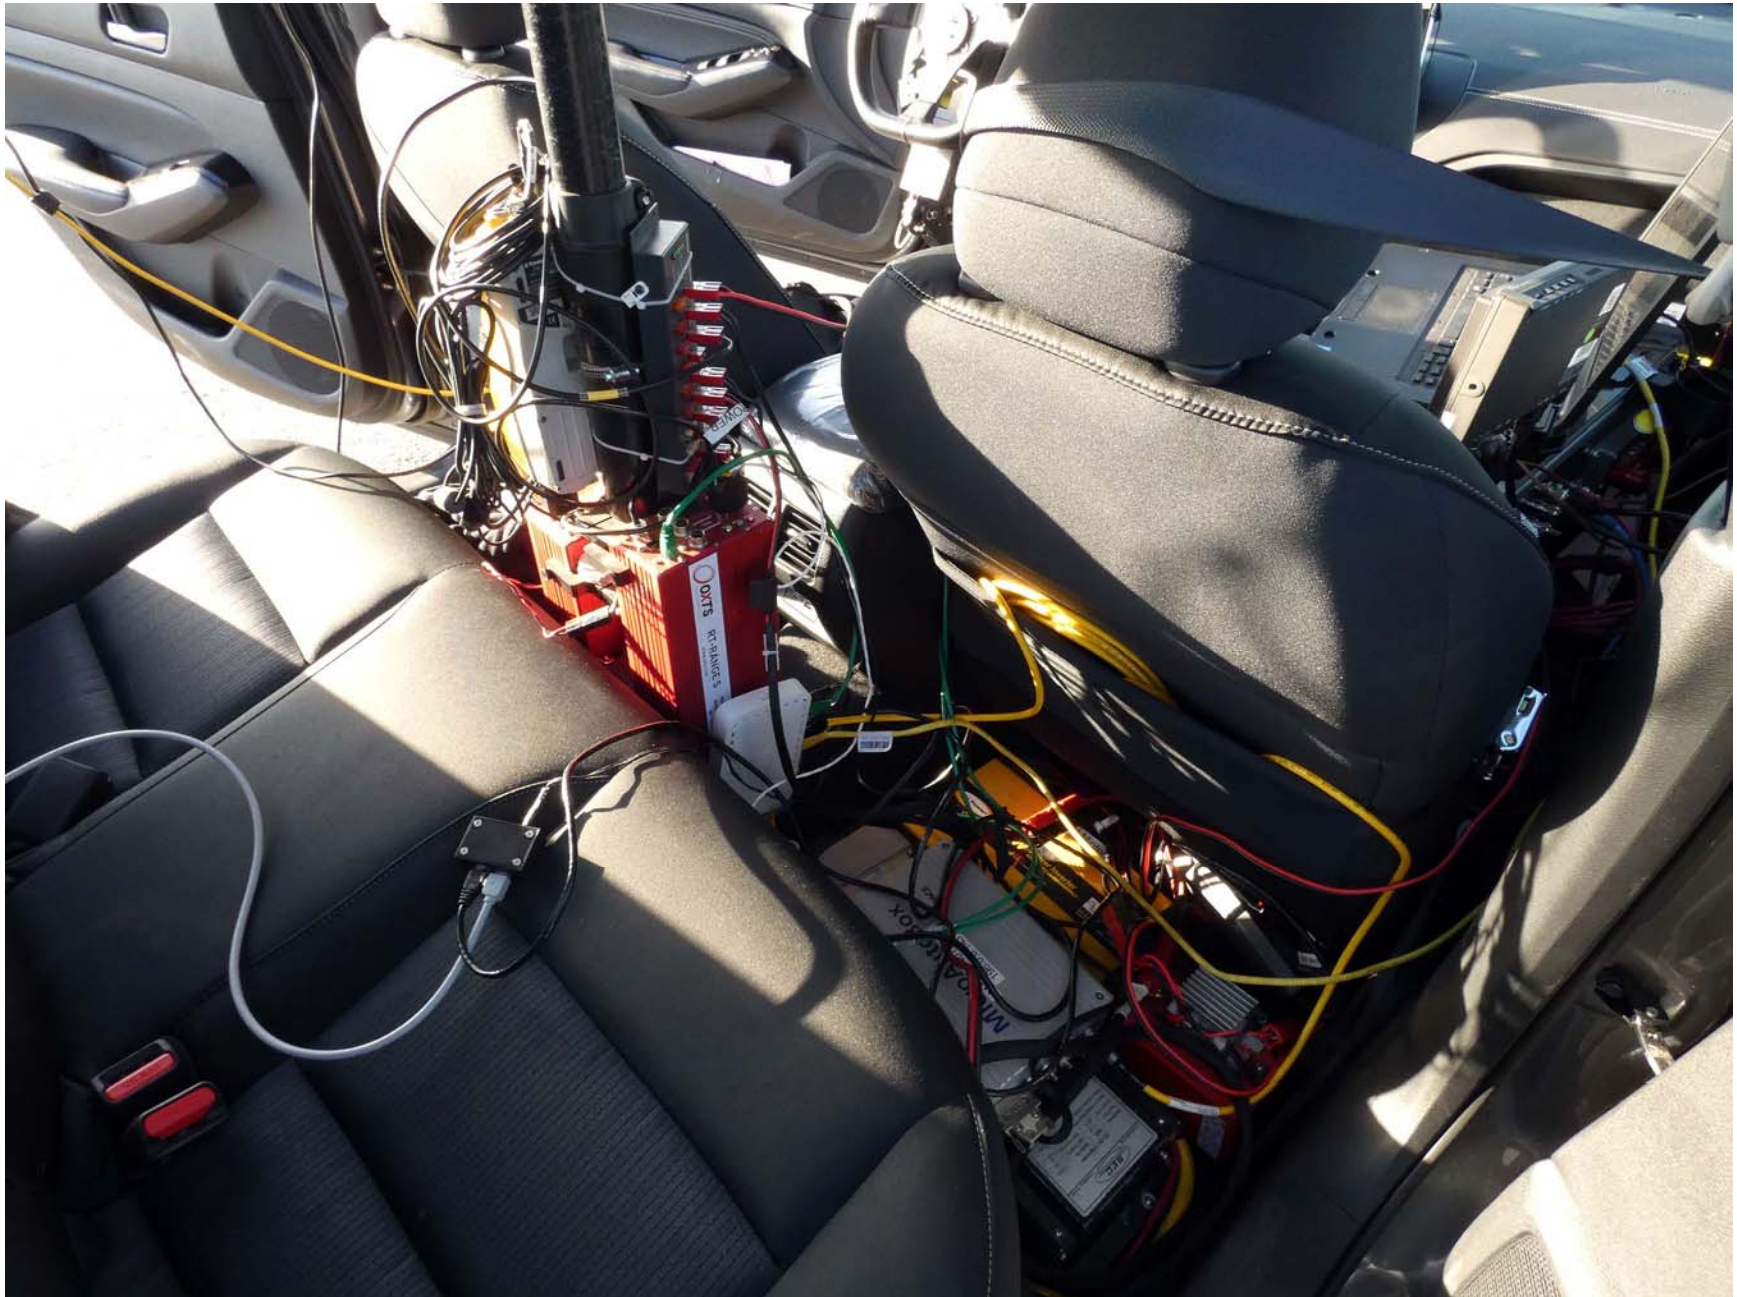
Figure A10. DGPS, Inertial Measurement Unit, and MicroAutoBox Installed in Subject Vehicle

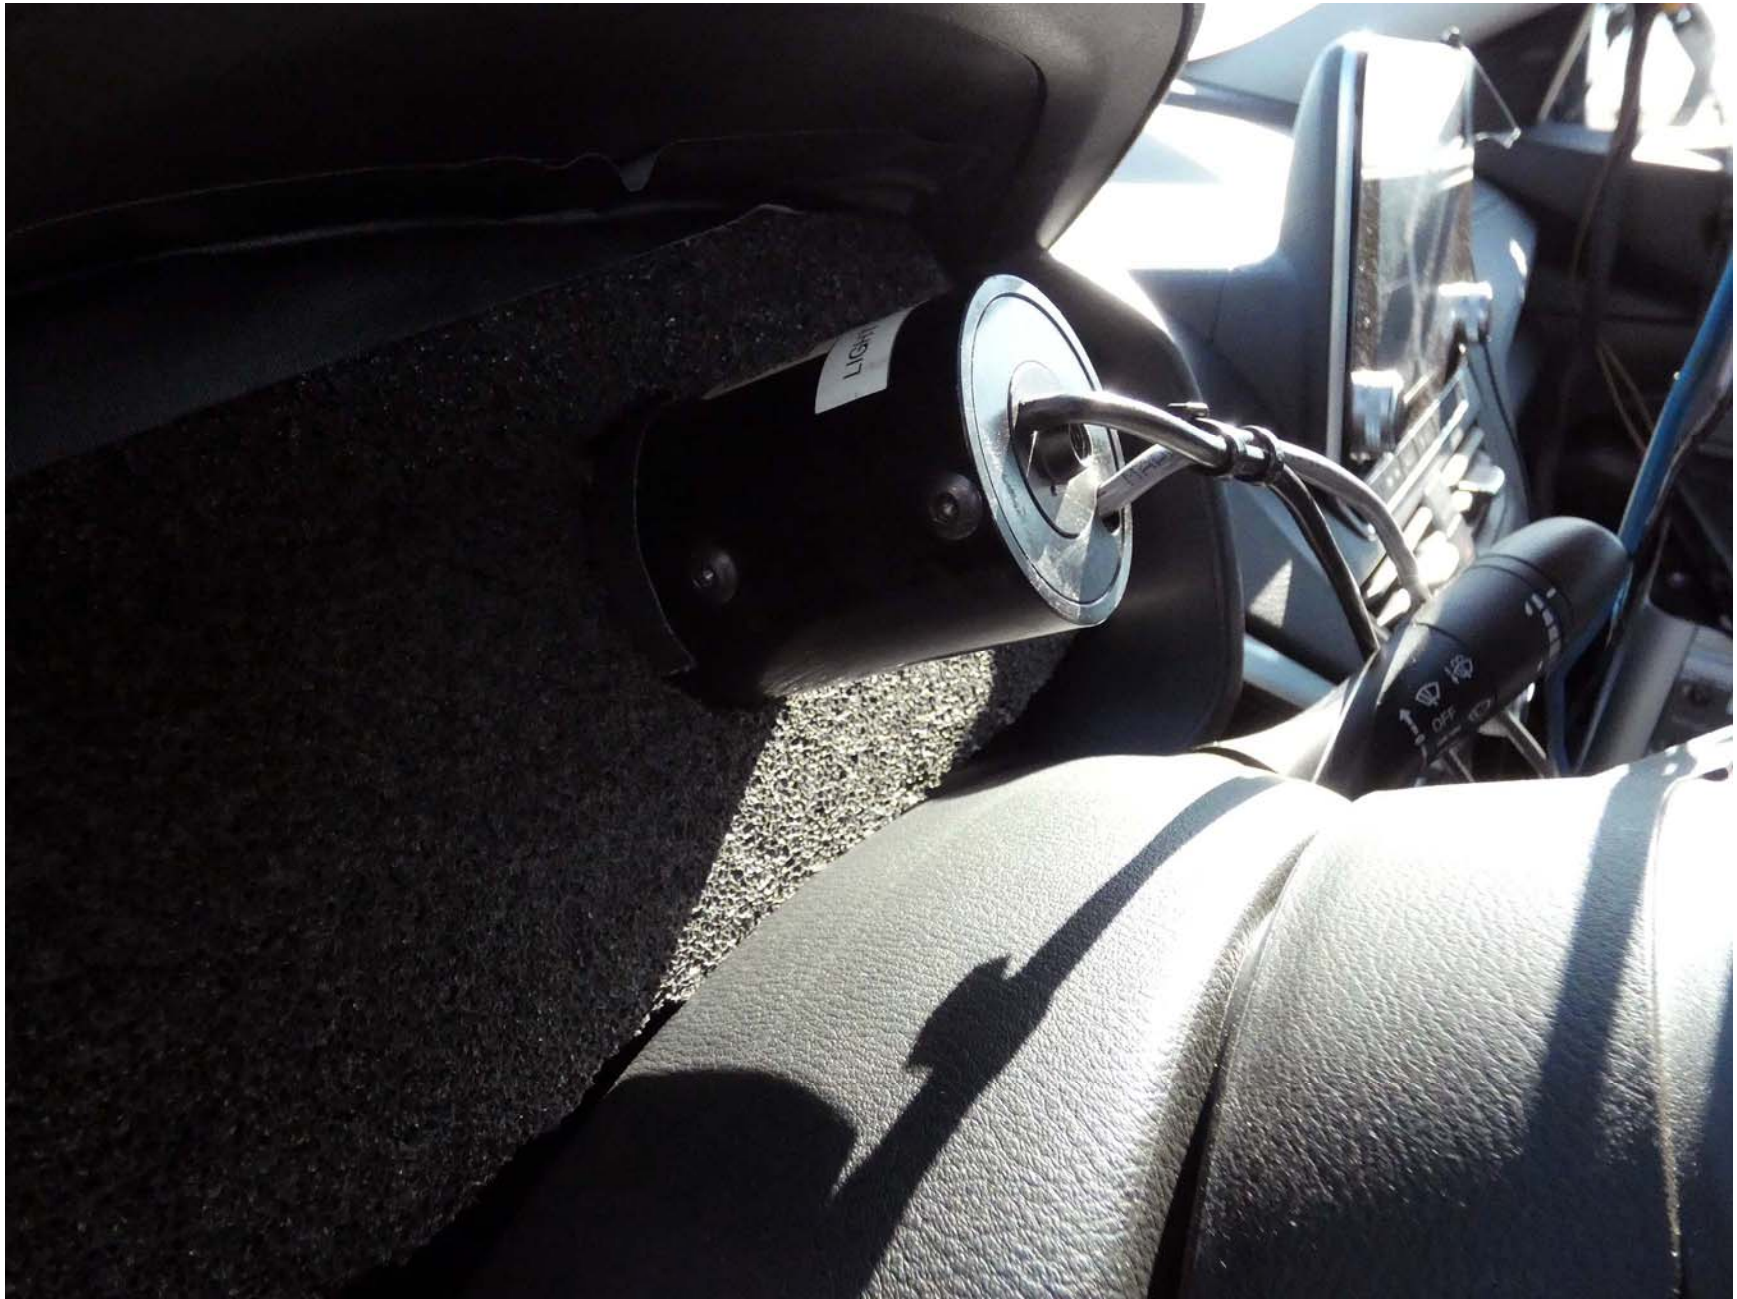
Figure A11. Sensor for Detecting Visual Alerts

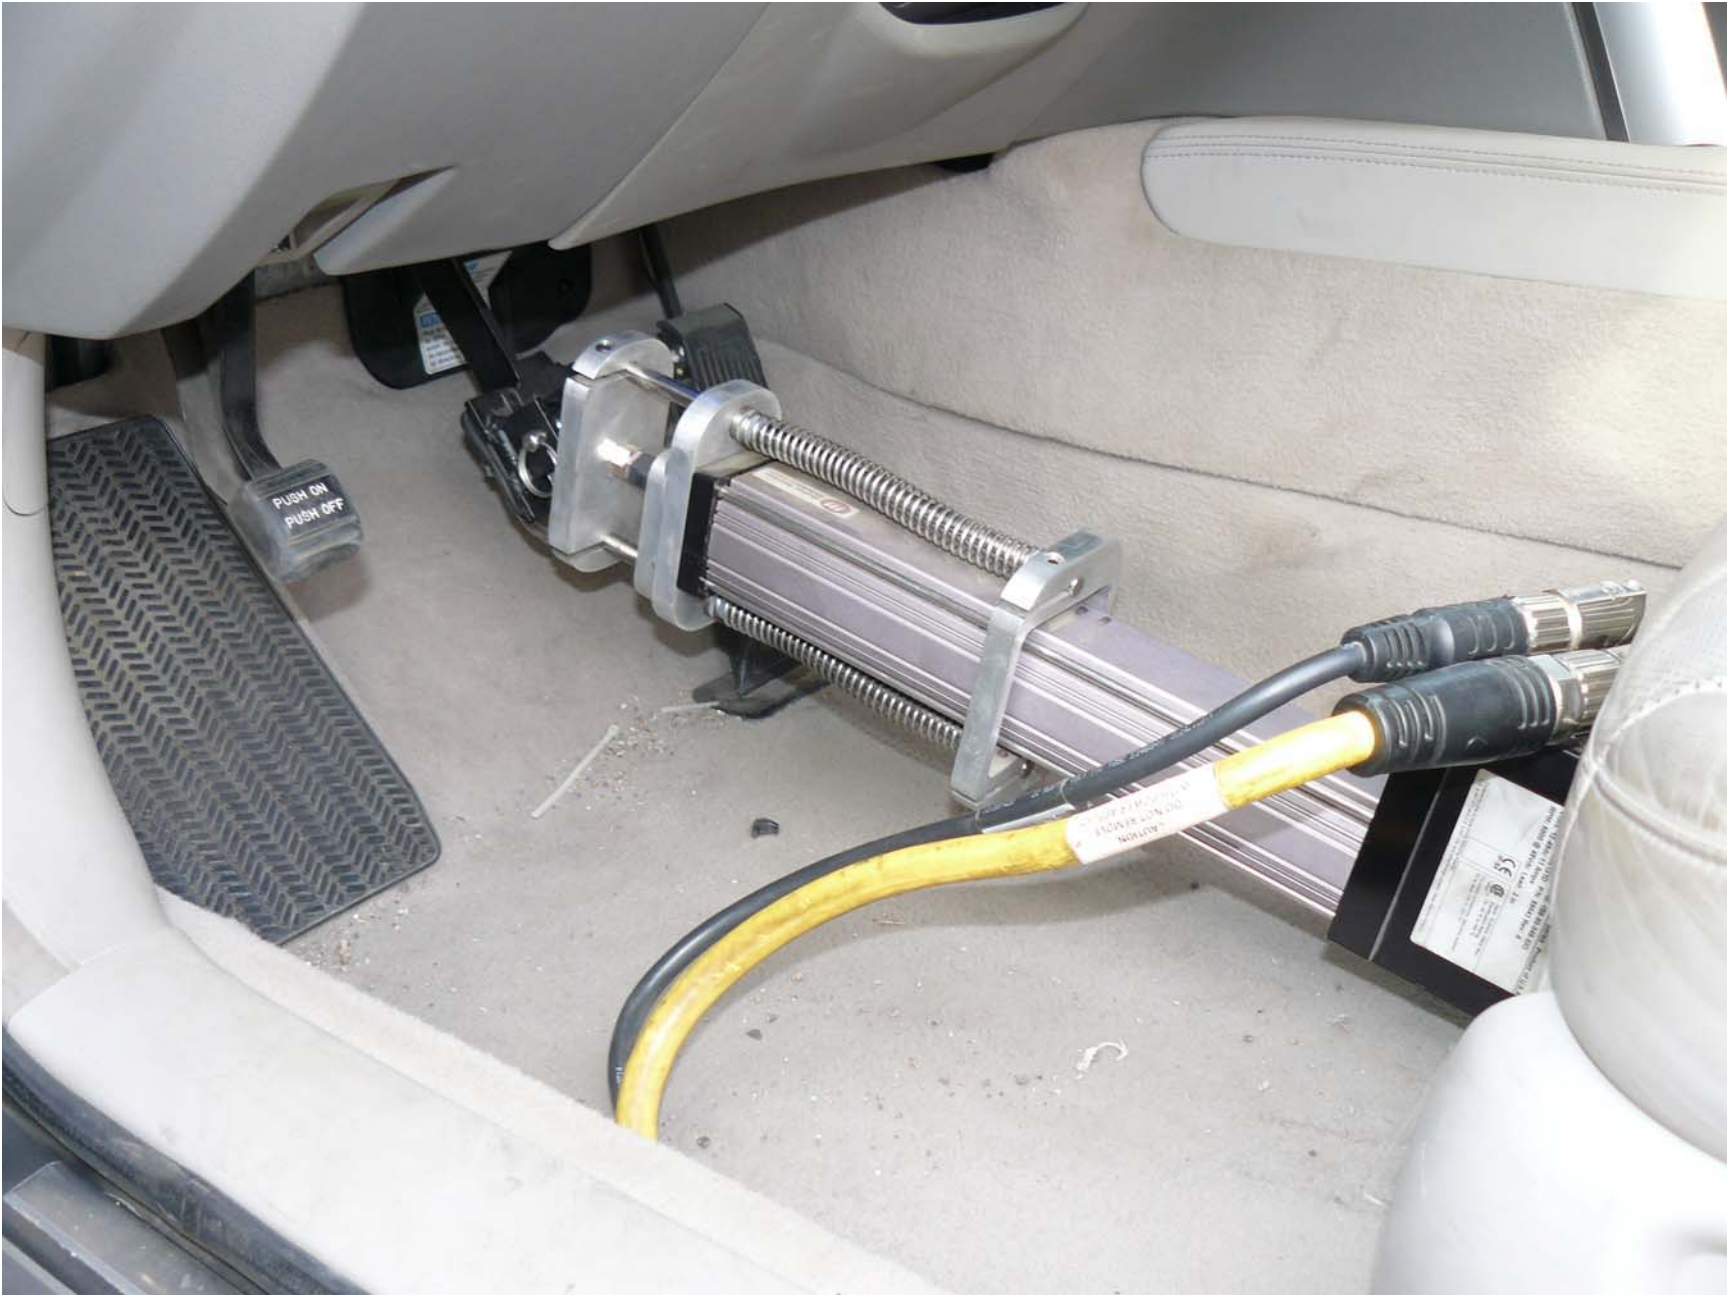
Figure A14. Brake Actuator Installed in POV System

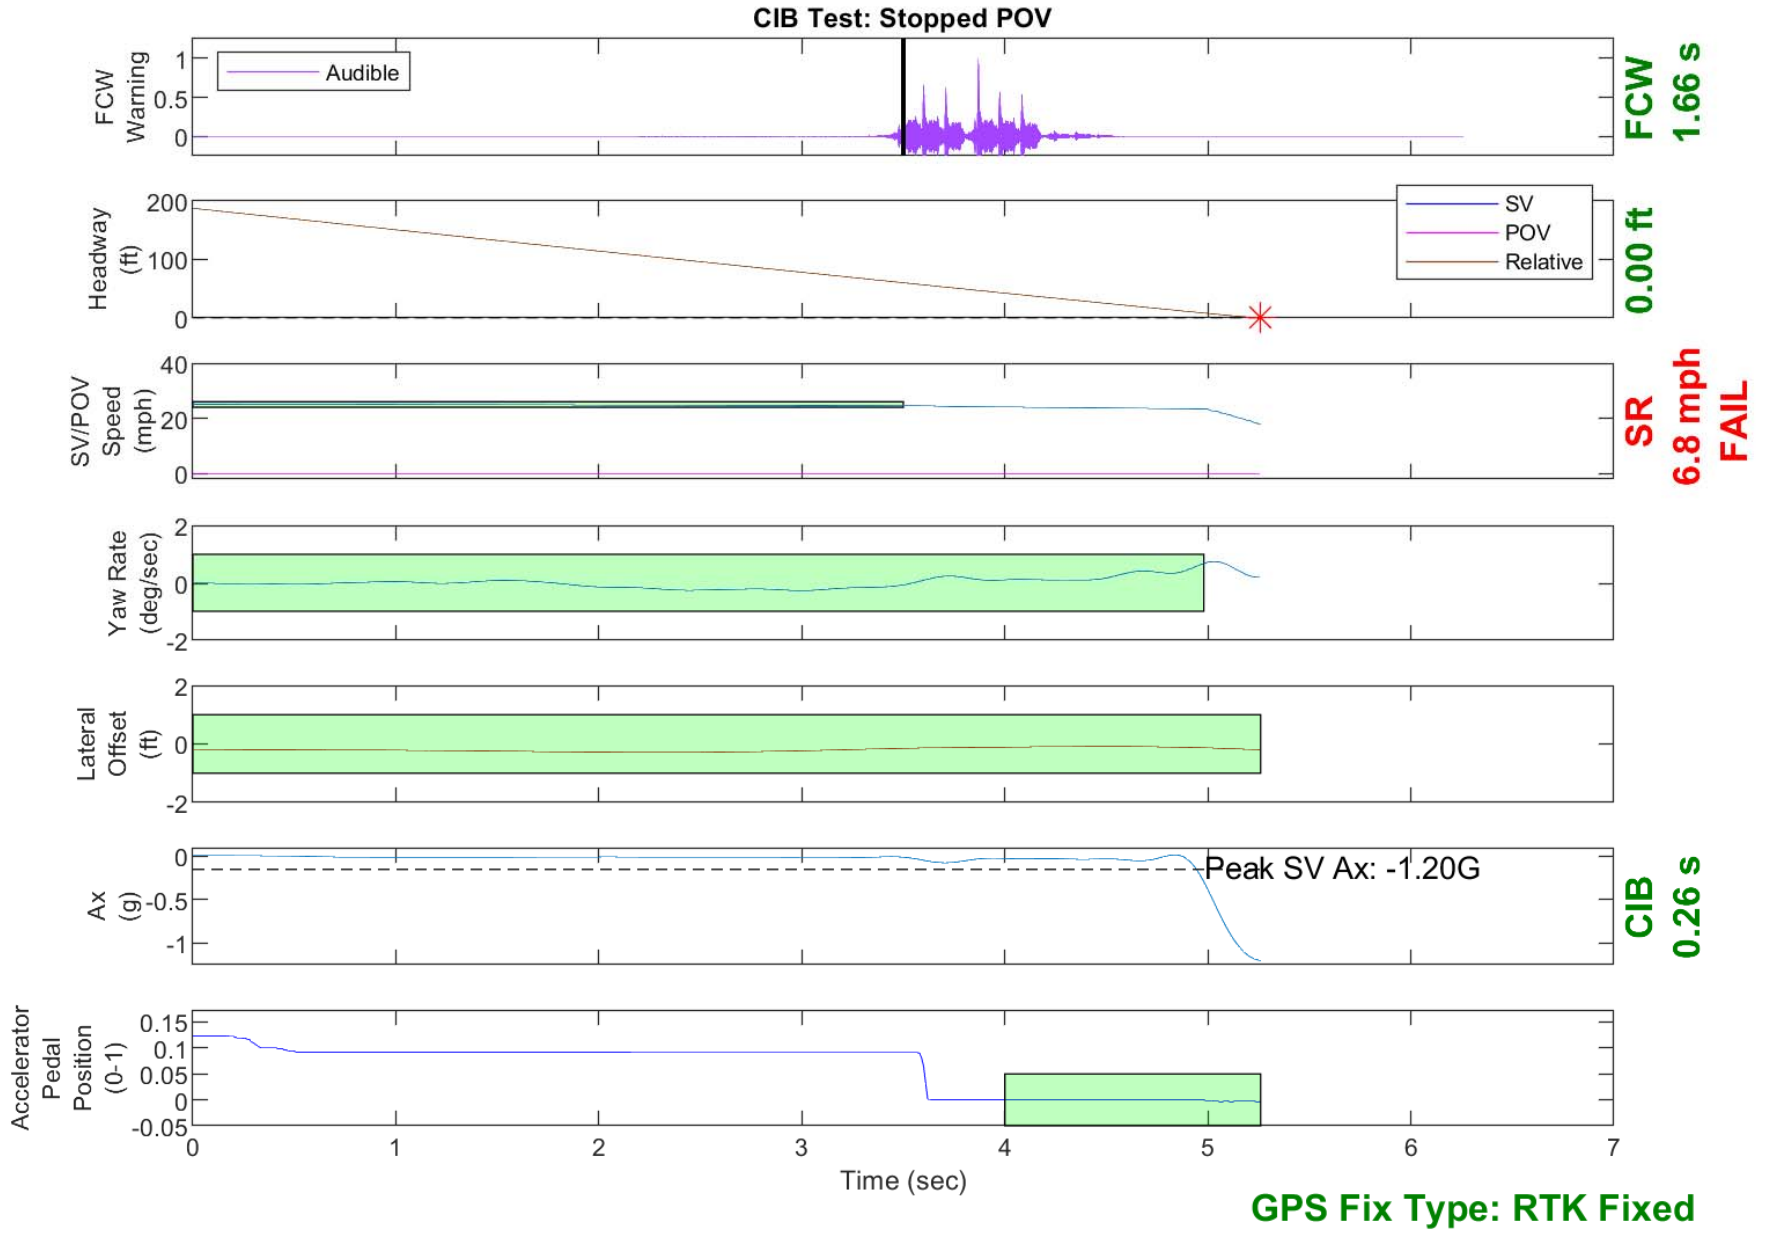
Figure D9. Example Time History for a Failed Run

Examples of time history plots for each test type (including passing, failing and invalid runs) are shown in Figure 1 through Figure 9. Figures 1 through 6 show passing runs for each of the 6 test types. Figures 7 and 8 show examples of invalid runs. Figure 9 shows an example of a valid test that failed the CIB requirements.
