NEW CAR ASSESSMENT PROGRAM FORWARD COLLISION WARNING CONFIRMATION TEST OCAS-DRI-FCW-20-06

2020 Honda Civic 2.0L 4D Sport

DYNAMIC RESEARCH, INC. 355 Van Ness Avenue, STE 200 Torrance, California 90501

Final Report

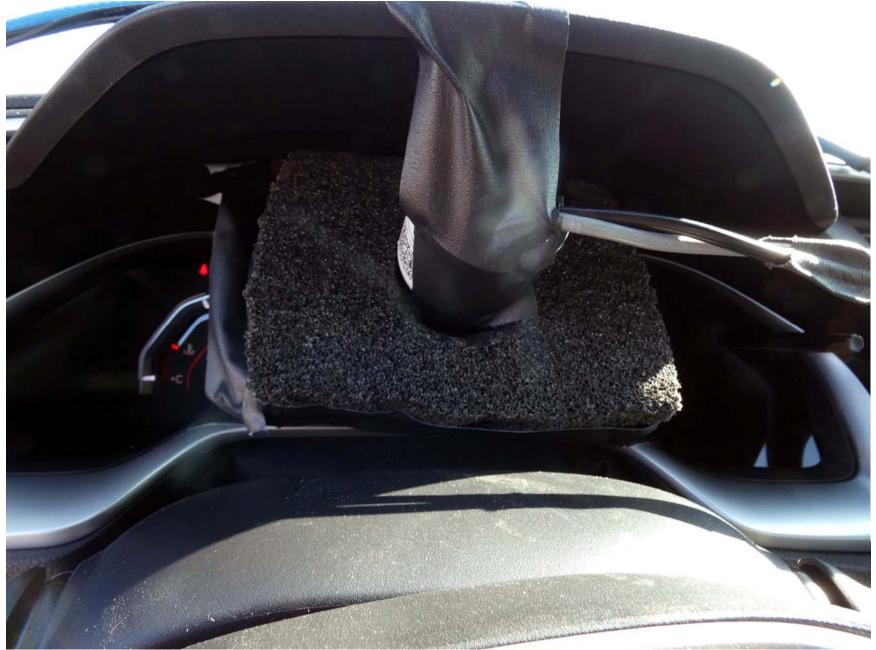
Figure A9. Sensor for Detecting Visual Alerts

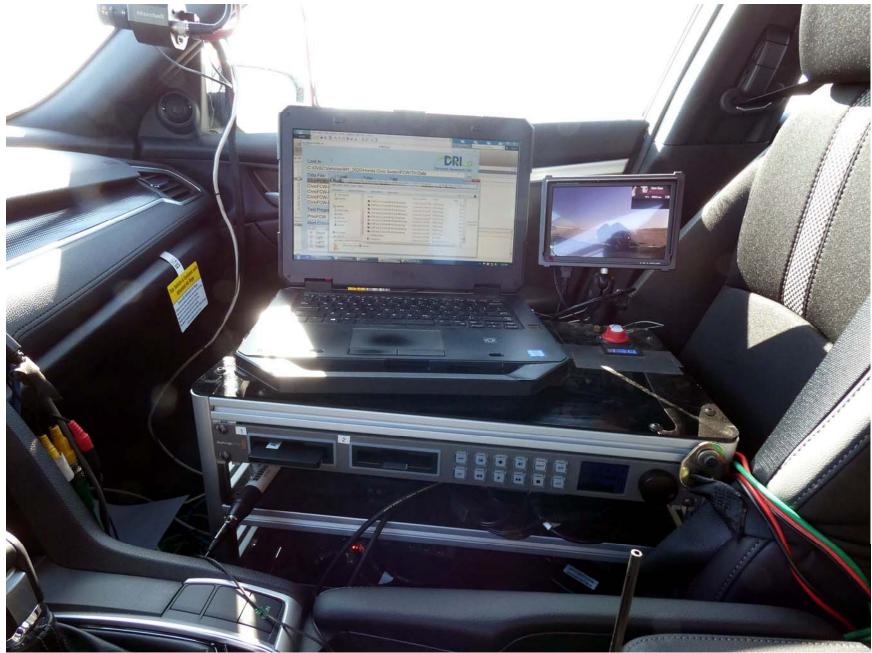
Figure A11. Computer Installed in Subject Vehicle

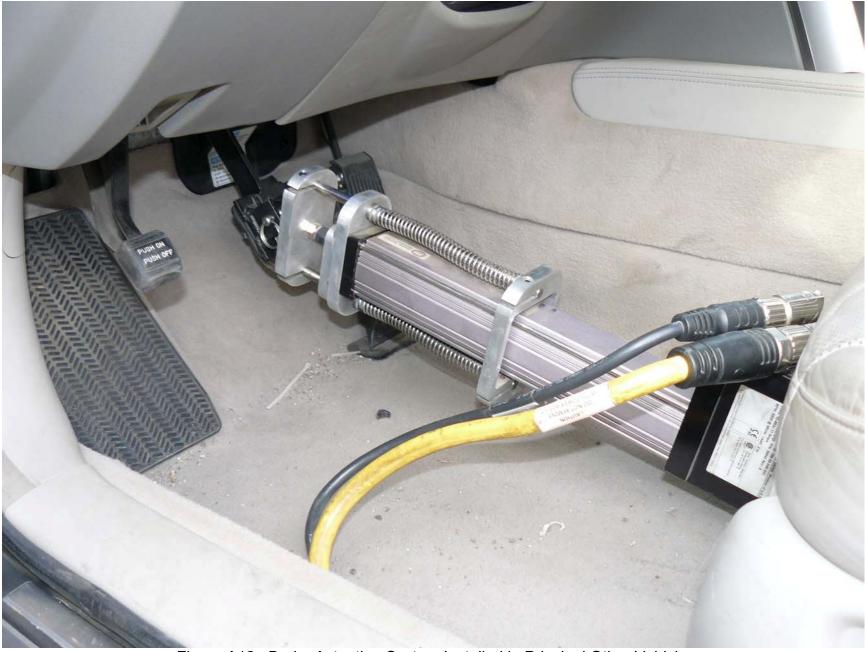
Figure A12. Brake Actuation System Installed in Principal Other Vehicle

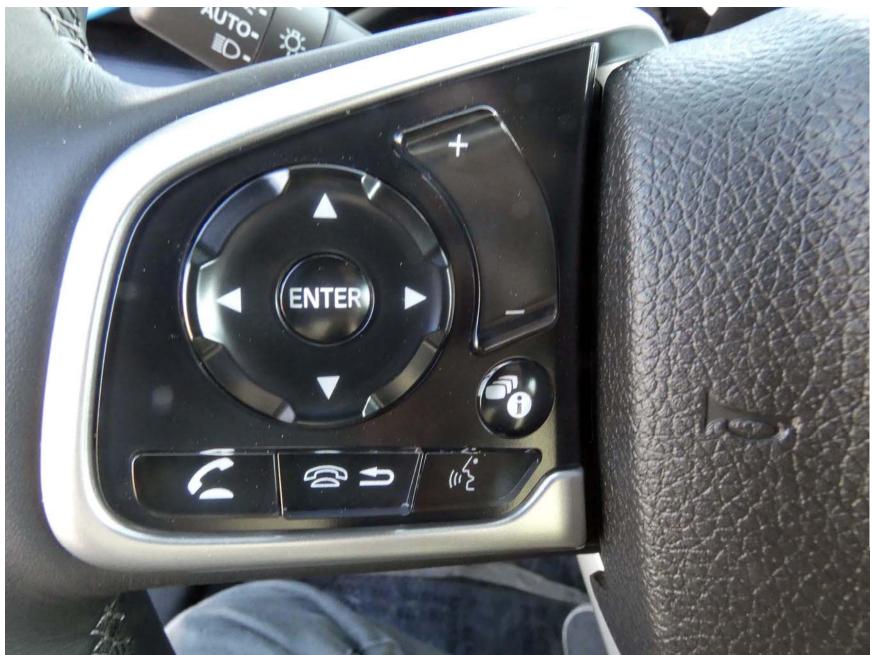
Figure A14. Steering Wheel Mounted Controls for Adjusting Settings

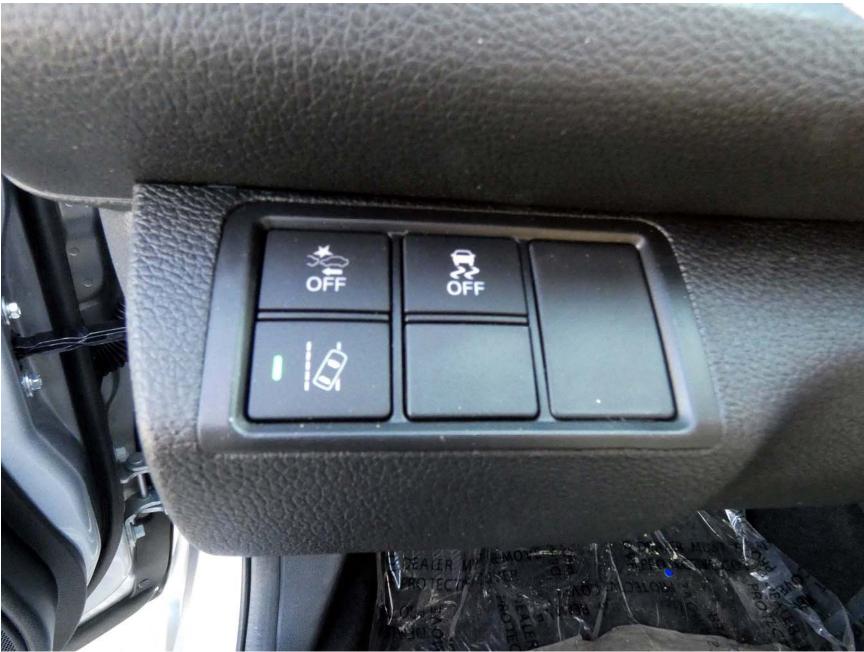
Figure A15. CMBS (FCW) On/Off Switch

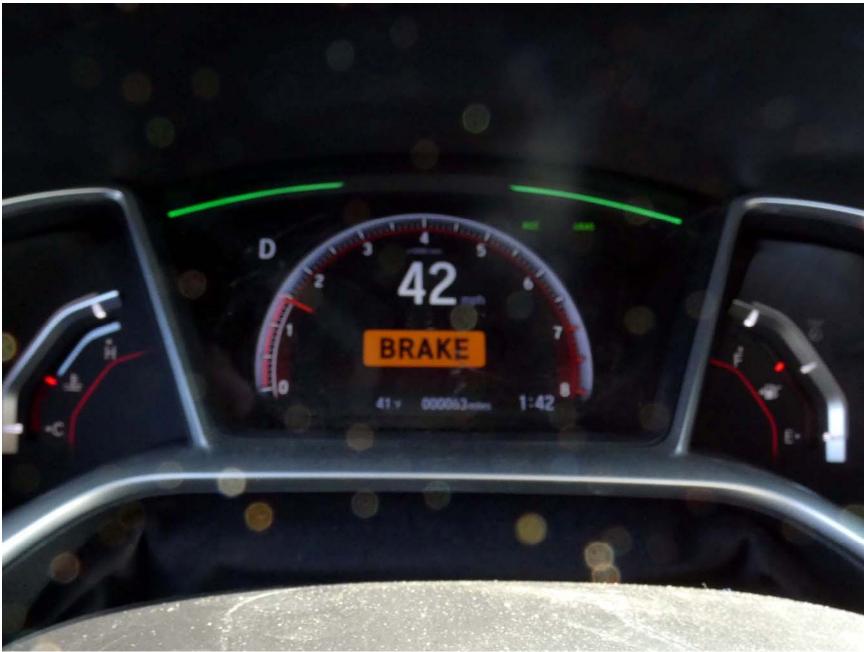
Figure A16. CMBS (FCW) Visual Alert
