**REPORT NUMBER: NCAP-CAL-20-012**

**NEW CAR ASSESSMENT PROGRAM (NCAP)  
FRONTAL BARRIER IMPACT TEST**

**GM Korea Company  
2020 Buick Encore GX  
Four Door SUV**

**NHTSA No: M20200100**

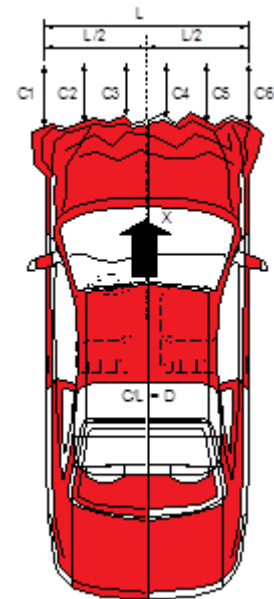
**CRUSH PROFILE**

Collision Deformation Classification: 12FDEW2  
 Midpoint of Damage: C3  
 Damage Region Length (mm): 1292  
 Impact Mode: Frontal

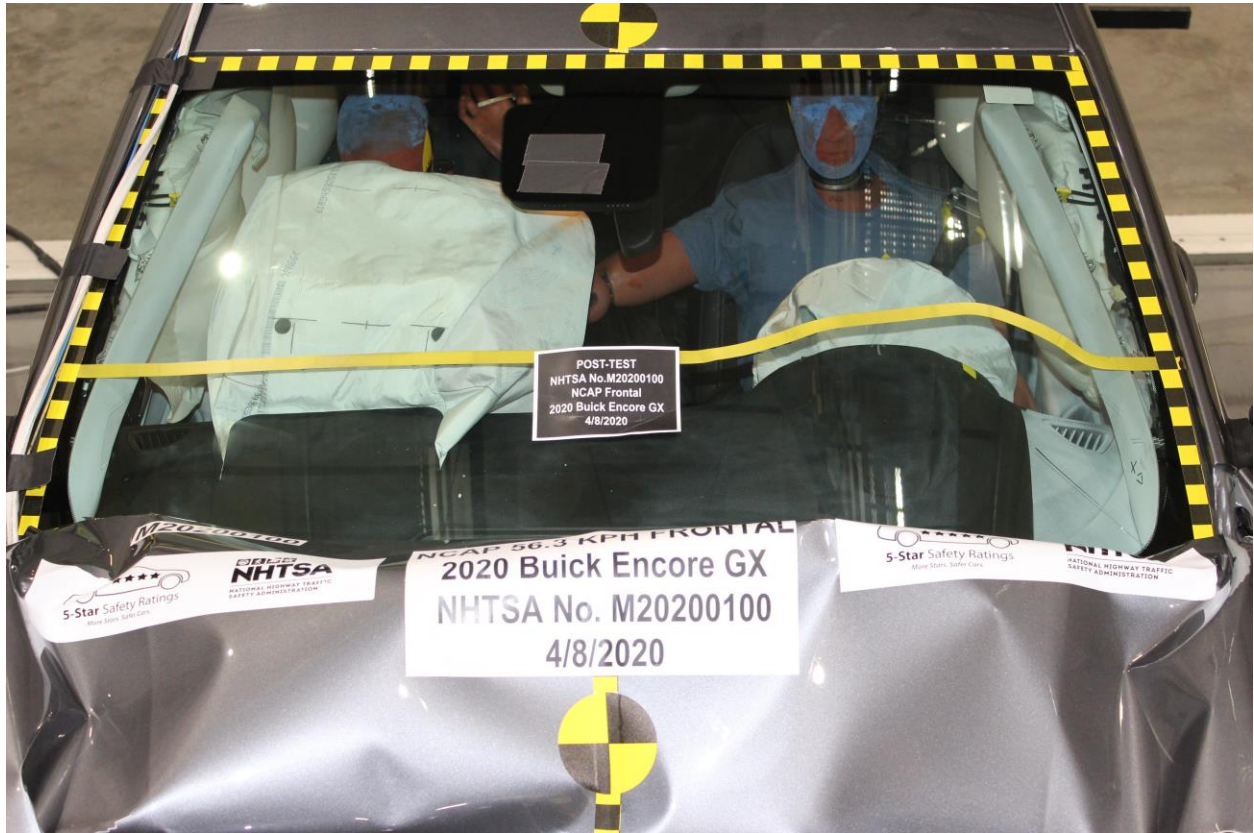
**Figure A-19: Post-Test Windshield View**

Critical Areas of Performance	Observations and Conclusions
Windshield Damage	Minor cracks along driver side
Window Damage	None
Other	None

There was 100 percent windshield retention and no intrusion into the protected zone of the windshield during the event. There was a total of 0.0 grams of stoddard solvent leakage after the event or during any phase of the static rollover. The maximum static crush of the vehicle was 459 mm and both driver and passenger side doors remained closed during the impact event and were operable after the impact.

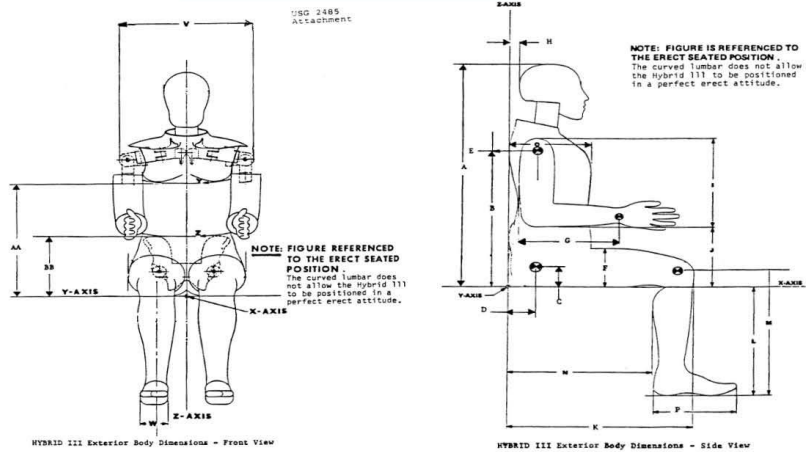
Symbol	Description	Specification (in)		Result (in)	Pass/Fail
A	Sitting Height	34.6	35.0	34.8	Pass
B	Shoulder Pivot Height	19.9	20.5	20.2	Pass
C	H-Point Height	3.3	3.5	3.4	Pass
D	H-Point from Backline	5.3	5.5	5.4	Pass
E	Shoulder Pivot from Backline	3.3	3.7	3.6	Pass
F	Thigh Clearance	5.5	6.1	5.9	Pass
G	Back of Elbow to Wrist Pivot	11.4	12.0	11.6	Pass
H	Head Back to Backline	1.6	1.8	1.7	Pass
I	Shoulder to Elbow Length	13.0	13.6	13.4	Pass
J	Elbow Rest Height	7.5	8.3	8.0	Pass
K	Buttock to Knee Length	22.8	23.8	23.5	Pass
L	Popliteal Height	16.9	17.9	17.4	Pass
M	Knee Pivot Height	19.1	19.7	19.6	Pass
N	Buttock Popliteal Length	17.8	18.8	18.4	Pass
O	Chest Depth without Jacket	8.4	9.0	8.7	Pass
P	Foot Length (right)	9.9	10.5	10.3	Pass
V	Shoulder Breadth	16.3	17.2	16.9	Pass
W	Foot Breadth	3.6	4.2	3.8	Pass
Y	Chest Circumference with Jacket	38.2	39.4	38.8	Pass
Z	Waist Circumference	32.9	34.1	33.7	Pass
AA	Reference Location (Chest Circumference)	16.9	17.1	17.0	Pass

BB	Reference Location (Waist Circumference)	8.9	9.1	9.0	Pass

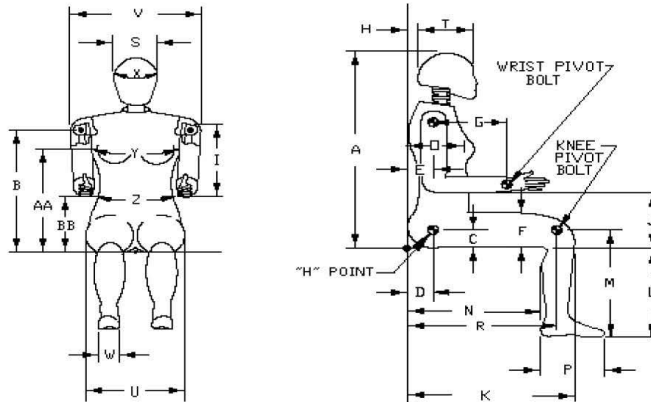
Symbol	Description	Specification (mm)		Result (mm)	Pass/Fail
A	Sitting Height	775	800	791	Pass
B	Shoulder Pivot Height	432	457	442	Pass
C	H-Point Height	81	86	83	Pass
D	H-Point from Backline	145	150	146	Pass
E	Shoulder Pivot from Backline	69	84	77	Pass
F	Thigh Clearance	119	135	126	Pass
G	Back of Elbow to Wrist Pivot	244	259	252	Pass
H	Head Back to Backline	43	48	45	Pass
I	Shoulder to Elbow Length	277	297	291	Pass
J	Elbow Rest Height	183	203	197	Pass
K	Buttock to Knee Length	521	546	537	Pass
L	Popliteal Height	356	376	366	Pass
M	Knee Pivot Height	394	419	409	Pass
N	Buttock Popliteal Length	414	439	428	Pass
O	Chest Depth without Jacket	175	191	182	Pass
P	Foot Length (right)	219	234	229	Pass
R	Buttock To Knee Pivot Length	457	483	465	Pass
S	Head Breadth	137	147	142	Pass
T	Head Depth	178	188	180	Pass
U	Hip Breadth	300	315	313	Pass
V	Shoulder Breadth	351	366	361	Pass
W	Foot Breadth	79	94	83	Pass
X	Head Circumference	528	549	540	Pass

Y	Chest Circumference with Jacket	851	881	874	Pass
Z	Waist Circumference	460	790	624	Pass
AA	Reference Location (Chest Circumference)	333	358	345	Pass
BB	Reference Location (Waist Circumference)	160	170	165	Pass

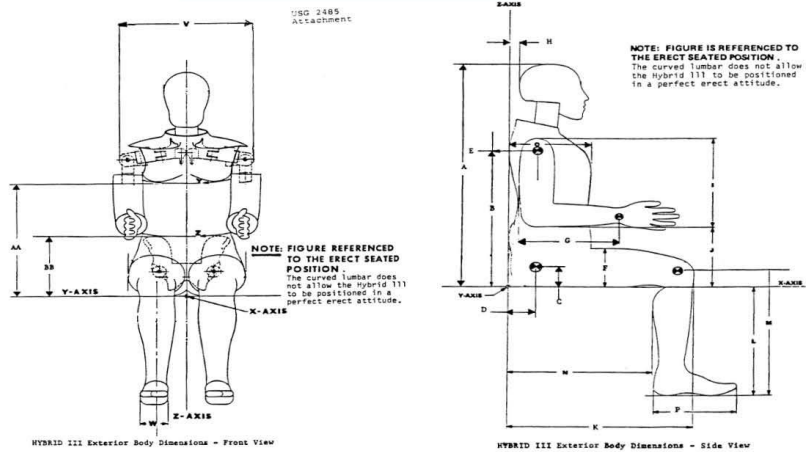
Symbol	Description	Specification (in)		Result (in)	Pass/Fail
A	Sitting Height	34.6	35.0	34.8	Pass
B	Shoulder Pivot Height	19.9	20.5	20.2	Pass
C	H-Point Height	3.3	3.5	3.4	Pass
D	H-Point from Backline	5.3	5.5	5.4	Pass
E	Shoulder Pivot from Backline	3.3	3.7	3.6	Pass
F	Thigh Clearance	5.5	6.1	5.9	Pass
G	Back of Elbow to Wrist Pivot	11.4	12.0	11.6	Pass
H	Head Back to Backline	1.6	1.8	1.7	Pass
I	Shoulder to Elbow Length	13.0	13.6	13.4	Pass
J	Elbow Rest Height	7.5	8.3	8.0	Pass
K	Buttock to Knee Length	22.8	23.8	23.5	Pass
L	Popliteal Height	16.9	17.9	17.4	Pass
M	Knee Pivot Height	19.1	19.7	19.6	Pass
N	Buttock Popliteal Length	17.8	18.8	18.5	Pass
O	Chest Depth without Jacket	8.4	9.0	8.7	Pass
P	Foot Length (right)	9.9	10.5	10.3	Pass
V	Shoulder Breadth	16.3	17.2	16.9	Pass
W	Foot Breadth	3.6	4.2	3.8	Pass
Y	Chest Circumference with Jacket	38.2	39.4	38.8	Pass
Z	Waist Circumference	32.9	34.1	33.7	Pass
AA	Reference Location (Chest Circumference)	16.9	17.1	17.0	Pass

BB	Reference Location (Waist Circumference)	8.9	9.1	9.0	Pass

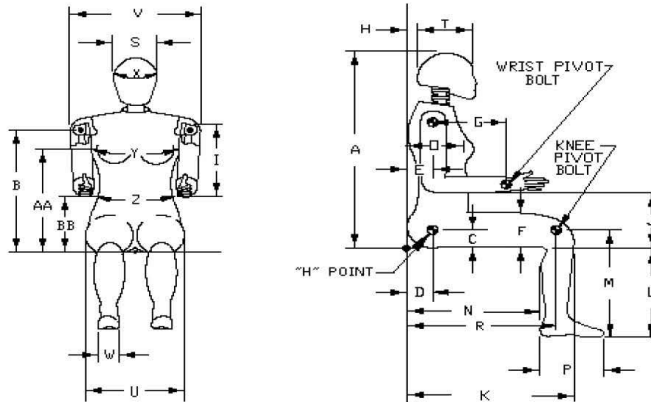
Symbol	Description	Specification (mm)		Result (mm)	Pass/Fail
A	Sitting Height	775	800	791	Pass
B	Shoulder Pivot Height	432	457	442	Pass
C	H-Point Height	81	86	83	Pass
D	H-Point from Backline	145	150	146	Pass
E	Shoulder Pivot from Backline	69	84	77	Pass
F	Thigh Clearance	119	135	126	Pass
G	Back of Elbow to Wrist Pivot	244	259	252	Pass
H	Head Back to Backline	43	48	45	Pass
I	Shoulder to Elbow Length	277	297	291	Pass
J	Elbow Rest Height	183	203	197	Pass
K	Buttock to Knee Length	521	546	539	Pass
L	Popliteal Height	356	376	366	Pass
M	Knee Pivot Height	394	419	409	Pass
N	Buttock Popliteal Length	414	439	428	Pass
O	Chest Depth without Jacket	175	191	182	Pass
P	Foot Length (right)	219	234	229	Pass
R	Buttock To Knee Pivot Length	457	483	465	Pass
S	Head Breadth	137	147	142	Pass
T	Head Depth	178	188	180	Pass
U	Hip Breadth	300	315	313	Pass
V	Shoulder Breadth	351	366	361	Pass
W	Foot Breadth	79	94	83	Pass
X	Head Circumference	528	549	540	Pass

Y	Chest Circumference with Jacket	851	881	874	Pass
Z	Waist Circumference	460	790	624	Pass
AA	Reference Location (Chest Circumference)	333	358	345	Pass
BB	Reference Location (Waist Circumference)	160	170	165	Pass
