REPORT NUMBER: SPNCAP-CAL-20-008

**NEW CAR ASSESSMENT PROGRAM (NCAP)
SIDE IMPACT POLE TEST**

**GM Korea Company
2020 Buick Encore GX
SUV**

FINAL REPORT

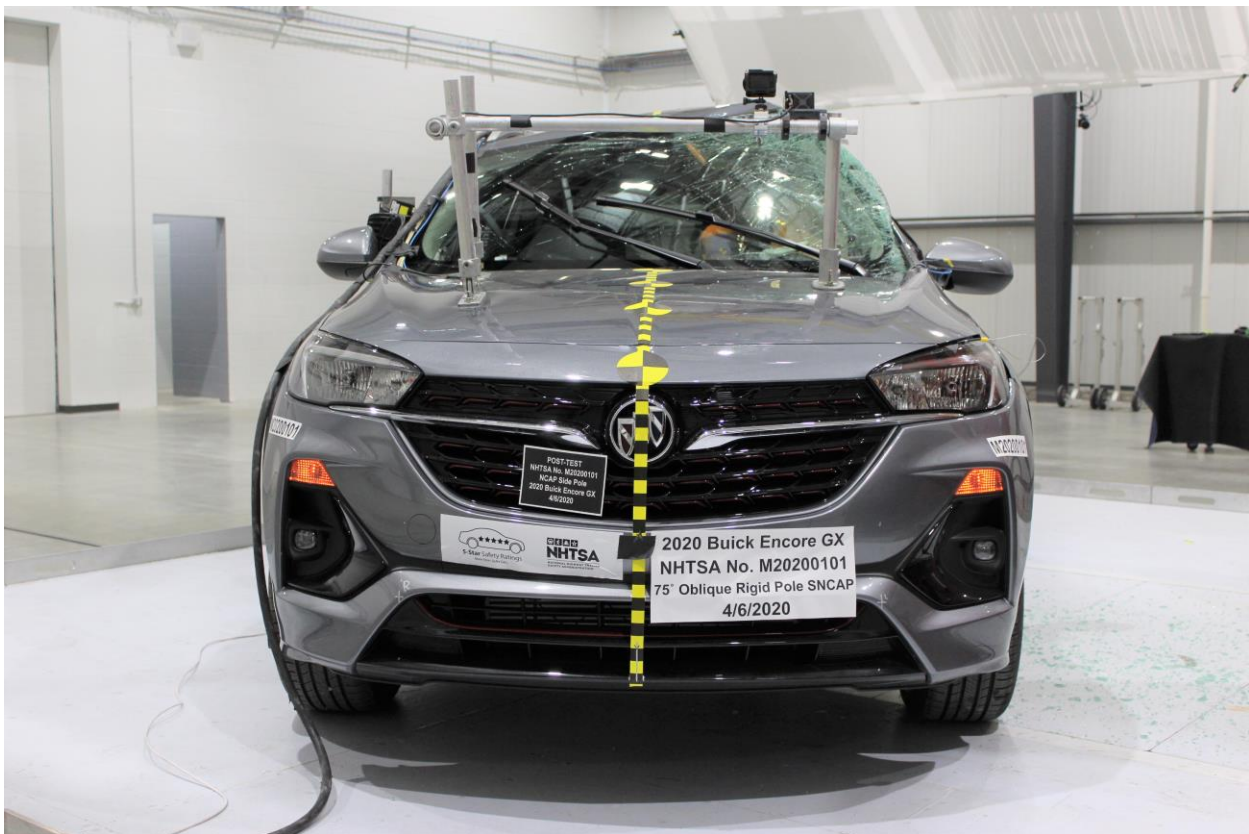
Figure A-4: Post-Test Frontal View of Test Vehicle

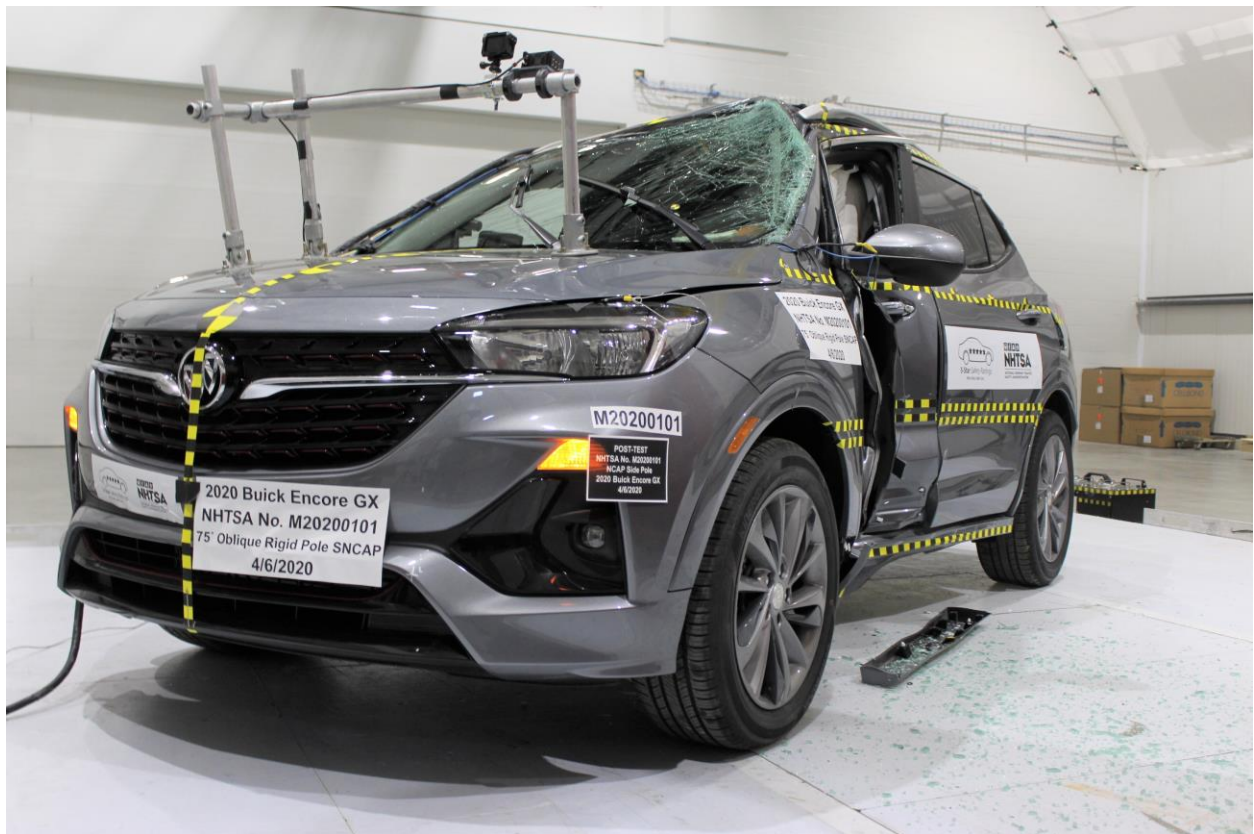
Figure A-6: Post-Test Left Front ¾ View of Test Vehicle

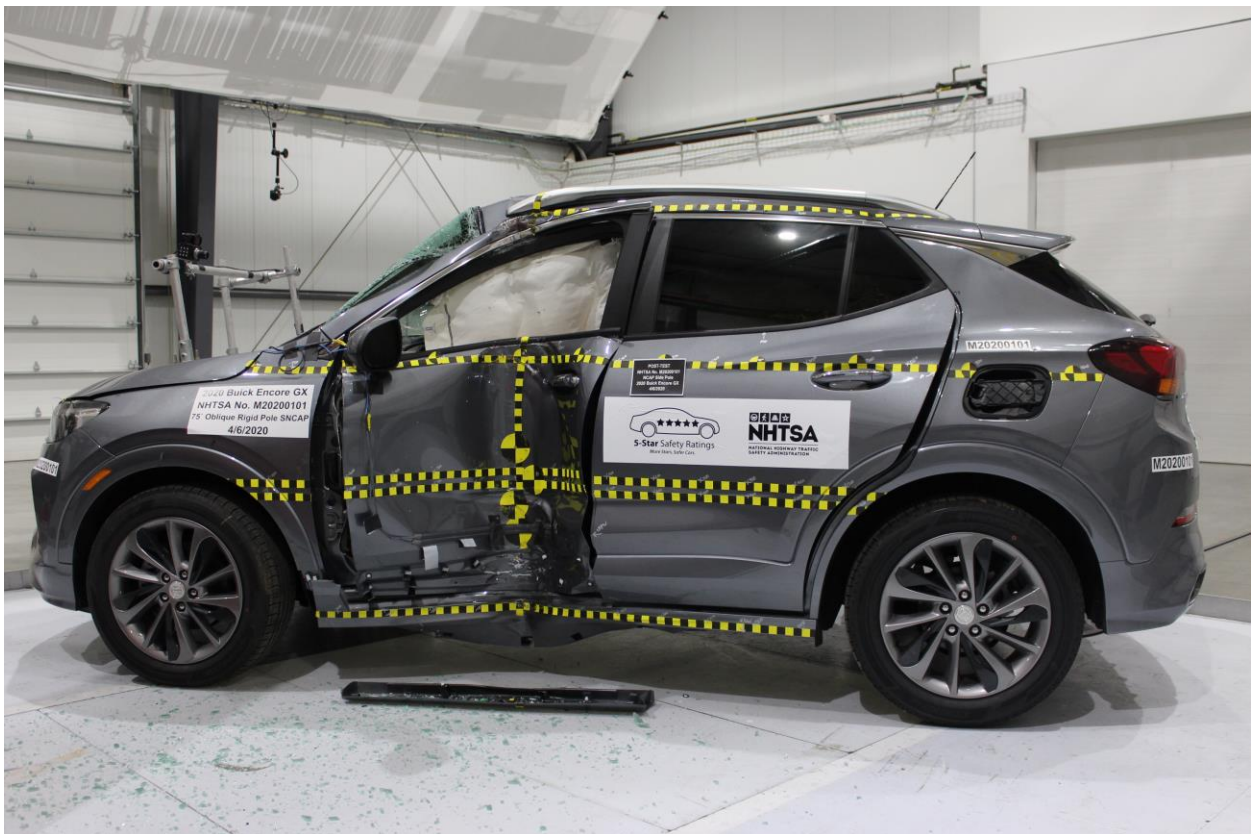
Figure A-8: Post-Test Left Side View of Test Vehicle

Critical Areas of Performance	Observations and Conclusions
Pillar Performance	A-Pillar & C-Pillar buckled
Sill Separation	None
Windshield Damage	Cracks throughout with separation along Driver A-Pillar
Side Window Damage	Driver window shattered
Other Notable Effects	None

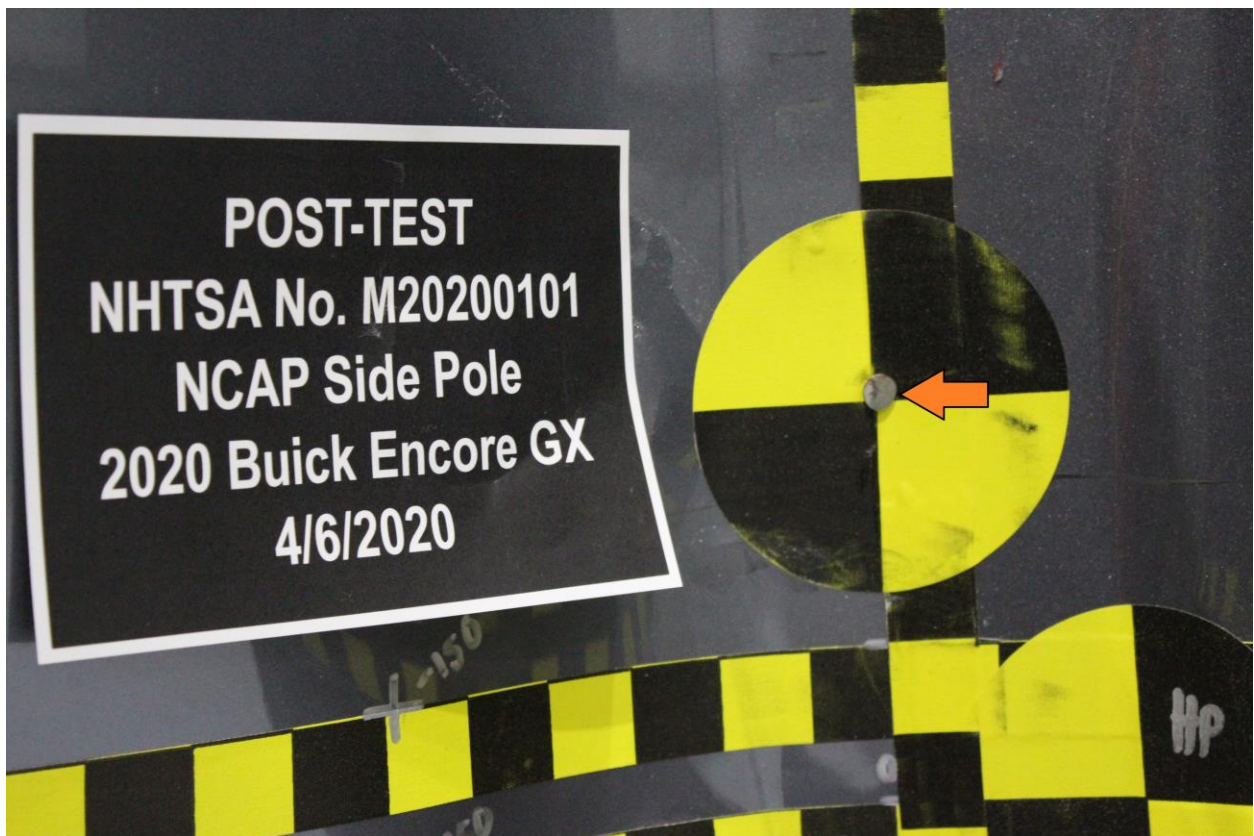
Figure A-20: Post-Test Close-Up View of Impact Point Target Showing Impact Location

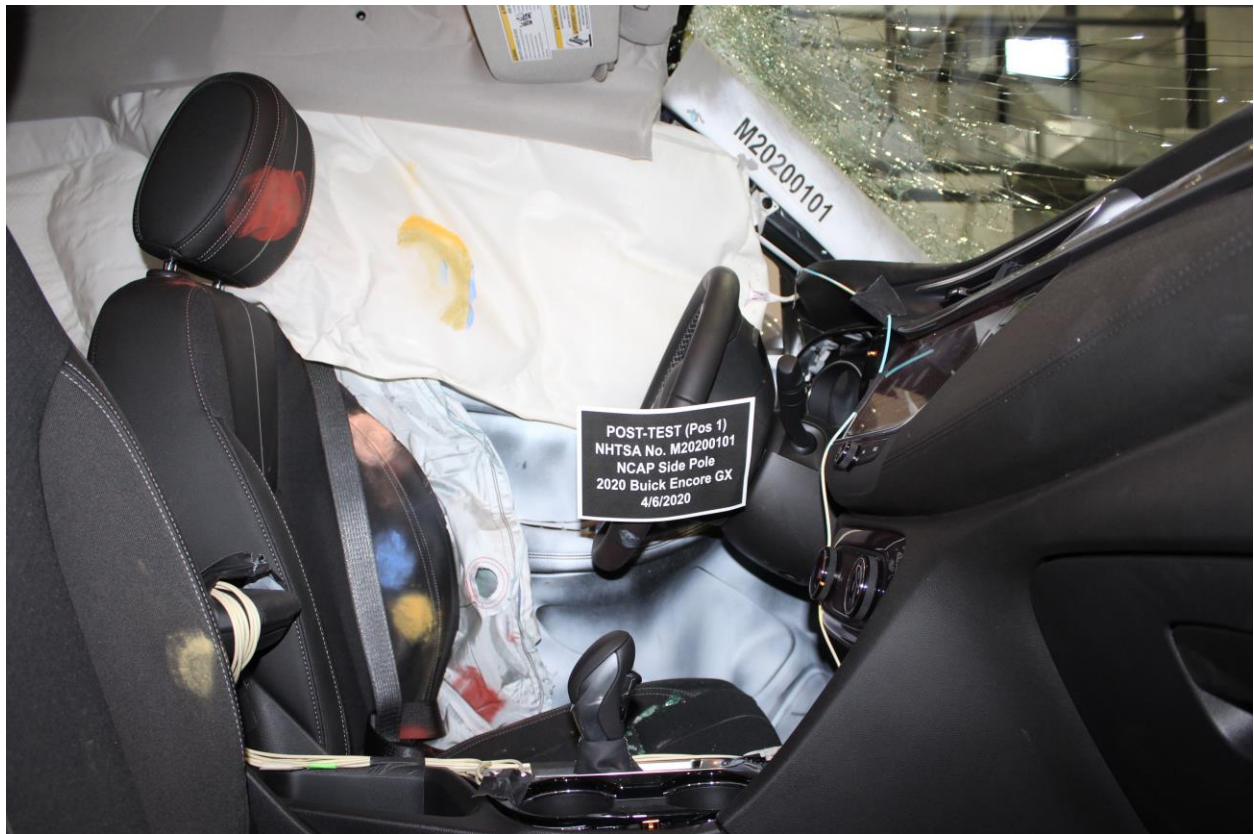
Figure A-45: Post-Test Inner Door Panel View Showing Dummy Contact Location

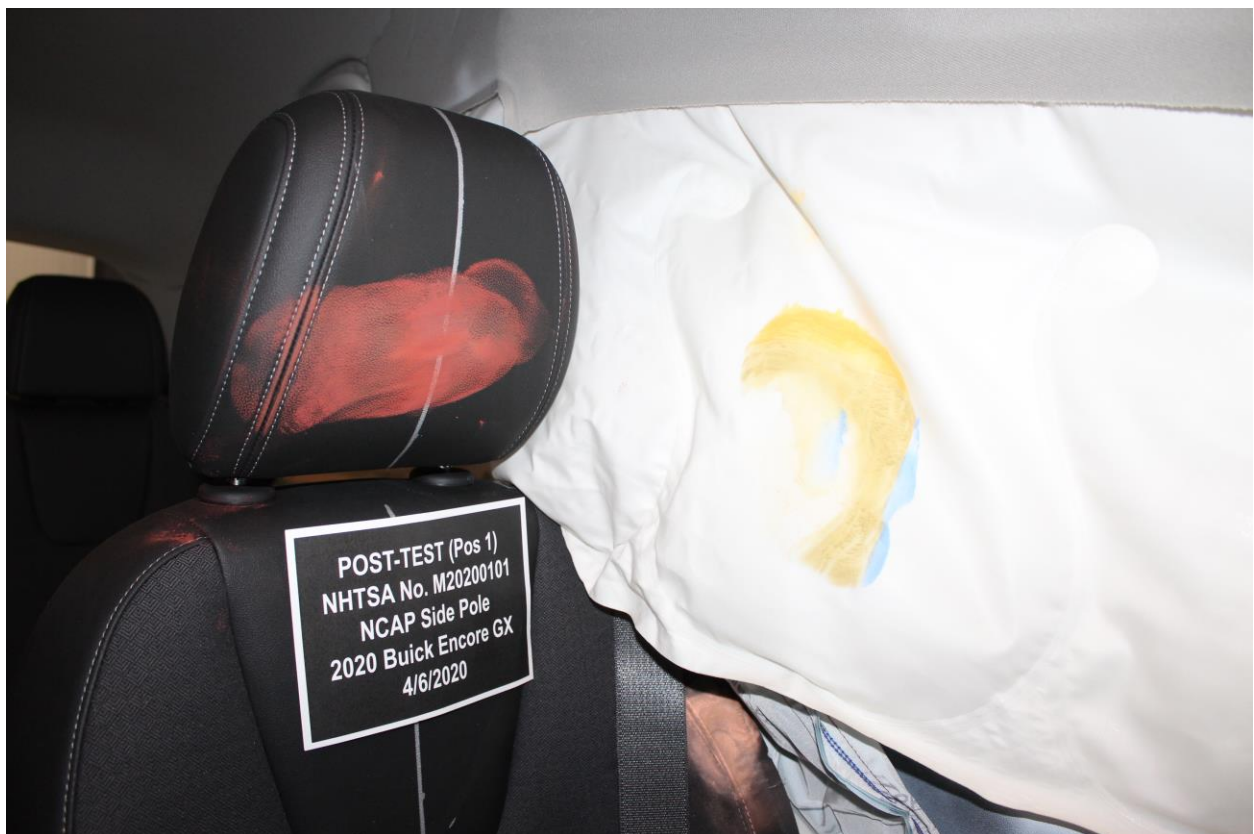
Figure A-46: Post-Test Dummy Close-Up Head Contact with Vehicle Interior View

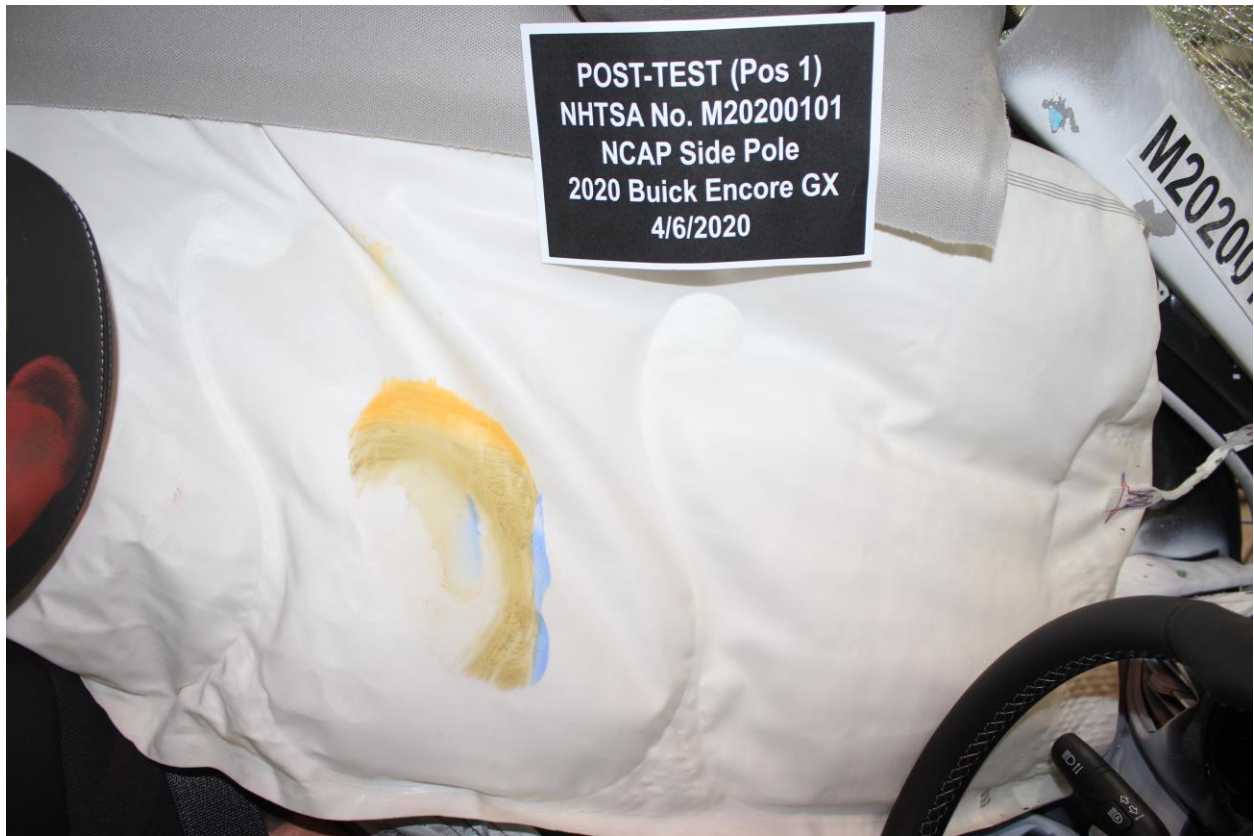
Figure A-47: Post-Test Dummy Close-Up Head Contact with Side Airbag View

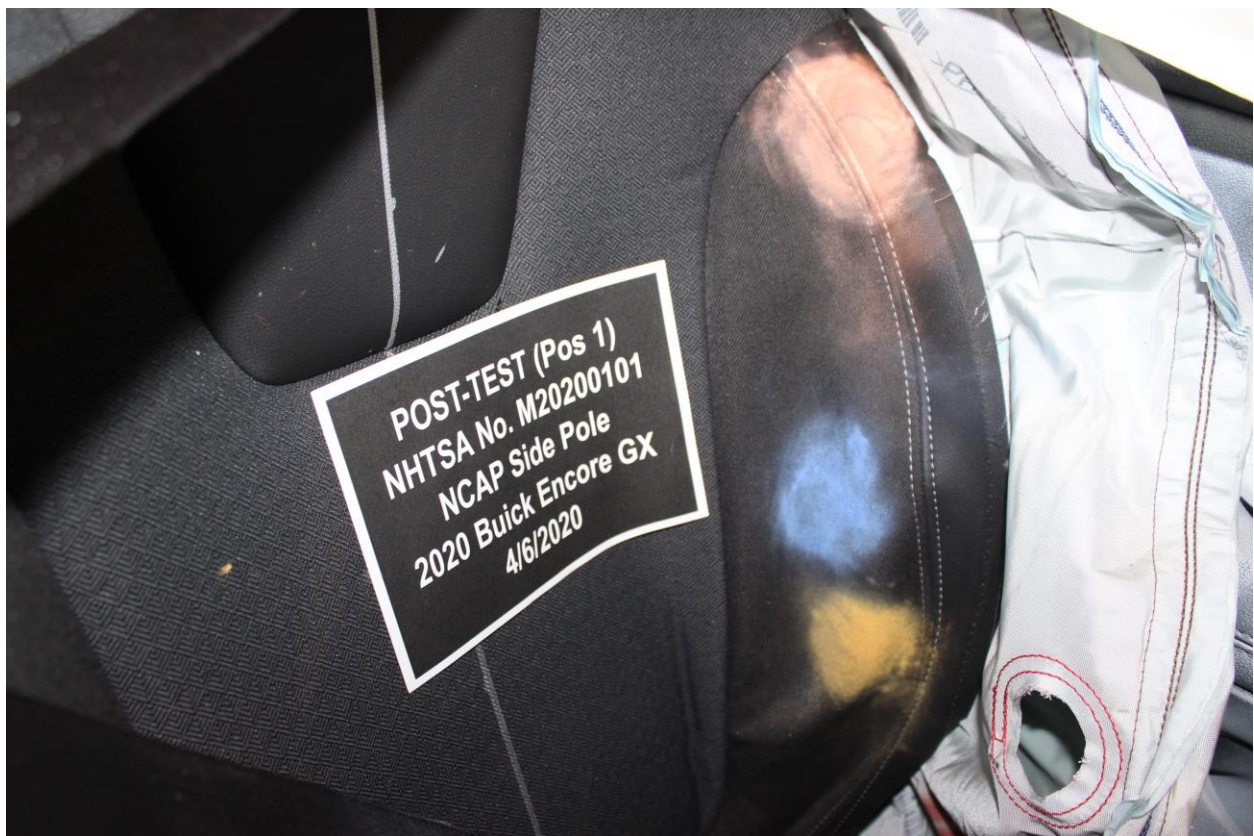
Figure A-48: Post-Test Dummy Close-Up Torso Contact with Vehicle Interior View

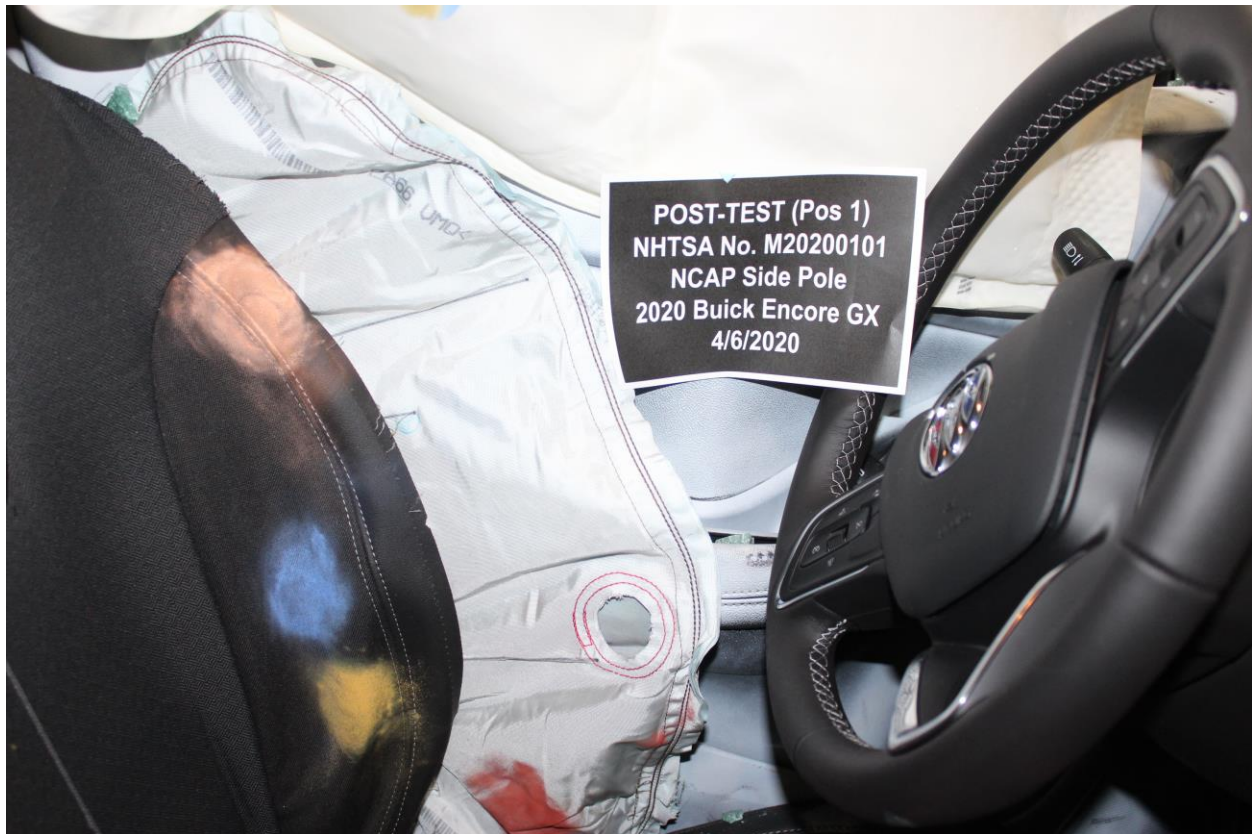
Figure A-49: Post-Test Dummy Close-Up Torso Contact with Side Airbag View

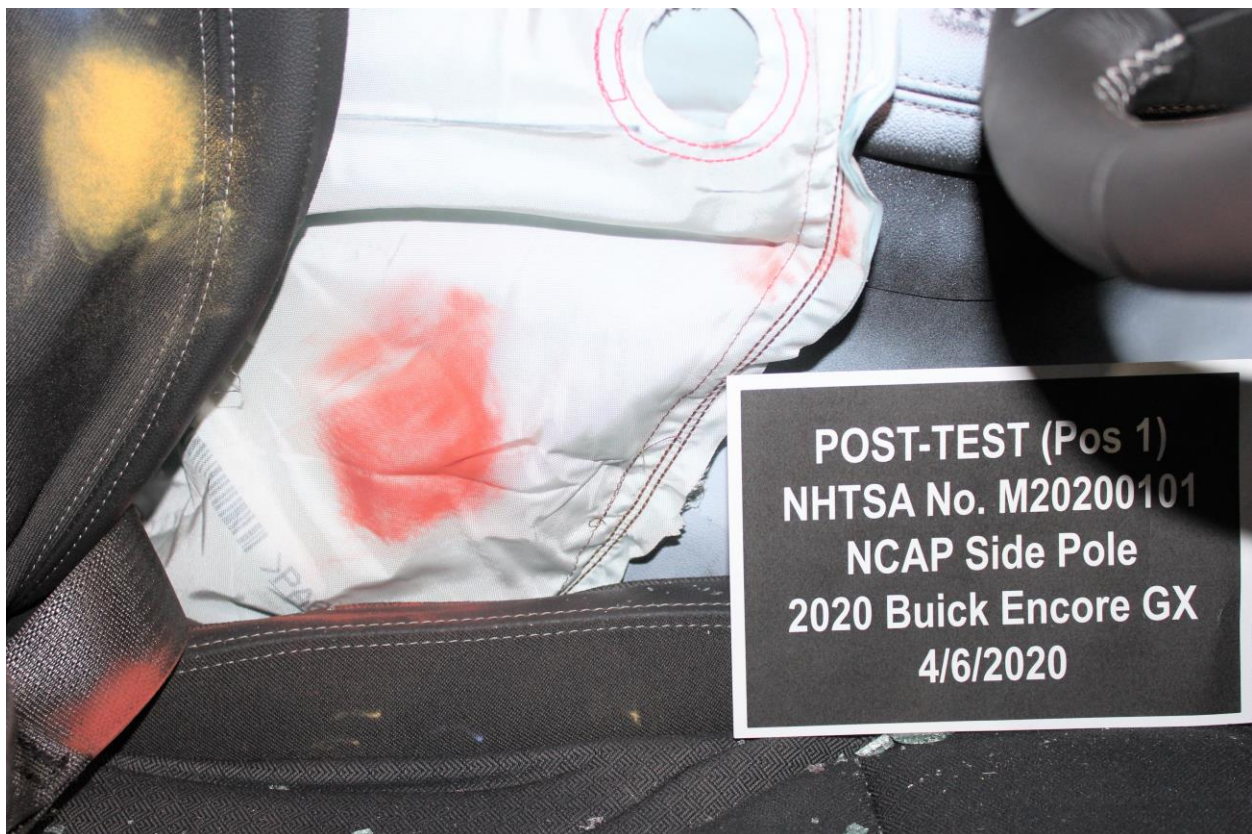
Figure A-50: Post-Test Dummy Close-Up Pelvis Contact with Vehicle Interior View

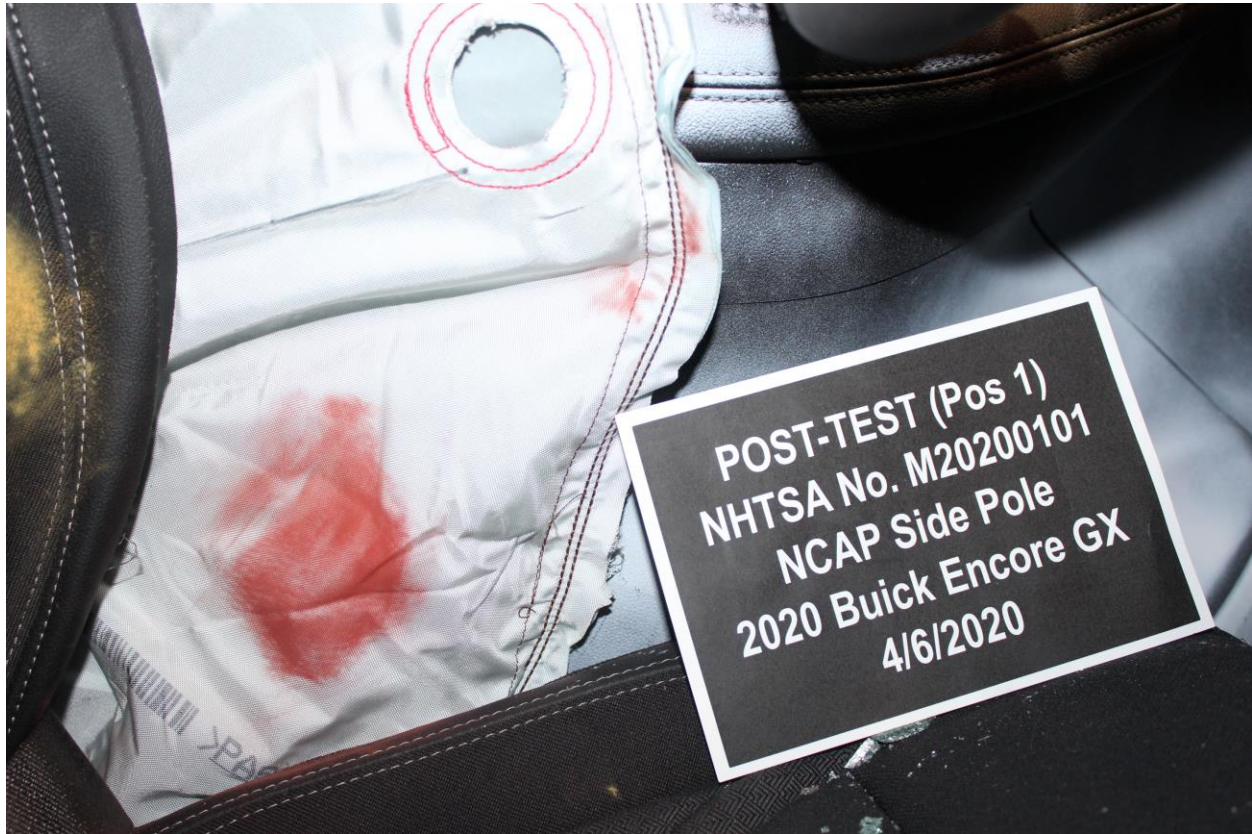
Figure A-51: Post-Test Dummy Close-Up Pelvis Contact with Side Airbag View
