**REPORT NUMBER: SINCAP-CAL-20-008**

**NEW CAR ASSESSMENT PROGRAM (NCAP)  
MOVING DEFORMABLE BARRIER SIDE IMPACT TEST**

**GM Korea Company  
2020 Buick Encore GX  
Four Door SUV**

**NHTSA No: M20200102**

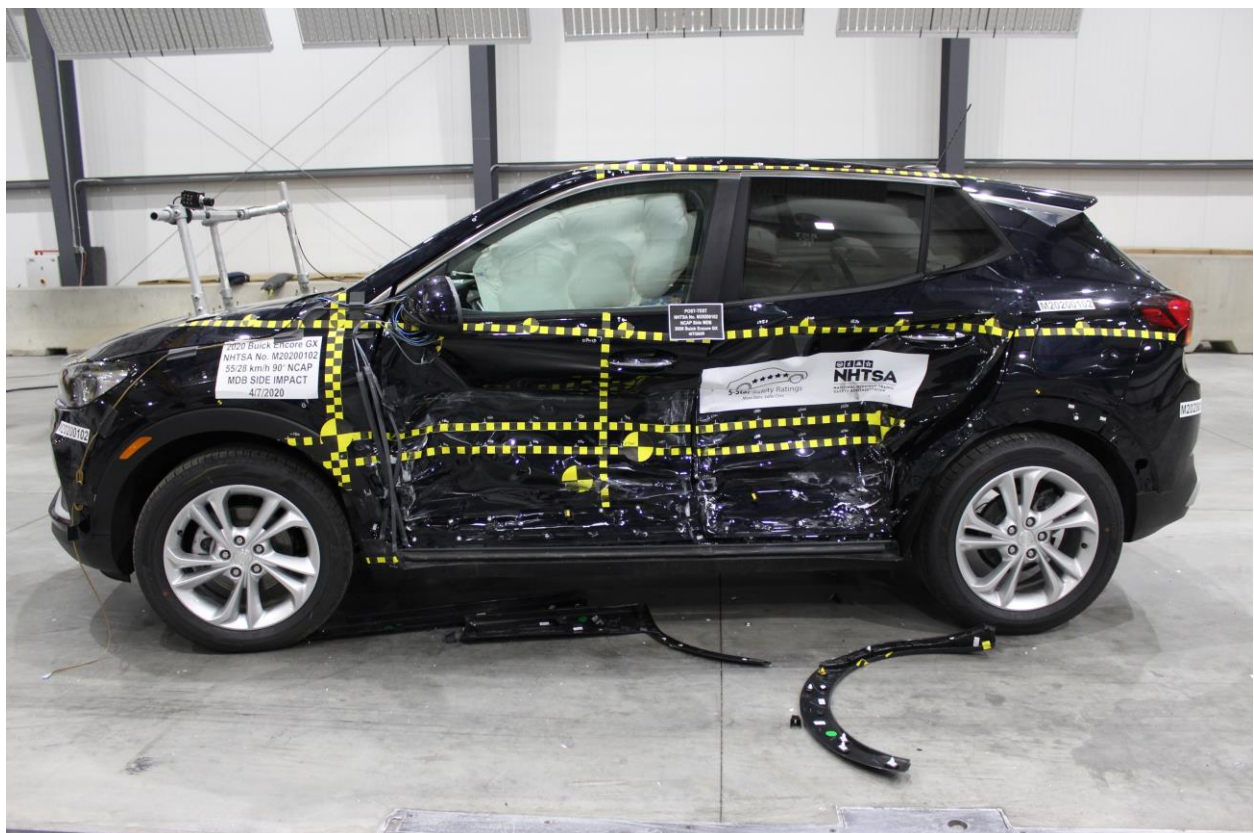
**Figure A-8: Post-Test Left Side View of Test Vehicle**

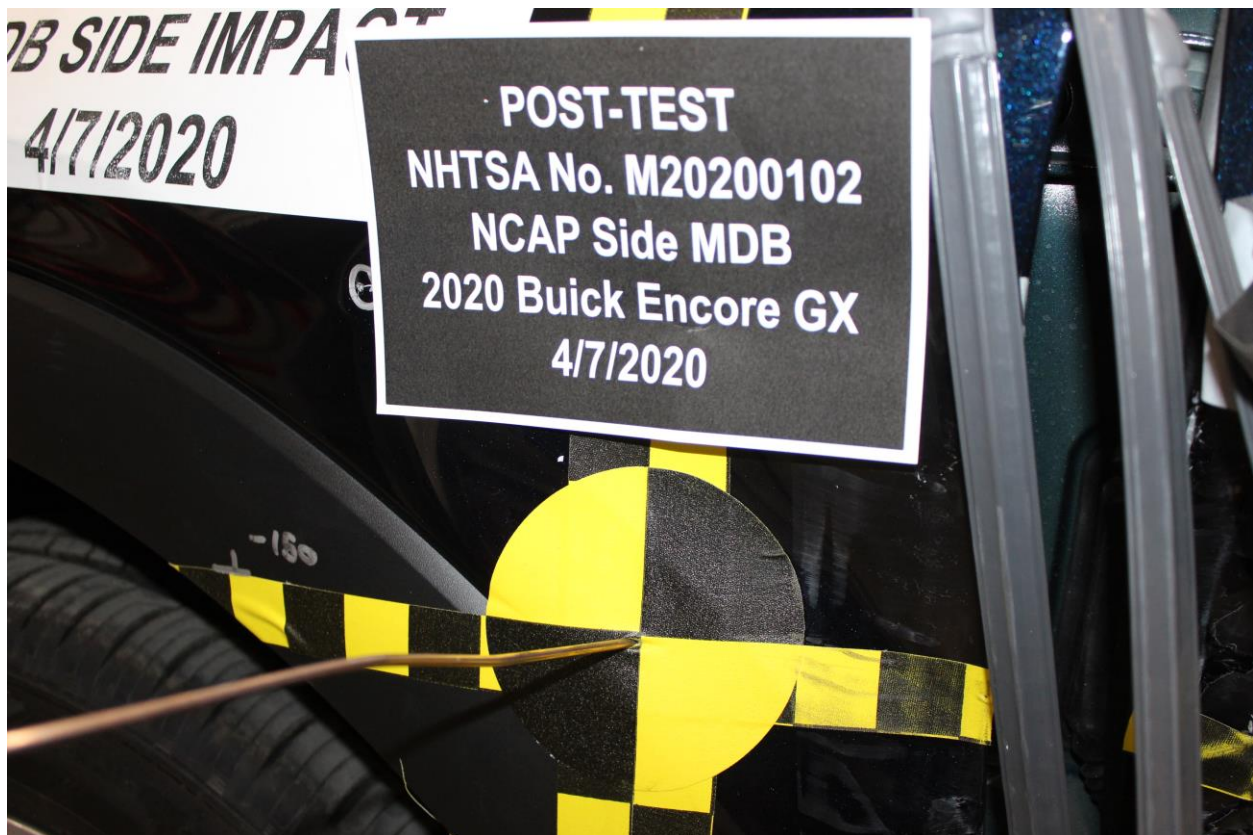
Figure A-20: Post-Test Close-up View of Impact Point Target

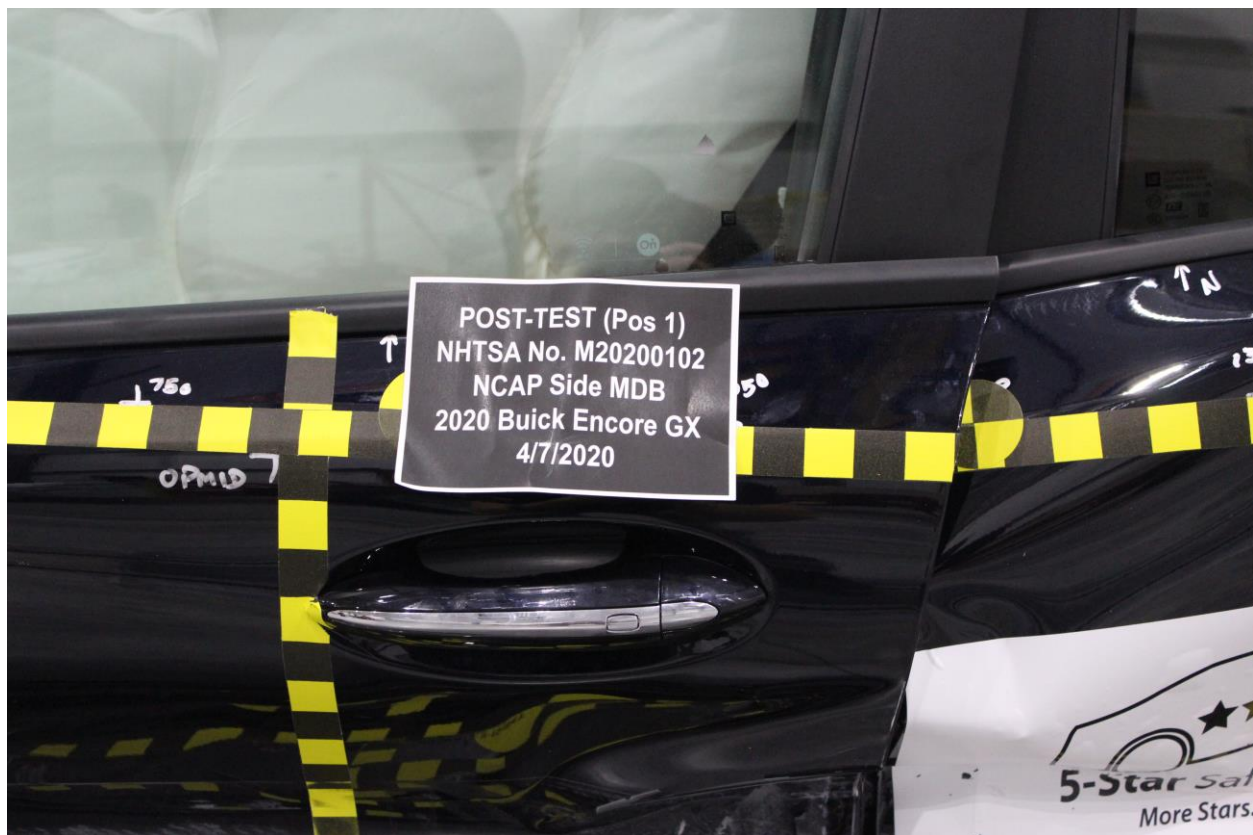
Figure A-22: Post-Test Left Front Door Latch Close-Up

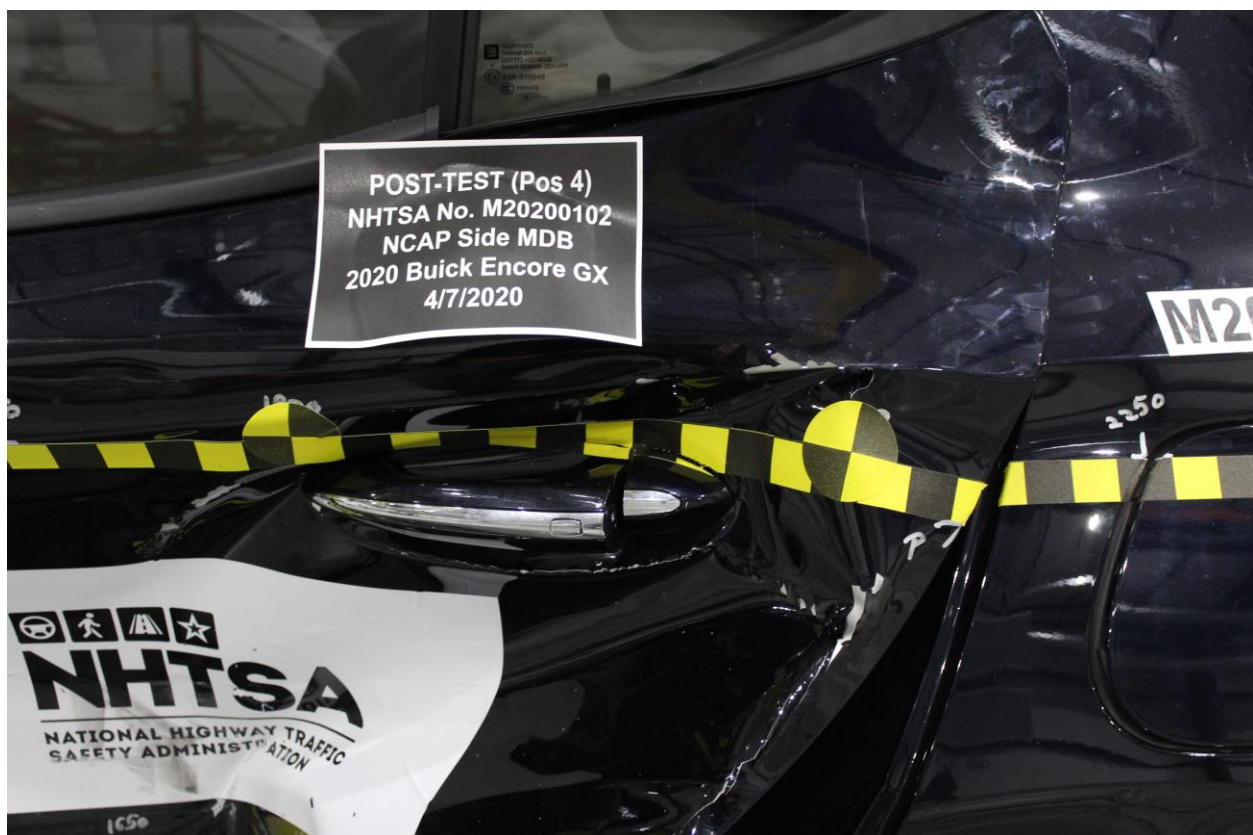
Figure A-24: Post-Test Left Rear Door Latch Close-Up

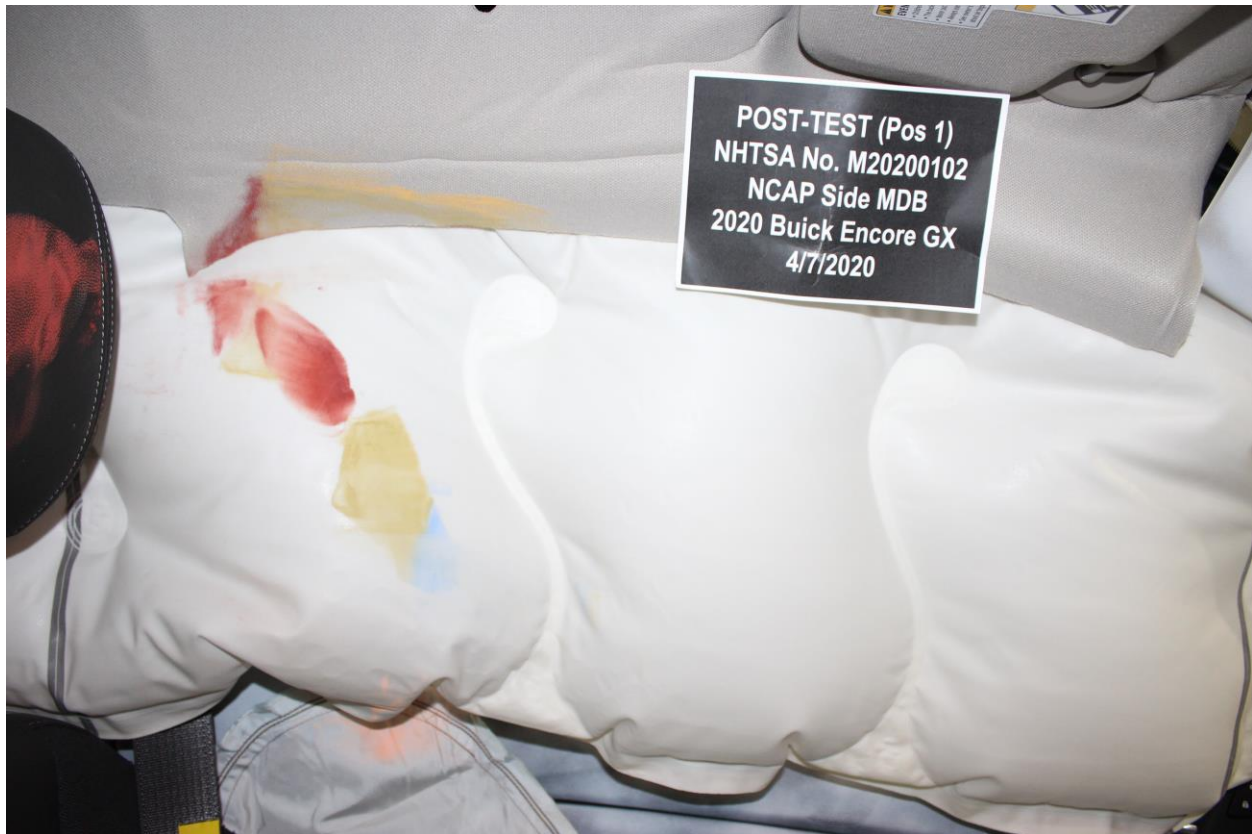
**Figure A-49: Post-Test Driver Dummy Close-Up Head Contact with Side Air bag View**

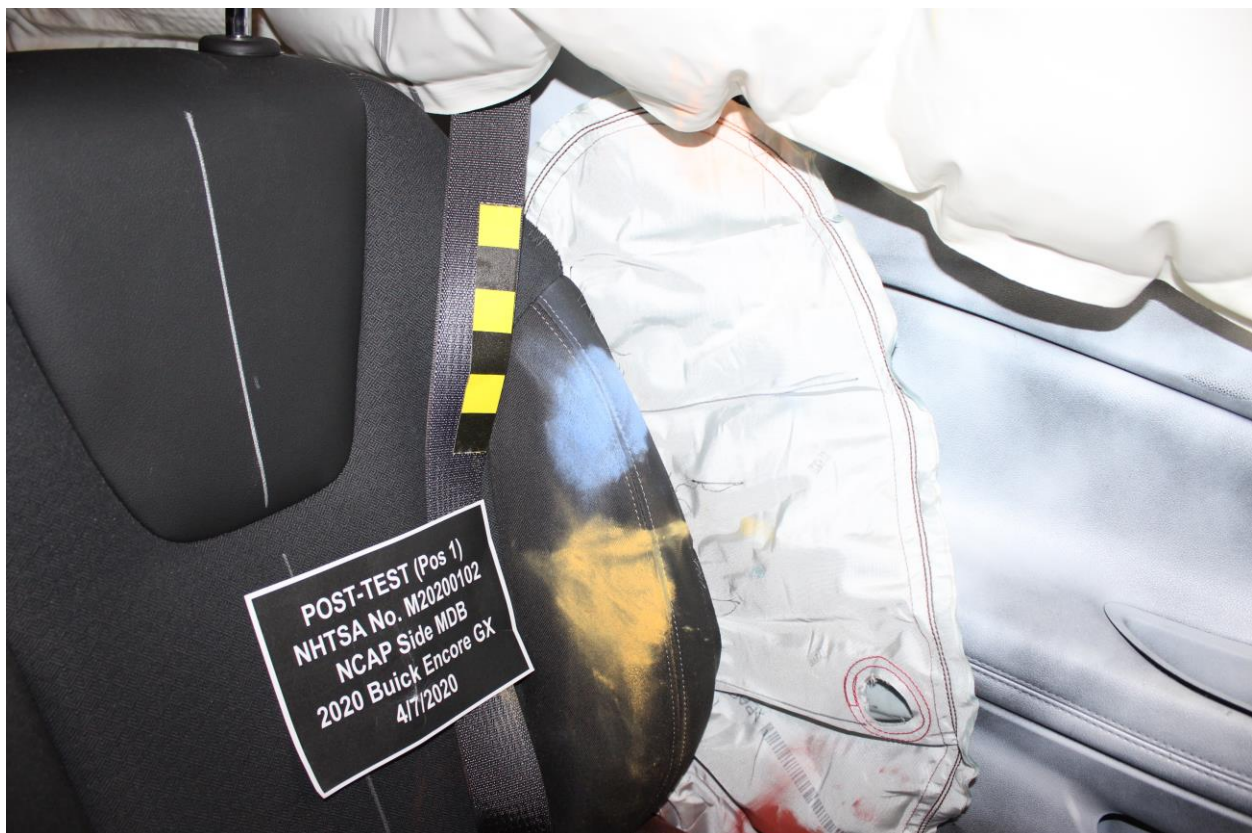
**Figure A-50: Post-Test Driver Dummy Close-Up Torso Contact with Vehicle Interior View**

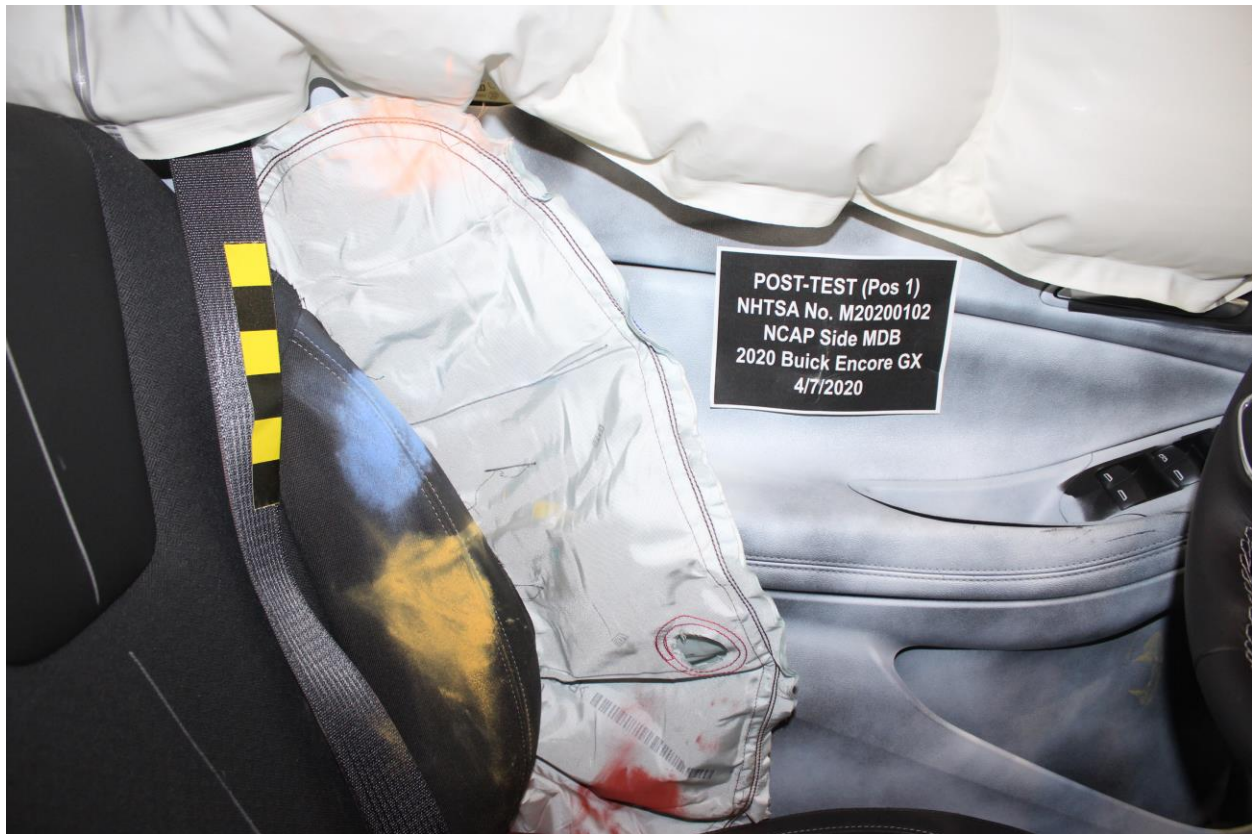
**Figure A-51: Post-Test Driver Dummy Close-Up Torso Contact with Side Air bag View**

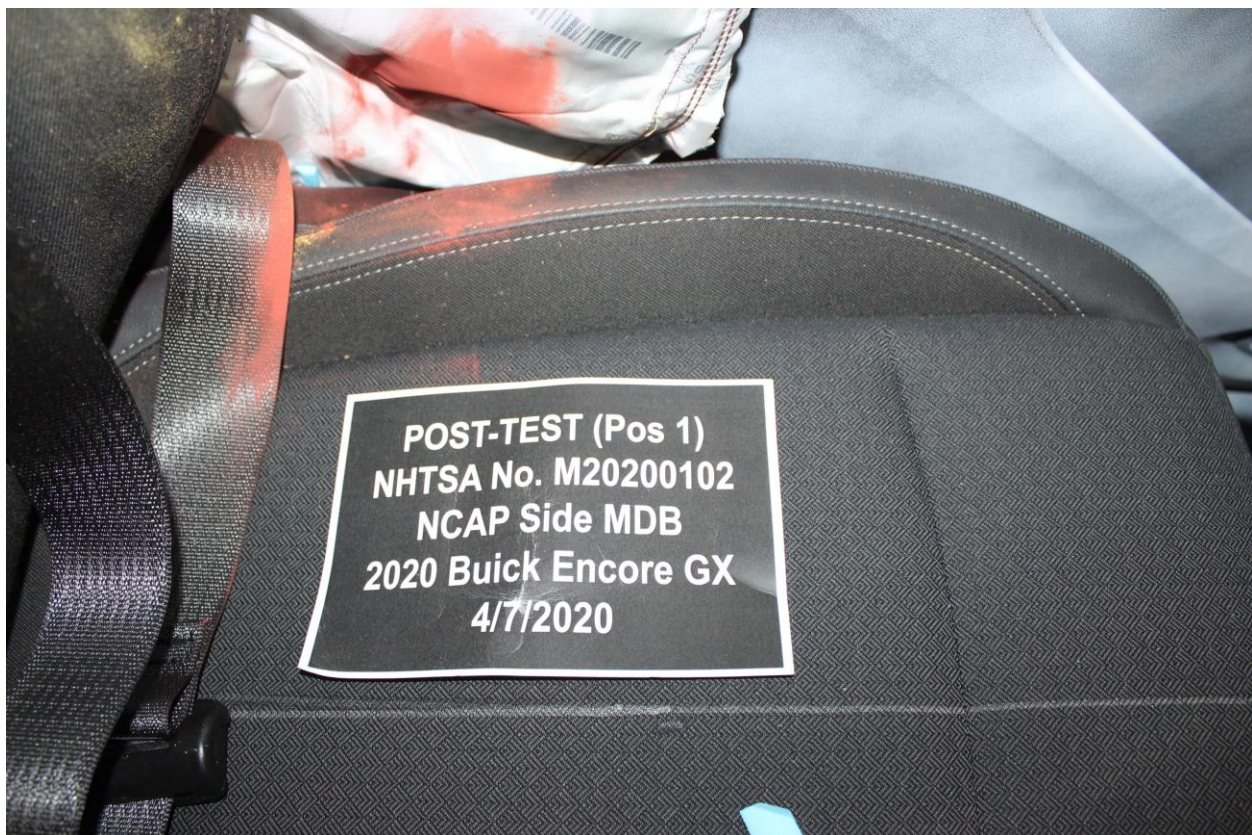
**Figure A-52: Post-Test Driver Dummy Close-Up Pelvis Contact View**

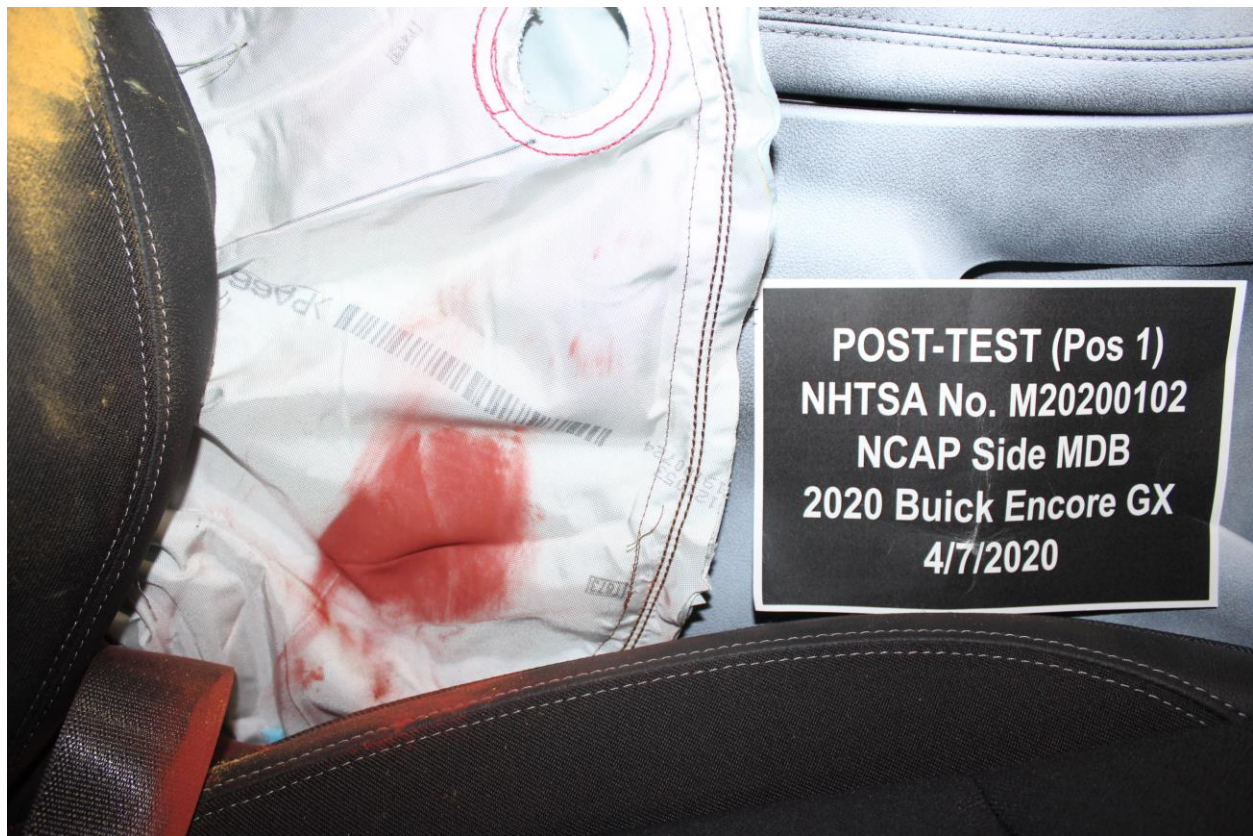
**Figure A-53: Post-Test Driver Dummy Close-Up Pelvis Contact with Side Air bag View**

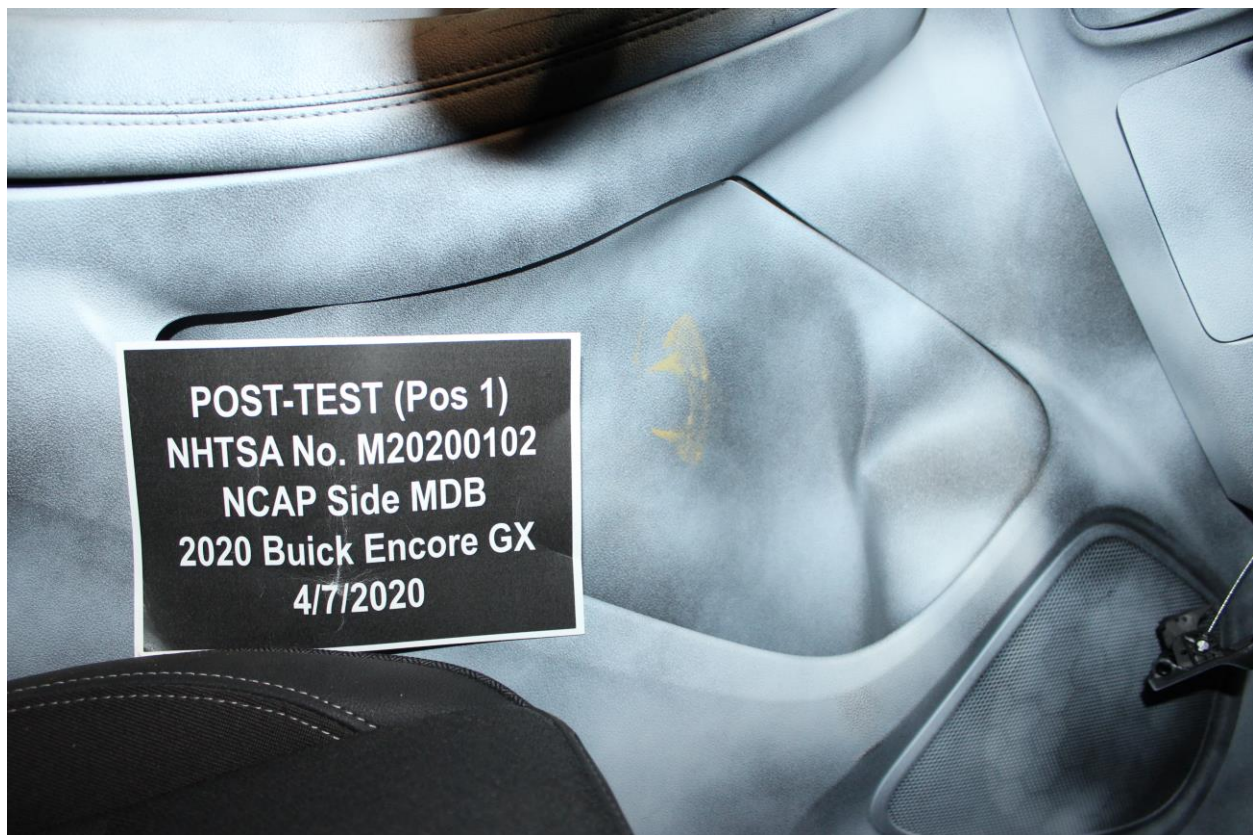
**Figure A-54: Post-Test Driver Dummy Close-Up Knee Contact View**

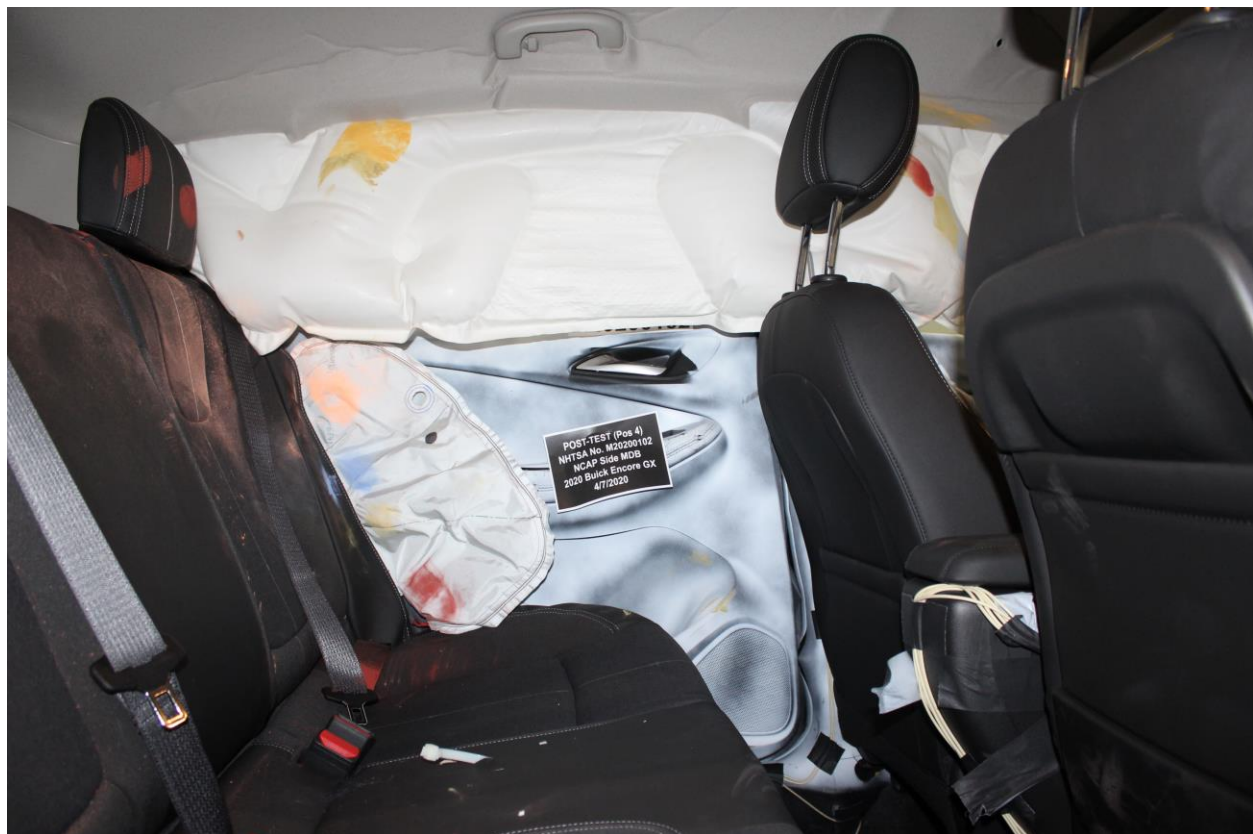
**Figure A-74: Post-Test Rear Passenger Inner Door Panel View Showing Rear Passenger Dummy Contact Locations**

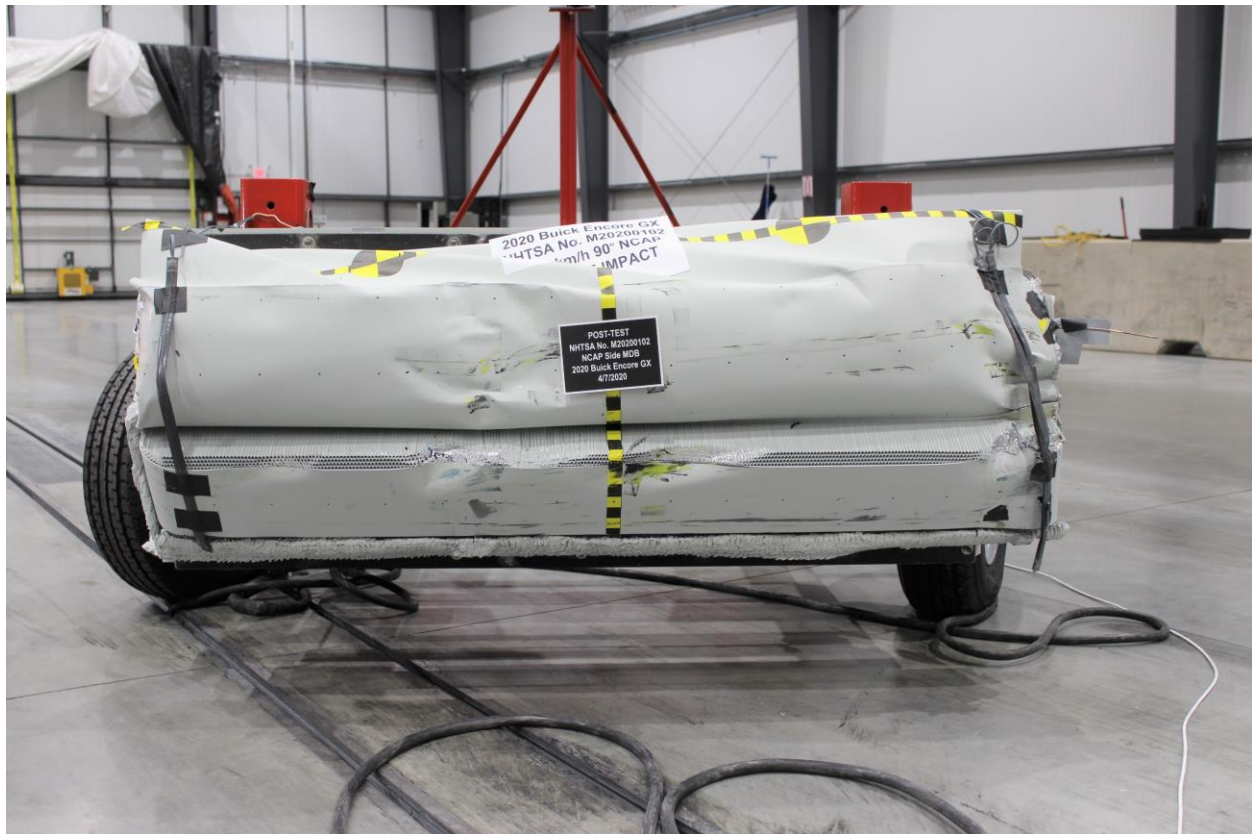
**Figure A-85: Post-Test Front View of MDB Impactor Face**

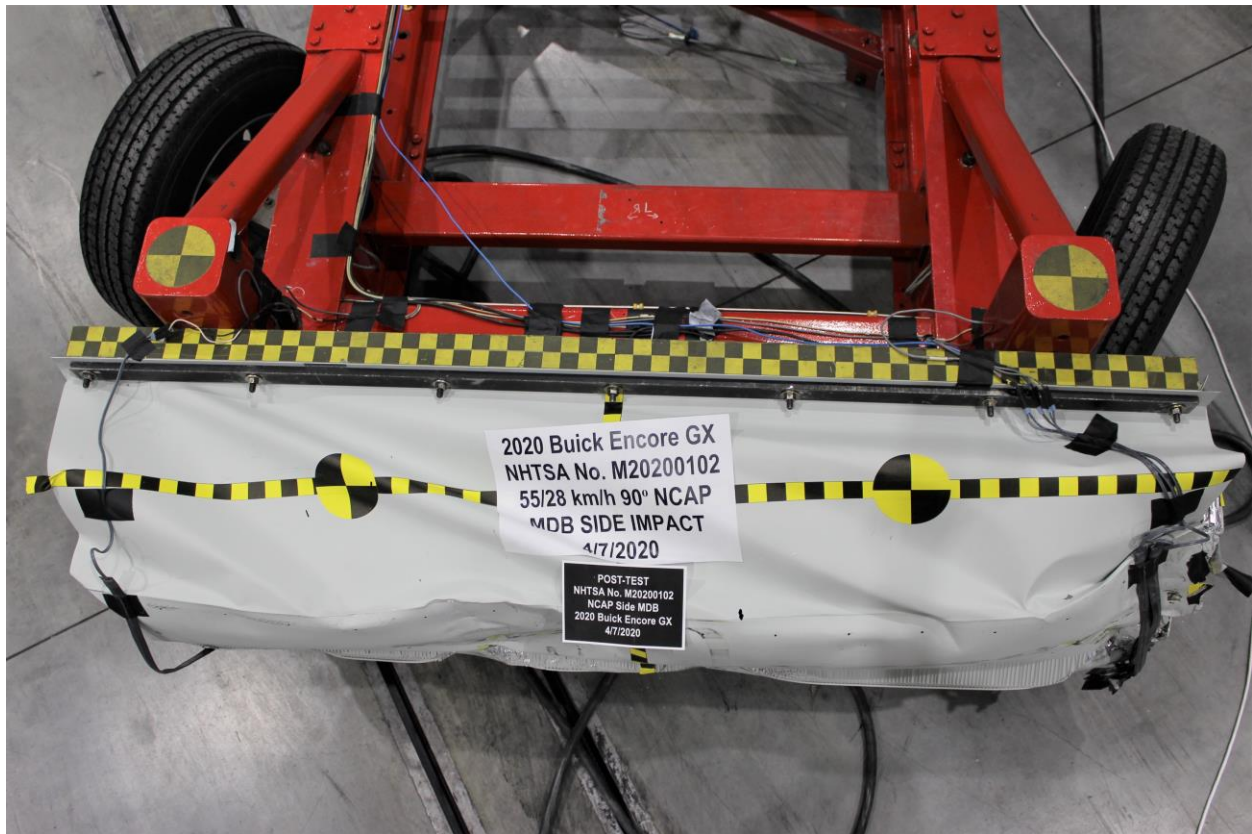
**Figure A-87: Post-Test Top View of MDB Impactor Face**

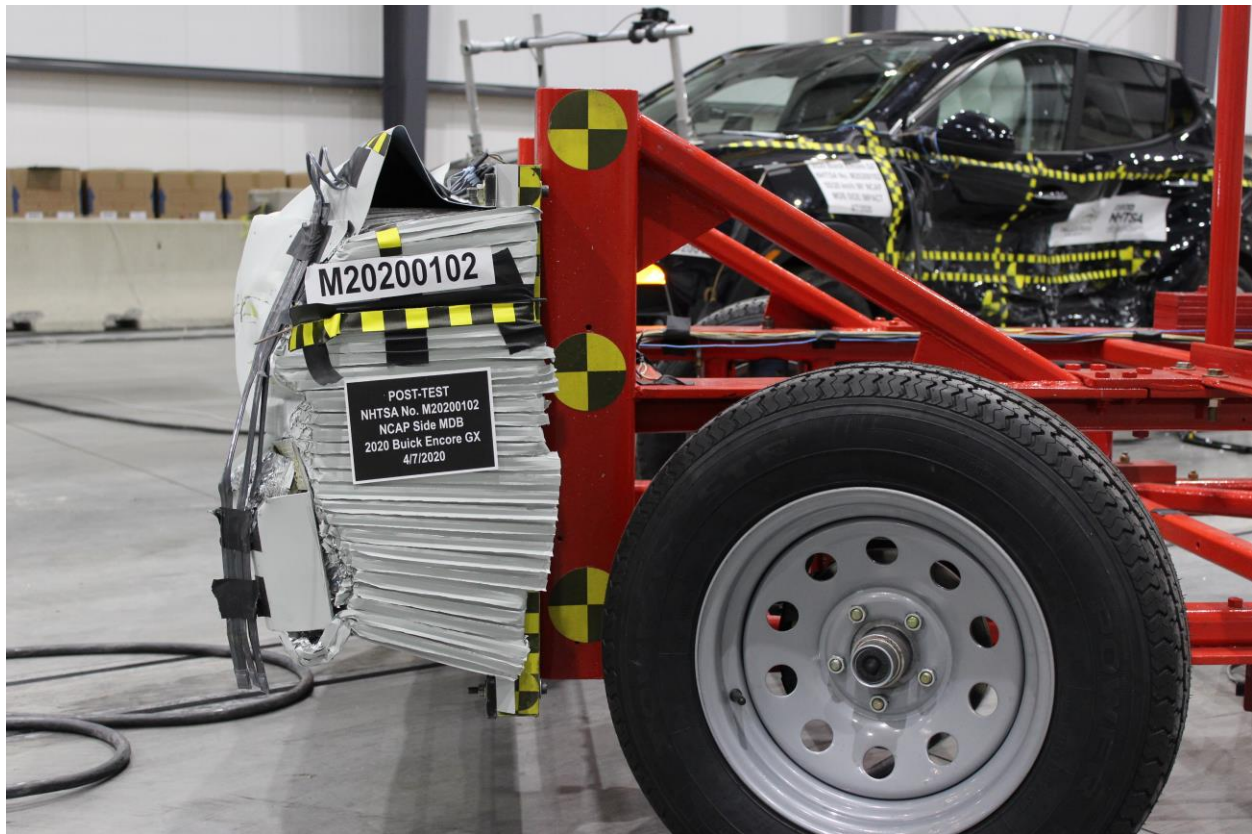
**Figure A-89: Post-Test Left Side View of MDB Impactor Face**
