**REPORT NUMBER: SPNCAP-CAL-20-009**

**NEW CAR ASSESSMENT PROGRAM (NCAP)  
SIDE IMPACT POLE TEST**

**KIA Motors Corporation  
2020 KIA Stinger GT-Line  
Four Door Sedan**

**NHTSA No: M20204216**

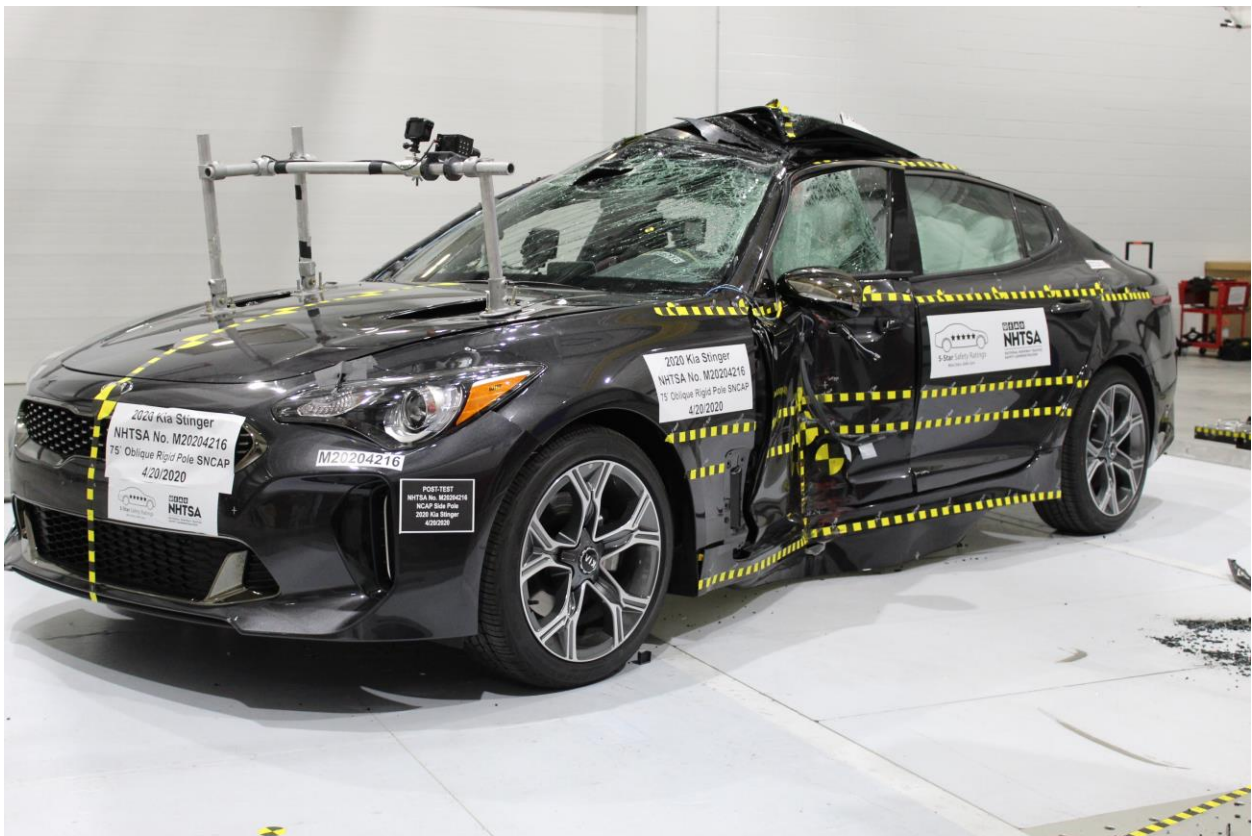
**Figure A-6: Post-Test Left Front ¾ View of Test Vehicle**

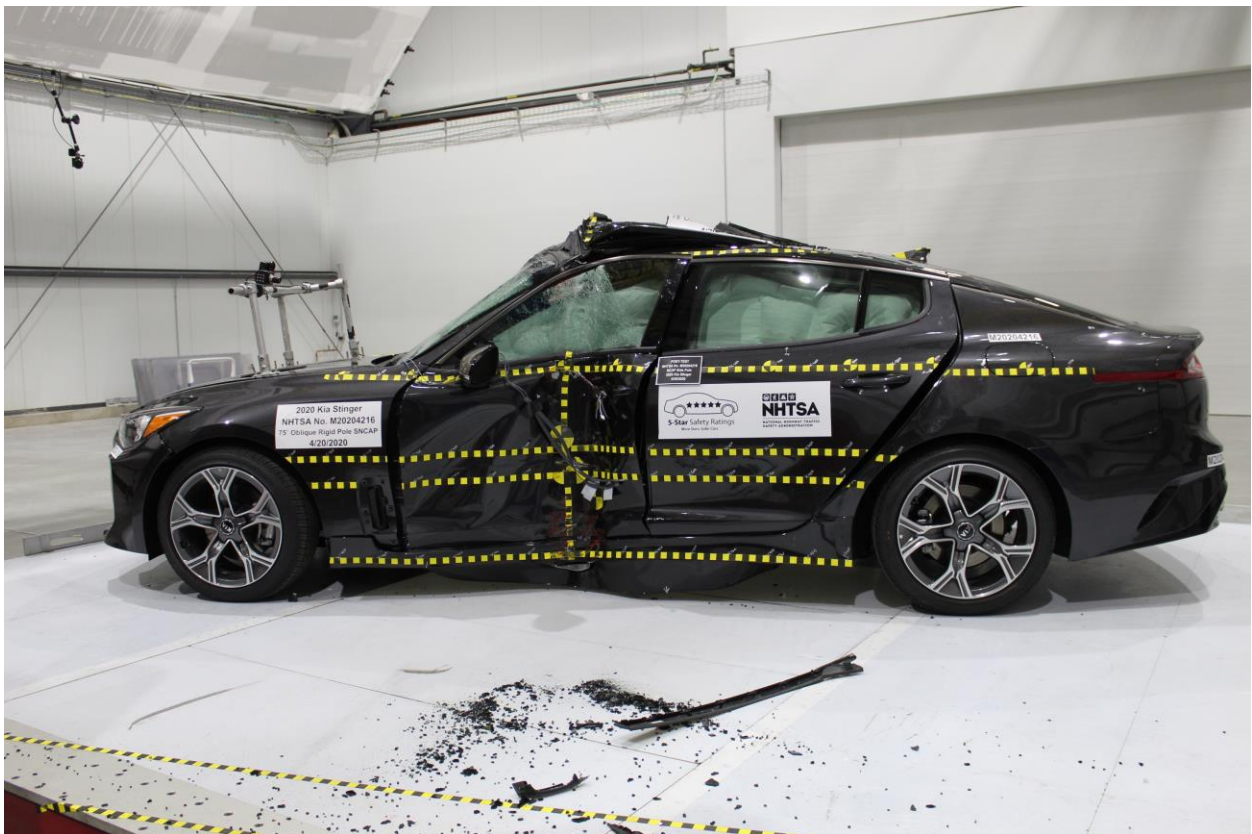
**Figure A-8: Post-Test Left Side View of Test Vehicle**

Critical Areas of Performance	Observations and Conclusions
Pillar Performance	A-Pillar & B-Pillar Buckled
Sill Separation	None
Windshield Damage	Cracks throughout with a hole at rearview mirror attachment
Side Window Damage	Driver window has cracks throughout
Other Notable Effects	Sunroof shattered

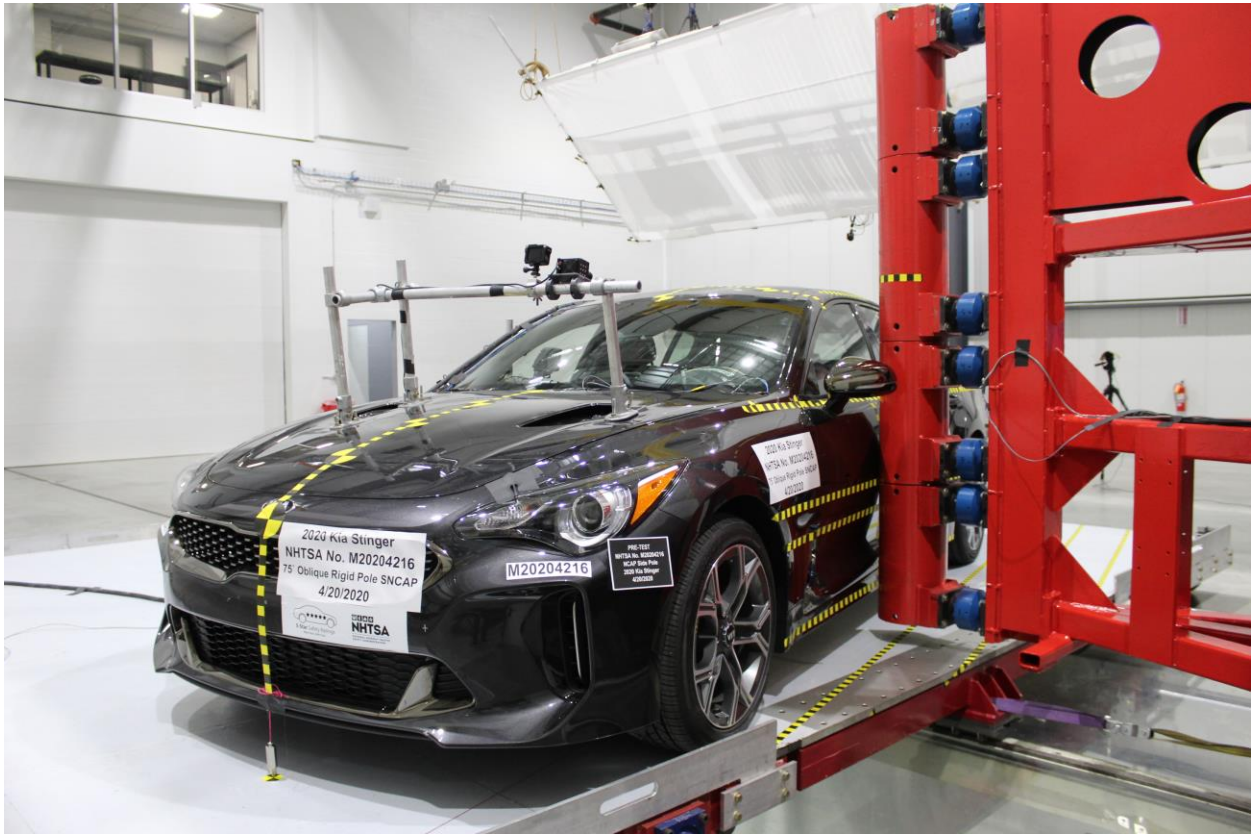
**Figure A-17: Pre-Test Left Side View of Pole Positioned Against Side of Vehicle**

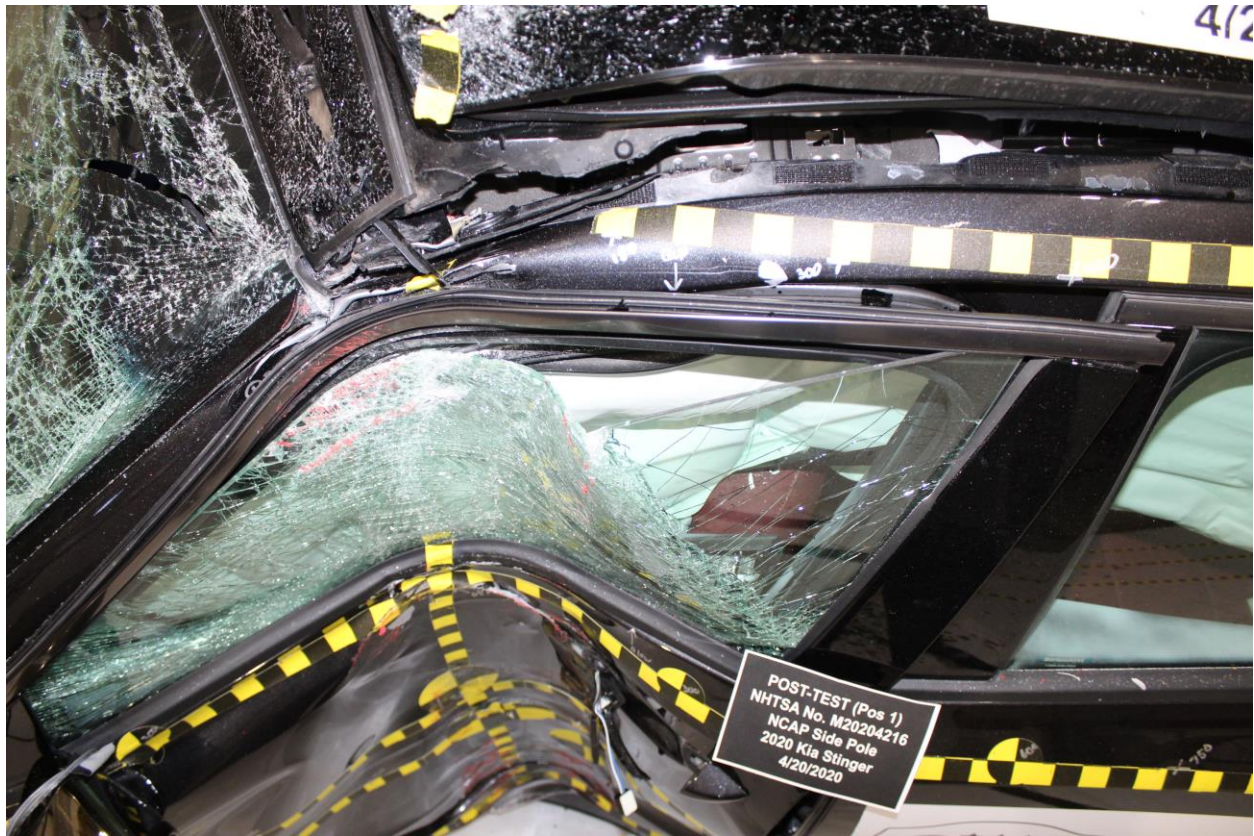
**Figure A-41: Post-Test Dummy and Door Clearance View**

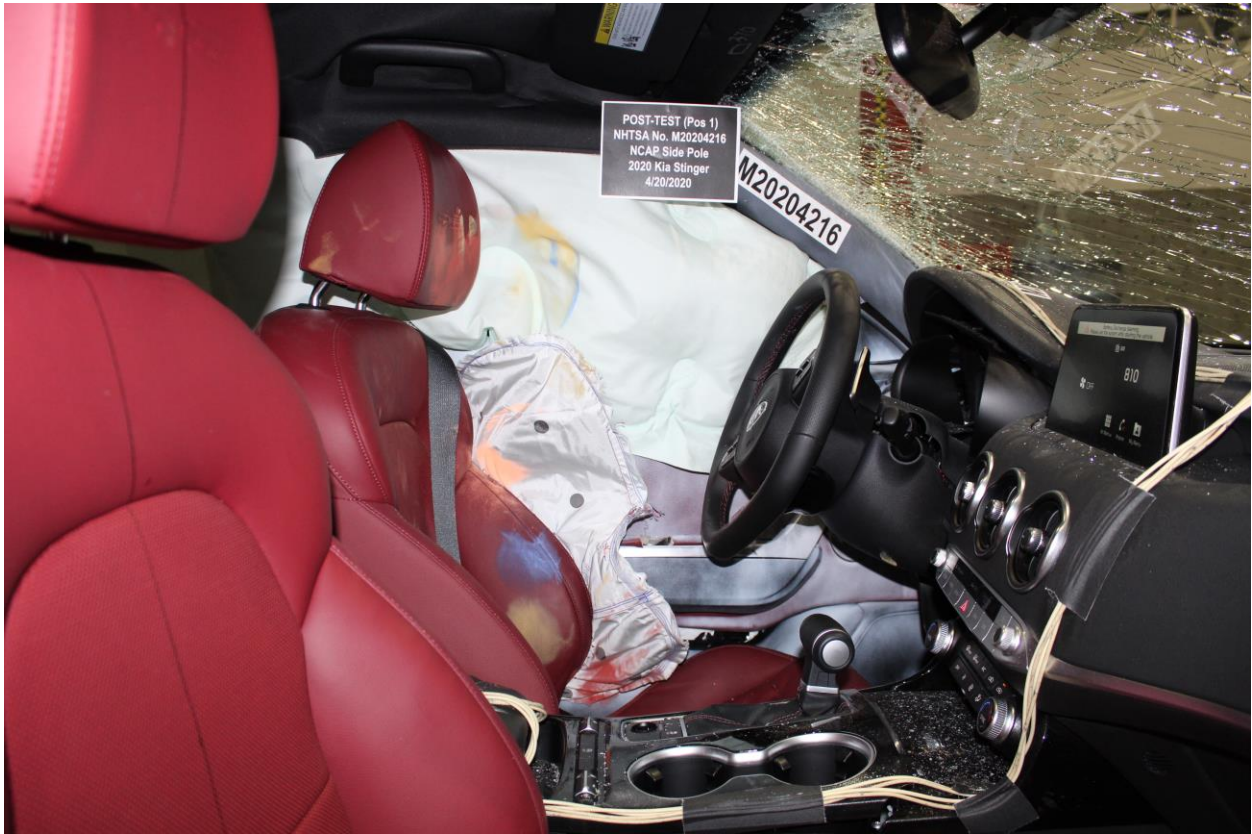
**Figure A-45: Post-Test Inner Door Panel View Showing Dummy Contact Location**

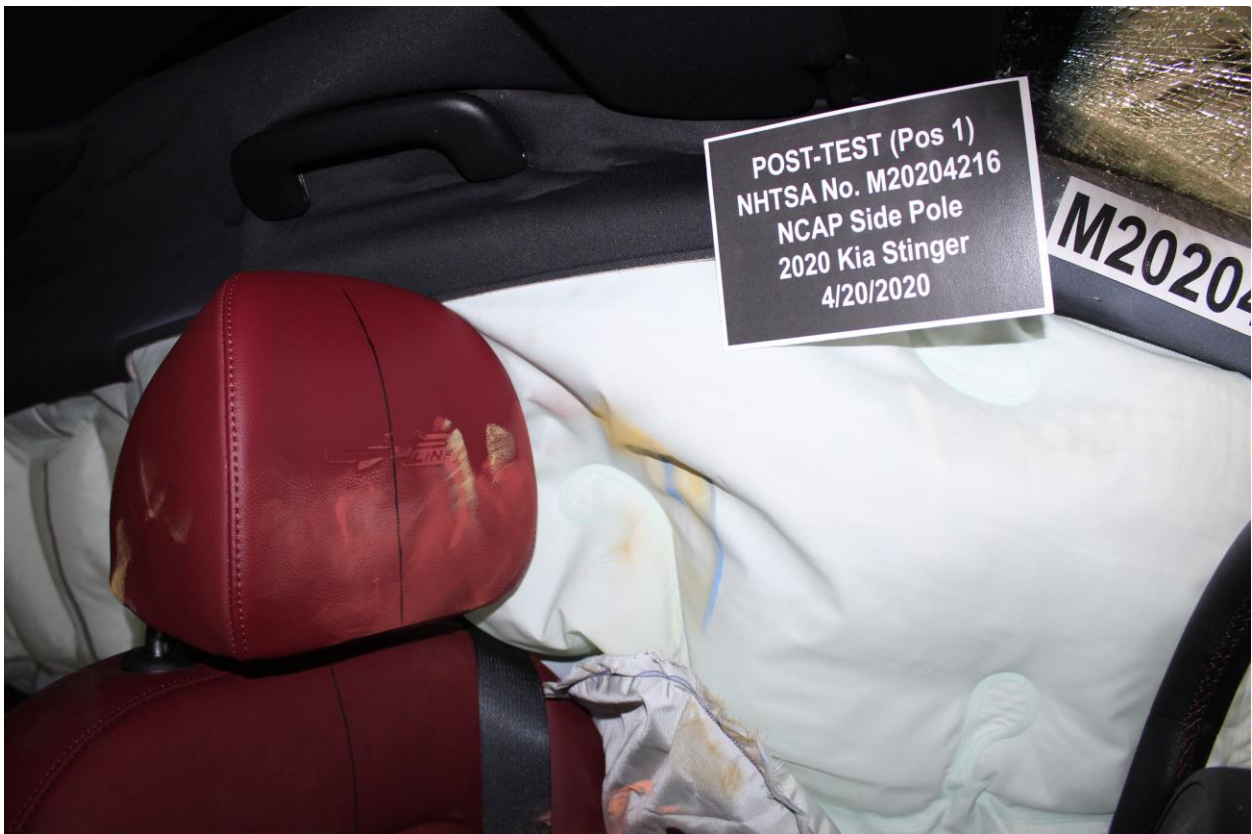
**Figure A-46: Post-Test Dummy Close-Up Head Contact with Vehicle Interior View**

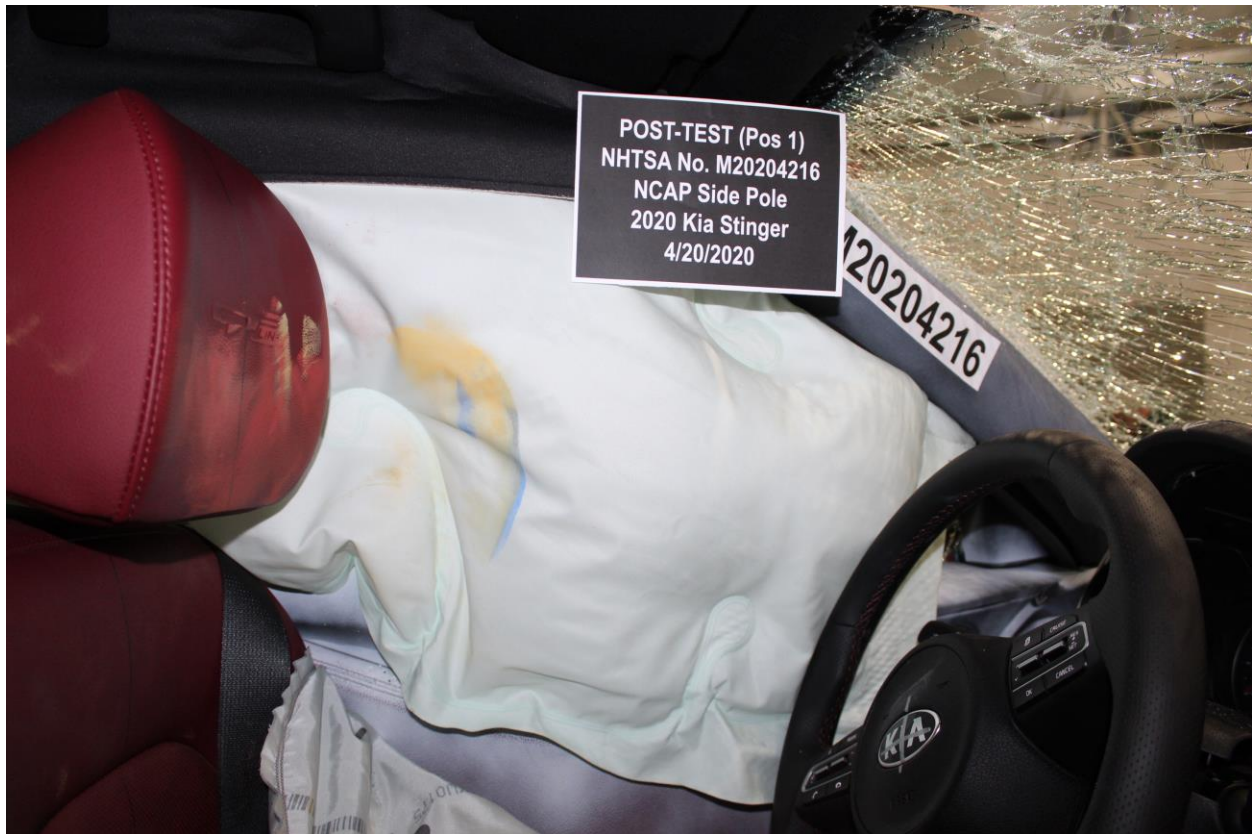
**Figure A-47: Post-Test Dummy Close-Up Head Contact with Side Airbag View**

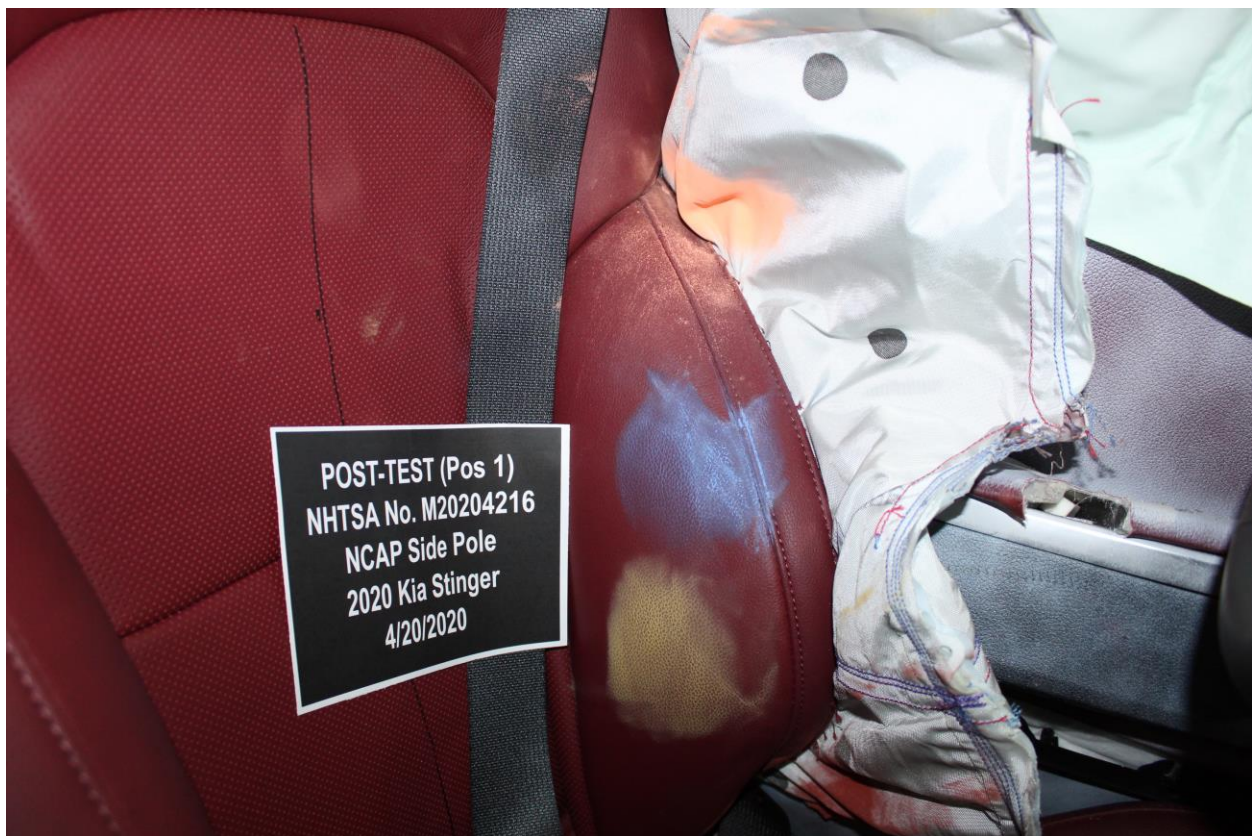
**Figure A-48: Post-Test Dummy Close-Up Torso Contact with Vehicle Interior View**

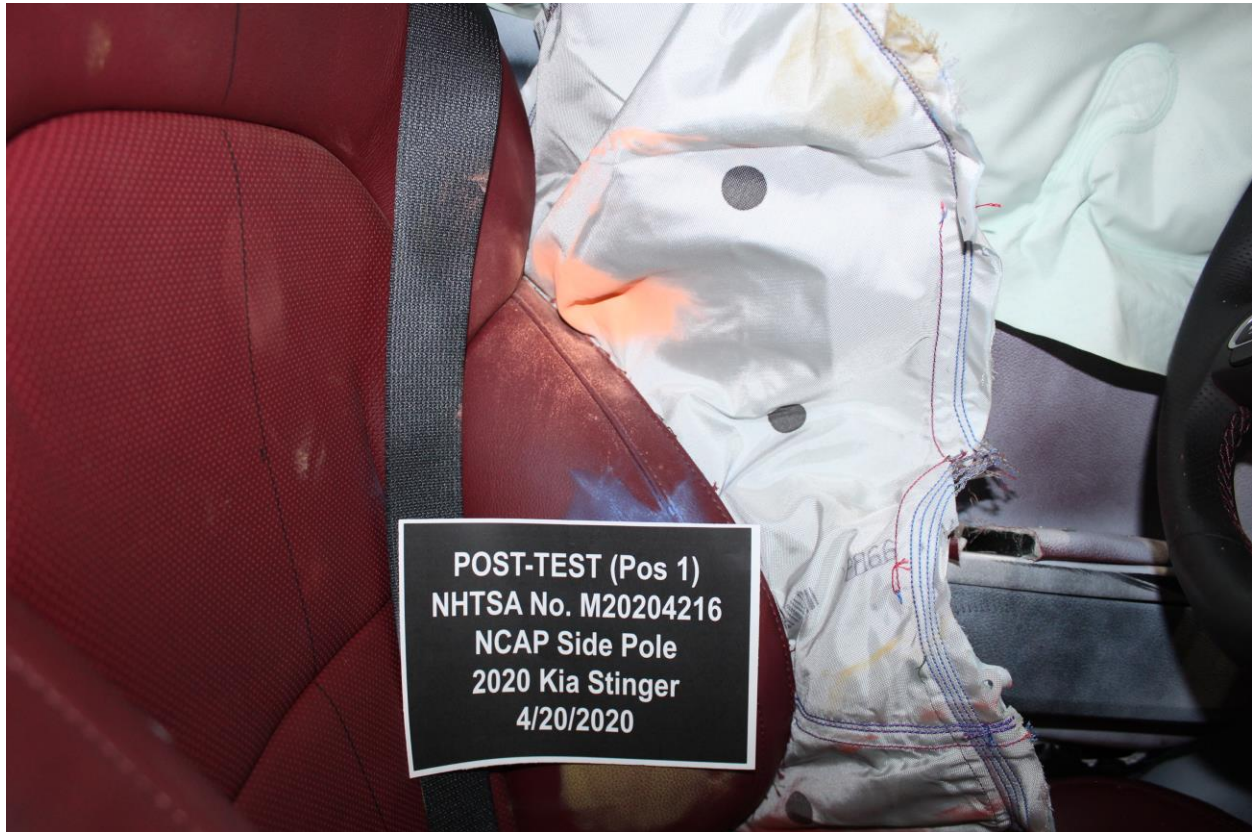
**Figure A-49: Post-Test Dummy Close-Up Torso Contact with Side Airbag View**

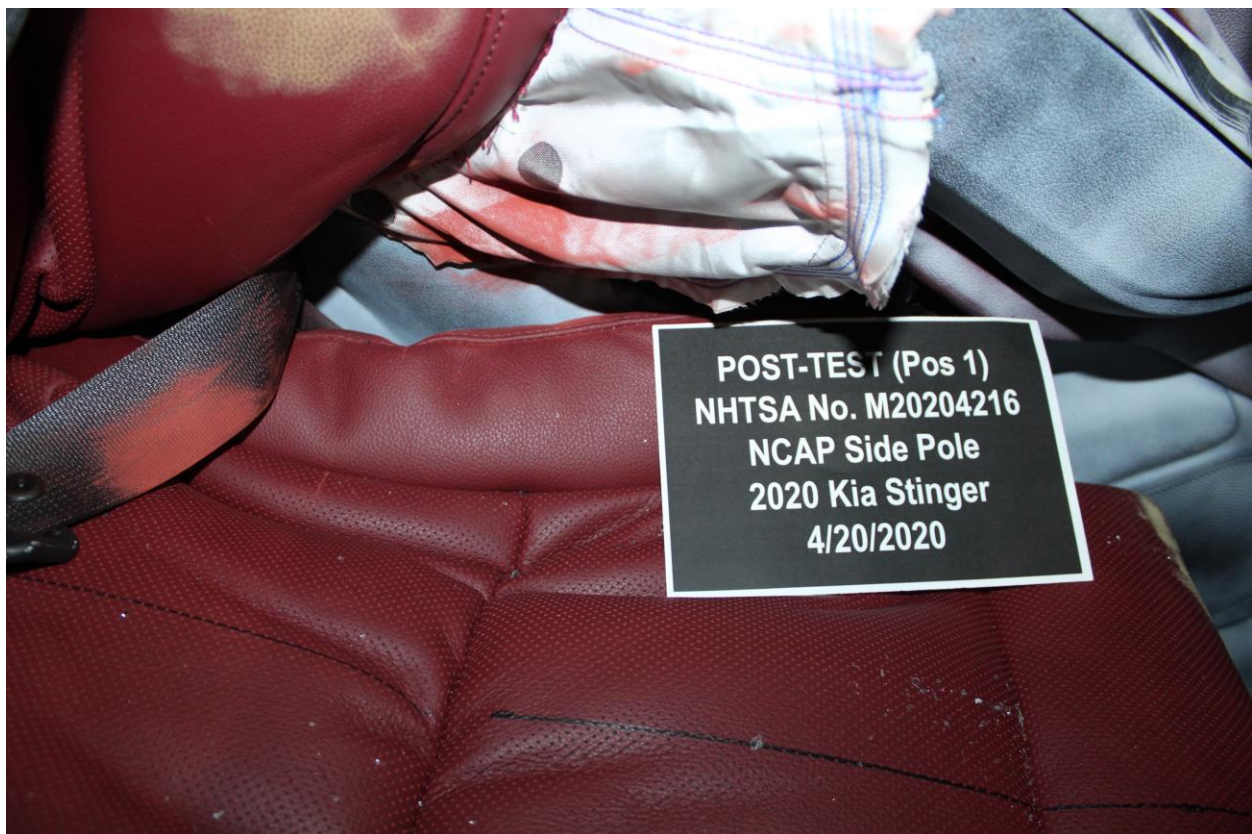
**Figure A-50: Post-Test Dummy Close-Up Pelvis Contact with Vehicle Interior View**

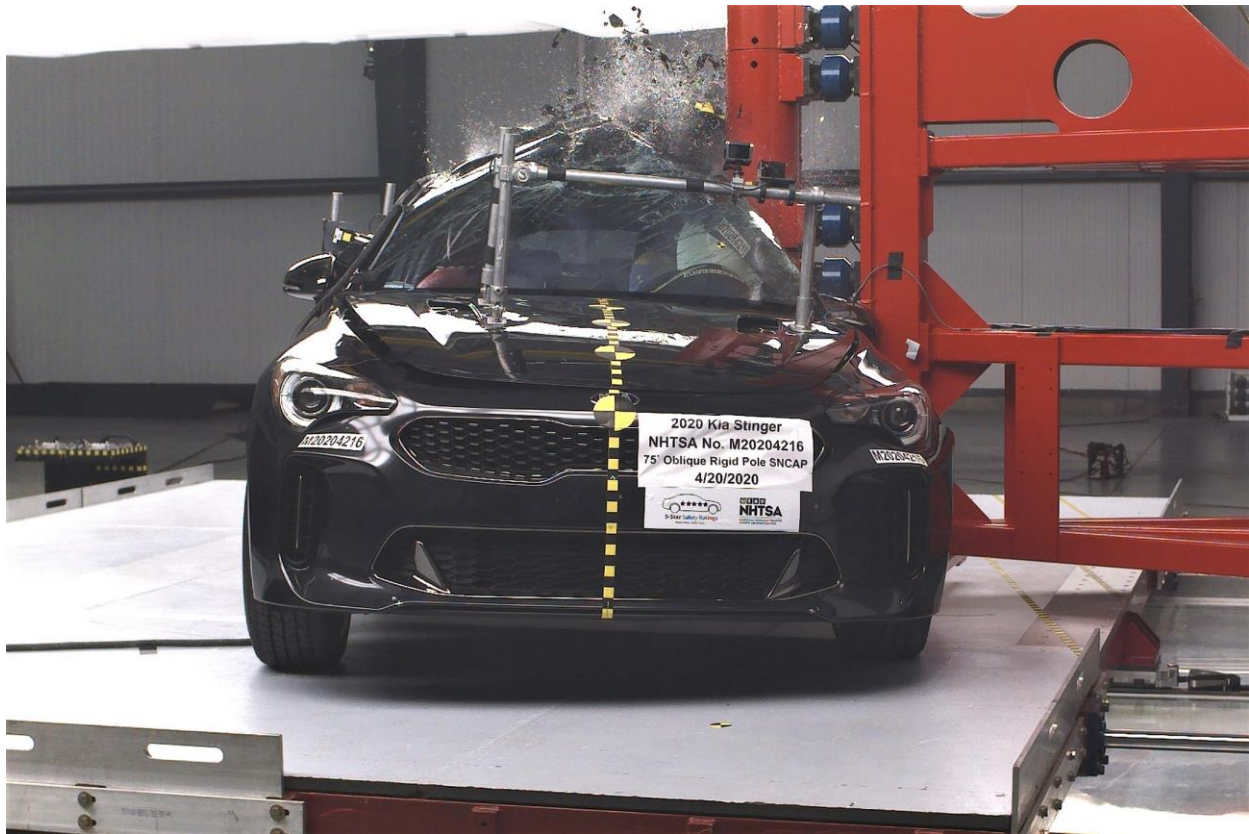
Figure A-68: Impact Event

A rigid pole side impact test was conducted on a 2020 KIA Stinger GT-Line four door sedan. The subject vehicle was towed into the rigid pole at an angle of 75° and a velocity of 32.22 km/h. The test was conducted by Calspan Corporation's Transportation Test Operations facility in Buffalo, New York on April 20, 2020. Pre-test and post-test photographs of the test vehicle and side impact dummy (SID-IIs) are included in Appendix A of this report.
