REPORT NUMBER: SINCAP-CAL-20-009

NEW CAR ASSESSMENT PROGRAM (NCAP) MOVING DEFORMABLE BARRIER SIDE IMPACT TEST

KIA Motors Corporation 2020 KIA Stinger GT-Line Four Door Sedan

NHTSA No: M20204217

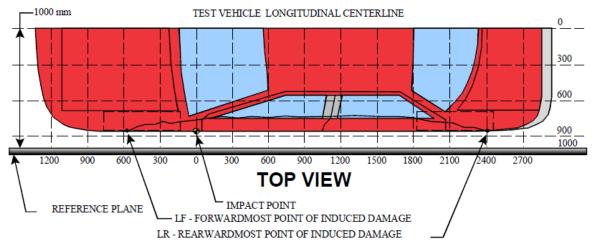
DATA SHEET NO. 13 VEHICLE AND MDB DAMAGE PROFILE DISTANCES

For guidance regarding damage profile distance measurements, pelase refer to the latest version of the *NHTSA Test Reference Guide*, *Volume 1: Vehicle Tests*.

MEASUREMENT CONVENTIONS:

Forward of the impact point (towards front of vehicle) is considered negative (—). Rearward of the impact point (toward rearend of vehicle) is considered positive (+).

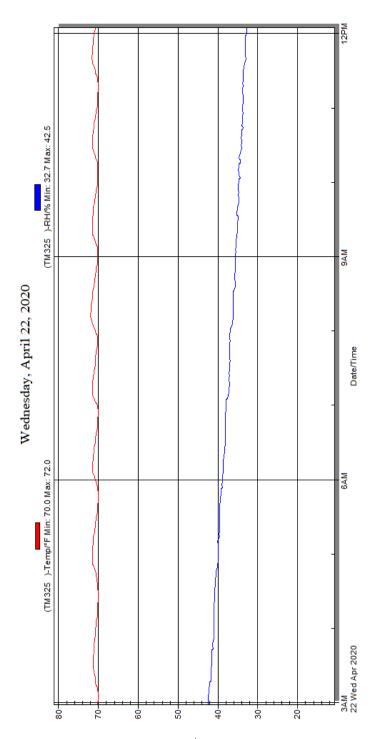
DATA SHEET NO. 15 DUMMY/VEHICLE TEMPERATURE AND HUMIDITY STABILIZATION DATA

Temperature and Humidity Stabilization Chart/Data for Dummies and Test Vehicle

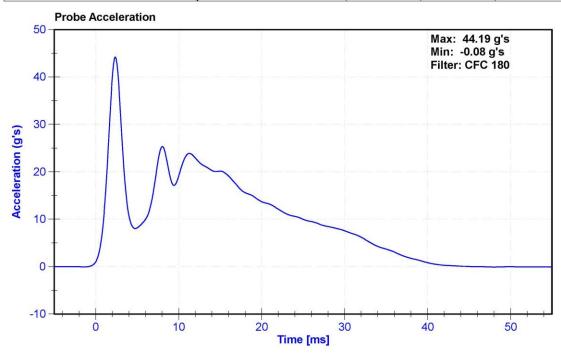
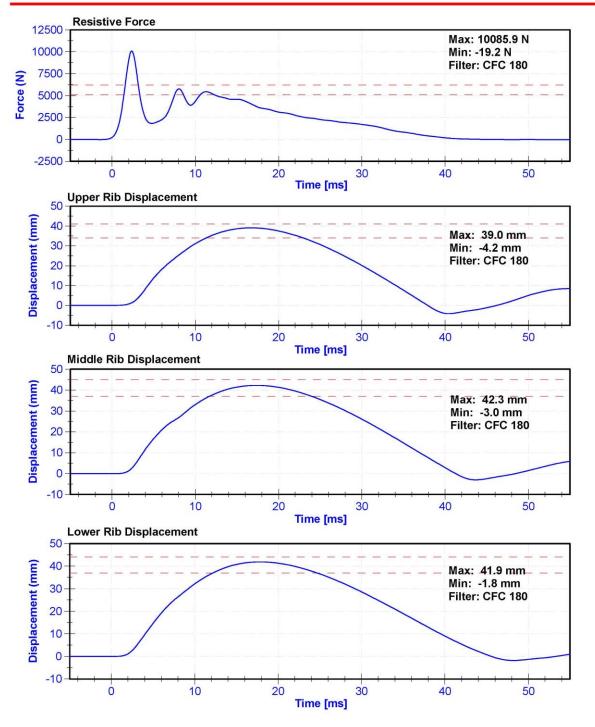
Certification Report ES-2re Thorax Impact - CFR 572

Test Parameter	Minimum Specification	Maximum Specification	Unit	Result	Pass/Fail
Temperature	20.6	22.2	°C	20.7	Pass
Humidity	10	70	%	29.0	Pass
Velocity	5.4	5.6	m/s	5.44	Pass
Resistive Force after 6ms	5100	6200	N	5778.0	Pass
Upper Thorax Rib Deflection	34	41	mm	39.0	Pass
Mid Thorax Rib Deflection	37	45	mm	42.3	Pass
Lower Thorax Rib Deflection	37	44	mm	41.9	Pass

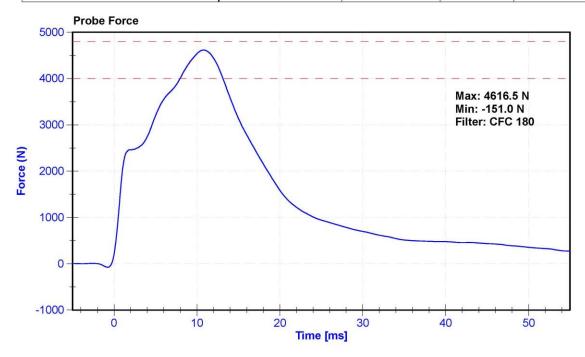
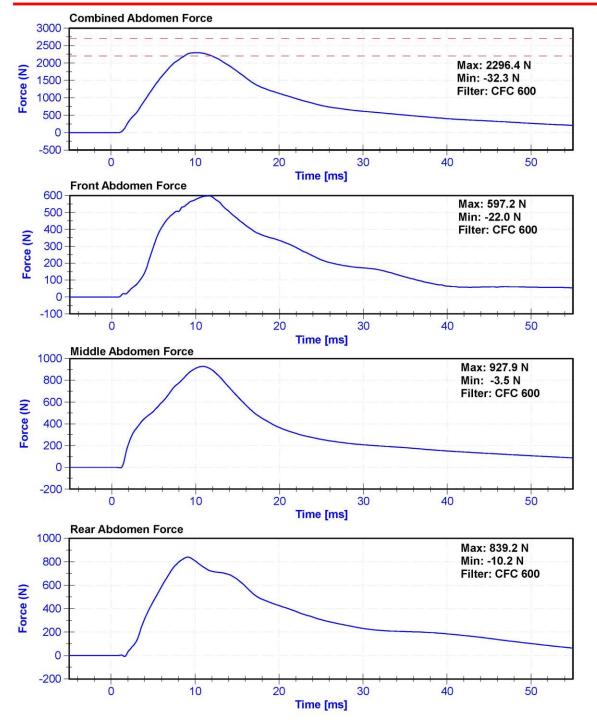
Certification Report ES-2re Abdomen Impact - CFR 572

Test Parameter	Minimum Specification	Maximum Specification	Unit	Result	Pass/Fail
Temperature	20.6	22.2	°C	20.7	Pass
Humidity	10	70	%	29	Pass
Velocity	3.9	4.1	m/s	4.09	Pass
Combined Abdomen Force	2200	2700	N	2296.4	Pass
Time at Peak Abdomen Force	10.0	12.3	ms	10.15	Pass
Resistive Probe Force	4000	4800	N	4616.5	Pass
Time at Peak Resistive Force	10.6	13.0	ms	10.80	Pass
