**REPORT NUMBER: NCAP-CAL-20-013**

**NEW CAR ASSESSMENT PROGRAM (NCAP)  
FRONTAL BARRIER IMPACT TEST**

**KIA Motors Corporation  
2020 KIA Stinger GT-Line  
Four Door Sedan**

**NHTSA No: M20204215**

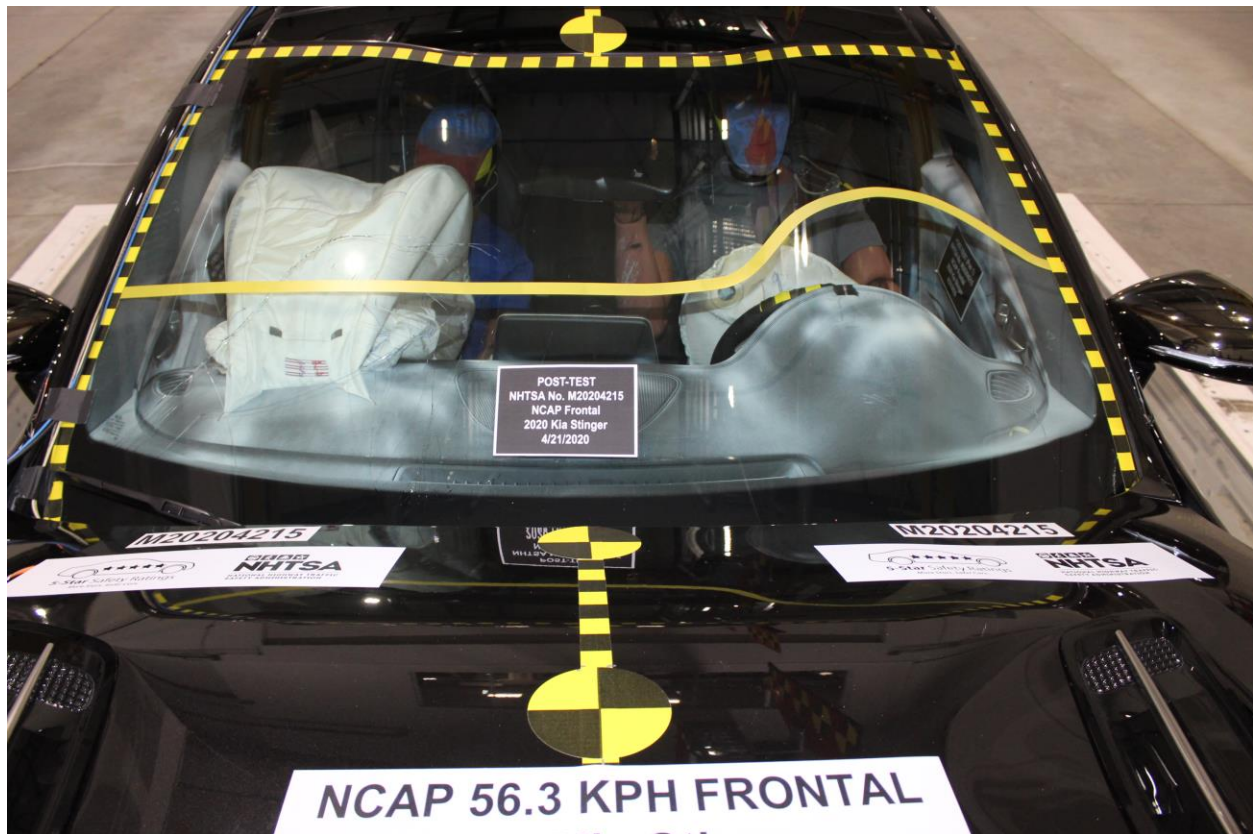
Figure A-19: Post-Test Windshield View

Critical Areas of Performance	Observations and Conclusions
Windshield Damage	Minor cracks along passenger side
Window Damage	None
Other	None
