**NEW CAR ASSESSMENT PROGRAM
LANE DEPARTURE WARNING CONFIRMATION TEST
NCAP-DRI-LDW-20-13**

2020 Mazda CX-30

DYNAMIC RESEARCH, INC.

Final Report

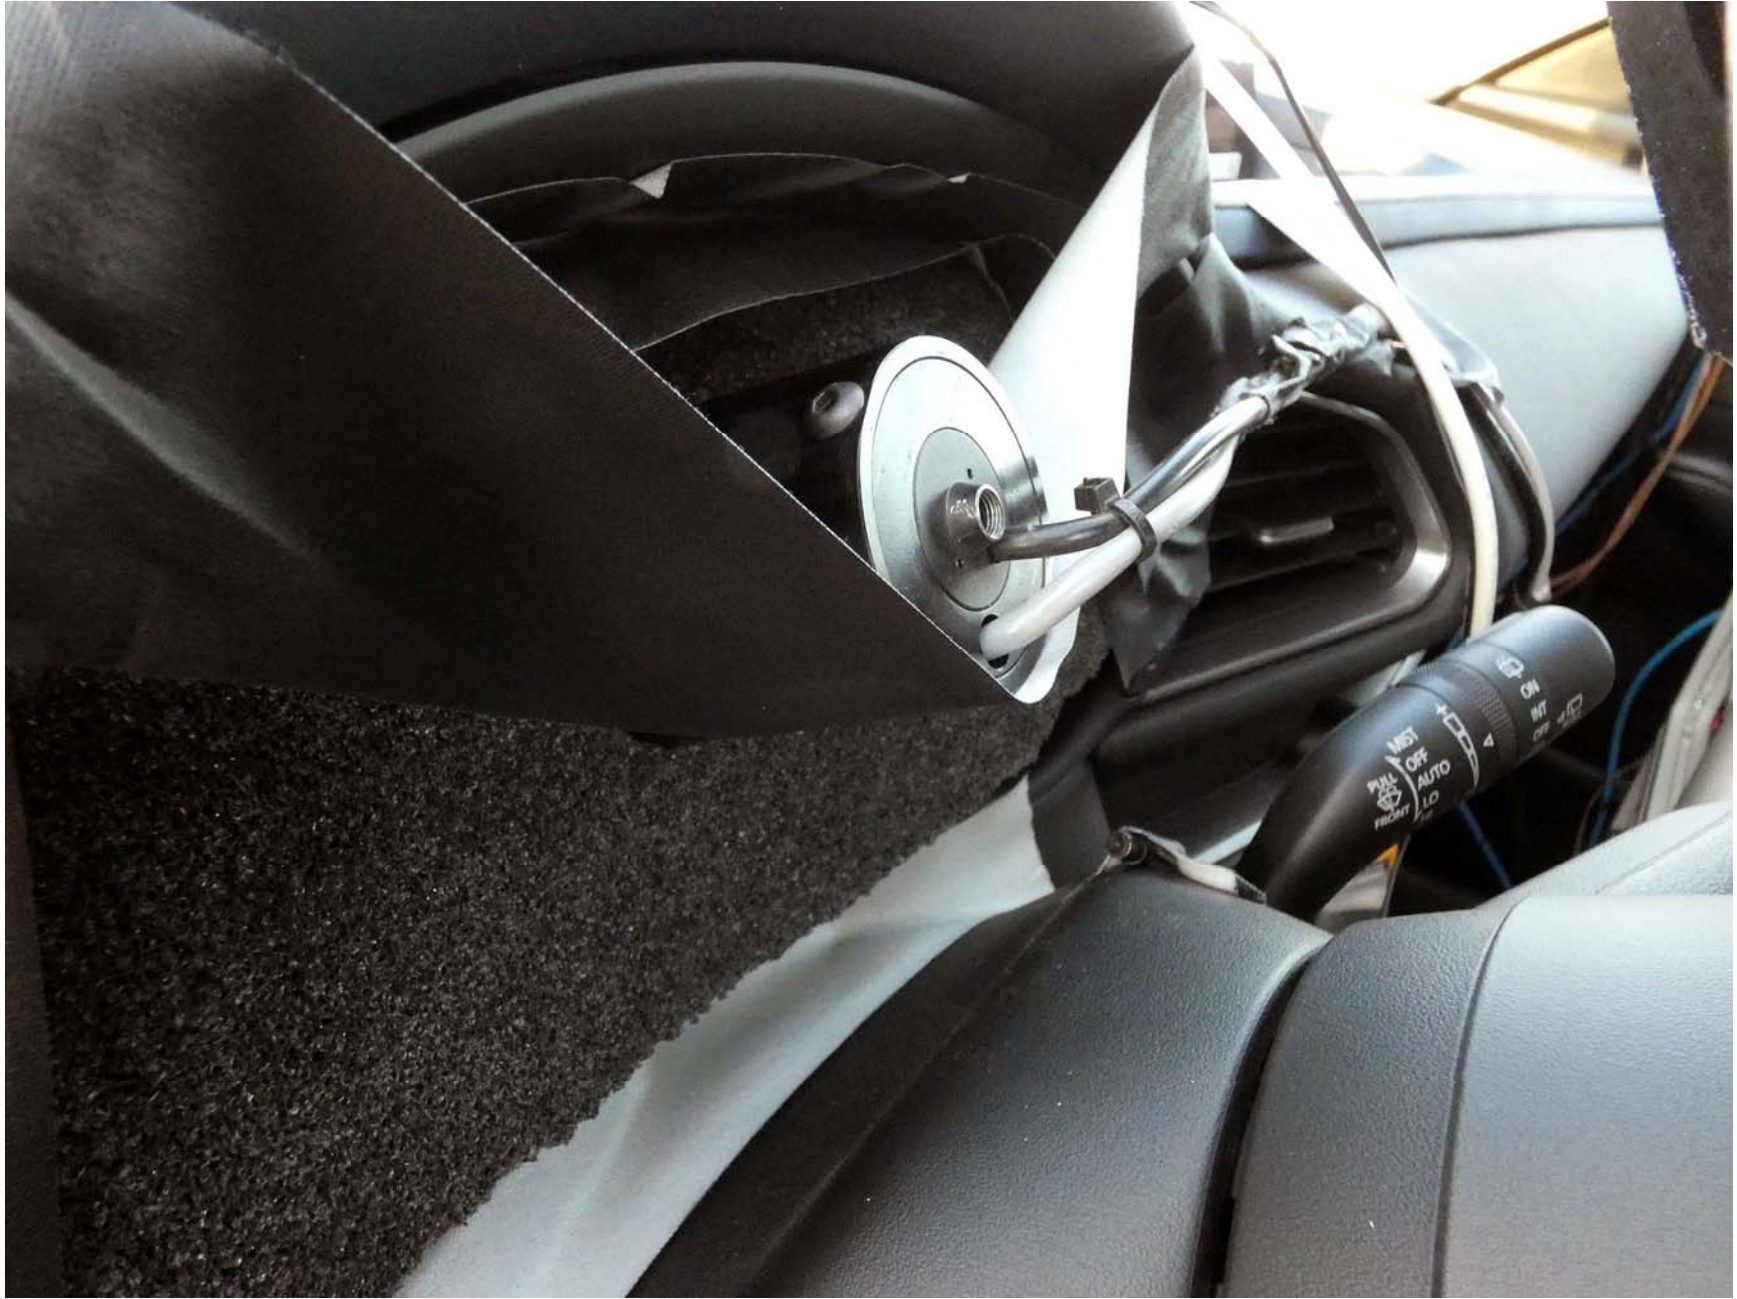
Figure A7. Sensor for Detecting Visual Alerts

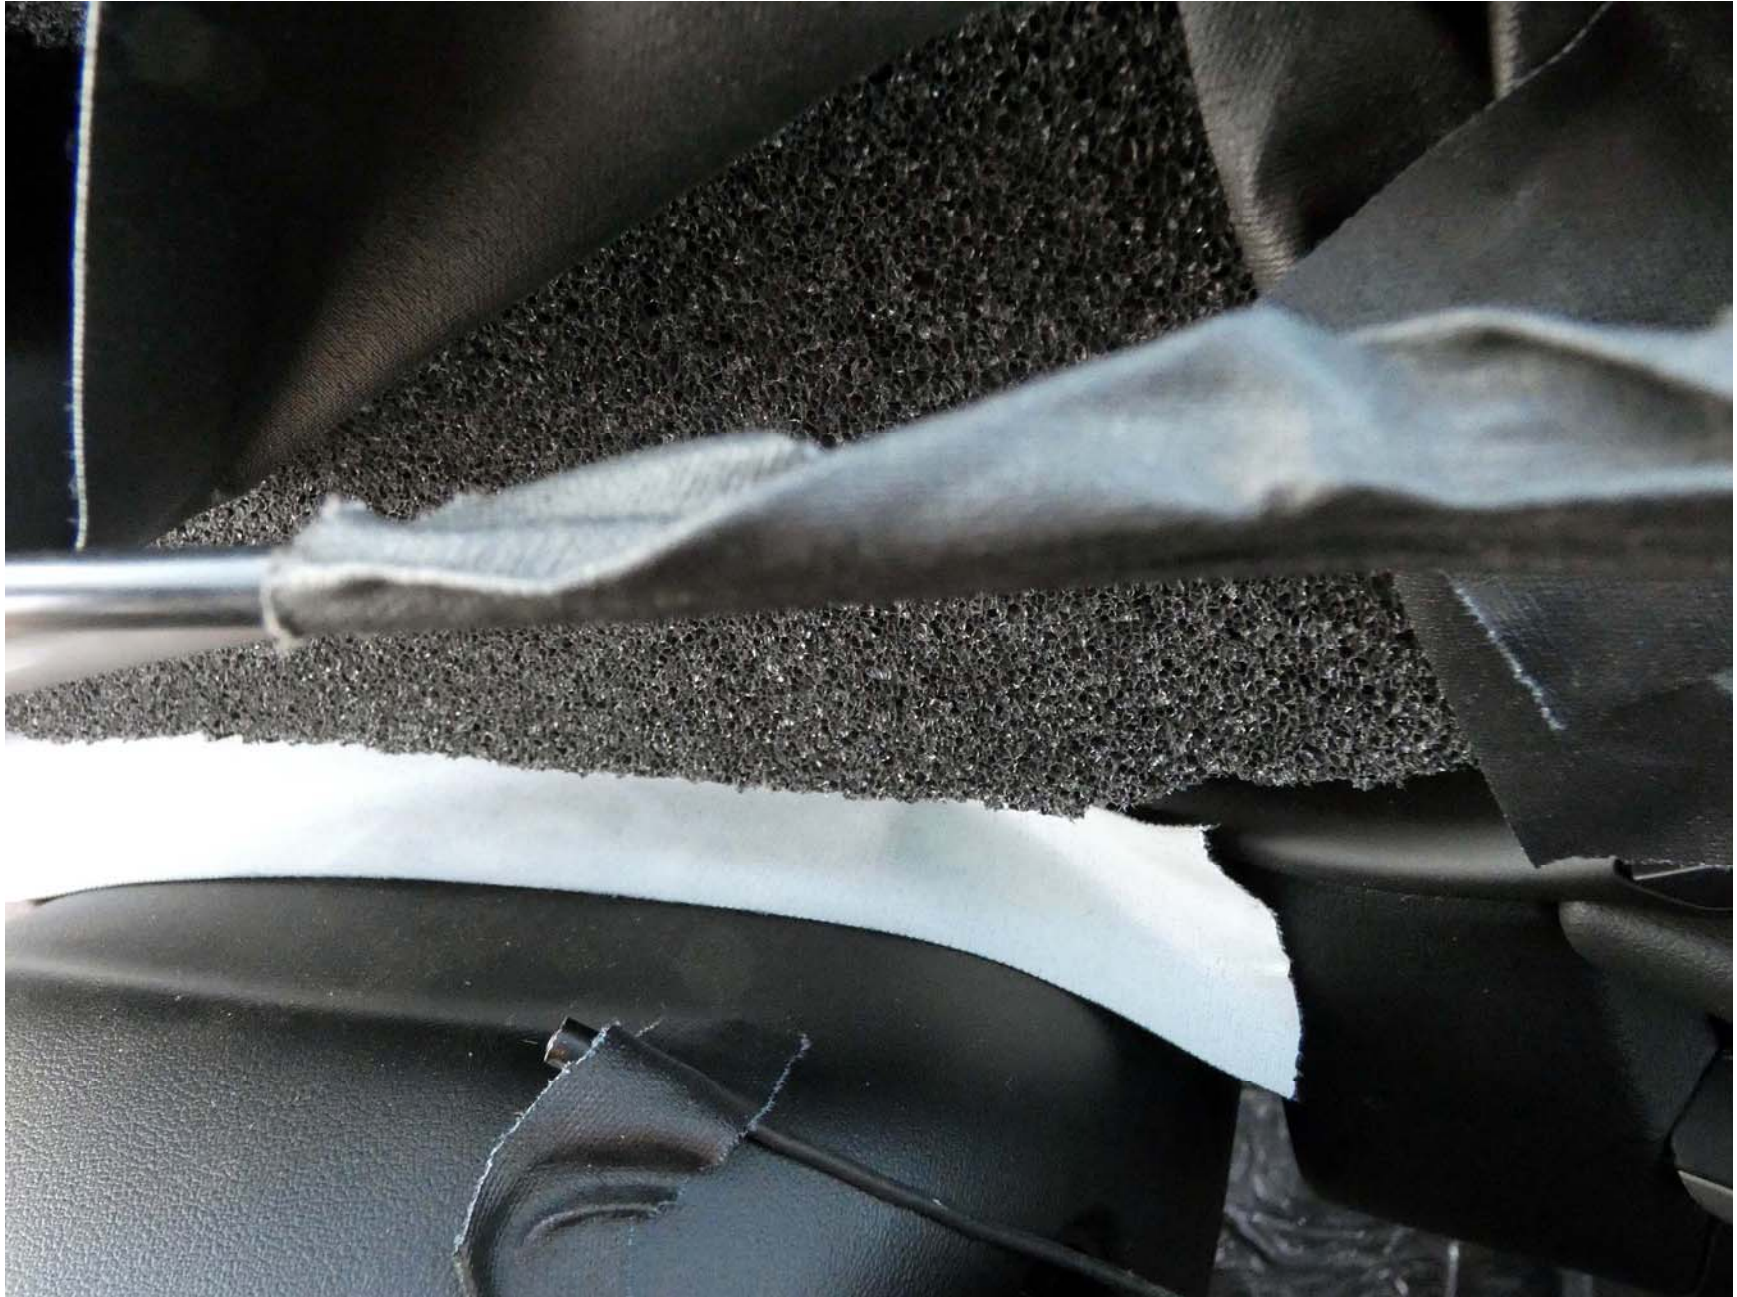
Figure A8. Sensor for Detecting Auditory Alerts

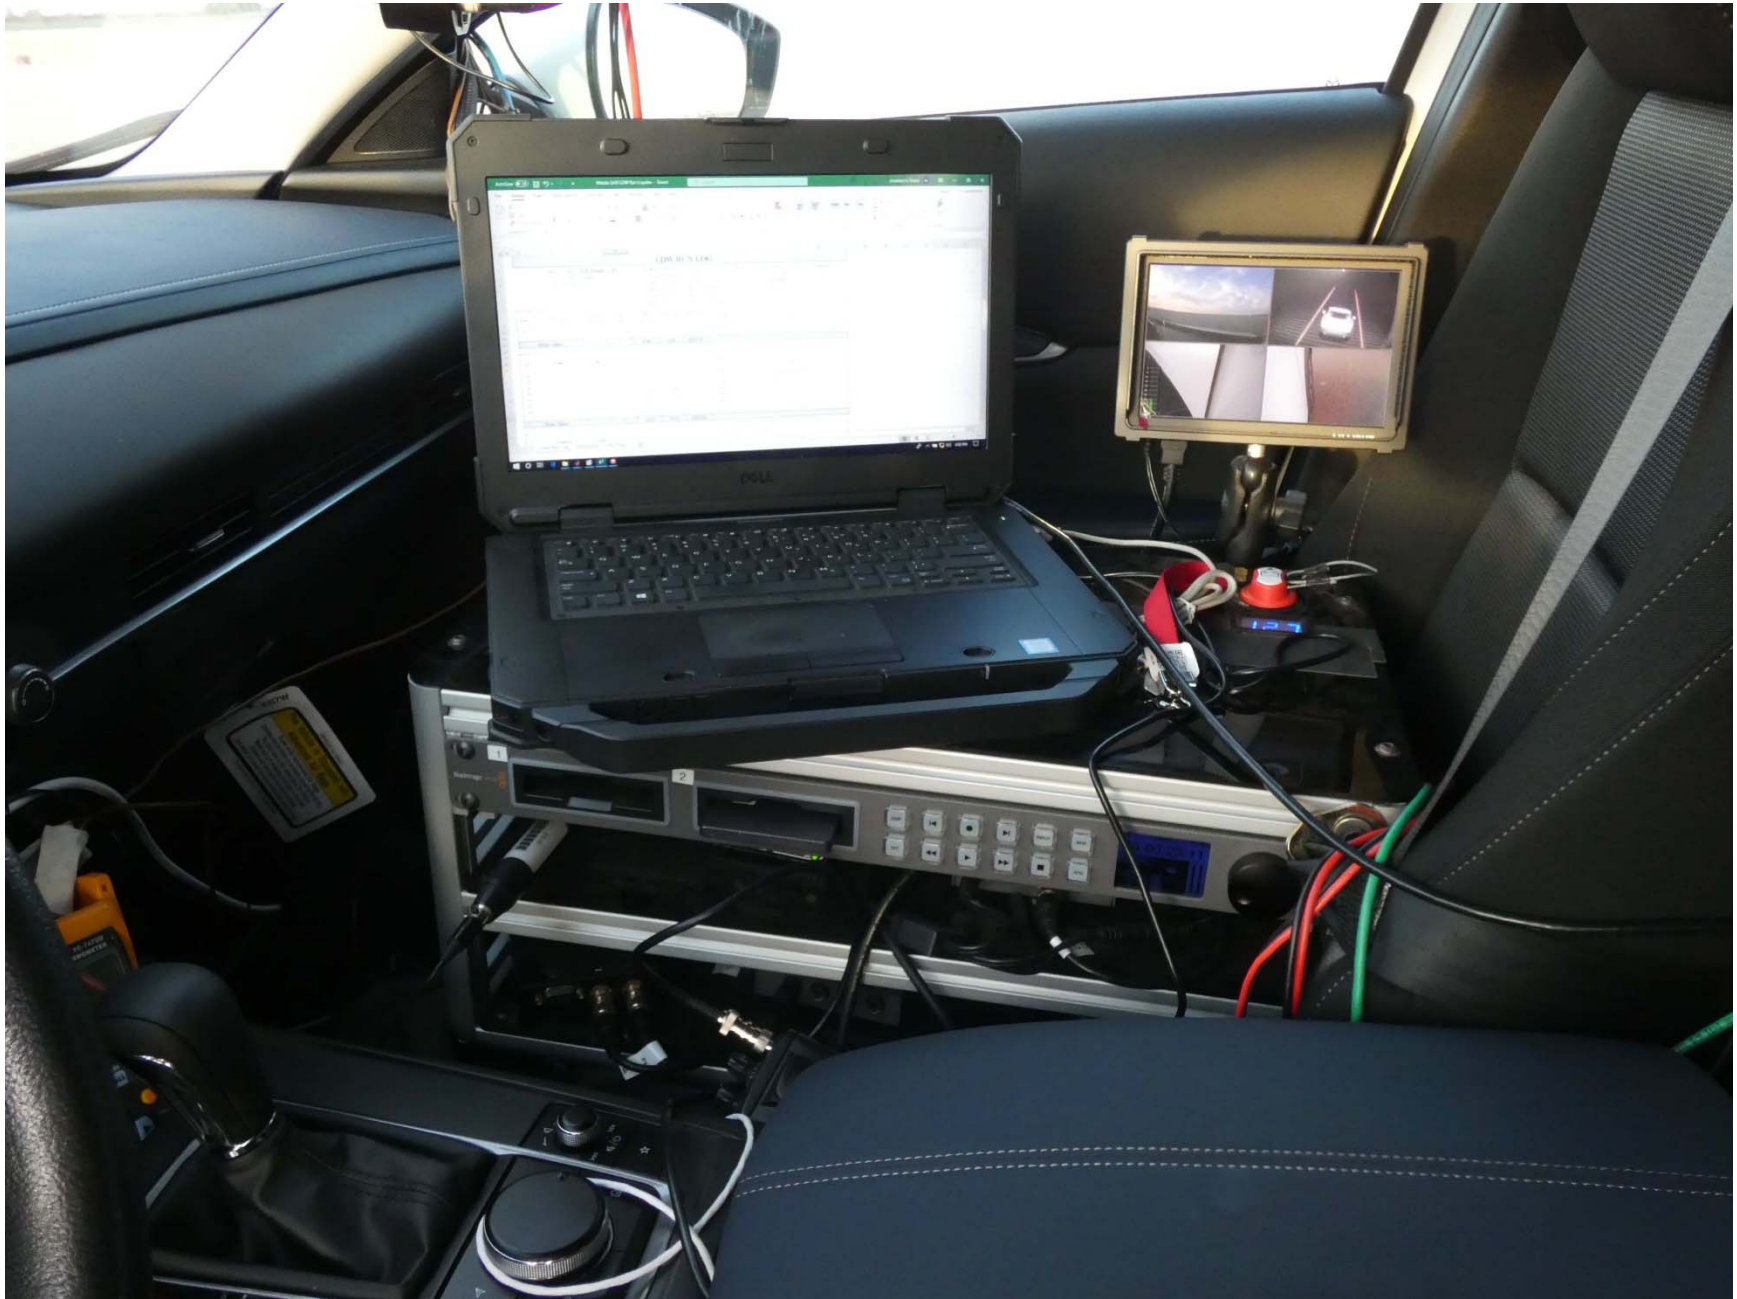
Figure A9. Computer Installed in Subject Vehicle

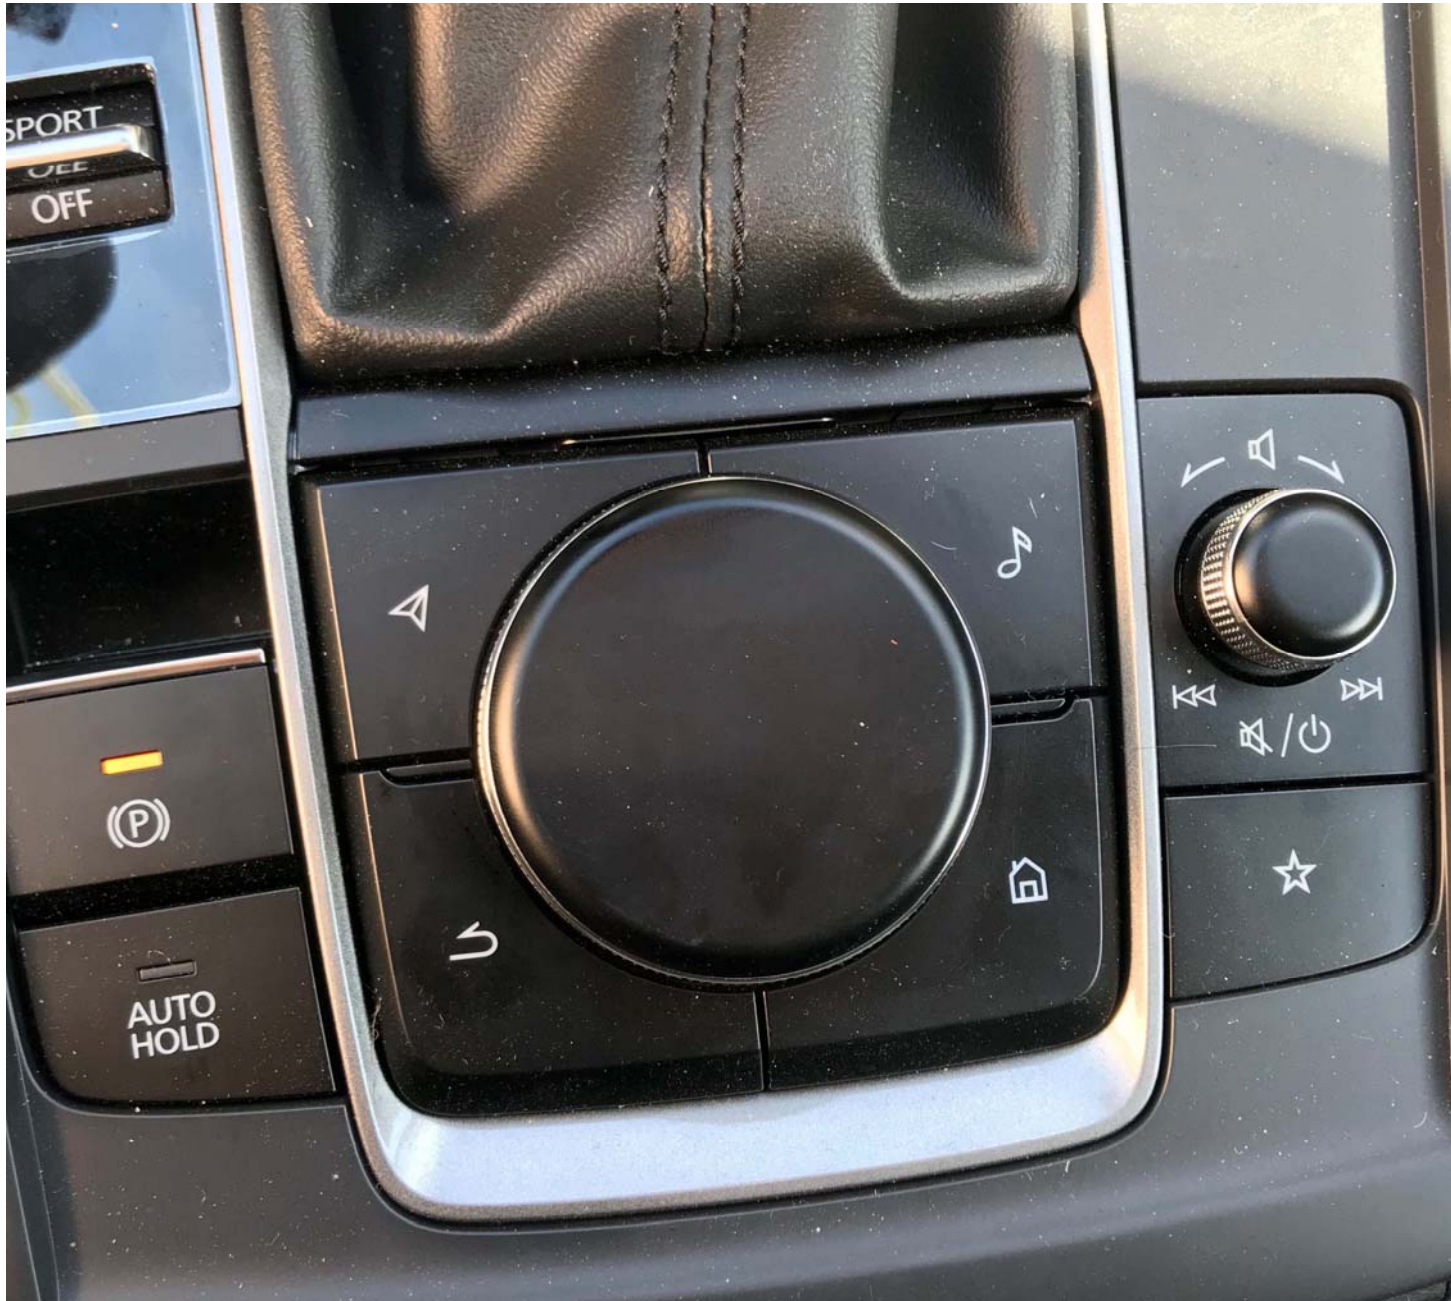
Figure A10. Controls for Interacting with LDW Settings

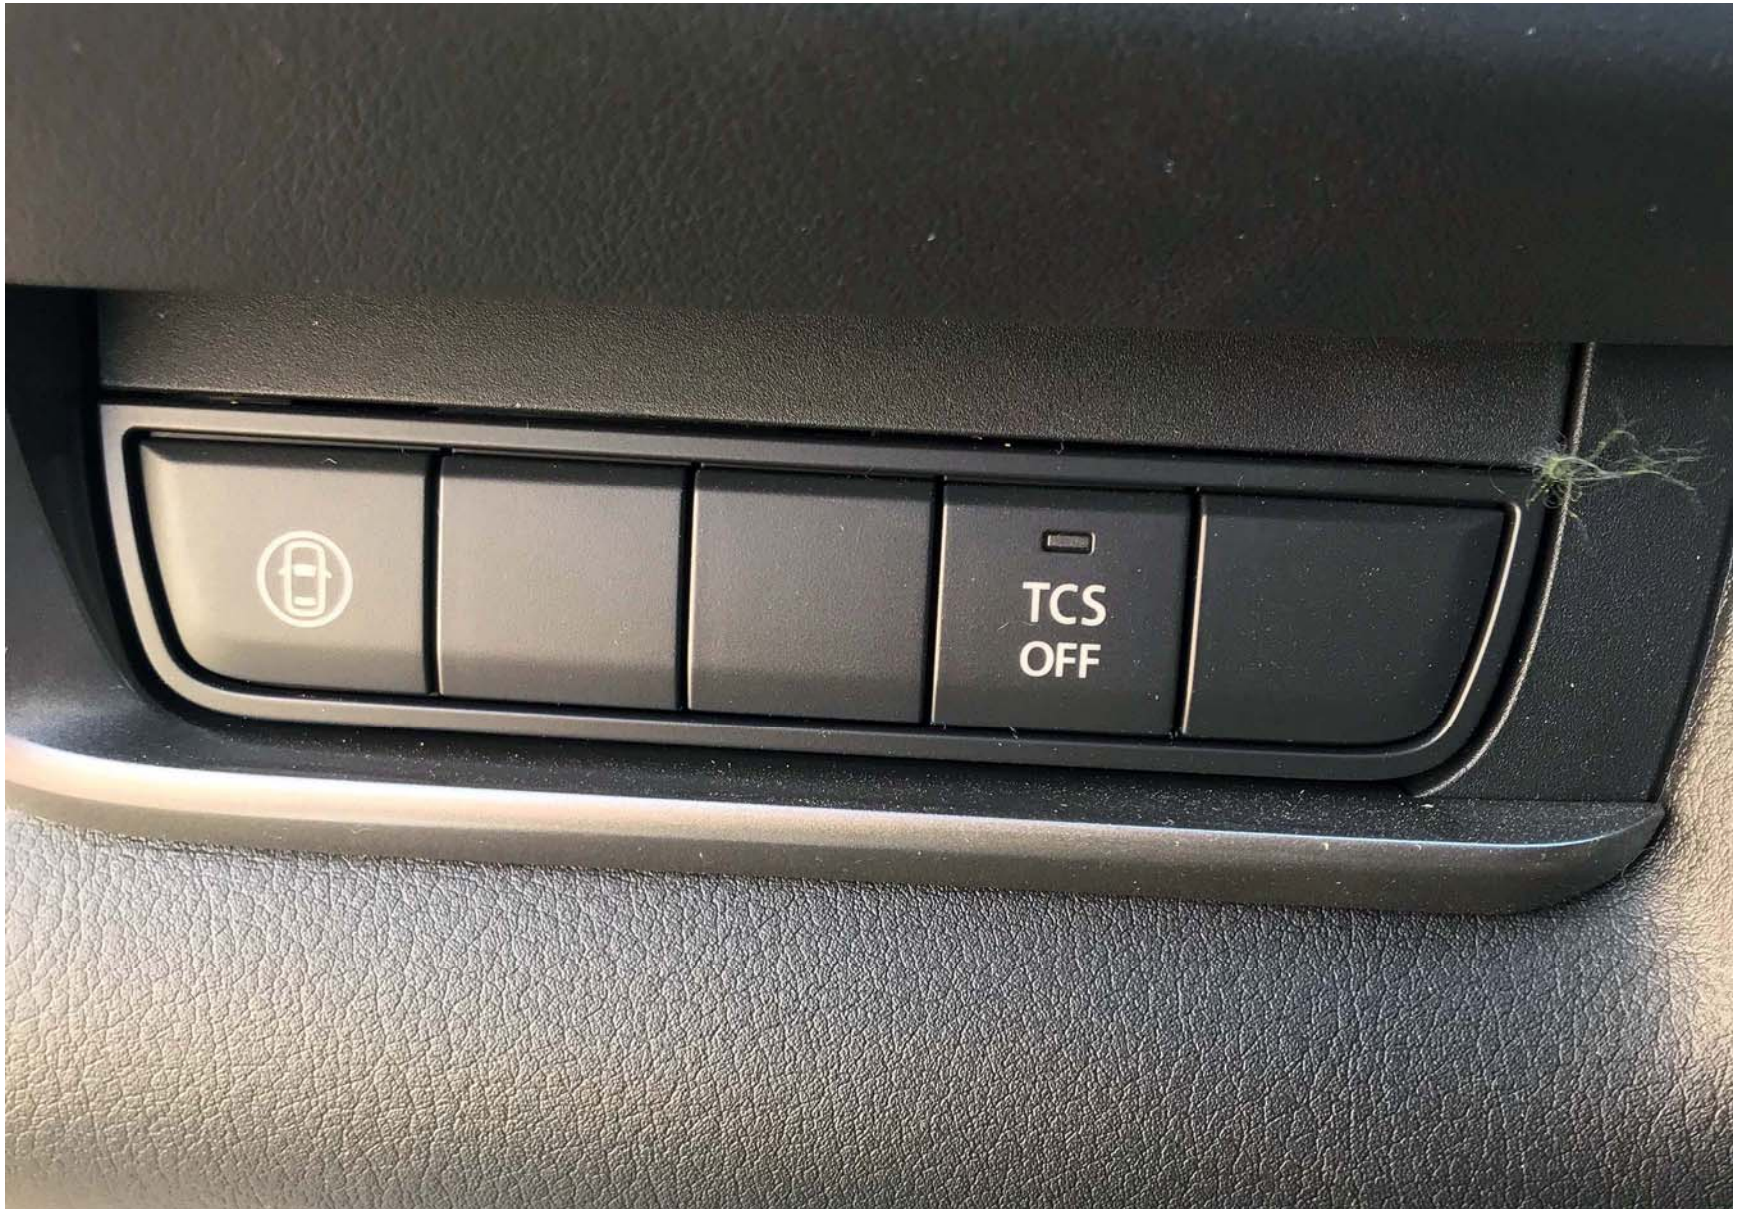
Figure A12. Switch to Enable/Disable i-ACTIVESENSE System Including LDW

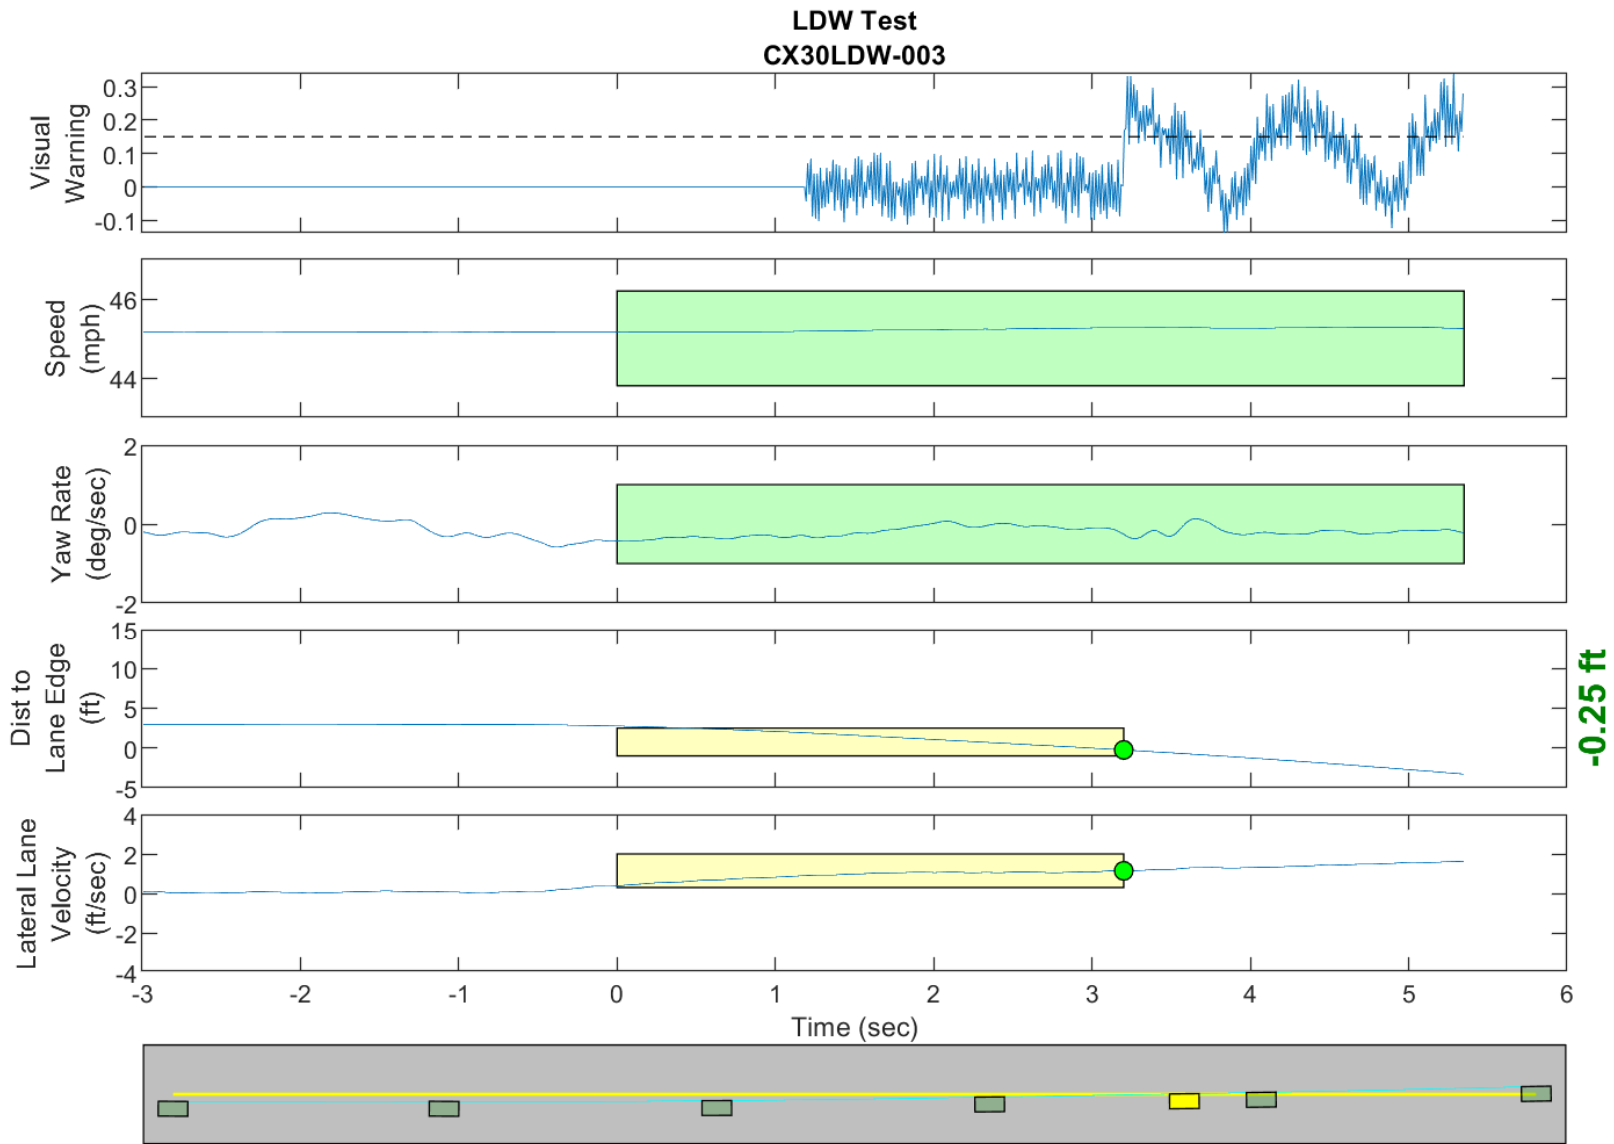
Figure D7. Time History for Run 03, Botts Dots, Left Departure, Visual Warning
